# Visual Site Inspection Report

<b>Project Name</b>	H-600 Pipeline Spread H	<b>AFE</b>	124300138	<b>Spread</b>	H-600 Pipeline Spread H
<b>Contractor</b>	Precision			<b>Report #</b>	7300
<b>Inspector</b>	Logan Box			<b>Date/Time</b>	1/13/2020 4:50 PM
<b>Permit #</b>	TBD	<b>Inspection Type</b>	VA SWPP	<b>Station Begin</b>	13415+51
<b>State</b>	VA	<b>Inspection Area</b>	Partial	<b>Station End</b>	13670+00
<b>County</b>	Franklin	<b>Ground</b>	Wet	<b>Temperature (°F)</b>	61.00
<b>Municipality</b>	N/A	<b>Weather</b>	Cloudy	<b>Rain Gauge (in)</b>	0.00
				<b>Rain Accumulation Time (days)</b>	0.00

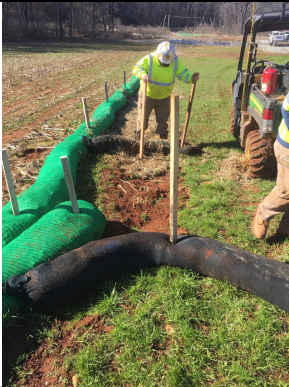
<b>GPS Location</b>	00000	<b>GPS Location</b>	00000		
<b>Field Station#</b>	13657+80	<b>Field Station#</b>	13657+80		
<b>Pic 1 Desc.</b>	P1 undermined , discussed with environmental crew what was needed to make repairs.		<b>Pic 2 Desc.</b>	P1 repaired

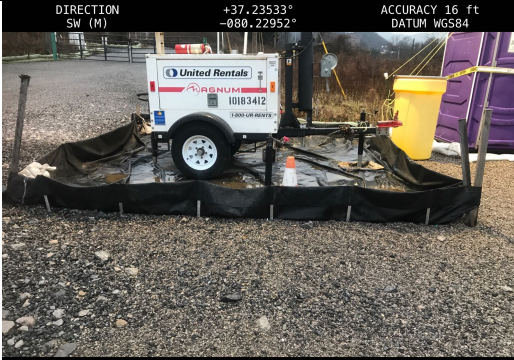
<p>DIRECTION SW (M) +37.23533° -080.22952° ACCURACY 16 ft DATUM WGS84</p> <p>MVP-PY-006_011420 Condition of containment 2020-01-14 07:56:34-05:00</p>

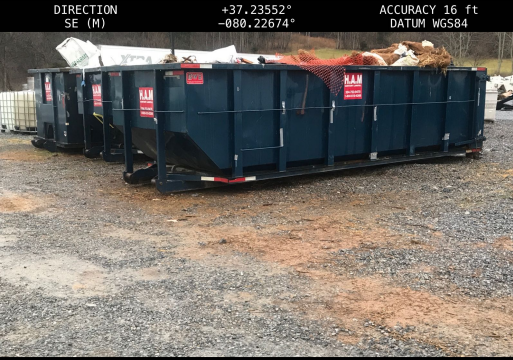
<p>DIRECTION SE (M) +37.23552° -080.22674° ACCURACY 16 ft DATUM WGS84</p> <p>MVP-PY-006_011420 No loose trash around dumpsters 2020-01-14 08:05:13-05:00</p>			
<b>GPS Location</b>	MVP-PY-006 See photo for gps data		<b>GPS Location</b>	MVP-PY-006 See photo for gps data	
<b>Field Station#</b>	+0		<b>Field Station#</b>	+0	
<b>Pic 1 Desc.</b>	Condition of containment under light plant. Looking SW.		<b>Pic 2 Desc.</b>	No loose trash around dumpsters. Looking SE.

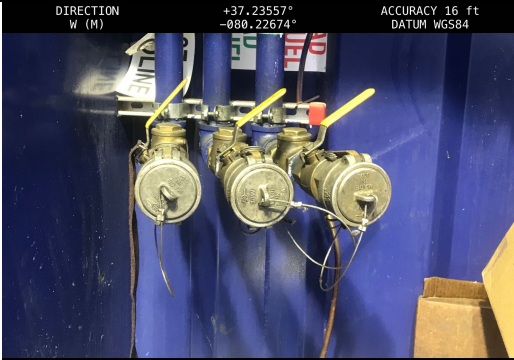
<p>DIRECTION W (M) +37.23557° -080.22674° ACCURACY 16 ft DATUM WGS84</p> <p>MVP-PY-006_011420 Blue Bulk Fuel tanks no leaky internal fi... 2020-01-14 08:06:08-05:00</p>

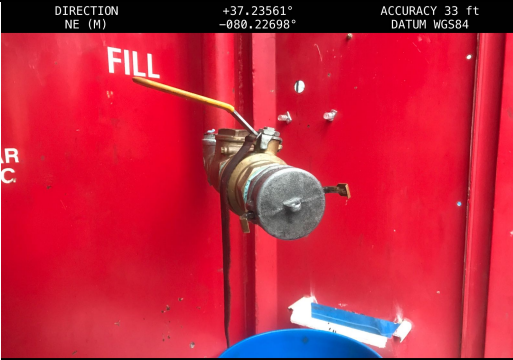
<p>DIRECTION NE (M) +37.23561° -080.22698° ACCURACY 33 ft DATUM WGS84</p> <p>MVP-PY-006_011420 Off Road Fuel unit no leaky internal fitti... 2020-01-14 08:08:16-05:00</p>

<b>GPS Location</b>	MVP-PY-006 See photo for gps data		<b>GPS Location</b>	MVP-PY-006 See photo for gps data	
<b>Field Station#</b>	+0		<b>Field Station#</b>	+0	
<b>Pic 3 Desc.</b>	Blue Bulk Fuel tanks no leaky internal fittings. Looking W.		<b>Pic 4 Desc.</b>	Off Road Fuel unit no leaky internal fittings. Looking NW.

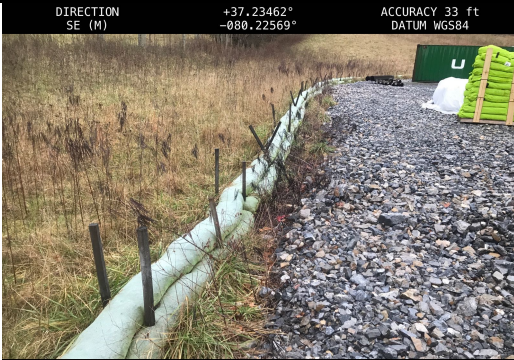
<p>DIRECTION SE (M) +37.23462° -080.22569° ACCURACY 33 ft DATUM WGS84</p> <p>MVP-PY-006_011420 Condition of CFS along East LOD 2020-01-14 08:11:17-05:00</p>

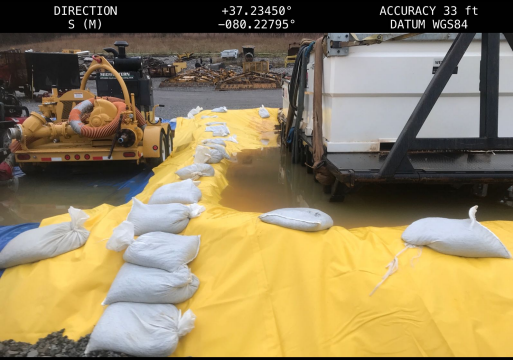
<p>DIRECTION S (M) +37.23450° -080.22795° ACCURACY 33 ft DATUM WGS84</p> <p>MVP-PY-006_011420 Condition of poly lined containment 2020-01-14 08:14:40-05:00</p>			
<b>GPS Location</b>	MVP-PY-006 See photo for gps data		<b>GPS Location</b>	MVP-PY-006 See photo for gps data	
<b>Field Station#</b>	+0		<b>Field Station#</b>	+0	
<b>Pic 5 Desc.</b>	Condition of compost filter sock around East LOD. Looking SE.		<b>Pic 6 Desc.</b>	Condition of poly lined containment. Looking S.

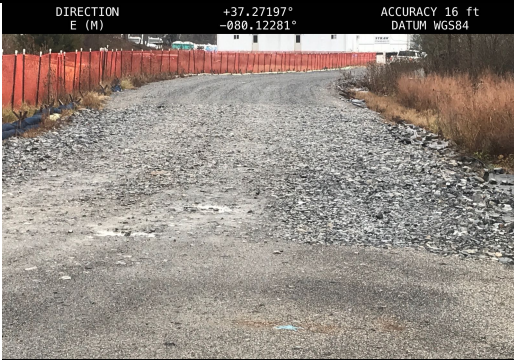
<p>DIRECTION E (M) +37.27197° -080.12281° ACCURACY 16 ft DATUM WGS84</p> <p>MVP-LY-049_011420 Condition of rock entrance 2020-01-14 08:46:44-05:00</p>

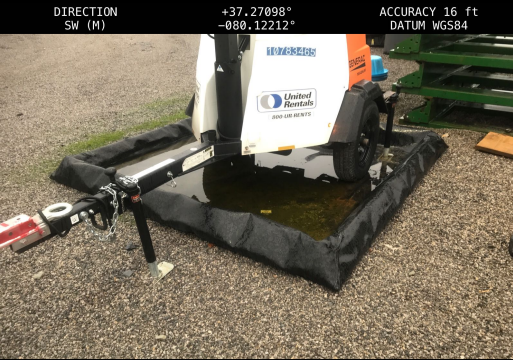
<p>DIRECTION SW (M) +37.27098° -080.12212° ACCURACY 16 ft DATUM WGS84</p> <p>MVPLY-049_011420 Condition of containment 2020-01-14 08:48:34-05:00</p>			
<b>GPS Location</b>	MVP-LY-049 See photo for gps data		<b>GPS Location</b>	MVP-LY-049 See photo for gps data	
<b>Field Station#</b>	+0		<b>Field Station#</b>	+0	
<b>Pic 1 Desc.</b>	Condition of rock entrance. No sediment on the stone. Looking S.		<b>Pic 2 Desc.</b>	Condition of containment under light plant. Holding some stormwater. Looking SW.

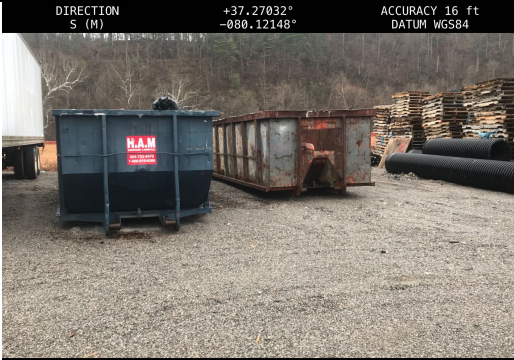
<p>DIRECTION S (M) +37.27032° -080.12148° ACCURACY 16 ft DATUM WGS84</p> <p>MVP-LY-049_011420 No loose trash around south dumpsters 2020-01-14 08:53:14-05:00</p>

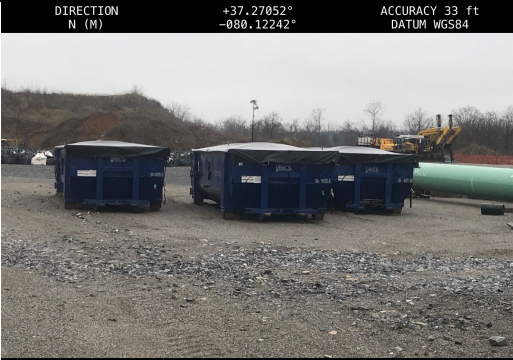
<p>DIRECTION N (M) +37.27052° -080.12242° ACCURACY 33 ft DATUM WGS84</p> <p>MVP-LY-049_011420 3 covered dumpsters for contaminated mat... 2020-01-14 08:54:21-05:00</p>

<b>GPS Location</b>	MVP-LY-049 See photo for gps data		<b>GPS Location</b>	MVP-LY-049 See photo for gps data	
<b>Field Station#</b>	+0		<b>Field Station#</b>	+0	
<b>Pic 3 Desc.</b>	No loose trash around the south dumpsters. Looking S.		<b>Pic 4 Desc.</b>	Three covered dumpsters for contaminated materials stationed in the yard. Looking NW.

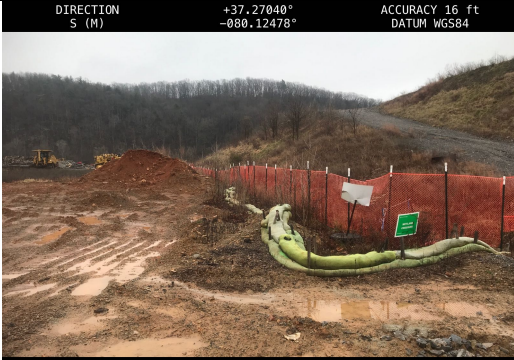
<p>DIRECTION S (M) +37.27040° -080.12478° ACCURACY 16 ft DATUM WGS84</p> <p>MVP-LY-049_011420 Landowner disturbance along CFS and feature 2020-01-14 08:56:28-05:00</p>

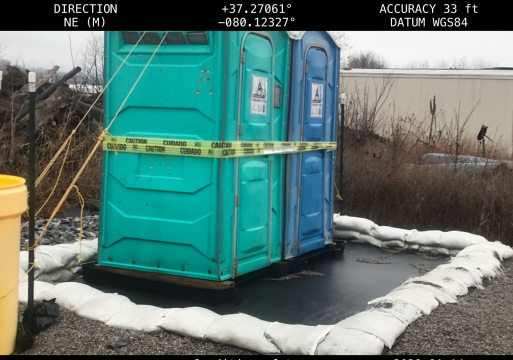
<p>DIRECTION NE (M) +37.27061° -080.12327° ACCURACY 33 ft DATUM WGS84</p> <p>MVP-LY-049_011420 Condition of trays and containment 2020-01-14 08:57:30-05:00</p>			
<b>GPS Location</b>	MVP-LY-049 See photo for gps data		<b>GPS Location</b>	MVP-LY-049 See photo for gps data	
<b>Field Station#</b>	+0		<b>Field Station#</b>	+0	
<b>Pic 5 Desc.</b>	Landowner disturbance next to compost filter sock and feature. No impacts. Looking S.		<b>Pic 6 Desc.</b>	Condition of trays and containment under toilets. Looking NE.

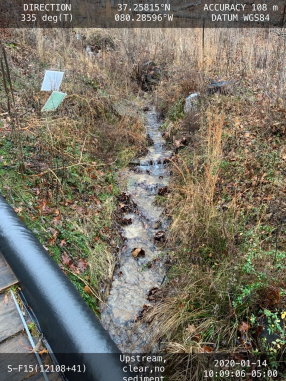
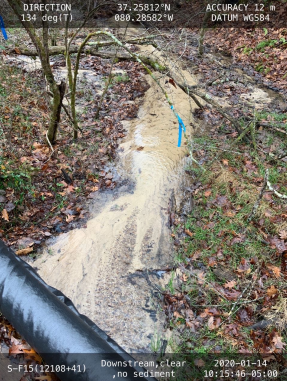
<b>GPS Location</b>	See GPS for location		<b>GPS Location</b>	See GPS for location	
<b>Field Station#</b>	12108+41		<b>Field Station#</b>	12108+41	
<b>Pic 1 Desc.</b>	Stream is free of ROW sediment and running clear.		<b>Pic 2 Desc.</b>	Stream is free of ROW sediment and running clear.

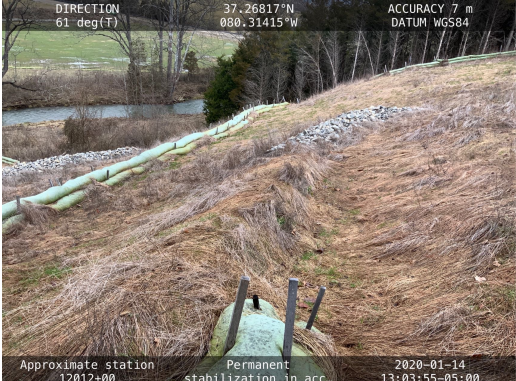
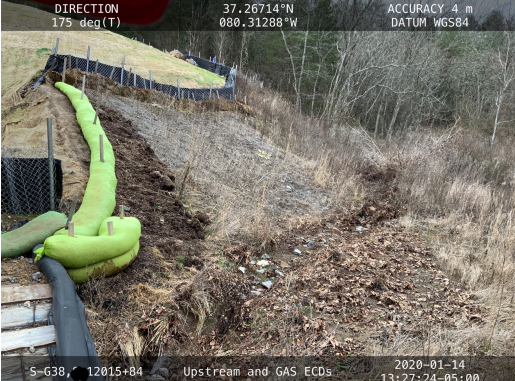
<b>GPS Location</b>	See GPS for location		<b>GPS Location</b>	See GPS for location	
<b>Field Station#</b>	12012+00		<b>Field Station#</b>	12015+84	
<b>Pic 3 Desc.</b>	Permanent restoration at Catawba is stable and perennial cover is sprouting beneath dead annual grasses.		<b>Pic 4 Desc.</b>	ECDs surrounding stream are in acceptable condition.

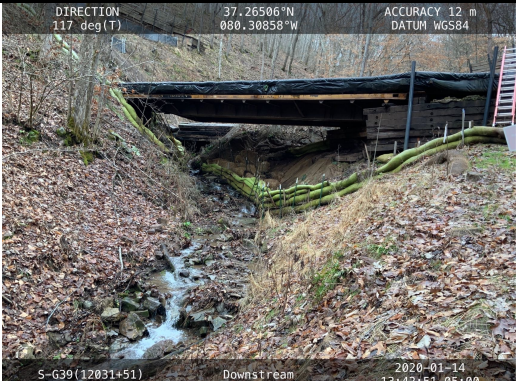
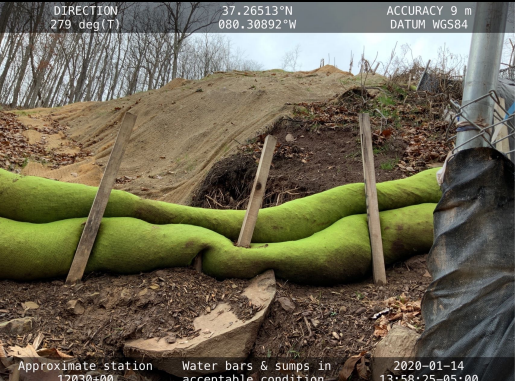
<b>Pic 5 Desc.</b>	Stream and bridge are in acceptable condition.		<b>Pic 6 Desc.</b>	Water bar and sump end treatments are in acceptable condition.

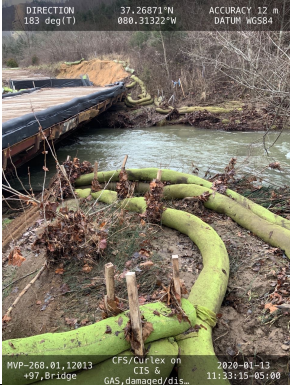
<p>DIRECTION 183 deg(T) 37.26871°N 080.31322°W ACCURACY 12 m DATUM WGS84</p> <p>MVP-268+01,12013 CFS/Curlex on CIS 6 2020-01-13 11:33:15-05:00 GAS,damaged/dis</p>

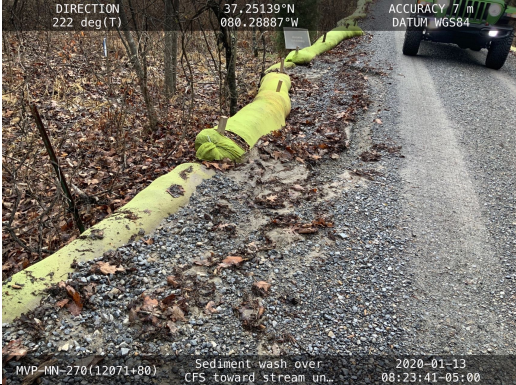
<p>DIRECTION 222 deg(T) 37.25139°N 080.28887°W ACCURACY 7 m DATUM WGS84</p> <p>MVP-MN-270(12071+80) Sediment wash over CFS toward stream un 2020-01-13 08:23:41-05:00</p>			
<b>GPS Location</b>	See GPS for location		<b>GPS Location</b>	See GPS for location	
<b>Field Station#</b>	12013+97		<b>Field Station#</b>	12071+80	
<b>Pic 7 Desc.</b>	Heavy rains falling in a small amount of time washed debris from off ROW under and around bridge.		<b>Pic 8 Desc.</b>	Heavy rains falling in a small amount of time washed gravel and caused gullyng.	
Insert image here			Insert image here		
<b>GPS Location</b>			<b>GPS Location</b>		
<b>Field Station#</b>			<b>Field Station#</b>

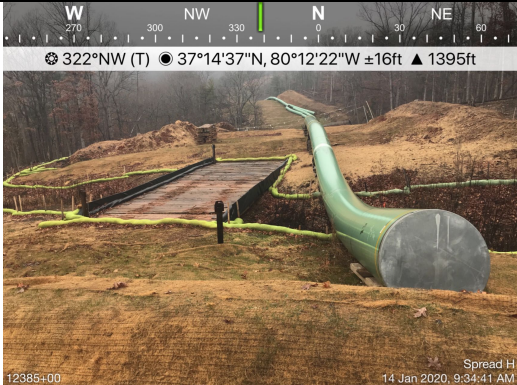
<p>322°NW (T) ● 37°14'37"N, 80°12'22"W ±16ft ▲ 1395ft</p> <p>12385+00 Spread H 14 Jan 2020, 9:34:41 AM</p>		<b>GPS Location</b>	See photo
<b>Field Station#</b>	12441+33	<b>Field Station#</b>	12385+00	<b>Pic 7 Desc.</b>	Roanoke River near the future bore crossing remains unimpacted by PL construction
<b>Pic 8 Desc.</b>	Bridge controls in good condition.

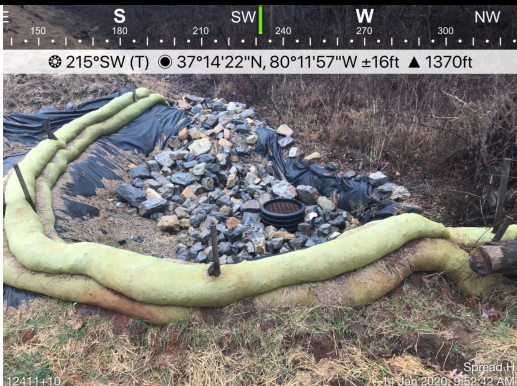
<p>215°SW (T) ● 37°14'22"N, 80°11'57"W ±16ft ▲ 1370ft</p> <p>12411+10 Spread H 14 Jan 2020, 9:58:42 AM</p>		<b>GPS Location</b>	See photo
<b>Field Station#</b>	12835+50	<b>Field Station#</b>	12411+10	<b>Pic 9 Desc.</b>	Controls at S-NN19 in good condition.

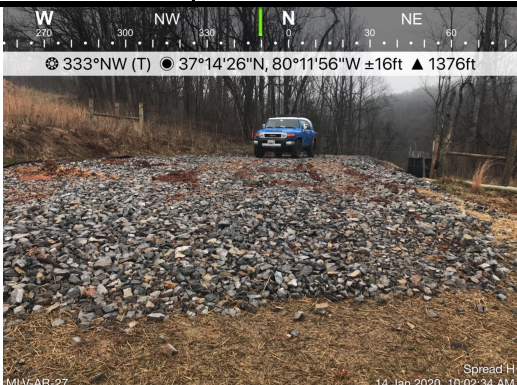
<p>333°NW (T) ● 37°14'26"N, 80°11'56"W ±16ft ▲ 1376ft</p> <p>MLV-AR-27 Spread H 14 Jan 2020, 10:02:34 AM</p>		<b>GPS Location</b>	See photo
<b>Field Station#</b>	12412+50	<b>Field Station#</b>	+27	<b>Pic 11 Desc.</b>	Some ponding occurring in this area, no issues have been observed as a result, and controls appear to be working as designed
<b>Pic 12 Desc.</b>	Rock CE at MLV-AR-27 in good condition

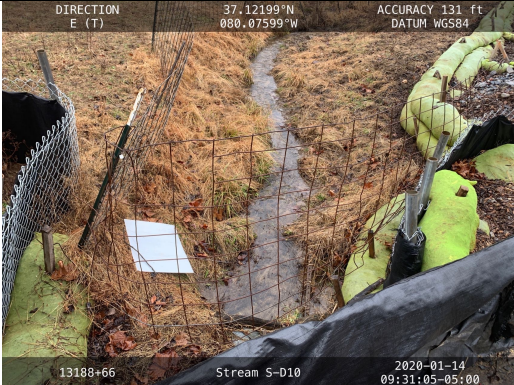
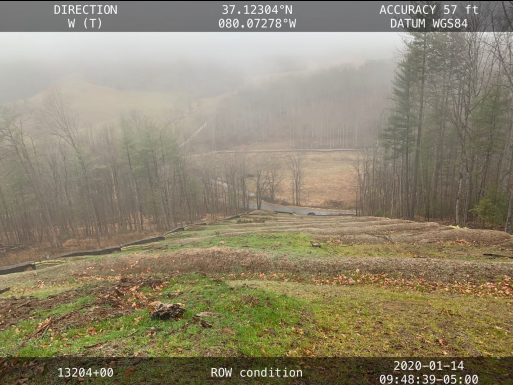
<b>GPS Location</b>	See photo for gps data.		<b>GPS Location</b>	See photo for gps data.	
<b>Field Station#</b>	13188+66		<b>Field Station#</b>	13204+00	
<b>Pic 1 Desc.</b>	Photo shows the ECDs and condition of stream S-D10.		<b>Pic 2 Desc.</b>	Photo shows the ROW condition from about 13204+00 to 13199+00.

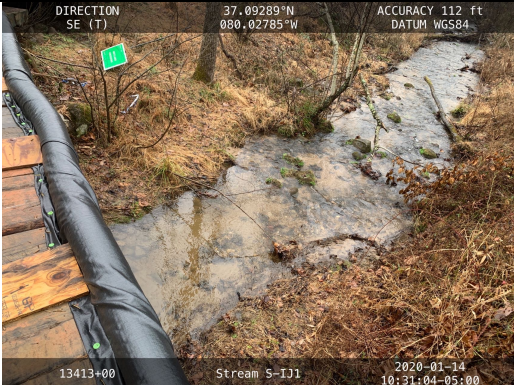
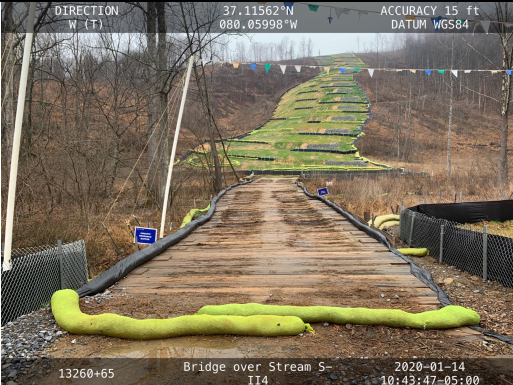
<b>GPS Location</b>	See photo for gps data.		<b>GPS Location</b>	See photo for gps data.	
<b>Field Station#</b>	13413+00		<b>Field Station#</b>	13260+65	
<b>Pic 3 Desc.</b>	Photo shows the condition of stream S-IJ1 downstream from the ROW.		<b>Pic 4 Desc.</b>	Photo shows the bridge over stream S-II4 and the ROW from about 13255+00 to 13260+65.

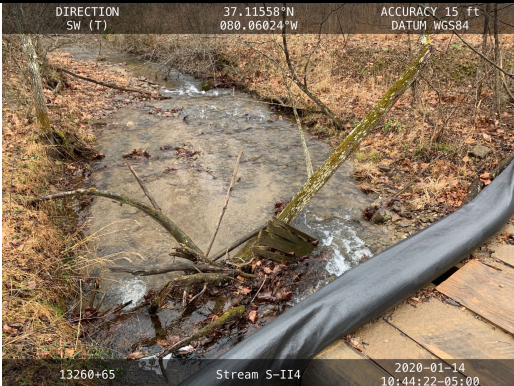
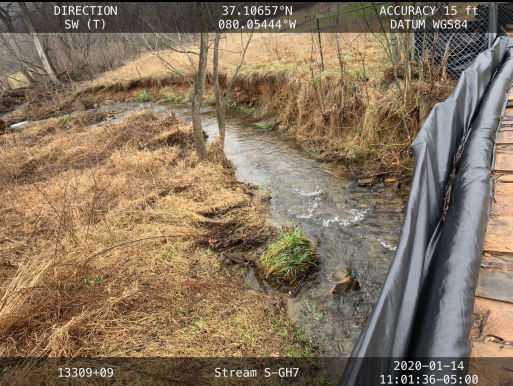
<b>Pic 5 Desc.</b>	Photo shows the stream condition downstream from the ROW.		<b>Pic 6 Desc.</b>	Photo shows the condition of stream S-GH7, downstream from the ROW.

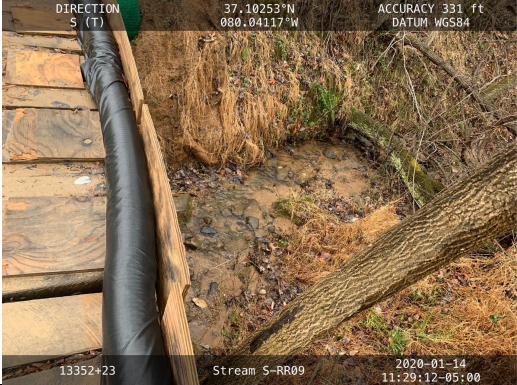
<p>DIRECTION S (T) 37.10253°N 080.04117°W ACCURACY 331 ft DATUM WGS84</p> <p>13352+23 Stream S-RR09 2020-01-14 11:29:12-05:00</p>			
<b>GPS Location</b>	See photo for gps data.		<b>GPS Location</b>	See photo for gps data.	
<b>Field Station#</b>	13348+46		<b>Field Station#</b>	13352+23	
<b>Pic 7 Desc.</b>	Photo shows the bridge over stream S-RR08		<b>Pic 8 Desc.</b>	Photo shows the condition of stream S-RR09, downstream from the ROW.

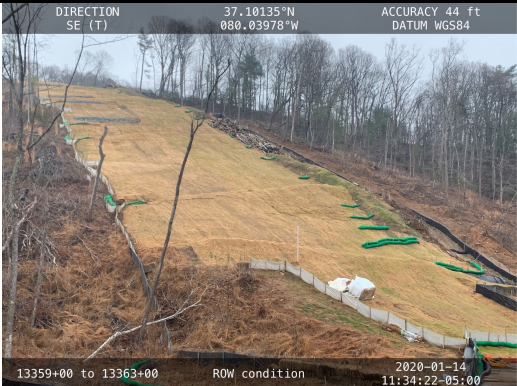
<p>DIRECTION SE (T) 37.10135°N 080.03978°W ACCURACY 44 ft DATUM WGS84</p> <p>13359+00 to 13363+00 ROW condition 2020-01-14 11:34:22-05:00</p>

<b>GPS Location</b>	See photo for gps data.		<b>GPS Location</b>	See photo for gps data.	
<b>Field Station#</b>	13352+23		<b>Field Station#</b>	13359+00	
<b>Pic 9 Desc.</b>	Photo shows the bridge over stream S-RR09.		<b>Pic 10 Desc.</b>	Photo shows the ROW condition from about 13359+00 to 13363+00.

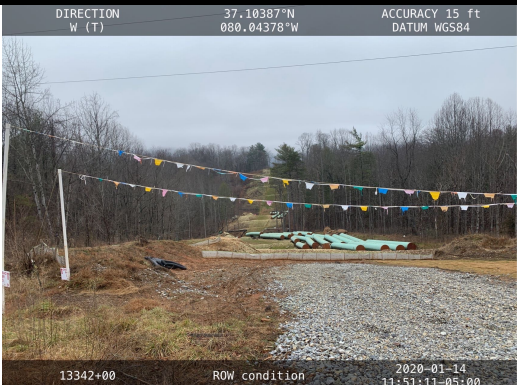
<p>DIRECTION W (T) 37.10387°N 080.04378°W ACCURACY 15 ft DATUM WGS84</p> <p>13342+00 ROW condition 2020-01-14 11:51:11-05:00</p>			
<b>GPS Location</b>	See photo for gps data.		<b>GPS Location</b>	See photo for gps data.	
<b>Field Station#</b>	13358+64		<b>Field Station#</b>	13342+00	
<b>Pic 11 Desc.</b>	Photo shows stream S-RR11, downstream from the ROW.		<b>Pic 12 Desc.</b>	Photo shows the ROW condition from about 13338+00 to 13342+00.

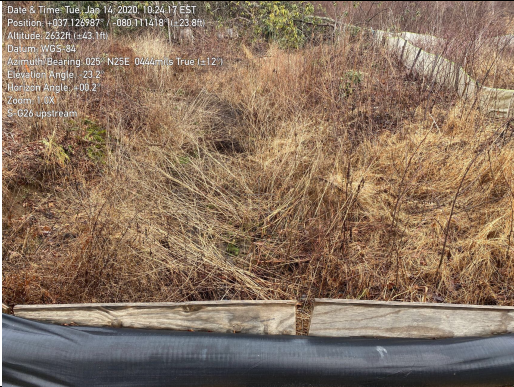
<b>GPS Location</b>	See photo for coordinates.		<b>GPS Location</b>	See photo for coordinates.	
<b>Field Station#</b>	13062+96		<b>Field Station#</b>	13062+96	
<b>Pic 1 Desc.</b>	S-G26, looking upstream of equipment bridge, banks heavily vegetated, water flowing clear, no environmental issues noted.		<b>Pic 2 Desc.</b>	S-G26, looking downstream of equipment bridge, stream bed and banks stable, no sediment impacts noted.

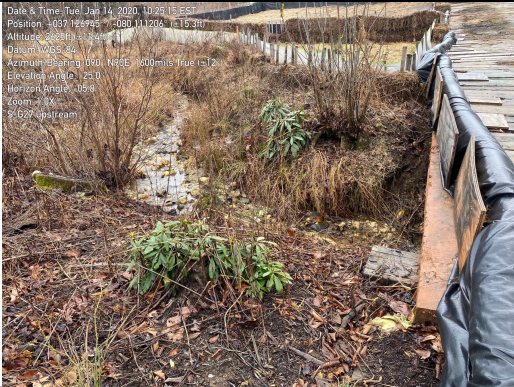
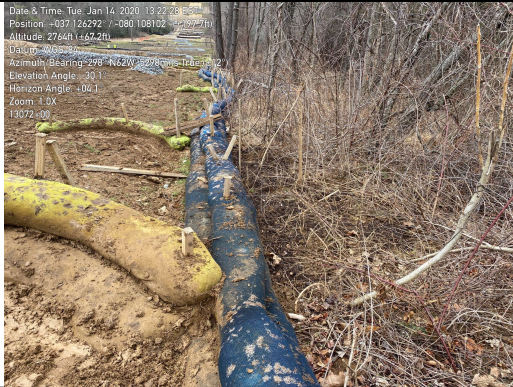
<b>GPS Location</b>	See photo for coordinates.		<b>GPS Location</b>	See photo for coordinates.	
<b>Field Station#</b>	13061+89		<b>Field Station#</b>	13072+00	
<b>Pic 3 Desc.</b>	S-G27, looking upstream of equipment bridge, water flowing clear, stream bed and banks appear stable, no impacts observed.		<b>Pic 4 Desc.</b>	Off ROW sediment brought back onto ROW, CFS waterbar extensions cleaned, CFS checks along LOD perimeter cleaned.

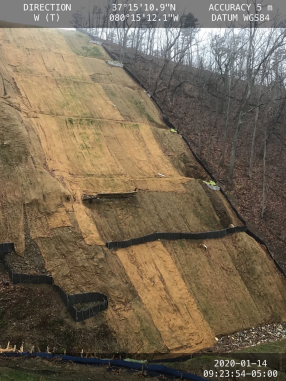
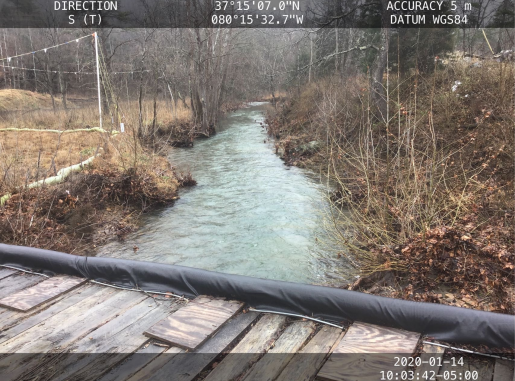
<b>GPS Location</b>	See photo		<b>GPS Location</b>	See photo	
<b>Field Station#</b>	12210+00		<b>Field Station#</b>	12192+50	
<b>Pic 1 Desc.</b>	The steep slope on the coming in side of the ravine between Bradshaw Road and Reese Mountain has remained stable.		<b>Pic 2 Desc.</b>	Stream S-C21, Bradshaw Creek, facing south, downstream.

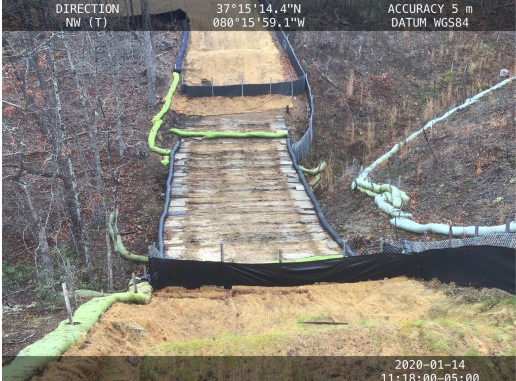
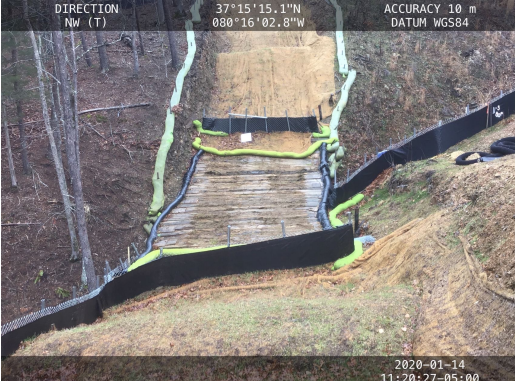
<b>GPS Location</b>	See photo		<b>GPS Location</b>	See photo	
<b>Field Station#</b>	12166+47		<b>Field Station#</b>	12163+05	
<b>Pic 3 Desc.</b>	Stream S-C24, facing northwest		<b>Pic 4 Desc.</b>	Stream S-C25, facing northwest

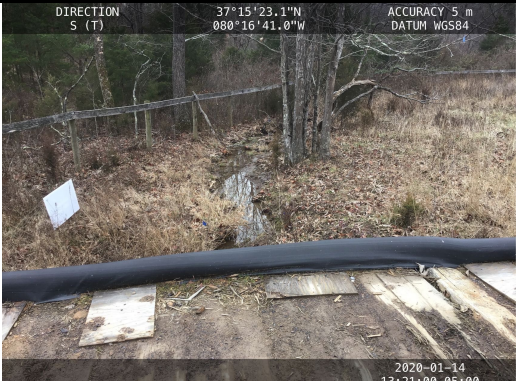
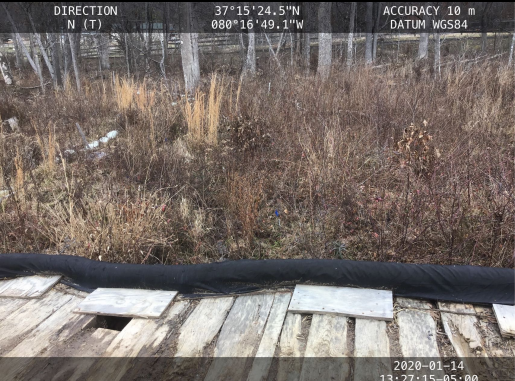
<b>GPS Location</b>	See photo		<b>GPS Location</b>	See photo	
<b>Field Station#</b>	12132+73		<b>Field Station#</b>	12125+65	
<b>Pic 5 Desc.</b>	Stream S-C29, facing south, downstream		<b>Pic 6 Desc.</b>	Stream S-MM31, facing north, upstream

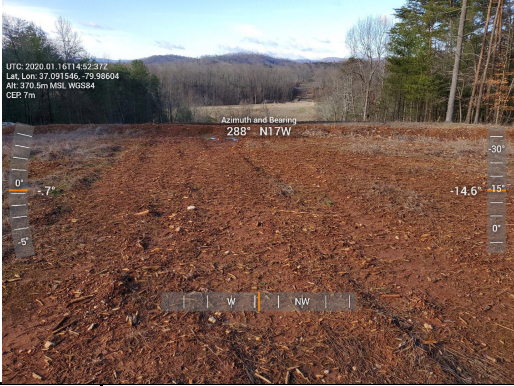
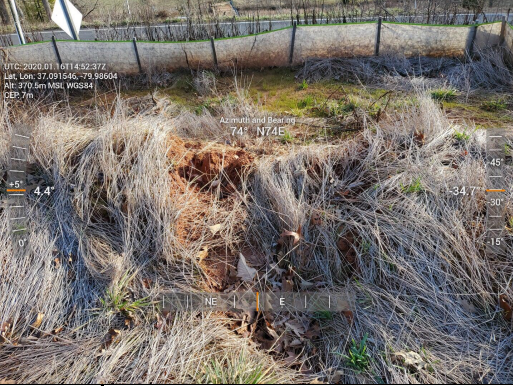
<b>GPS Location</b>	00000	<b>GPS Location</b>	00000		
<b>Field Station#</b>	13557+00	<b>Field Station#</b>	13562+37		
<b>Pic 1 Desc.</b>	Section of row with sparse vegetation, sent in for punch list to monitor until row conditions allow access for the contractor		<b>Pic 2 Desc.</b>	Water bar blown out during rain events. Added to the punch list for repair

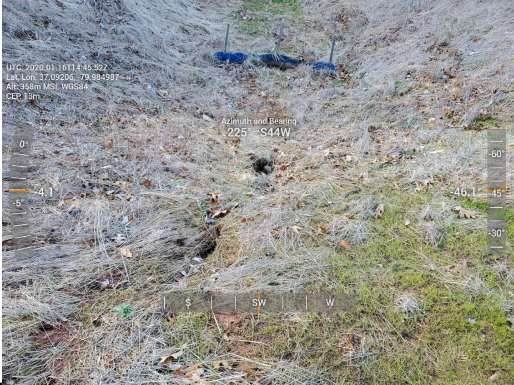
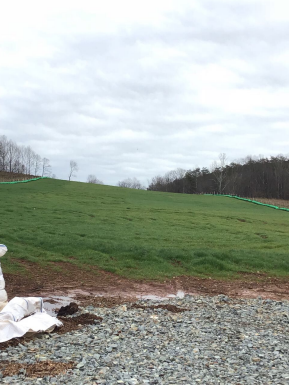
<b>GPS Location</b>	0000	<b>GPS Location</b>	0000		
<b>Field Station#</b>	13560+00	<b>Field Station#</b>	13644+90		
<b>Pic 3 Desc.</b>	Washing beginning on slope leading to natural drain, added to the punch list for repair		<b>Pic 4 Desc.</b>	Inspected RCE and row conditions after rain events	
Insert image here		Insert image here			
<b>GPS Location</b>		<b>GPS Location</b>			
<b>Field Station#</b>		<b>Field Station#</b>			
<b>Pic 5 Desc.</b>			<b>Pic 6 Desc.</b>
