Visual Site Inspection Report

Project Name	H-600 Pipeline Spread H	AFE	124300138	Spread	H-600 Pipeline Spread H
Contractor	Precision			Report #	7169
Inspector	Logan Box			Date/Time	1/7/2020 4:49 PM
Permit #	TBD	Inspection Type	VA SWPP	Station Begin	13415+51
State	VA	Inspection Area	Partial	Station End	13670+00
County	Franklin	Ground	Wet	Temperature (°F)	33.00
Municipality	N/A	Weather	Snow/Sleet	Rain Gauge (in)	0.00
				Rain Accumulation Time (days)	0.00

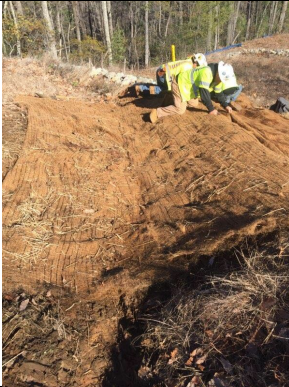
GPS Location	0000	GPS Location	0000		
Field Station#	13485+50	Field Station#	13485+50		
Pic 1 Desc.	Contractor making repairs to damaged water bars	Pic 2 Desc.	Water bars repaired and stabilized

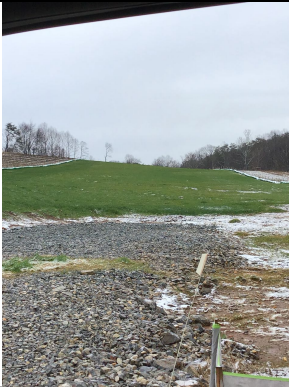
GPS Location	0000	GPS Location	0000		
Field Station#	13644+99	Field Station#	13643+33		
Pic 3 Desc.	Row conditions during winter weather events	Pic 4 Desc.	Row conditions during winter weather events		
Insert image here			Insert image here		
GPS Location		GPS Location			
Field Station#		Field Station#			
Pic 5 Desc.		Pic 6 Desc.

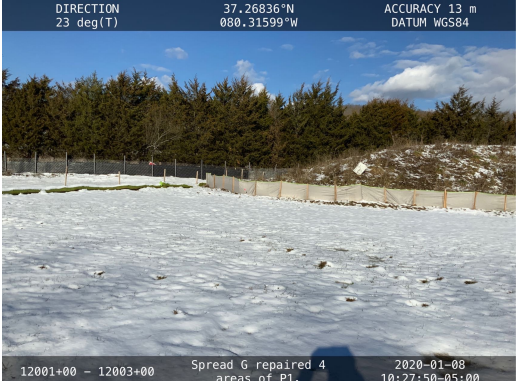
7. Identify all remedial measures that have been taken since the previous inspection was conducted.					
Four damaged P1 areas were repaired by the Spread G Precision environmental crew between stations #12001+00 and 12003+00 on Monday, January 6, 2020.					
Comments (Reference above questions as appropriate.)					
Attended general inspection meeting at inspection trailer. Attended EI Team meeting with other EI s and lead, Randy Clark. Performed SWPPP inspection of ROW, including streams and access roads between Station # 12001+00 to Station #12119+17. Access roads MVP-MN-268, MVP-MN-268.01(12013+97), MVP-MN-270(12071+80), MVP-MN-270.01, Half Acre of Rocks Rd.,(12102+69), MVP-MN-271(12109+), Half Acre of Rocks Rd., 270.01, (12102+69), and MVP-MN-271(12109+62) are in acceptable condition at the time of this inspection. S-G36(12008+69), S-G38(S-12015+84, S-G39(12031+51), S-G40(12035+11), S-PP23(12035+75), S-MM15(12076+95), S-MM14(12086+56), S-MM13(12098+44), S-MM11(12101+57),S--F15(12108+41), and appear to have no ROW sediment impact at time of this inspection. Equipment bridges, stream buffers, ECDs, and sensitive resource signage were all in acceptable condition at time of inspection. On ROW all water bars, clean water crossings, clean water conveyances, and plunge pools were in acceptable condition at time of this inspection. I observed P1, triple stack CFS end treatments, and sumps were in good condition. ROW perimeter controls including SSF, CFS, and P1 were all in satisfactory condition at time of inspection. Permanent restoration weirs and earthen berms were in acceptable condition. A small pine tree broke off and fell into MVP-MN-270 blocking the road. A Precision crew was notified and it was cut up and disposed of by early afternoon. High winds with gusts in excess of 50. MPH were hitting the ROW today. The approximate 3" of snow that fell yesterday is melting in sunny areas.

GPS Location	See photo GPS for location		GPS Location	See photo GPS for location	
Field Station#	12001+00		Field Station#	12015+84	
Pic 3 Desc.	Four damaged P1 areas were repaired by the Spread G Precision environmental crew.		Pic 4 Desc.	Water not flowing on S-G38.

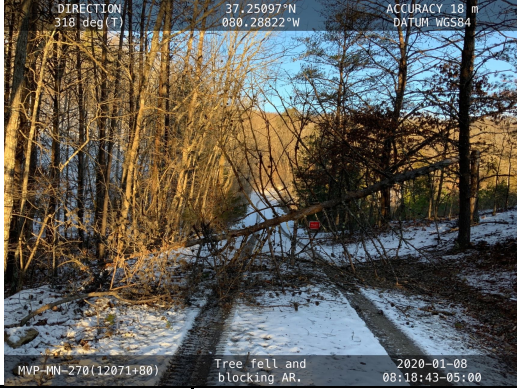
GPS Location	See photo GPS for location		GPS Location	See photo GPS for location	
Field Station#	12071+80		Field Station#	12071+80	
Pic 9 Desc.	Pine tree fell down across AR-270.		Pic 10 Desc.	Pine tree was removed by Precision crew .

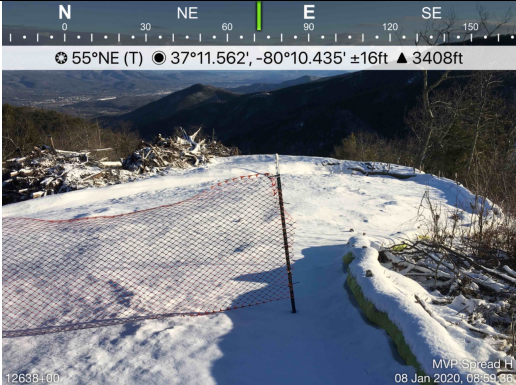
GPS Location	See Picture Watermark		GPS Location	See Picture Watermark	
Field Station#	12638+00		Field Station#	12638+50	
Pic 1 Desc.	ROW covered in snow and ground frozen. Controls in good condition.		Pic 2 Desc.	Waterbar sump pit/end treatment free of runoff and sediment. In good condition.

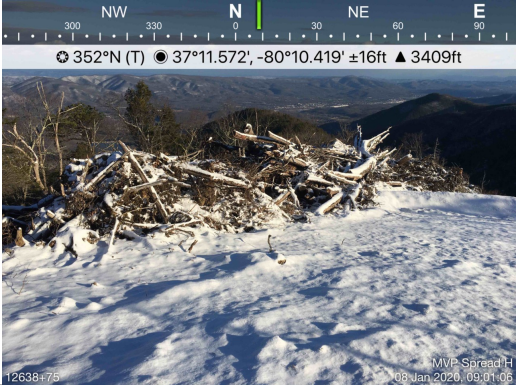
GPS Location	See Picture Watermark		GPS Location	See Picture Watermark	
Field Station#	12638+75		Field Station#	12639+25	
Pic 3 Desc.	Woody debris stockpiled on ROW.		Pic 4 Desc.	ROW frozen and covered in snow. In stable condition.

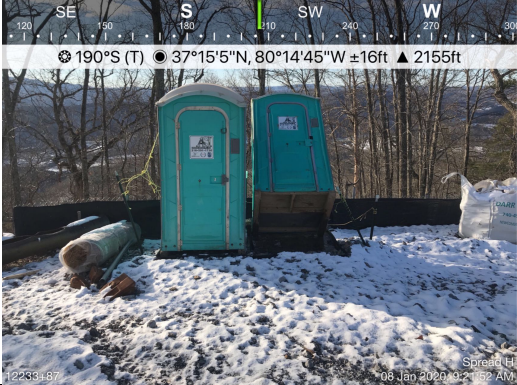
GPS Location	See photo		GPS Location	See photo	
Field Station#	12233+87		Field Station#	12441+33	
Pic 7 Desc.	Windy conditions causing the porta lets to tilt. They are tied to rope restraints and within secondary containment. Monitor as conditions permit.		Pic 8 Desc.	Roanoke River remains unimpacted and in good condition.
