# Visual Site Inspection Report

<b>Project Name</b>	H-600 Pipeline Spread H	<b>AFE</b>	124300138	<b>Spread</b>	H-600 Pipeline Spread H
<b>Contractor</b>	Precision			<b>Report #</b>	6276
<b>Inspector</b>	Logan Box			<b>Date/Time</b>	12/2/2019 5:32 PM
<b>Permit #</b>	TBD	<b>Inspection Type</b>	VA SWPP	<b>Station Begin</b>	13415+51
<b>State</b>	VA	<b>Inspection Area</b>	Partial	<b>Station End</b>	13670+00
<b>County</b>	Franklin	<b>Ground</b>	Wet	<b>Temperature (°F)</b>	41.00
<b>Municipality</b>	N/A	<b>Weather</b>	Cloudy	<b>Rain Gauge (in)</b>	0.00
				<b>Rain Accumulation Time (days)</b>	0.00

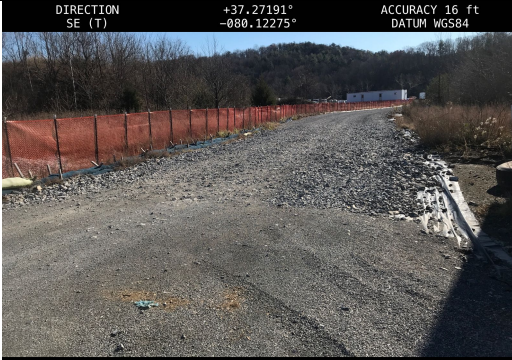
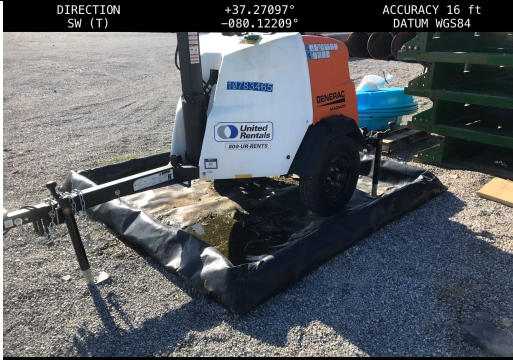
MVP-LY-049_120519 Condition of north rock entrance 2019-12-05 11:03:53-05:00		MVP-LY-049_120519 Condition of containment 2019-12-05 11:05:39-05:00			
<b>GPS Location</b>	MVP-LY-049 See photo for gps data		<b>GPS Location</b>	MVP-LY-049 See photo for gps data	
<b>Field Station#</b>	+0		<b>Field Station#</b>	+0	
<b>Pic 1 Desc.</b>	Condition of rock entrance on center driveway. Looking SE.		<b>Pic 2 Desc.</b>	Condition of containment under light plant. Looking SW.

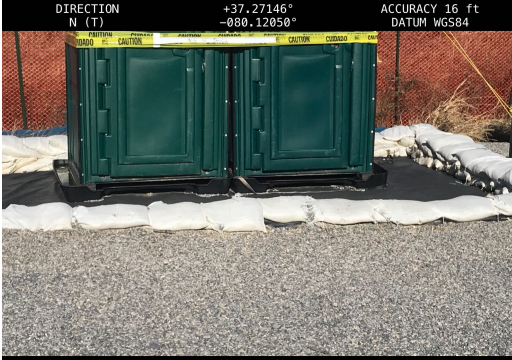
MVP-LY-049_120519 Condition of trays and containment 2019-12-05 11:06:53-05:00		MVP-LY-049_120519 Condition of CFS & safety fence East LOD 2019-12-05 11:08:15-05:00			
<b>GPS Location</b>	MVP-LY-049 See photo for gps data		<b>GPS Location</b>	MVP-LY-049 See photo for gps data	
<b>Field Station#</b>	+0		<b>Field Station#</b>	+0

<b>Pic 3 Desc.</b>	Condition of containment under toilets. Looking N.		<b>Pic 4 Desc.</b>	Condition of compost filter sock and safety fence along East LOD. Looking SE.

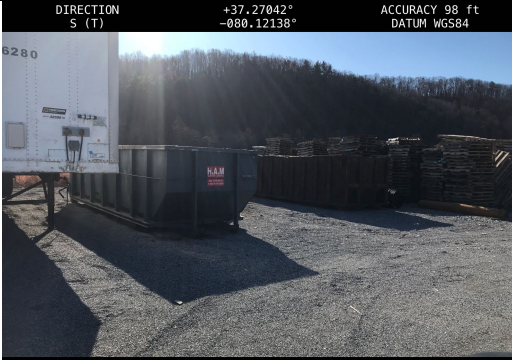
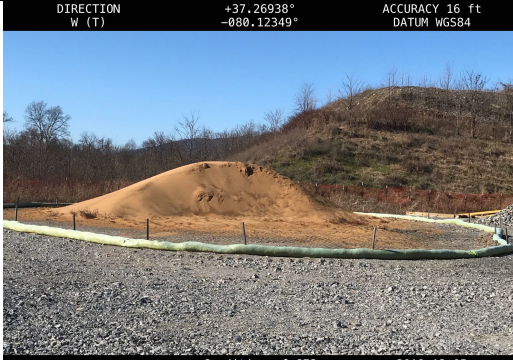
MVP-LY-049_120519 No loose trash around south dumpsters 2019-12-05 11:09:55-05:00		MVP-LY-049_120519 Condition of CFS around sand pile 2019-12-05 11:15:52-05:00			
<b>GPS Location</b>	MVP-LY-049 See photo for gps data		<b>GPS Location</b>	MVP-LY-049 See photo for gps data	
<b>Field Station#</b>	+0		<b>Field Station#</b>	+0	
<b>Pic 5 Desc.</b>	No loose trash around south dumpsters. Looking S.		<b>Pic 6 Desc.</b>	Condition of compost filter sock around sand pile. Looking W.

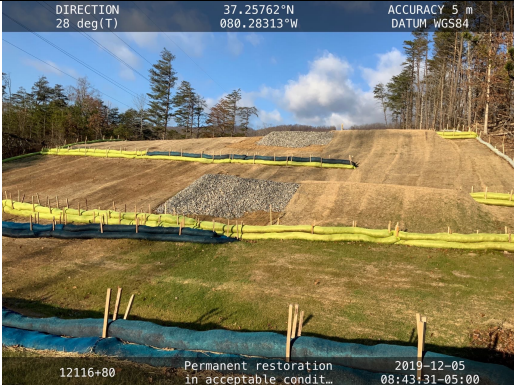
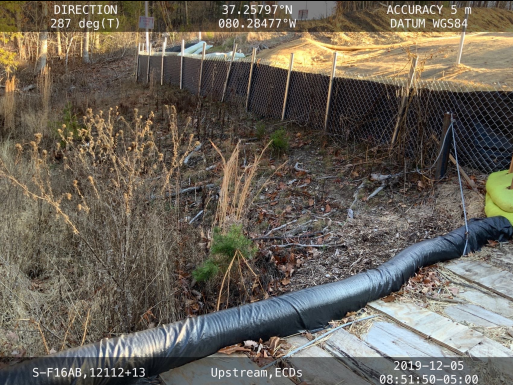
<b>GPS Location</b>	See photo GPS for location		<b>GPS Location</b>	See photo GPS for location	
<b>Field Station#</b>	12116+80		<b>Field Station#</b>	12112+13	
<b>Pic 1 Desc.</b>	Permanent restoration is stable. Vegetation is acceptable.		<b>Pic 2 Desc.</b>	ECDs are acceptable surrounding stream. No sediment impact from ROW to stream observed.

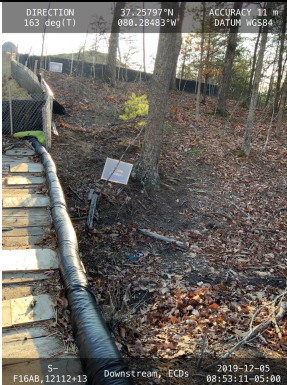
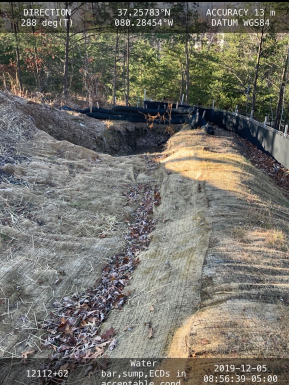
<b>GPS Location</b>	See photo GPS for location		<b>GPS Location</b>	See photo GPS for location	
<b>Field Station#</b>	12112+13		<b>Field Station#</b>	11212+62	
<b>Pic 3 Desc.</b>	ECDs are acceptable surrounding stream. No sediment impact from ROW to stream observed.		<b>Pic 4 Desc.</b>	Water bar, sump, ECDs, and vegetation is acceptable.

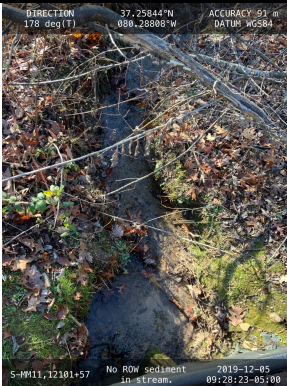
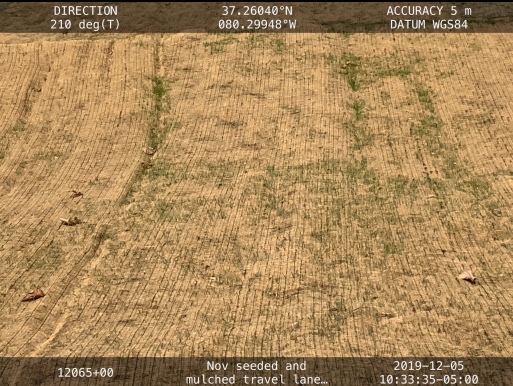
<b>Field Station#</b>	12101+97		<b>Field Station#</b>	12065+00	
<b>Pic 5 Desc.</b>	No sediment impact from ROW to stream observed.		<b>Pic 6 Desc.</b>	November seeding in travel lane is sprouting.

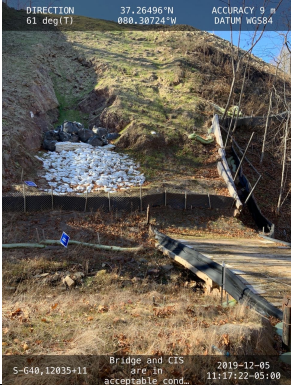
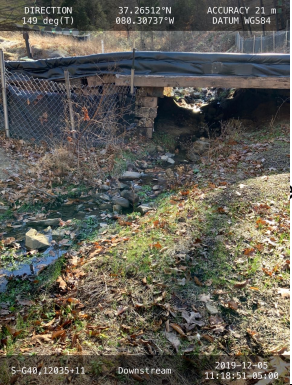
<b>GPS Location</b>	See photo GPS for location		<b>GPS Location</b>	See photo GPS for location	
<b>Field Station#</b>	12035+11		<b>Field Station#</b>	12035+11	
<b>Pic 7 Desc.</b>	Bridge and ECDs at S-G40 are stable and in acceptable condition.		<b>Pic 8 Desc.</b>	ECDs at S-G40 are stable and in acceptable condition. No sediment impact from ROW to stream observed.

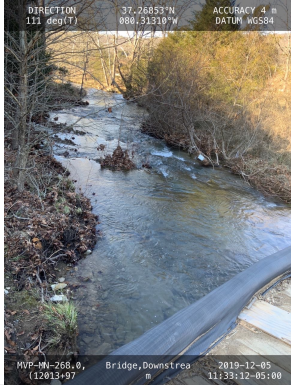
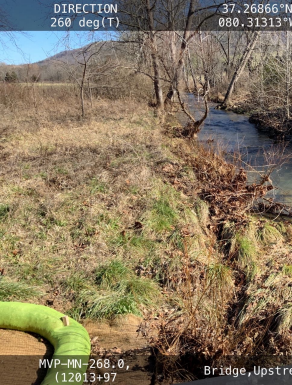
<b>GPS Location</b>	See photo GPS for location		<b>GPS Location</b>	See photo GPS for location	
<b>Field Station#</b>	12013+97		<b>Field Station#</b>	12013+97	
<b>Pic 9 Desc.</b>	Bridge and ECDs at S-G36 are stable and in acceptable condition.		<b>Pic 10 Desc.</b>	Stream running clear and ECDs in acceptable condition.

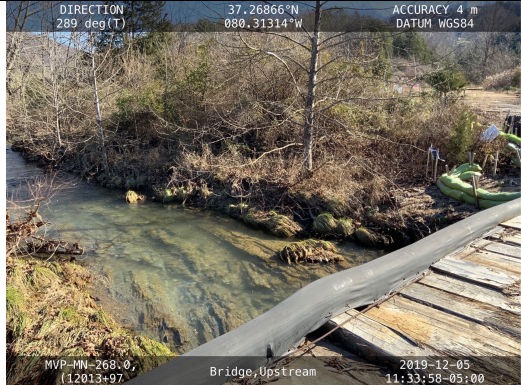
<b>Field Station#</b>	12013+97		<b>Field Station#</b>		
<b>Pic 11 Desc.</b>	Bridge and ECDs at S-G36 are stable and in acceptable condition.		<b>Pic 12 Desc.</b>

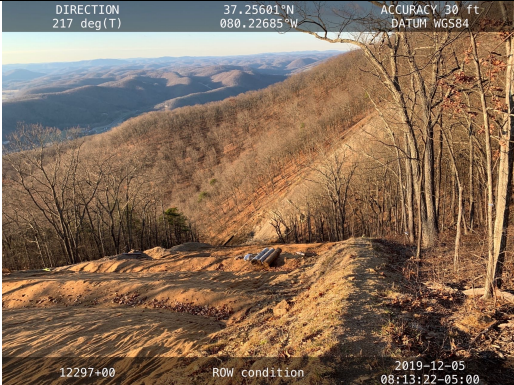
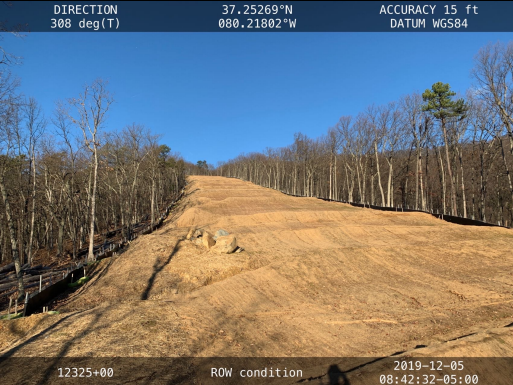
<b>GPS Location</b>	See photo for gps data.		<b>GPS Location</b>	See photo for gps data.	
<b>Field Station#</b>	12297+00		<b>Field Station#</b>	12325+00	
<b>Pic 1 Desc.</b>	Photo shows the ROW condition from about 12294+00 to 12297+00.		<b>Pic 2 Desc.</b>	Photo shows ROW from about 12322+00 to 12325+00.

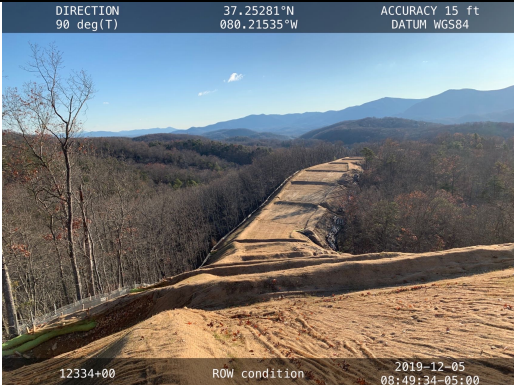
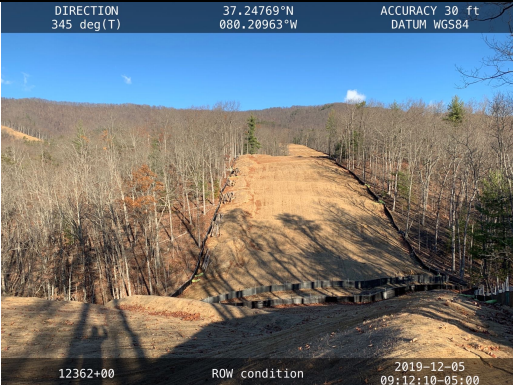
<b>GPS Location</b>	See photo for gps data.		<b>GPS Location</b>	See photo for gps data.	
<b>Field Station#</b>	12334+00		<b>Field Station#</b>	12362+00	
<b>Pic 3 Desc.</b>	Photo shows the ROW condition from about 12334+00 to 12339+00.		<b>Pic 4 Desc.</b>	Photo shows the ROW condition from about 12358+00 to 12362+00.

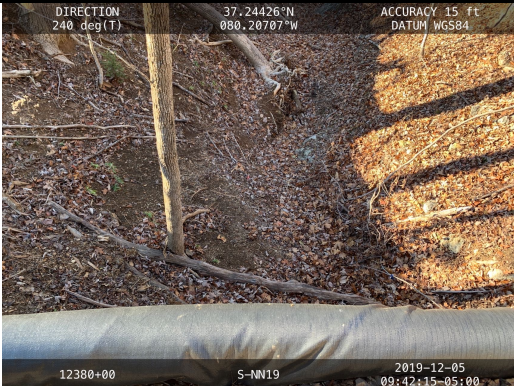
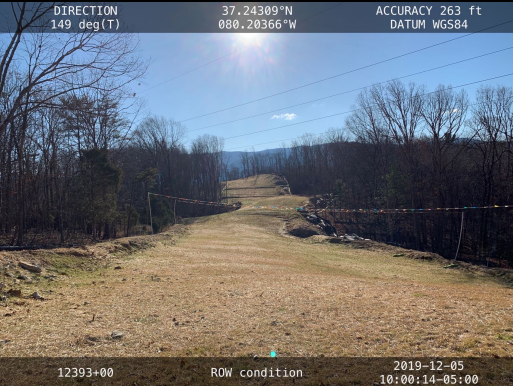
<b>Pic 5 Desc.</b>	Photo shows stream S-NN19.		<b>Pic 6 Desc.</b>	Photo shows the ROW condition from about 12393+00 to 12398+00

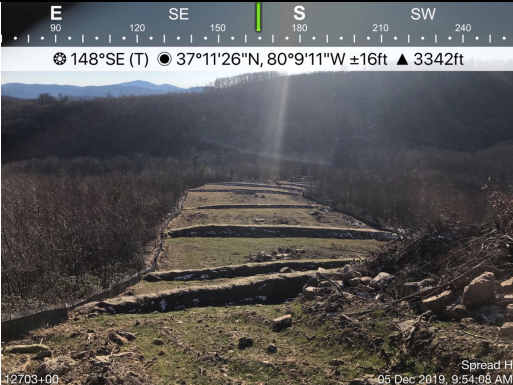
<b>GPS Location</b>	See photo		<b>GPS Location</b>	See photo	
<b>Field Station#</b>	2+80		<b>Field Station#</b>	12703+00	
<b>Pic 3 Desc.</b>	Controls in place and in good condition along AR-280		<b>Pic 4 Desc.</b>	Water bars along this slope in good condition and vegetation has become well established.

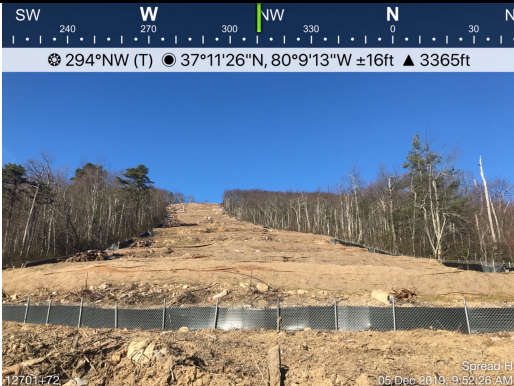
<b>GPS Location</b>	See photo		<b>GPS Location</b>	See photo	
<b>Field Station#</b>	12701+72		<b>Field Station#</b>	12691+00	
<b>Pic 5 Desc.</b>	SSF controls in good condition on the CIS of honeysuckle.		<b>Pic 6 Desc.</b>	Sump holding water and has frozen over.

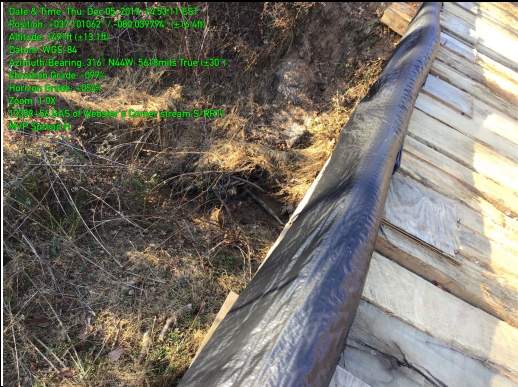
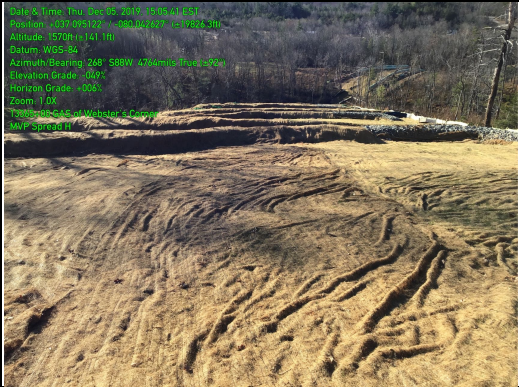
<b>Pic 13 Desc.</b>	No impacts found to stream S-RR11.		<b>Pic 14 Desc.</b>	ROW stabilized with Curlex and ECD's recently replaced or maintained.

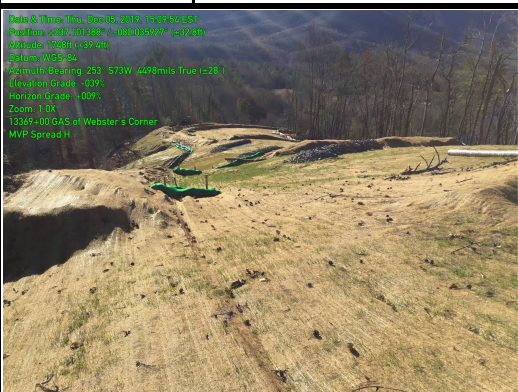
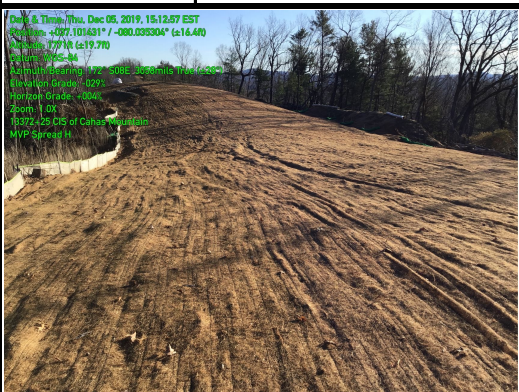
<b>Field Station#</b>	13369+00		<b>Field Station#</b>	13372+25	
<b>Pic 15 Desc.</b>	Vegetation growing through installed curlex on slope GAS of Stream S-RR11.		<b>Pic 16 Desc.</b>	Curlex installed across full width of ROW.

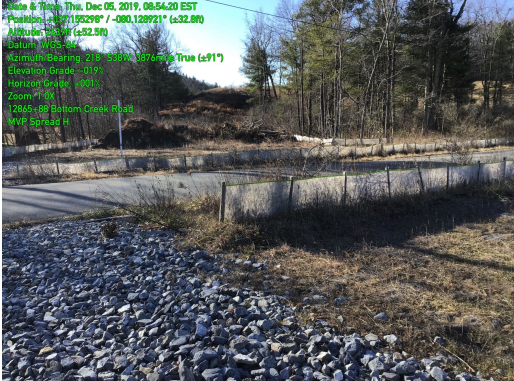
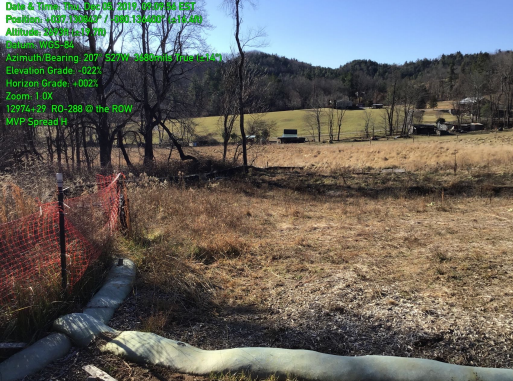
<b>GPS Location</b>	See pic for GPS location		<b>GPS Location</b>	See pic for GPS location	
<b>Field Station#</b>	12865+88		<b>Field Station#</b>	12974+29	
<b>Pic 1 Desc.</b>	No issues or impacts observed near Bottom Creek road.		<b>Pic 2 Desc.</b>	No issues with installed ECD's at access road RO-288.

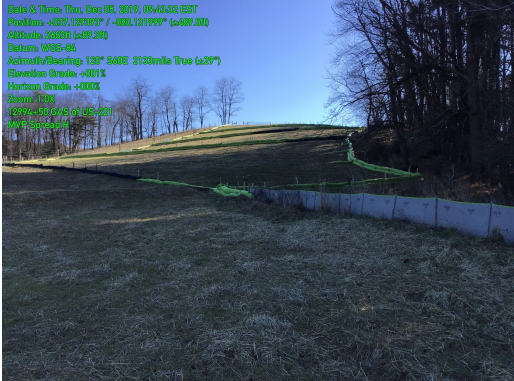
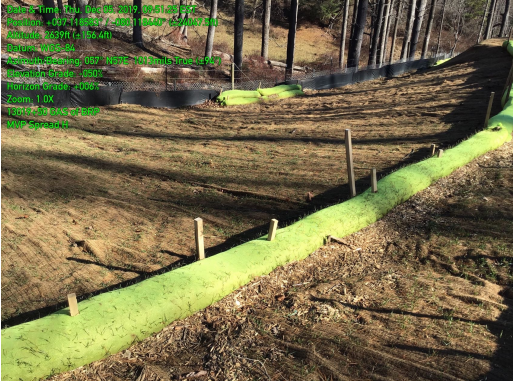
<b>GPS Location</b>	See pic for GPS location		<b>GPS Location</b>	See pic for GPS location	
<b>Field Station#</b>	12994+50		<b>Field Station#</b>	13019+50	
<b>Pic 3 Desc.</b>	Vegetative stabilization in good condition on the GAS of US-221.		<b>Pic 4 Desc.</b>	No ECD deficiencies observed on the GAS of the BRP.	
<p>Date &amp; Time: Thu, Dec 05, 2019, 09:43:43 EST  Position: +407.125311° / -080.122991° (+32.80)  Altitude: 2674ft (+39.40)  Datum: WGS-84  Azimuth/Bearing: 090° 58'00" (±92°)  Elevation Grade: -01%  Horizon Grade: +00%  Zoom: 12x  13021+00 stream S-G24 and S-G25  MVP Screenshot</p>

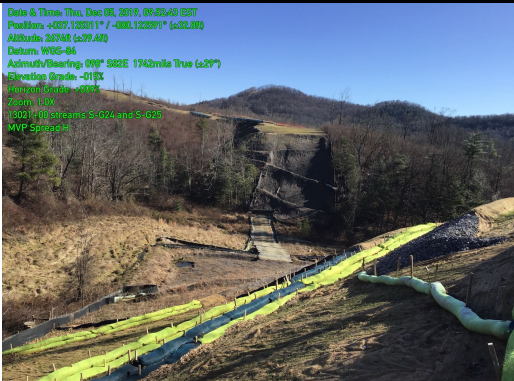
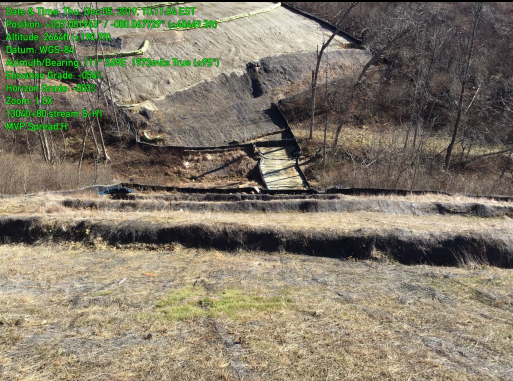
<b>GPS Location</b>	See pic for GPS location		<b>GPS Location</b>	See pic for GPS location	
<b>Field Station#</b>	13021+00		<b>Field Station#</b>	13040+80	
<b>Pic 5 Desc.</b>	No issues or impacts near streams S-G24 and S-G25		<b>Pic 6 Desc.</b>	No issues or impacts observed near stream S-H1.

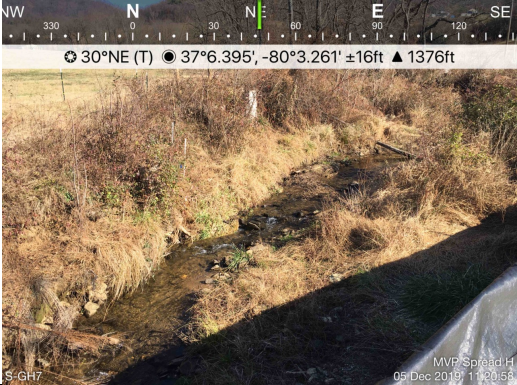
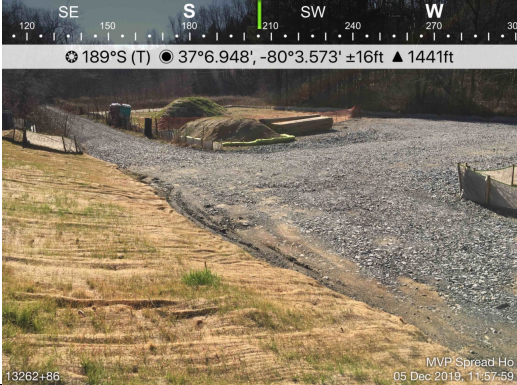
<b>GPS Location</b>	See Picture Watermark	<b>GPS Location</b>	See Picture Watermark		
<b>Field Station#</b>	13309+00	<b>Field Station#</b>	13262+86		
<b>Pic 7 Desc.</b>	Stream S-GH7 and buffer zone remain vegetated, undisturbed, and in good condition.	<b>Pic 8 Desc.</b>	ROW on GAS Flanders Road and adjacent ATWS in good condition, inactive, and vegetated.

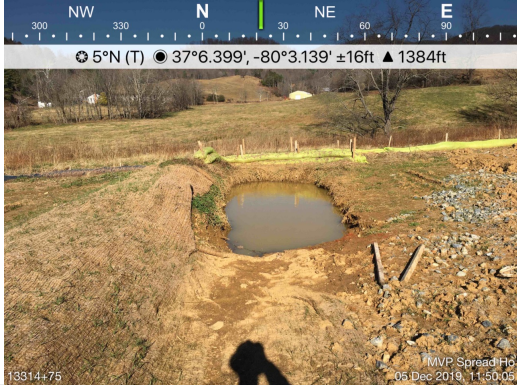
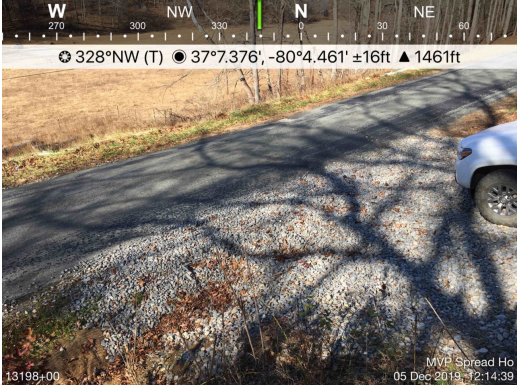
<b>GPS Location</b>	See Picture Watermark	<b>GPS Location</b>	See Picture Watermark		
<b>Field Station#</b>	13314+75	<b>Field Station#</b>	13198+00		
<b>Pic 9 Desc.</b>	Sump pit and end treatment for waterbar in good condition. No sediment observed to have discharged.	<b>Pic 10 Desc.</b>	Construction entrance at Dillons Mill remains in good condition and no sediment observed to be tracked.

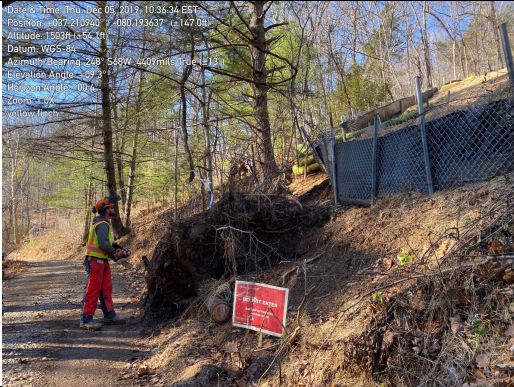
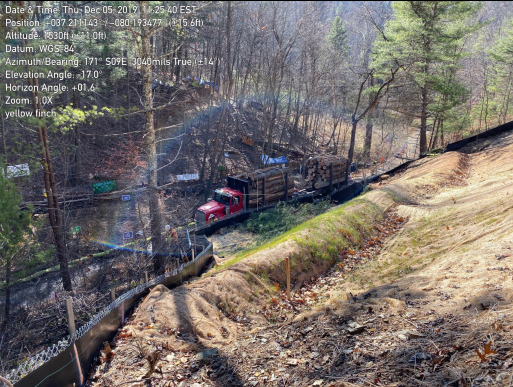
<b>GPS Location</b>		See photo for coordinates.		<b>GPS Location</b>	
<b>Field Station#</b>		12544+06		<b>Field Station#</b>	
<b>Pic 1 Desc.</b>		Removing small tree that slid when larger tree fell on Yellow Finch Road.		<b>Pic 2 Desc.</b>

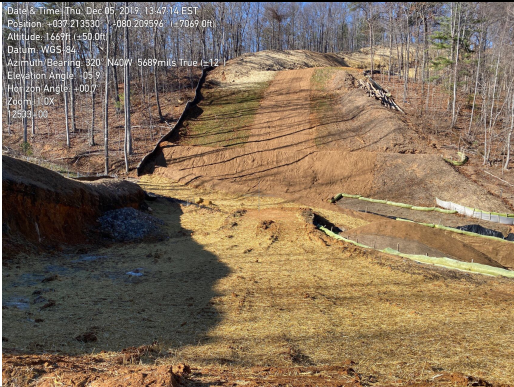
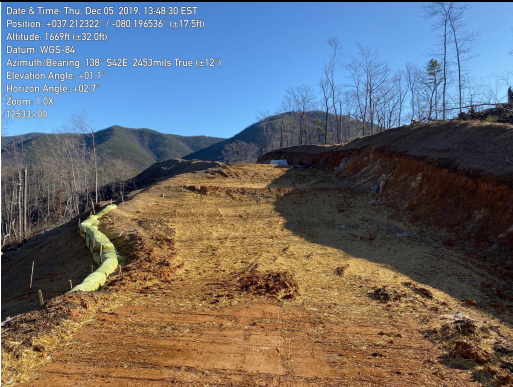
<b>GPS Location</b>		See photo for coordinates.		<b>GPS Location</b>	
<b>Field Station#</b>		12533+00		<b>Field Station#</b>	
<b>Pic 3 Desc.</b>		Clean water conveyance, travel lane seeded and mulched, mulched crimped in.		<b>Pic 4 Desc.</b>

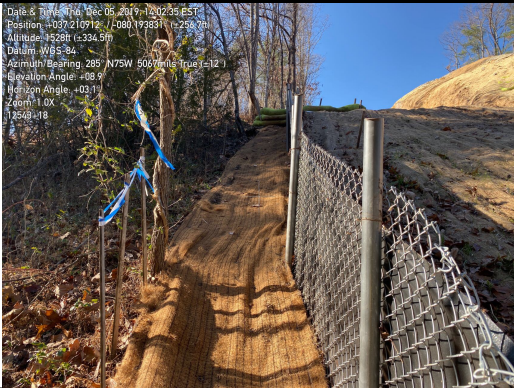
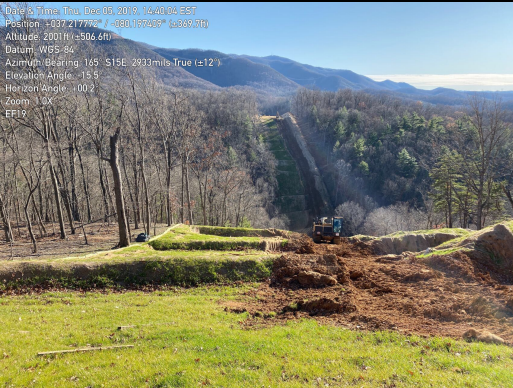
<b>GPS Location</b>		See photo for coordinates.		<b>GPS Location</b>	
<b>Field Station#</b>		12544+06		<b>Field Station#</b>	
<b>Pic 5 Desc.</b>		Curlex added outside SSF.		<b>Pic 6 Desc.</b>	
				CIS of S-EF19, beginning to stabilize travel lane.

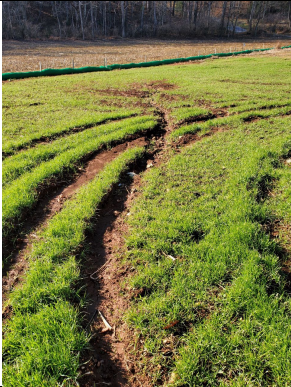
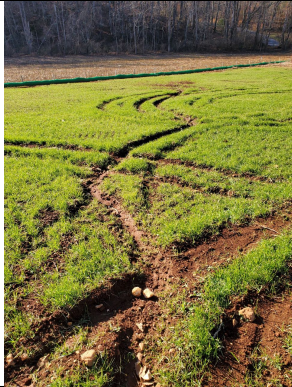
<b>GPS Location</b>	000000	<b>GPS Location</b>	000000		
<b>Field Station#</b>	13648+55	<b>Field Station#</b>	13649+00		
<b>Pic 1 Desc.</b>	Local on ATV rutted row causing a potential for erosion, documented to monitor after rain events.		<b>Pic 2 Desc.</b>	Locals on ATV's rutting the row , will continue to monitor after rain events for erosion

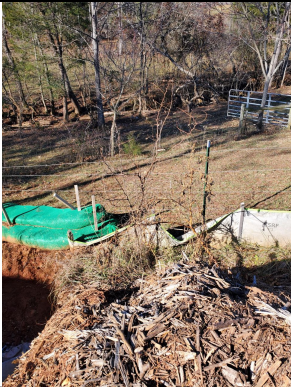
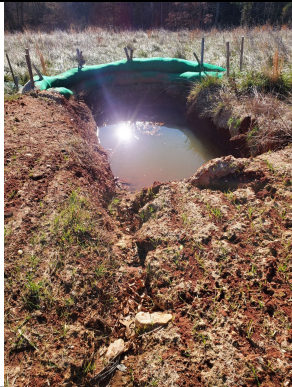
<b>GPS Location</b>	00000000	<b>GPS Location</b>	000000		
<b>Field Station#</b>	13660+00	<b>Field Station#</b>	13664+55		
<b>Pic 3 Desc.</b>	P1 damaged needs repair, added to the punch list		<b>Pic 4 Desc.</b>	Erosion at sump needs repair	
Insert image here			Insert image here		
<b>GPS Location</b>		<b>GPS Location</b>			
<b>Field Station#</b>		<b>Field Station#</b>			
<b>Pic 5 Desc.</b>		<b>Pic 6 Desc.</b>
