Visual Site Inspection Report

Project Name	H-600 Pipeline Spread H	AFE	124300138	Spread	H-600 Pipeline Spread H
Contractor	Precision			Report #	6860
Inspector	Pat Davis			Date/Time	12/23/2019 4:15 PM
Permit #	TBD	Inspection Type	VA SWPP	Station Begin	+0
State	VA	Inspection Area	Partial	Station End	+0
County	Montgomery	Ground	Damp	Temperature (°F)	41.00
Municipality	N/A	Weather	Cloudy	Rain Gauge (in)	0.00
				Rain Accumulation Time (days)	0.00

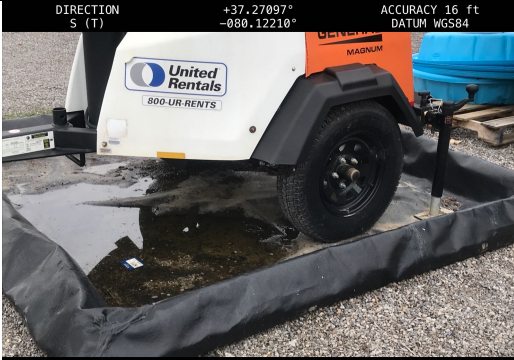
<p>DIRECTION S (T) +37.27097° -080.12210° ACCURACY 16 ft DATUM WGS84</p> <p>MVP-LY-049_122319 Condition of containment 2019-12-23 09:13:28-05:00</p>

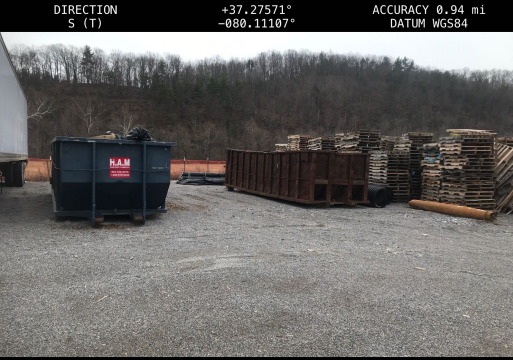
<p>DIRECTION S (T) +37.27571° -080.11107° ACCURACY 0.94 m1 DATUM WGS84</p> <p>MVP-LY-049_122319 No loose trash around south dumpsters 2019-12-23 09:36:51-05:00</p>			
GPS Location	MVP-LY-049 See photo for gps data		GPS Location	MVP-LY-049 See photo for gps data	
Field Station#	+0		Field Station#	+0	
Pic 1 Desc.	Condition of containment under light plant. Looking S.		Pic 2 Desc.	No loose trash around south dumpsters. Looking S.

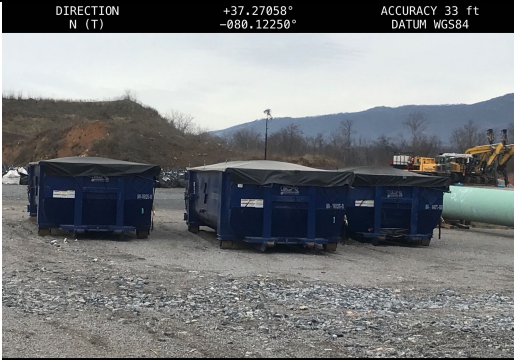
<p>DIRECTION N (T) +37.27058° -080.12250° ACCURACY 33 ft DATUM WGS84</p> <p>MVP-LY-049_122319 3 covered dumpsters for contaminated mat... 2019-12-23 09:37:58-05:00</p>

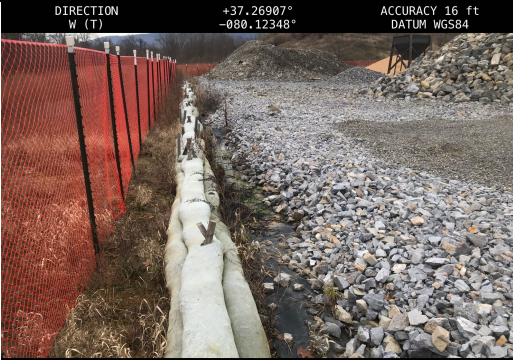
<p>DIRECTION W (T) +37.26907° -080.12348° ACCURACY 16 ft DATUM WGS84</p> <p>MVP-LY-049_122319 Condition of CFS & safety fence along S... 2019-12-23 09:41:37-05:00</p>

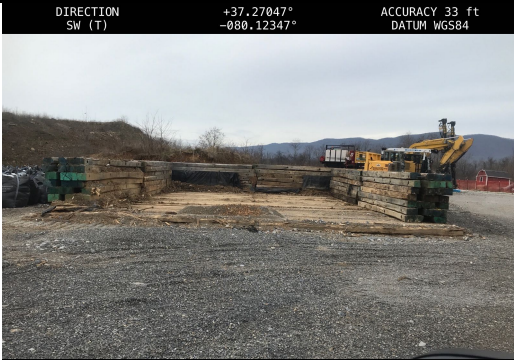
<p>DIRECTION SW (T) +37.27047° -080.12347° ACCURACY 33 ft DATUM WGS84</p> <p>MVP-LY-049_122319 Condition of temporary trash tran... 2019-12-23 09:44:49-05:00</p>

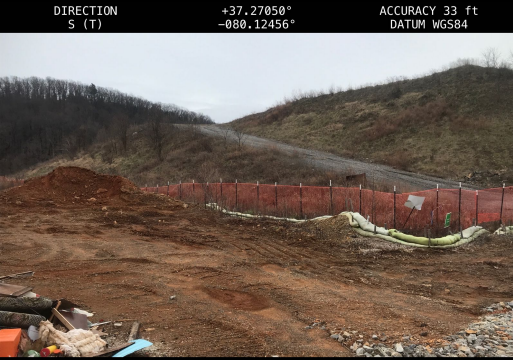
<p>DIRECTION S (T) +37.27050° -080.12456° ACCURACY 33 ft DATUM WGS84</p> <p>MVP-LY-049_122319 Landowner disturbance along CFS and feature 2019-12-23 09:45:48-05:00</p>			
GPS Location	MVP-LY-049 See photo for gps data		GPS Location	MVP-LY-049 See photo for gps data	
Field Station#	+0		Field Station#	+0	
Pic 5 Desc.	Condition of temporary trash transfer pit empty. Looking SW.		Pic 6 Desc.	Landowner disturbance along CFS and feature. No impacts. Looking S.

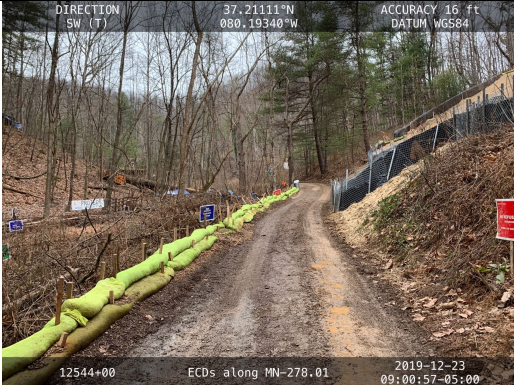
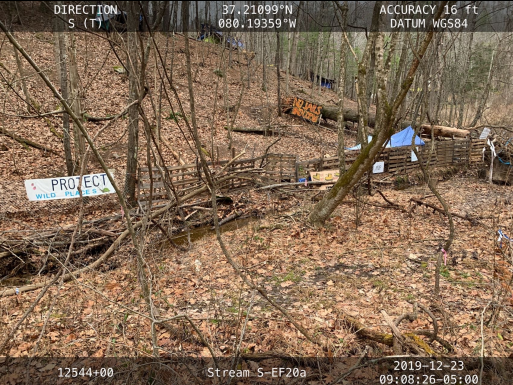
GPS Location	See photo for gps data.		GPS Location	See photo for gps data.	
Field Station#	12544+00		Field Station#	12544+50	
Pic 1 Desc.	Photo shows the ECDs along MN-278.01.		Pic 2 Desc.	Photo shows stream S-EF20a.

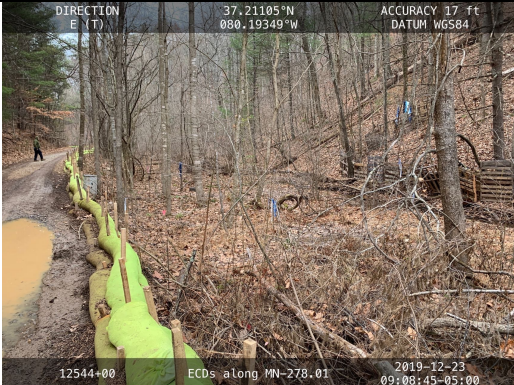
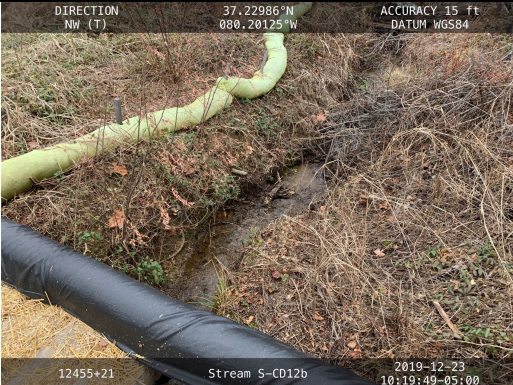
GPS Location	See photo for gps data.		GPS Location	See photo for gps data.	
Field Station#	12544+00		Field Station#	12455+21	
Pic 3 Desc.	Photo shows the ECDs along access road MN-278.01.		Pic 4 Desc.	Photo shows stream S-CD12b downstream of the ROW.

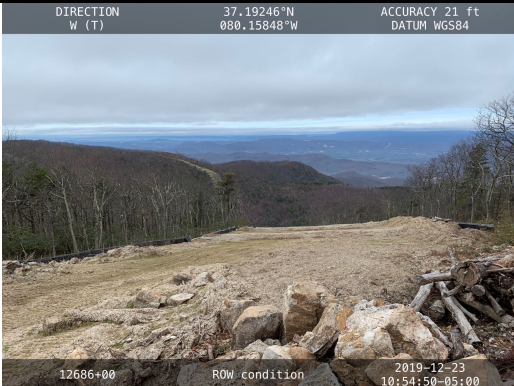
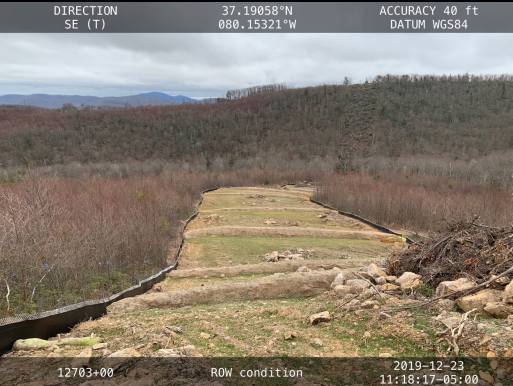
GPS Location	See photo for gps data.		GPS Location	See photo for gps data.	
Field Station#	12686+00		Field Station#	12703+00	
Pic 5 Desc.	Photo shows the ROW condition from about 12686+00 to 12683+00.		Pic 6 Desc.	Photo shows the ROW condition from about 12703+00 to 12710+00.

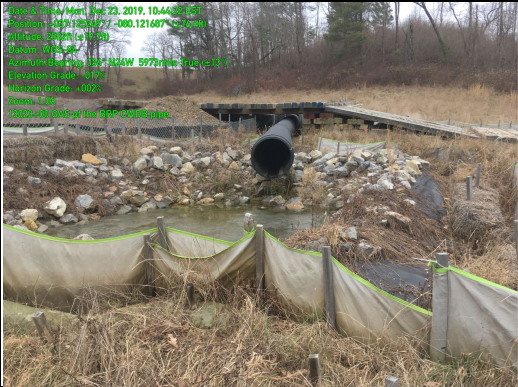
<p>Date & Time Mon, Dec 23, 2019, 10:44:55 EST Position: 40°11'18.34"N / -88°12'16.87"W (±16.40) Altitude: 250m (±16.40) Datum: WGS-84 Azimuth/Heading: 103° N33E 4887mils True (±13°) Elevation Grade: -02% Horizontal Grade: -00% Cross: 1.04 13023+00 GAS of the BRP CWDB pipe</p>

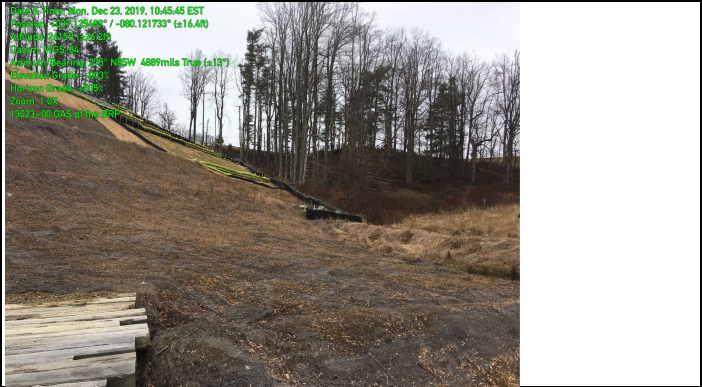
<p>Date & Time Mon, Dec 23, 2019, 10:45:45 EST Position: 40°11'25.40"N / -88°12'17.33"W (±16.40) Altitude: 250m (±16.40) Datum: WGS-84 Azimuth/Heading: 103° N33E 4887mils True (±13°) Elevation Grade: -02% Horizontal Grade: -00% Cross: 1.04 13023+00 GAS of the BRP</p>	
GPS Location	See pic for GPS location	GPS Location	See pic for GPS location		
Field Station#	13023+00	Field Station#	13023+00		
Pic 7 Desc.	No issues with CWDB, pipe or plunge pool.		Pic 8 Desc.	No issues or impacts on the GAS of the BRP. Final restoration performed in the BRP.

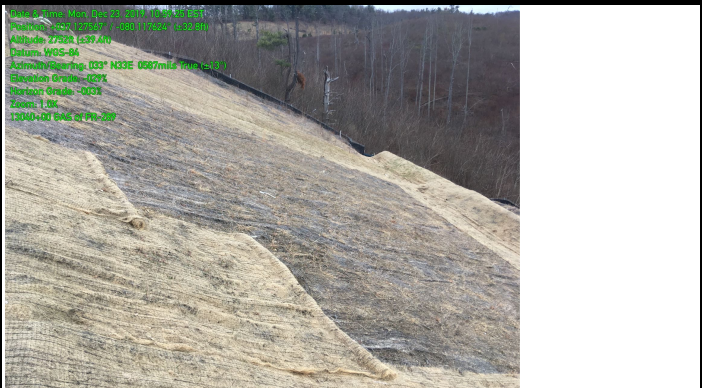
<p>Date & Time Mon, Dec 23, 2019, 10:46:00 EST Position: 40°11'25.40"N / -88°12'17.25"W (±16.40) Altitude: 250m (±16.40) Datum: WGS-84 Azimuth/Heading: 103° N33E 4887mils True (±13°) Elevation Grade: -02% Horizontal Grade: -00% Cross: 1.04 13040+00 GAS of the BRP</p>	
GPS Location	See pic for GPS location	GPS Location	See pic for GPS location		
Field Station#	13023+00	Field Station#	13040+00		
Pic 9 Desc.	The GAS of the BRP. No issues in the area.		Pic 10 Desc.	Vegetative stabilization was well established before winter throughout the area.

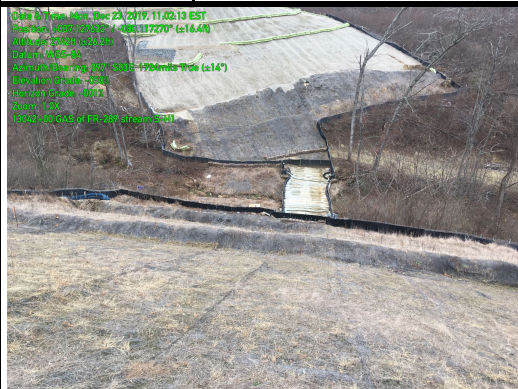
<p>Date & Time Mon, Dec 23, 2019, 11:02:13 EST Position: 40°11'25.40"N / -88°12'27.00"W (±16.40) Altitude: 250m (±16.40) Datum: WGS-84 Azimuth/Heading: 111° S45E 4887mils True (±14°) Elevation Grade: -02% Horizontal Grade: -00% Cross: 1.04 13042+00 GAS of the BRP stream S-H1</p>

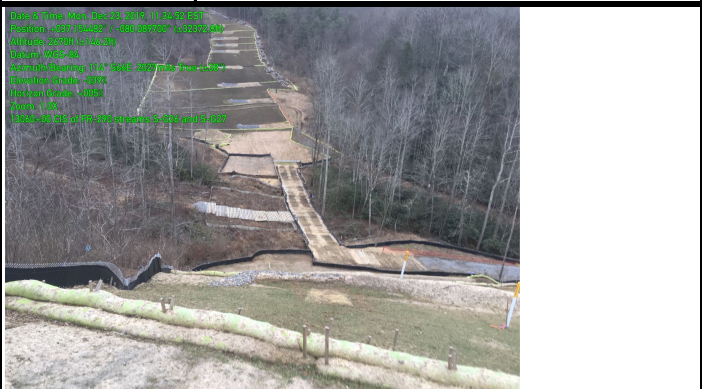
<p>Date & Time Mon, Dec 23, 2019, 11:02:20 EST Position: 40°11'25.40"N / -88°12'27.00"W (±16.40) Altitude: 250m (±16.40) Datum: WGS-84 Azimuth/Heading: 111° S45E 4887mils True (±14°) Elevation Grade: -02% Horizontal Grade: -00% Cross: 1.04 13060+00 GAS of the BRP stream S-G26 and S-G27</p>

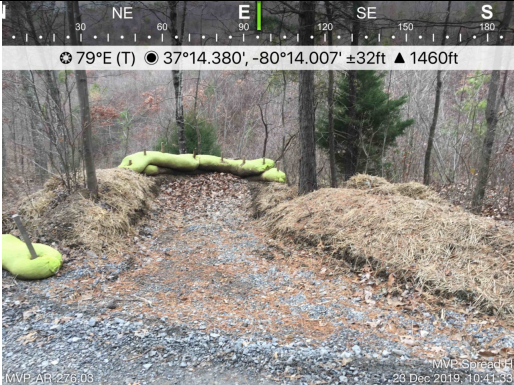
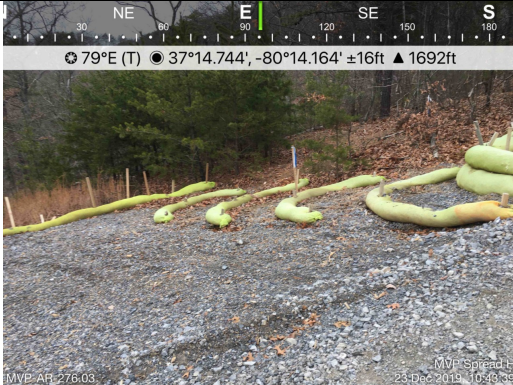
GPS Location	See Picture Watermark		GPS Location	See Picture Watermark	
Field Station#	12232+31		Field Station#	12232+31	
Pic 1 Desc.	End treatment along access road MVP-AR-276.03 in good condition.		Pic 2 Desc.	CFS check dams along access road MVP-AR-276.03 in good condition.

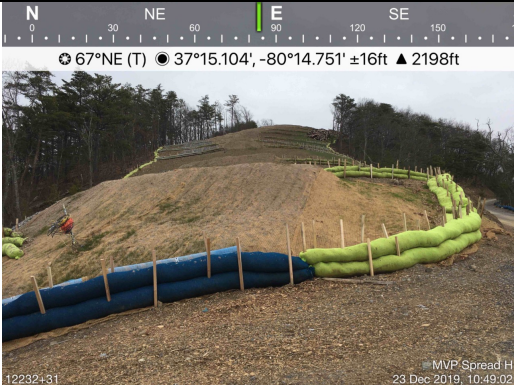
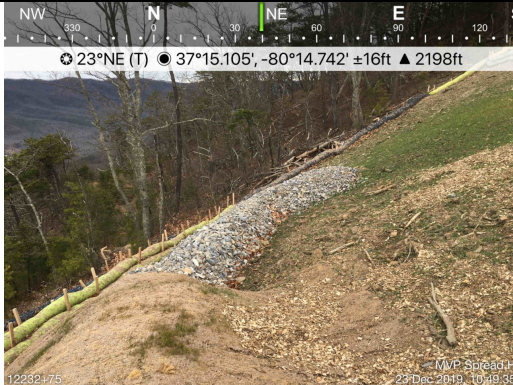
GPS Location	See Picture Watermark		GPS Location	See Picture Watermark	
Field Station#	12232+31		Field Station#	12232+75	
Pic 3 Desc.	Start of ROW inspection area is well stabilized with matting and in good condition.		Pic 4 Desc.	Permanent waterbar end treatment in good condition and free of excess sediment.

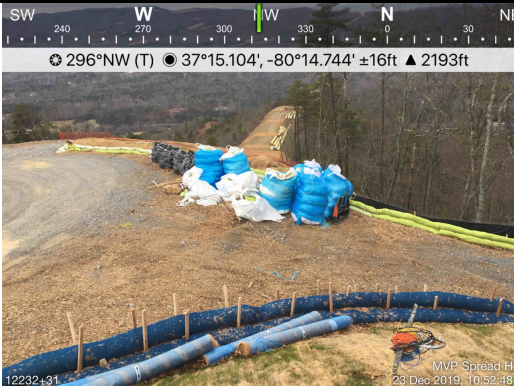
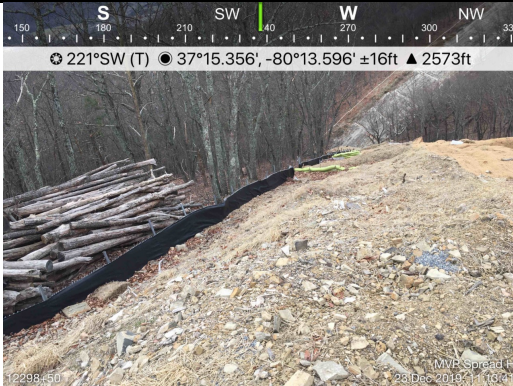
GPS Location	See Picture Watermark		GPS Location	See Picture Watermark	
Field Station#	12232+31		Field Station#	12298+50	
Pic 5 Desc.	Environmental materials staged on-site.		Pic 6 Desc.	Super silt fence along GAS Reese Mountain "V" is in good condition and appears functional.

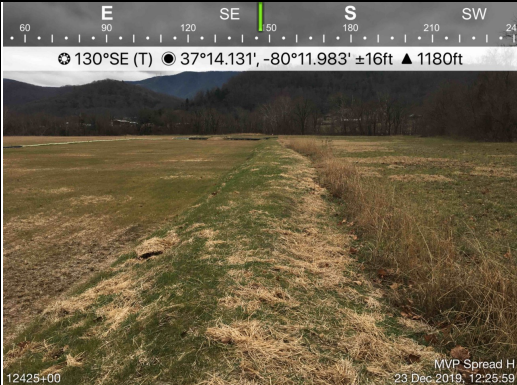
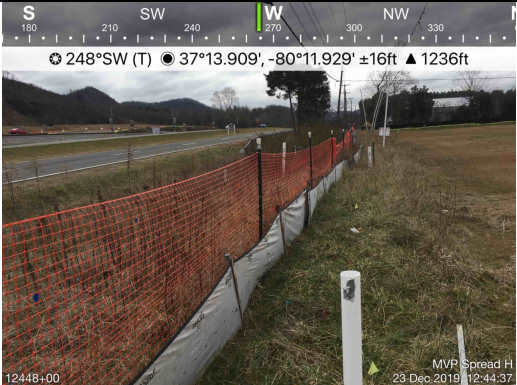
GPS Location	See Picture Watermark		GPS Location	See Picture Watermark	
Field Station#	12425+00		Field Station#	12448+00	
Pic 13 Desc.	Clean water diversion berm within Roanoke River floodplain in good condition and well vegetated.		Pic 14 Desc.	End of inspection area remains well vegetated and in good condition.

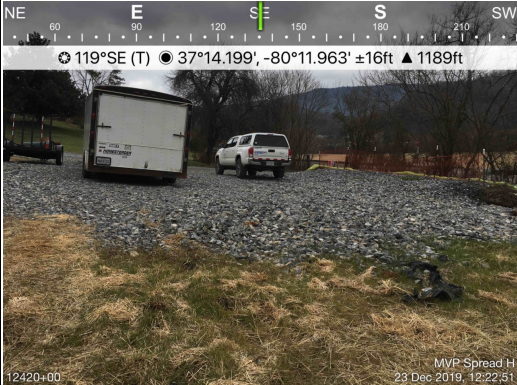
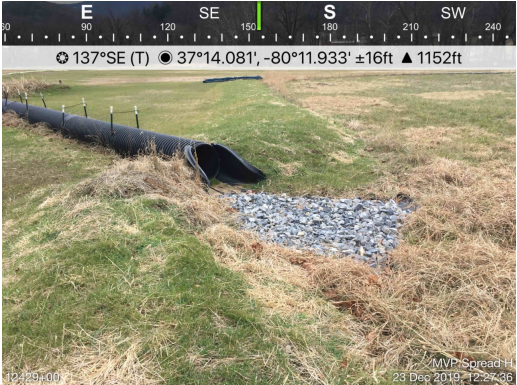
GPS Location	See Picture Watermark		GPS Location	See Picture Watermark	
Field Station#	12420+00		Field Station#	12429+00	
Pic 15 Desc.	Rock construction entrance in good condition and free of excess sediment. Adjacent landowner parked on entrance.		Pic 16 Desc.	CWD inlet at Roanoke River floodplain in good condition and free of sediment.

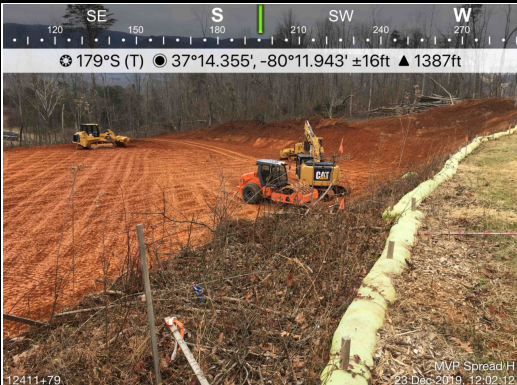
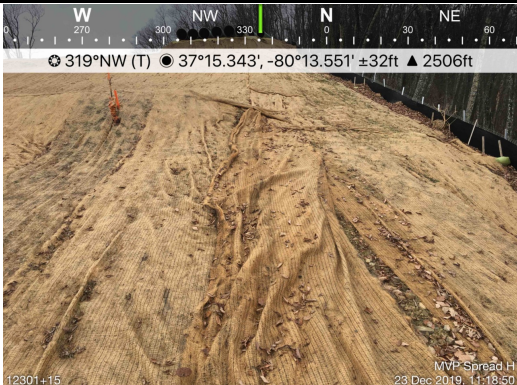
GPS Location	See Picture Watermark		GPS Location	See Picture Watermark	
Field Station#	12411+79		Field Station#	12301+15	
Pic 17 Desc.	Roanoke Gas construction adjacent to ROW.		Pic 18 Desc.	Area of stabilization matting that had become dislodged was repaired by inspector.

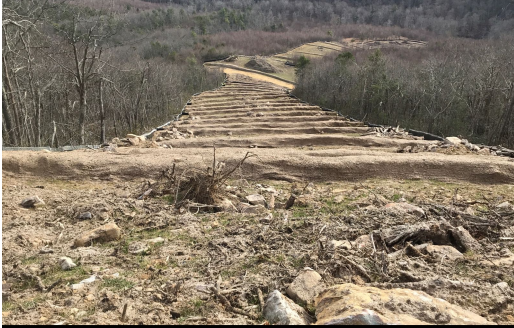
12692+47_122719 Condition of ROW 2019-12-27 10:52:18-05:00			DIRECTION W (T) +37.19290° -080.15940° ACCURACY 16 ft DATUM WGS84

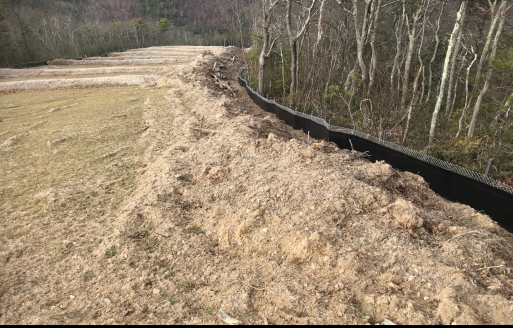
12683+09_122719 Condition of super silt fence 2019-12-27 11:04:21-05:00	
GPS Location	see photo for gps data		GPS Location	see photo for gps data	
Field Station#	12692+47		Field Station#	12683+09	
Pic 1 Desc.	Condition of temporary stabilized ROW and erosion controls. Looking E.		Pic 2 Desc.	Condition of temporary stabilized ROW and super silt fence. Looking W.	
	DIRECTION NW (T) +37.19070° -080.15393° ACCURACY 16 ft DATUM WGS84

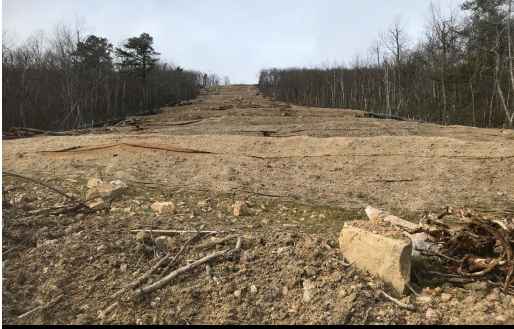
12702+53_122719 Condition of ROW 2019-12-27 12:00:15-05:00			DIRECTION SE (T) +37.19070° -080.15393° ACCURACY 1.42 mi DATUM WGS84

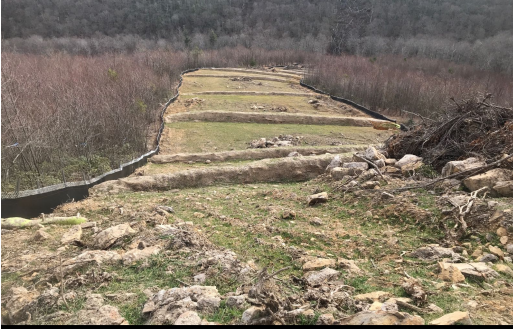
12703+08_122719 Condition of ROW 2019-12-27 12:02:40-05:00	
GPS Location	see photo for gps data		GPS Location	see photo for gps data

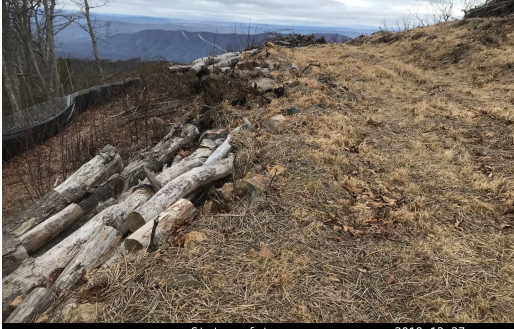
12637+71_122719 Status of temporary stabilization in ATWS 2019-12-27 12:28:59-05:00			DIRECTION E (T) +37.19387° -080.17233° ACCURACY 16 ft DATUM WGS84

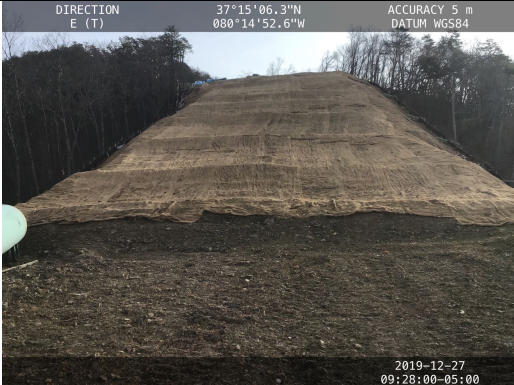
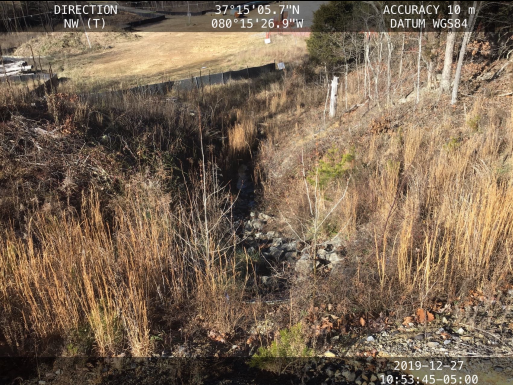
GPS Location	See photo		GPS Location	See photo	
Field Station#	12227+00		Field Station#	12197+37	
Pic 1 Desc.	The slope leading up to the switchback on Reese Mountain is still stable, although only minimally vegetated.		Pic 2 Desc.	Stream S-0011, facing northwest, downstream

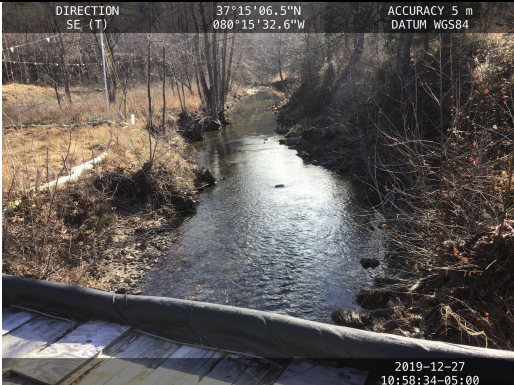
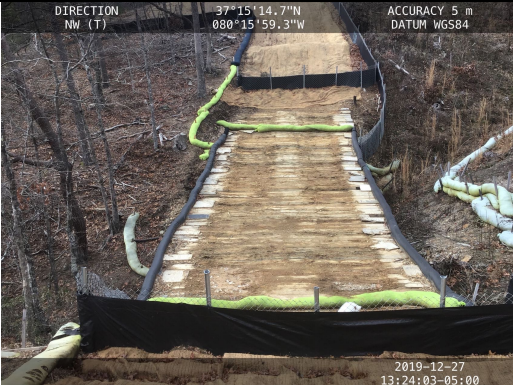
GPS Location	See photo		GPS Location	See photo	
Field Station#	12192+50		Field Station#	12166+47	
Pic 3 Desc.	Stream S-C21, Bradshaw Creek, facing southeast, downstream		Pic 4 Desc.	Stream S-C24, facing northwest

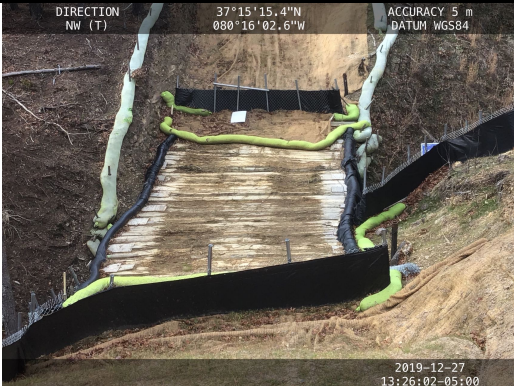
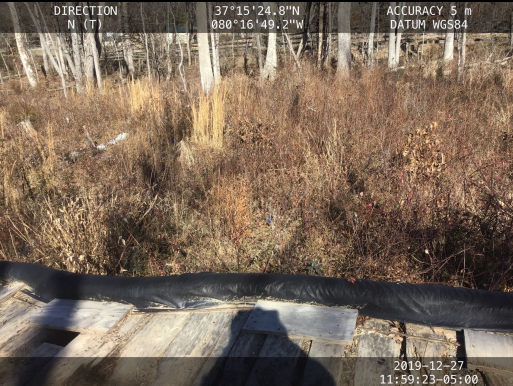
GPS Location	See photo		GPS Location	See photo	
Field Station#	12163+05		Field Station#	12125+65	
Pic 5 Desc.	Stream S-C25, facing northwest		Pic 6 Desc.	Stream S-MM11, facing north, upstream

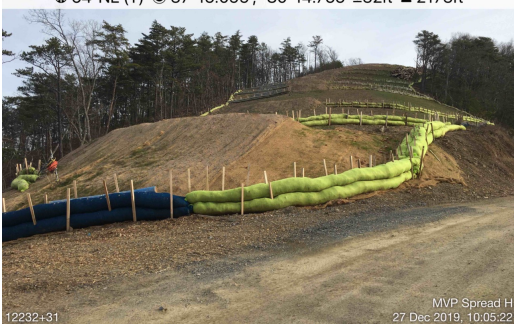
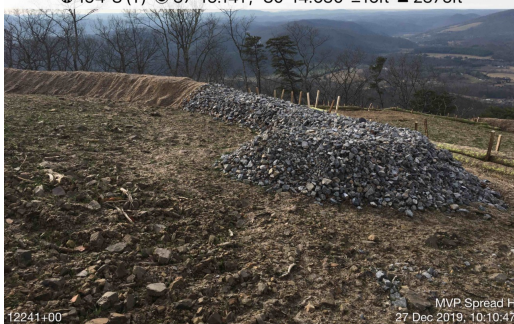
GPS Location	See Picture Watermark		GPS Location	See Picture Watermark	
Field Station#	12232+31		Field Station#	12241+00	
Pic 1 Desc.	Start of inspection. ROW remains stabilized with matting and perimeter controls are in good condition.		Pic 2 Desc.	Permanent waterbar and end treatment installed and in good condition.

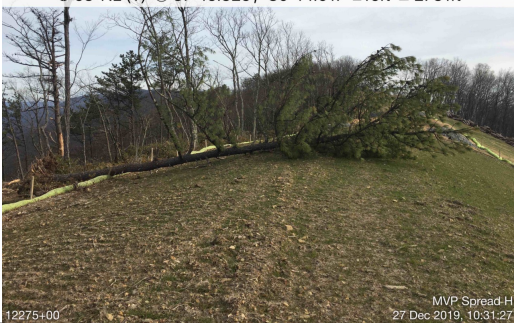
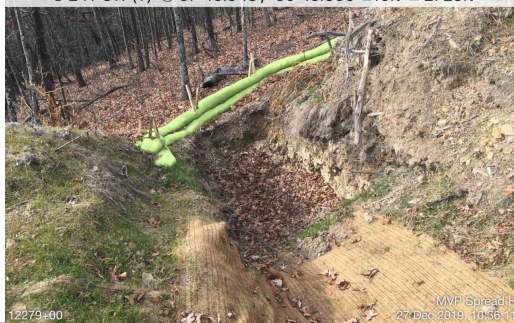
GPS Location	See Picture Watermark		GPS Location	See Picture Watermark	
Field Station#	12275+00		Field Station#	12279+00	
Pic 3 Desc.	Tree fallen on ROW. CFS remains in good condition and functional.		Pic 4 Desc.	Sump pit at end of waterbar in good condition and free of sediment.

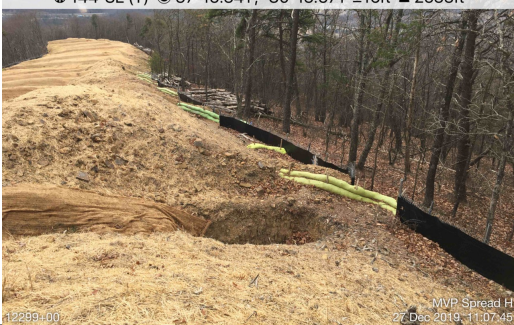
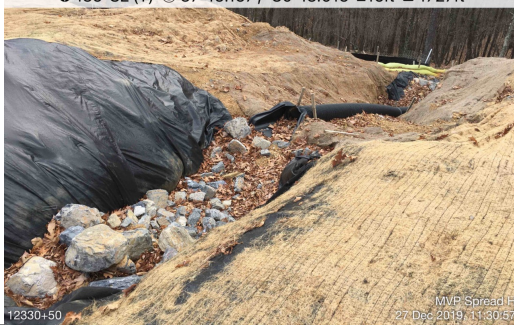
GPS Location	See Picture Watermark		GPS Location	See Picture Watermark	
Field Station#	12299+00		Field Station#	12330+50	
Pic 5 Desc.	Sumps and CFS end treatments along ROW in good condition and functional.		Pic 6 Desc.	Slope drain in good condition. Leaves within inlet and outfall do not inhibit functionality.

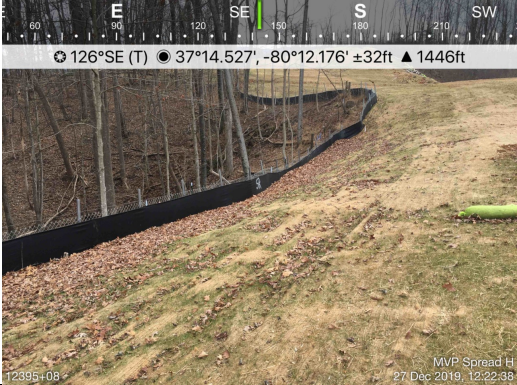
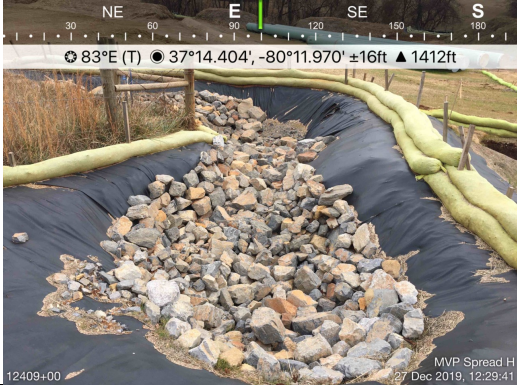
GPS Location	See Picture Watermark		GPS Location	See Picture Watermark	
Field Station#	12395+08		Field Station#	12409+00	
Pic 7 Desc.	SSF along ROW perimeter in good condition and functioning.		Pic 8 Desc.	CWD inlet in good condition and free of sediment.

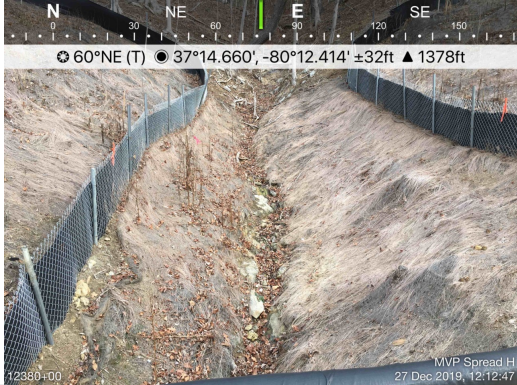
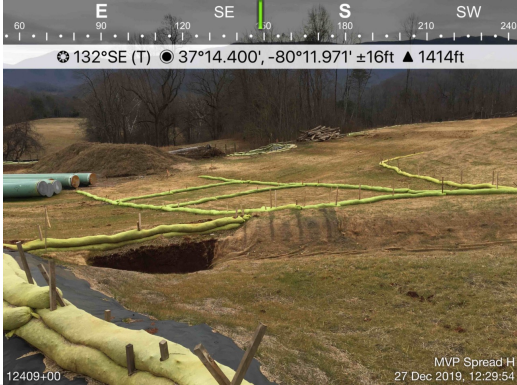
GPS Location	See Picture Watermark		GPS Location	See Picture Watermark	
Field Station#	12380+00		Field Station#	12409+00	
Pic 9 Desc.	Stream S-NN19 in good condition and remains unimpacted by construction.		Pic 10 Desc.	ATWS at MLV-26 is well stabilized and CFS controls are in good condition.

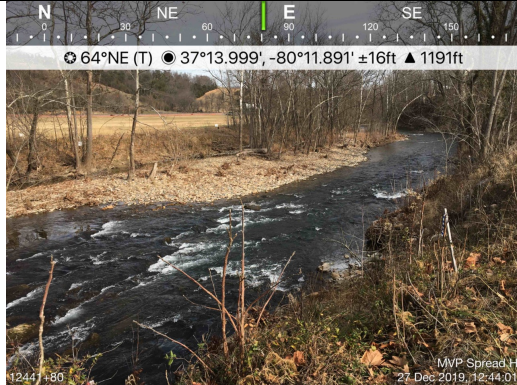
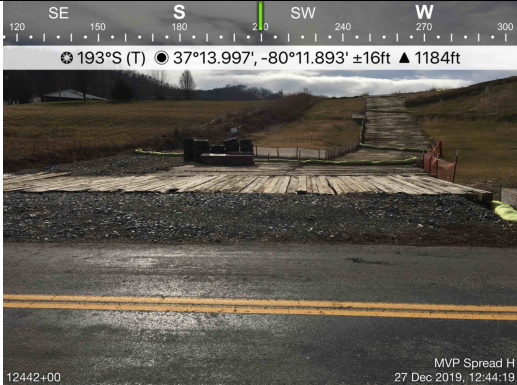
GPS Location	See Picture Watermark		GPS Location	See Picture Watermark	
Field Station#	12441+80		Field Station#	12442+00	
Pic 11 Desc.	Roanoke River remains unimpacted from construction and in good condition.		Pic 12 Desc.	Rock construction entrance in good condition and no sediment tracking was observed.

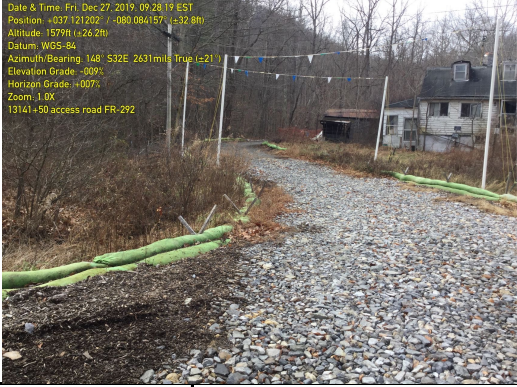
Insert image here	
GPS Location	See pic for GPS location	GPS Location			
Field Station#	13141+50	Field Station#			
Pic 7 Desc.	No issues or impacts observed at FR-292.	Pic 8 Desc.			
Insert image here		Insert image here			
GPS Location		GPS Location			
Field Station#		Field Station#			
Pic 9 Desc.		Pic 10 Desc.			
Insert image here		Insert image here			
GPS Location		GPS Location			
Field Station#		Field Station#			
Pic 11 Desc.		Pic 12 Desc.

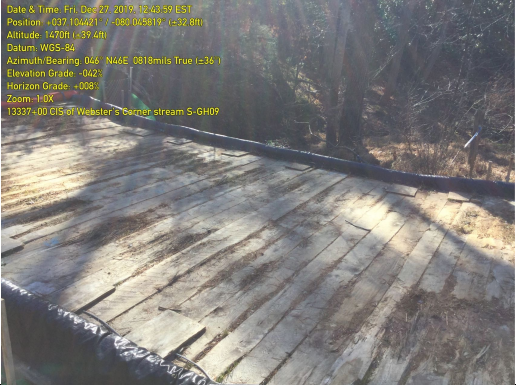
<p>Date & Time: Fri Dec 27, 2019 12:43:50 (EST) Position: -93.7106235, -4080.06235, -132.400 Altitude: 1629ft (+3.14m) Datum: WGS-84 Azimuth Bearing: 315.1447W 83.66mils True (+36.1) Elevation Grade: +00% Horizon Grade: +00% Zoom: 1.0X 13337+00 GIS of Webster's Corner stream S-GH09</p>			
GPS Location	See pic for GPS location		GPS Location	See pic for GPS location	
Field Station#	13339+84		Field Station#	13337+00	
Pic 13 Desc.	No impacts observed at stream S-GH09.		Pic 14 Desc.	Mat bridges cleaned off throughout the inspected area.

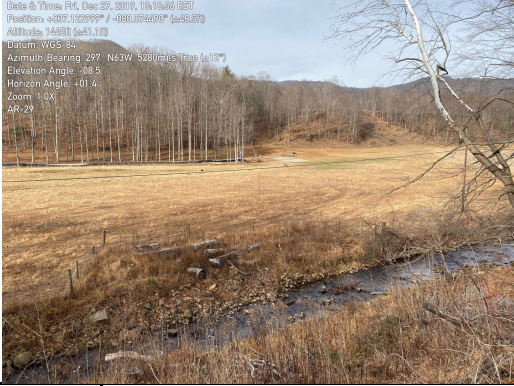
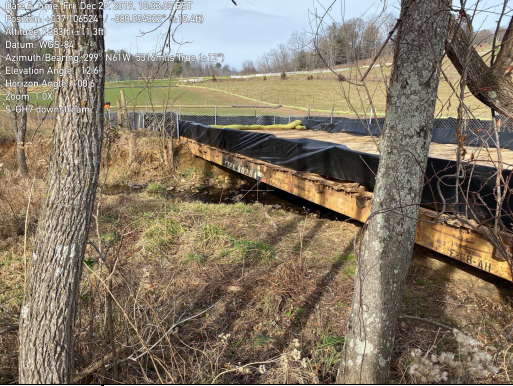
GPS Location	See photo for coordinates.		GPS Location	See photo for coordinates.	
Field Station#	13196+79		Field Station#	13309+09	
Pic 1 Desc.	S-D8, MVP-MLV-AR-29, ECDs functioning acceptably along access road, stream bed and banks stable.		Pic 2 Desc.	S-GH7, downstream, equipment bridge in acceptable condition, stream bed and banks stable, no environmental issues noted.

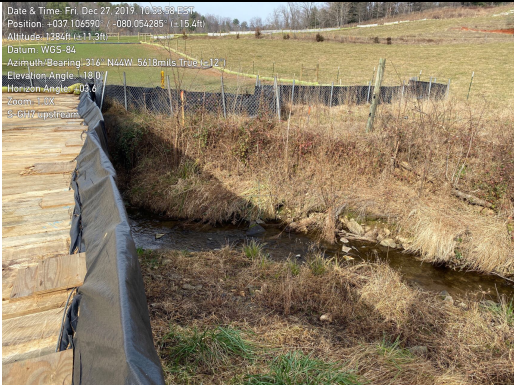
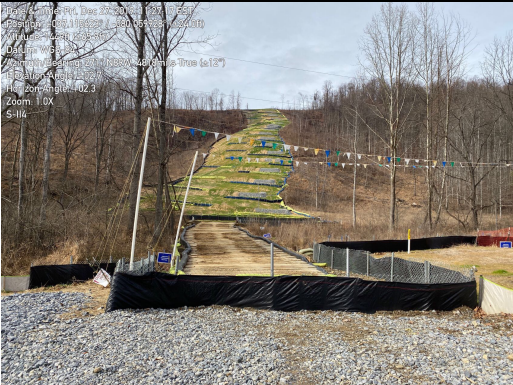
GPS Location	See photo for coordinates.		GPS Location	See photo for coordinates.	
Field Station#	13309+09		Field Station#	13261+00	
Pic 3 Desc.	S-GH7, upstream, equipment bridge in acceptable condition, stream bed and banks stable, no environmental issues noted.		Pic 4 Desc.	S-II4, ECDs functioning acceptable at steam crossing, permanent and temporary vegetation noted.
