Visual Site Inspection Report

Project Name	H-600 Pipeline Spread H	AFE	124300138	Spread	H-600 Pipeline Spread H
Contractor	Precision			Report #	8339
Inspector	Pat Davis			Date/Time	2/17/2020 4:22 PM
Permit #	TBD	Inspection Type	VA SWPP	Station Begin	+0
State	VA	Inspection Area	Partial	Station End	+0
County	Montgomery	Ground	Damp	Temperature (°F)	55.00
Municipality	N/A	Weather	Sunny	Rain Gauge (in)	0.00
				Rain Accumulation Time (days)	0.00

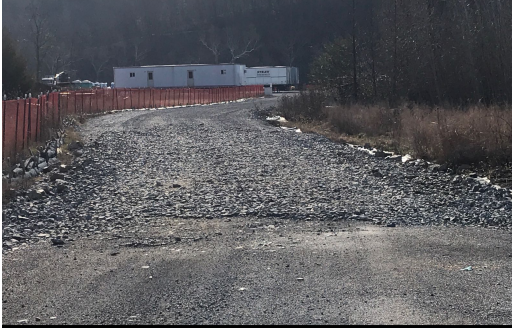
MVP-LY-049_021720 Condition of rock entrance 2020-02-17 09:48:27-05:00			DIRECTION N (M) +37.27112° -080.12166° ACCURACY 33 ft DATUM WGS84

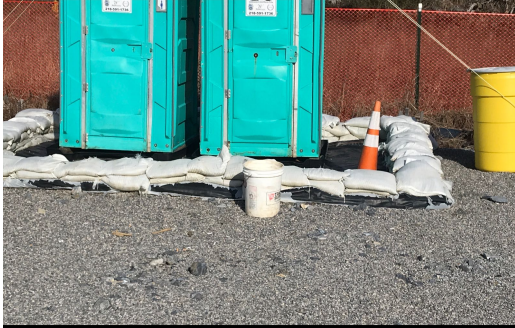
MVP-LY-049_021720 Condition of trays and containment 2020-02-17 09:51:01-05:00	
GPS Location	MVP-LY-049 See photo for gps data		GPS Location	MVP-LY-049 See photo for gps data	
Field Station#	+0		Field Station#	+0	
Pic 1 Desc.	Condition of rock entrance on center driveway. Looking S.		Pic 2 Desc.	Condition of trays and containment under toilets. Looking N.	
	DIRECTION S (M) +37.27443° -080.11671° ACCURACY 0.97 mi DATUM WGS84

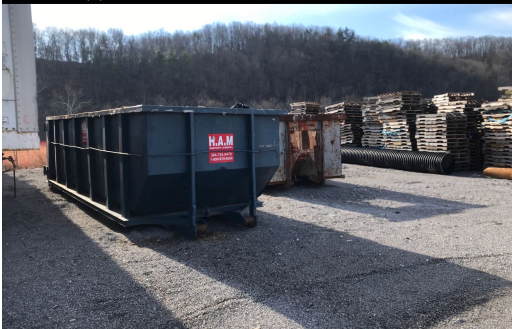
MVP-LY-049_021720 No loose trash around south dumpsters 2020-02-17 09:59:20-05:00			DIRECTION W (M) +37.27043° -080.12334° ACCURACY 33 ft DATUM WGS84

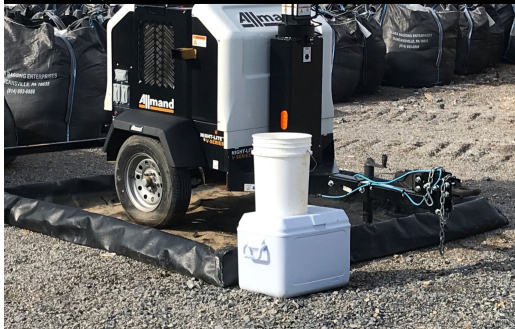
MVP-LY-049_021720 Condition of containment 2020-02-17 10:06:25-05:00

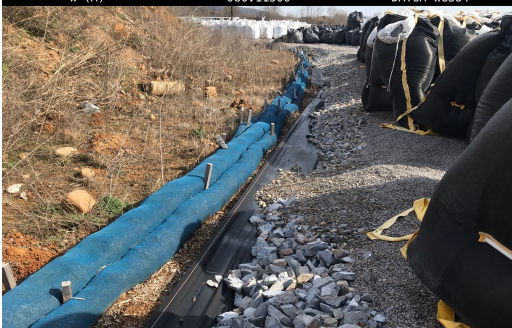
MVP-LY-049_021720 Condition of CFS north LOD 2020-02-17 10:25:26-05:00			DIRECTION S (M) +37.27046° -080.12467° ACCURACY 16 ft DATUM WGS84

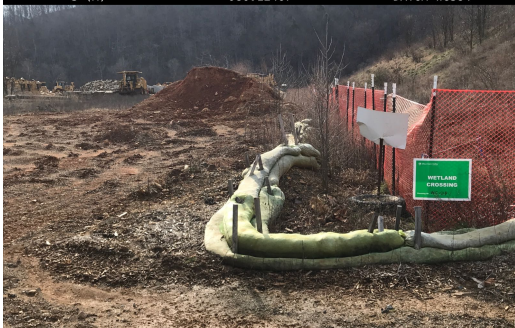
MVP-LY-049_021720 Landowner disturbance along CFS and feature 2020-02-17 10:08:56-05:00	
GPS Location	MVP-LY-049 See photo for gps data		GPS Location	MVP-LY-049 See photo for gps data	
Field Station#	+0		Field Station#	+0	
Pic 5 Desc.	Condition of compost filter sock along North LOD. Looking W.		Pic 6 Desc.	Landowner disturbance along compost filter sock and feature. No impacts. Looking S.

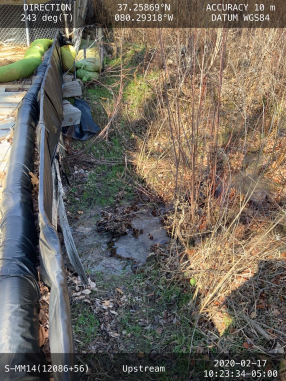
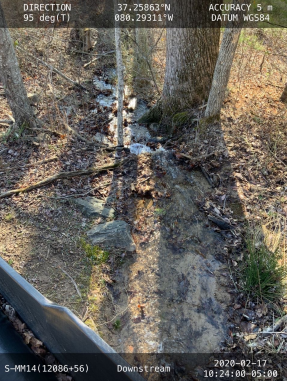
GPS Location	See GPS for location		GPS Location	See GPS for location	
Field Station#	12086+56		Field Station#	12086+56	
Pic 1 Desc.	No turbid water in stream.		Pic 2 Desc.	No ROW sediment in stream. Surrounding ECDs in acceptable condition.

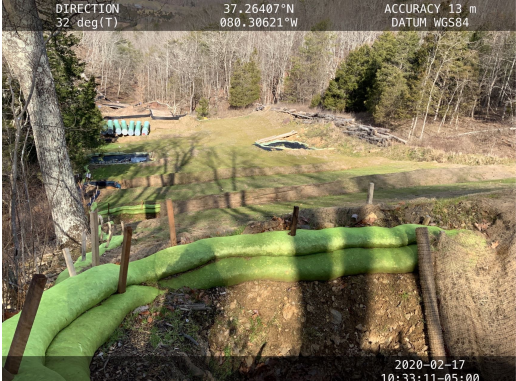
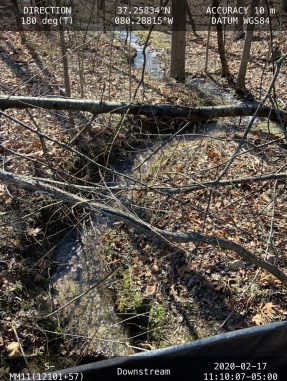
GPS Location	See GPS for location		GPS Location	See GPS for location	
Field Station#	12038+00		Field Station#	12101+57	
Pic 3 Desc.	Sumps and water bars in acceptable condition.		Pic 4 Desc.	No ROW sediment in stream.

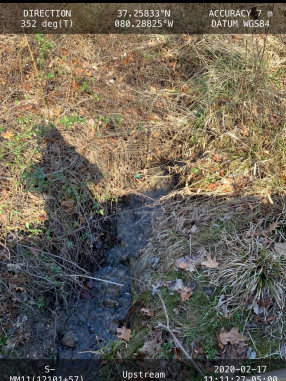
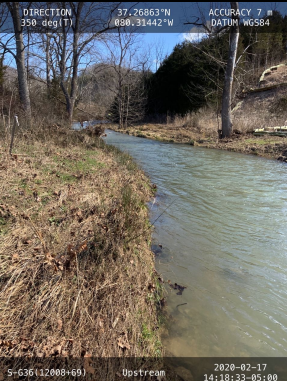
GPS Location	See GPS for location		GPS Location	See GPS for location	
Field Station#	12101+57		Field Station#	12008+69	
Pic 5 Desc.	No ROW sediment in stream.		Pic 6 Desc.	S-G36 banks in good condition. No ROW sediment in stream.

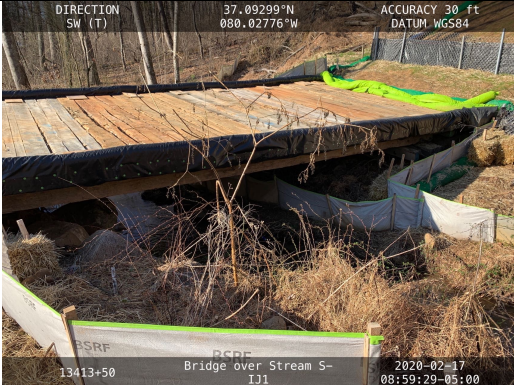
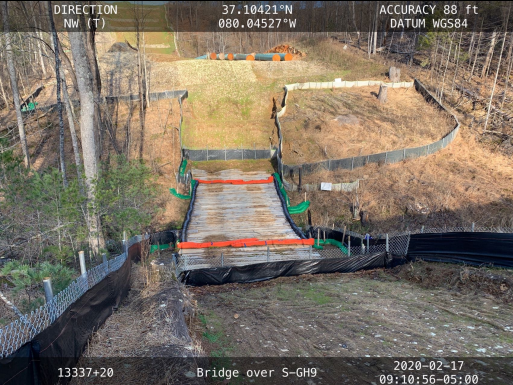
GPS Location	See photo for gps location data.		GPS Location	See photo for gps location data.	
Field Station#	13413+50		Field Station#	13337+20	
Pic 1 Desc.	Photo shows the bridge over stream S-IJ1. No environmental issues were observed.		Pic 2 Desc.	Photo shows the bridge over stream S-GH9. No environmental issues were observed.

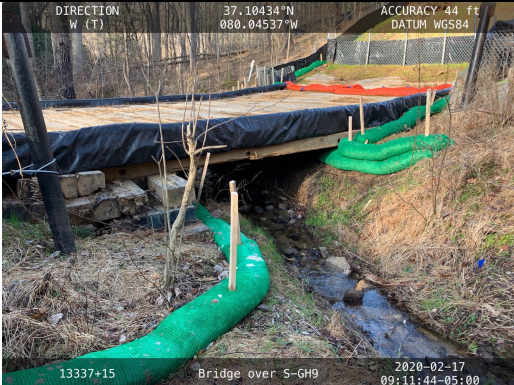
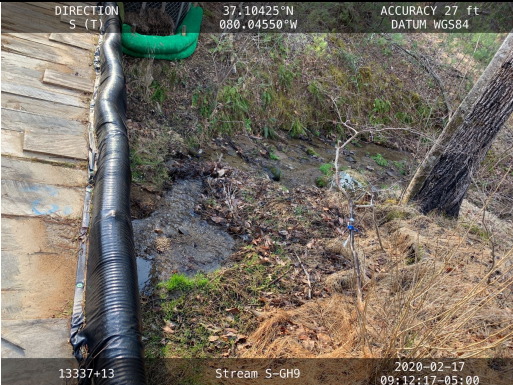
GPS Location	See photo for gps location data.		GPS Location	See photo for gps location data.	
Field Station#	13337+15		Field Station#	13337+13	
Pic 3 Desc.	Photo shows the bridge over stream S-GH9. No environmental issues were observed.		Pic 4 Desc.	Photo shows stream S-GH9, downstream from the ROW. no environmental issues were observed.

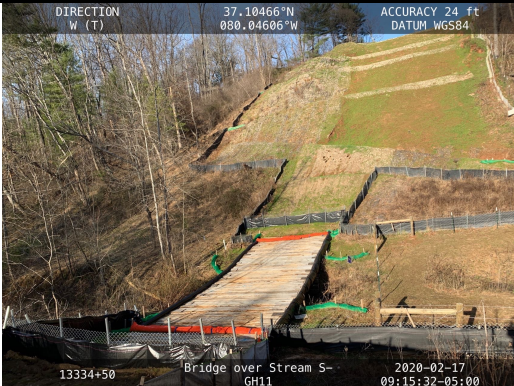
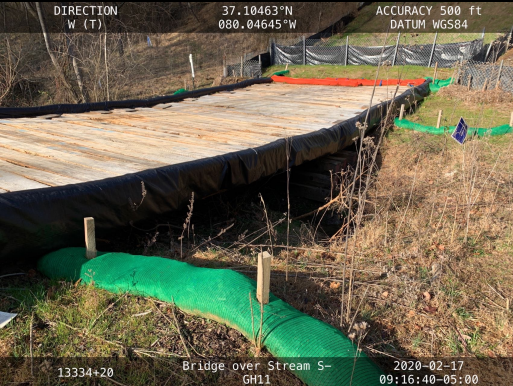
Pic 5 Desc.	Photo shows the bridge over stream S-GH11. No environmental issues were observed.		Pic 6 Desc.	Photo shows the bridge over stream S-GH11. No environmental issues were observed.

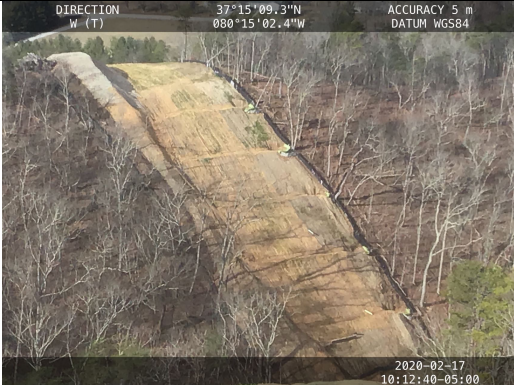
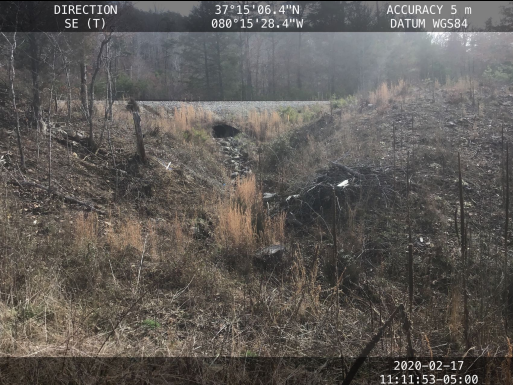
GPS Location	See photo		GPS Location	See photo	
Field Station#	12210+00		Field Station#	12196+50	
Pic 1 Desc.	The slope on the coming in side of the ravine between Bradshaw Road and Reese Mountain remains stable.		Pic 2 Desc.	Stream S-0011, facing southeast, upstream

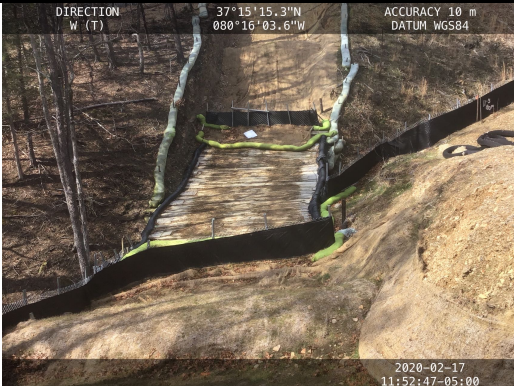
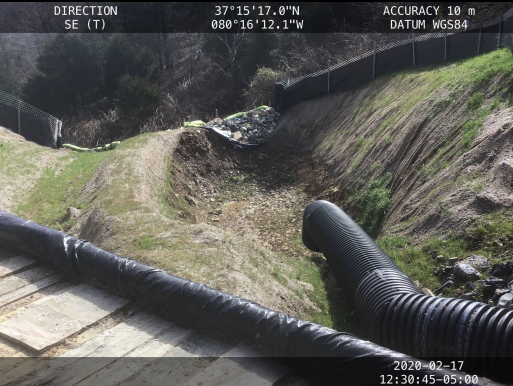
GPS Location	See photo		GPS Location	See photo	
Field Station#	12163+05		Field Station#	12157+00	
Pic 5 Desc.	Stream S-C25, facing west		Pic 6 Desc.	The temporary sediment trap on the going away side of AR 273 remains in good condition. No apparent need for maintenance.

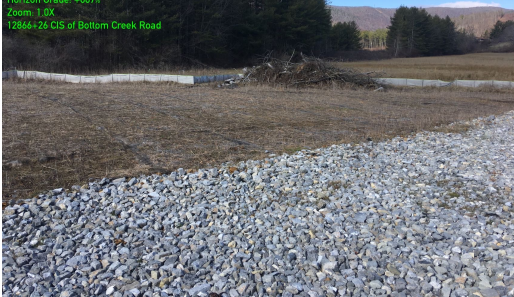
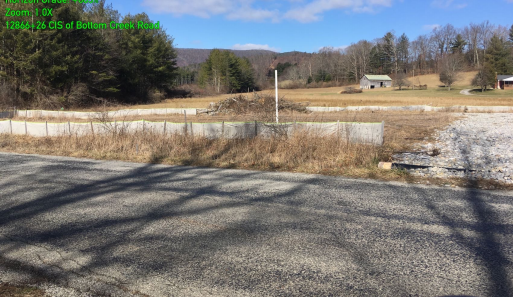
GPS Location	See pic for GPS location		GPS Location	See pic for GPS location	
Field Station#	12866+26		Field Station#	12866+26	
Pic 1 Desc.	No ECD deficiencies found on the CIS of the Bottom Creek Road crossing.		Pic 2 Desc.	No issues or impacts observed throughout the area.

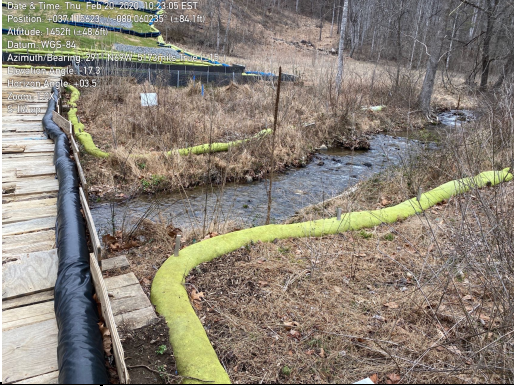
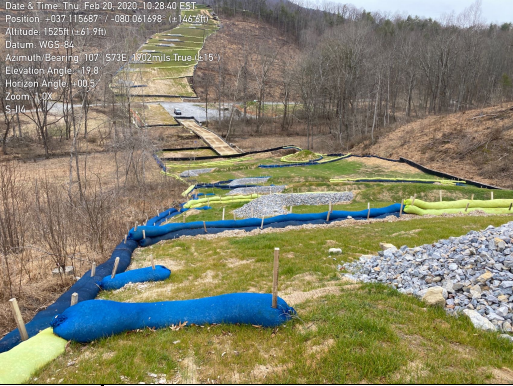
GPS Location	See photo for coordinates.		GPS Location	See photo for coordinates.	
Field Station#	13260+60		Field Station#	13254+00	
Pic 1 Desc.	S-II4, upstream of equipment bridge, ECDs functioning acceptably.		Pic 2 Desc.	ROW restored, moderate vegetative cover noted, permanent waterbars functioning acceptably.

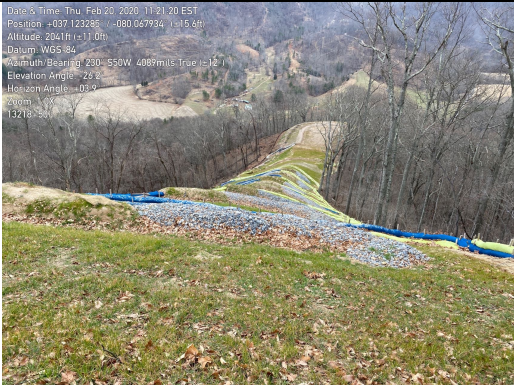
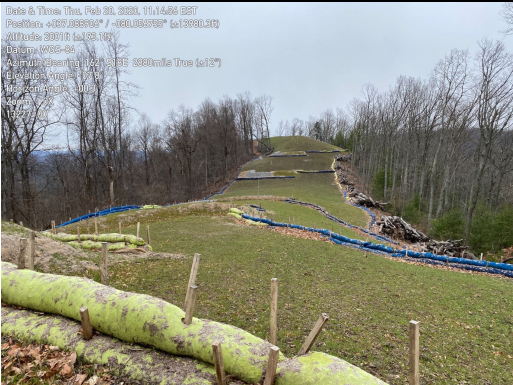
GPS Location	See photo for coordinates.		GPS Location	See photo for coordinates.	
Field Station#	13218+50		Field Station#	13227+00	
Pic 3 Desc.	ROW restored with moderate to good vegetative cover, permanent waterbars functioning acceptably.		Pic 4 Desc.	ROW restored with moderate to good vegetative cover, permanent waterbars functioning acceptably.

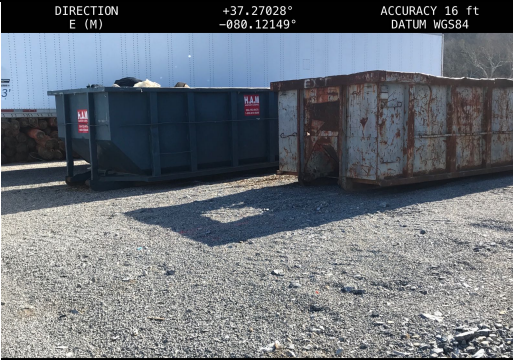
<p>DIRECTION E (M) +37.27028° -080.12149° ACCURACY 16 ft DATUM WGS84</p> <p>MVP-LY-049_022120 No loose trash around south dumpsters 2020-02-21 10:01:17-05:00</p>

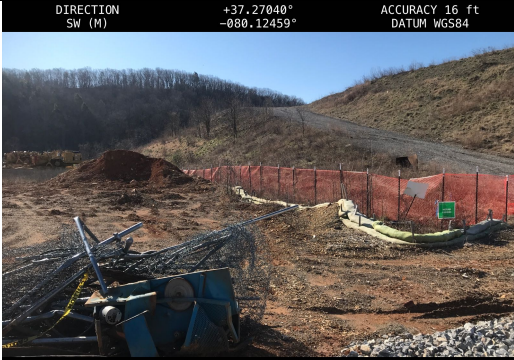
<p>DIRECTION SW (M) +37.27040° -080.12459° ACCURACY 16 ft DATUM WGS84</p> <p>MVP-LY-049_022120 Landowner disturbance along CFS and feature 2020-02-21 10:17:14-05:00</p>		  <p>DIRECTION SE (M) +37.26921° -080.12357° ACCURACY 16 ft DATUM WGS84</p> <p>MVP-LY-049_022120 Condition of CFS around sand pile 2020-02-21 10:19:19-05:00</p>			
GPS Location	MVP-LY-049 See photo for gps data		GPS Location	MVP-LY-049 See photo for gps data	
Field Station#	+0		Field Station#	+0	
Pic 5 Desc.	Landowner disturbance along compost filter sock and feature. No impacts. Looking SW.		Pic 6 Desc.	Condition of compost filter sock and sand pile. Looking NW.

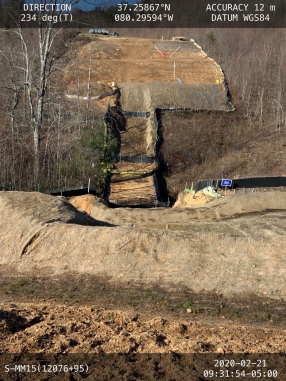
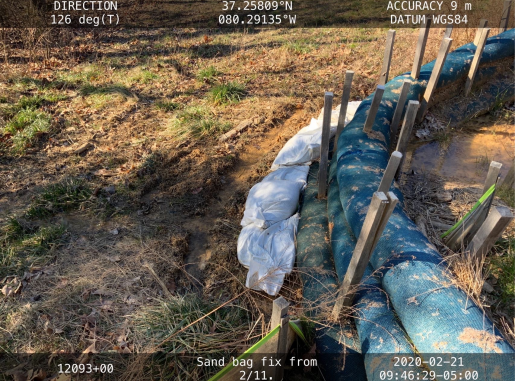
GPS Location	See GPS for location		GPS Location	See GPS for location	
Field Station#	12076+95		Field Station#	12093+00	
Pic 1 Desc.	ECDs surrounding stream in acceptable condition.		Pic 2 Desc.	No sediment filled water leaving the the sump.

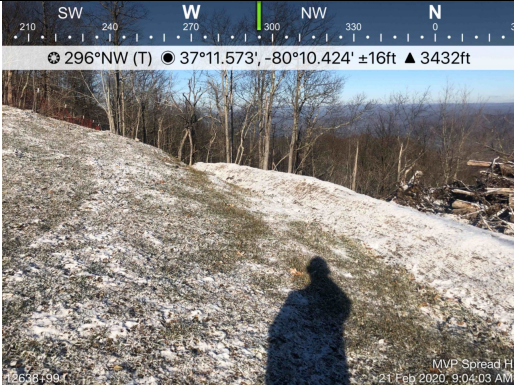
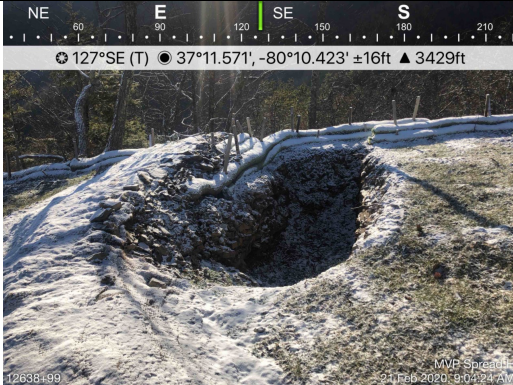
GPS Location	See Picture Watermark		GPS Location	See Picture Watermark	
Field Station#	12638+99		Field Station#	12638+99	
Pic 1 Desc.	Waterbar is vegetated and functioning as installed.		Pic 2 Desc.	Sump pit and CFS end treatment in good condition.

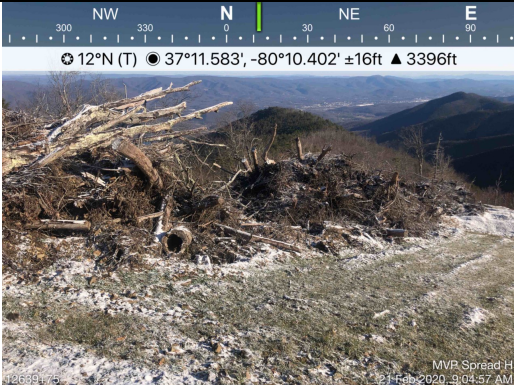
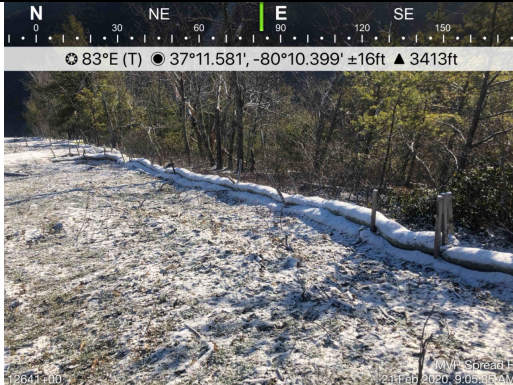
GPS Location	See Picture Watermark		GPS Location	See Picture Watermark	
Field Station#	12639+75		Field Station#	12641+00	
Pic 3 Desc.	Clearing debris stockpiled in middle of ROW.		Pic 4 Desc.	CFS triple stack installed and functional.

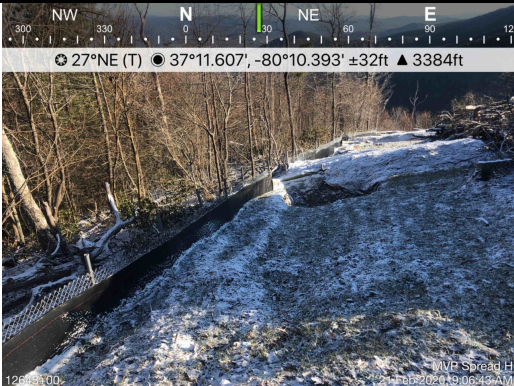
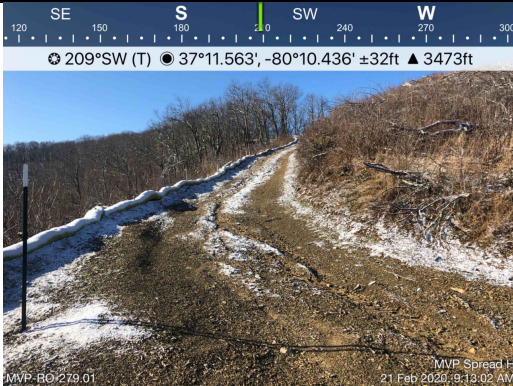
GPS Location	See Picture Watermark		GPS Location	See Picture Watermark	
Field Station#	12643+00		Field Station#	12638+50	
Pic 5 Desc.	SSF installed and functional along perimeter of ROW.		Pic 6 Desc.	Access road MVP-RO-279.01 in good condition.
