## Visual Site Inspection Report

<b>Project Name</b>	H-600 Pipeline Spread H	<b>AFE</b>	124300138	<b>Spread</b>	H-600 Pipeline Spread H
<b>Contractor</b>	Precision			<b>Report #</b>	7929
<b>Inspector</b>	Logan Box			<b>Date/Time</b>	2/4/2020 4:59 PM
<b>Permit #</b>	TBD	<b>Inspection Type</b>	VA SWPP	<b>Station Begin</b>	13415+51
<b>State</b>	VA	<b>Inspection Area</b>	Partial	<b>Station End</b>	13670+00
<b>County</b>	Franklin	<b>Ground</b>	Damp	<b>Temperature (°F)</b>	65.00
<b>Municipality</b>	N/A	<b>Weather</b>	Cloudy	<b>Rain Gauge (in)</b>	0.00
				<b>Rain Accumulation Time (days)</b>	0.00

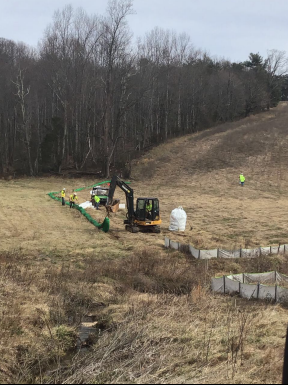
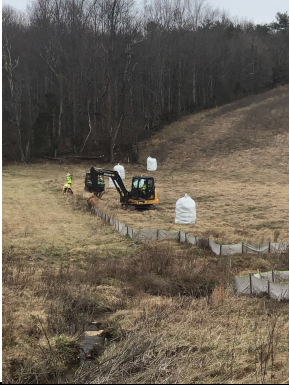
<b>GPS Location</b>	0000		<b>GPS Location</b>	0000	
<b>Field Station#</b>	13548+99		<b>Field Station#</b>	13549+00	
<b>Pic 1 Desc.</b>	Installing new CFS in the place of P1		<b>Pic 2 Desc.</b>	Removing old P1

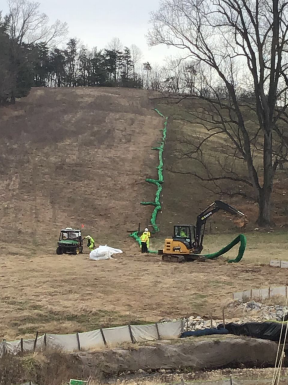
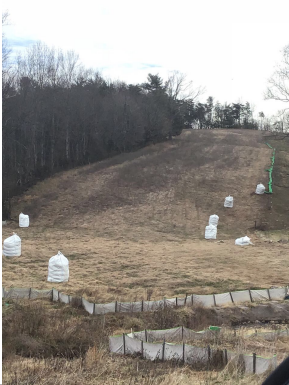
<b>GPS Location</b>	0000		<b>GPS Location</b>	0000	
<b>Field Station#</b>	13549+00		<b>Field Station#</b>	13548+99	
<b>Pic 3 Desc.</b>	Crew installing new CFS on row edge		<b>Pic 4 Desc.</b>	Crew getting materials ready to replace old P1	
Insert image here			Insert image here		
<b>GPS Location</b>			<b>GPS Location</b>		
<b>Field Station#</b>			<b>Field Station#</b>		
<b>Pic 5 Desc.</b>			<b>Pic 6 Desc.</b>

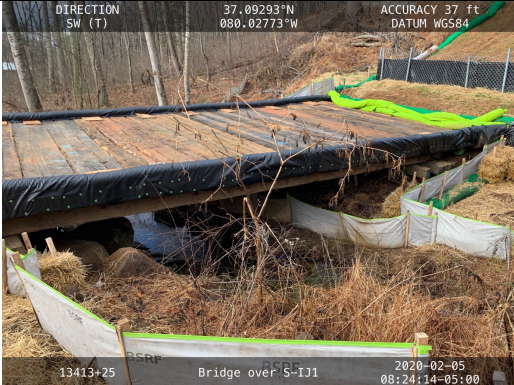
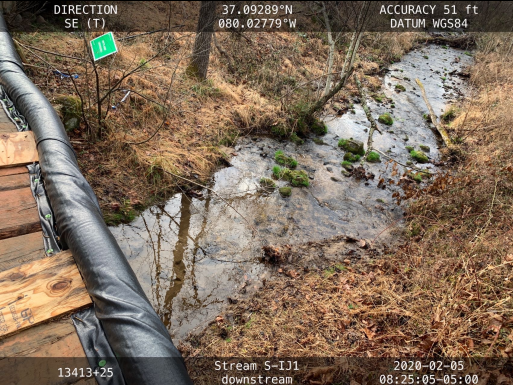
<b>GPS Location</b>	See photo for gps location data.		<b>GPS Location</b>	See photo for gps location data.	
<b>Field Station#</b>	13413+25		<b>Field Station#</b>	13413+00	
<b>Pic 1 Desc.</b>	Photo shows the bridge over stream S-IJ1. No environmental issues were observed.		<b>Pic 2 Desc.</b>	Photo shows stream S-IJ1 downstream from the ROW. No environmental issues were observed.

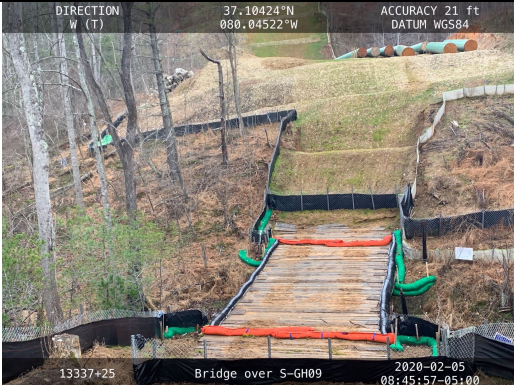
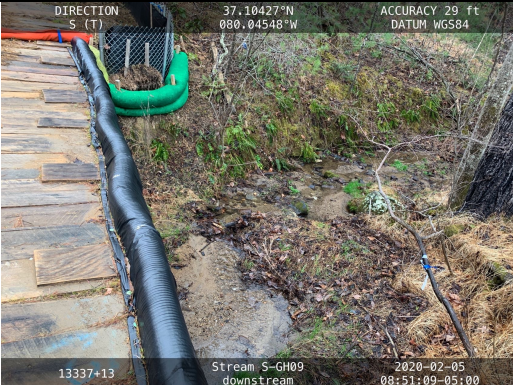
<b>GPS Location</b>	See photo for gps location data.		<b>GPS Location</b>	See photo for gps location data.	
<b>Field Station#</b>	13337+25		<b>Field Station#</b>	13337+13	
<b>Pic 3 Desc.</b>	Photo shows the bridge over stream S-GH09 and adjacent ROW. No environmental issues were observed.		<b>Pic 4 Desc.</b>	Photo shows stream S-GH09 downstream from the ROW. No environmental issues were observed.

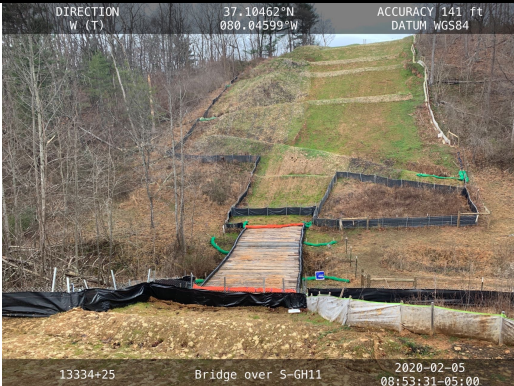
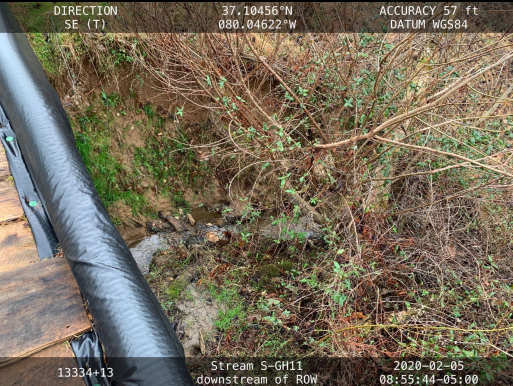
<b>GPS Location</b>	See photo for gps location data.		<b>GPS Location</b>	See photo for gps location data.	
<b>Field Station#</b>	13334+25		<b>Field Station#</b>	13334+17	
<b>Pic 5 Desc.</b>	Photo shows the bridge over stream S-GH11 and adjacent ROW. No environmental issues were observed.		<b>Pic 6 Desc.</b>	Photo shows stream S-GH11 downstream from the ROW. No environmental issues were observed.

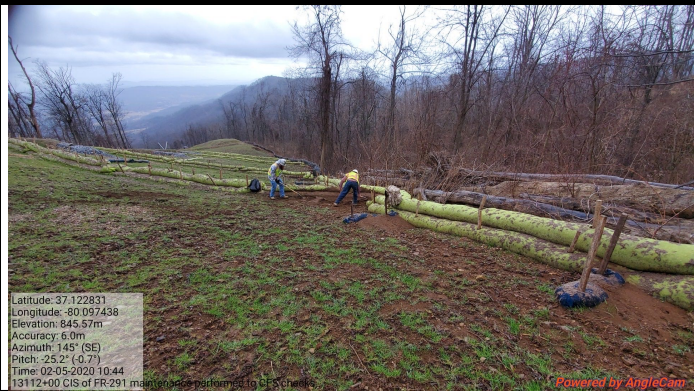
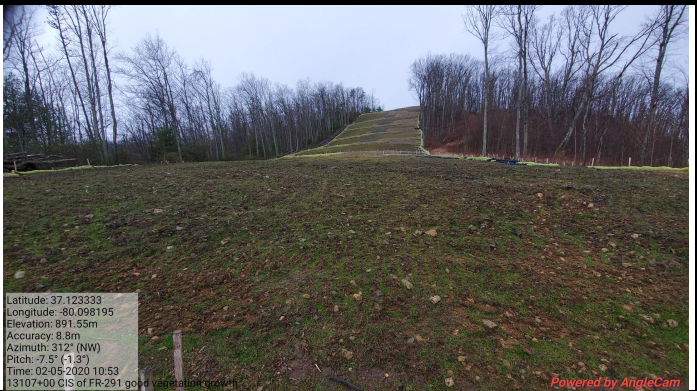
GPS Location	See pic for GPS location		GPS Location	See pic for GPS location	
Field Station#	13112+00		Field Station#	13107+00	
Pic 1 Desc.	2 crew members from John Mueller's crew performed maintenance to the CFS on the CIS of FR-291.		Pic 2 Desc.	Very little erosion observed and good vegetative stabilization coverage across the ROW.

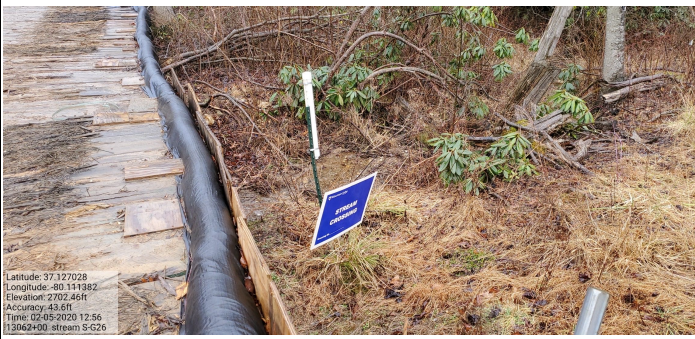
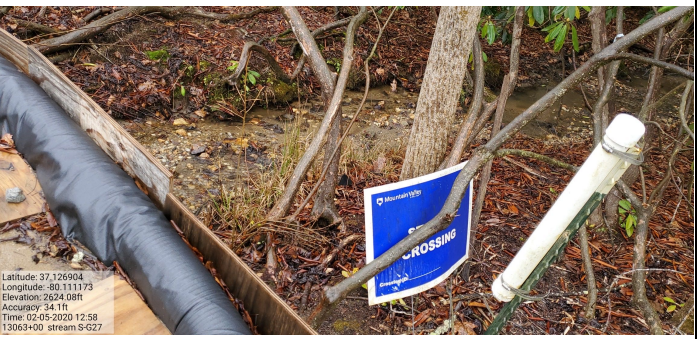
GPS Location	See pic for GPS location		GPS Location	See pic for GPS location	
Field Station#	13062+00		Field Station#	13063+00	
Pic 3 Desc.	No impacts were observed at stream S-G26.		Pic 4 Desc.	No impacts were observed at stream S-G27.

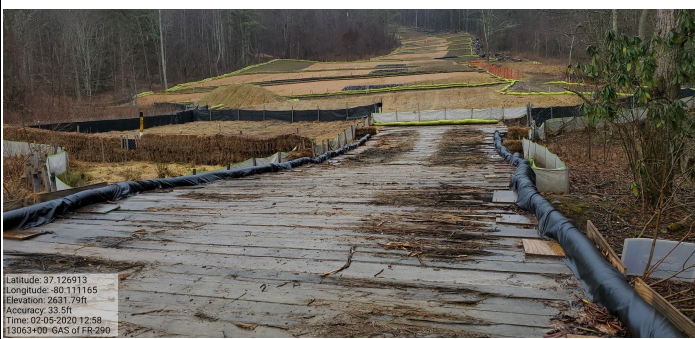
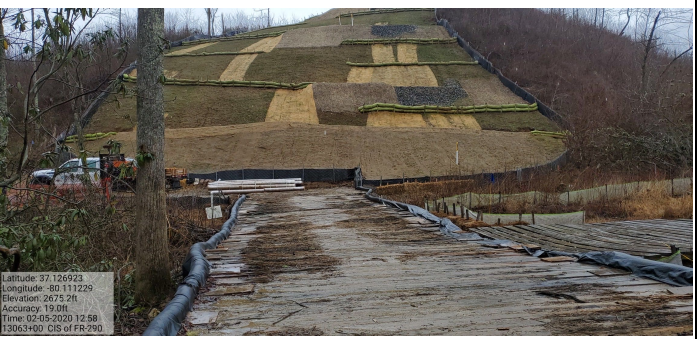
GPS Location	See pic for GPS location		GPS Location	See pic for GPS location	
Field Station#	13063+00		Field Station#	13063+00	
Pic 5 Desc.	GAS of stream S-G27 has had Curlex installed where signs of erosion are beginning to occur.		Pic 6 Desc.	No issues or impacts observed on the CIS of FR-290.

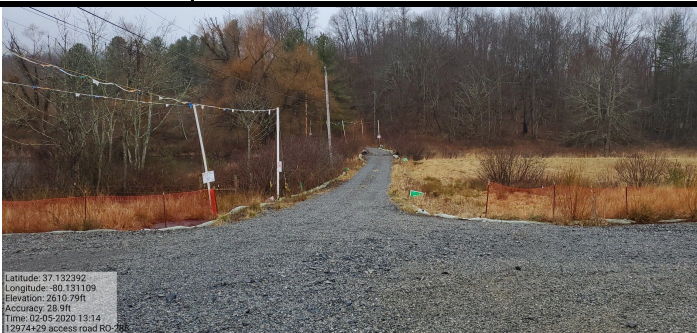
Field Station#	12994+50		Field Station#	12974+29	
Pic 9 Desc.	ECD's and BMP's sufficient on the GAS of the US-221 crossing.		Pic 10 Desc.	No issues or impacts observed on access road RO-288.

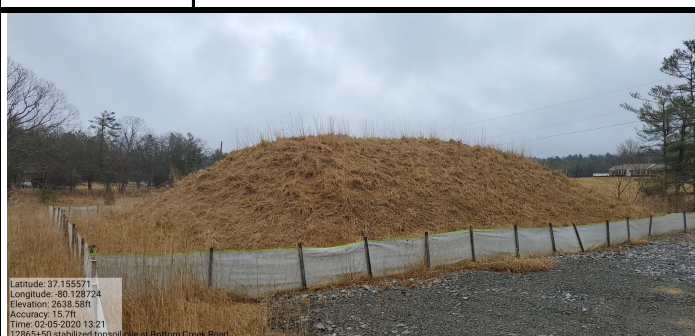
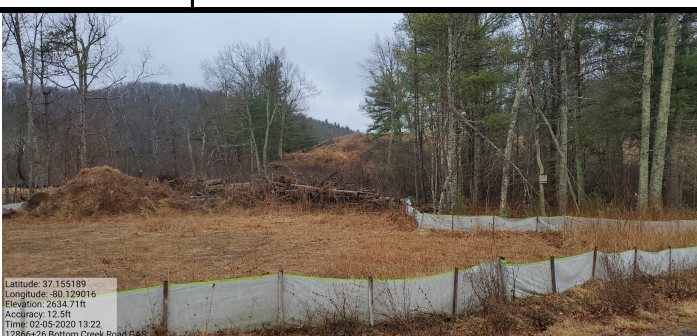
<p>Latitude: 37.155189 Longitude: -80.129016 Elevation: 2634.71ft Accuracy: 12.5ft Time: 02-05-2020 13:22 12866+26 Bottom Creek Road GAS</p>		
GPS Location	See pic for GPS location		GPS Location	See pic for GPS location	
Field Station#	12865+50		Field Station#	12866+26	
Pic 11 Desc.	Topsoil pile remains well stabilized with vegetation at Bottom Creek Road.		Pic 12 Desc.	GAS of the road crossing at Bottom Creek Road remains in good condition.

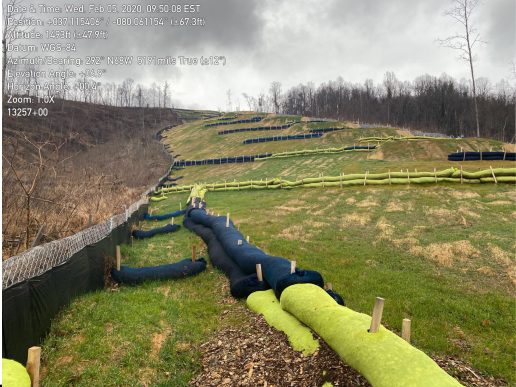
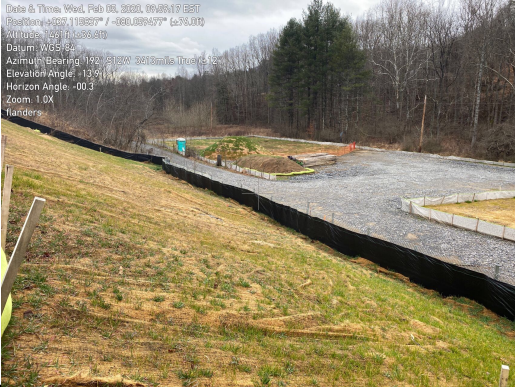
<b>Field Station#</b> 13257+00		<b>Field Station#</b> 13263+00		<b>Pic 3 Desc.</b> ROW stable, perimeter ECDs functioning acceptably.

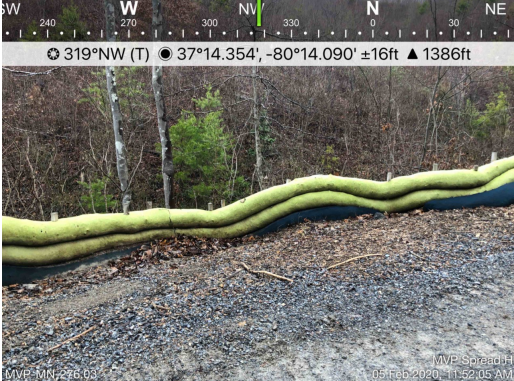
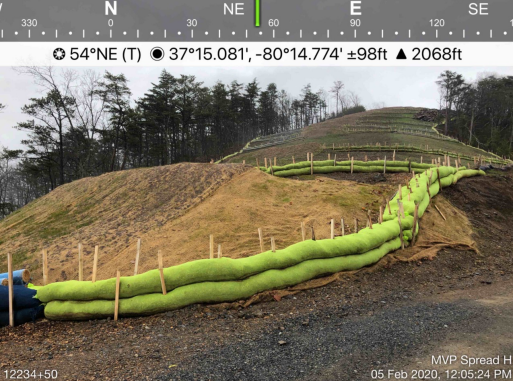
<b>GPS Location</b>	See Picture Watermark		<b>GPS Location</b>	See Picture Watermark	
<b>Field Station#</b>	12234+50		<b>Field Station#</b>	12234+50	
<b>Pic 1 Desc.</b>	Controls along MVP-MN-276.03 are installed and in good condition.		<b>Pic 2 Desc.</b>	Start of inspection at switchback. ROW is stabilized and controls remain installed and functioning as intended.

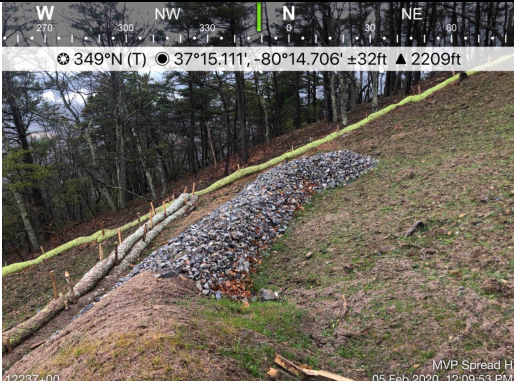
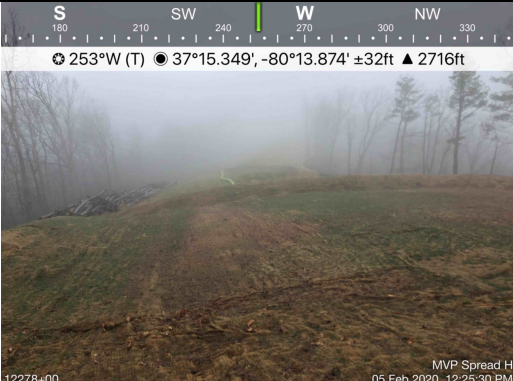
<b>GPS Location</b>	See Picture Watermark		<b>GPS Location</b>	See Picture Watermark	
<b>Field Station#</b>	12237+00		<b>Field Station#</b>	12278+00	
<b>Pic 3 Desc.</b>	Permanent waterbar end treatment (level spreader) installed and appears to functioning as intended.		<b>Pic 4 Desc.</b>	ROW remains stabilized and in good condition.

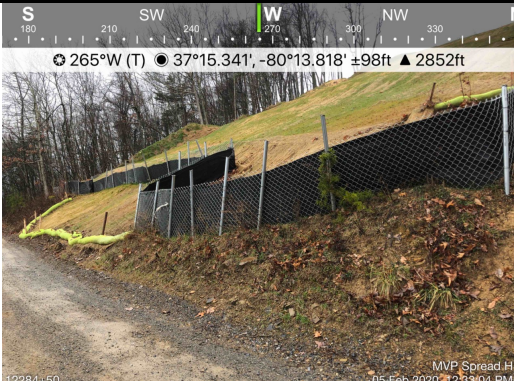
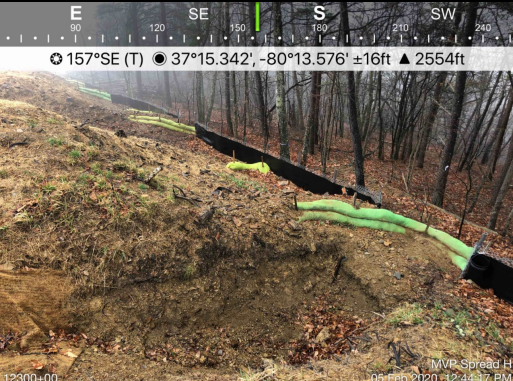
<b>Field Station#</b>	12284+50		<b>Field Station#</b>	12300+00	
<b>Pic 5 Desc.</b>	SSF at access road crossing is in good condition and appears to be functioning.		<b>Pic 6 Desc.</b>	Sump pits and CFS end treatments along ROW are installed and in good condition.

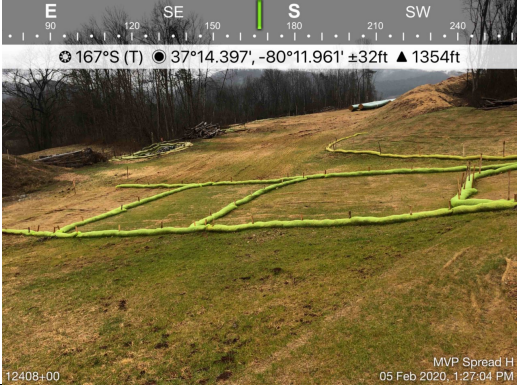
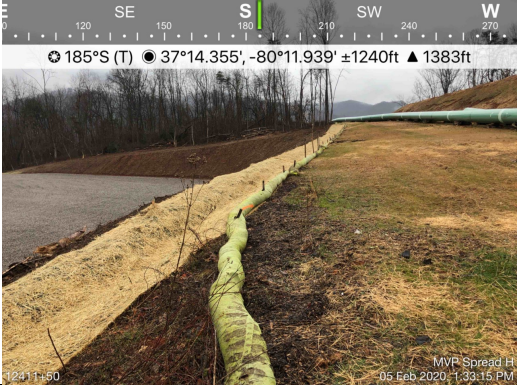
<b>GPS Location</b>	See Picture Watermark		<b>GPS Location</b>	See Picture Watermark	
<b>Field Station#</b>	12408+00		<b>Field Station#</b>	12411+50	
<b>Pic 7 Desc.</b>	ROW and controls near MLV-27 are in good condition.		<b>Pic 8 Desc.</b>	ROW and controls near MLV-27 and Roanoke Gas activity are in good condition.

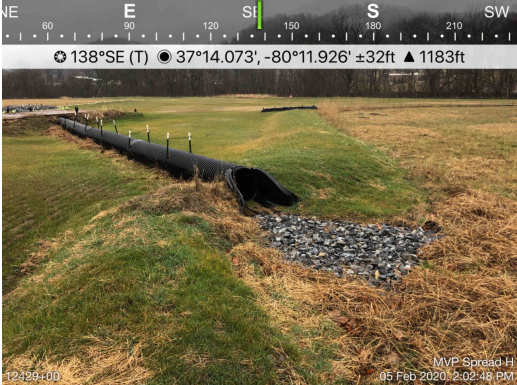
<b>GPS Location</b>	See Picture Watermark		<b>GPS Location</b>	See Picture Watermark	
<b>Field Station#</b>	12408+00		<b>Field Station#</b>	12429+00	
<b>Pic 9 Desc.</b>	CWD inlet structure in good condition and free of excess sediment.		<b>Pic 10 Desc.</b>	Floodplain CWD in good condition and free of excess sediment.

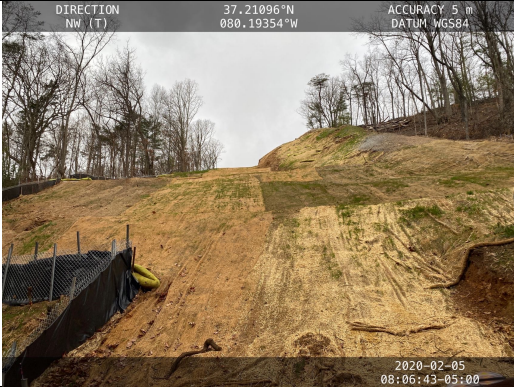
<b>GPS Location</b>	See picture for GPS data		<b>GPS Location</b>	See picture for GPS data	
<b>Field Station#</b>	12542+00		<b>Field Station#</b>	12543+56	
<b>Pic 1 Desc.</b>	Stabilized hillside.		<b>Pic 2 Desc.</b>	Triple stack CFS protecting wetland alongside yellow finch road

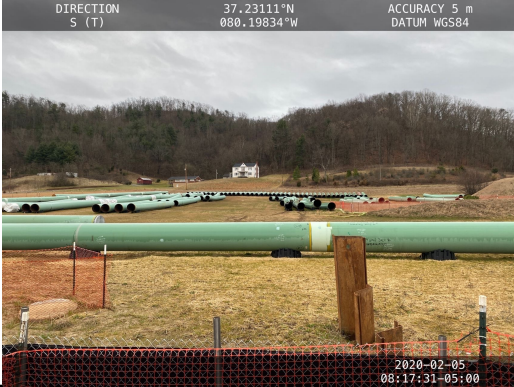
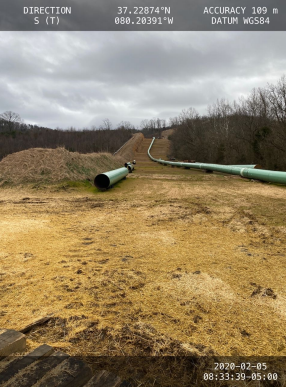
<b>GPS Location</b>	See picture for GPS data		<b>GPS Location</b>	See picture for GPS data	
<b>Field Station#</b>	12445+80		<b>Field Station#</b>	12464+50	
<b>Pic 3 Desc.</b>	Stabilized ATWS		<b>Pic 4 Desc.</b>	Stabilized ROW

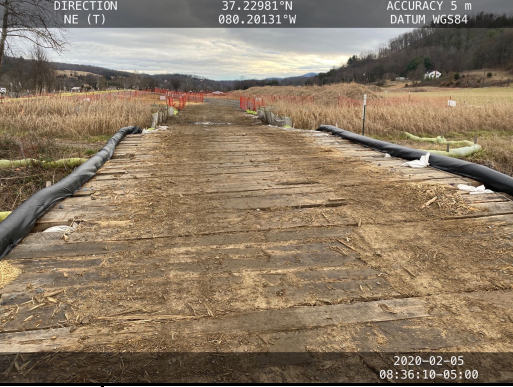
<b>GPS Location</b>	See picture for GPS data		<b>GPS Location</b>	See picture for GPS data	
<b>Field Station#</b>	12460+76		<b>Field Station#</b>	12455+21	
<b>Pic 5 Desc.</b>	Wetland W-KL58		<b>Pic 6 Desc.</b>	Bridge over feature S-CD12b
