Visual Site Inspection Report

Project Name	H-600 Pipeline Spread H	AFE	124300138	Spread	H-600 Pipeline Spread H
Contractor	Precision			Report #	9190
Inspector	Pat Davis			Date/Time	3/16/2020 4:00 PM
Permit #	TBD	Inspection Type	VA SWPP	Station Begin	+0
State	VA	Inspection Area	Partial	Station End	+0
County	Montgomery	Ground	Wet	Temperature (°F)	46.00
Municipality	N/A	Weather	Cloudy	Rain Gauge (in)	0.60
				Rain Accumulation Time (days)	3.00

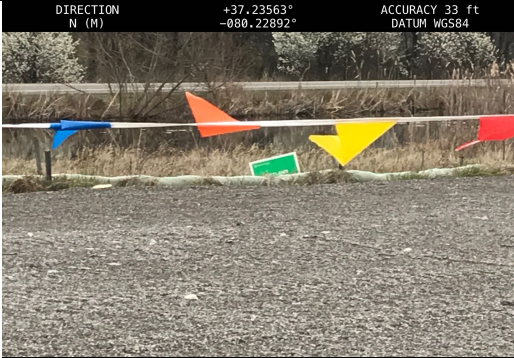
<p>DIRECTION N (M) +37.23563° -080.22892° ACCURACY 33 ft DATUM WGS84</p> <p>MVP-PY-006_031620 Condition of signage and buffer flagging 2020-03-16 08:54:25-04:00</p>

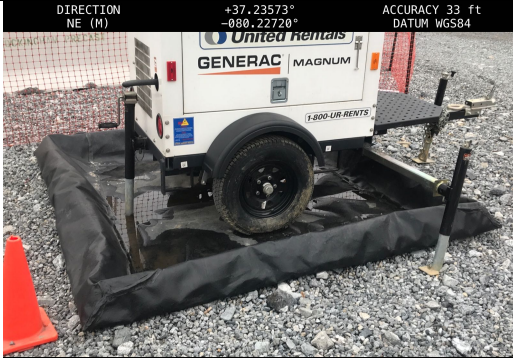
<p>DIRECTION NE (M) +37.23573° -080.22720° ACCURACY 33 ft DATUM WGS84</p> <p>MVP-PY-006_031620 Condition of containment 2020-03-16 08:55:26-04:00</p>			
GPS Location	MVP-PY-006 See photo for gps data		GPS Location	MVP-PY-006 See photo for gps data	
Field Station#	+0		Field Station#	+0	
Pic 1 Desc.	Signage and buffer flagging for feature. Looking N.		Pic 2 Desc.	Condition of containment under light plant. Looking NE.

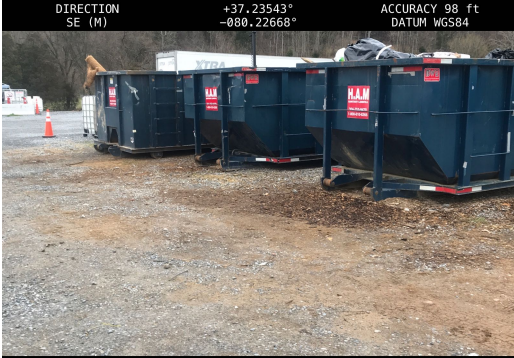
<p>DIRECTION SE (M) +37.23543° -080.22668° ACCURACY 98 ft DATUM WGS84</p> <p>MVP-PY-006_031620 No loose trash around dumpsters 2020-03-16 08:58:22-04:00</p>

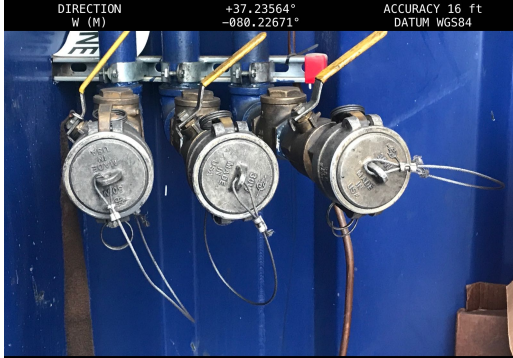
<p>DIRECTION W (M) +37.23564° -080.22671° ACCURACY 16 ft DATUM WGS84</p> <p>MVP-PY-006_031620 Fuel tanks no leaky internal fittings 2020-03-16 08:59:06-04:00</p>

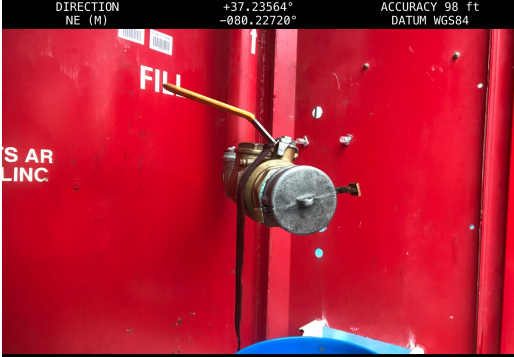
<p>DIRECTION NE (M) +37.23564° -080.22720° ACCURACY 98 ft DATUM WGS84</p> <p>MVP-PY-006_031620 No leaky internal fittings 2020-03-16 09:01:04-04:00</p>

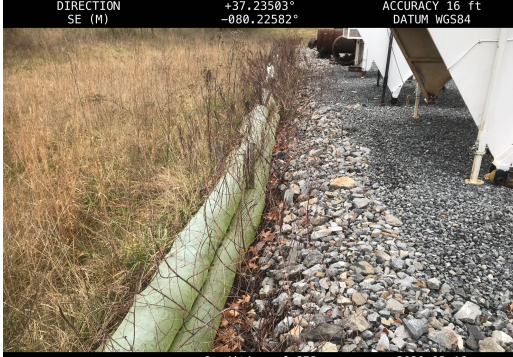
<p>DIRECTION SE (M) +37.23503° -080.22582° ACCURACY 16 ft DATUM WGS84</p> <p>MVP-PY-006_031620 Condition of CFS along East LOD 2020-03-16 09:04:47-04:00</p>			
GPS Location	MVP-PY-006 See photo for gps data		GPS Location	MVP-PY-006 See photo for gps data	
Field Station#	+0		Field Station#	+0	
Pic 5 Desc.	Off Road Fuel unit no leaky internal fittings. Looking NE.		Pic 6 Desc.	Condition of compost filter sock along the East LOD. Looking SE.

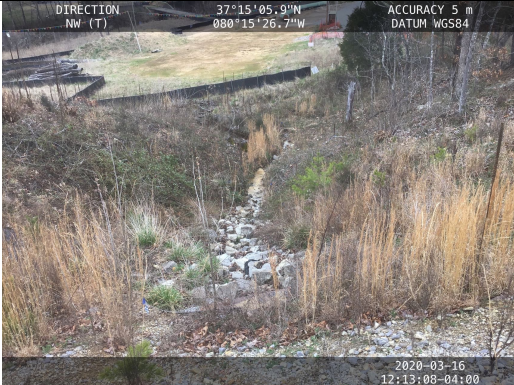
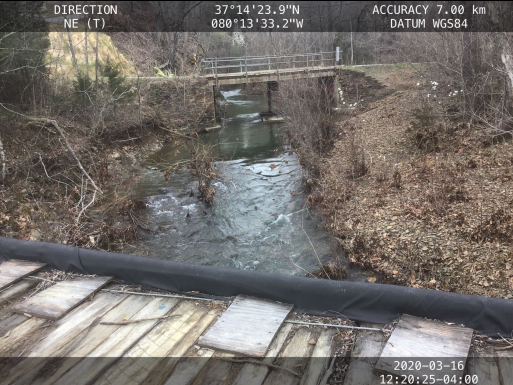
GPS Location	See photo		GPS Location	See photo	
Field Station#	12197+37		Field Station#	12192+50	
Pic 1 Desc.	Stream S-OO11, facing northwest, downstream		Pic 2 Desc.	Stream S-C21, facing northeast, upstream

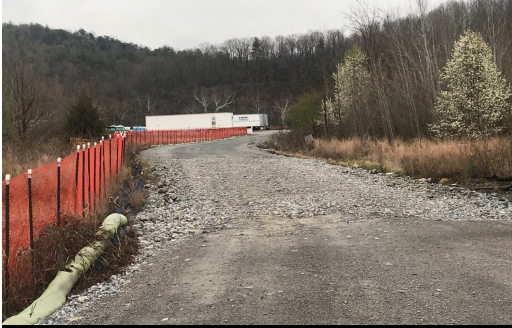
MVP-LY-049_031620 Condition of rock entrance 2020-03-16 09:26:06-04:00		DIRECTION N (M) +37.27185° -080.12172° ACCURACY 33 ft DATUM WGS84

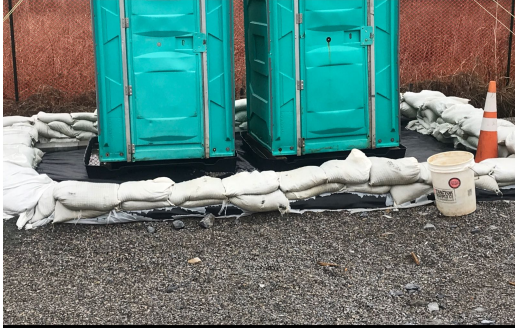
MVP-LY-049_031620 Condition of trays and containment 2020-03-16 09:33:52-04:00			
GPS Location	MVP-LY-049 See photo for gps data		GPS Location	MVP-LY-049 See photo for gps data	
Field Station#	+0		Field Station#	+0	
Pic 1 Desc.	Condition of rock entrance on center driveway. Looking S.		Pic 2 Desc.	Condition of trays and containment under toilets. Looking N.	
DIRECTION SE (M) +37.27095° -080.11990° ACCURACY 16 ft DATUM WGS84

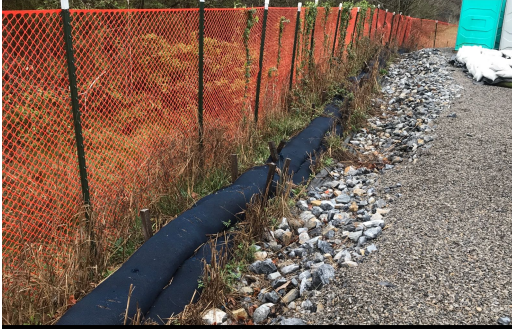
MVP-LY-049_031620 Condition of CFS & safety fence 2020-03-16 09:35:40-04:00		DIRECTION S (M) +37.27369° -080.11599° ACCURACY 0.88 mi DATUM WGS84

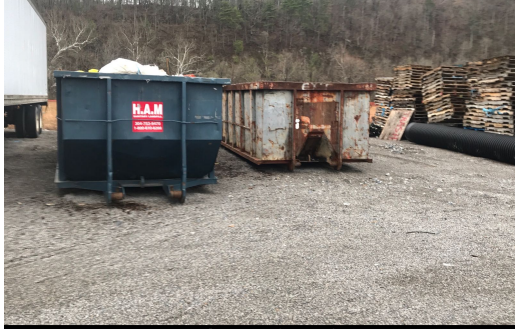
MVP-LY-049_031620 No loose trash around south dumpsters 2020-03-16 09:37:58-04:00

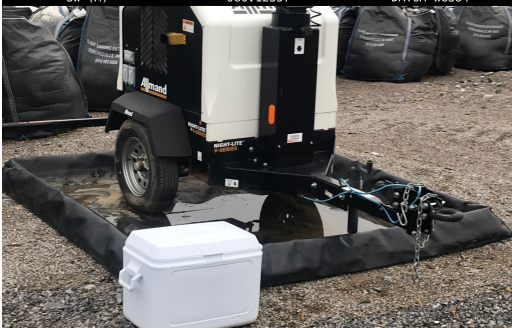
MVP-LY-049_031620 Condition of containment 2020-03-16 09:40:05-04:00		DIRECTION S (M) +37.27036° -080.12470° ACCURACY 16 ft DATUM WGS84

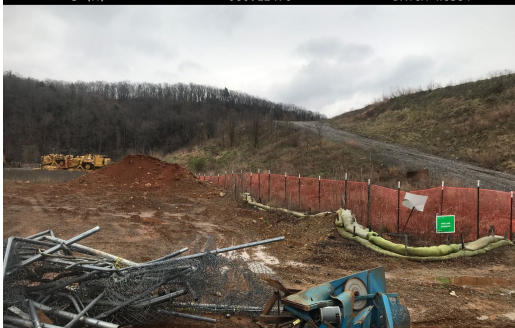
MVP-LY-049_031620 Landowner disturbance along CFS & feature 2020-03-16 09:41:12-04:00			
GPS Location	MVP-LY-049 See photo for gps data		GPS Location	MVP-LY-049 See photo for gps data	
Field Station#	+0		Field Station#	+0	
Pic 5 Desc.	Condition of containment under light plant. Holding some stormwater. No sheen. Looking SW.		Pic 6 Desc.	Landowner disturbance along compost filter sock and feature. No impacts. Looking S.

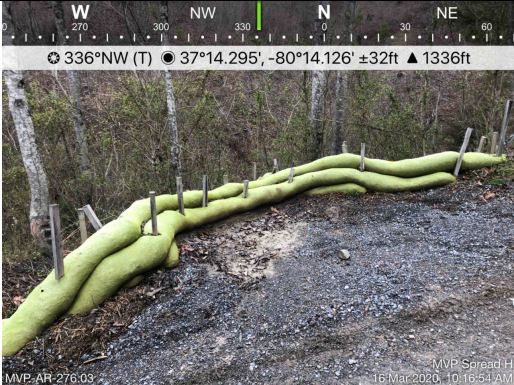
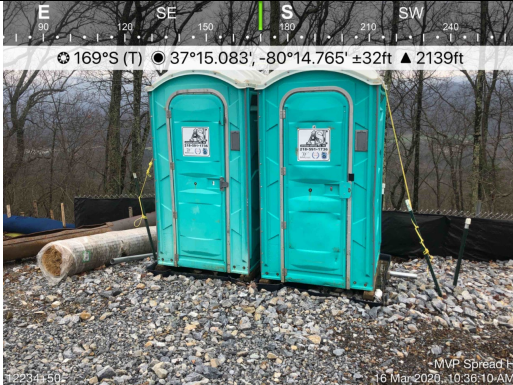
GPS Location	See Picture Coordinates		GPS Location	See Picture Coordinates	
Field Station#	12234+50		Field Station#	12234+50	
Pic 1 Desc.	Access road MVP-AR-176.03 is in good condition and all controls appeared functional.		Pic 2 Desc.	Portable toilets at inspection start area are in good condition and secondary containment is adequate.

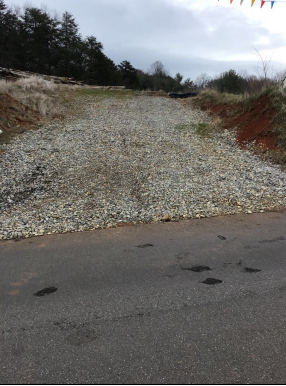
GPS Location	0000	GPS Location	0000		
Field Station#	13575+35	Field Station#	13574+80		
Pic 1 Desc.	Observed RCEs at road crossings while traveling the row.	Pic 2 Desc.	Observed erosion control blanket to be sure it was in place and functioning properly

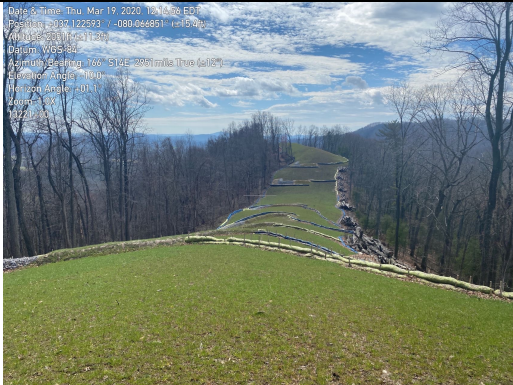
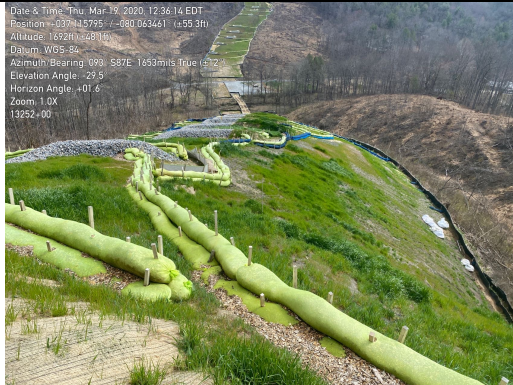
GPS Location				See photo for coordinates.				GPS Location				See photo for coordinates.			
Field Station#				13221+00				Field Station#				13252+00			
Pic 3 Desc.				LOW restored, permanent waterbars stable, vegetative cover noted across LOD.				Pic 4 Desc.				Sediment accumulating along SSF at bottom of steep slope.
