Visual Site Inspection Report

Project Name	H-600 Pipeline Spread H	AFE	124300138	Spread	H-600 Pipeline Spread H
Contractor	Precision			Report #	9981
Inspector	Pat Davis			Date/Time	4/13/2020 4:00 PM
Permit #	TBD	Inspection Type	VA SWPP	Station Begin	+0
State	VA	Inspection Area	Partial	Station End	+0
County	Montgomery	Ground	Wet	Temperature (°F)	66.00
Municipality	N/A	Weather	Light Rain	Rain Gauge (in)	2.30
				Rain Accumulation Time (days)	0.00

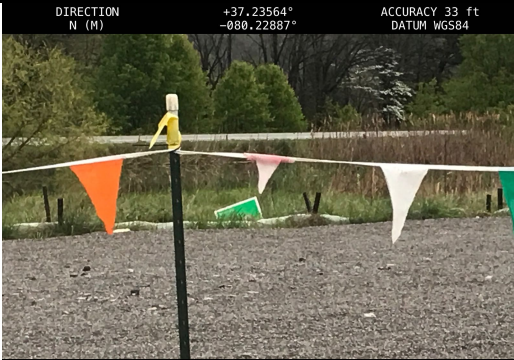
<p>DIRECTION N (M) +37.23564° -080.22687° ACCURACY 33 ft DATUM WGS84</p> <p>MVP-PY-006_041320 Signage and buffer flagging for feature 2020-04-13 07:25:51-04:00</p>

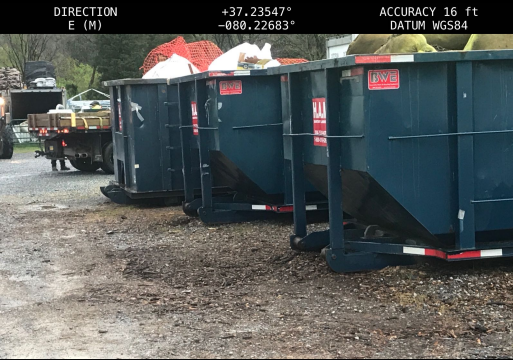
<p>DIRECTION E (M) +37.23547° -080.22683° ACCURACY 16 ft DATUM WGS84</p> <p>MVP-PY-006_041320 No loose trash around dumpsters 2020-04-13 07:28:40-04:00</p>			
GPS Location	MVP-PY-006 See photo for gps data		GPS Location	MVP-PY-006 See photo for gps data	
Field Station#	+0		Field Station#	+0	
Pic 1 Desc.	Signage and buffer flagging for feature W-008. Looking N.		Pic 2 Desc.	No loose trash around dumpsters. Looking E.

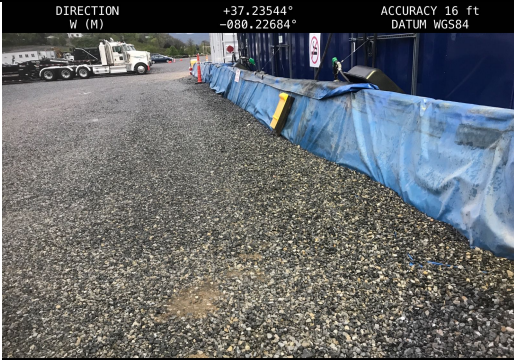
<p>DIRECTION W (M) +37.23544° -080.22684° ACCURACY 16 ft DATUM WGS84</p> <p>MVP-PY-006_041320 No fuel spills south of bulk tanks 2020-04-13 07:29:00-04:00</p>

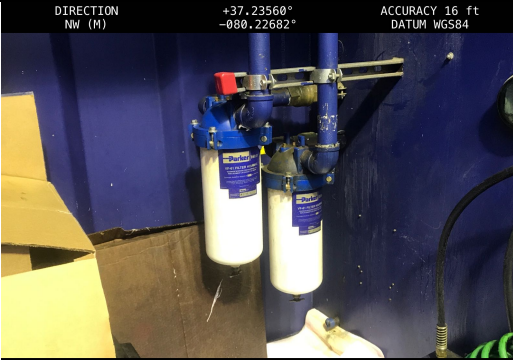
<p>DIRECTION NW (M) +37.23560° -080.22682° ACCURACY 16 ft DATUM WGS84</p> <p>MVP-PY-006_041320 No leaky internal fittings 2020-04-13 07:30:04-04:00</p>

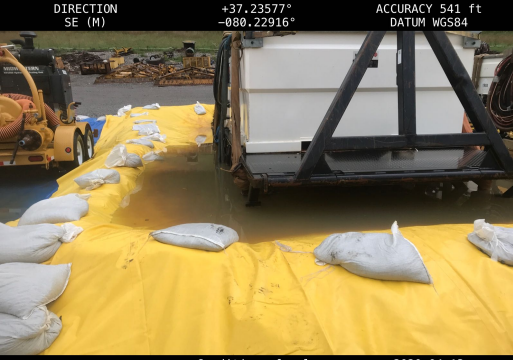
<p>DIRECTION SE (M) +37.23577° -080.22916° ACCURACY 541 ft DATUM WGS84</p> <p>MVP-PY-006_041320 Condition of poly lined containment 2020-04-13 07:51:03-04:00</p>			
GPS Location	MVP-PY-006 See photo for gps data		GPS Location	MVP-PY-006 See photo for gps data	
Field Station#	+0		Field Station#	+0	
Pic 5 Desc.	Off Road Fuel unit no leaky internal fittings. Looking NW.		Pic 6 Desc.	Condition of poly lined containment. Holding stormwater. Looking SE.

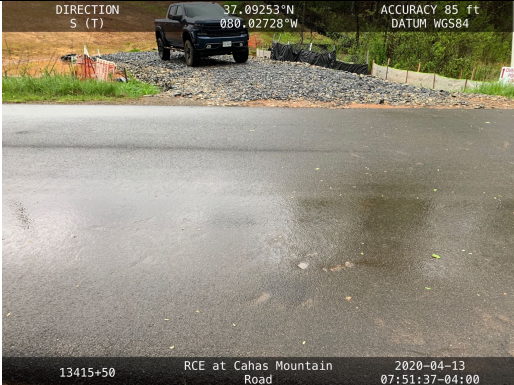
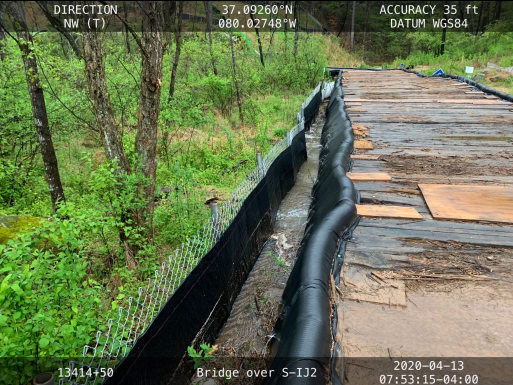
GPS Location	See photo for gps location data.		GPS Location	See photo for gps location data.	
Field Station#	13415+50		Field Station#	13414+50	
Pic 1 Desc.	Photo shows the RCE on the east side Cahas Mountain Road.		Pic 2 Desc.	Photo shows the holes in the equipment bridge geotechnical fabric.

E&S BMPs	Compliance Level	Corrective Action	Corrective Time Frame	Date Repaired
Compost Filter Sock	Acceptable			
Equipment Bridge	Communication	Holes in Geotech under bridge	24 Hours	4/14/2020
Rock Construction Entrance	Acceptable			
Silt Fence (Filter Fabric Fence)	Acceptable			
Silt Fence (Reinforced Filter Fabric Fence)	Acceptable			
Sump Pit	Acceptable

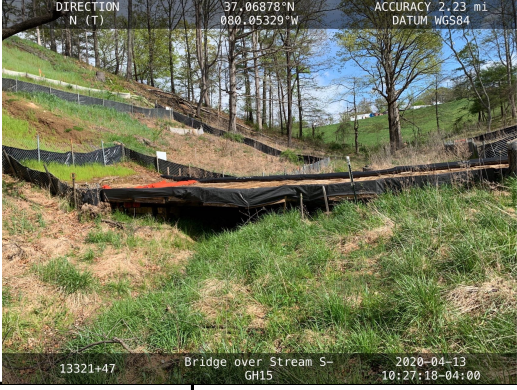
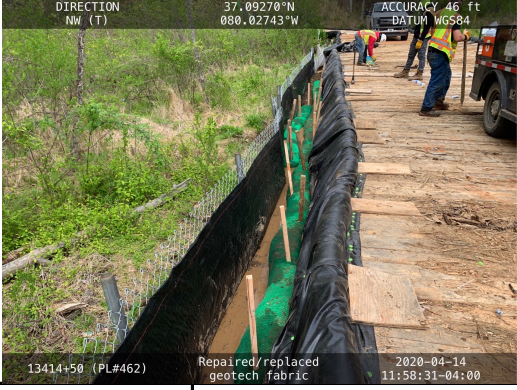
GPS Location	See photo for gps location data.		GPS Location	See photo for gps location data.	
Field Station#	13321+47		Field Station#	13414+50	
Pic 17 Desc.	Photo shows the bridge over stream S-GH15.		Pic 18 Desc.	Photo shows the repaired geotechnical fabric. Punch list item number 462.

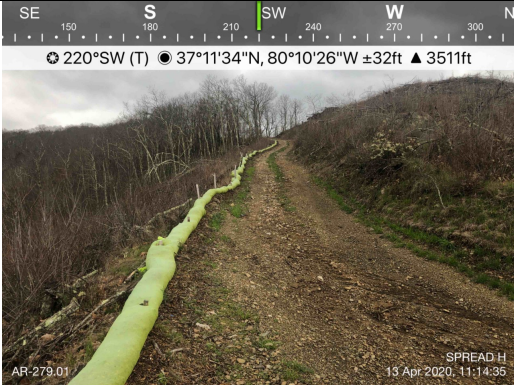
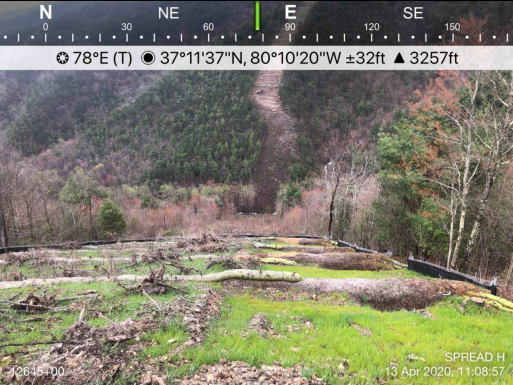
GPS Location	see photo		GPS Location	see photo	
Field Station#	279+01		Field Station#	12645+00	
Pic 1 Desc.	AR-279.01 in good condition.		Pic 2 Desc.	GAS slope of AR-279.01 in good condition with controls in place.

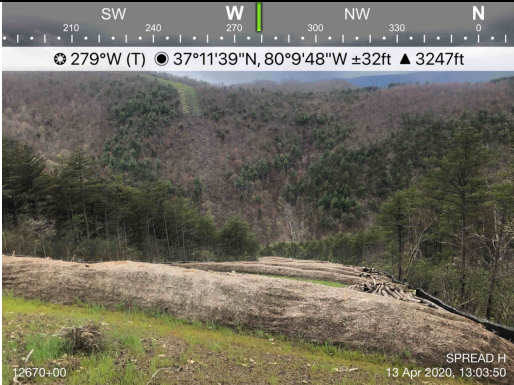
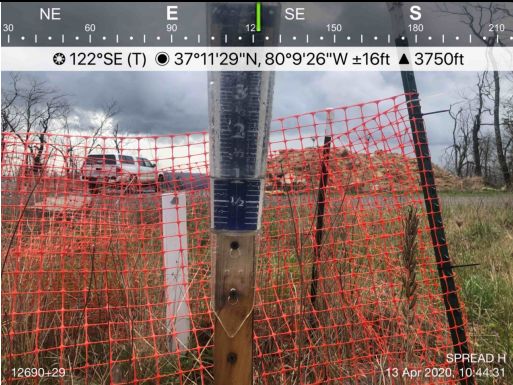
GPS Location	see photo		GPS Location	see photo	
Field Station#	12670+00		Field Station#	12690+29	
Pic 3 Desc.	CIS of Honeysuckle Rd. in good condition.		Pic 4 Desc.	Rain gauge at Honeysuckle reading 1"

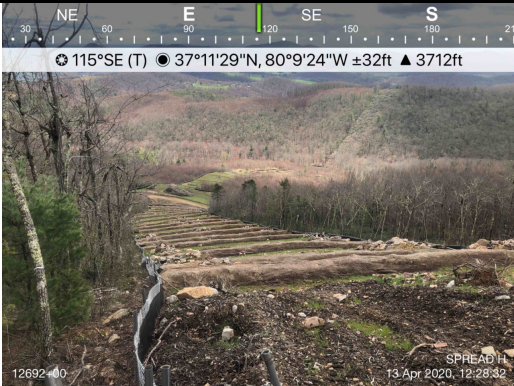
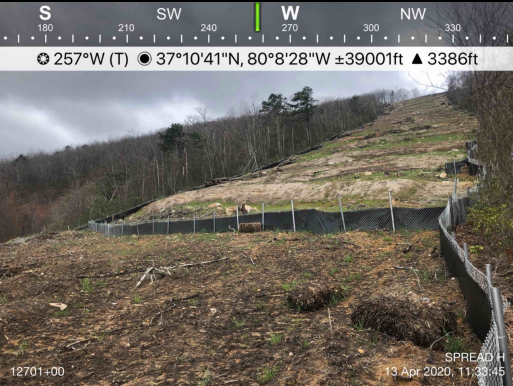
GPS Location	see photo		GPS Location	see photo	
Field Station#	12692+00		Field Station#	12701+00	
Pic 5 Desc.	GAS of Honeysuckle in good condition.		Pic 6 Desc.	Additional controls at this location are functioning.

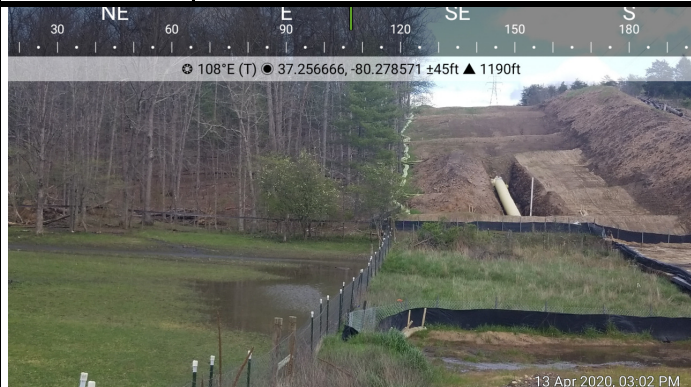
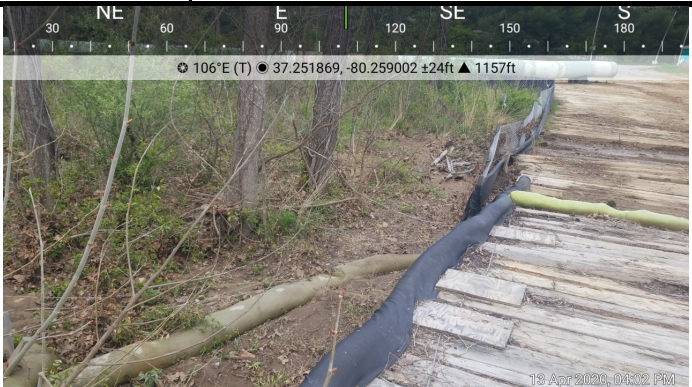
GPS Location	See Above		GPS Location	See Above	
Field Station#	12132+00		Field Station#	12193+00	
Pic 5 Desc.	Punchlist Item. Super Siltfence requires repair near Stream S-C29.		Pic 6 Desc.	Punchlist Item. Supersiltfence and CFS require repair/maintenance near Stream S-C21.

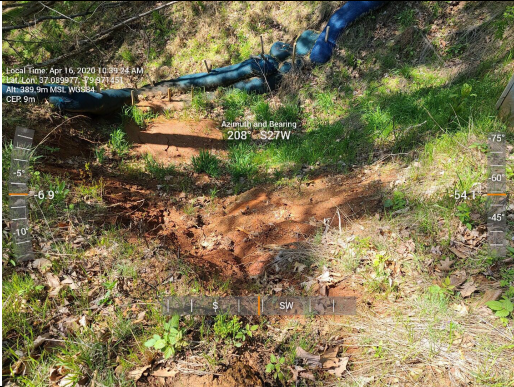
GPS Location	0000	GPS Location	0000		
Field Station#	13590+00	Field Station#	13592+00		
Pic 1 Desc.	Erosion at start of natural drain, recommend installing erosion blanket	Pic 2 Desc.	Row photo showing vegetation while inspecting areas of row

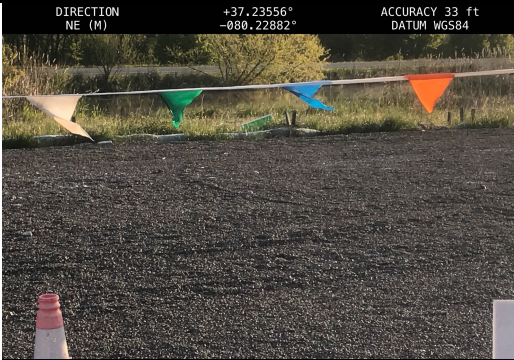
<p>DIRECTION NE (M) +37.23556° -080.22882° ACCURACY 33 ft DATUM WGS84</p> <p>MVP-PY-006_041720 Signage and buffer flagging for feature 2020-04-17 07:32:02-04:00</p>

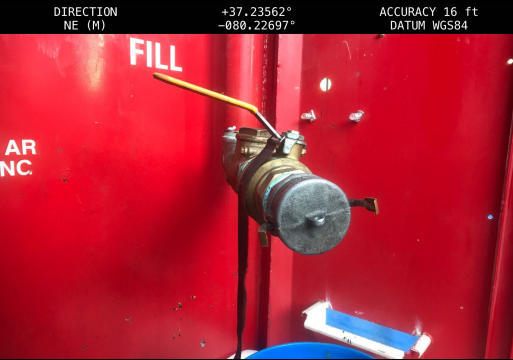
<p>DIRECTION NE (M) +37.23562° -080.22697° ACCURACY 16 ft DATUM WGS84</p> <p>MVP-PY-006_041720 No leaky internal fittings 2020-04-17 07:38:58-04:00</p>			
GPS Location	MVP-PY_006 See photo for gps data	GPS Location	MVP-PY_006 See photo for gps data		
Field Station#	+0	Field Station#	+0		
Pic 1 Desc.	Condition of signage and buffer flagging at feature W-008. Looking NE.	Pic 2 Desc.	Off Road Fuel unit no leaky internal fittings. Looking NW.

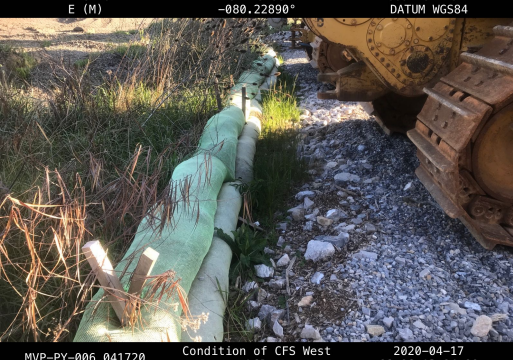
<p>DIRECTION E (M) +37.23453° -080.22690° ACCURACY 16 ft DATUM WGS84</p> <p>MVP-PY-006_041720 Condition of CFS West LOD 2020-04-17 08:06:13-04:00</p>			
GPS Location	MVP-PY_006 See photo for gps data	GPS Location	MVP-PY_006 See photo for gps data		
Field Station#	+0	Field Station#	+0		
Pic 5 Desc.	Blue Bulk Fuel tanks no leaky internal fittings. Looking SW.	Pic 6 Desc.	Condition of compost filter sock along West LOD. Looking N.

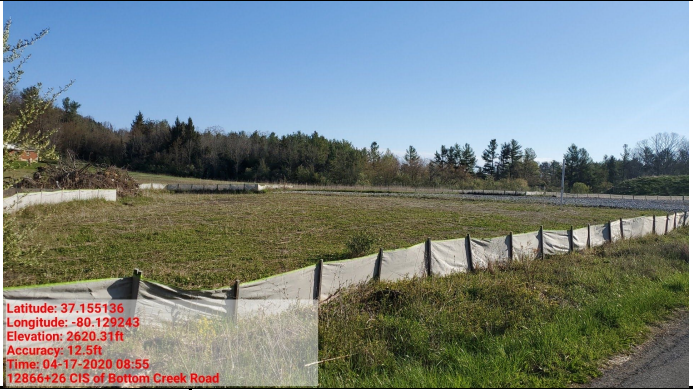
<p>Latitude: 37.155136 Longitude: -80.129243 Elevation: 2620.31ft Accuracy: 12.5ft Time: 04-17-2020 08:55 12866+26 CIS of Bottom Creek Road</p>		
GPS Location	See pic for GPS location		GPS Location	See pic for GPS location	
Field Station#	12866+26		Field Station#	12866+26	
Pic 1 Desc.	No issues or impacts observed on the GAS of Bottom Creek Road.		Pic 2 Desc.	No issues or impacts observed on the CIS of Bottom Creek Road.

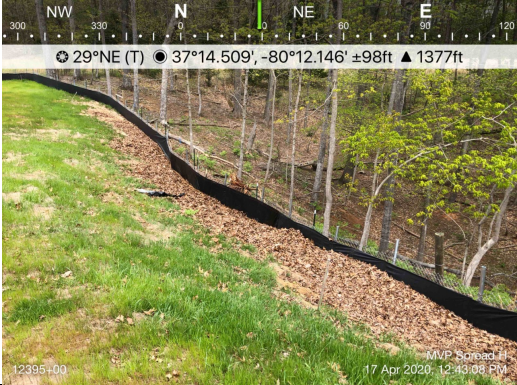
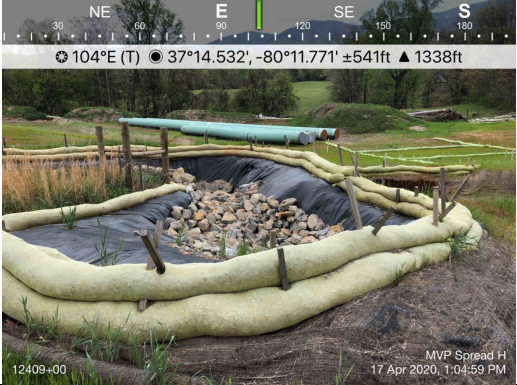
GPS Location	See Picture Watermark		GPS Location	See Picture Watermark	
Field Station#	12395+00		Field Station#	12409+00	
Pic 13 Desc.	Previously damaged SSF by uprooted tree has been repaired, and controls are in good condition.		Pic 14 Desc.	CWD inlet is in good condition and free of sediment/material.

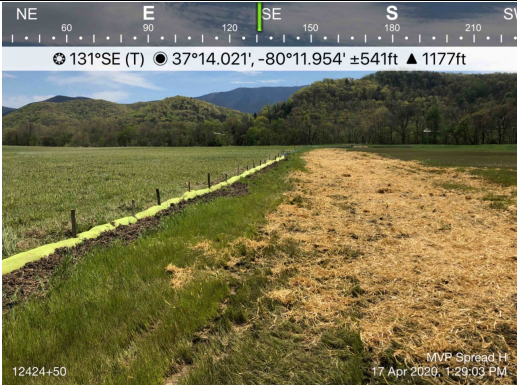
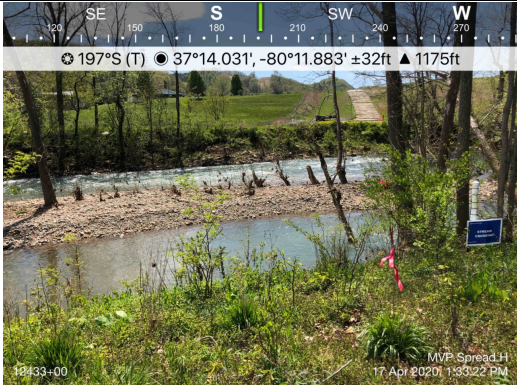
GPS Location	See Picture Watermark		GPS Location	See Picture Watermark	
Field Station#	12424+50		Field Station#	12433+00	
Pic 17 Desc.	Crews were in the area stabilizing previously disturbed areas from CFS repair/replacement.		Pic 18 Desc.	Roanoke River (S-NN16) is in good condition, and buffer area remains un-impacted.
