Visual Site Inspection Report

Project Name	H-600 Pipeline Spread H	AFE	124300138	Spread	H-600 Pipeline Spread H
Contractor	Precision	Report #	10835		
Inspector	Pat Davis	Date/Time	5/11/2020 4:00 PM		
Permit #	TBD	Inspection Type	VA SWPP	Station Begin	+0
State	VA	Inspection Area	Partial	Station End	+0
County	Montgomery	Ground	Dry	Temperature (°F)	52.00
Municipality	N/A	Weather	Cloudy	Rain Gauge (in)	0.00
				Rain Accumulation Time (days)	0.00

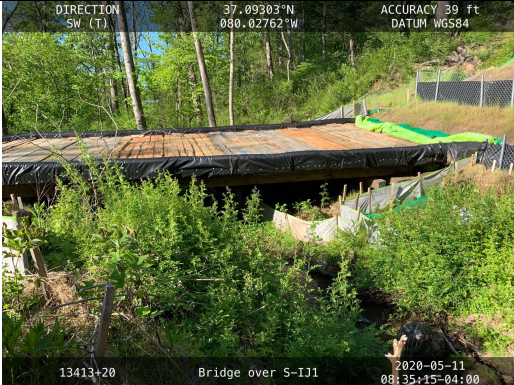
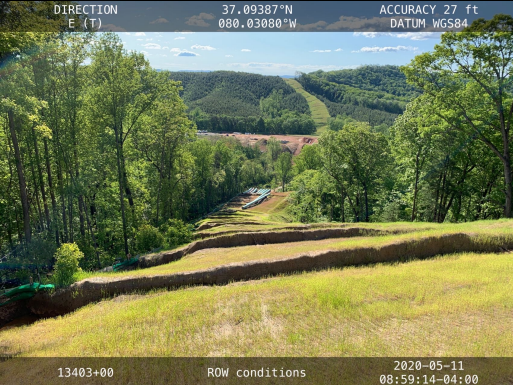
GPS Location	See photo for gps location data.		GPS Location	See photo for gps location data.	
Field Station#	13413+20		Field Station#	13403+00	
Pic 1 Desc.	Photo shows the bridge over stream S-IJ1.		Pic 2 Desc.	Photo shows the ROW conditions from about 13403+00 to 13410+00

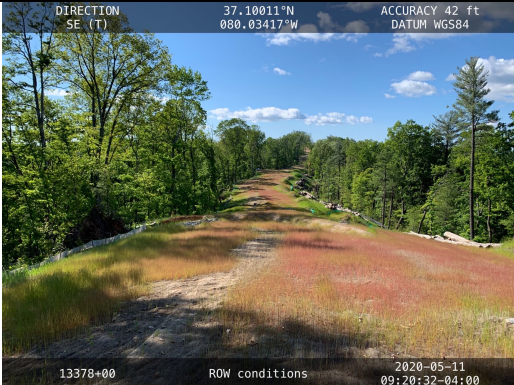
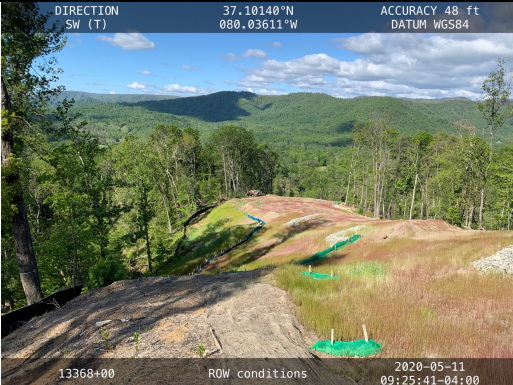
GPS Location	See photo for gps location data.		GPS Location	See photo for gps location data.	
Field Station#	13378+00		Field Station#	13368+00	
Pic 3 Desc.	Photo shows the ROW conditions from about 13378+00 to 13385+00.		Pic 4 Desc.	Photo shows the ROW conditions from about 13365+00 to 13368+00.

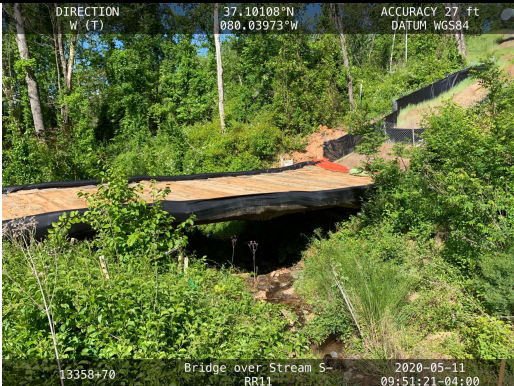
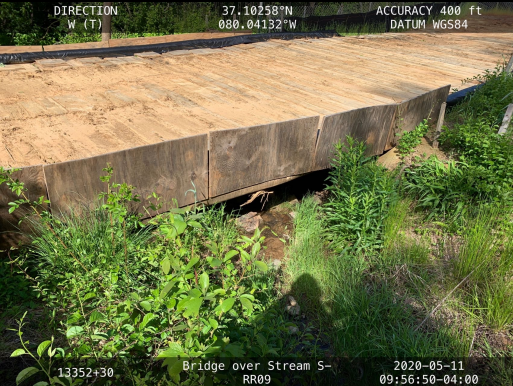
GPS Location	See photo for gps location data.		GPS Location	See photo for gps location data.	
Field Station#	13358+70		Field Station#	13352+30	
Pic 5 Desc.	Photo shows the bridge over stream S-RR11.		Pic 6 Desc.	Photo shows the bridge over stream S-RR09.

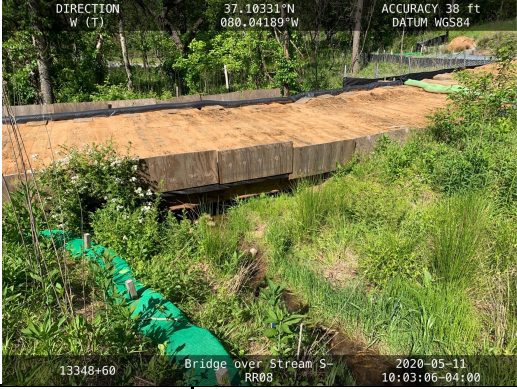
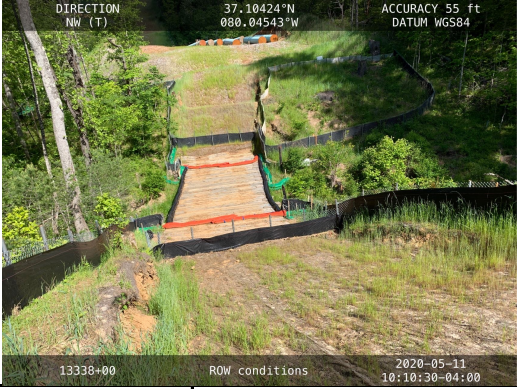
GPS Location	See photo for gps location data.		GPS Location	See photo for gps location data.	
Field Station#	13348+60		Field Station#	13338+00	
Pic 7 Desc.	Photo shows the bridge over stream S-RR08.		Pic 8 Desc.	Photo shows the bridge over stream S-GH9 and adjacent ROW conditions.

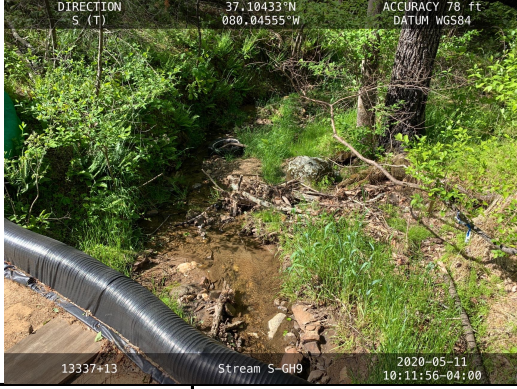
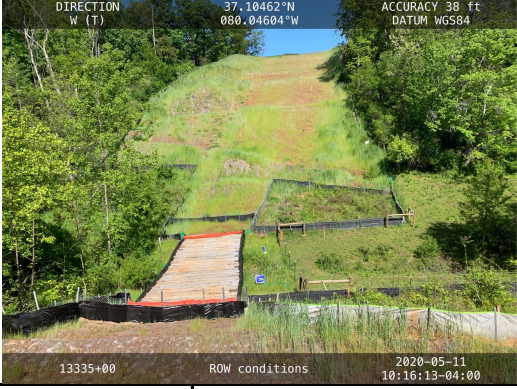
GPS Location	See photo for gps location data.		GPS Location	See photo for gps location data.	
Field Station#	13337+13		Field Station#	13335+00	
Pic 9 Desc.	Photo shows stream S-GH9 downstream from the ROW crossing.		Pic 10 Desc.	Photo shows the bridge over stream S-GH11 and adjacent ROW conditions.

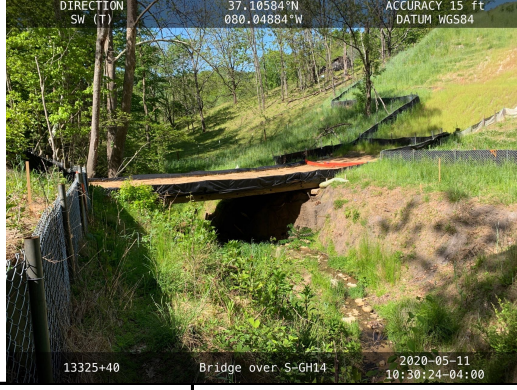
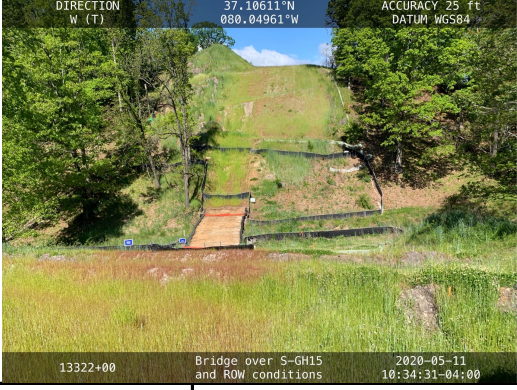
GPS Location	See photo for gps location data.		GPS Location	See photo for gps location data.	
Field Station#	13325+40		Field Station#	13322+00	
Pic 11 Desc.	Photo shows the bridge over stream S-GH14.		Pic 12 Desc.	Photo shows the bridge over stream S-GH15 and adjacent ROW conditions.

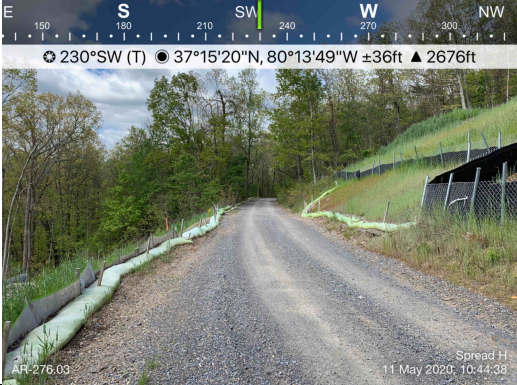
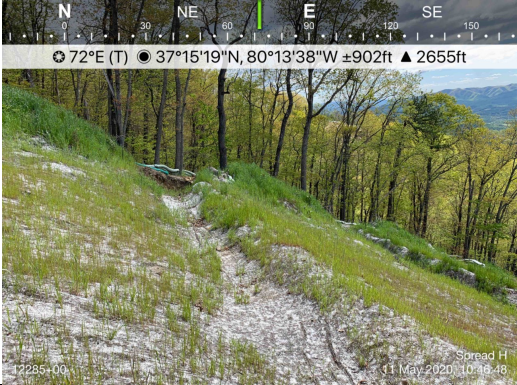
GPS Location	See Photo		GPS Location	See Photo	
Field Station#	276+03		Field Station#	12285+00	
Pic 7 Desc.	AR 276.03 is in acceptable condition.		Pic 8 Desc.	Waterbars, end treatment, and sump pits are in acceptable condition.

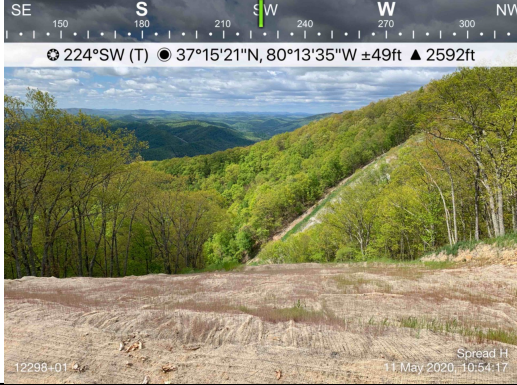
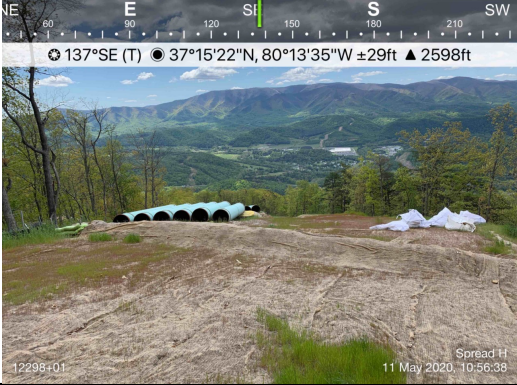
GPS Location	See Photo		GPS Location	See Photo	
Field Station#	12298+01		Field Station#	12298+01	
Pic 9 Desc.	ROW vegetation is well established and erosion control blankets installed.		Pic 10 Desc.	ROW is well vegetated and erosion control blankets installed.

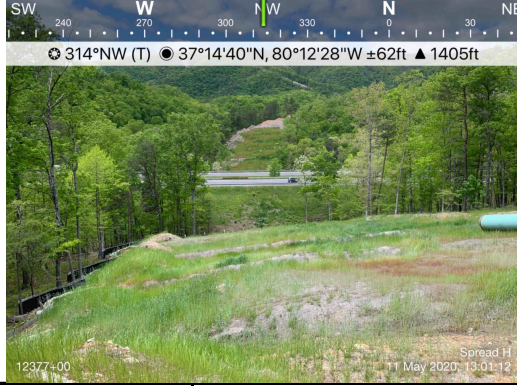
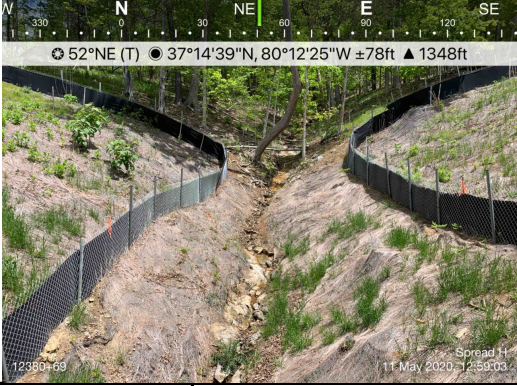
GPS Location	See Photo		GPS Location	See Photo	
Field Station#	12377+00		Field Station#	12380+69	
Pic 11 Desc.	ROW is well vegetated.		Pic 12 Desc.	SSF at stream crossing is in acceptable condition.

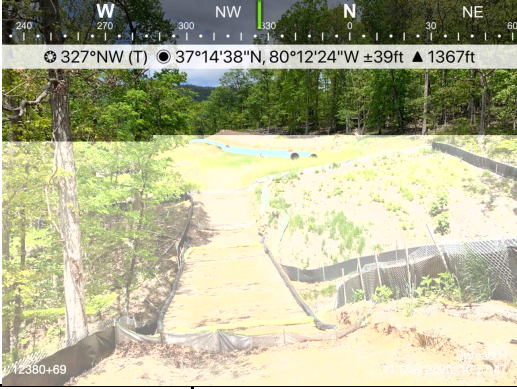
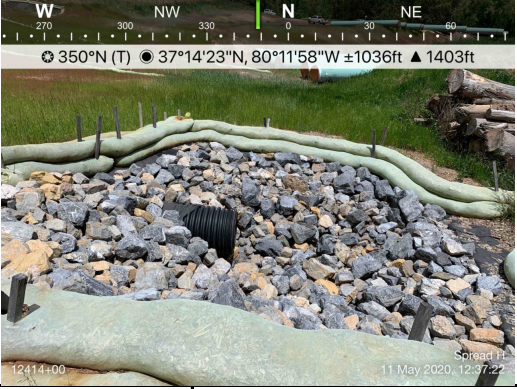
GPS Location	See Photo	GPS Location	See Photo		
Field Station#	123680+69	Field Station#	12414+00		
Pic 13 Desc.	Bridge and stream crossing controls are in acceptable condition.	Pic 14 Desc.	Clean Water diversion outfall is in acceptable condition.

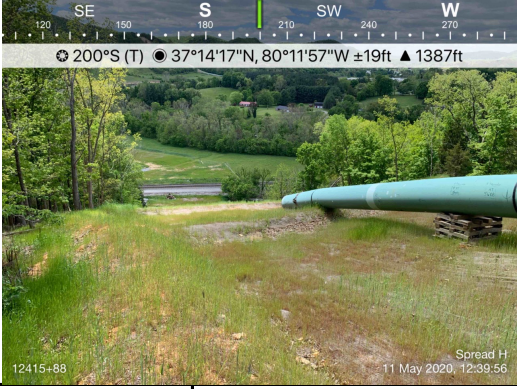
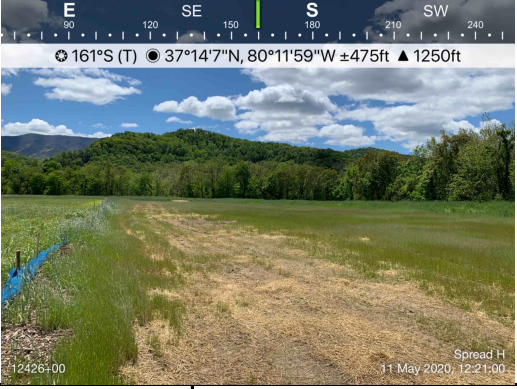
GPS Location	See Photo	GPS Location	See Photo		
Field Station#	12415+88	Field Station#	12426+00		
Pic 15 Desc.	ROW is and waterbars are well vegetated and in acceptable condition.	Pic 16 Desc.	ROW vegetation is well established.

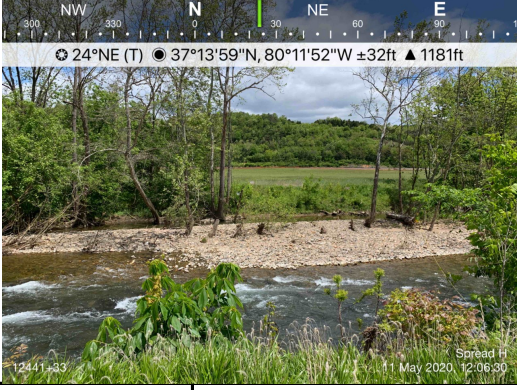
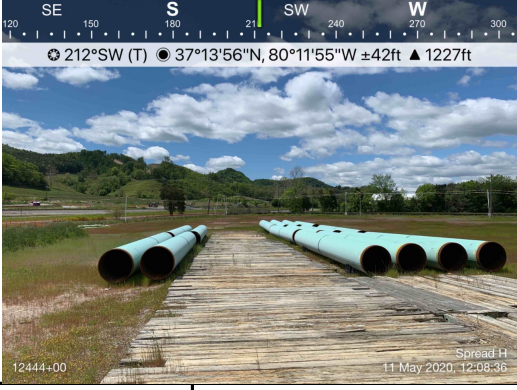
GPS Location	See Photo	GPS Location	See Photo		
Field Station#	12441+33	Field Station#	12444+00		
Pic 17 Desc.	Looking at the Roanoke River. Stream protection controls are installed and in acceptable condition. Banks stable/vegetated.	Pic 18 Desc.	The section of ROW is well vegetated and compost filter socks are in acceptable condition.

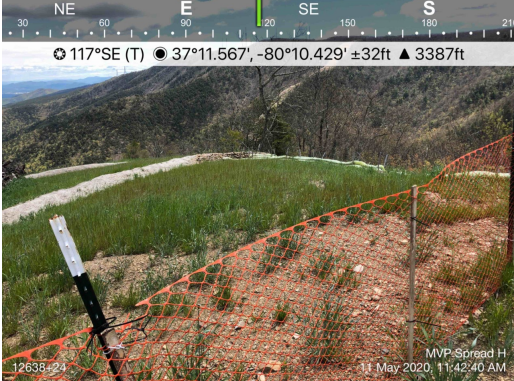
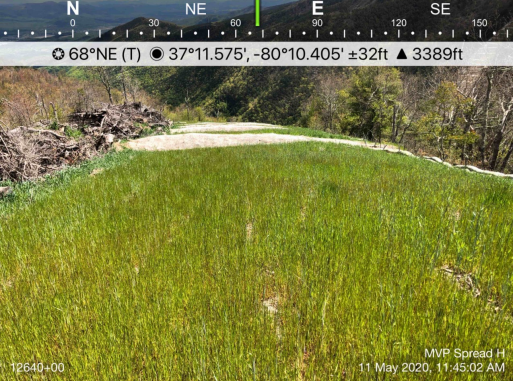
GPS Location	See Picture Watermark		GPS Location	See Picture Watermark	
Field Station#	12638+24		Field Station#	12640+00	
Pic 1 Desc.	Start of inspection area. Vegetation on ROW is well established.		Pic 2 Desc.	Vegetation and wood debris piles within ROW.

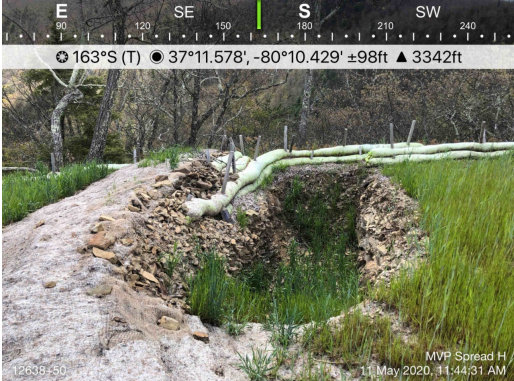
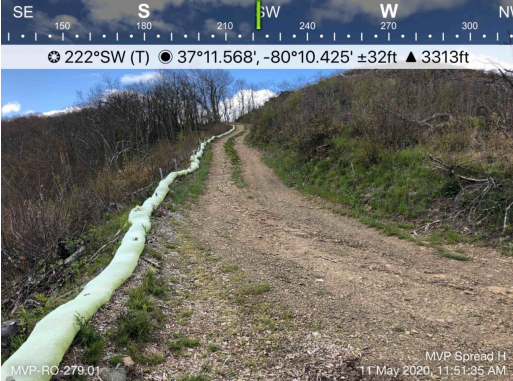
GPS Location	See Picture Watermark		GPS Location	See Picture Watermark	
Field Station#	12638+50		Field Station#	12638+24	
Pic 3 Desc.	Waterbar sump pit and end treatment.		Pic 4 Desc.	Access road 279.01 controls are in good condition.

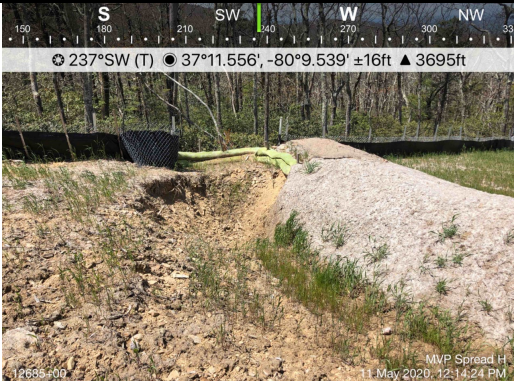
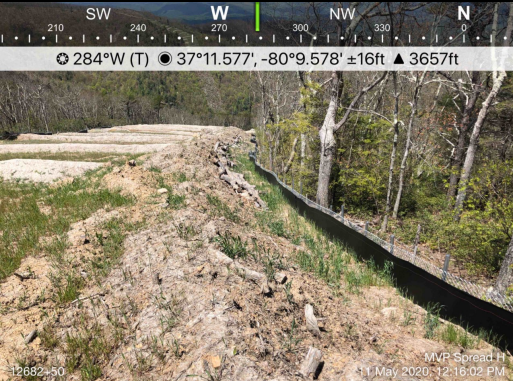
GPS Location	See Picture Watermark		GPS Location	See Picture Watermark	
Field Station#	12685+00		Field Station#	12682+50	
Pic 5 Desc.	Waterbar end treatment and sump pit.		Pic 6 Desc.	Perimeter super silt fence in good condition and functional.

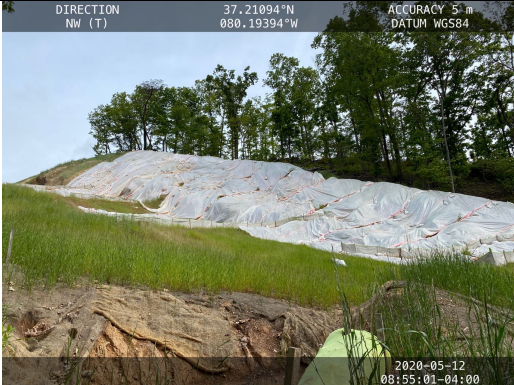
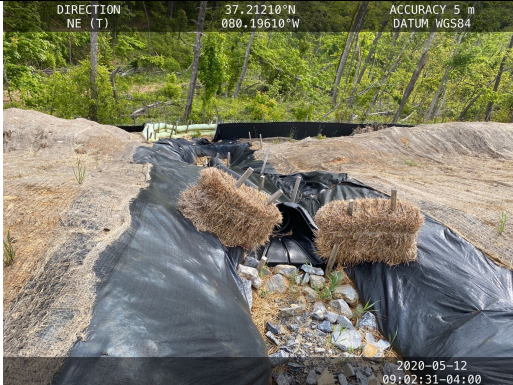
GPS Location	See photo		GPS Location	See photo	
Field Station#	12543+00		Field Station#	12535+00	
Pic 1 Desc.	Plastic sheeting on stockpiles nearest to Yellow Finch Road remains intact and functional.		Pic 2 Desc.	Fill slope drains near the landowner crossing near Yellow Finch Road remain in satisfactory condition and effective.

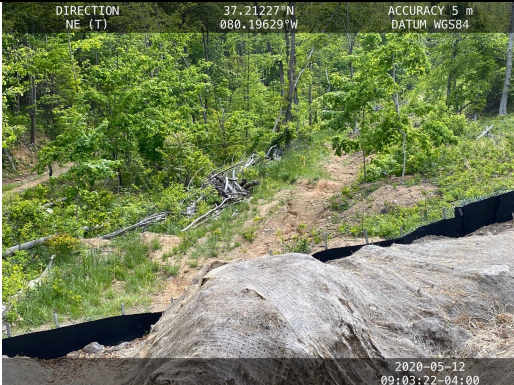
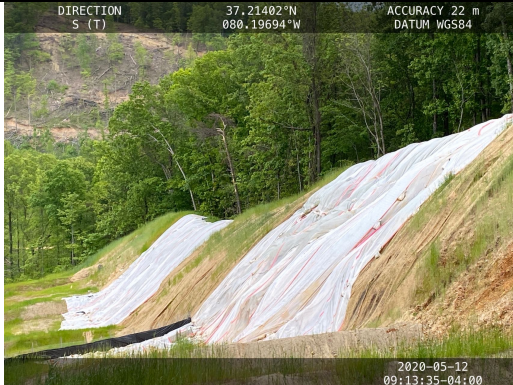
GPS Location	See photo		GPS Location	See photo	
Field Station#	12534+00		Field Station#	12529+00	
Pic 3 Desc.	Unstabilized logging roads adjacent to MVP ROW exhibit rill erosion.		Pic 4 Desc.	Plastic sheeting approximately 1500 feet from Yellow Finch Road remains intact and functional.

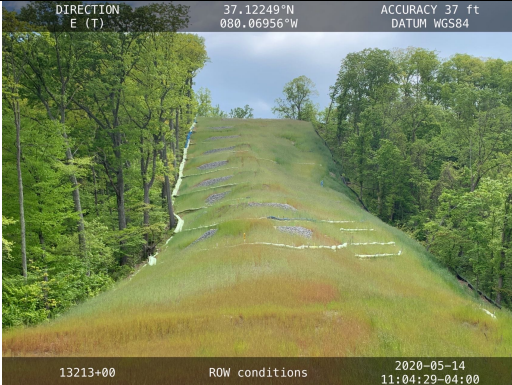
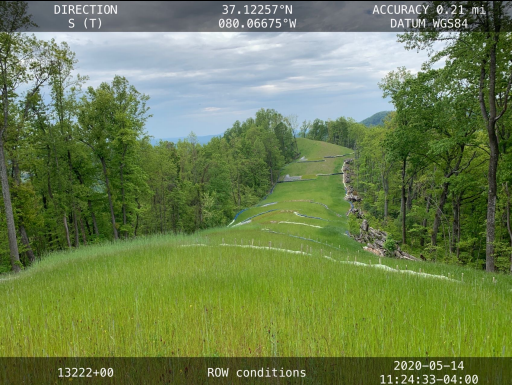
GPS Location	See photo for coordinates.		GPS Location	See photo for coordinates.	
Field Station#	13213+00		Field Station#	13222+00	
Pic 1 Desc.	Acceptable vegetative coverage in permanently restored area, permanent waterbars and CFS extensions table.		Pic 2 Desc.	Good vegetative cover noted across LOD, permanent waterbars and CFS extensions stable.

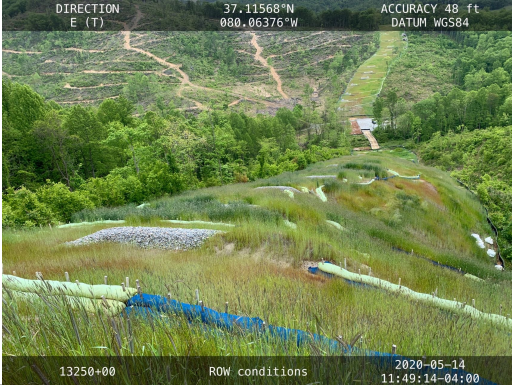
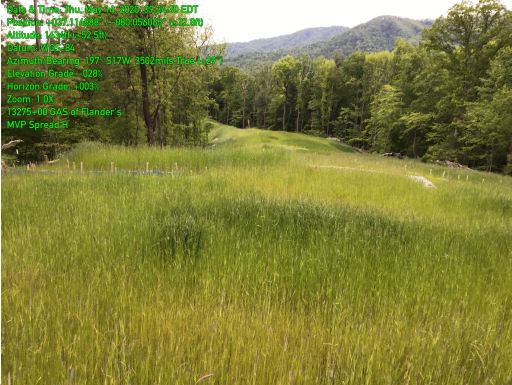
GPS Location	See photo for coordinates.		GPS Location	See photo for coordinates.	
Field Station#	13250+00		Field Station#	13275+00	
Pic 3 Desc.	Hillside CIS of S-II4, good vegetative cover, permanent waterbars stable, perimeter controls functioning accetbaly		Pic 4 Desc.	Good vegetative cover observed across LOD, vegetation establishing on permanent waterbar berms.

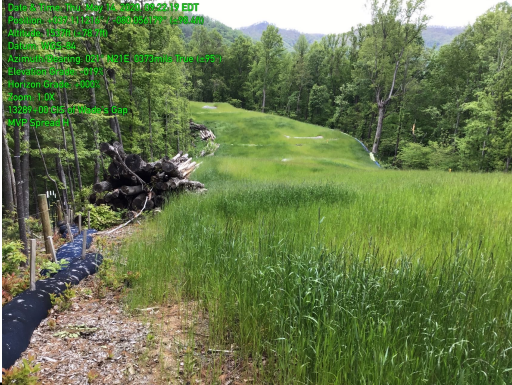
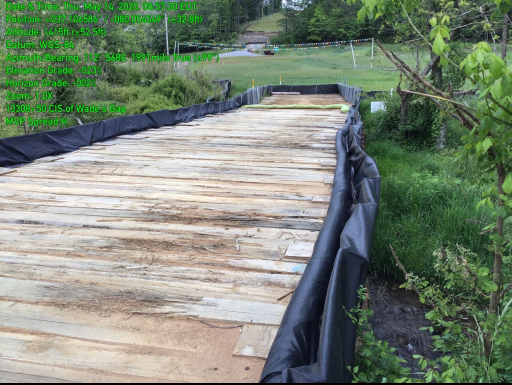
Pic 5 Desc.	Good vegetative cover across LOD, perimeter controls functioning acceptably.		Pic 6 Desc.	S-GH7, bridge over stream crossing in acceptable condition, no ECD failures observed.

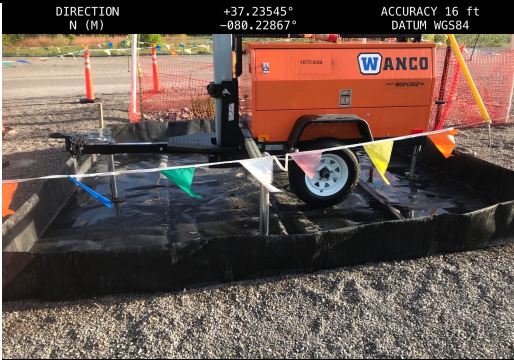
<p>DIRECTION N (M) +37.23545° -080.22867° ACCURACY 16 ft DATUM WGS84</p> <p>MVP-PY-006_051520 Condition of containment 2020-05-15 07:35:41-04:00</p>

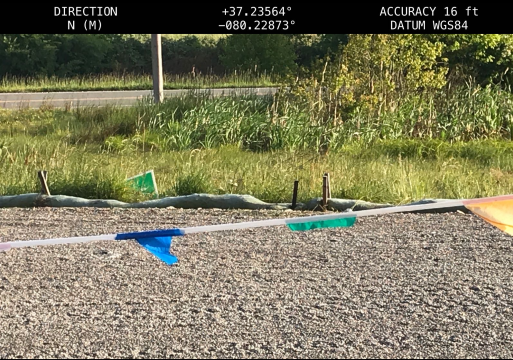
<p>DIRECTION N (M) +37.23564° -080.22873° ACCURACY 16 ft DATUM WGS84</p> <p>MVP-PY-006_051520 Signage and buffer flagging for feature 2020-05-15 07:36:12-04:00</p>			
GPS Location	MVP-PY-006 See photo for gps data		GPS Location	MVP-PY-006 See photo for gps data	
Field Station#	+0		Field Station#	+0	
Pic 1 Desc.	Condition of containment under light plant. Looking N.		Pic 2 Desc.	Signage and buffer flagging for feature W-008. Looking N.

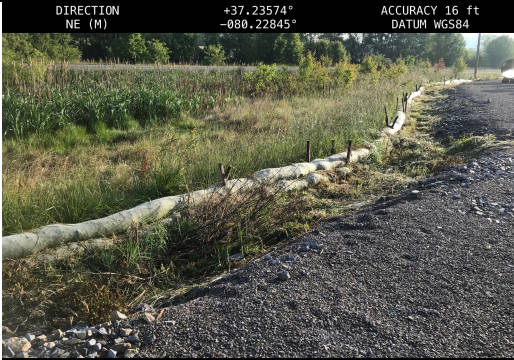
<p>DIRECTION NE (M) +37.23574° -080.22845° ACCURACY 16 ft DATUM WGS84</p> <p>MVP-PY-006_051520 Condition of CFS along feature 2020-05-15 07:37:01-04:00</p>

GPS Location	MVP-PY-006 See photo for gps data		GPS Location	MVP-PY-006 See photo for gps data	
Field Station#	+0		Field Station#	+0	
Pic 3 Desc.	Condition of compost filter sock along south edge of feature W-008. Looking NE.		Pic 4 Desc.	No loose trash around dumpsters. Looking SE.

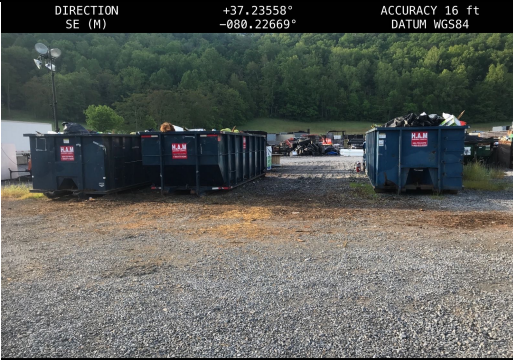
<p>DIRECTION SE (M) +37.23558° -080.22669° ACCURACY 16 ft DATUM WGS84</p> <p>MVP-PY-006_051520 No loose trash around dumpsters 2020-05-15 07:39:12-04:00</p>

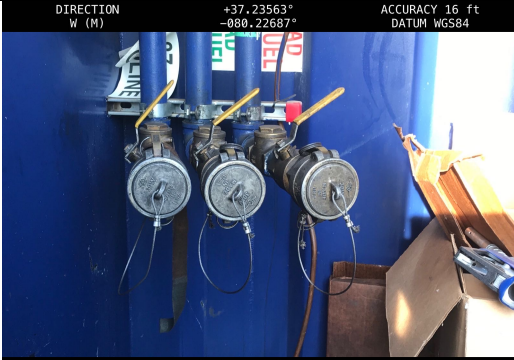
<p>DIRECTION W (M) +37.23563° -080.22867° ACCURACY 16 ft DATUM WGS84</p> <p>MVP-PY-006_051520 No leaky internal fittings 2020-05-15 07:40:07-04:00</p>

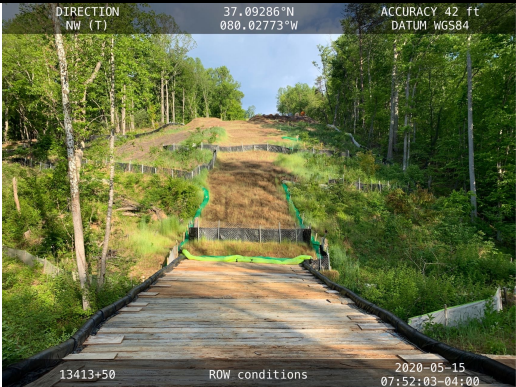
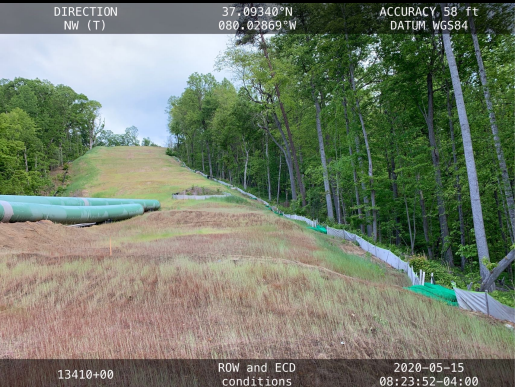
GPS Location	See photo for gps location data.		GPS Location	See photo for gps location data.	
Field Station#	13413+50		Field Station#	13410+00	
Pic 1 Desc.	Photo shows the ROW and ECD conditions from about 13411+00 to 13413+50.		Pic 2 Desc.	Photo shows the ROW and ECD conditions from about 13403+00 to 13410+00.

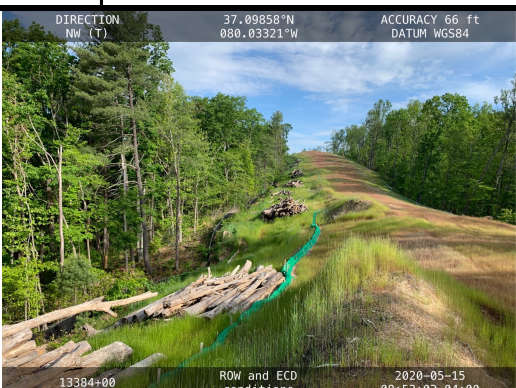
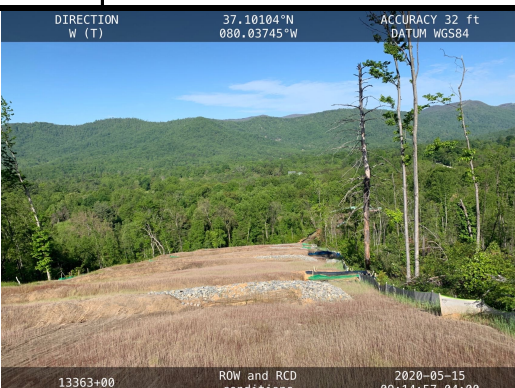
GPS Location	See photo for gps location data.		GPS Location	See photo for gps location data.	
Field Station#	13384+00		Field Station#	13363+00	
Pic 3 Desc.	Photo shows the ROW and ECD conditions from about 13378+00 to 13384+00.		Pic 4 Desc.	Photo shows the ROW and ECD conditions from about 13361+00 to 13363+00.

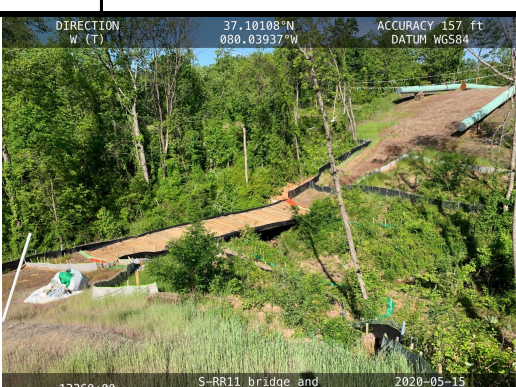
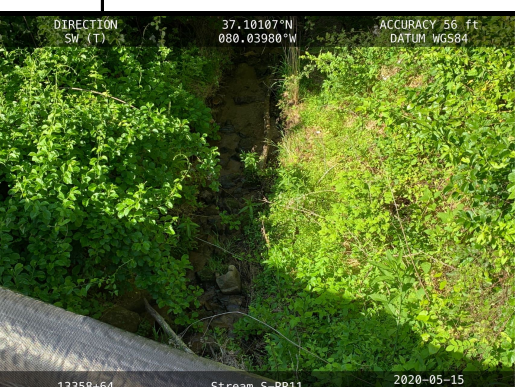
GPS Location	See photo for gps location data.		GPS Location	See photo for gps location data.	
Field Station#	13360+00		Field Station#	13358+64	
Pic 5 Desc.	Photo shows the bridge over stream S-RR11 and buffer area ECDs.		Pic 6 Desc.	Photo shows stream S-RR11 downstream from the ROW crossing.

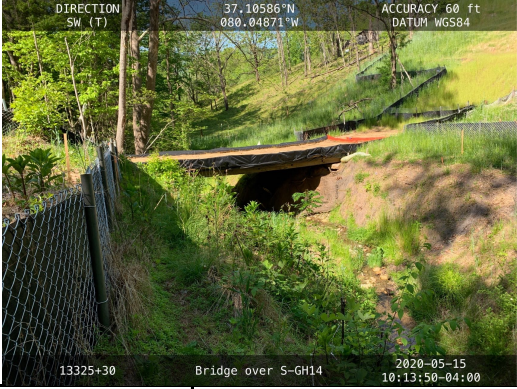
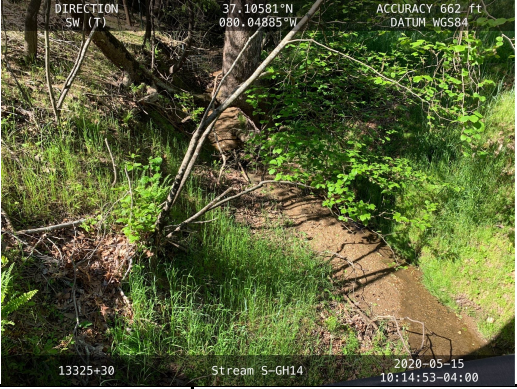
GPS Location	See photo for gps location data.		GPS Location	See photo for gps location data.	
Field Station#	13325+30		Field Station#	13325+31	
Pic 13 Desc.	Photo shows the bridge over stream S-GH14.		Pic 14 Desc.	Photo shows stream S-GH14 downstream from the ROW crossing.

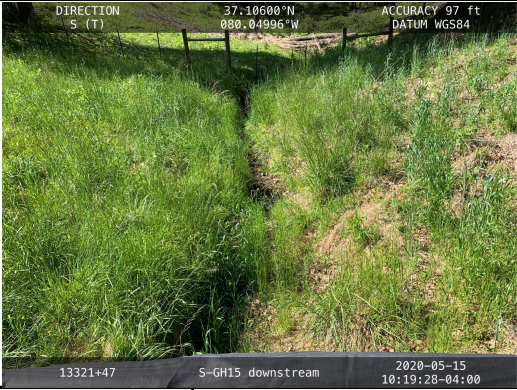
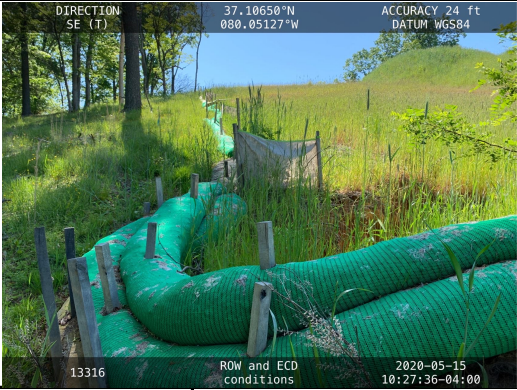
GPS Location	See photo for gps location data.		GPS Location	See photo for gps location data.	
Field Station#	13321+47		Field Station#	13316+00	
Pic 17 Desc.	Photo shows stream S-GH15 downstream from the ROW crossing.		Pic 18 Desc.	Photo shows the ROW and ECD conditions from about 13316+00 to 13318+00.

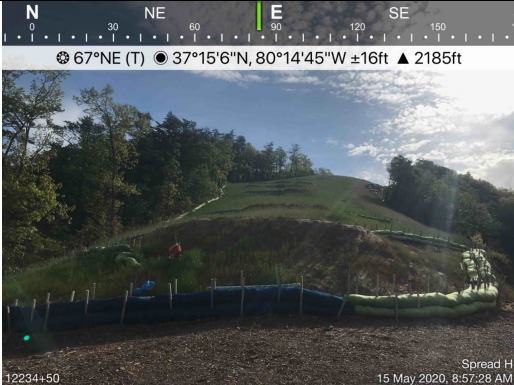
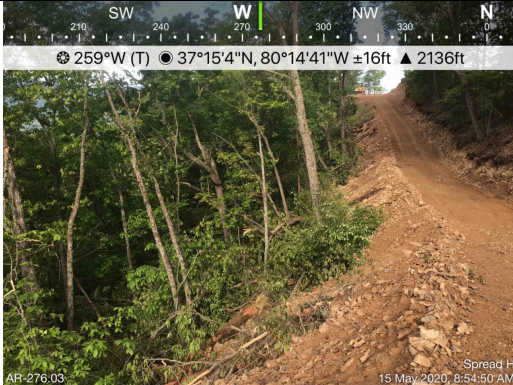
GPS Location	See photo	GPS Location	See photo		
Field Station#	12234+50	Field Station#	276+03		
Pic 1 Desc.	Start of inspection area, permanent waterbars and CFS controls in good condition.	Pic 2 Desc.	Third party grading activities perpendicular to AR-276.03

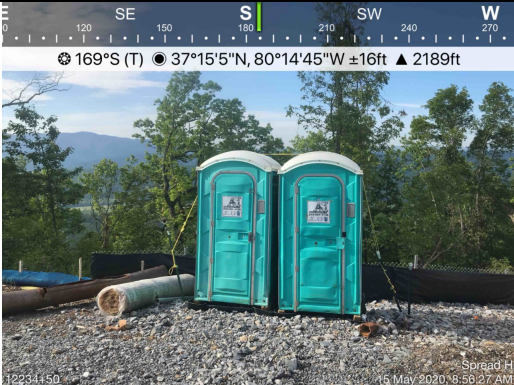
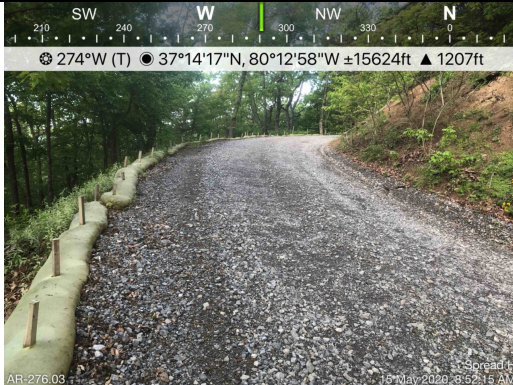
GPS Location	See photo	GPS Location	See photo		
Field Station#	12234+50	Field Station#	276+03		
Pic 3 Desc.	Portajohns in secondary containment.	Pic 4 Desc.	Controls in place and functioning on AR-276.03

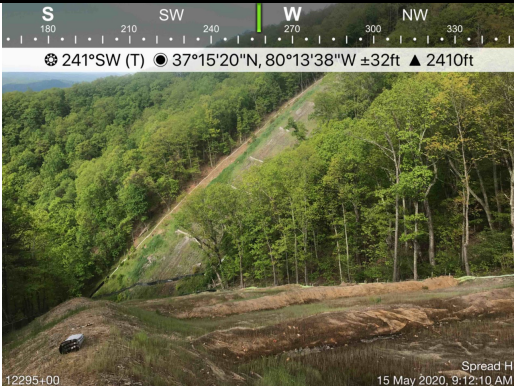
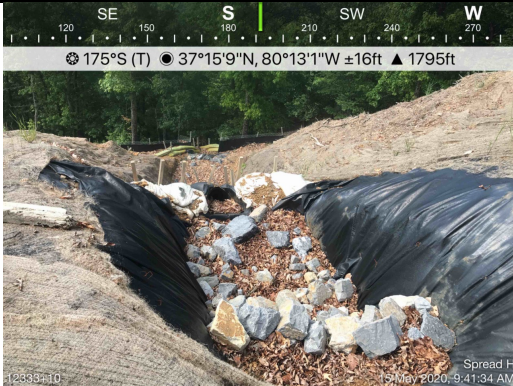
GPS Location	See photo	GPS Location	See photo		
Field Station#	12295+00	Field Station#	12333+10		
Pic 5 Desc.	Waterbars and end treatments in the Reese Mtn "V" are in acceptable condition	Pic 6 Desc.	Slope drain keyed in and in good condition.

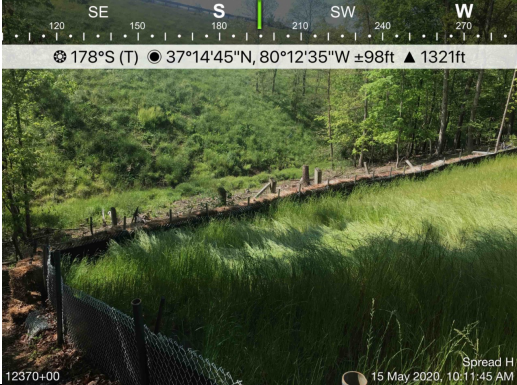
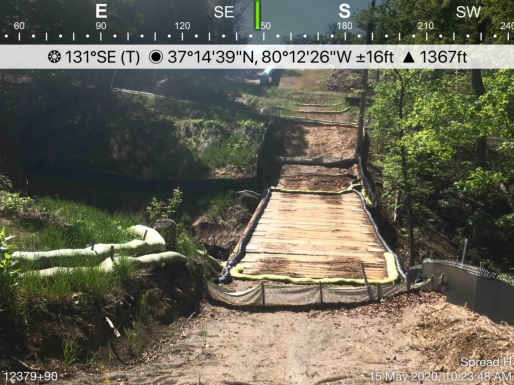
GPS Location	See photo	GPS Location	See photo		
Field Station#	12370+00	Field Station#	12379+00		
Pic 7 Desc.	Straw bale barrier near the I-81 intersection in good condition.	Pic 8 Desc.	Bridge controls at this stream crossing in good condition.

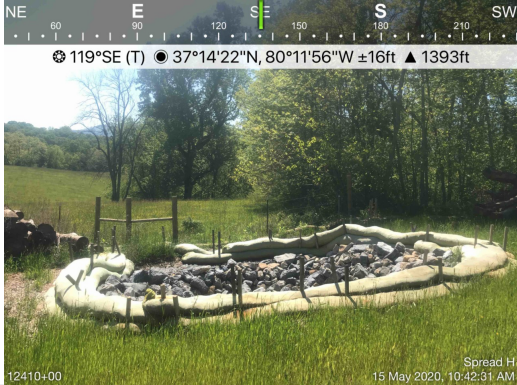
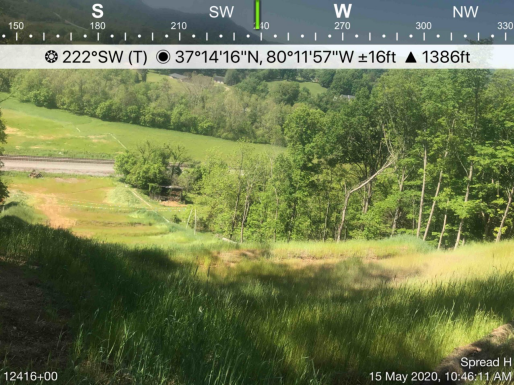
GPS Location	See photo	GPS Location	See photo		
Field Station#	12410+00	Field Station#	12416+00		
Pic 9 Desc.	Rock outlet protection in good condition.	Pic 10 Desc.	Vegetative stabilization on this slope is mature and uniform.

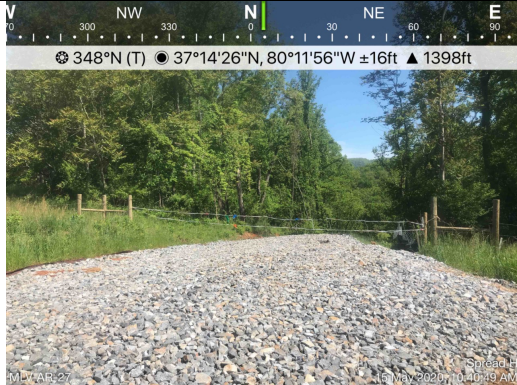
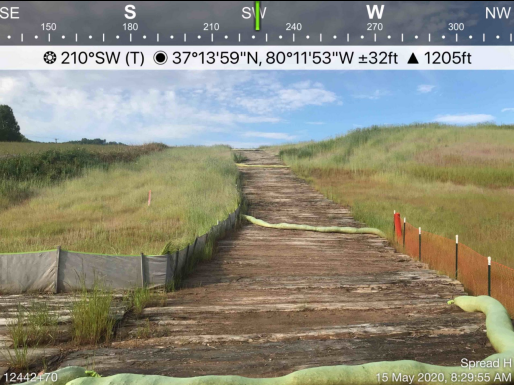
GPS Location	See photo	GPS Location	See photo		
Field Station#	+27	Field Station#	12442+70		
Pic 11 Desc.	Rock CE at MLV-AR-27 in good condition.	Pic 12 Desc.	Controls in place and functioning on the CIS of Rte 11.

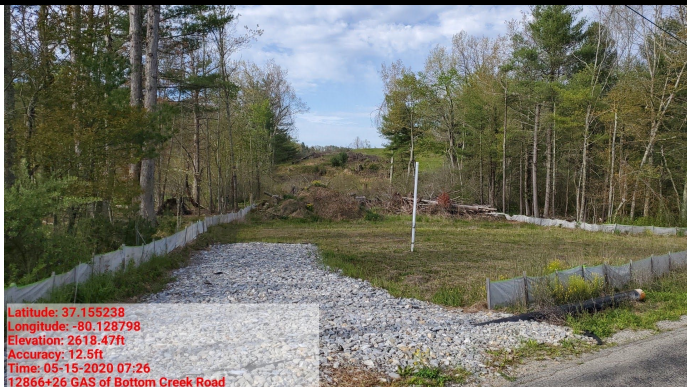
<p>Latitude: 37.155238 Longitude: -80.128798 Elevation: 2618.47ft Accuracy: 12.5ft Time: 05-15-2020 07:26 12866+26 GAS of Bottom Creek Road</p>

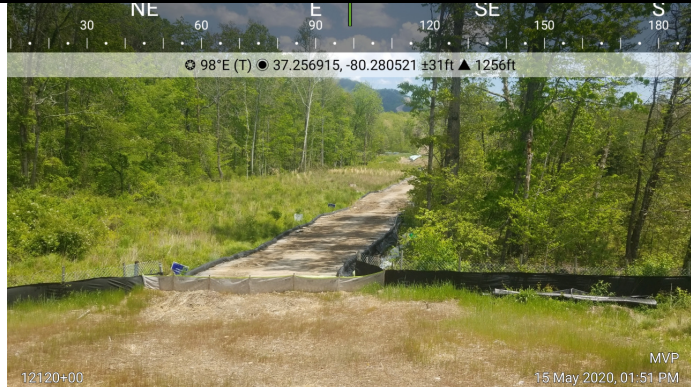
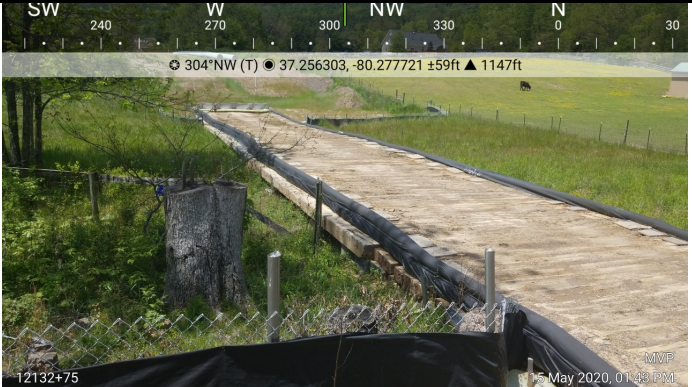
GPS Location	See Above	GPS Location	See Above		
Field Station#	12120+00	Field Station#	12132+75		
Pic 1 Desc.	Wetland W-C12, Looking East.	Pic 2 Desc.	Stream S-C29, Looking NorthWest.
