Visual Site Inspection Report

Project Name	H-600 Pipeline Spread H	AFE	124300138	Spread	H-600 Pipeline Spread H
Contractor	Precision			Report #	11052
Inspector	John Brcic			Date/Time	5/18/2020 10:43 AM
Permit #	TBD	Inspection Type	VA SWPP	Station Begin	12433+75
State	VA	Inspection Area	Partial	Station End	12544+06
County	Montgomery	Ground	Dry	Temperature (°F)	65.00
Municipality	N/A	Weather	Cloudy	Rain Gauge (in)	0.00
				Rain Accumulation Time (days)	1.00

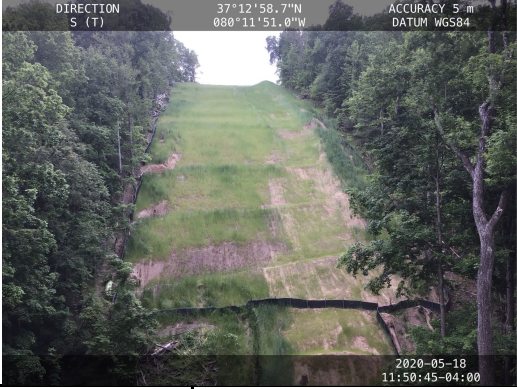
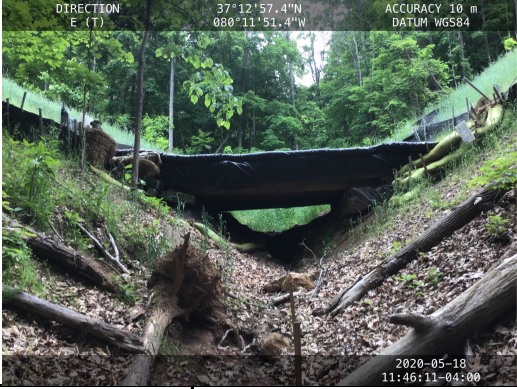
GPS Location	See photo		GPS Location	See photo	
Field Station#	12522+00		Field Station#	12519+41	
Pic 7 Desc.	Slope on going away side of stream S-EF19 remains stable.		Pic 8 Desc.	Stream S-EF19, facing east, upstream

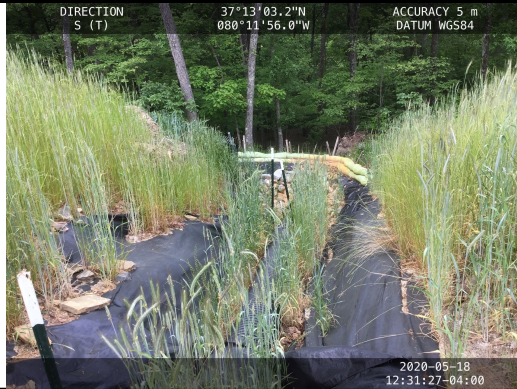
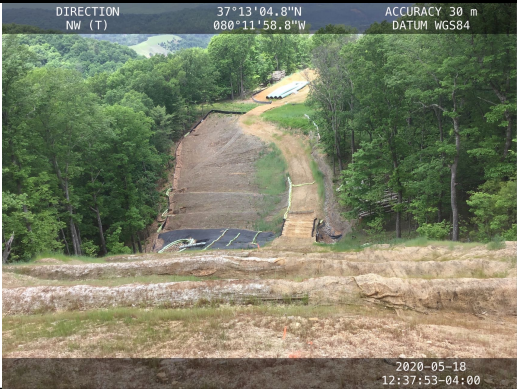
GPS Location	See photo		GPS Location	See photo	
Field Station#	12508+50		Field Station#	12506+24	
Pic 11 Desc.	Fill slope drain in satisfactory condition and functioning properly.		Pic 12 Desc.	ROW stable, blanket remains intact and effective where vegetation is negligible.

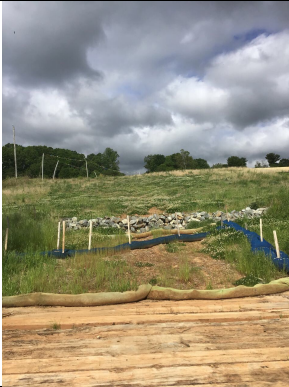
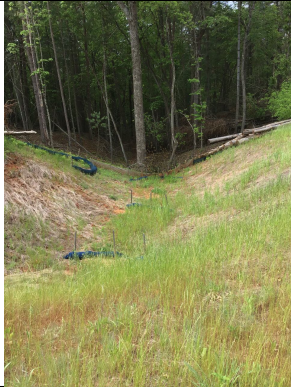
GPS Location	0000	GPS Location	0000		
Field Station#	13550+70	Field Station#	13560+00		
Pic 1 Desc.	Observed ECDs at stream crossings to be sure they were up to date and functioning properly before the rain events began.		Pic 2 Desc.	Inspected ECDs In a natural drain while completing routine inspection

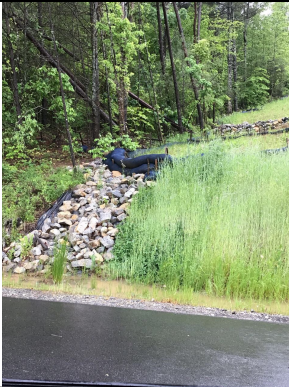
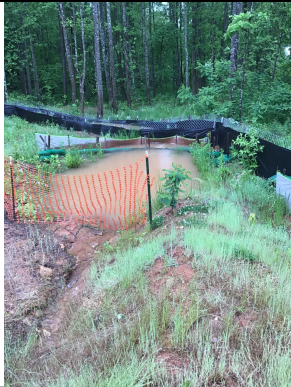
GPS Location	00000	GPS Location	0000		
Field Station#	13496+76	Field Station#	13415+60		
Pic 3 Desc.	Checked rock lined channel during rain events at CAHAS #2, no environmental issues were observed		Pic 4 Desc.	Monitored sump pit and ECDs protecting a wetland at CAHAS#1 crossing	
Insert image here			Insert image here		
GPS Location		GPS Location			
Field Station#		Field Station#			
Pic 5 Desc.			Pic 6 Desc.

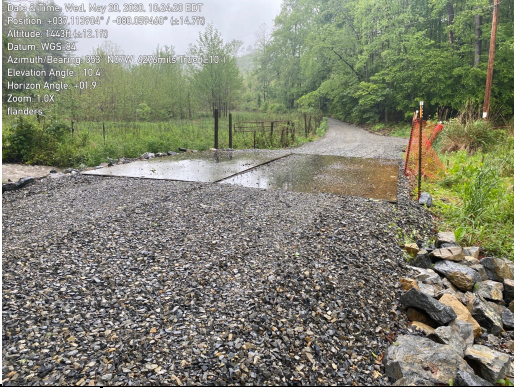
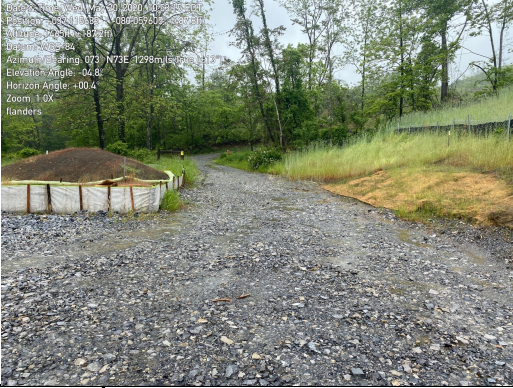
GPS Location	See photo for coordinates.		GPS Location	See photo for coordinates.	
Field Station#	13262+50		Field Station#	13262+50	
Pic 1 Desc.	Flanders Road, MVP-FR-293.01.		Pic 2 Desc.	Flanders Road, MVP-FR-293.01.

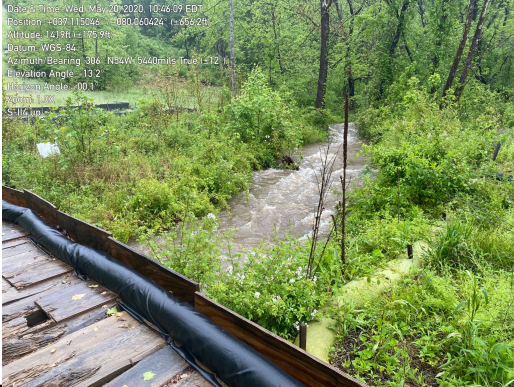
GPS Location	See photo for coordinates.		GPS Location	See photo for coordinates.	
Field Station#	13260+60		Field Station#	13260+60	
Pic 3 Desc.	S-II4, upstream, ECDs functioning acceptably.		Pic 4 Desc.	S-II4, upstream, ECDs functioning acceptably.

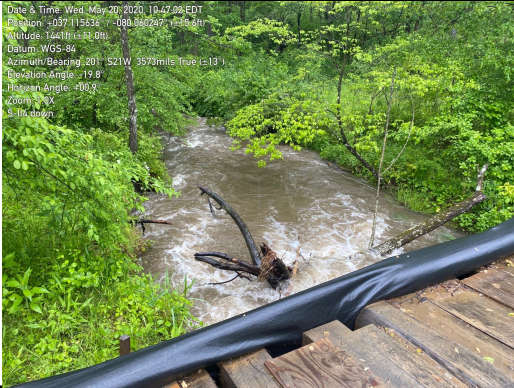
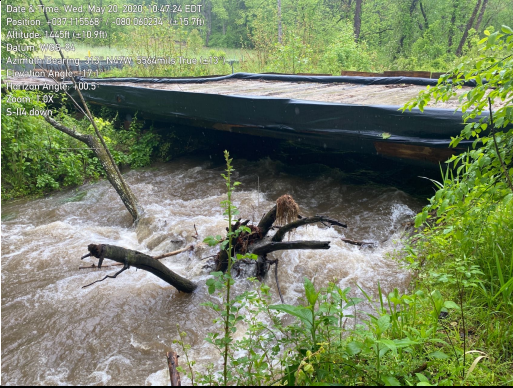
GPS Location	See photo for coordinates.		GPS Location	See photo for coordinates.	
Field Station#	13260+60		Field Station#	13260+60	
Pic 5 Desc.	S-II4, downstream, ECDs functioning acceptably.		Pic 6 Desc.	S-II4, downstream, ECDs functioning acceptably.

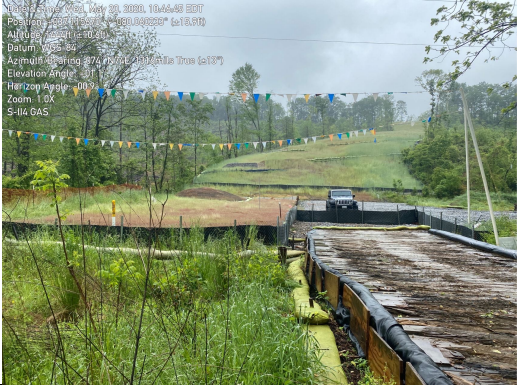
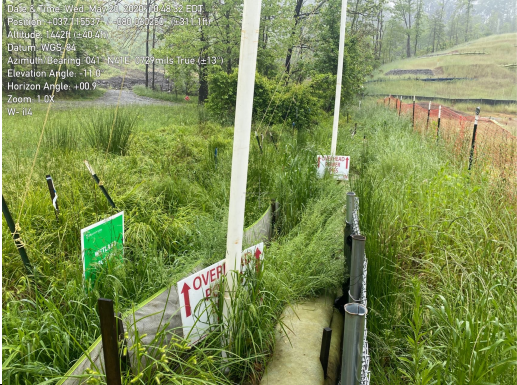
GPS Location	See photo for coordinates.		GPS Location	See photo for coordinates.	
Field Station#	13260+70		Field Station#	13261+00	
Pic 7 Desc.	GAS S-II4, ECDs functioning acceptably.		Pic 8 Desc.	W-II4, ECDs functioning acceptably.

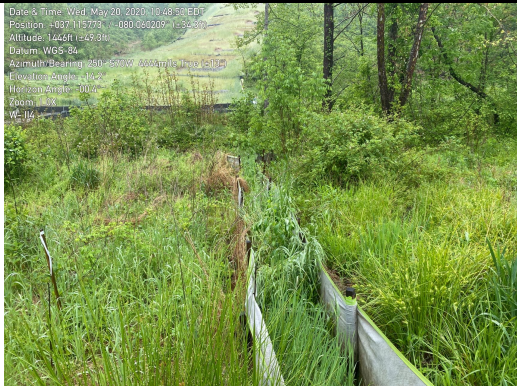
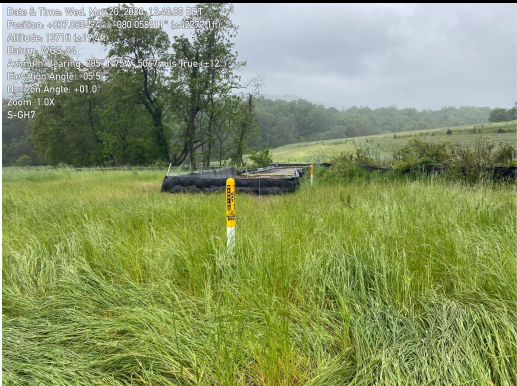
GPS Location	See photo for coordinates.		GPS Location	See photo for coordinates.	
Field Station#	1326+10		Field Station#	13311+00	
Pic 9 Desc.	W-II4, ECDs functioning acceptably.		Pic 10 Desc.	GAS S-GH7, ECDs functioning acceptably.

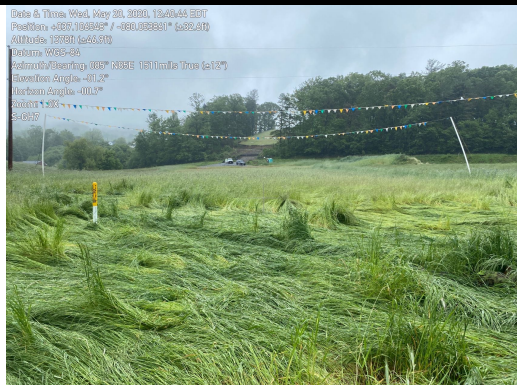
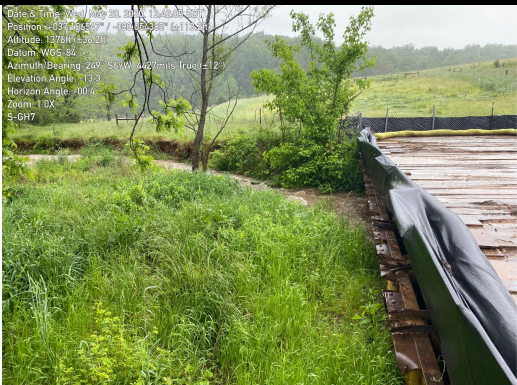
GPS Location	See photo for coordinates.		GPS Location	See photo for coordinates.	
Field Station#	13311+00		Field Station#	13309+40	
Pic 11 Desc.	GAS S-GH7, ECDs functioning acceptably.		Pic 12 Desc.	S-GH7, downstream, ECDs functioning acceptably.

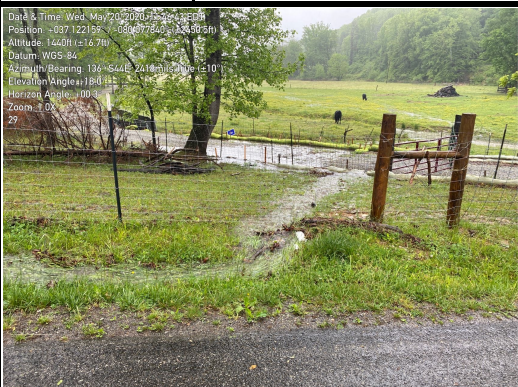
GPS Location	See photo for coordinates.		GPS Location	See photo for coordinates.	
Field Station#	13191+00		Field Station#	13191+00	
Pic 17 Desc.	MVP-AR-29, ECDs functioning acceptably.		Pic 18 Desc.	MVP-AR-29, ECDs functioning acceptably.

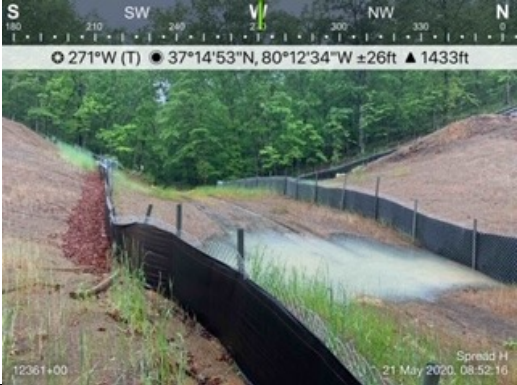
GPS Location	See Photo		GPS Location	See Photo	
Field Station#	12357+00		Field Station#	12361+00	
Pic 7 Desc.	The ROW and waterbars are in acceptable condition.		Pic 8 Desc.	SSF is in acceptable condition.

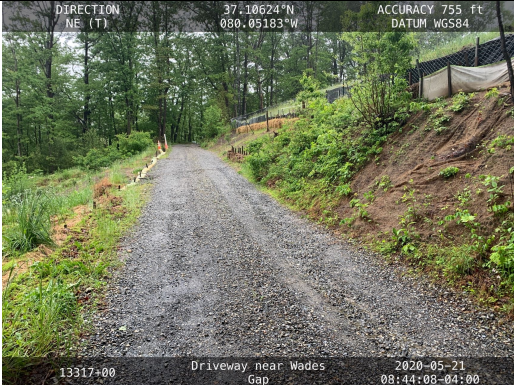
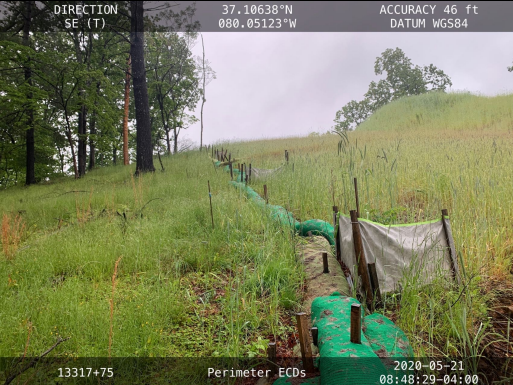
GPS Location	See photo for gps location data.		GPS Location	See photo for gps location data.	
Field Station#	13317+00		Field Station#	13317+75	
Pic 1 Desc.	Photo shows the landowner driveway near Wades Gap Road.		Pic 2 Desc.	Photo shows the perimeter ECDs from about 13317+75 to 13319+00.

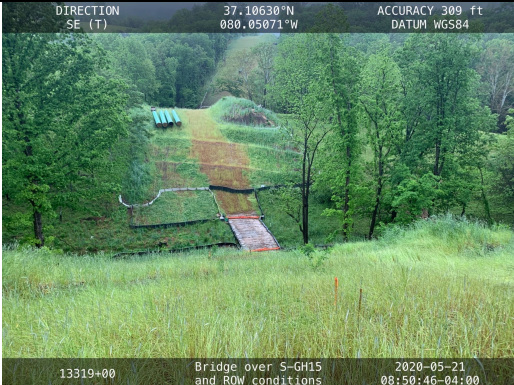
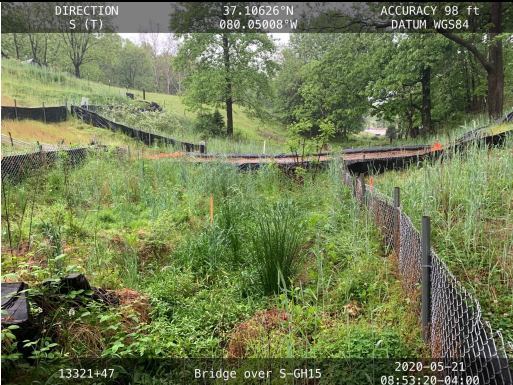
GPS Location	See photo for gps location data.		GPS Location	See photo for gps location data.	
Field Station#	13319+00		Field Station#	13321+47	
Pic 3 Desc.	Photo shows the ROW conditions from about 13319+00 to 13322+00 including the bridge over stream S-GH15.		Pic 4 Desc.	Photo shows the bridge over stream S-GH15.

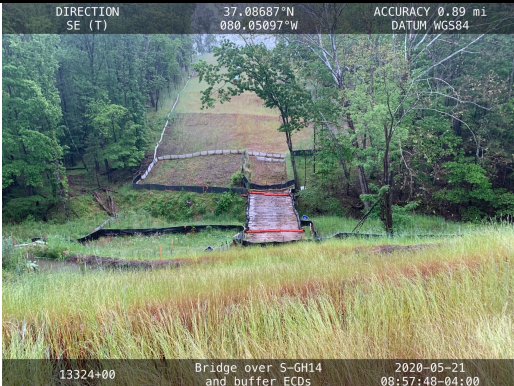
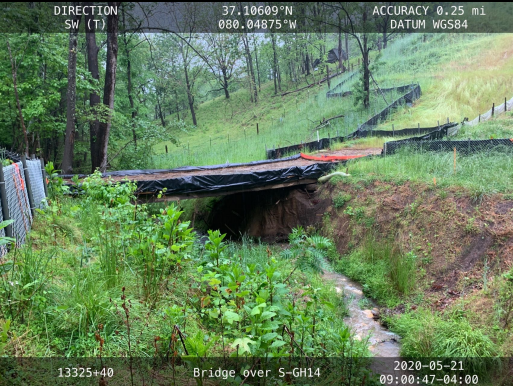
GPS Location	See photo for gps location data.		GPS Location	See photo for gps location data.	
Field Station#	13324+00		Field Station#	13325+40	
Pic 5 Desc.	Photo shows the ROW conditions from about 13324+00 to 13327+00 including the bridge over stream S-GH14.		Pic 6 Desc.	Photo shows the bridge over stream S-GH14.

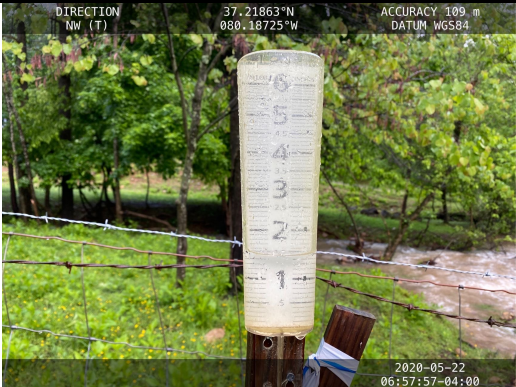
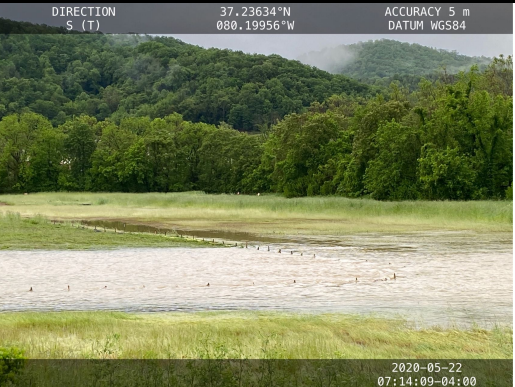
GPS Location	See photo		GPS Location	See photo	
Field Station#	12544+06		Field Station#	12425+00	
Pic 1 Desc.	Another 1.5 inches of precipitation accumulated at the rain gauge on Yellow Finch Road over the past 24 hours.		Pic 2 Desc.	Water level was still too high on the going away side of MVP-MN-279 to assess any damage to ECDs a Roanoke River overflow.

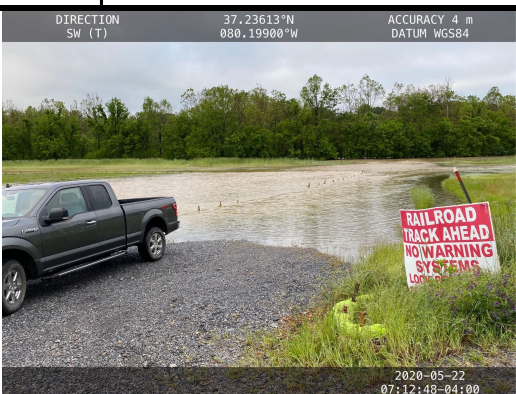
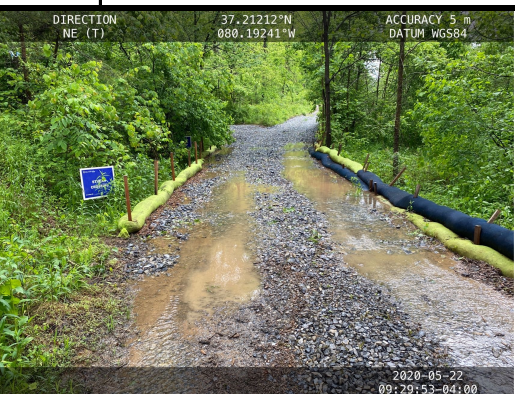
GPS Location	See photo		GPS Location	See photo	
Field Station#	12424+00		Field Station#	12544+06	
Pic 3 Desc.	Water was still up into the construction entrance on access road MVP-MN-279.		Pic 4 Desc.	Yellow Finch Road, stream S-EF54, facing northeast

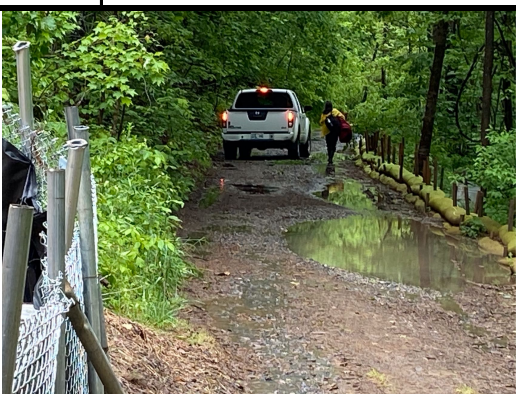
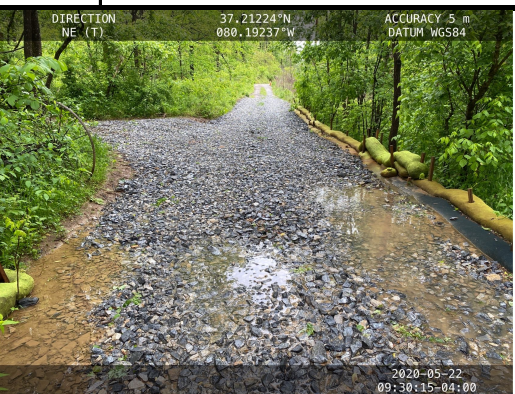
GPS Location	See photo		GPS Location	See photo	
Field Station#	12544+06		Field Station#	12544+06	
Pic 5 Desc.	Yellow Finch Road near ROW crossing		Pic 6 Desc.	Yellow Finch Road at turnaround

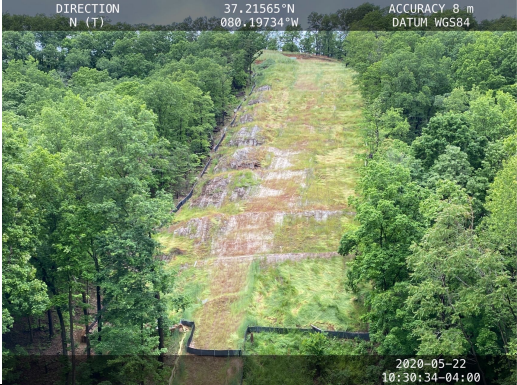
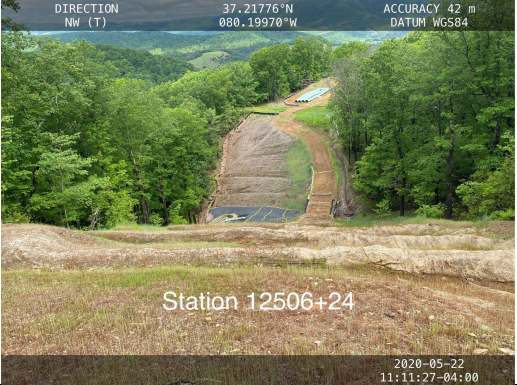
GPS Location	See photo		GPS Location	See photo	
Field Station#	12517+00		Field Station#	12506+24	
Pic 13 Desc.	The slope on the coming in side of stream S-EF19 remains stable.		Pic 14 Desc.	ROW stable, ECDs functioning as needed.

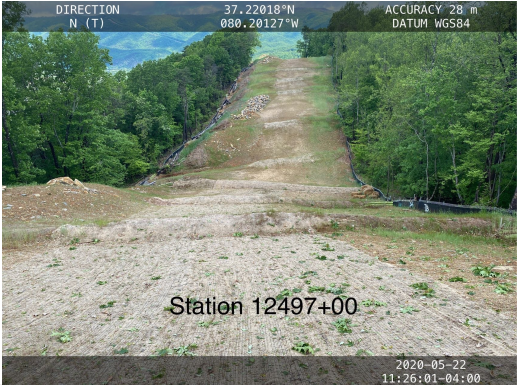
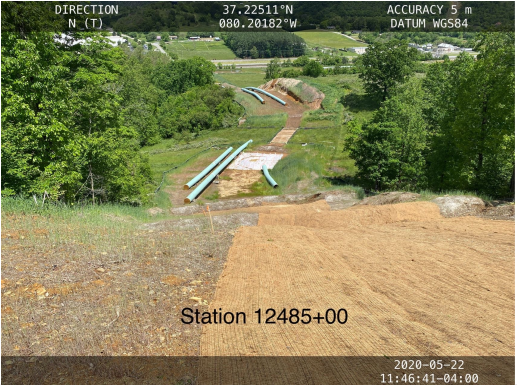
GPS Location	See photo		GPS Location	See photo	
Field Station#	12497+00		Field Station#	12485+00	
Pic 15 Desc.	ROW stable, ECDs in good repair.		Pic 16 Desc.	ROW stable where blanket was recently installed on coming in side of MLV-28.

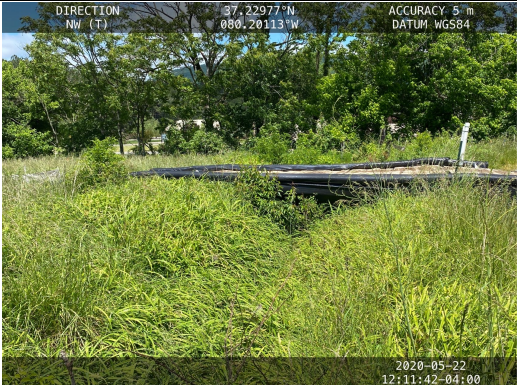
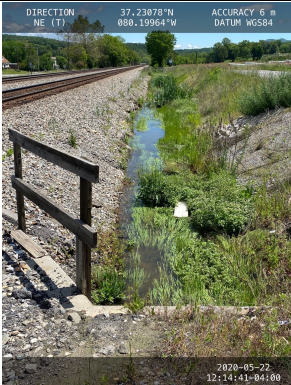
GPS Location	See photo		GPS Location	See photo	
Field Station#	12455+21		Field Station#	12444+94	
Pic 17 Desc.	Stream S-CD12, facing northwest, downstream		Pic 18 Desc.	Stream S-I1, facing northeast, downstream
