Visual Site Inspection Report

Project Name	H-600 Pipeline Spread H	AFE	124300138	Spread	H-600 Pipeline Spread H
Contractor	Precision			Report #	11299
Inspector	Dawn McCullough			Date/Time	5/26/2020 3:26 PM
Permit #	TBD	Inspection Type	VA SWPP	Station Begin	13140+00
State	VA	Inspection Area	Partial	Station End	13315+70
County	Franklin	Ground	Damp	Temperature (°F)	75.00
Municipality	N/A	Weather	Cloudy	Rain Gauge (in)	0.40
				Rain Accumulation Time (days)	1.00

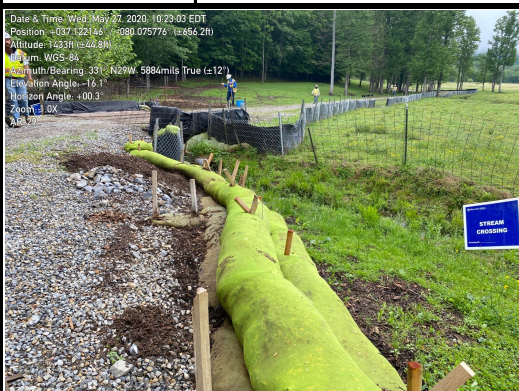
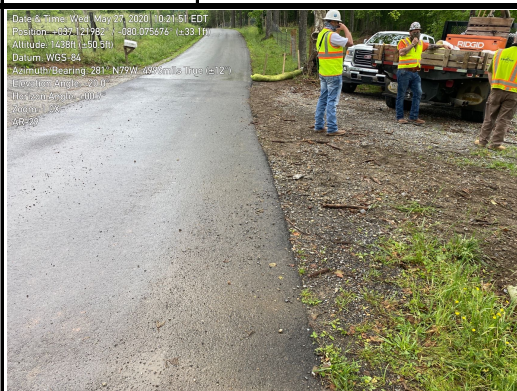
GPS Location	See photo for coordinates.		GPS Location	See photo for coordinates.	
Field Station#	13190+00		Field Station#	13190+00	
Pic 17 Desc.	MVP-AR-29, punch list item repaired.		Pic 18 Desc.	MVP-AR-29, punch list item repaired.

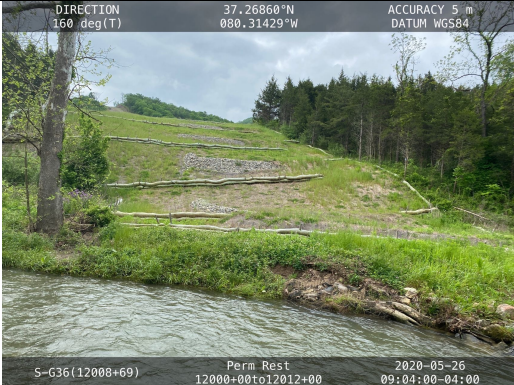
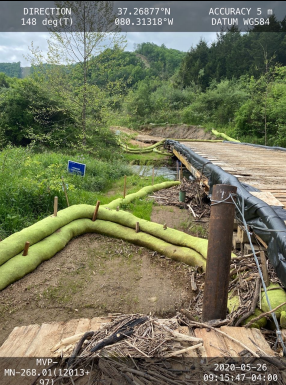
GPS Location	See photo GPS for location		GPS Location	See photo GPS for location	
Field Station#	12008+69		Field Station#	12013+97	
Pic 1 Desc.	Stream and GAS permanent restoration		Pic 2 Desc.	Bridge over S-G36/ upstream banks

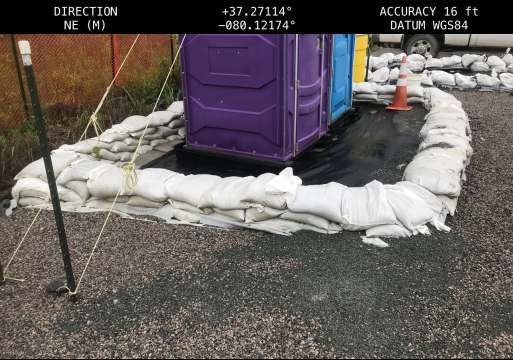
<p>DIRECTION NE (M) +37.27114° -080.12174° ACCURACY 16 ft DATUM WGS84</p> <p>MVP-LY-049_052720 Condition of trays and containment 2020-05-27 08:18:58-04:00</p>			
GPS Location	MVP-LY-049 See photo for gps data		GPS Location	MVP-LY-049 See photo for gps data	
Field Station#	+0		Field Station#	+0	
Pic 1 Desc.	Condition of the rock entrance on the center driveway. Looking S.		Pic 2 Desc.	Condition of trays and containment under toilets. Looking NE.

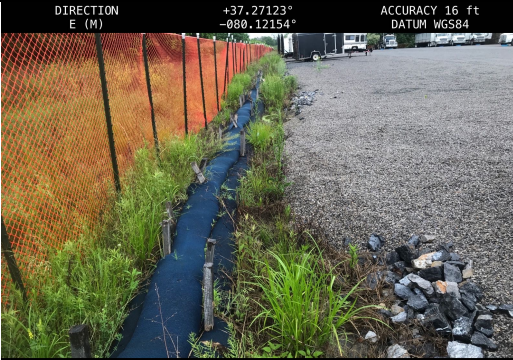
<p>DIRECTION E (M) +37.27123° -080.12154° ACCURACY 16 ft DATUM WGS84</p> <p>MVP-LY-049_052720 Condition of CFS & safety fence 2020-05-27 08:19:40-04:00</p>

GPS Location	MVP-LY-049 See photo for gps data		GPS Location	MVP-LY-049 See photo for gps data	
Field Station#	+0		Field Station#	+0	
Pic 3 Desc.	Containment under stored vehicle. Looking NW.		Pic 4 Desc.	Condition of compost filter sock and safety fence along north LOD. Looking E.

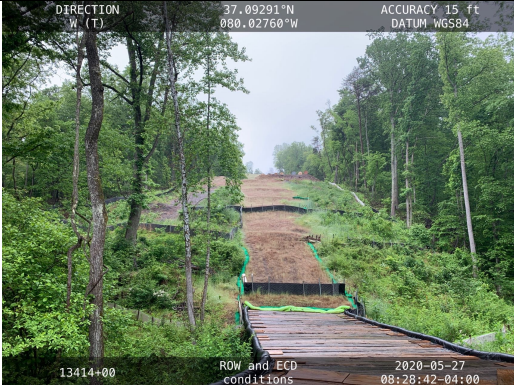
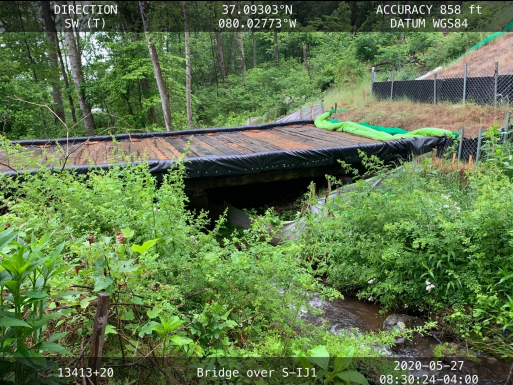
GPS Location	See photo for gps location data.		GPS Location	See photo for gps location data.	
Field Station#	13414+00		Field Station#	13413+00	
Pic 1 Desc.	Photo shows the ROW and ECD conditions from about 13410+00 to 13414+00.		Pic 2 Desc.	Photo shows the bridge over stream S-IJ1.

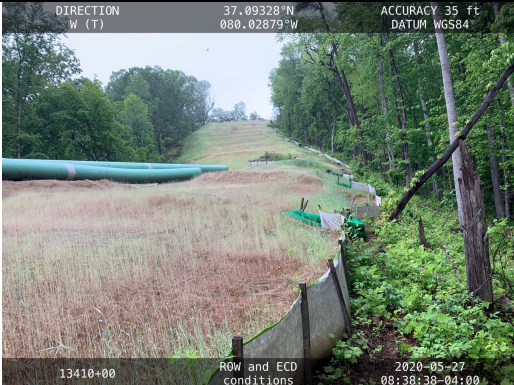
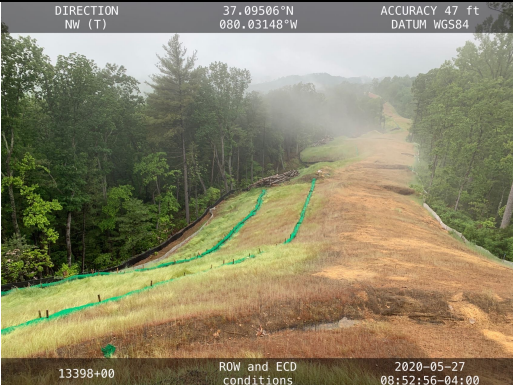
GPS Location	See photo for gps location data.		GPS Location	See photo for gps location data.	
Field Station#	13410+00		Field Station#	13398+00	
Pic 3 Desc.	photo shows the ROW and perimeter ECDs from about 13405+00 to 13410+00.		Pic 4 Desc.	Photo shows the ROW and ECD conditions from about 13390+00 to 13398+00.

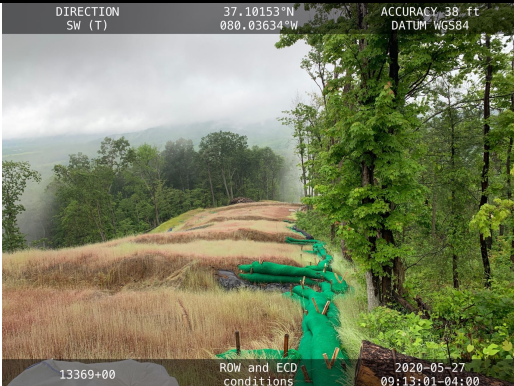
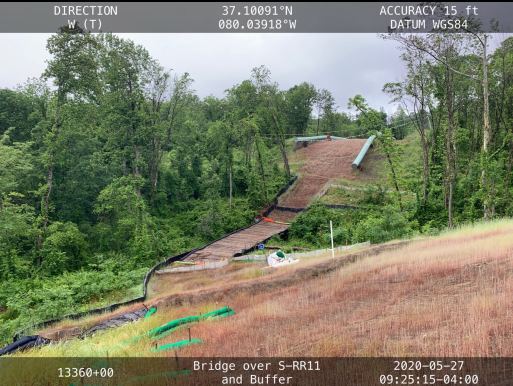
GPS Location	See photo for gps location data.		GPS Location	See photo for gps location data.	
Field Station#	13369+00		Field Station#	13360+00	
Pic 5 Desc.	Photo shows the ROW and ECD conditions from about 13365+00 to 13369+00.		Pic 6 Desc.	Photo shows the bridge over stream S-RR11 and buffer ECDs.

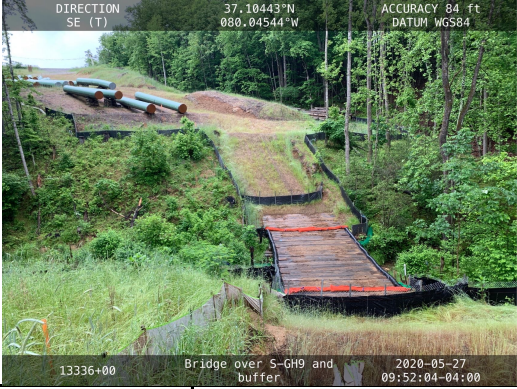
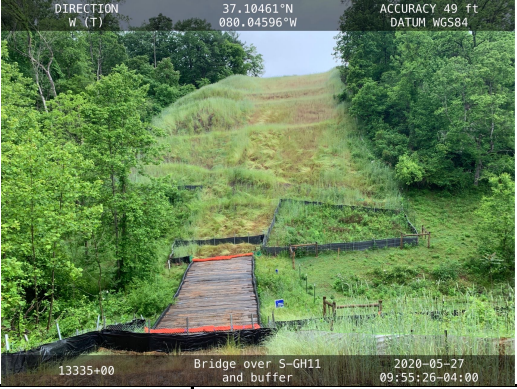
GPS Location	See photo for gps location data.		GPS Location	See photo for gps location data.	
Field Station#	13336+00		Field Station#	13335+00	
Pic 13 Desc.	Photo shows the bridge over stream S-GH9 and buffer ECDs.		Pic 14 Desc.	Photo shows the bridge over stream S-GH11 and buffer ECDs.

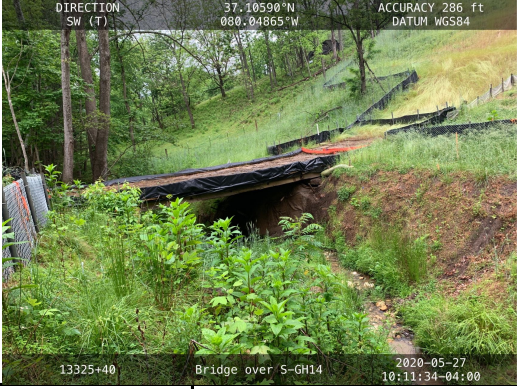
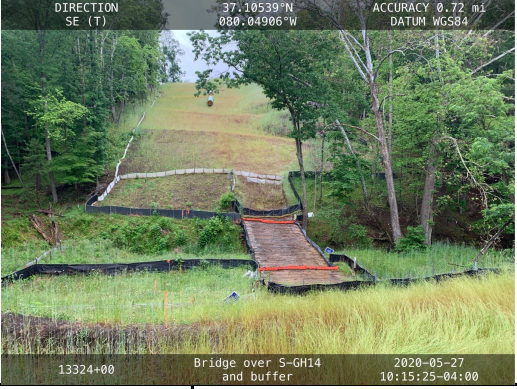
GPS Location	See photo for gps location data.		GPS Location	See photo for gps location data.	
Field Station#	13325+40		Field Station#	13324+00	
Pic 15 Desc.	Photo shows the bridge over stream S-GH14.		Pic 16 Desc.	Photo shows the bridge over stream S-GH14 and buffer ECDs.

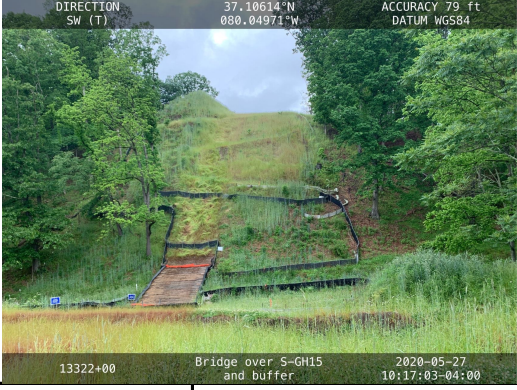
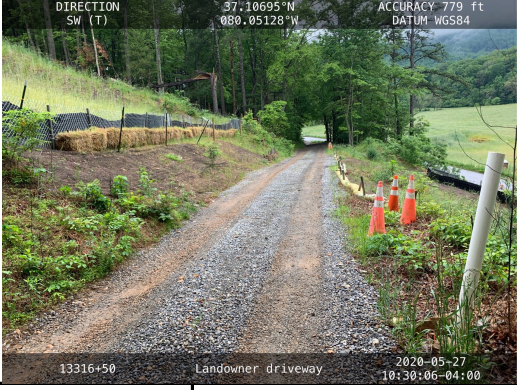
GPS Location	See photo for gps location data.		GPS Location	See photo for gps location data.	
Field Station#	13322+00		Field Station#	13316+50	
Pic 17 Desc.	Photo shows the bridge over stream S-GH15 and buffer ECDs.		Pic 18 Desc.	Photo shows the landowner driveway near Wades Gap Road.

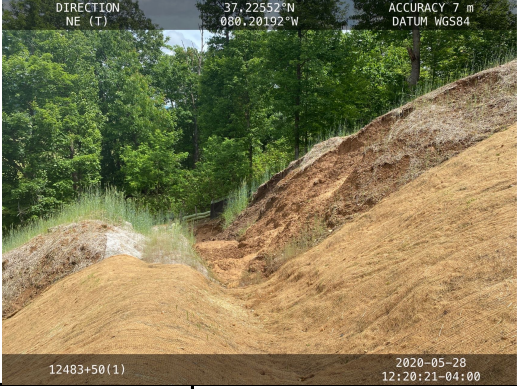
GPS Location	See photo		GPS Location	See photo	
Field Station#	12483+00		Field Station#	12455+21	
Pic 15 Desc.	End of stockpile sloughed into waterbar. Will be added to the punch list.		Pic 16 Desc.	Stream S-CD12, facing northwest, downstream

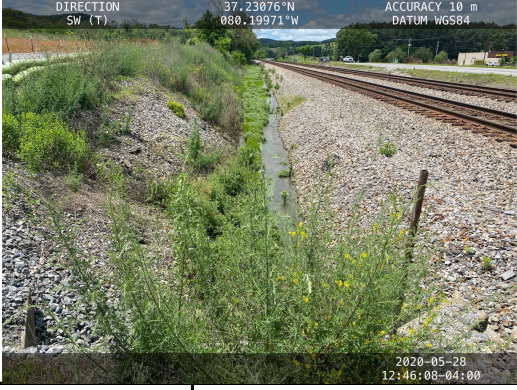
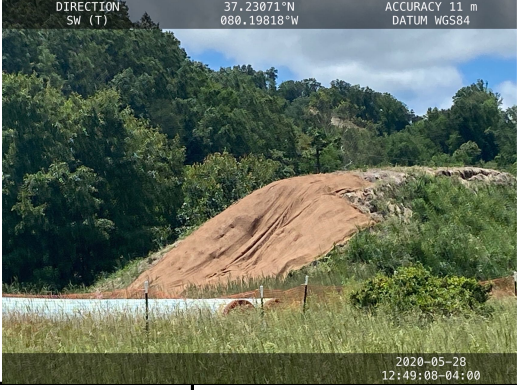
GPS Location	See photo		GPS Location	See photo	
Field Station#	12444+87		Field Station#	12441+40	
Pic 17 Desc.	Stream S-I1, facing southwest, upstream		Pic 18 Desc.	Topsoil pile was restabilized with blanket where it sloughed behind the parking area at Cove Hollow Road.
