# Visual Site Inspection Report

<b>Project Name</b> H-600 Pipeline Spread H		<b>AFE</b> 124300138	<b>Spread</b> H-600 Pipeline Spread H
<b>Contractor</b> Precision		<b>Report #</b> 10637	
<b>Inspector</b> Logan Box		<b>Date/Time</b> 5/4/2020 5:12 PM	
<b>Permit #</b> TBD	<b>Inspection Type</b> VA SWPP	<b>Station Begin</b> 13415+51	
<b>State</b> VA	<b>Inspection Area</b> Partial	<b>Station End</b> 13670+00	
<b>County</b> Franklin	<b>Ground</b> Dry	<b>Temperature (°F)</b> 74.00	
<b>Municipality</b> N/A	<b>Weather</b> Sunny	<b>Rain Gauge (in)</b> 2.30	
			<b>Rain Accumulation Time (days)</b> 6.00

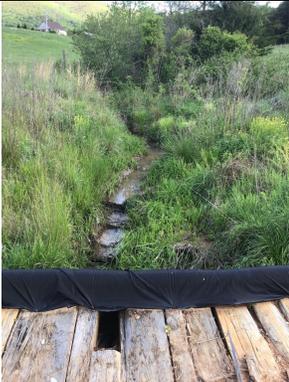
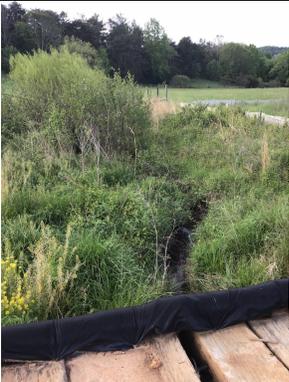
<b>GPS Location</b>	00000	<b>GPS Location</b>	00000		
<b>Field Station#</b>	13568+79	<b>Field Station#</b>	13568+79		
<b>Pic 1 Desc.</b>	Photo of natural drain crossing facing upstream showing vegetation		<b>Pic 2 Desc.</b>	Photo of natural drain crossing facing downstream

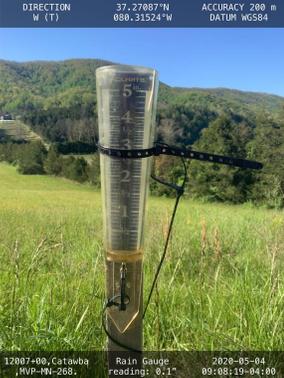
<p>DIRECTION M (T) 37.27887°N 080.31524°W ACCURACY 200 m DATUM WGS84</p> <p>12007+00, Catawba, MVP-MN-268, Rain Gauge reading: 0.1" 2020-05-04 09:08:19-04:00</p>

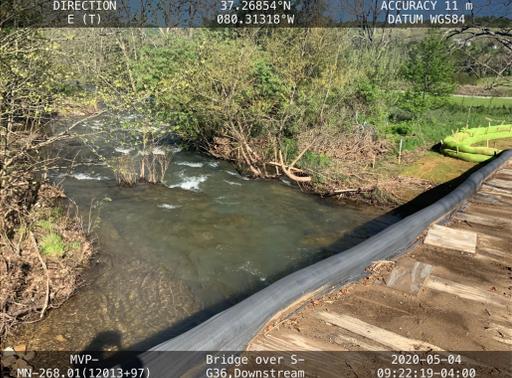
<p>DIRECTION E (T) 37.26854°N 080.31318°W ACCURACY 11 m DATUM WGS84</p> <p>MVP-MN-268, 01(12013+97) Bridge over S-G36, Downstream 2020-05-04 09:22:19-04:00</p>			
<b>GPS Location</b>	See photo GPS for location		<b>GPS Location</b>	See photo GPS for location	
<b>Field Station#</b>	12007+00		<b>Field Station#</b>	12013+97	
<b>Pic 1 Desc.</b>	Rainfall total was 0.10" at Catawba.		<b>Pic 2 Desc.</b>	ECDs surrounding the bridge over S-G36 on this access road are in acceptable condition. Water is free of turbidity.

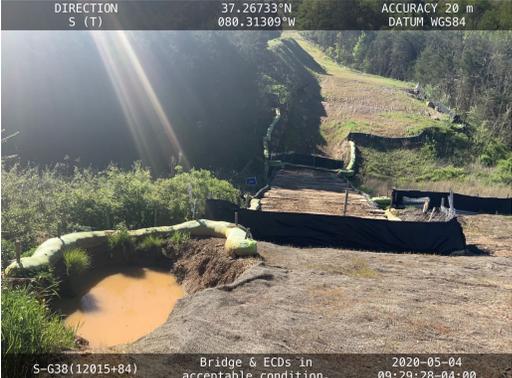
<p>DIRECTION S (T) 37.26733°N 080.31309°W ACCURACY 20 m DATUM WGS84</p> <p>S-G38(12015+84) Bridge &amp; ECDs in acceptable condition, 2020-05-04 09:29:28-04:00</p>

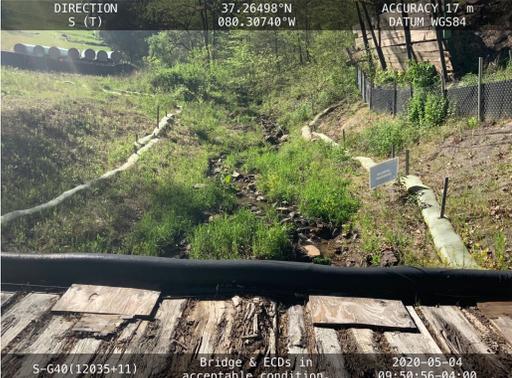
<p>DIRECTION S (T) 37.26498°N 080.30740°W ACCURACY 17 m DATUM WGS84</p> <p>S-G40(12035+11) Bridge &amp; ECDs in acceptable condition, 2020-05-04 09:50:56-04:00</p>

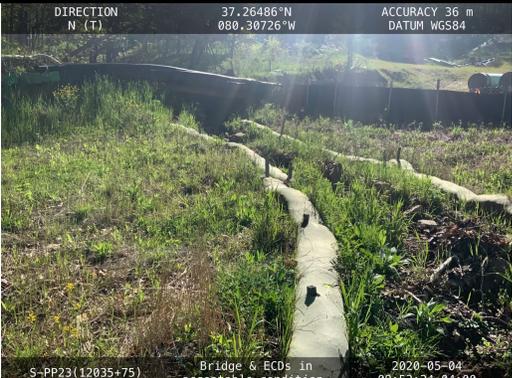
<p>DIRECTION N (T) 37.26486°N 080.30726°W ACCURACY 36 m DATUM WGS84</p> <p>S-PP23(12035+75) Bridge &amp; ECDs in acceptable condition, 2020-05-04 09:52:24-04:00</p>

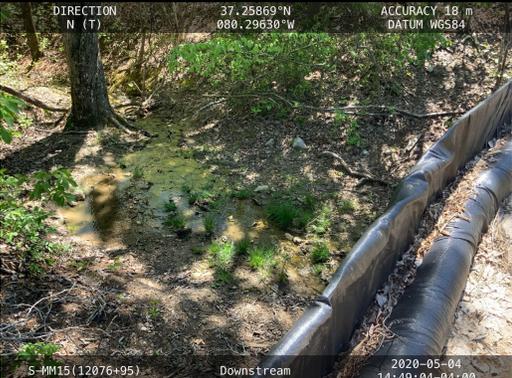
<p>DIRECTION N (T) 37.25869°N 080.29530°W ACCURACY 18 m DATUM WGS84</p> <p>S-MM15(12076+95) Downstream 2020-05-04 14:49:04-04:00</p>			
<b>GPS Location</b>	See photo GPS for location		<b>GPS Location</b>	See photo GPS for location	
<b>Field Station#</b>	12035+75		<b>Field Station#</b>	12076+95	
<b>Pic 5 Desc.</b>	Bridge and ECDs are in acceptable condition.		<b>Pic 6 Desc.</b>	ECDs are in acceptable condition surrounding stream and bridge. The water is free of turbidity.

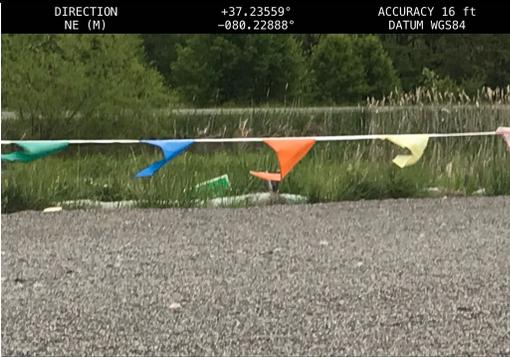
<p>DIRECTION NE (M) +37.23559° -080.22688° ACCURACY 16 ft DATUM WGS84</p> <p>MVP-PY-006_050520 Condition of signage and buffer flagging 2020-05-05 07:00:09-04:00</p>

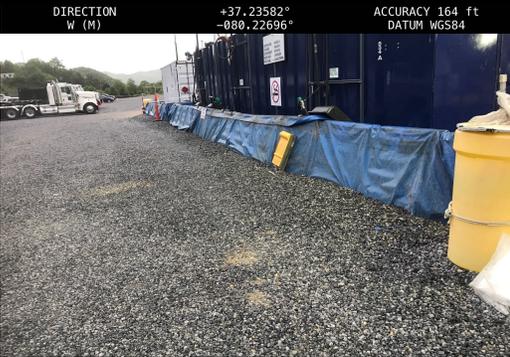
<p>DIRECTION W (M) +37.23582° -080.22696° ACCURACY 164 ft DATUM WGS84</p> <p>MVP-PY-006_050520 No fuel spills south of bulk tanks 2020-05-05 07:04:26-04:00</p>			
<b>GPS Location</b> MVP-PY-006 See photo for gps data		<b>GPS Location</b> MVP-PY-006 See photo for gps data			
<b>Field Station#</b> +0		<b>Field Station#</b> +0			
<b>Pic 1 Desc.</b> Condition of signage and buffer flagging for feature. Looking NE.		<b>Pic 2 Desc.</b> No fuel spills south of blue bulk fuel tanks. Looking W.

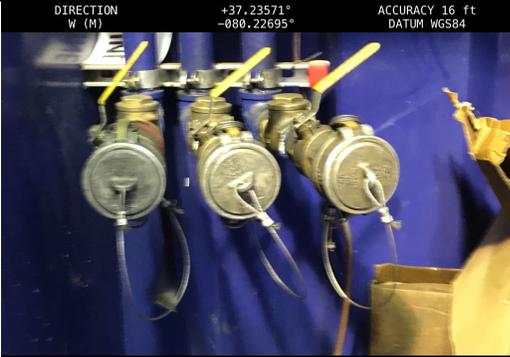
<p>DIRECTION W (M) +37.23571° -080.22695° ACCURACY 16 ft DATUM WGS84</p> <p>MVP-PY-006_050520 No leaky internal fittings 2020-05-05 07:04:58-04:00</p>

<b>GPS Location</b> MVP-PY-006 See photo for gps data		<b>GPS Location</b> MVP-PY-006 See photo for gps data			
<b>Field Station#</b> +0		<b>Field Station#</b> +0			
<b>Pic 3 Desc.</b> Blue Bulk Fuel tanks no leaky internal fittings. Looking W.		<b>Pic 4 Desc.</b> Condition of containments for DEF tank and light plant. Looking S.

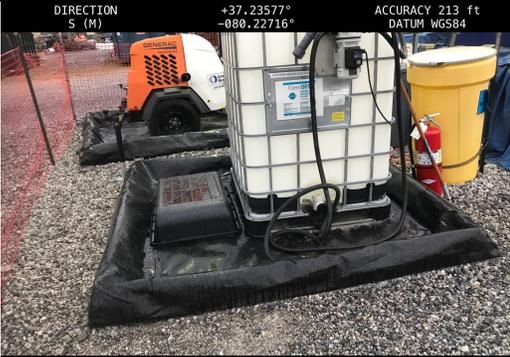
<p>DIRECTION S (M) +37.23577° -080.22716° ACCURACY 213 ft DATUM WGS84</p> <p>MVP-PY-006_050520 Condition of containments 2020-05-05 07:05:40-04:00</p>

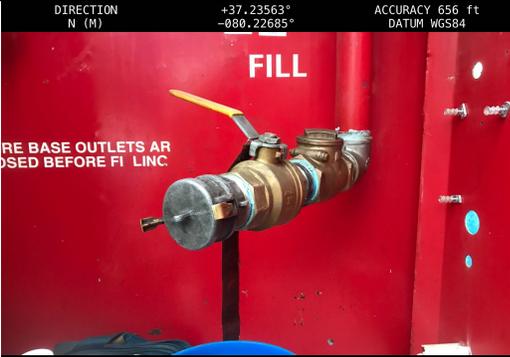
<p>DIRECTION N (M) +37.23563° -080.22685° ACCURACY 656 ft DATUM WGS84</p> <p>MVP-PY-006_050520 No leaky internal fittings 2020-05-05 07:06:45-04:00</p>

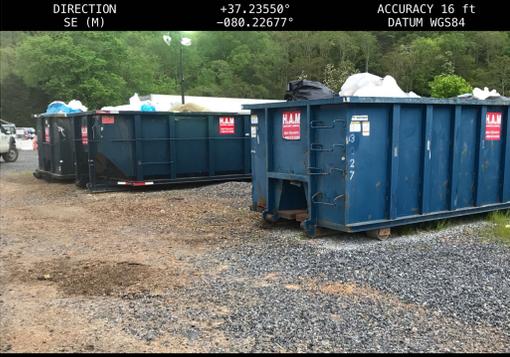
<p>DIRECTION SE (M) +37.23550° -080.22677° ACCURACY 16 ft DATUM WGS84</p> <p>MVP-PY-006_050520 No loose trash around dumpsters 2020-05-05 07:09:37-04:00</p>			
<b>GPS Location</b> MVP-PY-006 See photo for gps data		<b>GPS Location</b> MVP-PY-006 See photo for gps data			
<b>Field Station#</b> +0		<b>Field Station#</b> +0			
<b>Pic 5 Desc.</b> Off Road Fuel unit no leaky internal fittings. Looking W.		<b>Pic 6 Desc.</b> No loose trash around dumpsters. Looking SE.

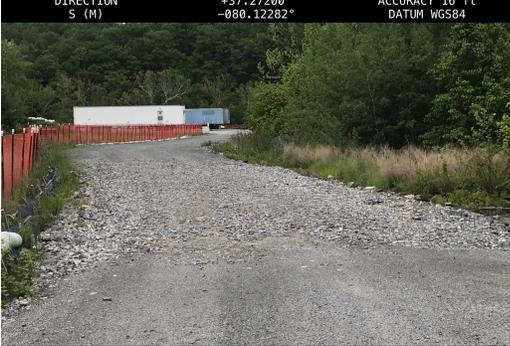
<p>MVP-LY-049_050520 Condition of rock entrance 2020-05-05 07:46:07-04:00</p>		<p>DIRECTION S (M) +37.27037° -080.12138° ACCURACY 16 ft DATUM WGS84</p>

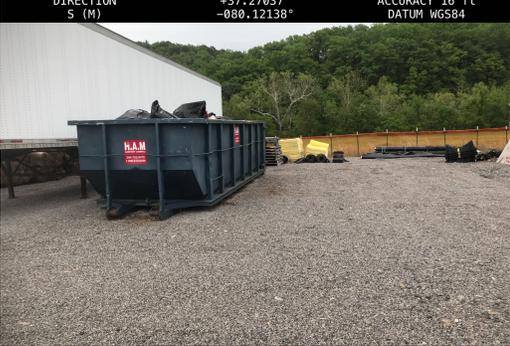
<p>MVP-LY-049_050520 No loose trash around south dumpster 2020-05-05 08:51:19-04:00</p>			
<b>GPS Location</b> MVP-LY-049 See photo for gps data		<b>GPS Location</b> MVP-LY-049 See photo for gps data			
<b>Field Station#</b> +0		<b>Field Station#</b> +0			
<b>Pic 1 Desc.</b> Condition of rock entrance on center driveway. Looking S.		<b>Pic 2 Desc.</b> No loose trash around south dumpster. Looking S.			
<p>DIRECTION NW (M) +37.27092° -080.12217° ACCURACY 33 ft DATUM WGS84</p>

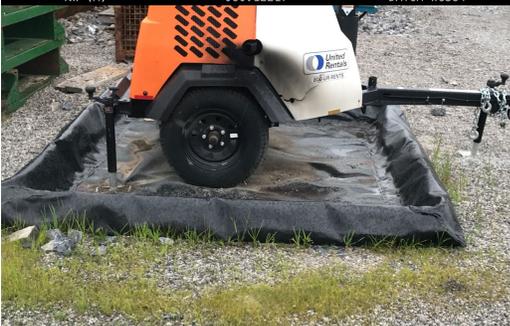
<p>MVP-LY-049_050520 Condition of containment 2020-05-05 08:52:43-04:00</p>		<p>DIRECTION SW (M) +37.27065° -080.12237° ACCURACY 33 ft DATUM WGS84</p>

<b>GPS Location</b> MVP-LY-049 See photo for gps data		<b>GPS Location</b> MVP-LY-049 See photo for gps data			
<b>Field Station#</b> +0		<b>Field Station#</b> +0			
<b>Pic 3 Desc.</b> Condition of containment under light plant. Looking NW.		<b>Pic 4 Desc.</b> Condition of hazardous waste dumpsters. No debris around dumpsters. Looking NW.			
<p>DIRECTION W (M) +37.27048° -080.12341° ACCURACY 16 ft DATUM WGS84</p>

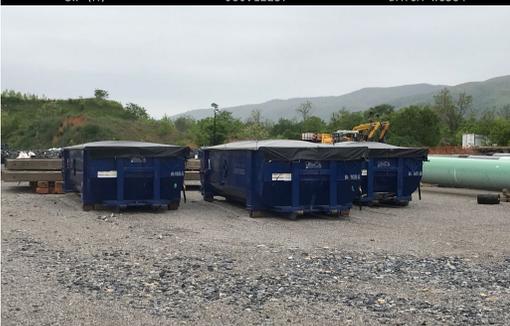
<p>MVP-LY-049_050520 Condition of hazardous waste dump... 2020-05-05 08:53:23-04:00</p>

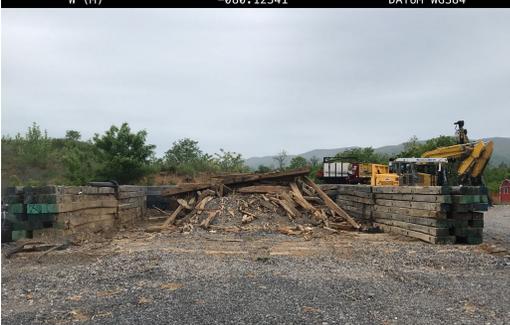
<p>MVP-LY-049_050520 Condition of temporary trash tran... 2020-05-05 08:54:09-04:00</p>		<p>DIRECTION S (M) +37.27040° -080.12474° ACCURACY 16 ft DATUM WGS84</p>

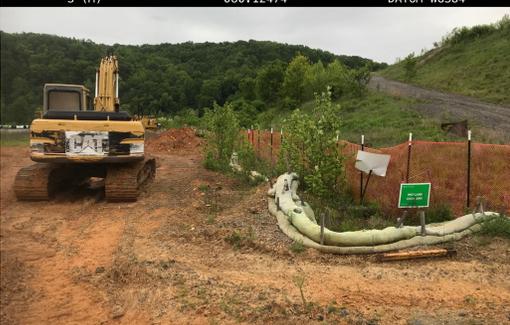
<p>MVP-LY-049_050520 Landowner disturbance &amp; parked equipment 2020-05-05 08:55:14-04:00</p>			
<b>GPS Location</b> MVP-LY-049 See photo for gps data		<b>GPS Location</b> MVP-LY-049 See photo for gps data			
<b>Field Station#</b> +0		<b>Field Station#</b> +0			
<b>Pic 5 Desc.</b> Condition of temporary trash transfer pit. Looking W.		<b>Pic 6 Desc.</b> Landowner disturbance and equipment parked next to compost filter sock and feature. No impacts. Looking S.

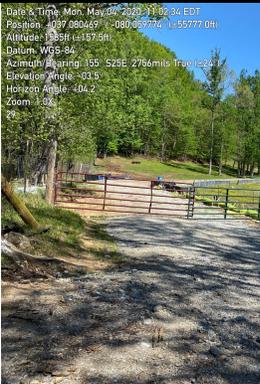
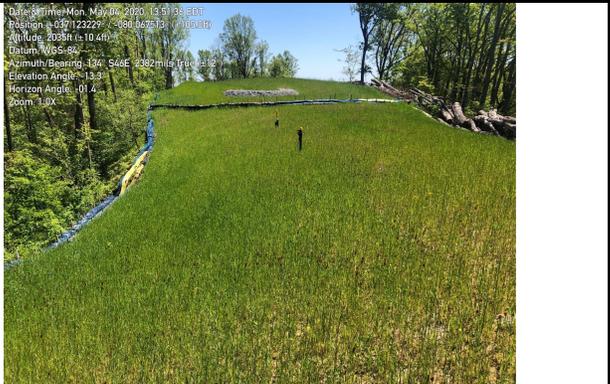
<b>GPS Location</b>	See photo for coordinates.	<b>GPS Location</b>	See photo for coordinates.
<b>Field Station#</b>	13190+00	<b>Field Station#</b>	13222+00	<b>Pic 1 Desc.</b>	MVP-AR-29, access road in acceptable condition, cattle disturbance noted.	<b>Pic 2 Desc.</b>	ROW in acceptable condition, permanent waterbars stable, no changes noted to off ROW slip (under investigation).

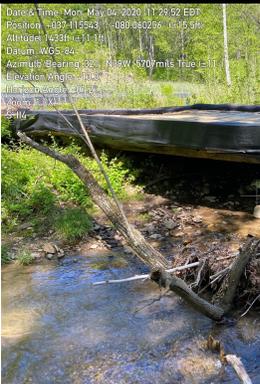
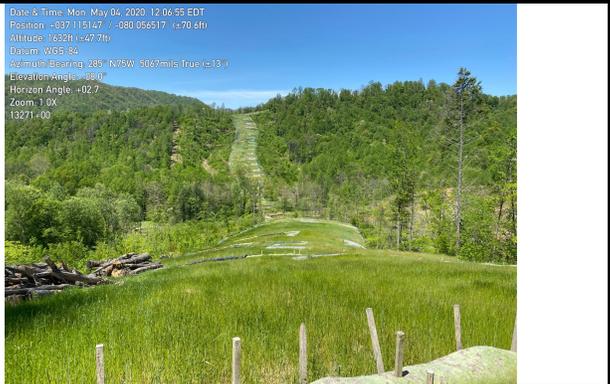
<b>GPS Location</b>	See photo for coordinates.	<b>GPS Location</b>	See photo for coordinates.
<b>Field Station#</b>	13260+60	<b>Field Station#</b>	132730+00	<b>Pic 3 Desc.</b>	S-II4, downstream side of equipment bridge, bridge in acceptable condition, no ECD failures noted, no stream impacts.	<b>Pic 4 Desc.</b>	ROW stable with moderate to good vegetative cover in area, permanent waterbars stable, perimeter controls functioning acceptably.

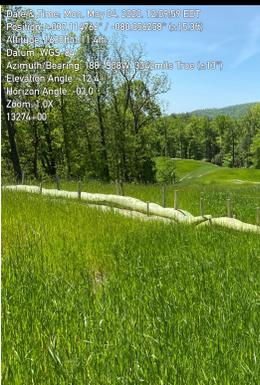
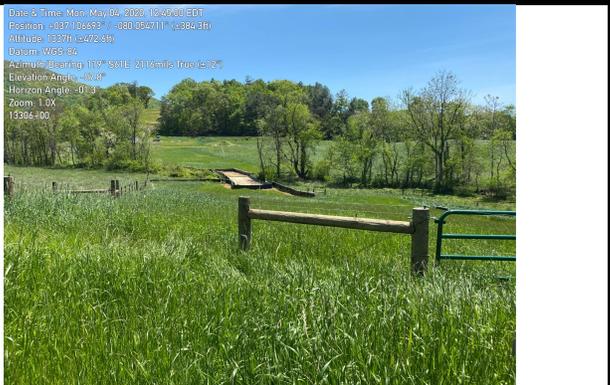
<b>GPS Location</b>	See photo for coordinates.	<b>GPS Location</b>	See photo for coordinates.
<b>Field Station#</b>	13278+00	<b>Field Station#</b>	13306+00	<b>Pic 5 Desc.</b>	Good vegetative cover noted in permanently restored section, permanent waterbars stable, no off ROW impacts noted.	<b>Pic 6 Desc.</b>	Good vegetative cover noted, no environmental issues noted at S-GH7.

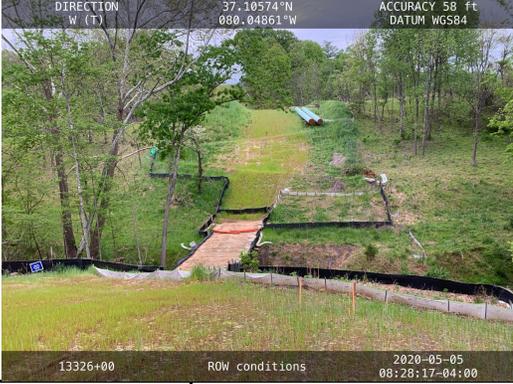
<p>DIRECTION W (T) 37.10574°N 080.04861°W ACCURACY 58 ft DATUM WGS84 13326+00 ROW conditions 2020-05-05 08:29:17-04:00</p>

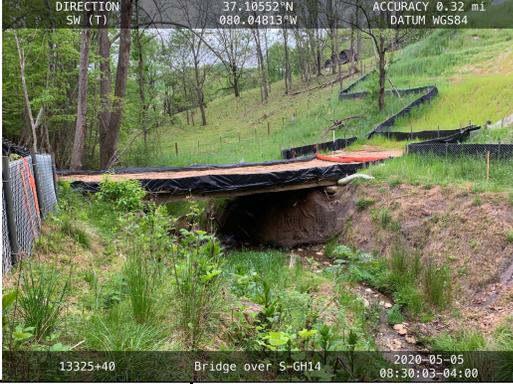
<p>DIRECTION SW (T) 37.10552°N 080.04813°W ACCURACY 0.32 mi DATUM WGS84 13325+40 Bridge over S-GH14 2020-05-05 08:30:03-04:00</p>	
<b>GPS Location</b>	See photo for gps location data.	<b>GPS Location</b>	See photo for gps location data.
<b>Field Station#</b>	13326+00	<b>Field Station#</b>	13325+30
<b>Pic 7 Desc.</b>	Photo shows the ROW conditions from about 13324+00 to 13326+00.	<b>Pic 8 Desc.</b>	Photo shows the bridge over stream S-GH14.

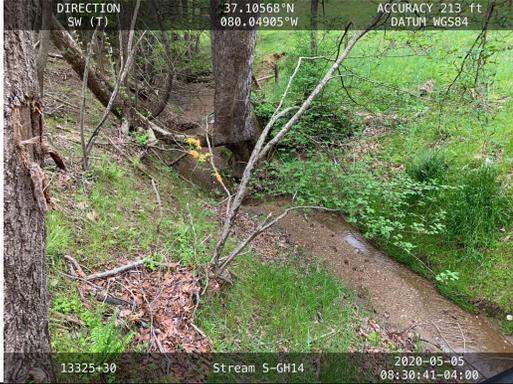
<p>DIRECTION SW (T) 37.10568°N 080.04905°W ACCURACY 213 ft DATUM WGS84 13325+30 Stream S-GH14 2020-05-05 08:30:41-04:00</p>

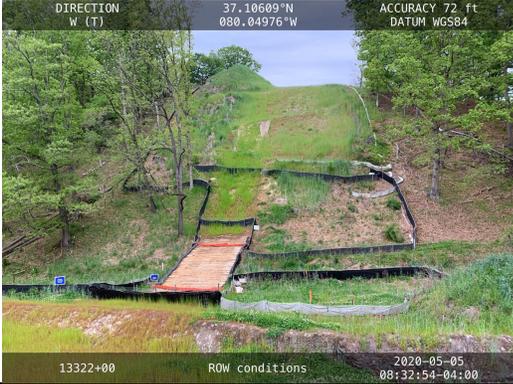
<p>DIRECTION W (T) 37.10609°N 080.04976°W ACCURACY 72 ft DATUM WGS84 13322+00 ROW conditions 2020-05-05 08:32:54-04:00</p>	
<b>GPS Location</b>	See photo for gps location data.	<b>GPS Location</b>	See photo for gps location data.

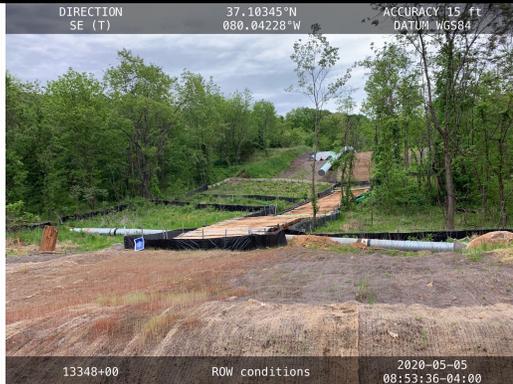
<p>DIRECTION SE (T) 37.10345°N 080.04228°W ACCURACY 15 ft DATUM WGS84 13348+00 ROW conditions 2020-05-05 08:53:36-04:00</p>

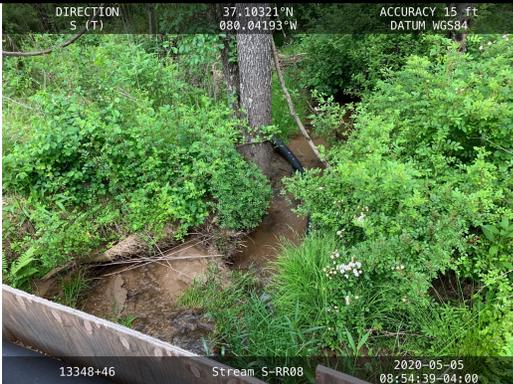
<p>DIRECTION S (T) 37.10321°N 080.04193°W ACCURACY 15 ft DATUM WGS84 13348+46 Stream S-RR08 2020-05-05 08:54:39-04:00</p>	
<b>GPS Location</b>	See photo for gps location data.	<b>GPS Location</b>	See photo for gps location data.
<b>Field Station#</b>	13348+00	<b>Field Station#</b>	13348+46
<b>Pic 11 Desc.</b>	Photo shows the ROW conditions from about 13348+00 to 13350+00.	<b>Pic 12 Desc.</b>	Photo shows stream S-RR08, downstream from the ROW crossing.

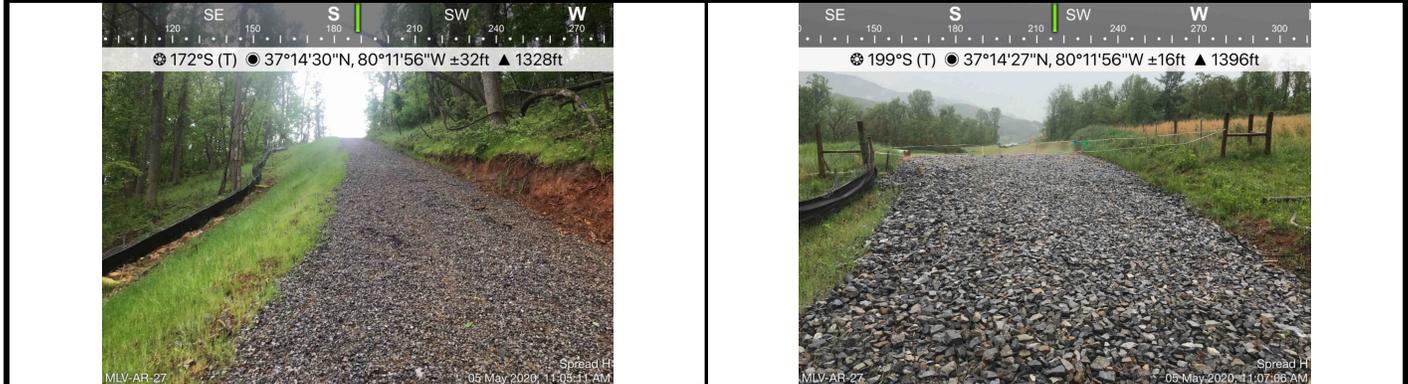
<b>GPS Location</b>	See photo	<b>GPS Location</b>	See photo
<b>Field Station#</b>	+27	<b>Field Station#</b>	+27
<b>Pic 1 Desc.</b>	Controls are in place and functioning on MLV-AR-27	<b>Pic 2 Desc.</b>	Rock CE at MLV-27 in good condition.

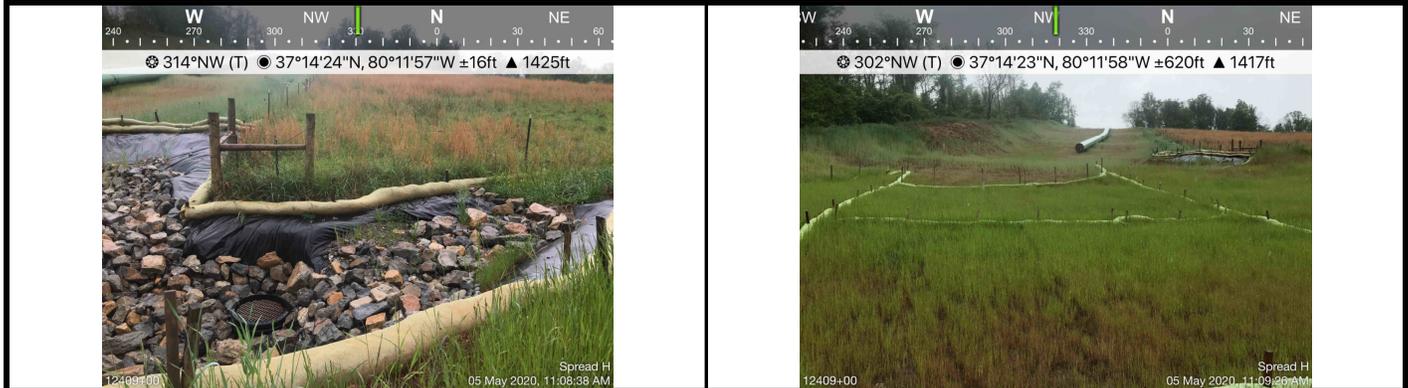
<b>GPS Location</b>	See photo	<b>GPS Location</b>	See photo
<b>Field Station#</b>	12409+00	<b>Field Station#</b>	12409+00
<b>Pic 3 Desc.</b>	CWD inlet in good condition.	<b>Pic 4 Desc.</b>	CFS controls in good condition. Temporary vegetation established and mature.

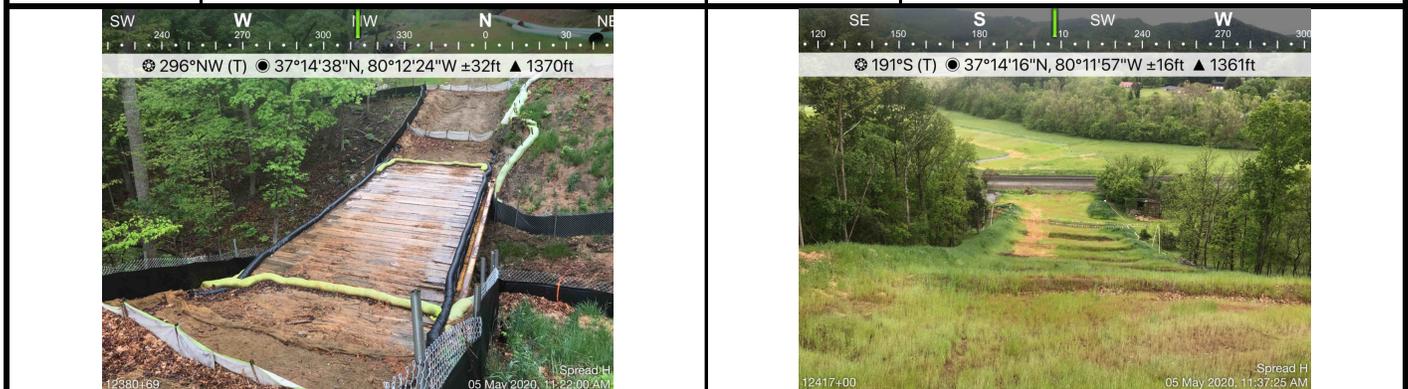
<b>GPS Location</b>	See photo	<b>GPS Location</b>	See photo
<b>Field Station#</b>	12380+69	<b>Field Station#</b>	12417+00
<b>Pic 5 Desc.</b>	Bridge controls at this stream crossing in good condition.	<b>Pic 6 Desc.</b>	Waterbars and end treatments on this slope in good condition. Vegetation well-established.

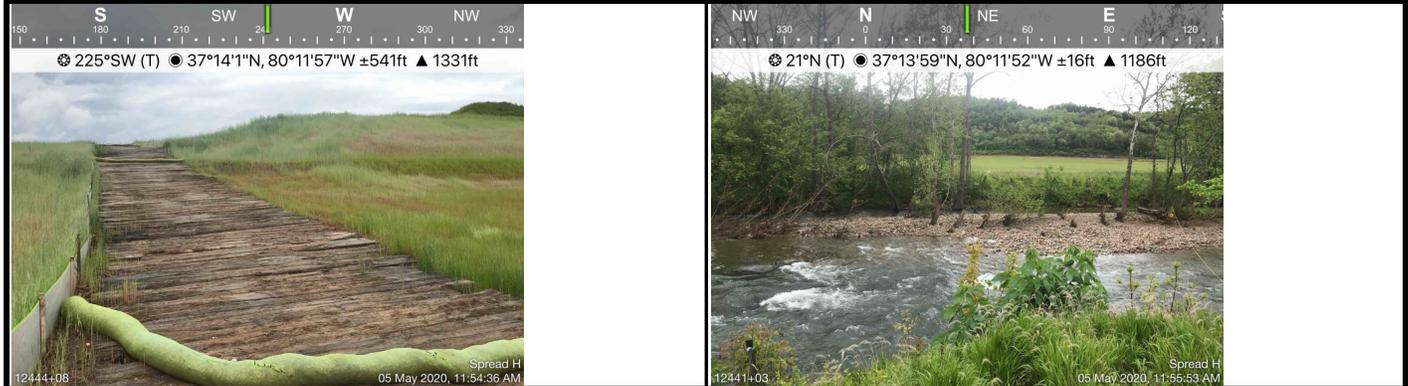
<b>GPS Location</b>	See photo	<b>GPS Location</b>	See photo
<b>Field Station#</b>	12444+08	<b>Field Station#</b>	12441+03
<b>Pic 7 Desc.</b>	Timbermatting controls in good condition on the CIS of Rte 11	<b>Pic 8 Desc.</b>	Roanoke river crossing area in good condition, no impacts to the resource were observed.

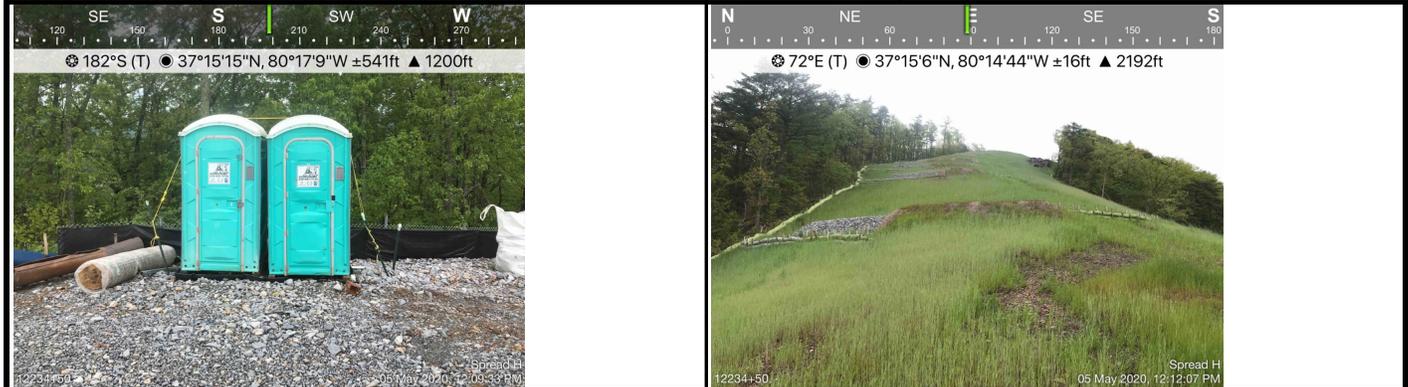
<b>GPS Location</b>	See photo	<b>GPS Location</b>	See photo
<b>Field Station#</b>	12234+50	<b>Field Station#</b>	12234+50
<b>Pic 9 Desc.</b>	Portajohns within secondary containment.	<b>Pic 10 Desc.</b>	Start of inspection area, Permanent waterbars in good condition and vegetation is established.

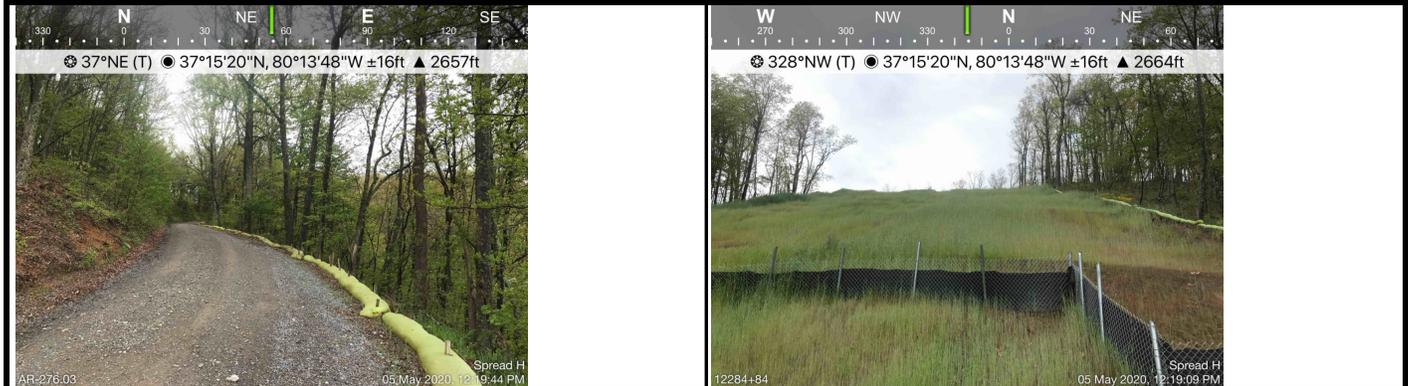
<b>GPS Location</b>	See photo	<b>GPS Location</b>	See photo
<b>Field Station#</b>	276+03	<b>Field Station#</b>	12284+84
<b>Pic 11 Desc.</b>	Controls in place and functioning on AR-276.03	<b>Pic 12 Desc.</b>	SSF controls in good condition.

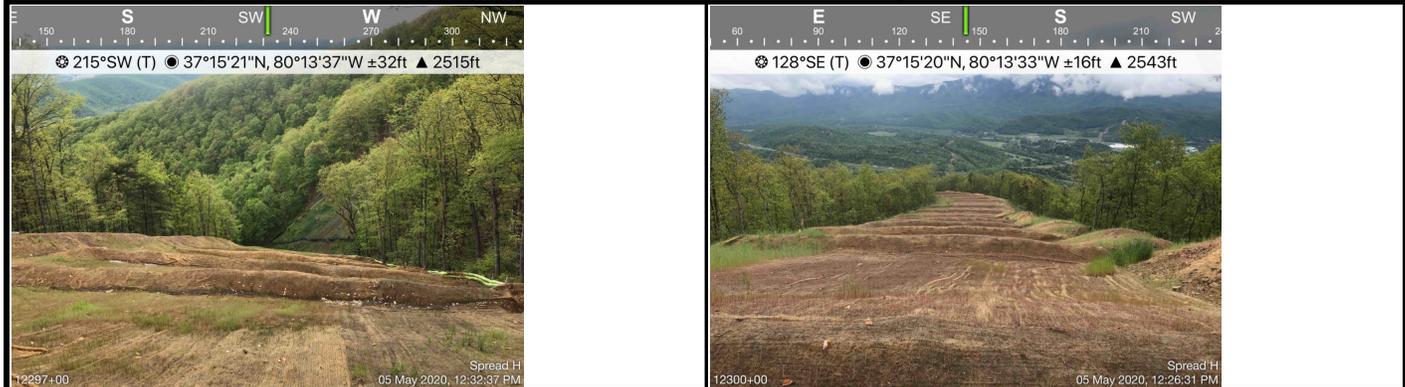
<b>GPS Location</b>	See photo	<b>GPS Location</b>	See photo
<b>Field Station#</b>	12297+00	<b>Field Station#</b>	12300+00
<b>Pic 15 Desc.</b>	Reese Mtn "V" in good condition. Waterbars and end treatments appear to be functioning.	<b>Pic 16 Desc.</b>	Waterbar and end treatments along this slope in good condition.

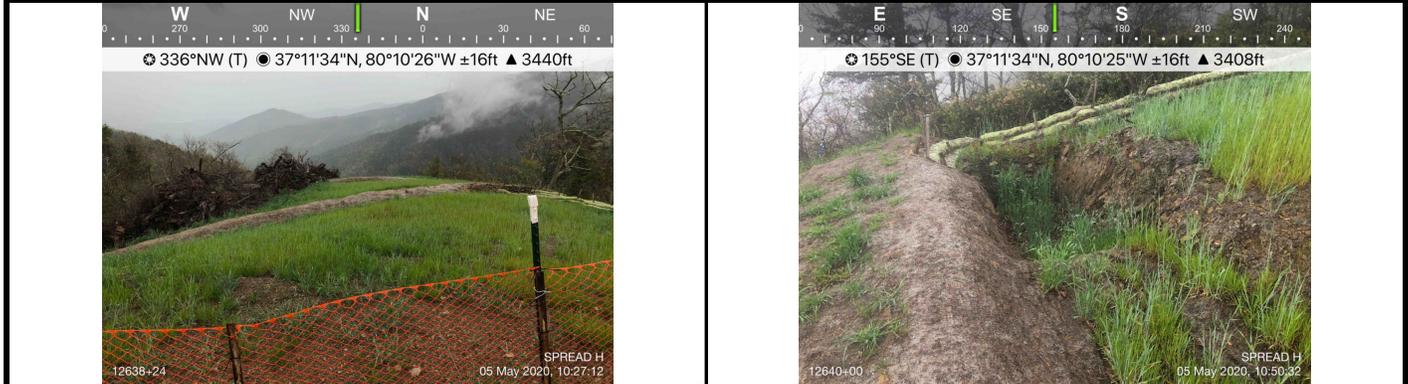
<b>GPS Location</b>	See Photo	<b>GPS Location</b>	See Photo
<b>Field Station#</b>	12638+24	<b>Field Station#</b>	12640+00
<b>Pic 1 Desc.</b>	Slope on the GAS of AR-279.01 in good condition.	<b>Pic 2 Desc.</b>	Waterbars in good condition on this slope. Sumps have received minimal amounts of runoff from the rain event.

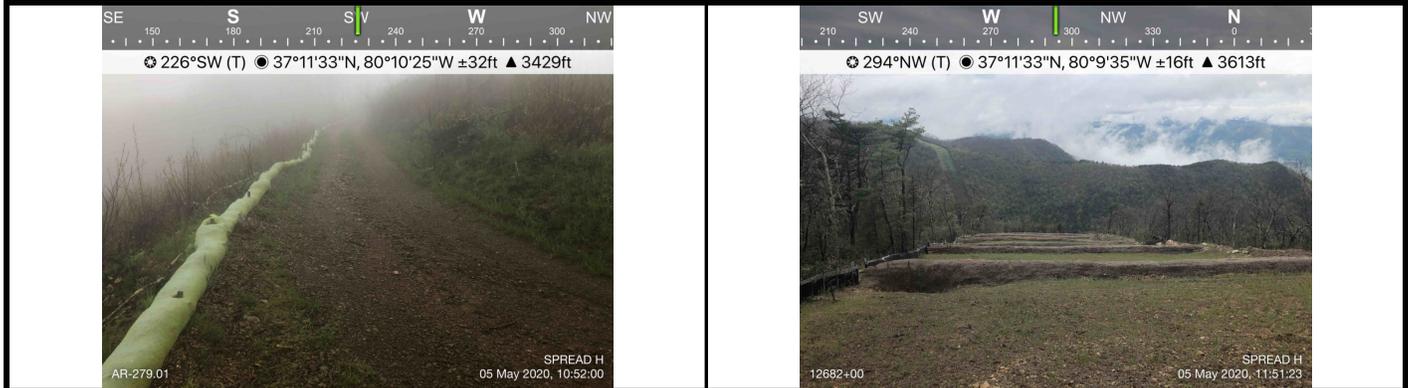
<b>GPS Location</b>	See Photo	<b>GPS Location</b>	See Photo
<b>Field Station#</b>	279+01	<b>Field Station#</b>	12682+00
<b>Pic 3 Desc.</b>	AR-279.02 in good condition with controls in place.	<b>Pic 4 Desc.</b>	Vegetation slowly filling in on the CIS of Honeysuckle Rd.

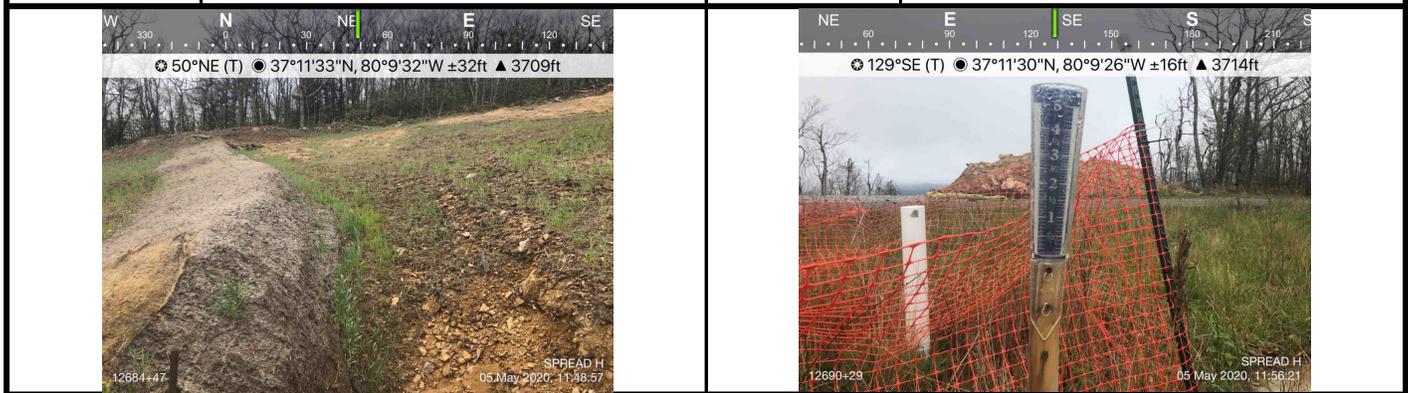
<b>GPS Location</b>	See Photo	<b>GPS Location</b>	See Photo
<b>Field Station#</b>	12684+47	<b>Field Station#</b>	12690+29
<b>Pic 5 Desc.</b>	Waterbars and sumps in good condition on the CIS slope of Honeysuckle Rd.	<b>Pic 6 Desc.</b>	Rain gauge at Honeysuckle Rd. crossing showing 0.10".

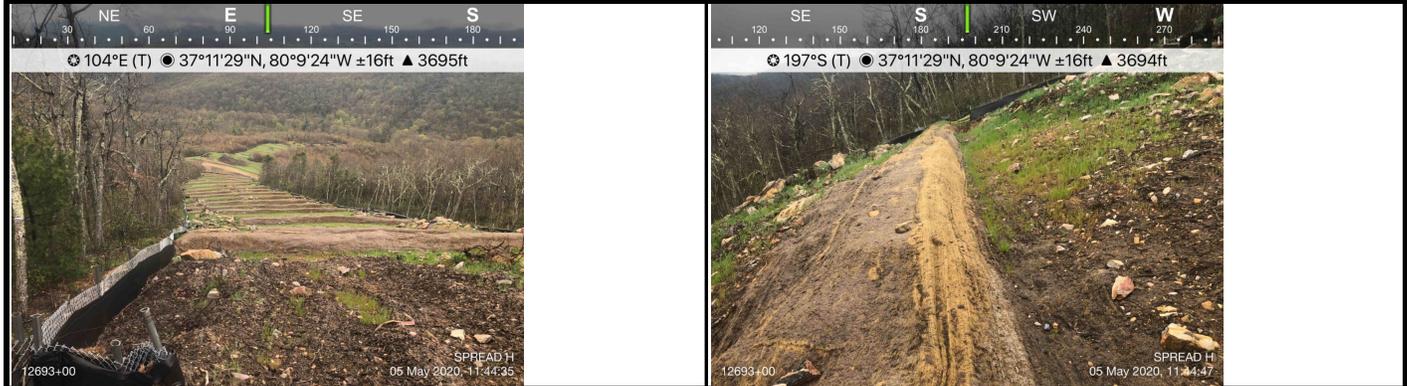
<b>GPS Location</b>	See Photo	<b>GPS Location</b>	See Photo
<b>Field Station#</b>	12693+00	<b>Field Station#</b>	12693+00
<b>Pic 7 Desc.</b>	Controls in place and functioning on the GAS of Honeysuckle Rd.	<b>Pic 8 Desc.</b>	Waterbars in good condition on this slope.

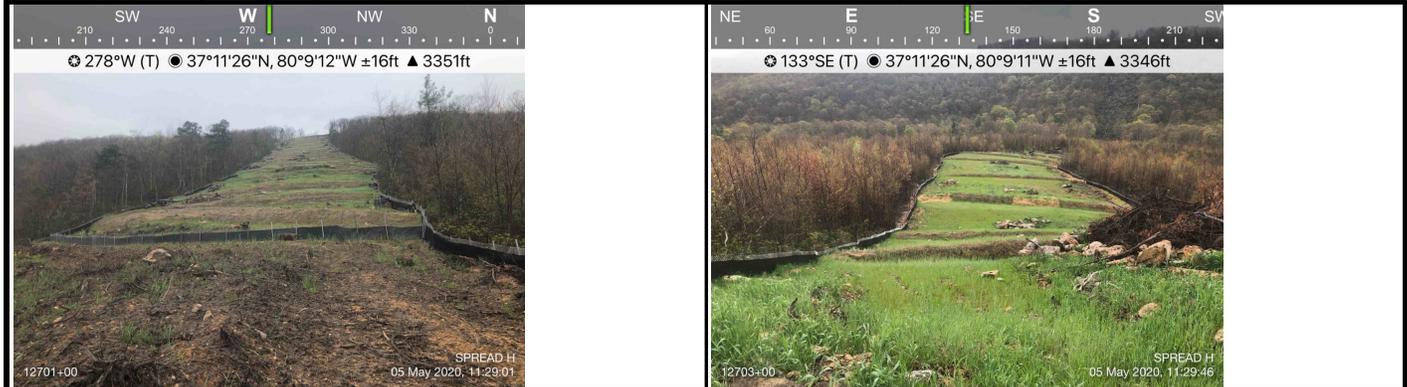
<b>GPS Location</b>	See Photo	<b>GPS Location</b>	See Photo
<b>Field Station#</b>	12701+00	<b>Field Station#</b>	12703+00
<b>Pic 9 Desc.</b>	Additional controls at the base of this slope in good condition and functioning.	<b>Pic 10 Desc.</b>	GAS slope of AR-280 in good condition. Vegetation filling in on this slope.

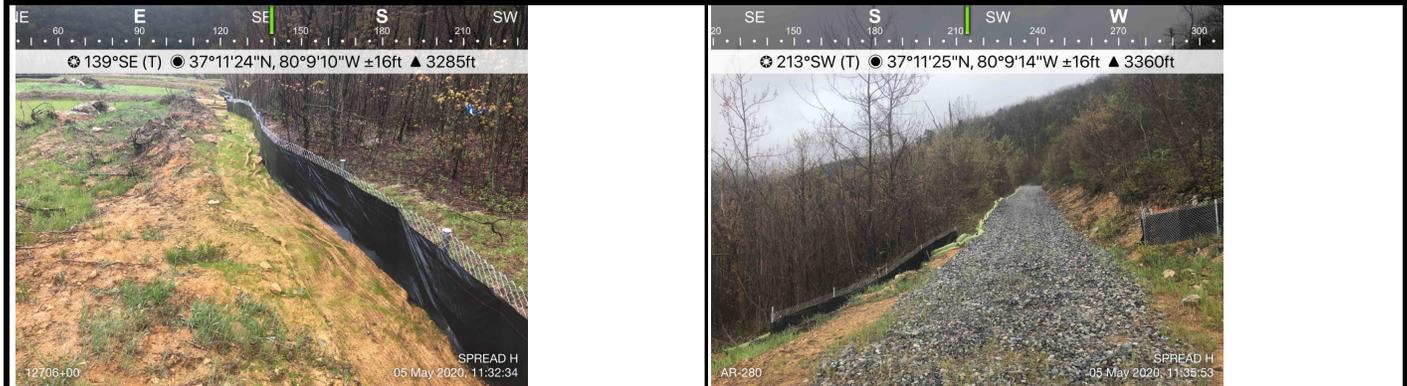
<b>GPS Location</b>	See Photo	<b>GPS Location</b>	See Photo
<b>Field Station#</b>	12706+00	<b>Field Station#</b>	280+00
<b>Pic 11 Desc.</b>	Area previously repaired in good condition. Vegetation growing through matting.	<b>Pic 12 Desc.</b>	AR-280 in good condition with controls in place.

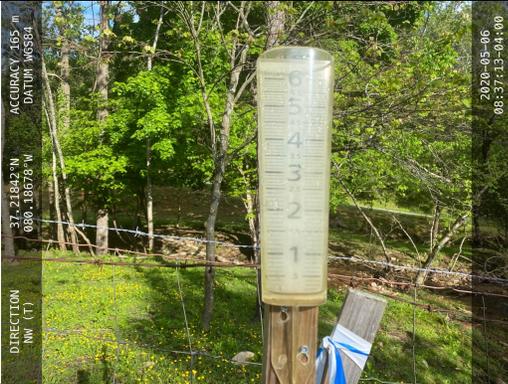
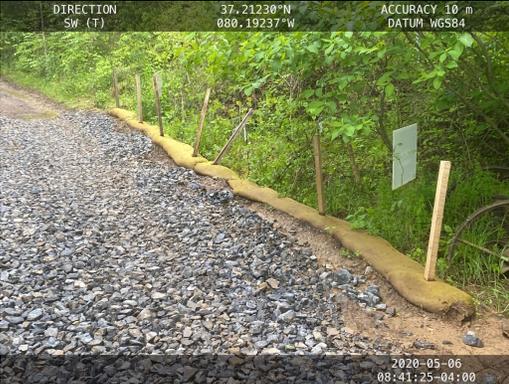
<p>DIRECTION SW (T) 37.21230°N 080.19237°W ACCURACY 10 m DATUM WGS84 2020-05-06 08:41:25-04:00</p>	
<b>GPS Location</b> See photo		<b>GPS Location</b> See photo		<b>GPS Location</b> See photo	
<b>Field Station#</b> 12544+06		<b>Field Station#</b> 12544+06		<b>Field Station#</b> 12544+06	
<b>Pic 1 Desc.</b> 0.2 inches of precipitation accumulated in the rain gauge at Yellow Finch Road overnight.		<b>Pic 2 Desc.</b> CFS alongside Yellow Finch Road needs to be replaced where it has been flattened where stream S-EF54 crosses the road.		<b>Pic 2 Desc.</b> CFS alongside Yellow Finch Road needs to be replaced where it has been flattened where stream S-EF54 crosses the road.

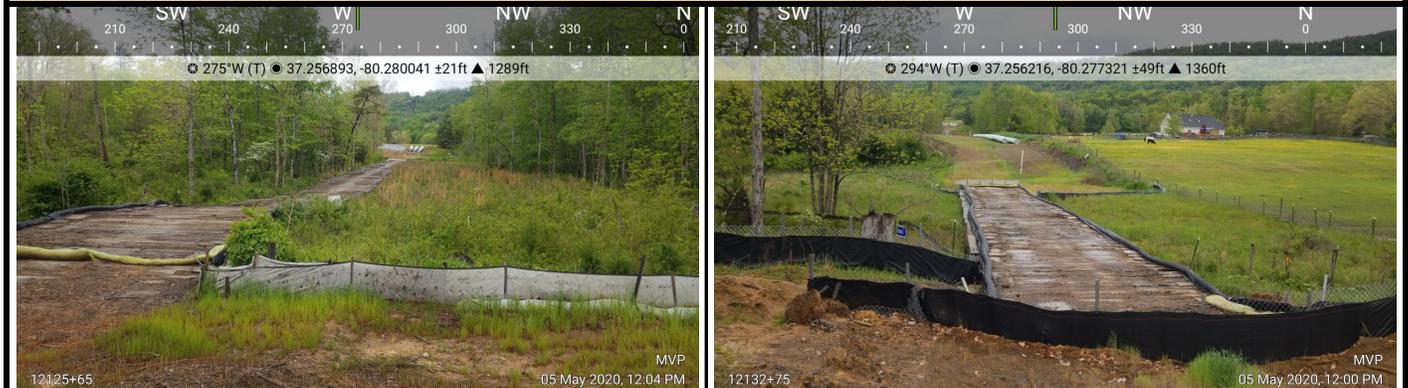
<b>GPS Location</b> See Above	<b>GPS Location</b> See Above
<b>Field Station#</b> 12125+65	<b>Field Station#</b> 12132+75
<b>Pic 1 Desc.</b> Stream S-MM31, Looking West.	<b>Pic 2 Desc.</b> Stream S-C29, Looking West.

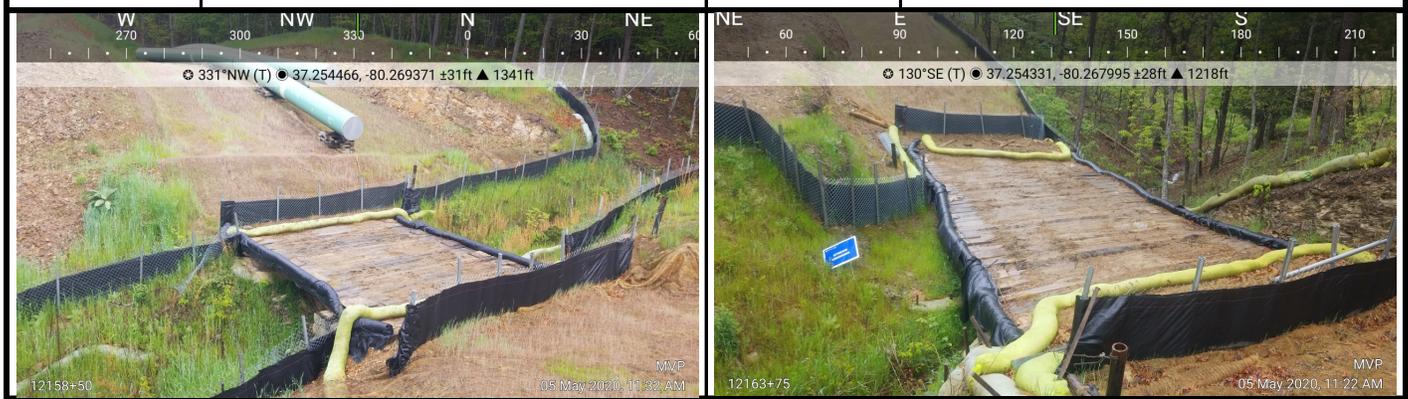
<b>GPS Location</b> See Above	<b>GPS Location</b> See Above
<b>Field Station#</b> 12158+50	<b>Field Station#</b> 12163+75
<b>Pic 5 Desc.</b> Head-water area Stream S-C23, Looking NorthWest.	<b>Pic 6 Desc.</b> Stream S-C25, Looking SouthEast.

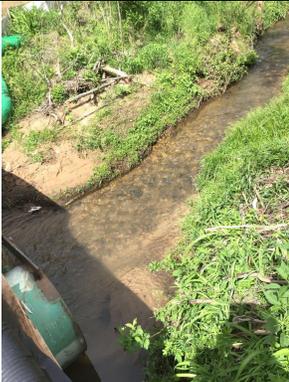
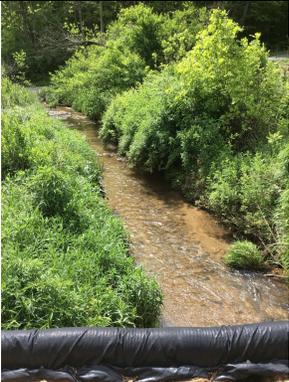
<b>GPS Location</b>	00000	<b>GPS Location</b>	00000		
<b>Field Station#</b>	13643+55	<b>Field Station#</b>	13643+55		
<b>Pic 1 Desc.</b>	Checked flume pipe to be sure the contractor removed debris	<b>Pic 2 Desc.</b>	Stream crossing photo facing downstream, showing clear water

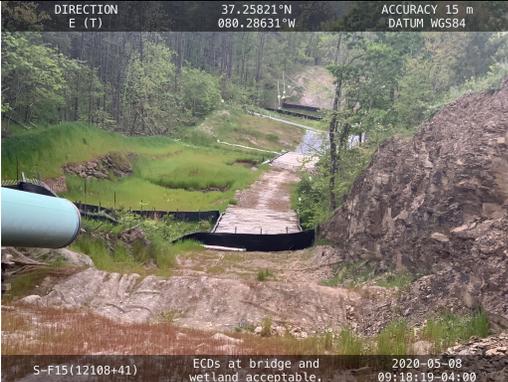
<p>DIRECTION E (T) 37.25821°N 080.28631°W ACCURACY 15 m DATUM WGS84 S-F15(12108+41) ECDs at bridge and wetland acceptable. 2020-05-08 09:18:19-04:00</p>

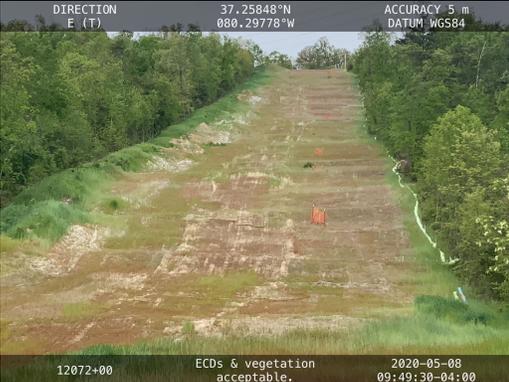
<p>DIRECTION E (T) 37.25848°N 080.29778°W ACCURACY 5 m DATUM WGS84 12072+00 ECDs &amp; vegetation acceptable. 2020-05-08 09:49:30-04:00</p>			
<b>GPS Location</b> See photo GPS for location		<b>GPS Location</b> See photo GPS for location			
<b>Field Station#</b> 12108+41		<b>Field Station#</b> 12072+00			
<b>Pic 1 Desc.</b> Bridge, wetland matting, and ECDs are in acceptable condition.		<b>Pic 2 Desc.</b> Slope is adequately vegetated and sumps, water bars, and CFS are in acceptable condition.
