Visual Site Inspection Report

| Project Name | H-600 Pipeline Spread I | AFE | 124300139 | Spread | H-600 Pipeline Spread I |

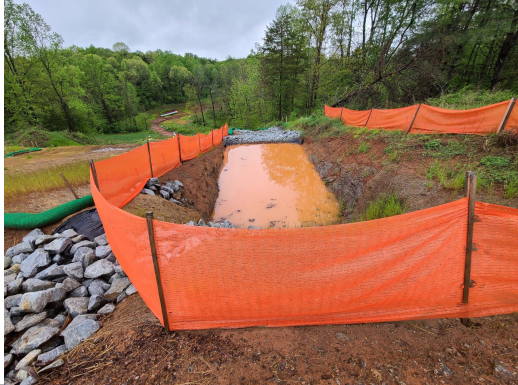
| Field Station# | 13692+77 | Field Station# | 13692+77 | | |

| Pic 1 Desc. | Stream bank needing stabilized where mats were , added to the punch list to be addressed | | Pic 2 Desc. | Stream bank stabilized and erosion blanket installed where mats were originally placed. | |

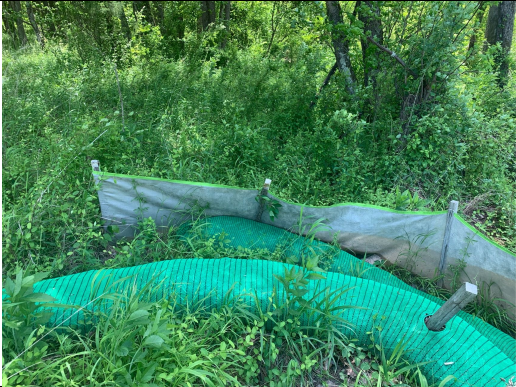
| Pic 1 Desc. | Observing p1 that requires maintenance. | Pic 2 Desc. | Observing cfs that requires maintenance. | | |

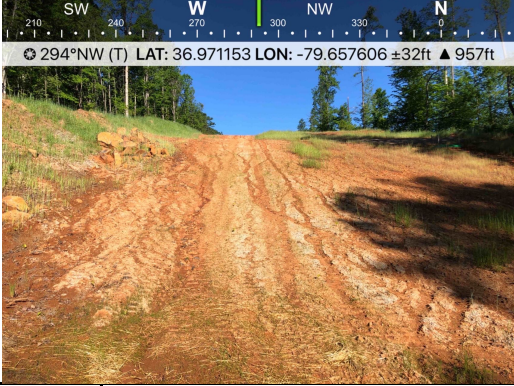
| Pic 1 Desc. | Travel lane needs to be stabilized on the GAS of Bar Ridge Road | | Pic 2 Desc. | Equipment bridge clean at stream S-SS8 | |

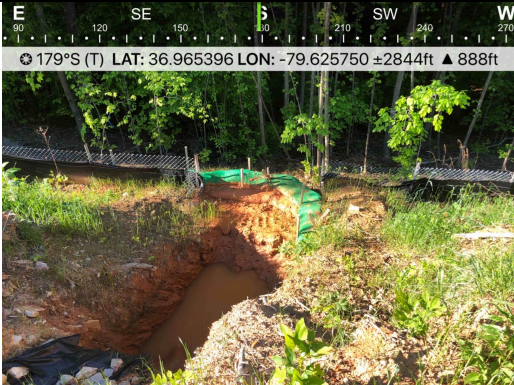
| Pic 3 Desc. | CFS on end treatment needs to be cleaned so that it filters properly | | Pic 4 Desc. | CFS on end treatment needs to be cleaned so that it filters properly | |

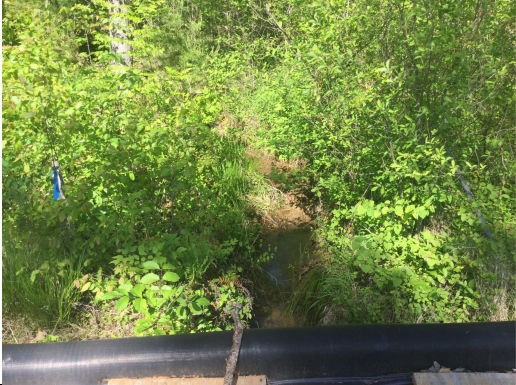
| Pic 1 Desc. | Upstream view of S-A6 at ROW crossing. | | Pic 2 Desc. | Downstream view of S-A6 at ROW crossing. | |

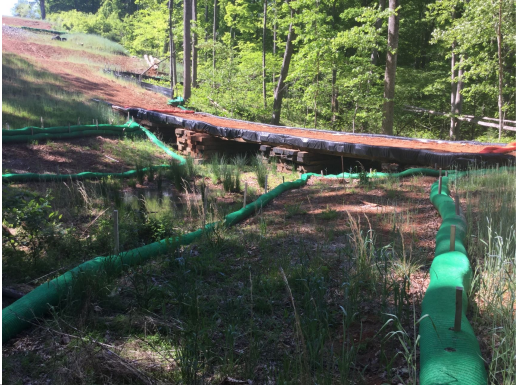
| Pic 3 Desc. | Equipment bridge and ECD's at crossing of S-H9 in good condition. | | Pic 4 Desc. | Equipment bridge and ECD's at crossing of S-C7 in good condition. | |

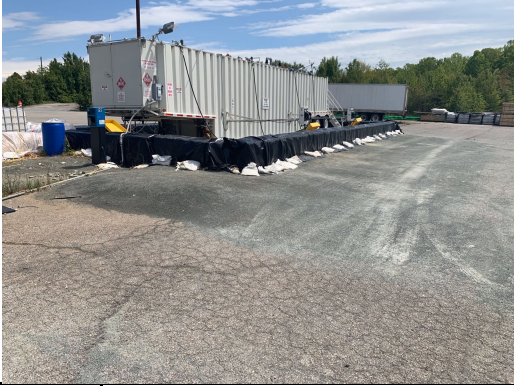
| Pic 1 Desc. | Secondary containment structure for fuel cell in compliance | Pic 2 Desc. | Perimeter ECD's on west side of paved yard in good condition | | |

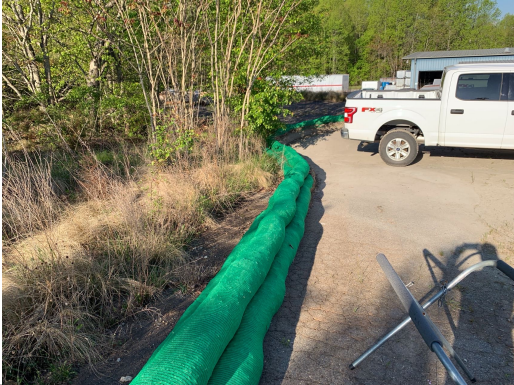
| Pic 3 Desc. | Perimeter ECD's on southwest corner of paved yard in good condition | Pic 4 Desc. | Perimeter ECD's on north end of gravel yard in good condition | | |

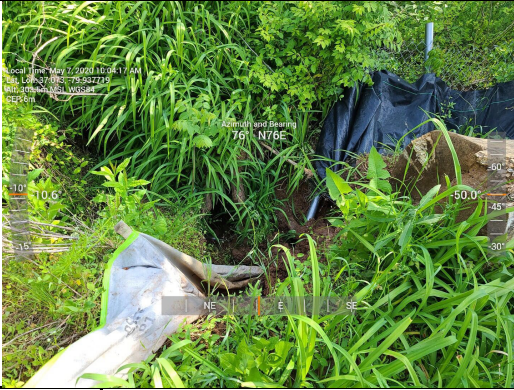
| Pic 1 Desc. | Storm events causing natural drain to become larger causing ECDs to wash out, recommended installing a CFS outlet | | Pic 2 Desc. | Monitored equipment bridge and ECDs | |

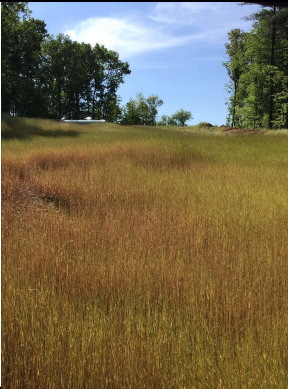
| Pic 3 Desc. | Row photo showing vegetation | | Pic 4 Desc. | Photo showing row conditions | |

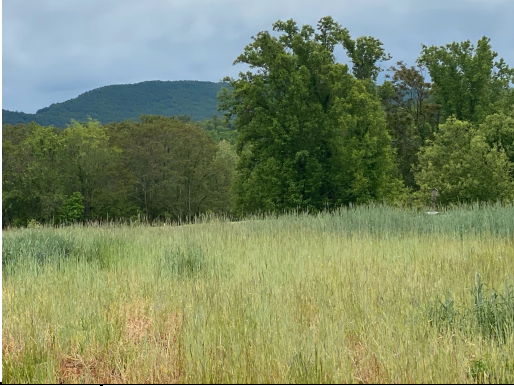
| Pic 1 Desc. | Approximately 13895+00. Overview of ROW. ROW temporarily stabilized and has winter vegetation growing. | Pic 2 Desc. | Approximately 13998+15. Overview of stream crossing, equipment bridge and ECDs at stream S-KL36. | | |

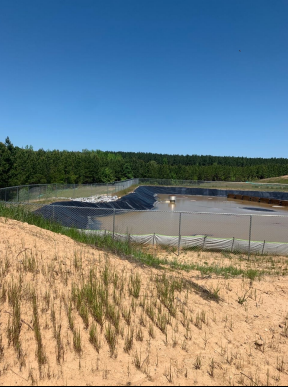
| Pic 1 Desc. | Observing storm water pond. | Pic 2 Desc. | Observing storm water pond. | | |

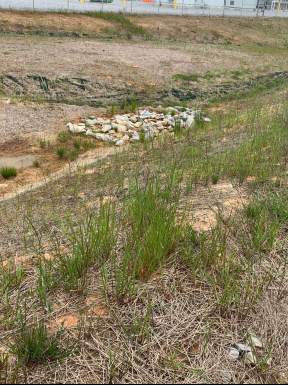
| Pic 1 Desc. | Observing ECD's performing as they should. | Pic 2 Desc. | Observing ECD's performing as they should. | | |
