# Visual Site Inspection Report

<b>Project Name</b> H-600 Pipeline Spread I		<b>AFE</b> 124300139	<b>Spread</b> H-600 Pipeline Spread I
<b>Contractor</b> Precision		<b>Report #</b> 7281	
<b>Inspector</b> Ben Davenport		<b>Date/Time</b> 1/13/2020 5:00 PM	
<b>Permit #</b> TBD	<b>Inspection Type</b> VA SWPP	<b>Station Begin</b> 14928+52	
<b>State</b> VA	<b>Inspection Area</b> Partial	<b>Station End</b> 15296+00	
<b>County</b> Franklin/Pittsylvania	<b>Ground</b> Muddy	<b>Temperature (°F)</b> 61.00	
<b>Municipality</b> Chatham	<b>Weather</b> Cloudy	<b>Rain Gauge (in)</b> 0.00	
			<b>Rain Accumulation Time (days)</b> 0.00

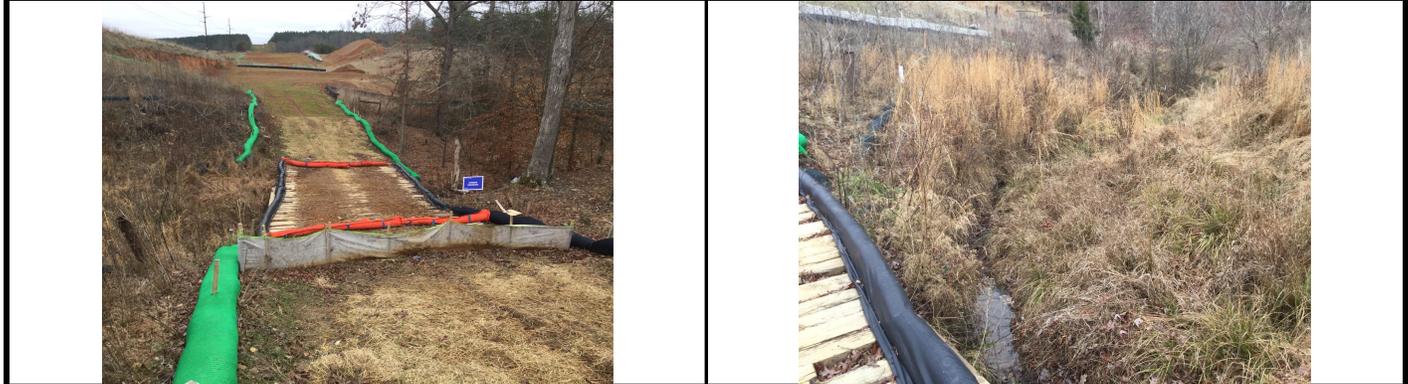
<b>GPS Location</b> 1	<b>GPS Location</b> 2
<b>Field Station#</b> 14932+89	<b>Field Station#</b> 14932+89
<b>Pic 1 Desc.</b> Bridge crossing of S-G15	<b>Pic 2 Desc.</b> Upstream view of S-G15

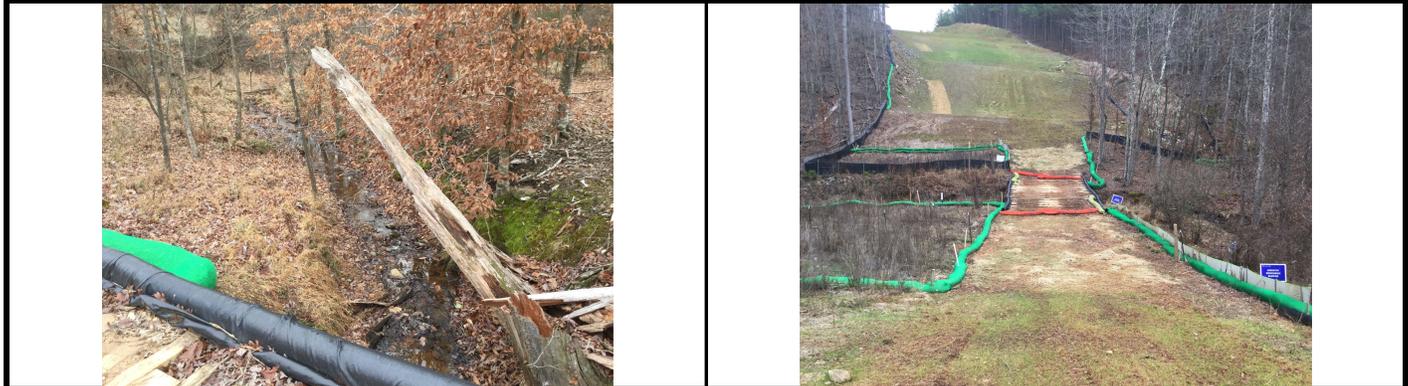
<b>GPS Location</b> 3	<b>GPS Location</b> 4
<b>Field Station#</b> 14932+89	<b>Field Station#</b> 14950+47
<b>Pic 3 Desc.</b> Downstream view of S-G15	<b>Pic 4 Desc.</b> Bridge crossing at S-G13

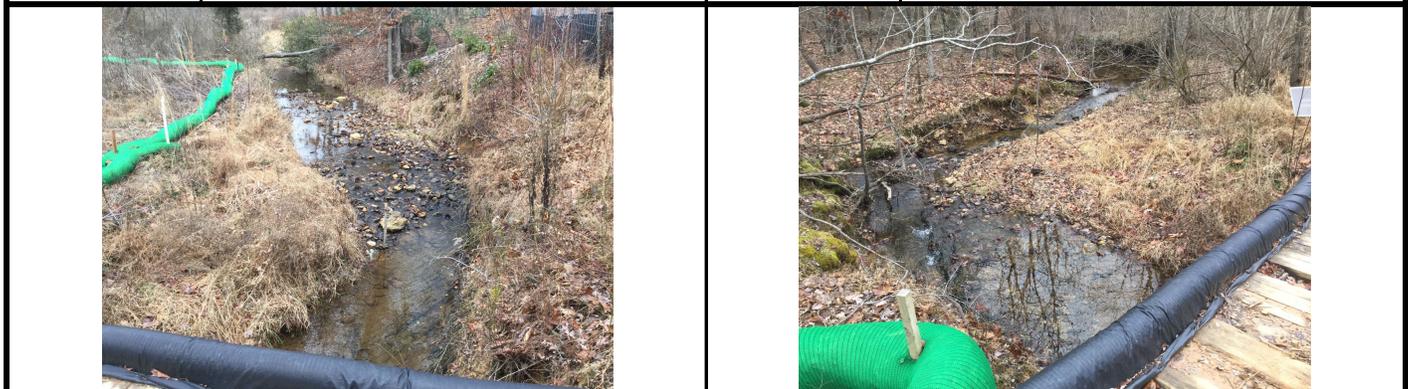
<b>GPS Location</b> 5	<b>GPS Location</b> 6
<b>Field Station#</b> 14950+47	<b>Field Station#</b> 14950+47
<b>Pic 5 Desc.</b> Upstream view of S-G13	<b>Pic 6 Desc.</b> Downstream view of S-G13

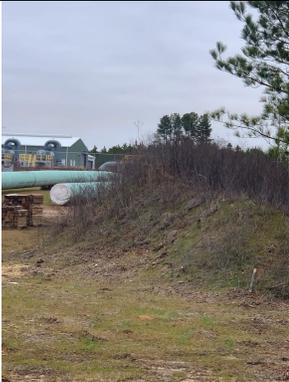
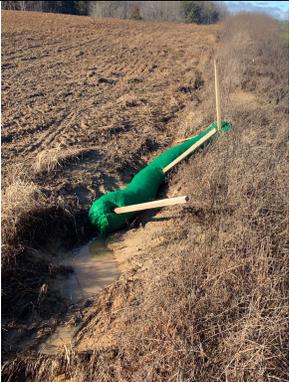
<b>GPS Location</b>	O	<b>GPS Location</b>	O		
<b>Field Station#</b>	16025+00	<b>Field Station#</b>	15775+00		
<b>Pic 1 Desc.</b>	Observing stabilized top soil pile.	<b>Pic 2 Desc.</b>	Observing ECD's that require maintenance.

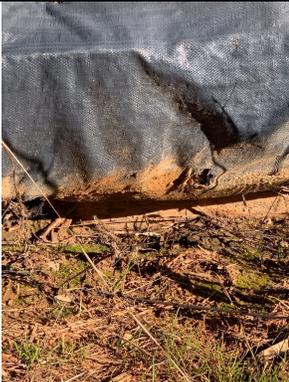
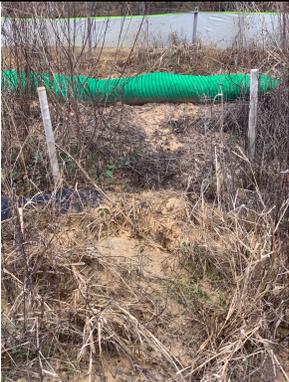
<b>GPS Location</b>	O	<b>GPS Location</b>	O		
<b>Field Station#</b>	15806+00	<b>Field Station#</b>	16026+00		
<b>Pic 3 Desc.</b>	Observing cap on bridge that requires maintenance.	<b>Pic 4 Desc.</b>	Observing CFS That Requires maintenance.		
Insert image here			Insert image here		
<b>GPS Location</b>		<b>GPS Location</b>			
<b>Field Station#</b>		<b>Field Station#</b>			
<b>Pic 5 Desc.</b>		<b>Pic 6 Desc.</b>

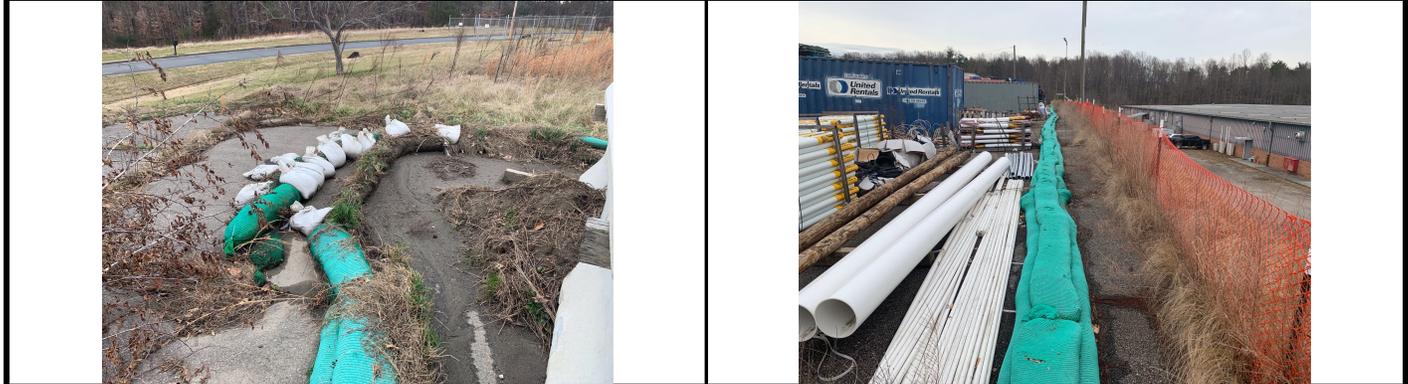
Preformed SWPPP inspection of Spread I main Laydown yard. All perimeter ECD's were inspected and one issue was found with the triple stacked CFS need to be restacked in the northwest corner of paved yard. The inlet protection for the parking lot drains in the paved yard were in good condition. The RCE at the gravel yard was clean and the road was clear of debris. All secondary containment structures were found to be in acceptable condition. The General Construction permits are posted at the main entrance of the paved yard as required. Any issues observed during the inspection were placed on a punch list and given to the contractor to address.

<b>GPS Location</b>	0000000000	<b>GPS Location</b>	0000000000
<b>Field Station#</b>	0000+00	<b>Field Station#</b>	0000+00
<b>Pic 1 Desc.</b>	Triple stack CFS at northwest corner of paved yard needs to be restacked.	<b>Pic 2 Desc.</b>	Perimeter ECD's on west side of paved yard in good condition.

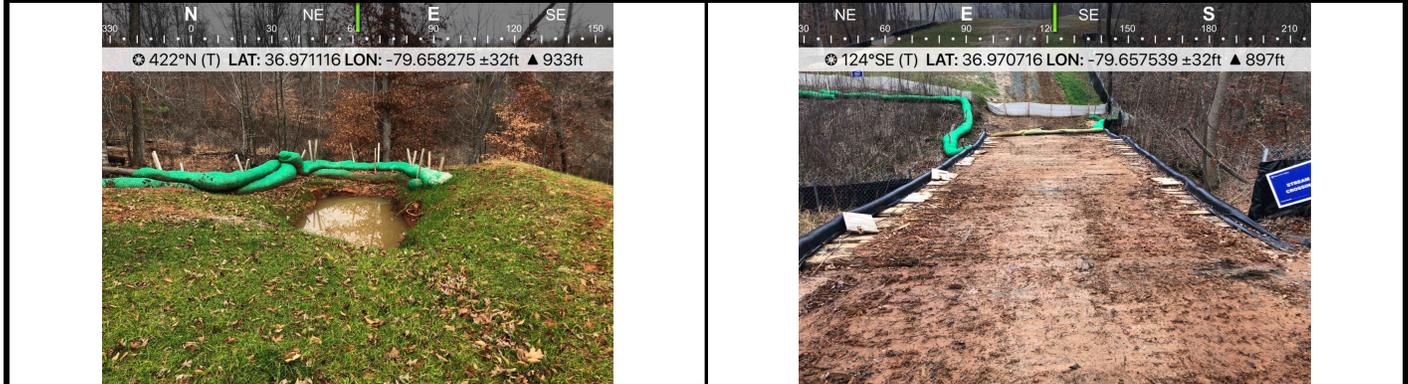
<b>GPS Location</b>	0	<b>GPS Location</b>	0
<b>Field Station#</b>	14865+00	<b>Field Station#</b>	14870+43
<b>Pic 1 Desc.</b>	Sump pit functioning as intended on the GAS of Bar Ridge Road	<b>Pic 2 Desc.</b>	Equipment bridge clean at stream S-SS8

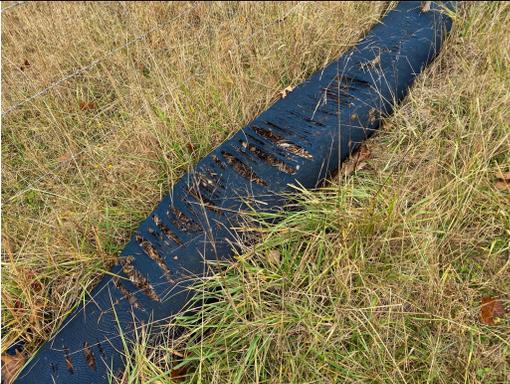
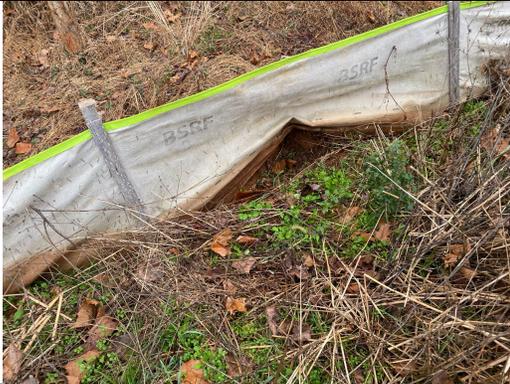
<b>GPS Location</b>	0	<b>GPS Location</b>	0		
<b>Field Station#</b>	15320+50	<b>Field Station#</b>	15372+30		
<b>Pic 1 Desc.</b>	Replace non functioning CFS.	<b>Pic 2 Desc.</b>	P1 fence undermined.

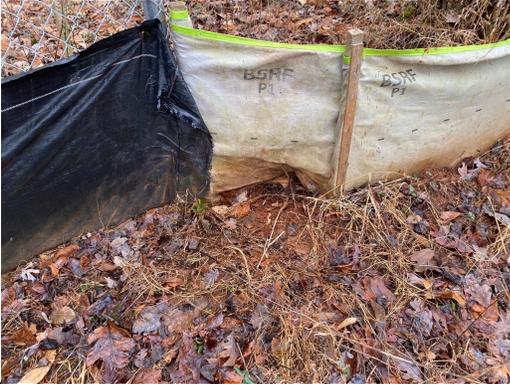
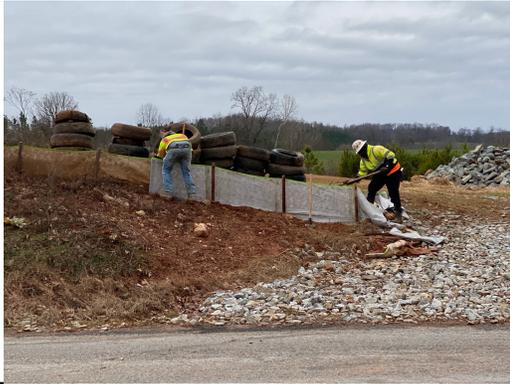
<b>GPS Location</b>	0	<b>GPS Location</b>	0		
<b>Field Station#</b>	15382+00	<b>Field Station#</b>	15370+00		
<b>Pic 3 Desc.</b>	P1 fence undermined.	<b>Pic 4 Desc.</b>	Environmental crew installing new P1 fence.

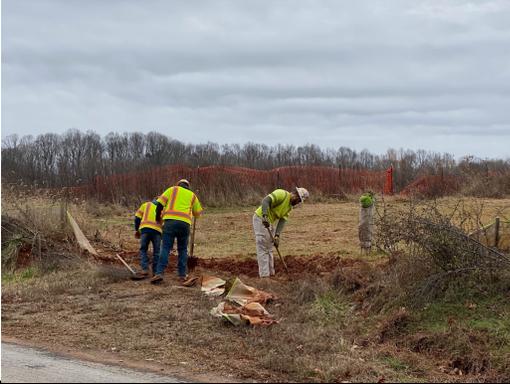
Insert image here		
<b>GPS Location</b>	0	<b>GPS Location</b>			
<b>Field Station#</b>	15370+00	<b>Field Station#</b>			
<b>Pic 5 Desc.</b>	Environmental crew installing new P1 fence.	<b>Pic 6 Desc.</b>

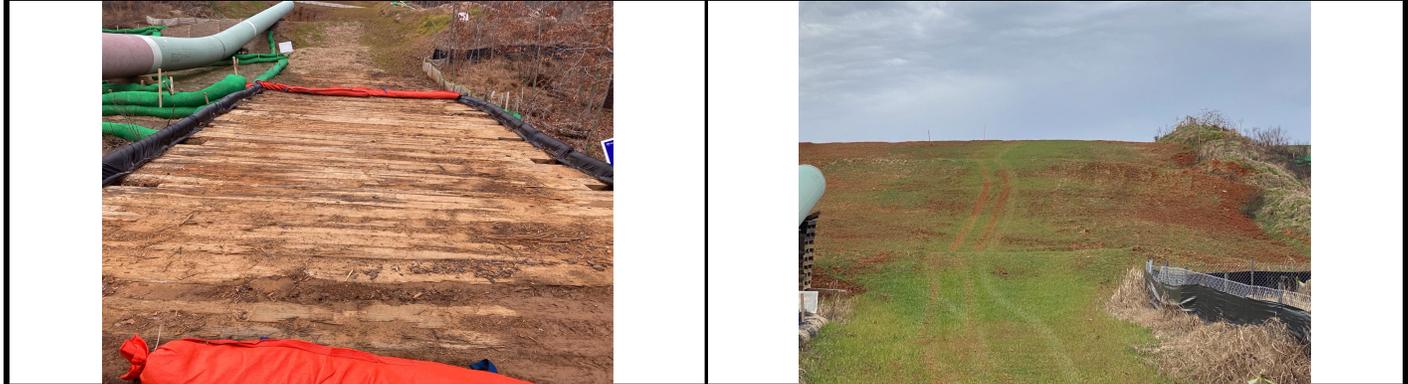
<b>Pic 1 Desc.</b>	Approximately 13998+15. Overview of stream crossing, equipment bridge and ECDs at stream S-KL36.	<b>Pic 2 Desc.</b>	Approximately 13947+00. Overview of ROW. ROW temporarily stabilized and has winter vegetation growing.
--------------------	--	--------------------	--

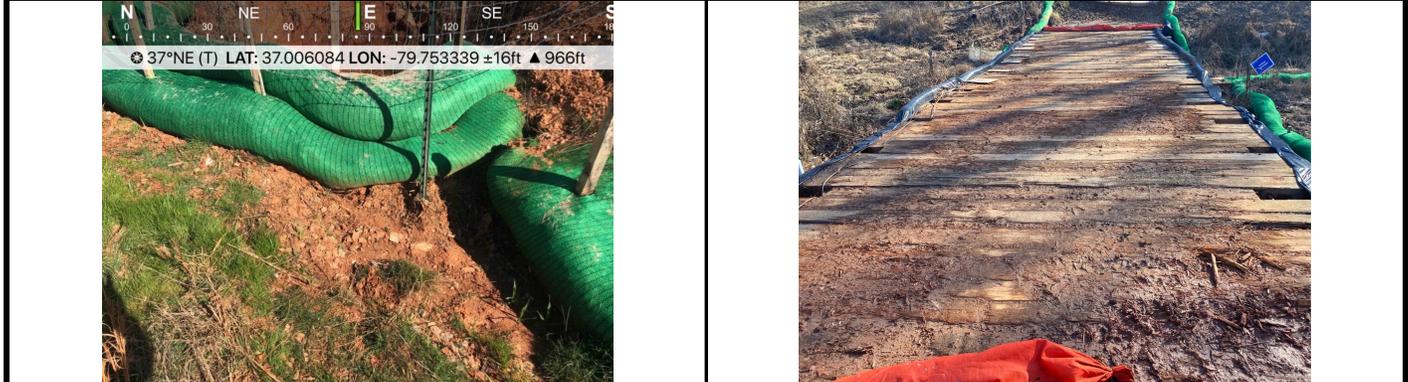
<b>GPS Location</b>	0	<b>GPS Location</b>	0
<b>Field Station#</b>	14542+00	<b>Field Station#</b>	14486+59
<b>Pic 1 Desc.</b>	CFS was undermining; maintenance was performed by the contractor	<b>Pic 2 Desc.</b>	Equipment bridge in acceptable condition

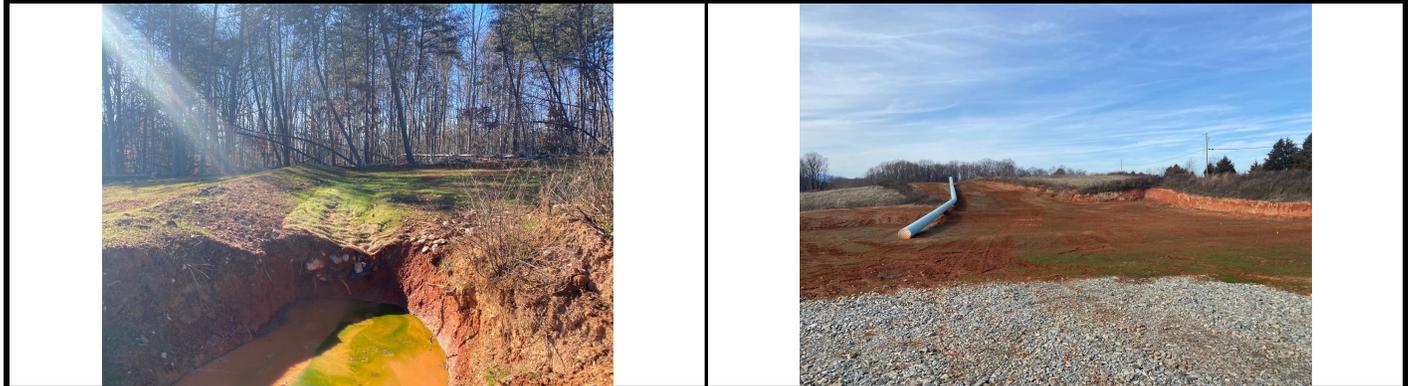
<b>GPS Location</b>	0	<b>GPS Location</b>	0
<b>Field Station#</b>	14470+00	<b>Field Station#</b>	14522+00
<b>Pic 3 Desc.</b>	Waterbar end treatment in acceptable condition	<b>Pic 4 Desc.</b>	Rock construction entrance in acceptable condition

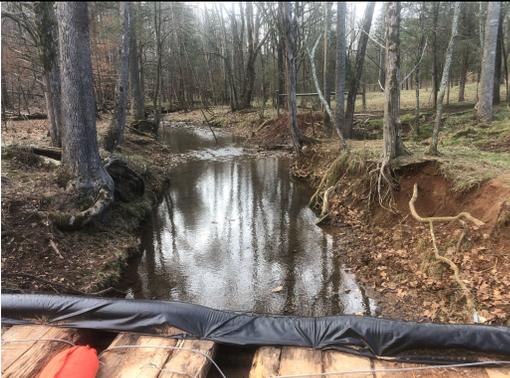
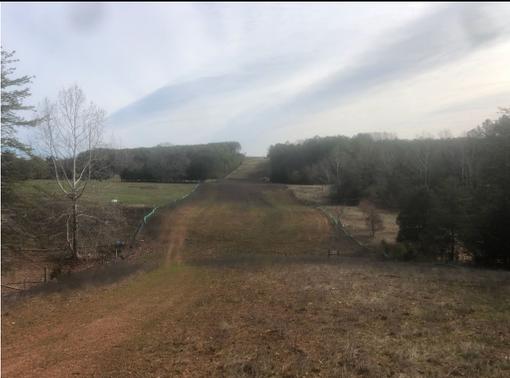
GPS Location 3		GPS Location 4			
Field Station# 15169+00		Field Station# 15191+00			
Pic 3 Desc. Downstream view of S-C7.		Pic 4 Desc. View of permanent vegetation growing along ROW. Noticeable wear along travel lane from landowner use.

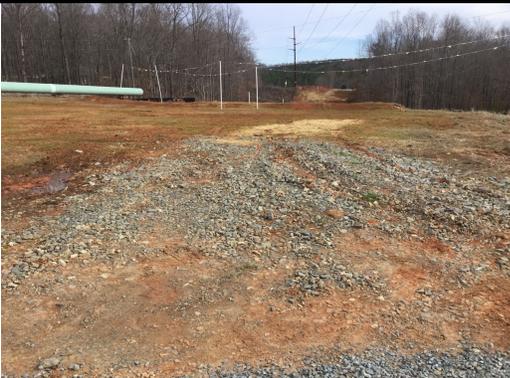
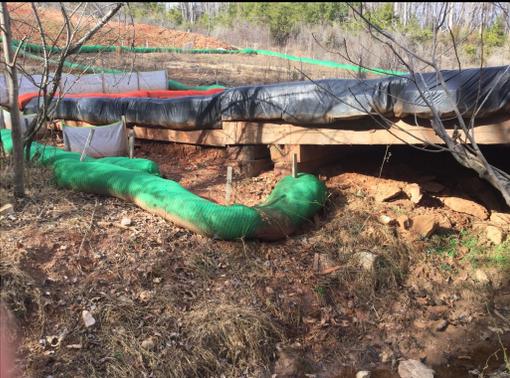
GPS Location 5		GPS Location 6			
Field Station# 14712+33		Field Station# 14673+10			
Pic 5 Desc. RCE needs built to spec at MVP-FR-321.01		Pic 6 Desc. CFS J Hook undermining which could lead to future stream impact. Maintenance required.

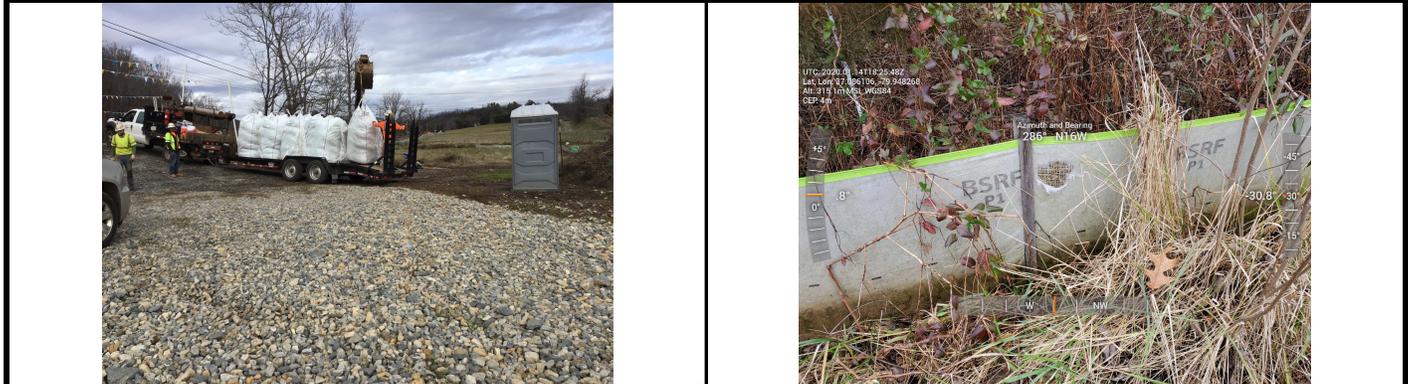
<b>GPS Location</b>	0000	<b>GPS Location</b>	0000
<b>Field Station#</b>	13691+00	<b>Field Station#</b>	13691+00
<b>Pic 1 Desc.</b>	Environmental crew unloading CFS to replace old damaged P1	<b>Pic 2 Desc.</b>	P1 needing maintenance, added to the punch list

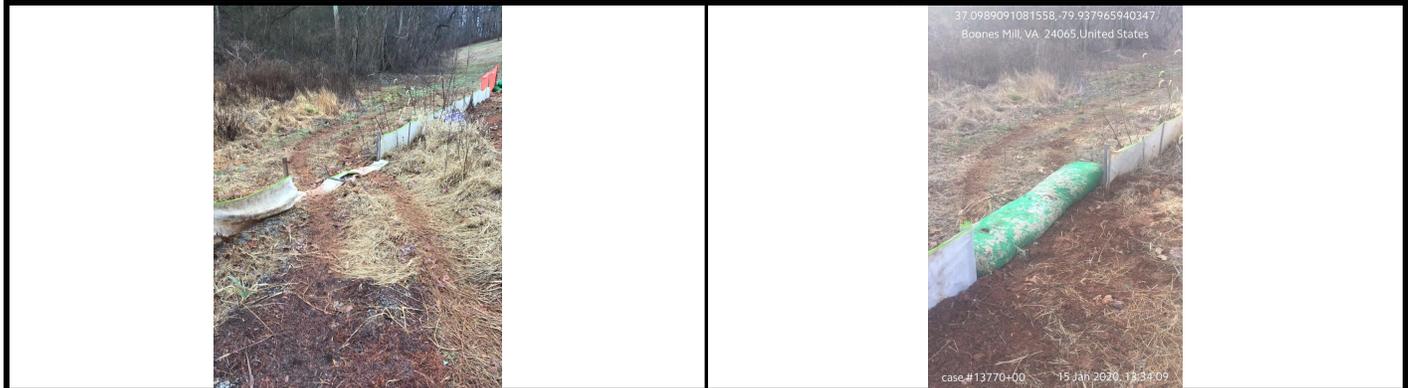
<b>GPS Location</b>	00000	<b>GPS Location</b>	0000
<b>Field Station#</b>	13770+00	<b>Field Station#</b>	13770+00
<b>Pic 3 Desc.</b>	Land owner damaged P1 crossing the row, added to the punch list	<b>Pic 4 Desc.</b>	Section of P1 damaged was replace with CFS to allow the land owner to cross the row if needed

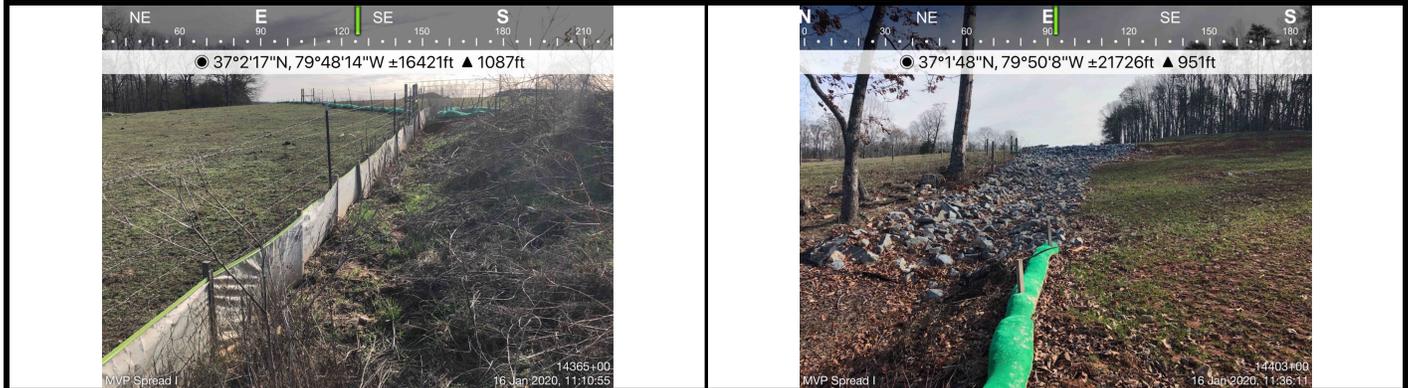
<b>GPS Location</b> 0	<b>GPS Location</b> 0
<b>Field Station#</b> 14365+00	<b>Field Station#</b> 14403+00
<b>Pic 3 Desc.</b> P1 silt fence in acceptable condition	<b>Pic 4 Desc.</b> Rock lined channel in acceptable condition

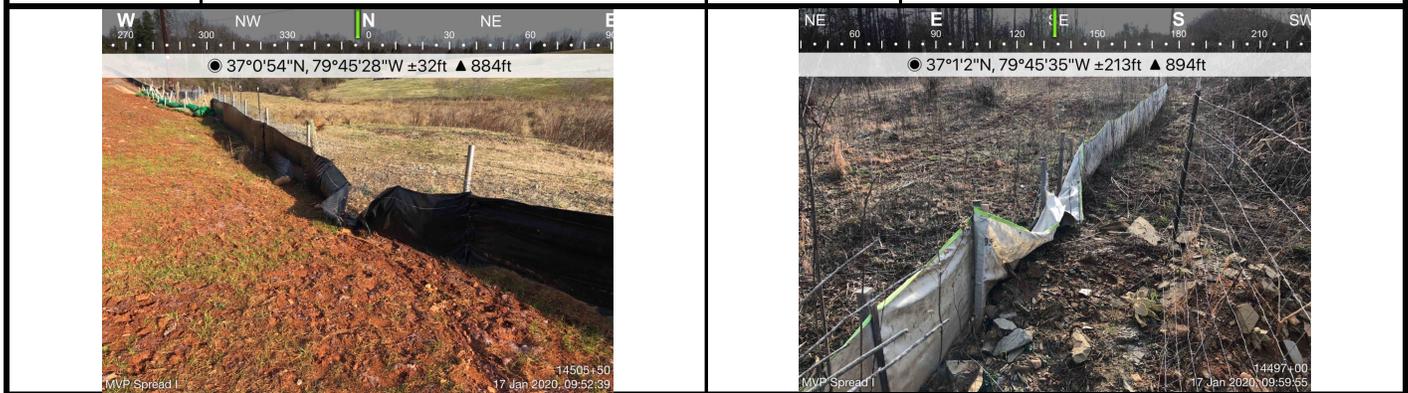
<b>GPS Location</b> 0	<b>GPS Location</b> 0
<b>Field Station#</b> 14505+50	<b>Field Station#</b> 14497+00
<b>Pic 5 Desc.</b> Super silt fence is damaged; requires maintenance	<b>Pic 6 Desc.</b> P1 silt fence is damaged; requires maintenance

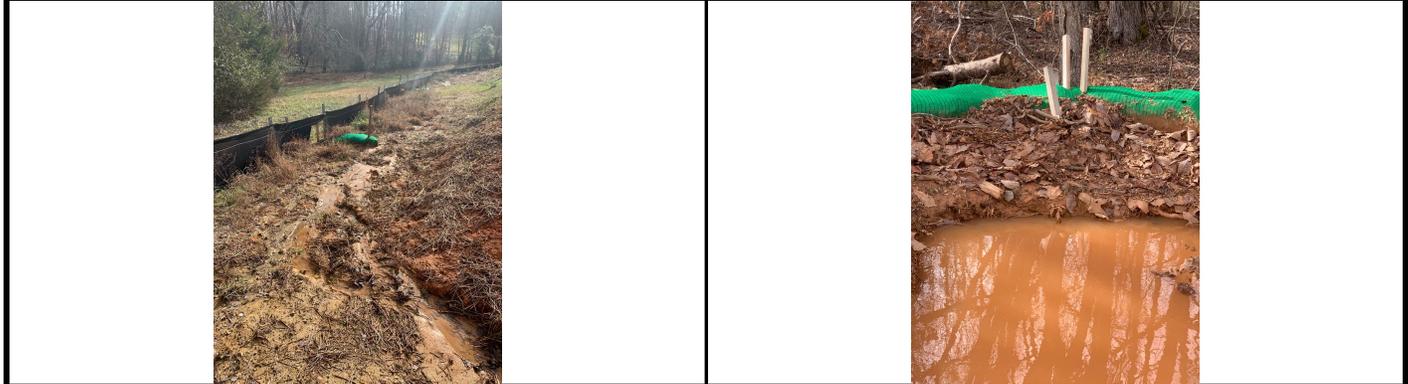
<b>Pic 1 Desc.</b>	Observing erosion that needs to be repaired.	<b>Pic 2 Desc.</b>	Observing end treatment that requires maintenance.
--------------------	--	--------------------	--

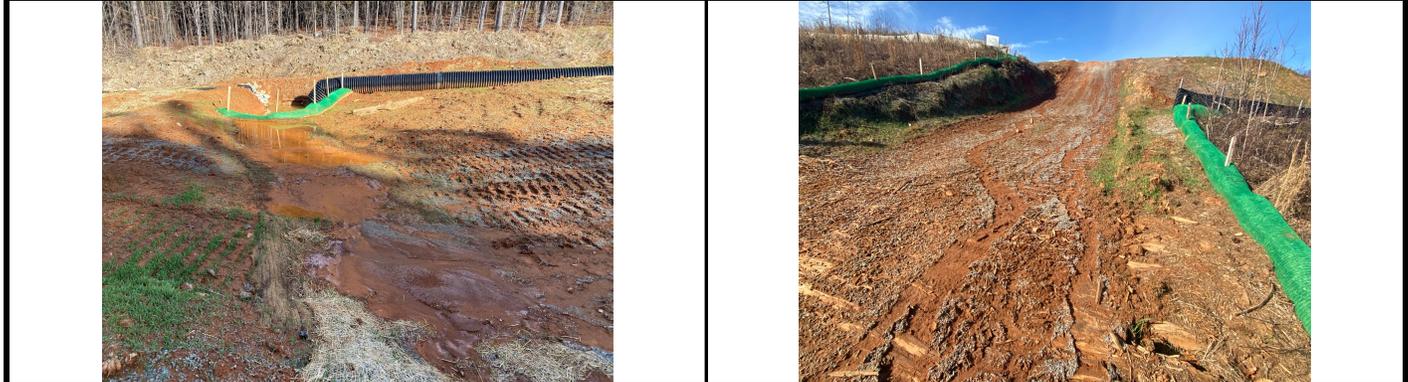
<b>Pic 1 Desc.</b>	Curlex along breaker is full of silt due to erosion along ROW.	<b>Pic 2 Desc.</b>	Erosion occurring in multiple places along ROW due to poor vegetative cover.
--------------------	--	--------------------	--

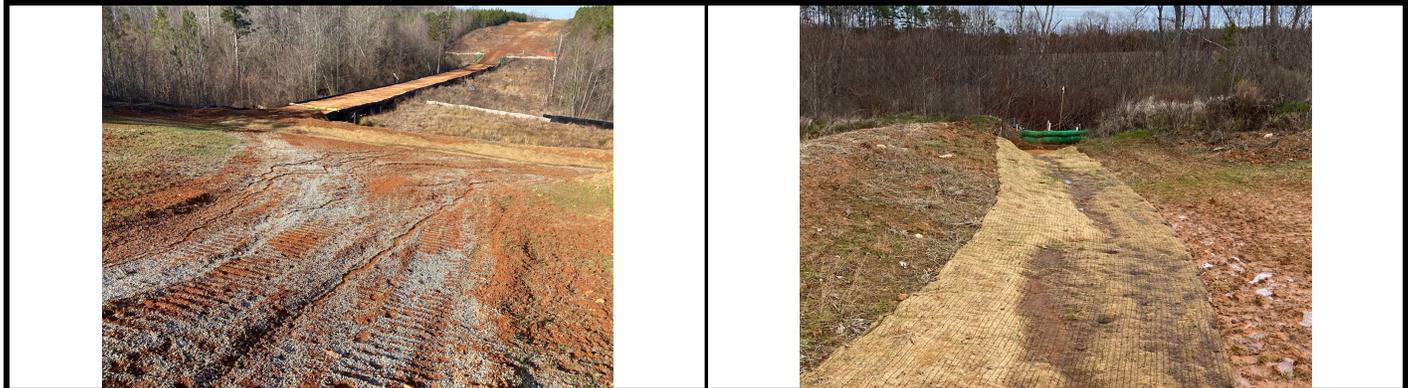
<b>Pic 3 Desc.</b>	Erosion occurring in multiple places along ROW due to poor vegetative cover.	<b>Pic 4 Desc.</b>	ECDs at breaker are in good condition and functioning properly.
--------------------	--	--------------------	---

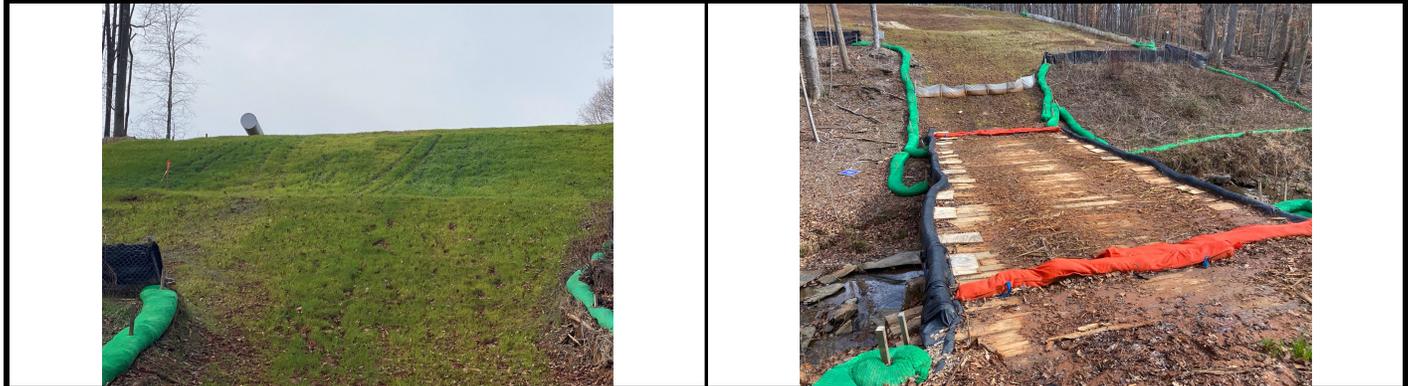
<b>GPS Location</b>	0	<b>GPS Location</b>	0
<b>Field Station#</b>	14103+00	<b>Field Station#</b>	14105+26
<b>Pic 3 Desc.</b>	Approximately 14103+00. Overview of ROW. ROW temporarily stabilized and has winter vegetation growing.	<b>Pic 4 Desc.</b>	Approximately 14105+26. Overview of stream crossing, equipment bridge and ECDs at stream S-KL41.

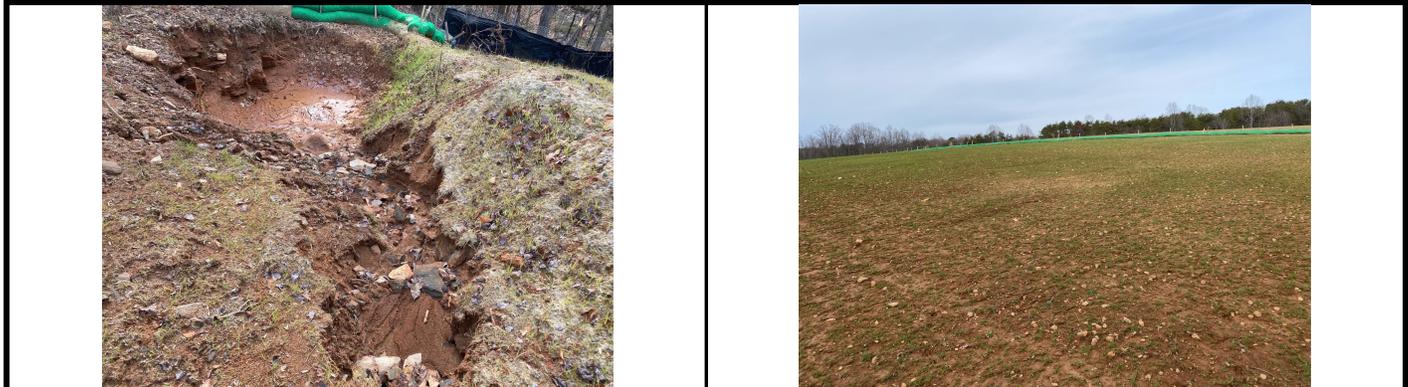
<b>GPS Location</b>	0	<b>GPS Location</b>	0
<b>Field Station#</b>	14106+25	<b>Field Station#</b>	14117+00
<b>Pic 5 Desc.</b>	Approximately 14106+25. Water bar trough eroding at mouth of sump. Item turned in for corrective action.	<b>Pic 6 Desc.</b>	Approximately 14117+00. ROW stabilized in this area and winter vegetation growing.

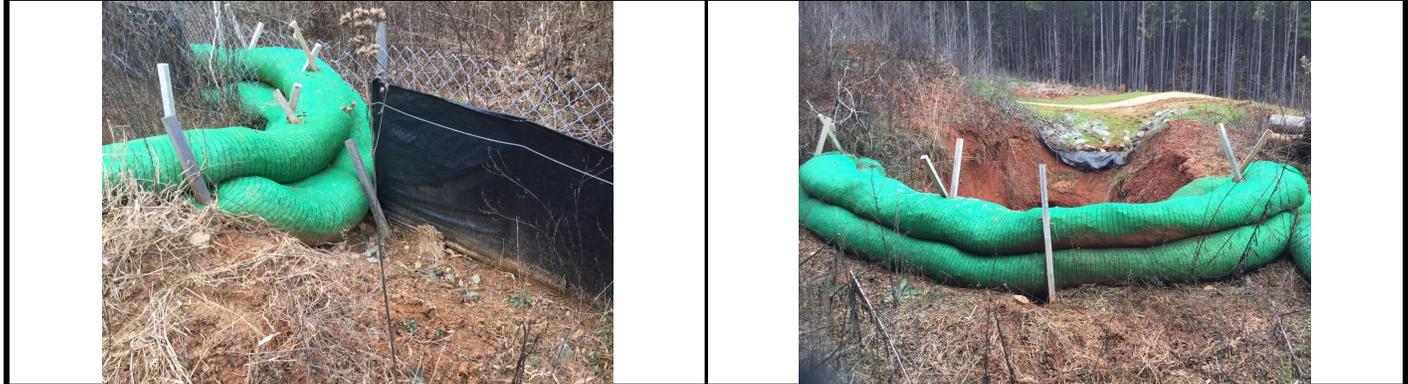
<b>Pic 1 Desc.</b>	Triple stack undermining and water/sediment not escaping the right of way	<b>Pic 2 Desc.</b>	Triple stack undermining and requires maintenance
--------------------	---	--------------------	---

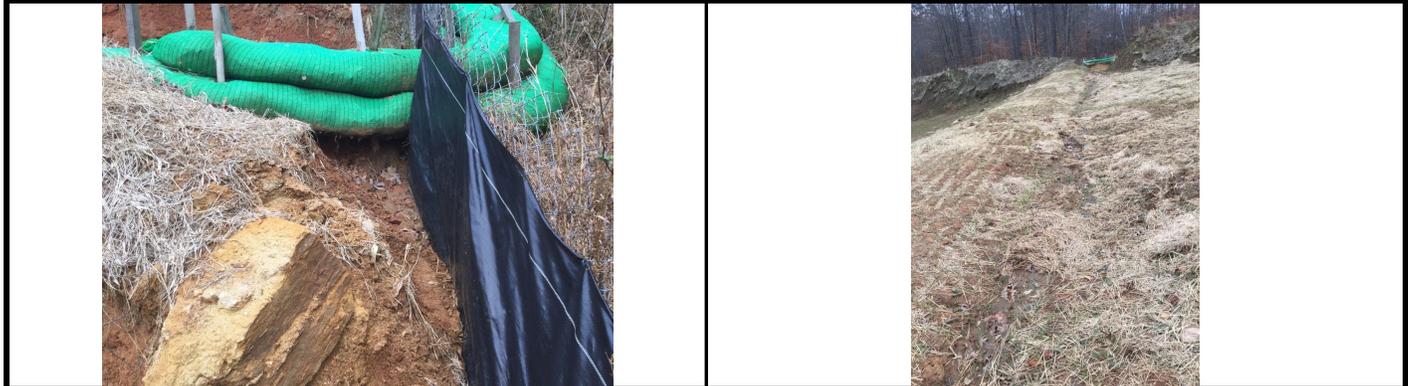
<b>Pic 3 Desc.</b>	Triple stack undermining and not escaping right of way	<b>Pic 4 Desc.</b>	Erosion channel in throat of water bar. Recommend curlex
--------------------	--	--------------------	--
