Visual Site Inspection Report

| Project Name | H-600 Pipeline Spread I | AFE | 124300139 | Spread | H-600 Pipeline Spread I |
| Contractor | Precision | | | Report # | 7576 |

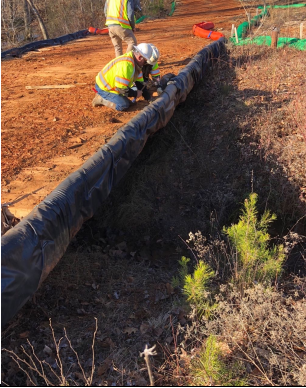
| Field Station# | 15027+97 | Field Station# | 15045+50 | | |

| Pic 1 Desc. | Contractor performing maintenance on side boards and geotextile fabric on equipment bridge crossing per punch list item. | | Pic 2 Desc. | Contractor removed trash and installed CFS where needed per punch list item. | |

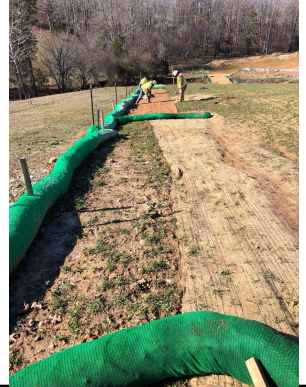
| Field Station# | 15096+00 | Field Station# | 15168+59 | | |

| Pic 3 Desc. | Contractor installed erosion control blanket and CFS check dams per punch list item. | | Pic 4 Desc. | Equipment bridge crossing with ECD's in functional condition at S-C7 | |

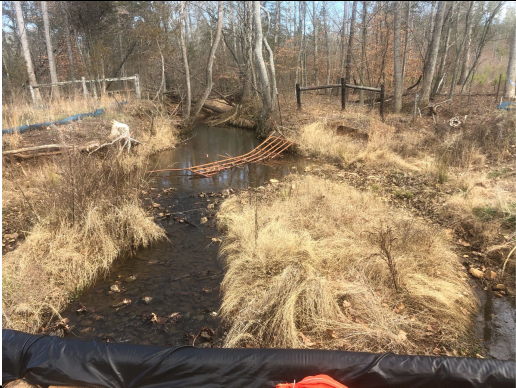
| Field Station# | 15168+59 | Field Station# | 15168+59 | | |

| Pic 5 Desc. | Upstream view of S-C7 | | Pic 6 Desc. | Downstream view of S-C7 | |

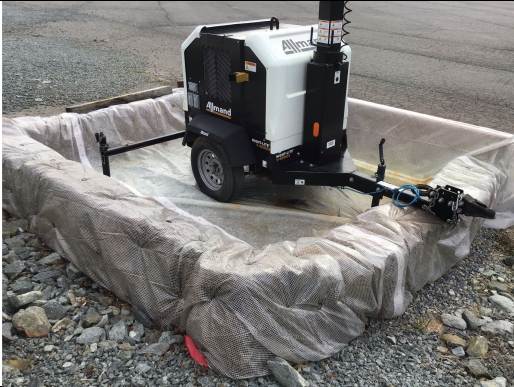
| Pic 1 Desc. | Secondary containment structure for light plant near office in compliance | | Pic 2 Desc. | Perimeter ECD's on north end of paved yard in need of maintenance. | |

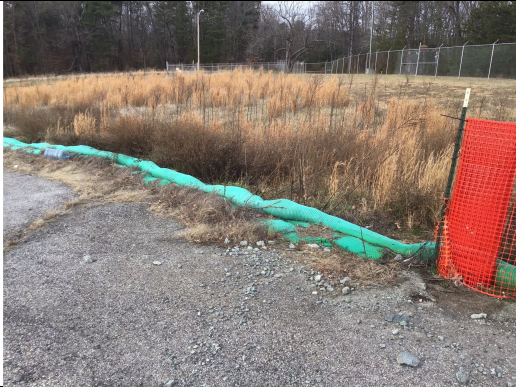
| Preformed SWPPP inspection on Spread I main laydown yard in Rocky Mount, Va. All perimeter ECD's were inspected and one issue was observed on the north end of the paved yard the triple stack CFS needs replaced or repaired. All secondary containment structures were found to be in compliance. The inlet protection for the parking lot drains were in good condition. The RCE at the gravel yard was in acceptable condition. Housekeeping needs to be addressed around the perimeter of both gravel and paved yards. All issues observed during the inspection placed on the punch list and given to the contractor to address. | | | | | |

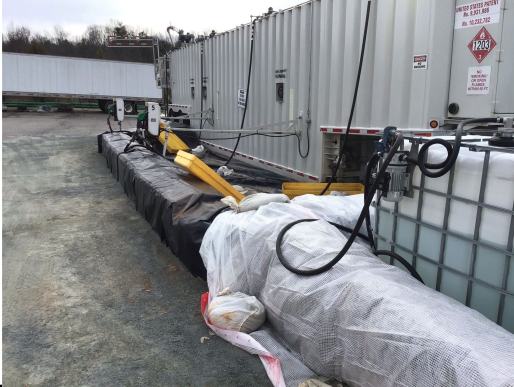
| Pic 3 Desc. | Secondary containment structure for fuel cell in compliance | | Pic 4 Desc. | Perimeter ECD's on west side of gravel yard in good condition | |

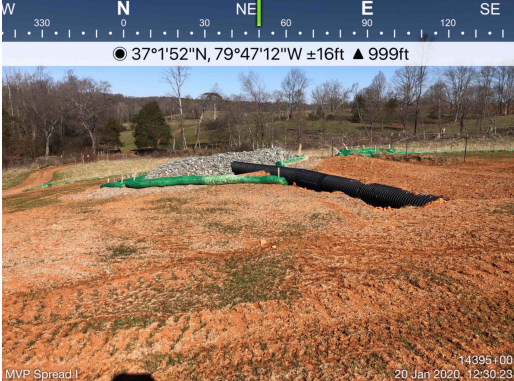
| Field Station# | 14395+00 | Field Station# | 14468+00 | | |

| Pic 1 Desc. | Clean water diversion pipe in acceptable condition | Pic 2 Desc. | Erosion control blanket in acceptable condition | | |

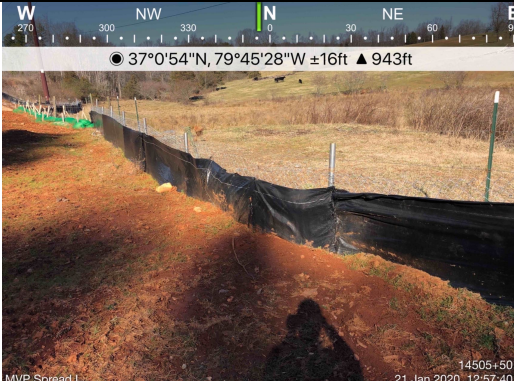
| Field Station# | 14505+50 | Field Station# | 14497+30 | | |

| Pic 3 Desc. | Super silt fence was repaired by the contractor | Pic 4 Desc. | P1 silt fence was repaired by the contractor | | |

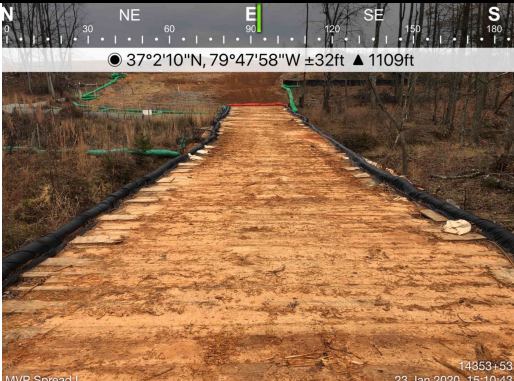
| Field Station# | 14353+53 | Field Station# | 14347+00 | | |

| Pic 5 Desc. | Equipment bridge in acceptable condition | Pic 6 Desc. | Waterbar in acceptable condition | | |

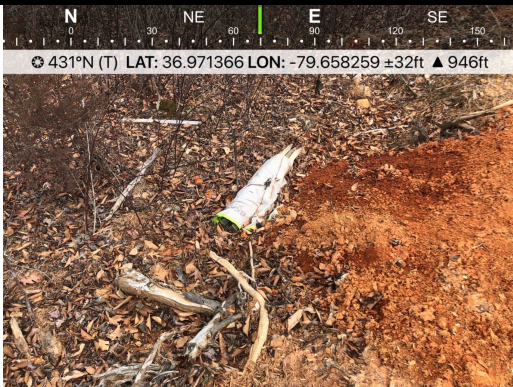
| Field Station# | 14868+00 | Field Station# | 14872+00 | | |

| Pic 1 Desc. | Housekeeping required | Pic 2 Desc. | SSF needs to be repaired so that sediment does not wash off ROW | | |

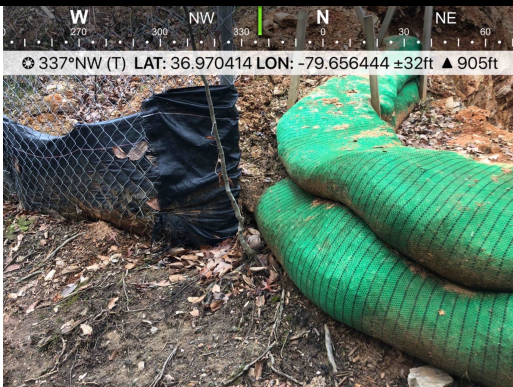
| Field Station# | 14874+00 | Field Station# | 14877+00 | | |

| Pic 3 Desc. | Gap between SSF and triple stack is allowing water/sediment to wash past without being filtered | Pic 4 Desc. | CFS damaged by land owner | | |

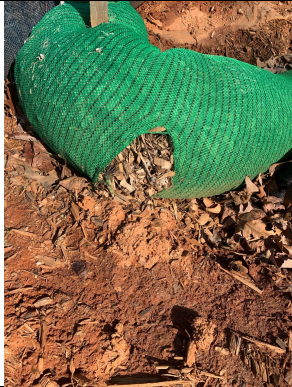
| Field Station# | 15696+00 | Field Station# | 15707+47 | | |

| Pic 1 Desc. | Observing water bar that requires maintenance. | Pic 2 Desc. | Observing CFS that requires maintenance. | | |
