Visual Site Inspection Report

Project Name	H-600 Pipeline Spread I	AFE	124300139	Spread	H-600 Pipeline Spread I
Contractor	Precision			Report #	7749
Inspector	Ben Davenport			Date/Time	1/29/2020 5:00 PM
Permit #	TBD	Inspection Type	VA SWPP	Station Begin	14928+52
State	VA	Inspection Area	Partial	Station End	15296+00
County	Franklin/Pittsylvania	Ground	Muddy	Temperature (°F)	46.00
Municipality	Chatham	Weather	Sunny	Rain Gauge (in)	0.00
				Rain Accumulation Time (days)	0.00

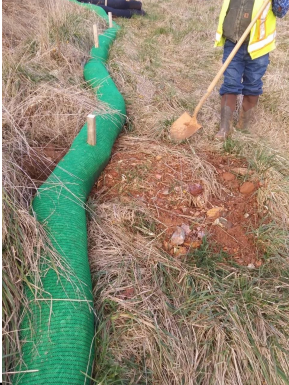
GPS Location	1	GPS Location	2		
Field Station#	14936+00	Field Station#	14985+00		
Pic 1 Desc.	View of stabilized ROW GAS Ramsey Memorial Rd.		Pic 2 Desc.	View of stabilized ROW GAS Snow Creek Rd.

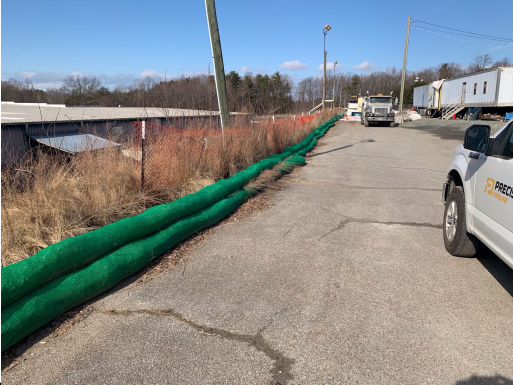
GPS Location	0000000000	GPS Location	0000000000		
Field Station#	0000+00	Field Station#	0000+00		
Pic 1 Desc.	RCE at gravel yard in good condition.	Pic 2 Desc.	Secondary containment structure for fuel cell in compliance.

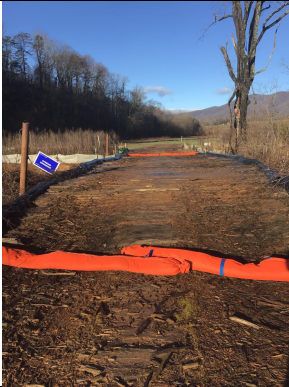
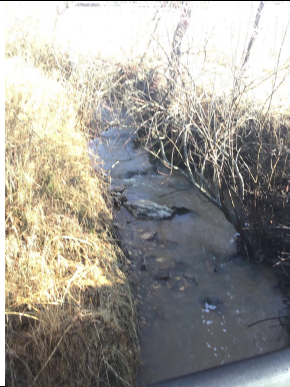
GPS Location	00000	GPS Location	0000		
Field Station#	13678+71	Field Station#	13678+71		
Pic 1 Desc.	Inspected ECDs at stream crossing after rain event	Pic 2 Desc.	Stream photo after rain event facing downstream

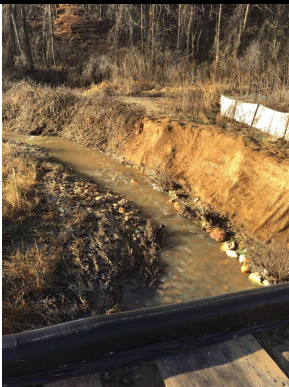
GPS Location	0000	GPS Location	0000		
Field Station#	13678+71	Field Station#	13784+35		
Pic 3 Desc.	Stream photo after rain event facing up stream	Pic 4 Desc.	Inspected ECDs and sump pit after rain event.		
Insert image here			Insert image here		
GPS Location		GPS Location			
Field Station#		Field Station#			
Pic 5 Desc.		Pic 6 Desc.

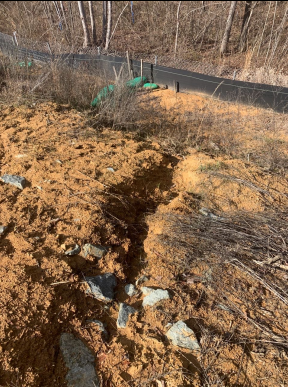
GPS Location	O		GPS Location	O	
Field Station#	16018+50		Field Station#	16018+50	
Pic 1 Desc.	Observing erosion that needs to be repaired.		Pic 2 Desc.	Observing CFS that requires maintenance.

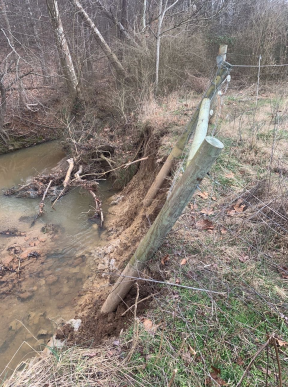
GPS Location	O		GPS Location	O	
Field Station#	15956+00		Field Station#	15930+00	
Pic 3 Desc.	Observing temporary fencing that needs to be moved due to heavy rains.		Pic 4 Desc.	Observing the Contractor repairing punch list items.

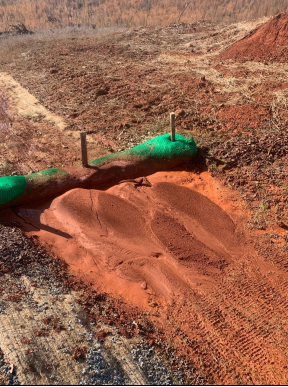
GPS Location	O		GPS Location	O	
Field Station#	15698+00		Field Station#	15697+50	
Pic 5 Desc.	Observing CFS That Requires Maintenance.		Pic 6 Desc.	Observing erosion that needs to be repaired.

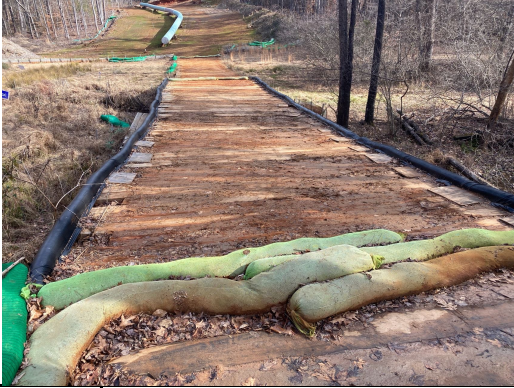
GPS Location	0	GPS Location	0		
Field Station#	14035+28	Field Station#	14038+00		
Pic 1 Desc.	Approximately 14035+28. Overview of stream crossing, equipment bridge and ECDs at stream S-KL39.		Pic 2 Desc.	Approximately 14038+00. Overview of ROW. ROW temporarily stabilized and has winter vegetation growing.

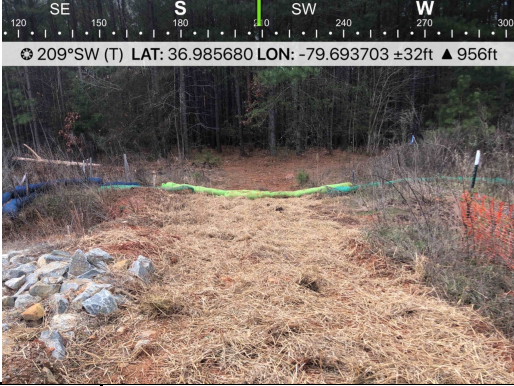
GPS Location	0	GPS Location	0		
Field Station#	14745+40	Field Station#	14752+00		
Pic 1 Desc.	Contractor replaced CFS and cleaned up sediment that was caused by land owner		Pic 2 Desc.	Contractor seeded and mulched area that was eroding

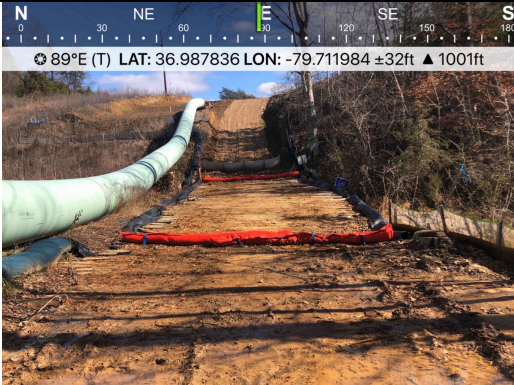
GPS Location	0	GPS Location	0		
Field Station#	14689+36	Field Station#	14685+00		
Pic 3 Desc.	Equipment bridge clean at stream S-H34		Pic 4 Desc.	Temporary stabilization on the CIS of Jacks Creek Road

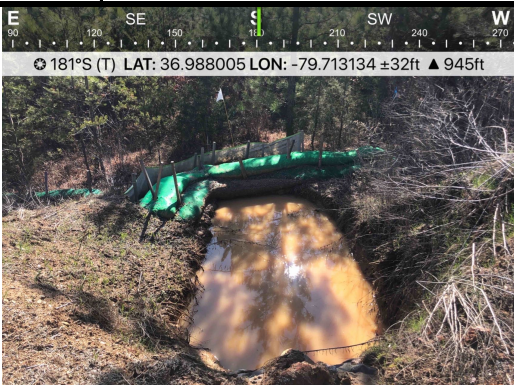
GPS Location	0	GPS Location	0		
Field Station#	14674+00	Field Station#	14680+37		
Pic 5 Desc.	Sump pit functioning as intended		Pic 6 Desc.	Equipment bridge clean at stream S-H36

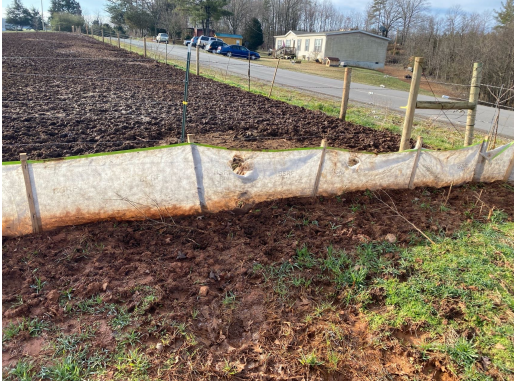
GPS Location	0	GPS Location	0		
Field Station#	15296+00	Field Station#	15300+25		
Pic 1 Desc.	Replace damaged P1 fence.	Pic 2 Desc.	Erosion occurring along natural drainage feature. Restabilization required.

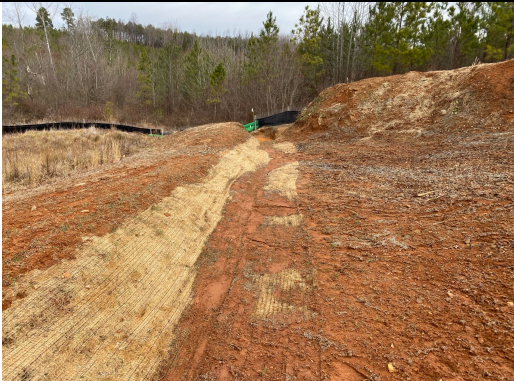
GPS Location	0	GPS Location	0		
Field Station#	15543+85	Field Station#	15556+80		
Pic 3 Desc.	Curlex full of silt due to erosion along ROW.	Pic 4 Desc.	CFS under bridge across S-CC9 is full.

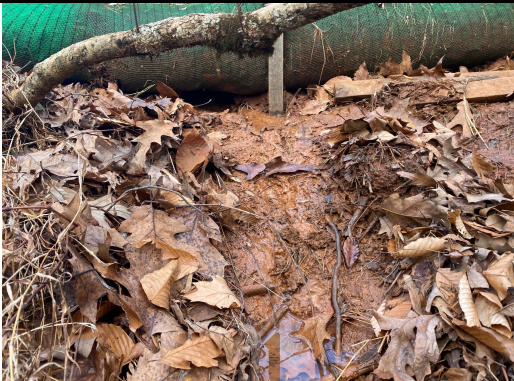
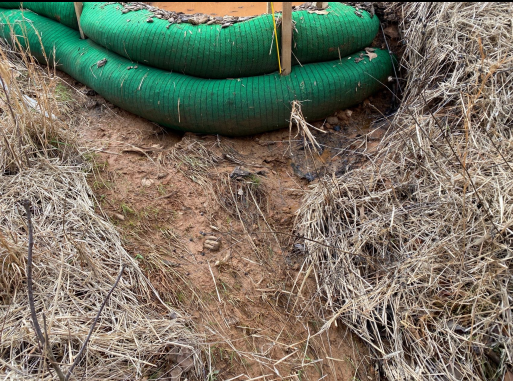
GPS Location	0	GPS Location	0		
Field Station#	15383+95	Field Station#	15436+00		
Pic 5 Desc.	Undermining beginning to occur under CFS.	Pic 6 Desc.	Undermining beginning to occur under CFS.

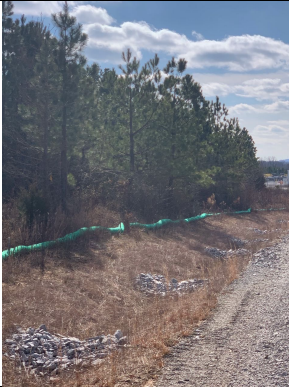
GPS Location	O		GPS Location	O	
Field Station#	00+00		Field Station#	00+00	
Pic 1 Desc.	Observing rock check dams performing as they should.		Pic 2 Desc.	Observing RCE at Transco.

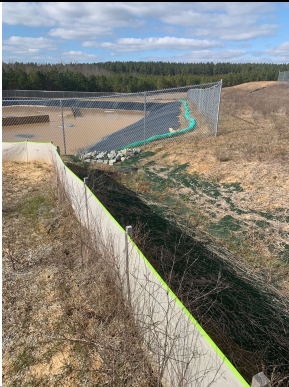
GPS Location	O		GPS Location	O	
Field Station#	00+00		Field Station#	00+00	
Pic 3 Desc.	Observing ECD's performing as they should.		Pic 4 Desc.	Observing storm water pond at Transco.	
Insert image here			Insert image here		
GPS Location			GPS Location		
Field Station#			Field Station#		
Pic 5 Desc.			Pic 6 Desc.
