Visual Site Inspection Report

Project Name	H-600 Pipeline Spread I	AFE	124300139	Spread	H-600 Pipeline Spread I
Contractor	Precision			Report #	6730
Inspector	Logan Box			Date/Time	12/18/2019 4:05 PM
Permit #	TBD	Inspection Type	VA SWPP	Station Begin	13670+00
State	VA	Inspection Area	Partial	Station End	13784+35
County	Franklin	Ground	Wet	Temperature (°F)	45.00
Municipality	N/A	Weather	Sunny	Rain Gauge (in)	1.20
				Rain Accumulation Time (days)	4.00

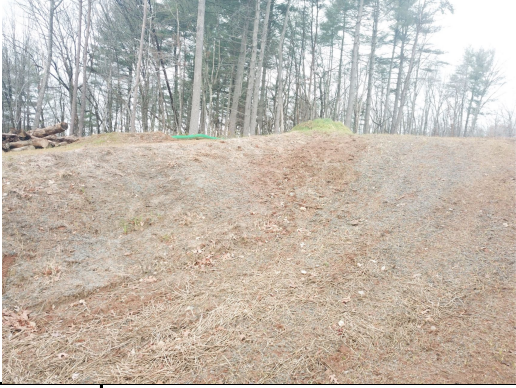
GPS Location	000000	GPS Location	000000		
Field Station#	13747+00	Field Station#	13692+64		
Pic 1 Desc.	Area with sparse vegetation, recommended seeding, added to the punch list	Pic 2 Desc.	Ecds in place on bridge at Teal Creek crossing

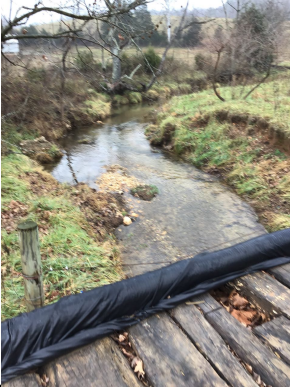
GPS Location	00000	GPS Location	00000		
Field Station#	13692+64	Field Station#	13692+64		
Pic 3 Desc.	Inspected Teal Creek crossing, facing downstream showing clear water flowing	Pic 4 Desc.	Inspected Teal Creek crossing, facing upstream showing clear water flowing		
Insert image here		Insert image here			
GPS Location		GPS Location			
Field Station#		Field Station#			
Pic 5 Desc.		Pic 6 Desc.

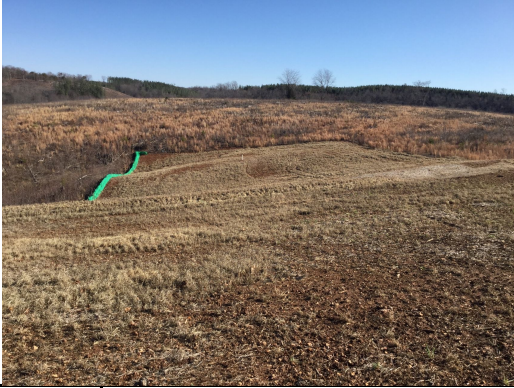
GPS Location	1	GPS Location	2		
Field Station#	15259+00	Field Station#	15225+00		
Pic 1 Desc.	HDD exit site has vegetation growing and perimeter ECD's in good condition.		Pic 2 Desc.	CFS is shredding/torn and needs to be repaired or replaced.

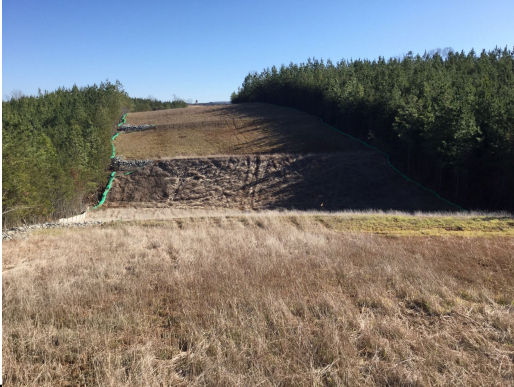
GPS Location	3	GPS Location	4		
Field Station#	15213+00	Field Station#	14942+00		
Pic 3 Desc.	Final cleanup section of ROW has uniform vegetation and no apparent signs of erosion.		Pic 4 Desc.	Perimeter ECD's in place and ROW properly stabilized.

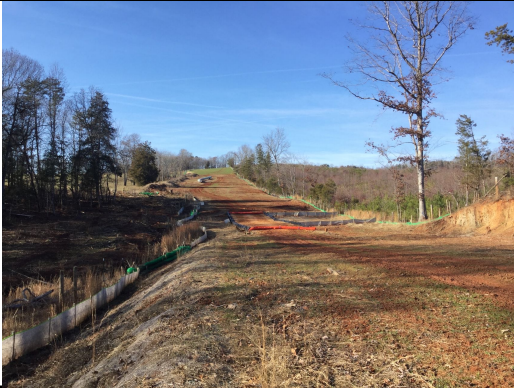
GPS Location	5	GPS Location	6		
Field Station#	15164+00	Field Station#	15020+00		
Pic 5 Desc.	Perimeter ECD's in place and ROW properly stabilized.		Pic 6 Desc.	Vegetation growing through erosion control blanket installed to help curb erosion. ROW in good condition.

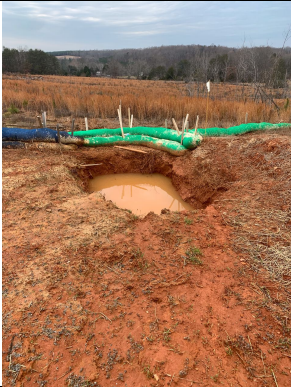
GPS Location	O	GPS Location	O		
Field Station#	15690+00	Field Station#	15678+57		
Pic 1 Desc.	Observing sump and end treatment performing as it should.	Pic 2 Desc.	Observing P-1 that requires maintenance.

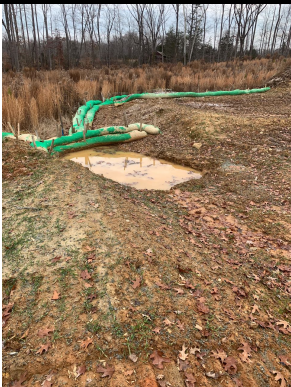
GPS Location	O	GPS Location	O		
Field Station#	15679+00	Field Station#	15679+25		
Pic 3 Desc.	Observing sump and end treatment performing as it should.	Pic 4 Desc.	Observing CWD Inlet that requires maintenance and safety fence installed.		
Insert image here			Insert image here		
GPS Location		GPS Location			
Field Station#		Field Station#			
Pic 5 Desc.		Pic 6 Desc.

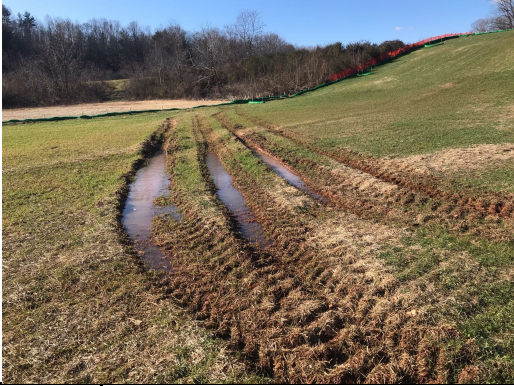
GPS Location	0	GPS Location	0		
Field Station#	13909+00	Field Station#	13915+82		
Pic 1 Desc.	Approximately 13909+00. Third party damage to ROW and CFS from landowner crossing ROW with agriculture equipment.		Pic 2 Desc.	Approximately 13915+82. Overview of stream crossing and equipment bridge at stream S-II2.

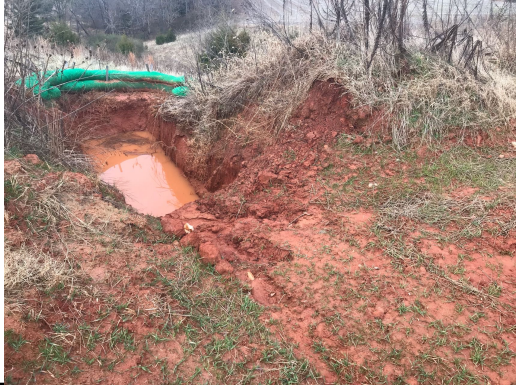
GPS Location	0	GPS Location	0		
Field Station#	13965+00	Field Station#	13972+00		
Pic 3 Desc.	Approximately 13965+00. CFS checks on slope. ROW temporarily seeded and stabilized in this area. Winter vegetation growing.		Pic 4 Desc.	Approximately 13972+00. Minor erosion issue at mouth of sump. Contractor notified and it was recommended to repair, seed and add erosion control blanket.	
Insert image here			Insert image here		
GPS Location		GPS Location			
Field Station#		Field Station#			
Pic 5 Desc.		Pic 6 Desc.

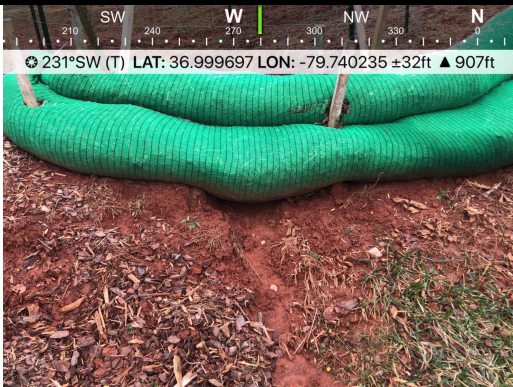
GPS Location		0		GPS Location		0	
Field Station#		14591+00		Field Station#		14710+00	
Pic 1 Desc.		CFS undermined on the CIS of Simmons Creek Road		Pic 2 Desc.		Third party contractor fixed ruts, seeded, and installed curlex on the GAS of Jacks Creek Road

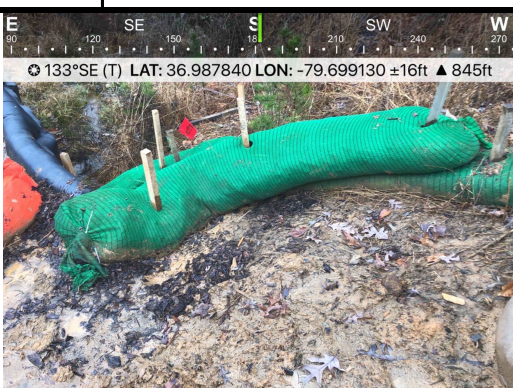
GPS Location		0		GPS Location		0	
Field Station#		14727+50		Field Station#		14795+00	
Pic 3 Desc.		CFS undermined on the GAS of Jacks Creek Road		Pic 4 Desc.		Sump pit functioning as intended

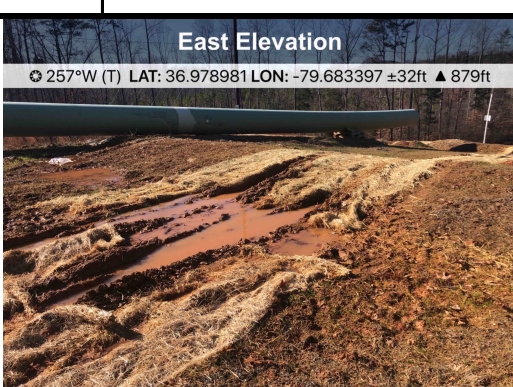
GPS Location		0		GPS Location		0	
Field Station#		14783+00		Field Station#		14784+00	
Pic 5 Desc.		Third party damage from land owner to water bar flow path and curlex causing water to build up		Pic 6 Desc.		Third party damage from land owner to water bar flow path and curlex causing water to build up

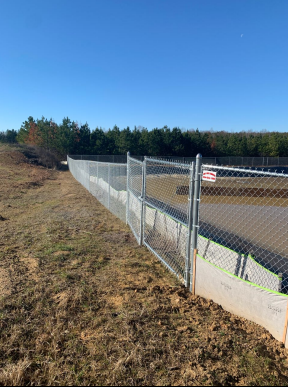
GPS Location	O	GPS Location	O		
Field Station#	00+00	Field Station#	00+00		
Pic 1 Desc.	Observing fence and ECD's at the storm water pond.	Pic 2 Desc.	Observing storm water pond at Transco.

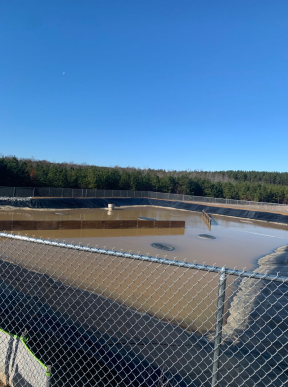
GPS Location	O	GPS Location	O		
Field Station#	00+00	Field Station#	00+00		
Pic 3 Desc.	Observing storm water pond at Transco.	Pic 4 Desc.	Observing rock check dam.		
Insert image here			Insert image here		
GPS Location		GPS Location			
Field Station#		Field Station#			
Pic 5 Desc.		Pic 6 Desc.
