Visual Site Inspection Report

Project Name H-600 Pipeline Spread I		AFE 124300139	Spread H-600 Pipeline Spread I
Contractor Precision		Report # 9466	
Inspector Ben Davenport		Date/Time 3/25/2020 5:00 PM	
Permit # TBD	Inspection Type VA SWPP	Station Begin 14928+52	
State VA	Inspection Area Partial	Station End 15296+00	
County Franklin/Pittsylvania	Ground Wet	Temperature (°F) 58.00	
Municipality Chatham	Weather Light Rain	Rain Gauge (in) 1.60	
Rain Accumulation Time (days)			4.00

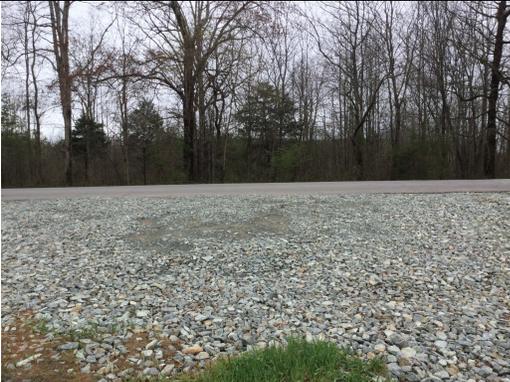
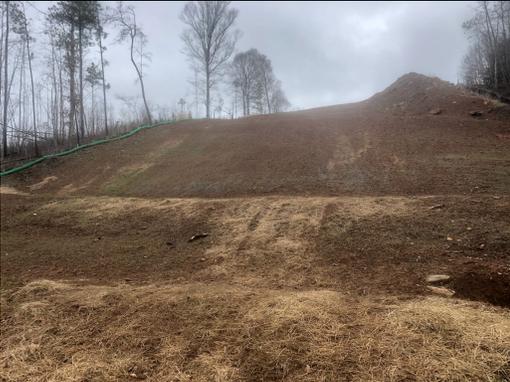
GPS Location 1		GPS Location 2			
Field Station# 15296+00		Field Station# 15171+00			
Pic 1 Desc. RCE at Oxford Rd in good condition. No issues observed.		Pic 2 Desc. Slope is stabilized with vegetation beginning to green. No signs of erosion occurring.

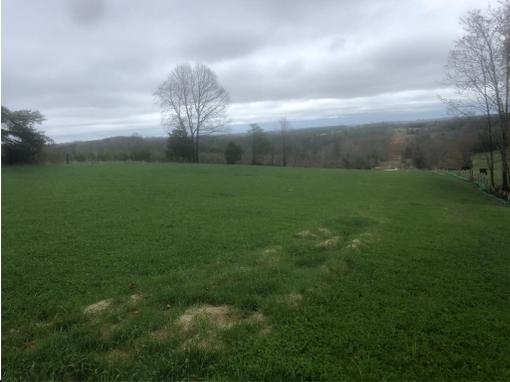
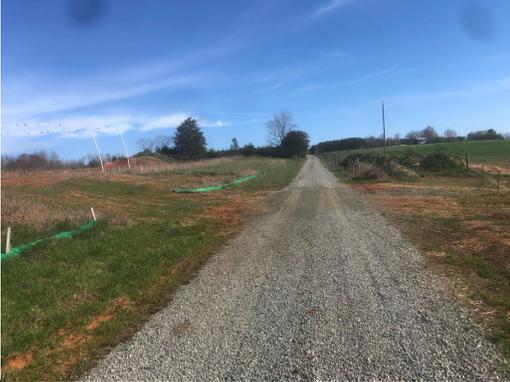
GPS Location 3		GPS Location 4			
Field Station# 15146+00		Field Station# 15080+64			
Pic 3 Desc. Permanent vegetation GAS Rock Creek Rd approximately 3 inches tall and growing. Will continue to monitor area.		Pic 4 Desc. MVP-AR-PI-325 in good condition with no issues observed.

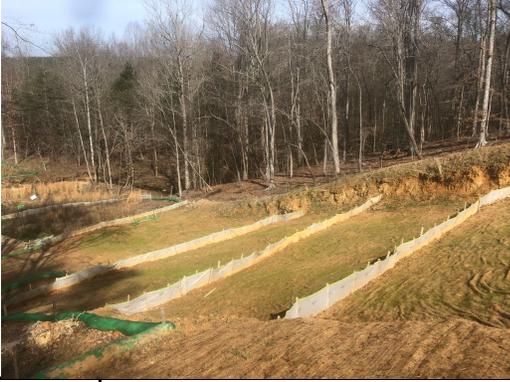
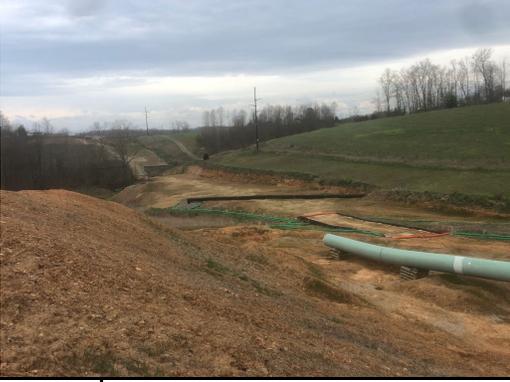
GPS Location 5		GPS Location 6			
Field Station# 15048+00		Field Station# 14941+50			
Pic 5 Desc. Vegetation beginning to grow through erosion control blanket and P1 silt fence performing intended function.		Pic 6 Desc. CWD functioning as intended and ROW stabilized with no observed erosion.

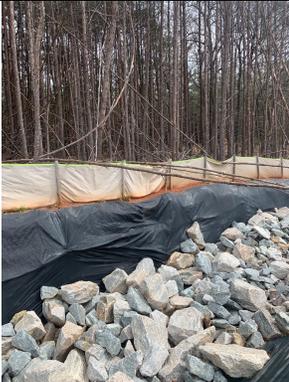
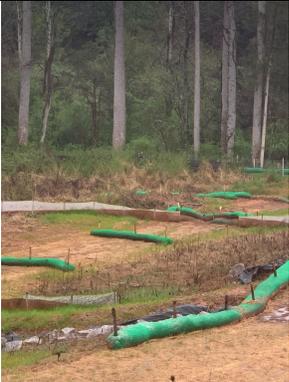
GPS Location O		GPS Location O			
Field Station# 15835+00		Field Station# 15945+00			
Pic 1 Desc. Observing ECD that requires maintenance.		Pic 2 Desc. Observing ECD's performing as they should during the rain event

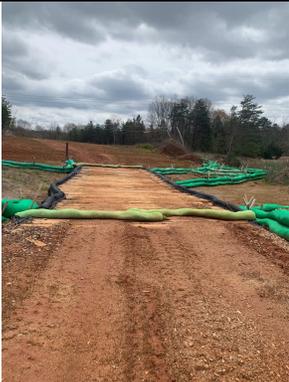
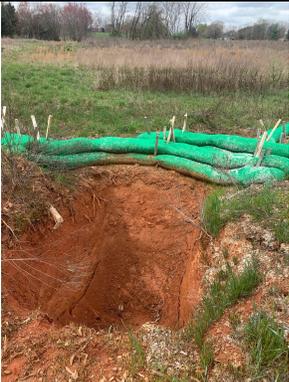
GPS Location O		GPS Location O			
Field Station# 15837+00		Field Station# 15810+00			
Pic 3 Desc. Observing equipment crossing and ECD's performing as they should.		Pic 4 Desc. Observing sump and end treatment performing as they should.

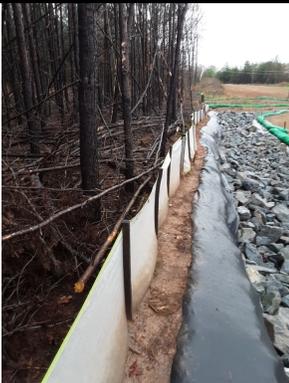
Insert image here			
GPS Location O		GPS Location			
Field Station# 15835+00		Field Station#			
Pic 5 Desc. Observing repaired punch list item.		Pic 6 Desc.

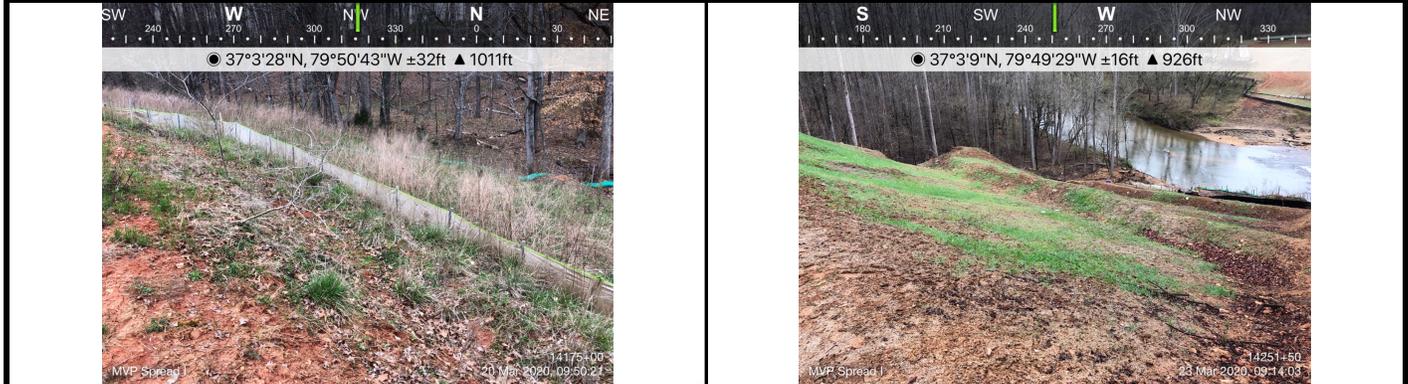
Field Station#	14175+00	Field Station#	14251+50
-----------------------	----------	-----------------------	----------

Pic 1 Desc.	P1 silt fence in acceptable condition	Pic 2 Desc.	Waterbars in acceptable condition
--------------------	---------------------------------------	--------------------	-----------------------------------

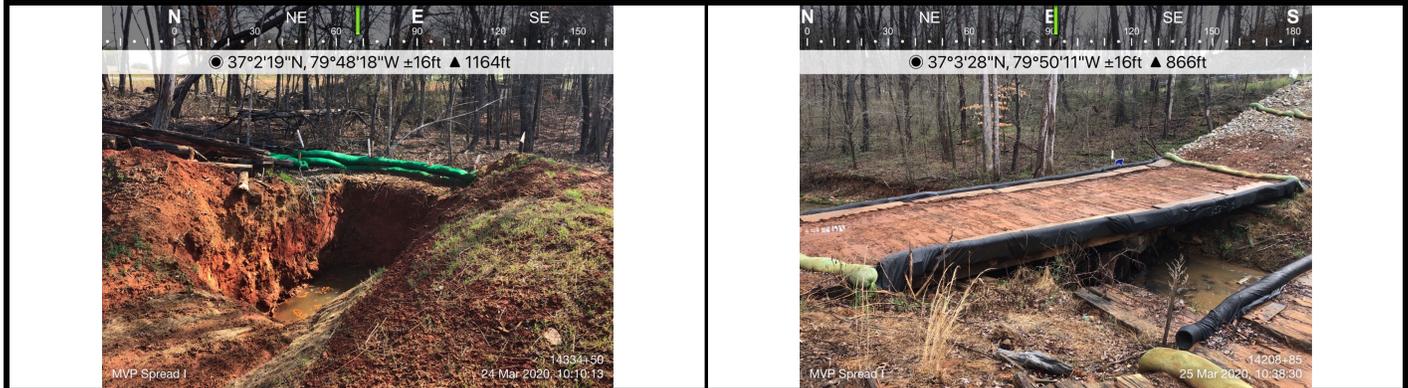
Field Station#	14334+50	Field Station#	14208+85
-----------------------	----------	-----------------------	----------

Pic 3 Desc.	Waterbar end treatment in acceptable condition	Pic 4 Desc.	Equipment bridge in acceptable condition
--------------------	--	--------------------	--

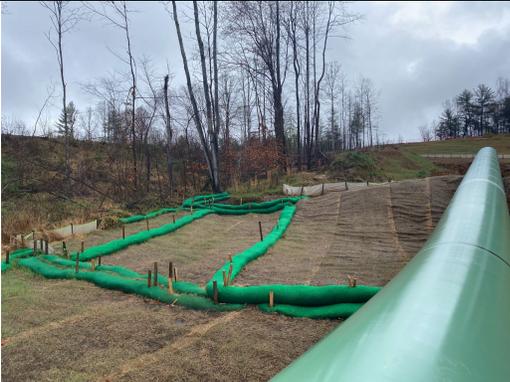
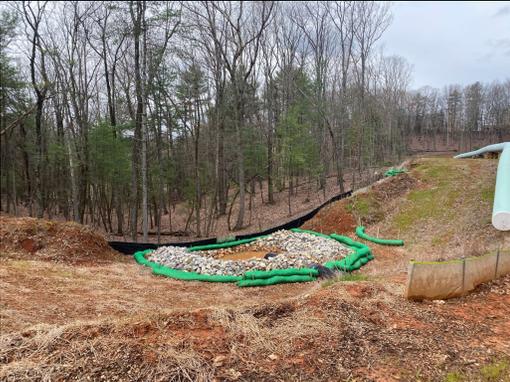
GPS Location	0		GPS Location	0	
Field Station#	13999+00		Field Station#	14071+00	
Pic 1 Desc.	Approximately 13999+00. Overview of ECDs installed in adjacent pond overflow path.		Pic 2 Desc.	Approximately 14071+00. Overview of CWD plunge pool. CWD appears to be installed and functioning correctly at time of inspection.

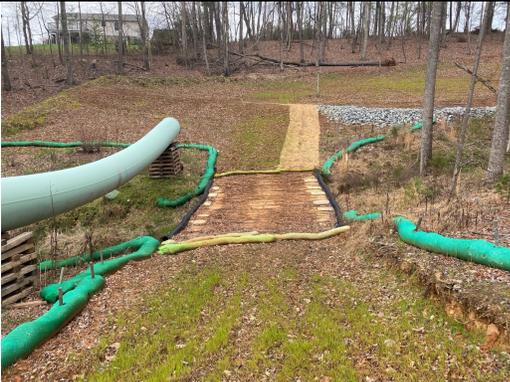
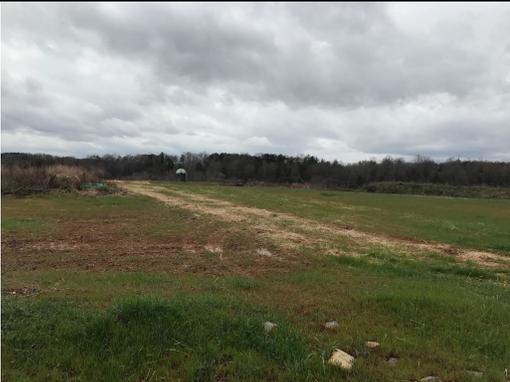
GPS Location	0		GPS Location	0	
Field Station#	14066+77		Field Station#	14169+00	
Pic 3 Desc.	Approximately 14066+77. Overview of stream crossing, equipment bridge and ECDs at stream S-EF48.		Pic 4 Desc.	Approximately 14169+00. Overview of ROW. ROW temporarily stabilized and has winter vegetation growing.	
Insert image here			Insert image here		
GPS Location			GPS Location		
Field Station#			Field Station#		
Pic 5 Desc.			Pic 6 Desc.

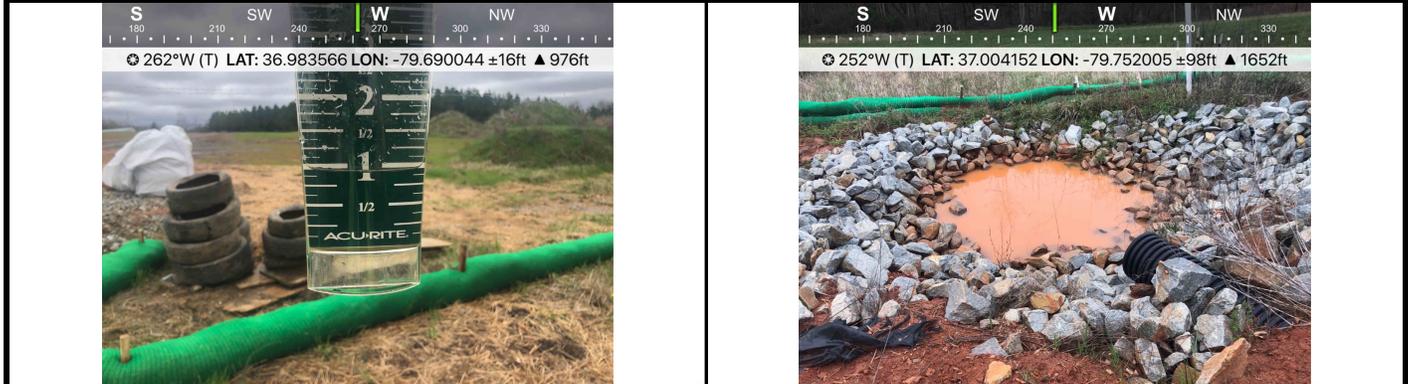
GPS Location 0	GPS Location 0
Field Station# 14758+16	Field Station# 14552+00
Pic 1 Desc. Rain gauge at Indian Cave Road 1.0"	Pic 2 Desc. Plunge pool functions as intended

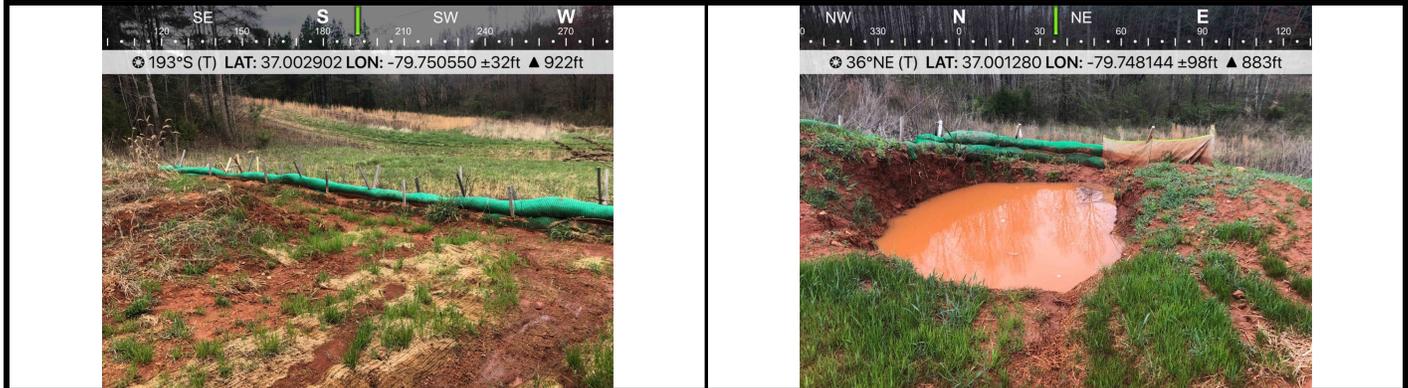
GPS Location 0	GPS Location 0
Field Station# 14558+00	Field Station# 14566+00
Pic 3 Desc. Perimeter CFS functioning as intended	Pic 4 Desc. Sump pit functioning as intended

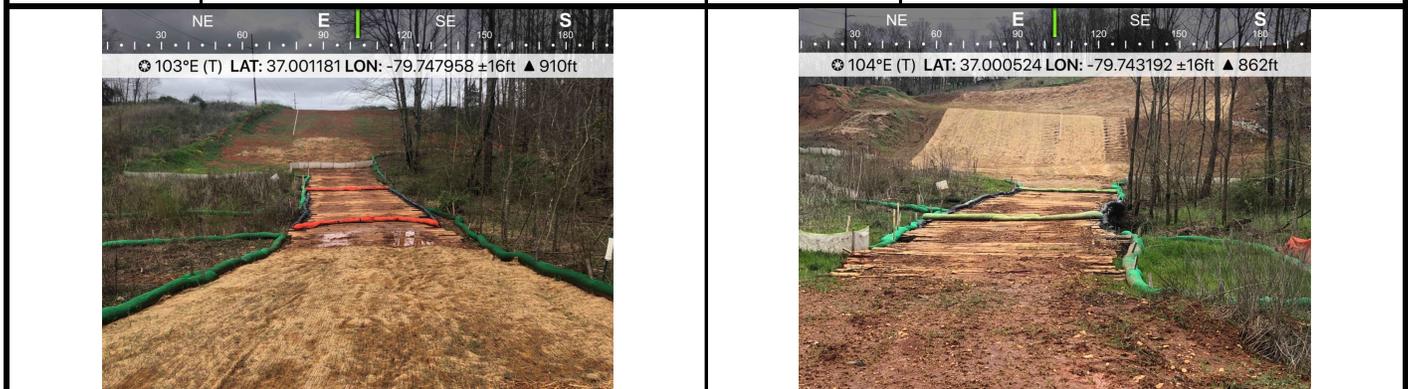
GPS Location 0	GPS Location 0
Field Station# 14568+10	Field Station# 14582+85
Pic 5 Desc. Equipment bridge clean at stream S-E18	Pic 6 Desc. Equipment bridge clean at stream S-E17

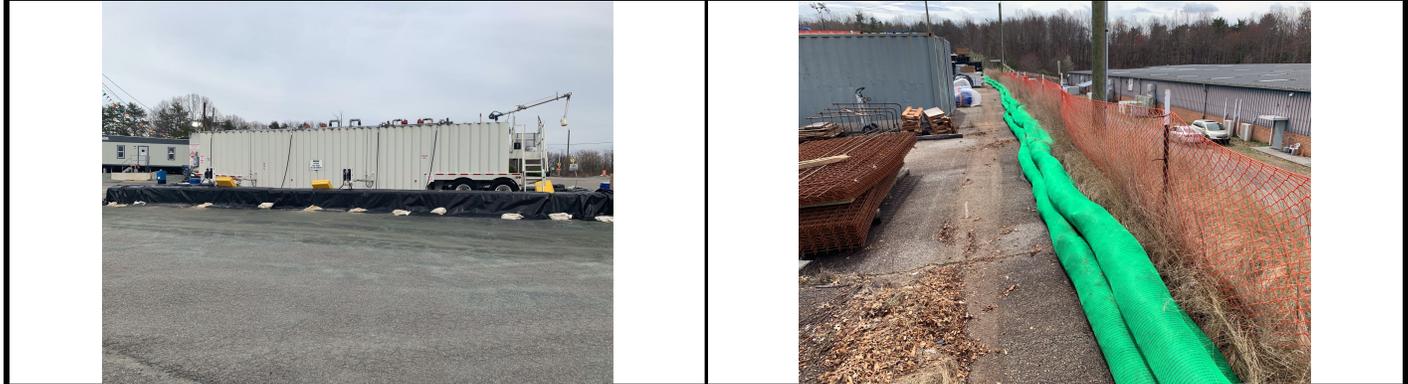
GPS Location	0000000000	GPS Location	0000000000
Field Station#	0000+00	Field Station#	0000+00
Pic 1 Desc.	Secondary containment structure for fuel cell in compliance	Pic 2 Desc.	Perimeter ECD's on west side of paved yard in good condition

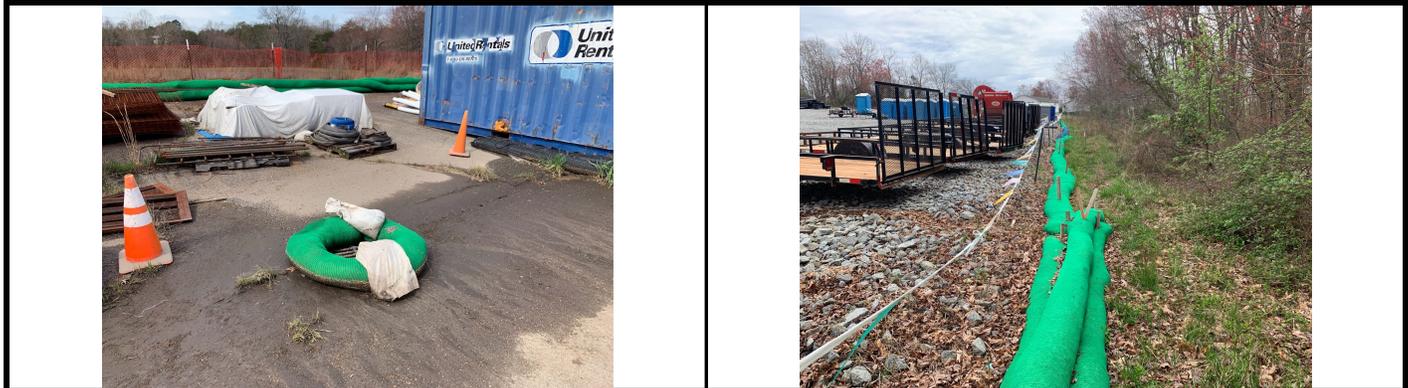
GPS Location	0000000000	GPS Location	0000000000
Field Station#	0000+00	Field Station#	0000+00
Pic 3 Desc.	Inlet protection for parking lot drain in acceptable condition.	Pic 4 Desc.	Perimeter ECD's on west side of gravel yard in good condition.

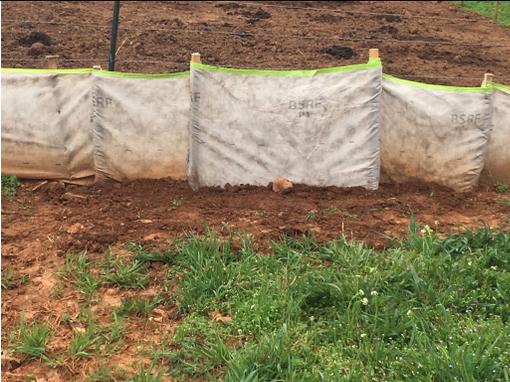
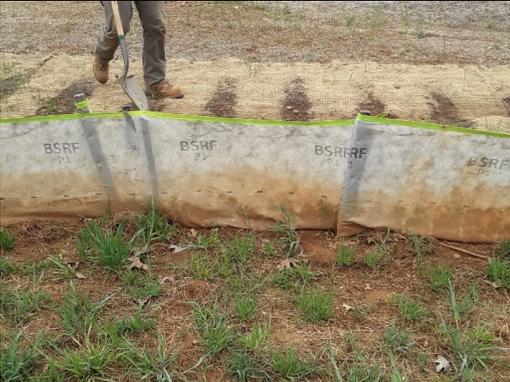
GPS Location	0		GPS Location	0	
Field Station#	15296+00		Field Station#	15300+00	
Pic 1 Desc.	Damaged P1 fence was replaced during maintenance process.		Pic 2 Desc.	Undermining issue was corrected along P1 fence during maintenance process.

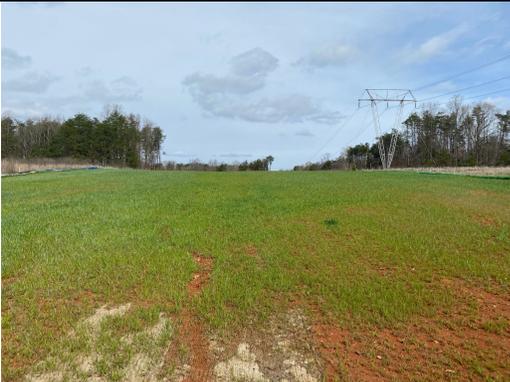
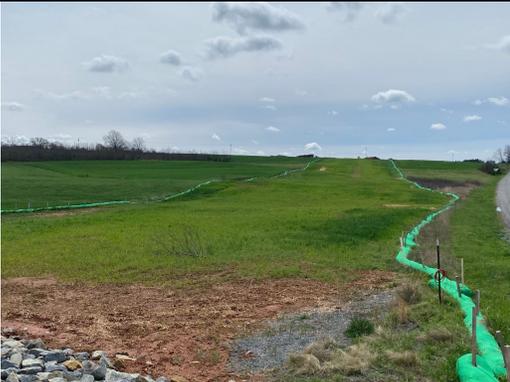
GPS Location	0		GPS Location	0	
Field Station#	15450+00		Field Station#	15483+00	
Pic 3 Desc.	Vegetation growing well along areas where final cleanup has been completed.		Pic 4 Desc.	Vegetation growing well along areas where final cleanup has been completed.	
Insert image here			Insert image here		
GPS Location			GPS Location		
Field Station#			Field Station#		
Pic 5 Desc.			Pic 6 Desc.

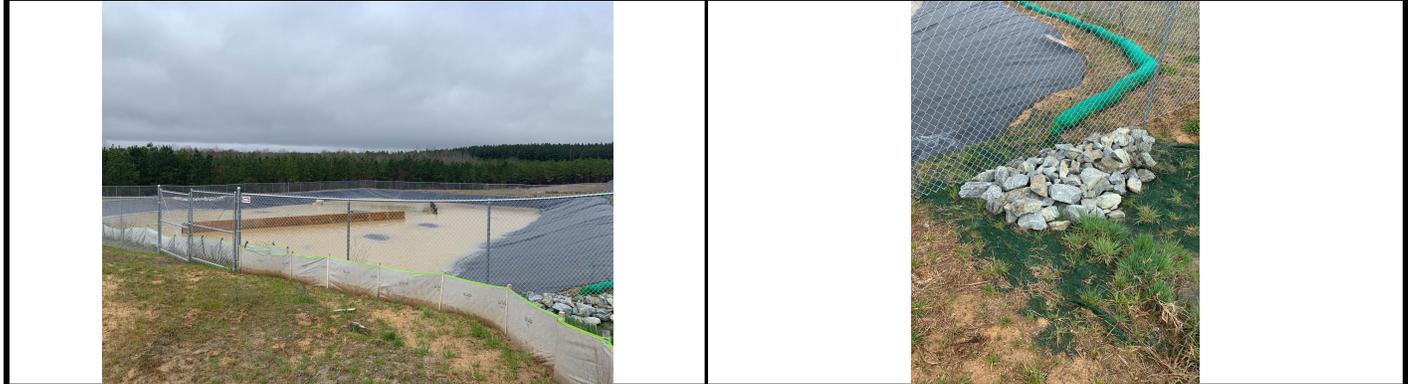
Field Station# 00+00	Field Station# 00+00
-----------------------------	-----------------------------

Pic 1 Desc. Observing storm water pond at Transco.	Pic 2 Desc. Observing ECD's performing as they should.
---	---
