Visual Site Inspection Report

Project Name	H-600 Pipeline Spread I	AFE	124300139	Spread	H-600 Pipeline Spread I
Contractor	Precision			Report #	10190
Inspector	Charles Head			Date/Time	4/22/2020 11:41 AM
Permit #	TBD	Inspection Type	VA SWPP	Station Begin	13784+36
State	VA	Inspection Area	Partial	Station End	14171+36
County	Franklin	Ground	Damp	Temperature (°F)	67.00
Municipality	N/A	Weather	Sunny	Rain Gauge (in)	0.50
				Rain Accumulation Time (days)	6.00

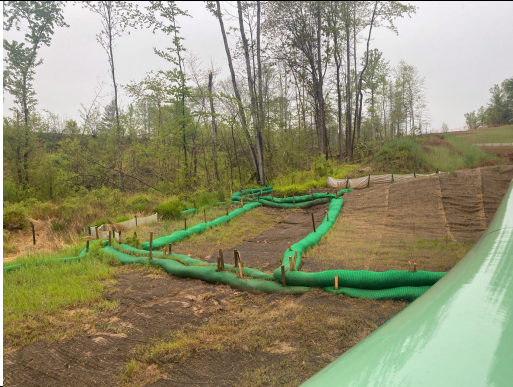
GPS Location	0	GPS Location	0		
Field Station#	13862+80	Field Station#	13999+00		
Pic 1 Desc.	Approximately 13862+80. Overview of stream crossing, equipment bridge and ECDs at stream S-C17.		Pic 2 Desc.	Approximately 13999+00. ECDs installed in flow path of adjacent pond. No flow observed at time of inspection.

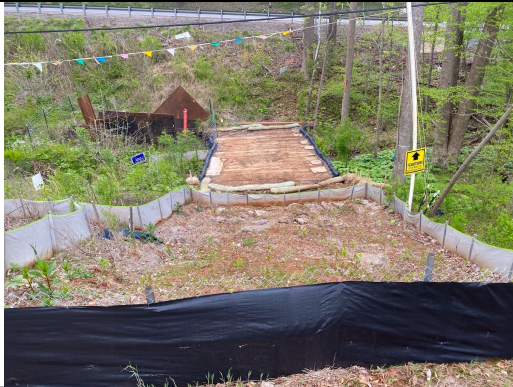
GPS Location	0	GPS Location	0		
Field Station#	13888+50	Field Station#	14009+20		
Pic 3 Desc.	Approximately 13888+50. Overview of wetland crossing, equipment bridge and ECDs at wetland W-CD5.		Pic 4 Desc.	Approximately 14009+20. Overview of stream crossing, equipment bridge and ECDs at stream S-KL38.	
Insert image here			Insert image here		
GPS Location		GPS Location			
Field Station#		Field Station#			
Pic 5 Desc.		Pic 6 Desc.

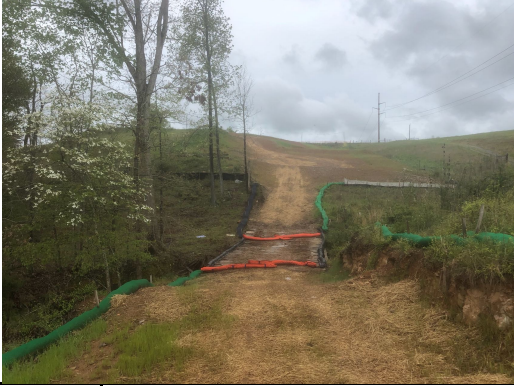
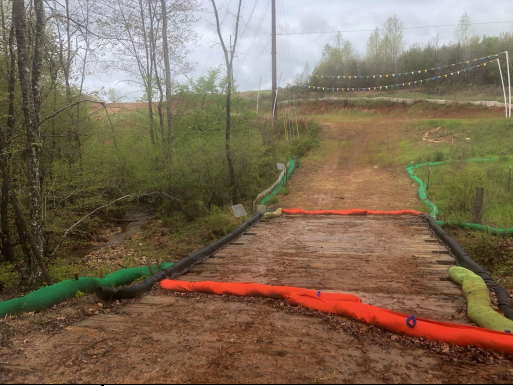
GPS Location	1	GPS Location	2		
Field Station#	14932+89	Field Station#	14950+47		
Pic 1 Desc.	Equipment bridge crossing and all ECD's at S-G15 in good condition.		Pic 2 Desc.	Equipment bridge crossing and all ECD's at S-G13 in good condition.

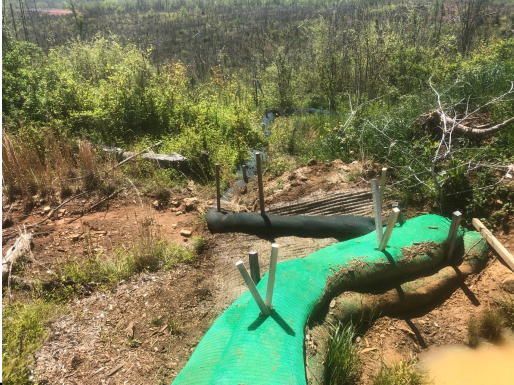
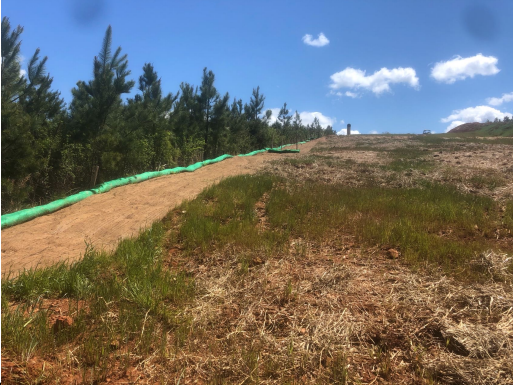
GPS Location	3	GPS Location	4		
Field Station#	15013+00	Field Station#	15031+00		
Pic 3 Desc.	Contractor repaired gully erosion at ROW perimeter and installed erosion control blanket to prevent further erosion issues.		Pic 4 Desc.	Contractor installed erosion control blanket and CFS check dams down perimeter of ROW to prevent further flow path erosion.

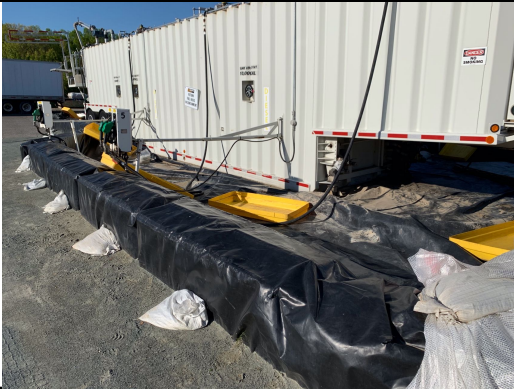
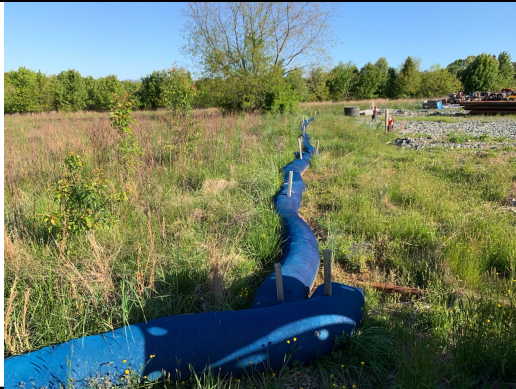
GPS Location	0000000000	GPS Location	0000000000		
Field Station#	0000+00	Field Station#	0000+00		
Pic 3 Desc.	Secondary containment structure for fuel cell in compliance		Pic 4 Desc.	Perimeter ECD's on north end of gravel yard in good condition.

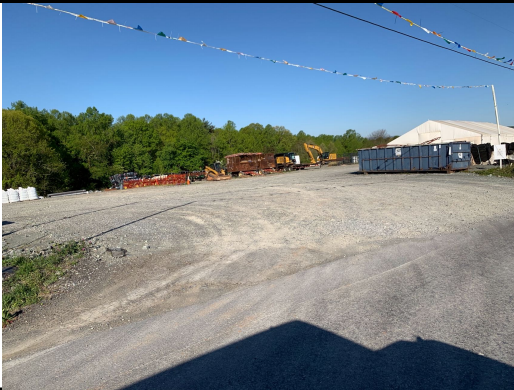
Insert image here			
GPS Location	0000000000	GPS Location			
Field Station#	0000+00	Field Station#			
Pic 5 Desc.	RCE at gravel yard in good condition.		Pic 6 Desc.

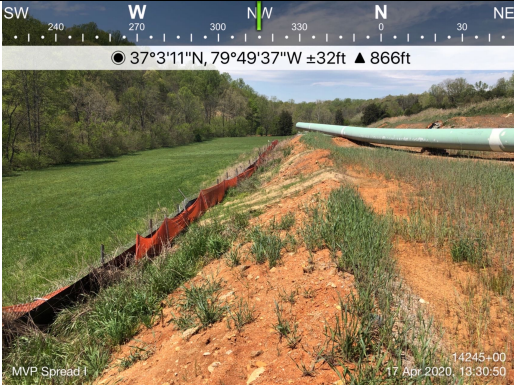
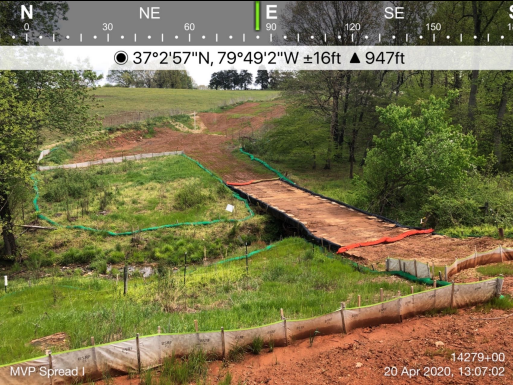
GPS Location	0	GPS Location	0		
Field Station#	14245+00	Field Station#	14279+00		
Pic 1 Desc.	Super silt fence in acceptable condition		Pic 2 Desc.	Equipment bridge in acceptable condition

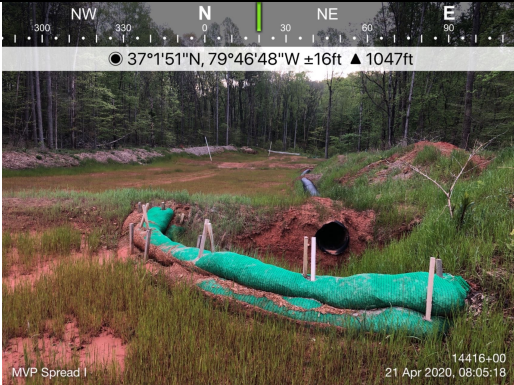
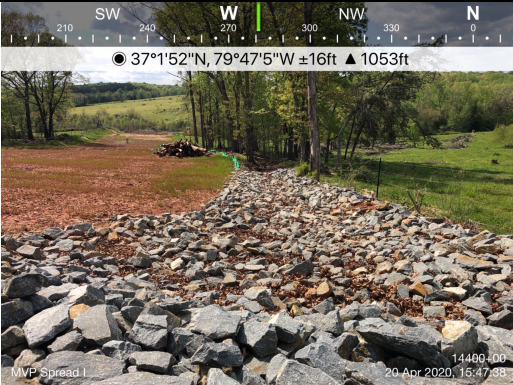
GPS Location	0	GPS Location	0		
Field Station#	14416+00	Field Station#	14400+00		
Pic 3 Desc.	Slope drain in acceptable condition		Pic 4 Desc.	Rock lined channel in acceptable condition

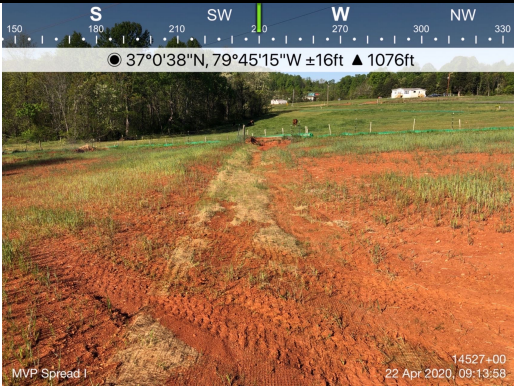
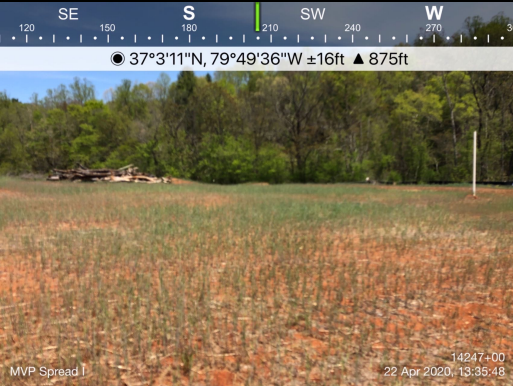
GPS Location	0	GPS Location	0		
Field Station#	14527+00	Field Station#	14247+00		
Pic 5 Desc.	Waterbar in acceptable condition		Pic 6 Desc.	Temporary vegetative stabilization in acceptable condition

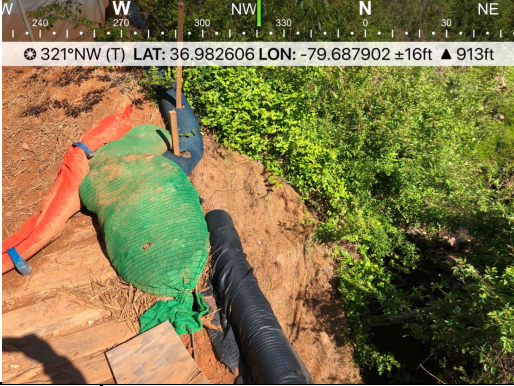
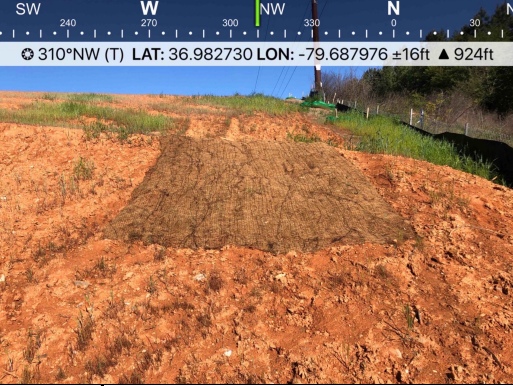
GPS Location	0	GPS Location	0		
Field Station#	14766+00	Field Station#	14765+00		
Pic 1 Desc.	ECDs replaced and curlex installed beside bridge at stream S-MM44	Pic 2 Desc.	Erosion fixed and curlex installed on back side of water bar

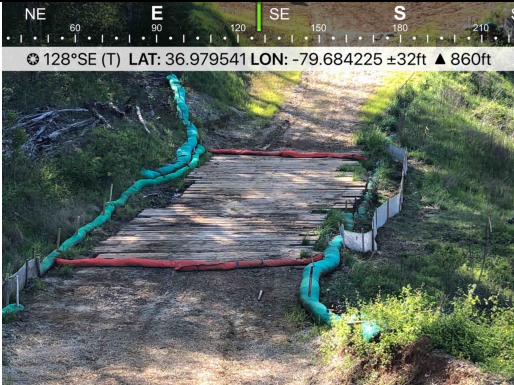
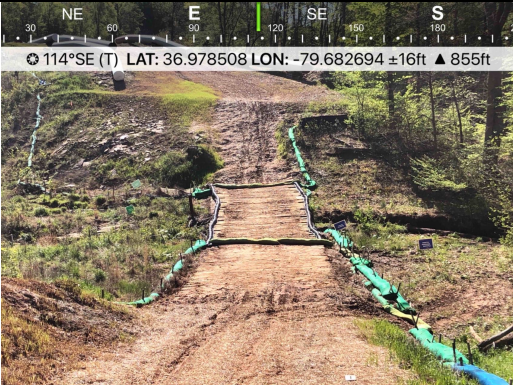
GPS Location	0	GPS Location	0		
Field Station#	14782+25	Field Station#	14788+77		
Pic 3 Desc.	ECDs replaced that got washed out on bridge at stream S-MM48	Pic 4 Desc.	Equipment bridge clean at stream S-H25

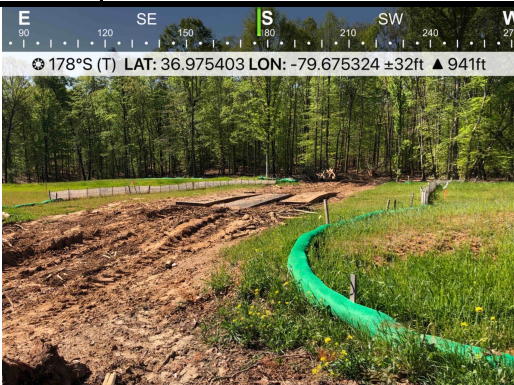
GPS Location	0	GPS Location	0		
Field Station#	14812+00	Field Station#	14722+60		
Pic 5 Desc.	Third party logging company crossing right of way	Pic 6 Desc.	Equipment bridge clean at steam S-A18

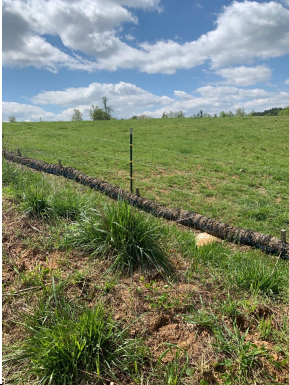
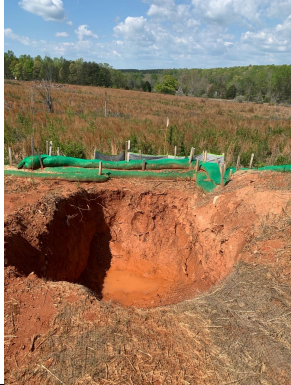
GPS Location	O	GPS Location	O		
Field Station#	15964+59	Field Station#	15690+00		
Pic 1 Desc.	Observing CFS that requires maintenance.	Pic 2 Desc.	Observing sump and end treatment.

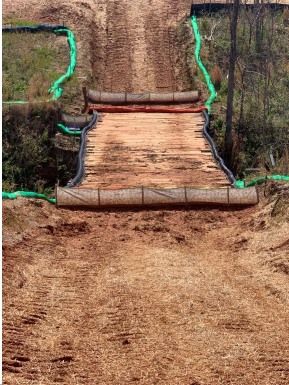
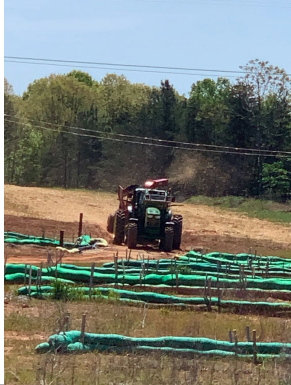
GPS Location	O	GPS Location	O		
Field Station#	15700+40	Field Station#	15837+00		
Pic 3 Desc.	Observing equipment crossing and ECD's performing as they should.	Pic 4 Desc.	Observing the Contractor stabilizing the row.		
Insert image here			Insert image here		
GPS Location		GPS Location			
Field Station#		Field Station#			
Pic 5 Desc.		Pic 6 Desc.

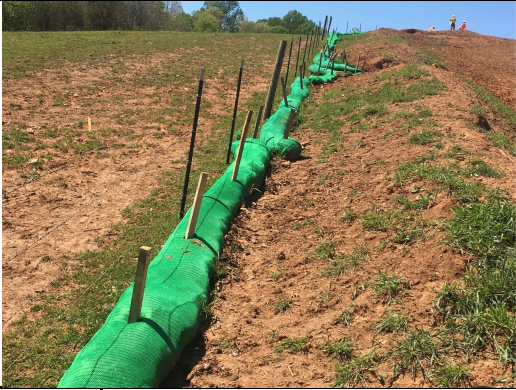
GPS Location	0	GPS Location	0		
Field Station#	15309+00	Field Station#	15310+00		
Pic 1 Desc.	New ECDs installed during maintenance process.	Pic 2 Desc.	New ECDs installed during maintenance process.

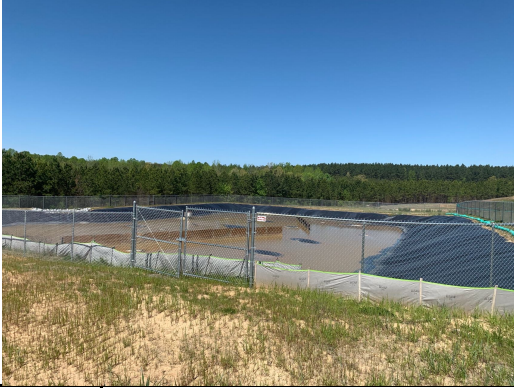
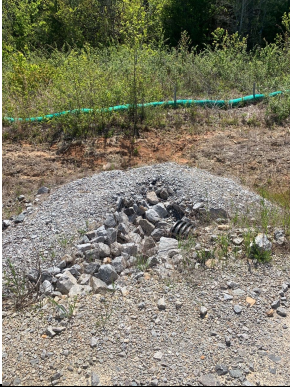
GPS Location	O	GPS Location	O		
Field Station#	00+00	Field Station#	00+00		
Pic 1 Desc.	Observing storm water pond	Pic 2 Desc.	Observing outlet and outlet protection.

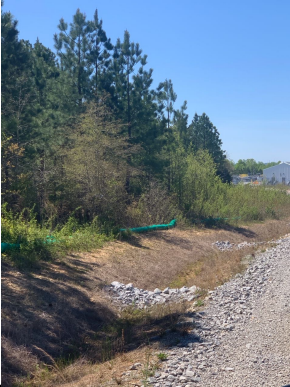
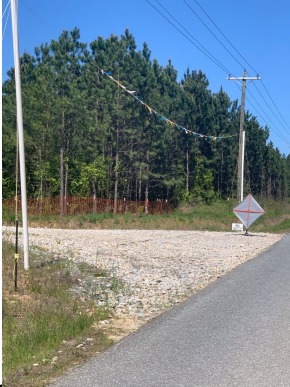
GPS Location	O	GPS Location	O		
Field Station#	00+00	Field Station#	00+00		
Pic 3 Desc.	Observing rock check dams.	Pic 4 Desc.	Observing RCE.		
Insert image here			Insert image here		
GPS Location		GPS Location			
Field Station#		Field Station#			
Pic 5 Desc.		Pic 6 Desc.
