Visual Site Inspection Report

Project Name	H-600 Pipeline Spread G	AFE	124300137	Spread	H-600 Pipeline Spread G
Contractor	Precision			Report #	11443
Inspector	Chris Burns			Date/Time	6/1/2020 7:55 AM
Permit #	TBD	Inspection Type	VA SWPP	Station Begin	11254+99
State	VA	Inspection Area	Partial	Station End	11353+67
County	Giles	Ground	Dry	Temperature (°F)	72.00
Municipality	N/A	Weather	Sunny	Rain Gauge (in)	0.00
				Rain Accumulation Time (days)	1.00

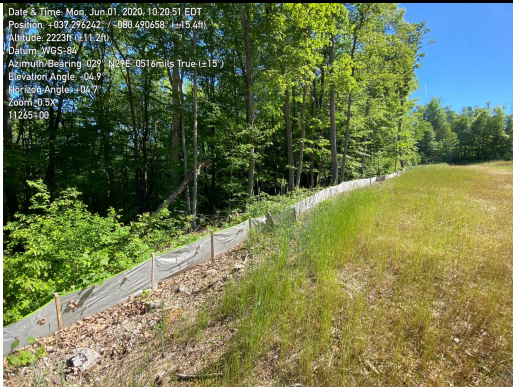
GPS Location	1	GPS Location	2		
Field Station#	11265+00	Field Station#	11286+00		
Pic 1 Desc.	Perimeter controls functional.	Pic 2 Desc.	Perimeter controls functional.

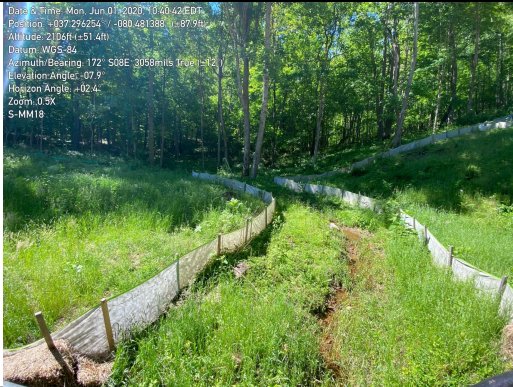
GPS Location	3	GPS Location	4		
Field Station#	11292+80	Field Station#	11327+85		
Pic 3 Desc.	S-MM18 and controls.	Pic 4 Desc.	S-NN12 and controls.

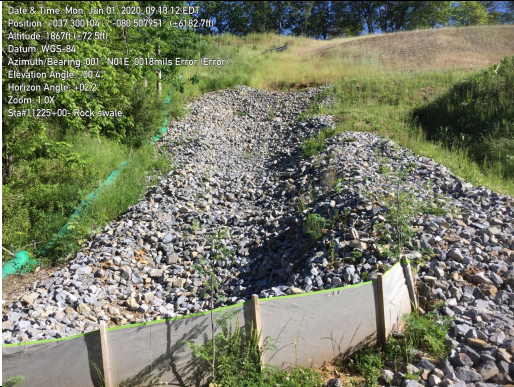
GPS Location	See photo GPS		GPS Location	See photo GPS	
Field Station#	11225+00		Field Station#	11218+00	
Pic 1 Desc.	Rock channel		Pic 2 Desc.	P1 silt fence perimeter controls.

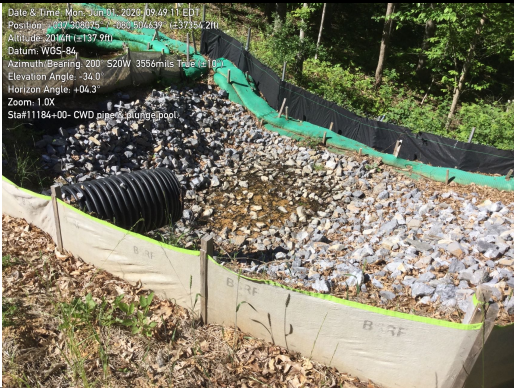
GPS Location	See photo GPS		GPS Location	See photo GPS	
Field Station#	11184+00		Field Station#	11172+70	
Pic 5 Desc.	CWD pipe and plunge pool are in good condition.		Pic 6 Desc.	Slope drain, checks, sump pit, end treatment

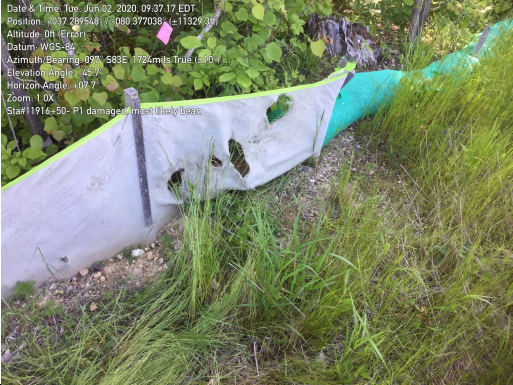
<p>Date & Time: Tue Jun 02, 2020, 09:37:17 EDT Position: +037.246876° / +080.390672° (±121.59 ft) Altitude: 0 ft (0.00 m) Datum: WGS-84 Azimuth/Bearing: 099° S83E 1724mils True (±10°) Elevation Angle: -45.7° Horizon Angle: -00.7° Zoom: 1.0X Sta#11916+50- P1 damaged, most likely bear.</p>			
GPS Location	See photo GPS		GPS Location	See photo GPS	
Field Station#	11900+00		Field Station#	11916+50	
Pic 1 Desc.	AR-266.03- Access road and controls.		Pic 2 Desc.	P1 perimeter controls damaged by bear. Added to the punch list.

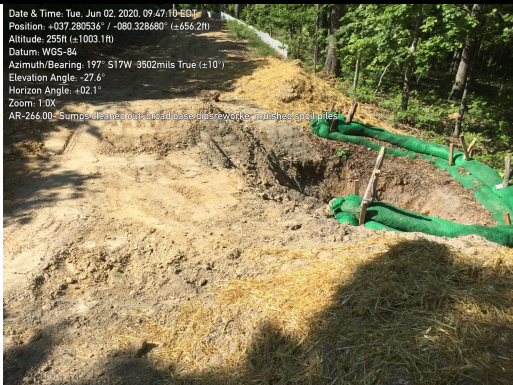
<p>Date & Time: Tue Jun 02, 2020, 09:47:10 EDT Position: +037.280534° / +080.328480° (±656.2 ft) Altitude: 255 ft (±1003.1 ft) Datum: WGS-84 Azimuth/Bearing: 197° S17W 3502mils True (±10°) Elevation Angle: -27.6° Horizon Angle: +02.1° Zoom: 1.0X AR-266.00- Sump cleaned, broad base dips, stabilized, mulched spoil stockpiles.</p>

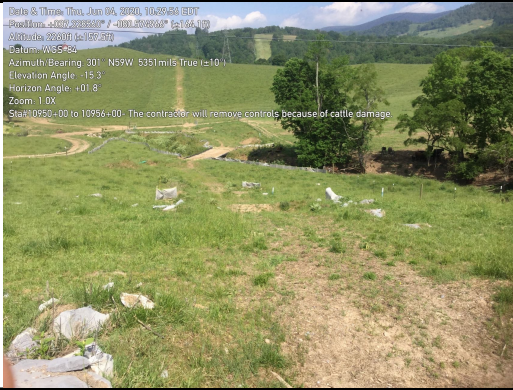
<p>Date & Time: Thu, Jun 04, 2020, 10:26:00 EDT Position: +037.325610 / -080.564912 (+32.0ft) Altitude: 2370ft (+26.2ft) Datum: WGS-84 Azimuth Bearing: 301° N39W 5351mils True (+10.1) Elevation Angle: +15.3° Horizon Angle: +01.8° Zoom: 1.0X Start 10950+00 to 10956+00. The contractor will remove controls because of cattle damage</p>		GPS Location	See photo GPS
Field Station#	10965+00	Field Station#	10956+00	GPS Location	See photo GPS
Pic 5 Desc.	Bat habitat	Pic 6 Desc.	Doe Creek Farms- PPL will remove P1 from sta#10950+00 to 10956+00 has cattle continue to damage controls.

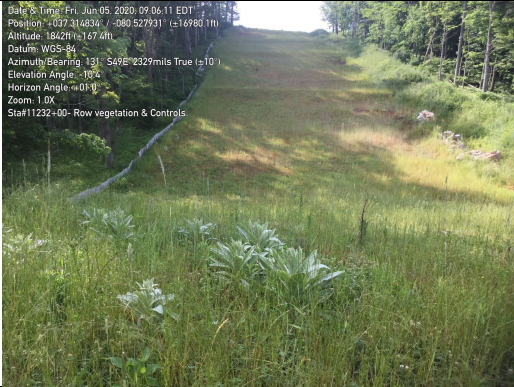
<p>Date & Time: Fri, Jun 05, 2020, 09:06:11 EDT Position: -037.314334 / -080.527931 (-16980.11) Altitude: 1842ft (-167.4m) (-515.75) Datum: WGS-84 Azimuth/Bearing: 131° S46°E 232mils True (-10°) Elevation Angle: -18.4° Horizon Angle: +01.9° Zoom: 1.0X Sta#11232+00- Row vegetation & Controls</p>

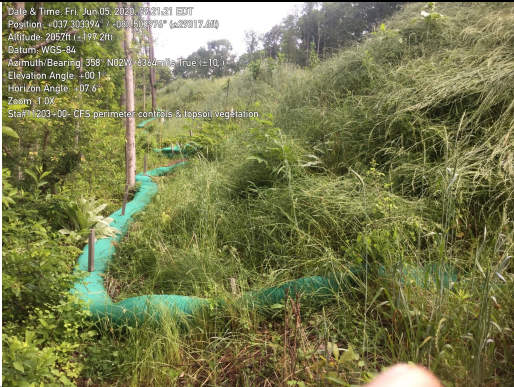
<p>Date & Time: Fri, Jun 05, 2020, 09:31:51 EDT Position: -037.301344 / -080.509708 (-169919.68) Altitude: 2057ft (-178.2m) (-54.50) Datum: WGS-84 Azimuth/Bearing: 358° N83°W 134mils True (-10°) Elevation Angle: +00.1° Horizon Angle: +07.6° Zoom: 1.0X Sta#11203+00- CFS perimeter controls & topsoil vegetation</p>

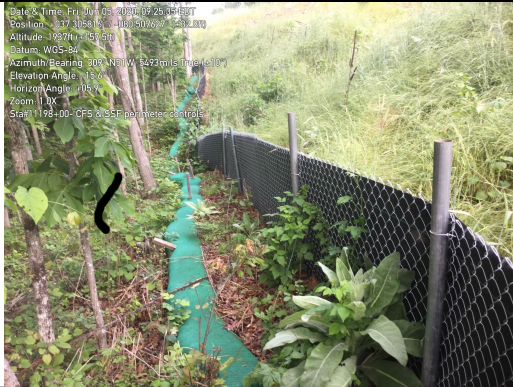
<p>Date & Time: Fri, Jun 05, 2020, 09:36:03 EDT Position: -037.305816 / -080.501627 (-169820.77) Altitude: 1937ft (-153.0m) (-46.89) Datum: WGS-84 Azimuth/Bearing: 205° N05°W 349mils True (-10°) Elevation Angle: +13.6° Horizon Angle: +05.9° Zoom: 1.0X Sta#11198+00- CFS & SSF perimeter controls</p>

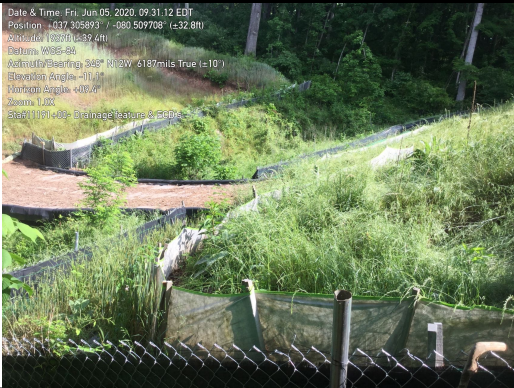
<p>Date & Time: Fri, Jun 05, 2020, 09:31:12 EDT Position: -037.305993 / -080.509708 (-169820.77) Altitude: 1959ft (-149.8m) (-45.72) Datum: WGS-84 Azimuth/Bearing: 345° N15°W 5187mils True (-10°) Elevation Angle: -01.1° Horizon Angle: +03.9° Zoom: 1.0X Sta#11191+00- Drainage feature & ECD's</p>
