# Visual Site Inspection Report

<b>Project Name</b>	H-600 Pipeline Spread G	<b>AFE</b>	124300137	<b>Spread</b>	H-600 Pipeline Spread G
<b>Contractor</b>	Precision			<b>Report #</b>	12240
<b>Inspector</b>	Len Kruizenga			<b>Date/Time</b>	6/29/2020 11:31 AM
<b>Permit #</b>	TBD	<b>Inspection Type</b>	VA SWPP	<b>Station Begin</b>	11254+99
<b>State</b>	VA	<b>Inspection Area</b>	Full	<b>Station End</b>	11158+27
<b>County</b>	Giles	<b>Ground</b>	Dry	<b>Temperature (°F)</b>	72.00
<b>Municipality</b>	N/A	<b>Weather</b>	Sunny	<b>Rain Gauge (in)</b>	0.10
				<b>Rain Accumulation Time (days)</b>	1.00

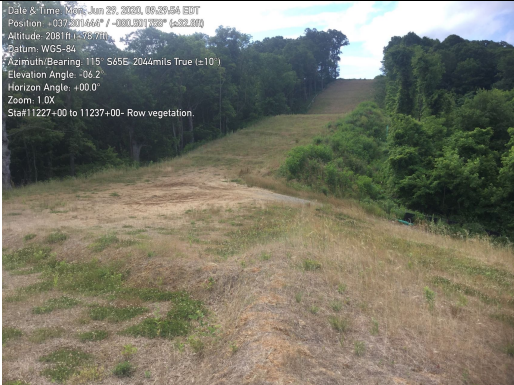
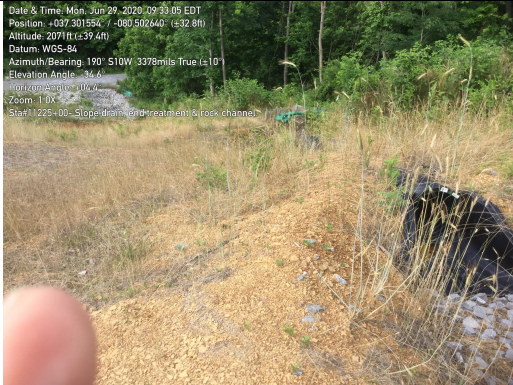
<b>GPS Location</b>	See photo GPS		<b>GPS Location</b>	See photo GPS	
<b>Field Station#</b>	12227+00		<b>Field Station#</b>	11225+00	
<b>Pic 1 Desc.</b>	Row is stable		<b>Pic 2 Desc.</b>	Slope drain, end treatment and rock channel are in acceptable condition.

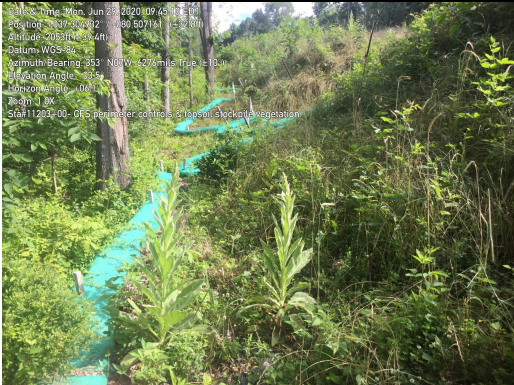
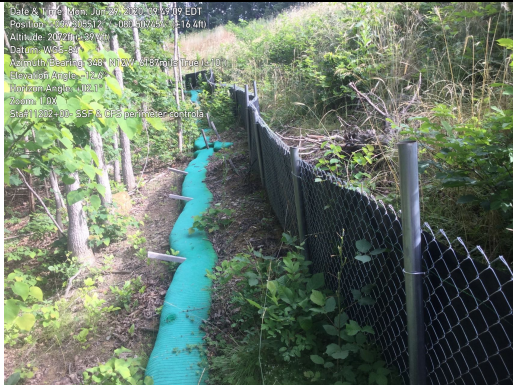
<b>GPS Location</b>	See photo GPS		<b>GPS Location</b>	See photo GPS	
<b>Field Station#</b>	11203+00		<b>Field Station#</b>	11202+00	
<b>Pic 3 Desc.</b>	CFS perimeter controls and topsoil stockpiles are well vegetated.		<b>Pic 4 Desc.</b>	CFS and SSF perimeter controls are in acceptable condition.

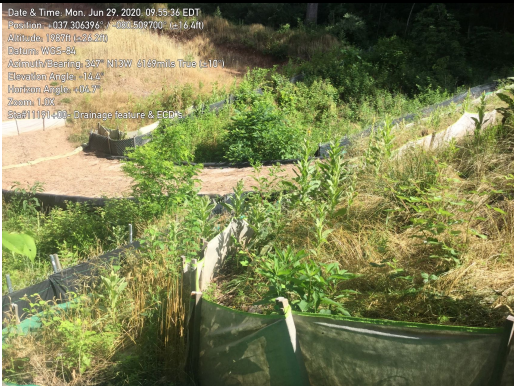
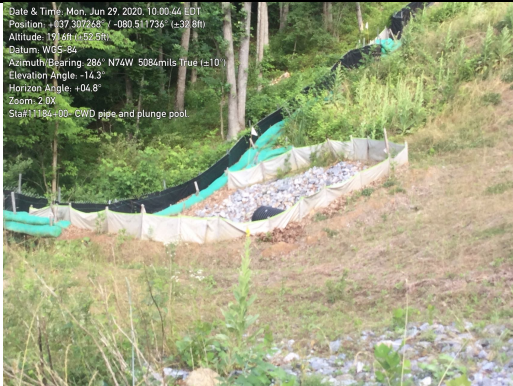
<b>GPS Location</b>	See photo GPS		<b>GPS Location</b>	See photo GPS	
<b>Field Station#</b>	11191+00		<b>Field Station#</b>	11184+00	
<b>Pic 5 Desc.</b>	Sensitive resource ECD's and bridge.		<b>Pic 6 Desc.</b>	CWD pipe and plunge pool are in good condition.

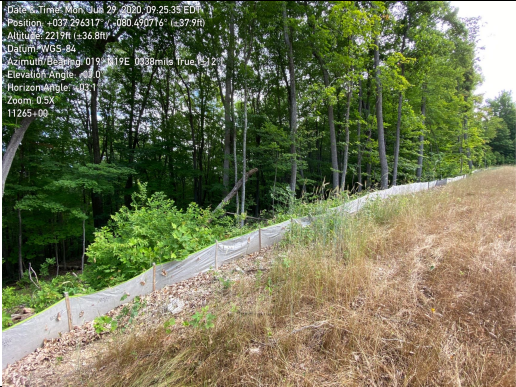
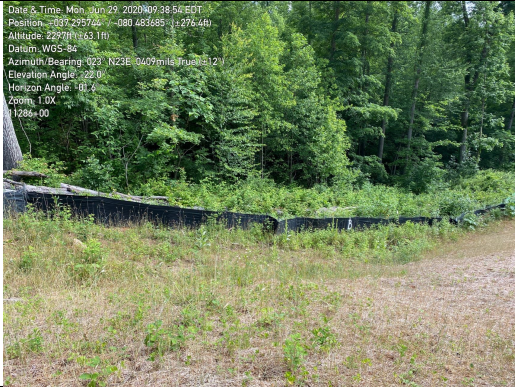
<b>GPS Location</b>	1	<b>GPS Location</b>	2		
<b>Field Station#</b>	11265+00	<b>Field Station#</b>	11286+00		
<b>Pic 1 Desc.</b>	Perimeter controls functional.	<b>Pic 2 Desc.</b>	Perimeter controls functional.

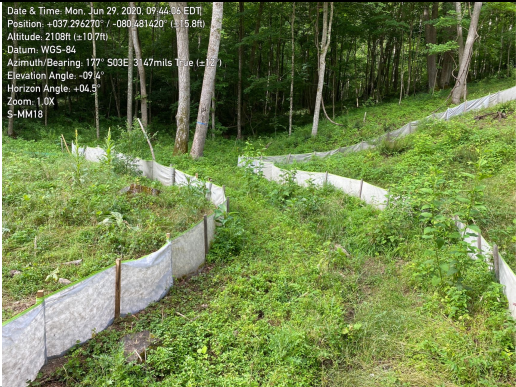
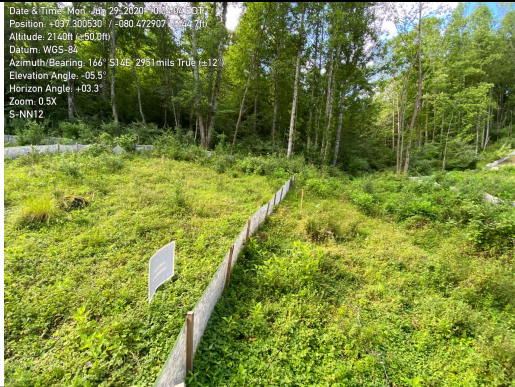
<b>GPS Location</b>	3	<b>GPS Location</b>	4		
<b>Field Station#</b>	11292+80	<b>Field Station#</b>	11327+85		
<b>Pic 3 Desc.</b>	S-MM18 and controls.	<b>Pic 4 Desc.</b>	S-NN12 and controls.

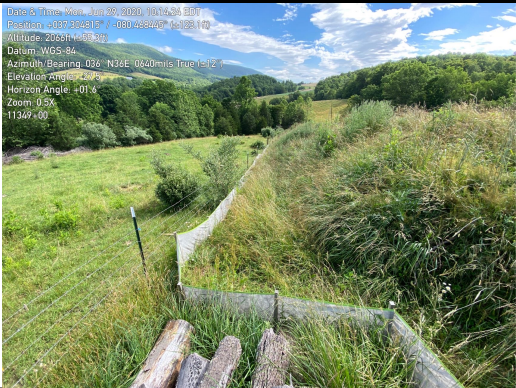
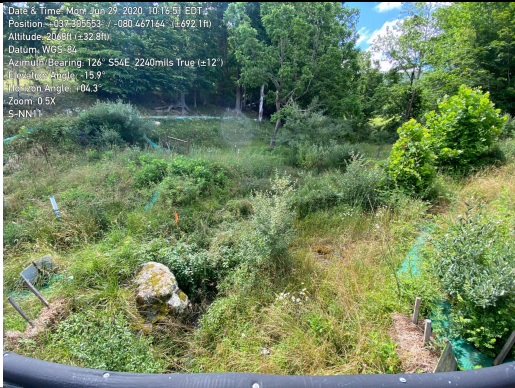
<b>GPS Location</b>	5	<b>GPS Location</b>	6		
<b>Field Station#</b>	11349+00	<b>Field Station#</b>	11352+97		
<b>Pic 5 Desc.</b>	Perimeter controls functional.	<b>Pic 6 Desc.</b>	S-NN11 and controls.

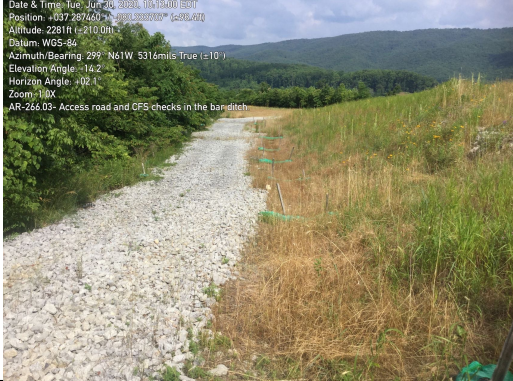
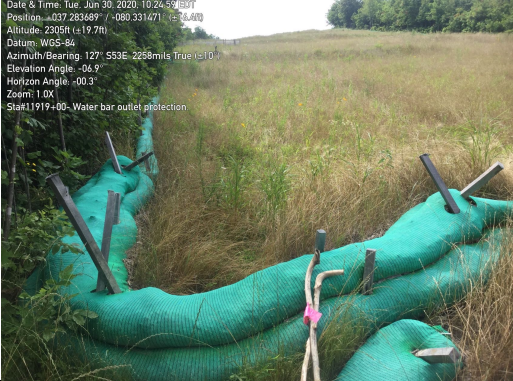
GPS Location	See photo GPS		GPS Location	See photo GPS	
Field Station#	11901+00		Field Station#	11919+00	
Pic 1 Desc.	AR-266.03- Access road and bar ditch CFS checks.		Pic 2 Desc.	Water bar outlet protection is in acceptable condition.

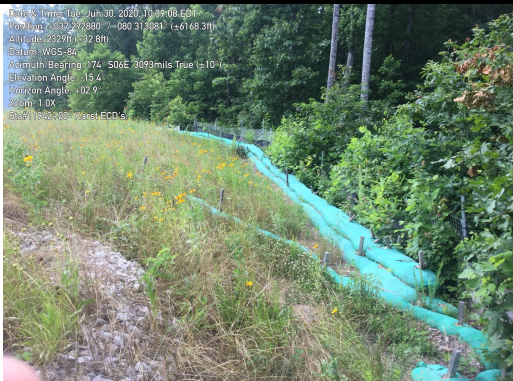
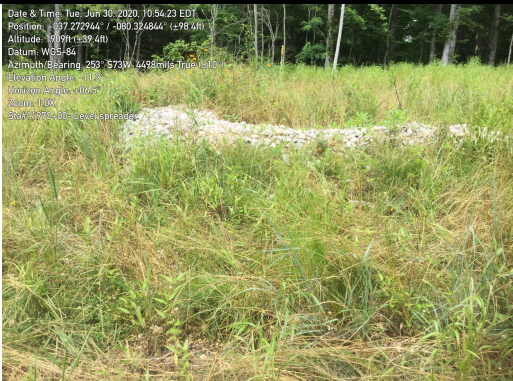
GPS Location	See photo GPS		GPS Location	See photo GPS	
Field Station#	11942+00		Field Station#	11970+00	
Pic 3 Desc.	Karst ECD's are in acceptable condition.		Pic 4 Desc.	Level spreaders are in good condition.	
<p>Date &amp; Time: Tue, Jun 30, 2020, 10:58:56 EDT Position: -037.269944° / -080.320000° (-62.0000°) Altitude: 1789ft (+26.2m) Datum: WGS-84 Azimuth/Bearing: 163° 51W 3333mils True (+10°) Elevation Angle: -25.5° Horizon Angle: +03.5° Zoom: 1.0x Star#11974+00- Row is dry &amp; stable and heavily vegetated</p>

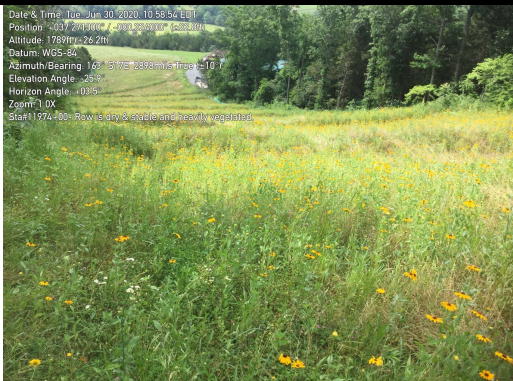
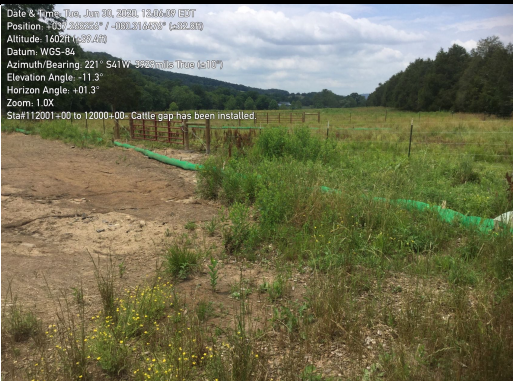
GPS Location	See photo GPS		GPS Location	See photo GPS	
Field Station#	11974+00		Field Station#	12001+00	
Pic 5 Desc.	Row is dry and in stable condition and heavily vegetated.		Pic 6 Desc.	Cattle gap has been installed at wetland at landowner request.

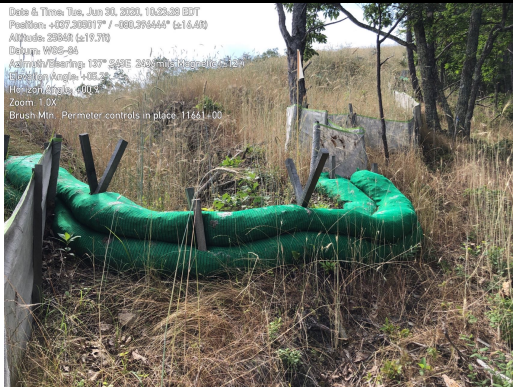
GPS Location		On photo		GPS Location		On photo	
Field Station#		11668+50		Field Station#		11661+00	
Pic 1 Desc.		ROW stable. Slope breakers in place and effective. Annual grasses turning brown.		Pic 2 Desc.		Perimeter controls in place and functioning.

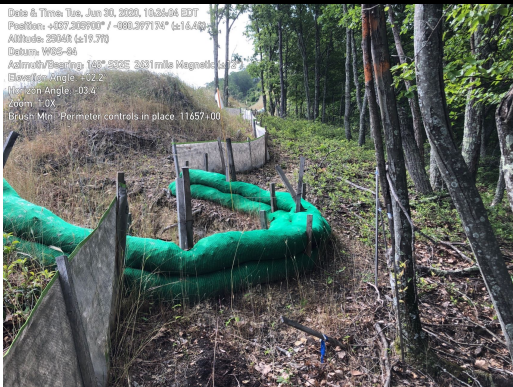
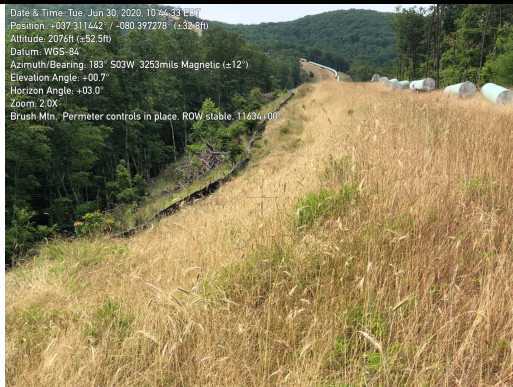
GPS Location		On photo		GPS Location		On photo	
Field Station#		11657+00		Field Station#		11634+00	
Pic 3 Desc.		Perimeter controls in place and functional.		Pic 4 Desc.		Perimeter controls in place and functional. Annual grasses turning brown.

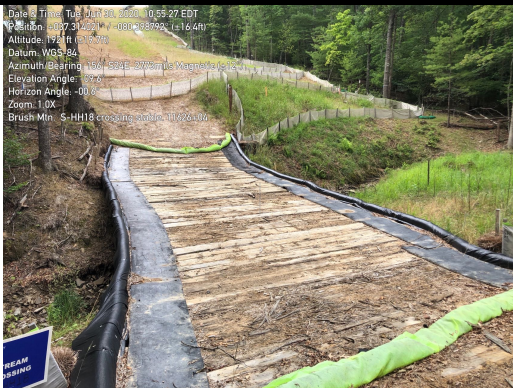
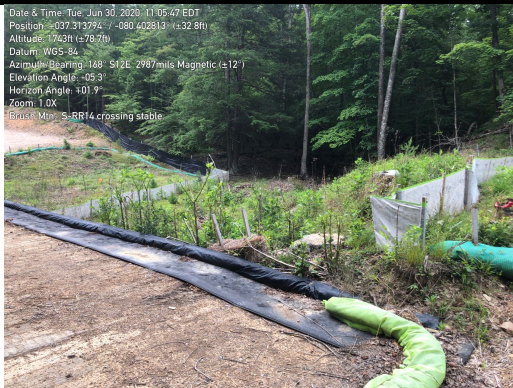
GPS Location		On photo		GPS Location		On photo	
Field Station#		11626+04		Field Station#		11614+20	
Pic 5 Desc.		S-HH18 crossing stable. Buffers and ECDs in good condition.		Pic 6 Desc.		S-RR14 crossing stable. Buffers and ECDs in good condition.

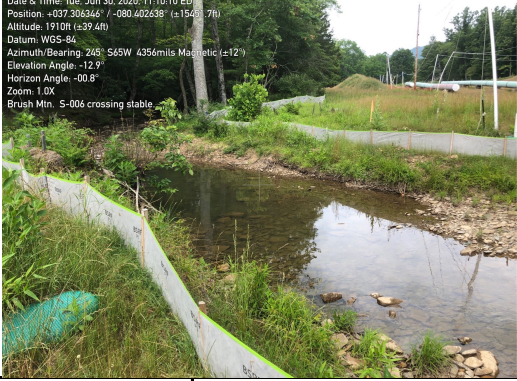
Insert image here	
<b>GPS Location</b>	On photo	<b>GPS Location</b>			
<b>Field Station#</b>	11608+17	<b>Field Station#</b>			
<b>Pic 7 Desc.</b>	S-006 crossing stable. Buffers and ECDs in good condition.	<b>Pic 8 Desc.</b>			
Insert image here		Insert image here			
<b>GPS Location</b>		<b>GPS Location</b>			
<b>Field Station#</b>		<b>Field Station#</b>			
<b>Pic 9 Desc.</b>		<b>Pic 10 Desc.</b>			
Insert image here		Insert image here

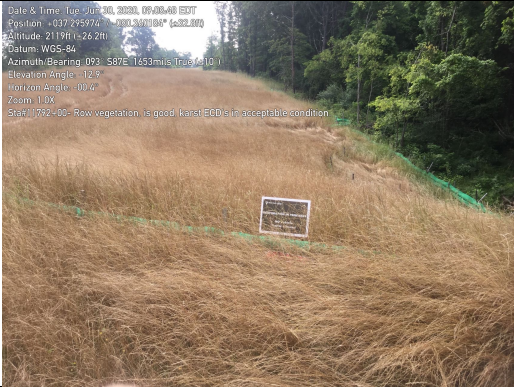
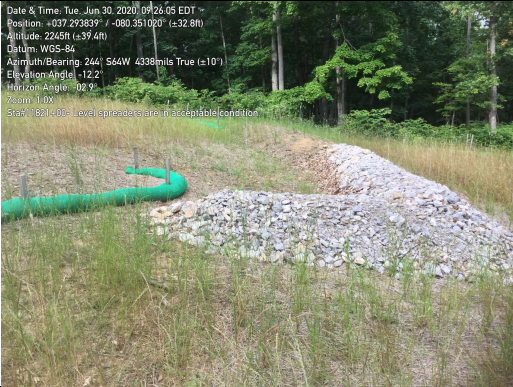
<b>GPS Location</b>	1	<b>GPS Location</b>	2		
<b>Field Station#</b>	11792+00	<b>Field Station#</b>	11821+00		
<b>Pic 1 Desc.</b>	Section of restored RoW showing karst feature controls functional.		<b>Pic 2 Desc.</b>	Water bar and level spreader functional.

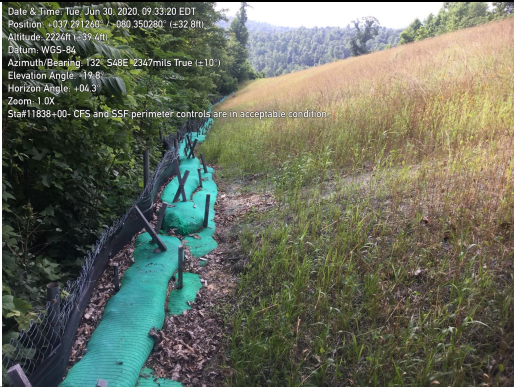
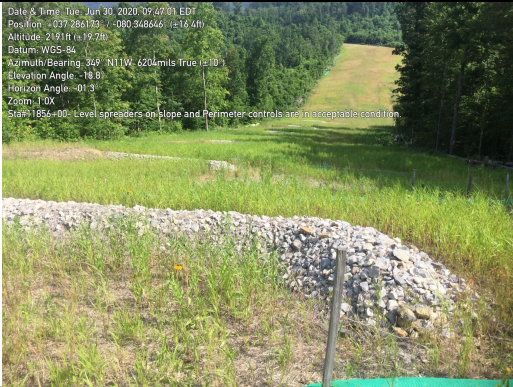
<b>GPS Location</b>	3	<b>GPS Location</b>	4		
<b>Field Station#</b>	11838+00	<b>Field Station#</b>	11856+00		
<b>Pic 3 Desc.</b>	Perimeter controls functional.		<b>Pic 4 Desc.</b>	Section of RoW showing conditions and controls.

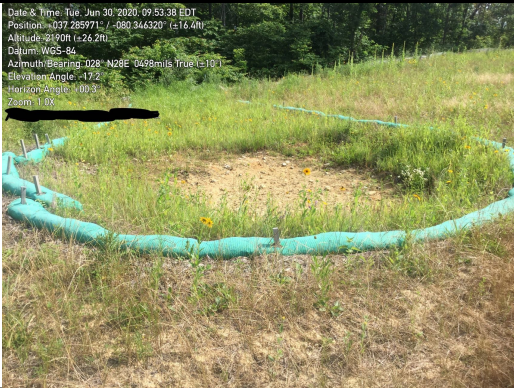
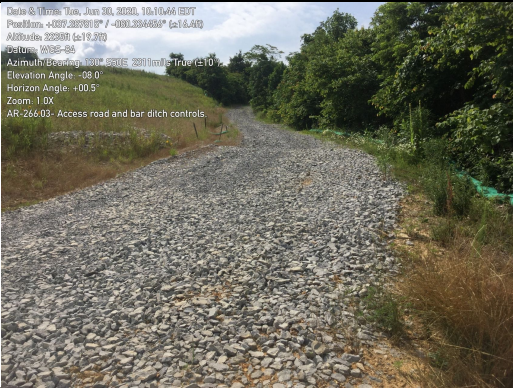
<b>GPS Location</b>	5	<b>GPS Location</b>	6		
<b>Field Station#</b>	11863+65	<b>Field Station#</b>	11899+99		
<b>Pic 5 Desc.</b>	P-KL2 and controls.		<b>Pic 6 Desc.</b>	AR 266.03 at intersection of RoW with functional controls.

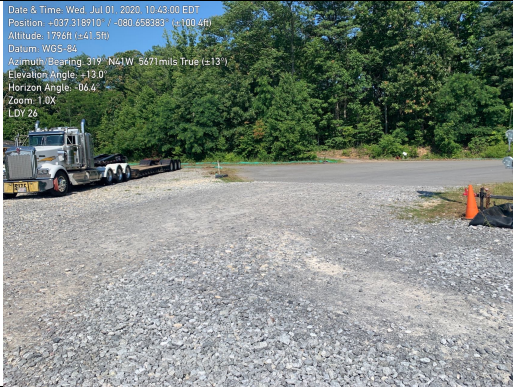
<p>Date &amp; Time: Wed Jul 01, 2020 10:45:00 EDT Position: +037 319310 / -080 658323 / (+100.4ft) Altitude: 1792ft (+100.4ft) Datum: WGS-84 Azimuth/Bearing: 312° N41W 5671mils True (+13.1°) Elevation Angle: +13.0° Horizon Angle: +06.4° Zoom: 1.0x LDY 26</p>			
<b>GPS Location</b>	See photo for GPS location.		<b>GPS Location</b>	See photo for GPS location.	
<b>Field Station#</b>	12005+00		<b>Field Station#</b>	12005+00	
<b>Pic 1 Desc.</b>	Triple stack compost filter sock in place around drainage.		<b>Pic 2 Desc.</b>	RCE in place at Lay Down Yard 26 entrance.

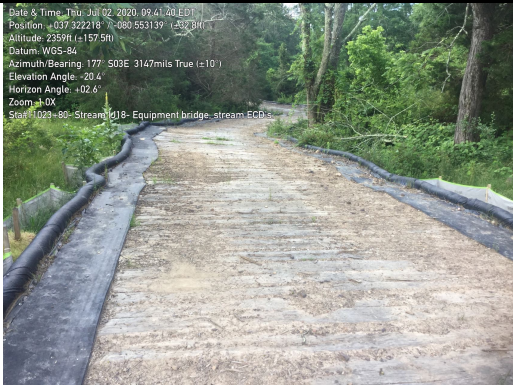
<p>Date &amp; Time: Thu Jul 02 2020 09:41:40 EDT Position: -037.322218° / -080.553139° (-037.322218° / -80.553139°) (NAD83) Altitude: 2359ft (+157.5m) Datum: WGS-84 Azimuth/Bearing: 177.503E 3147mils True (+10°) Elevation Angle: -20.4° Horizon Angle: +02.6° Zoom: 1.0X Sta#11023+80 - Stream S-IJ18 - Equipment bridge, stream ECD's</p>

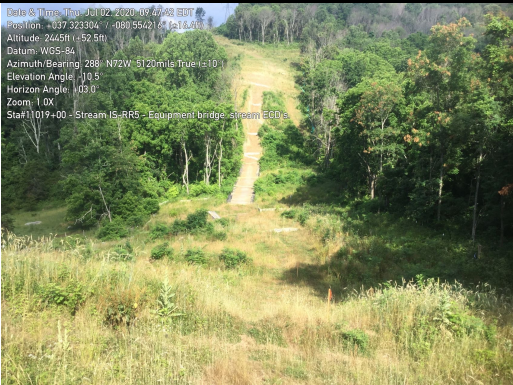
<p>Date &amp; Time: Thu Jul 02 2020 09:47:08 EDT Position: -037.322304° / -080.556216° (-037.322304° / -80.556216°) (NAD83) Altitude: 2465ft (+92.5m) Datum: WGS-84 Azimuth/Bearing: 288.922W 5120mils True (+10°) Elevation Angle: +10.5° Horizon Angle: +03.0° Zoom: 1.0X Sta#11019+00 - Stream S-RR5 - Equipment bridge, stream ECD's</p>			
GPS Location	See photo GPS		GPS Location	See photo GPS	
Field Station#	11023+80		Field Station#	11019+00	
Pic 1 Desc.	Stream S- IJ18, bridge, ECD's, buffers and signage.		Pic 2 Desc.	Stream S-RR5, equipment bridge, buffers signage are in acceptable condition.

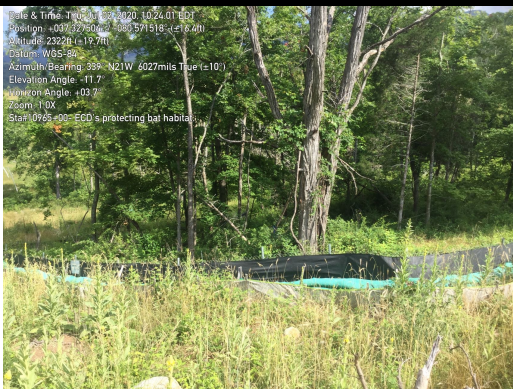
<p>Date &amp; Time: Thu Jul 02 2020 10:24:01 EDT Position: -037.322214° / -080.553139° (-037.322214° / -80.553139°) (NAD83) Altitude: 2320ft (+19.7m) Datum: WGS-84 Azimuth/Bearing: 395.921W 4027mils True (+10°) Elevation Angle: -11.7° Horizon Angle: +03.2° Zoom: 1.0X Sta#10965+00 - ECD's protecting bat habitat</p>

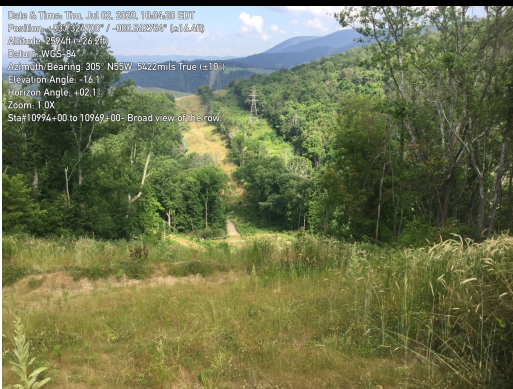
<p>Date &amp; Time: Thu Jul 02 2020 10:04:30 EDT Position: -037.322214° / -080.553139° (-037.322214° / -80.553139°) (NAD83) Altitude: 2364ft (+19.7m) Datum: WGS-84 Azimuth/Bearing: 305.933W 5422mils True (+10°) Elevation Angle: -16.1° Horizon Angle: +02.1° Zoom: 1.0X Sta#10994+00 to 10969+00 - Broad view of the row</p>			
GPS Location	See photo GPS		GPS Location	See photo GPS	
Field Station#	10965+00		Field Station#	10994+00	
Pic 3 Desc.	Bat habitat ECD's.		Pic 4 Desc.	Broad view of the row.

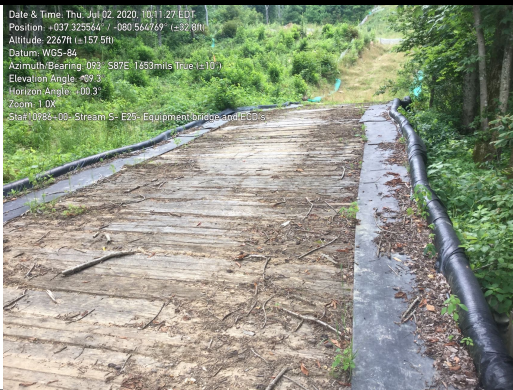
<p>Date &amp; Time: Thu Jul 02 2020 10:11:27 EDT Position: -037.322544° / -080.564769° (-037.322544° / -80.564769°) (NAD83) Altitude: 2267ft (+157.5m) Datum: WGS-84 Azimuth/Bearing: 034.587E 1833mils True (+10°) Elevation Angle: +09.3° Horizon Angle: +00.3° Zoom: 1.0X Sta#10986+00 - Stream S-E25- Equipment bridge and ECD's</p>

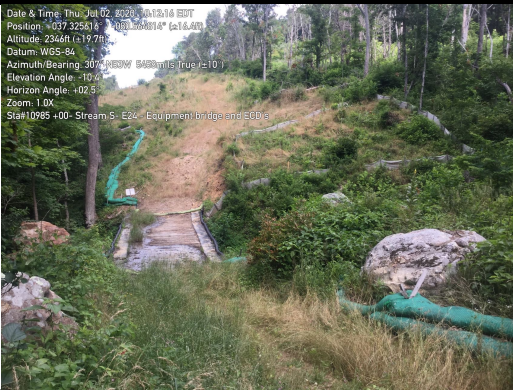
<p>Date &amp; Time: Thu Jul 02 2020 10:13:16 EDT Position: -037.322541° / -080.564769° (-037.322541° / -80.564769°) (NAD83) Altitude: 2364ft (+19.7m) Datum: WGS-84 Azimuth/Bearing: 307.933W 5433mils True (+10°) Elevation Angle: -10.0° Horizon Angle: +02.3° Zoom: 1.0X Sta#10985+00 - Stream S-E24- Equipment bridge and ECD's</p>

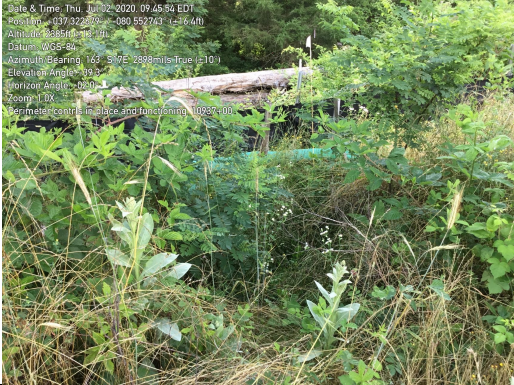
<p>Date &amp; Time: Thu, Jul 02, 2020, 09:45:54 EDT Position: +037.322707° / -080.552540° (±16.4ft) Altitude: 2403ft (±13.1ft) Datum: WGS-84 Azimuth/Bearing: 163° S 60E 233mils True (±10°) Elevation Angle: -15.6° Horizon Angle: -01.9° Zoom: 1.0X S-IJ16 crossing stable. ECDs in place. Equipment bridge appears in good condition. 10937+00</p>

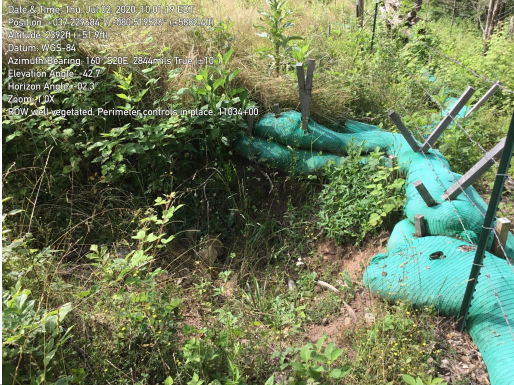
<p>Date &amp; Time: Thu, Jul 02, 2020, 10:11:31 EDT Position: +037.319000° / -080.550417° (±32.8ft) Altitude: 2312ft (±39.4ft) Datum: WGS-84 Azimuth/Bearing: 150° S 60E 234mils True (±10°) Elevation Angle: -42.7° Horizon Angle: -02.3° Zoom: 1.0X ROW well vegetated. Perimeter controls in place. 11034+00</p>

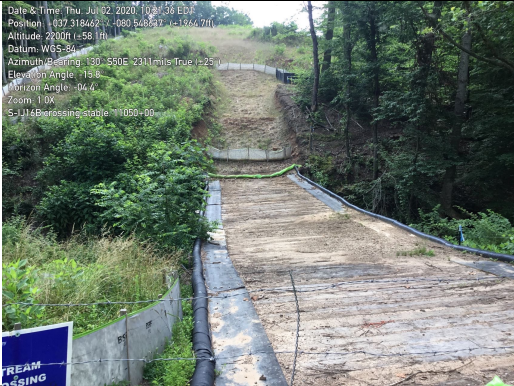
<p>Date &amp; Time: Thu, Jul 02, 2020, 10:51:38 EDT Position: +037.318445° / -080.545512° (±18.6ft) Altitude: 2095ft (±25.4ft) Datum: WGS-84 Azimuth/Bearing: 130° S 50E 231mils True (±25°) Elevation Angle: -15.6° Horizon Angle: -04.4° Zoom: 1.0X S-IJ16B crossing stable. 11050+00</p>

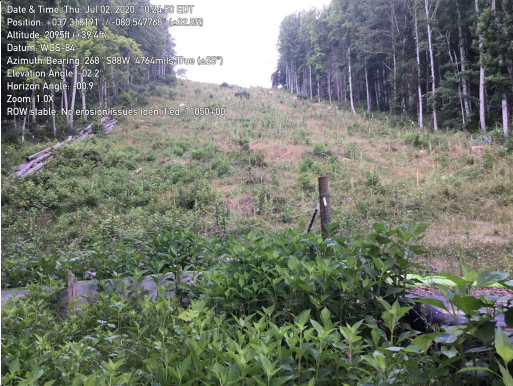
<p>Date &amp; Time: Thu, Jul 02, 2020, 10:51:38 EDT Position: +037.318445° / -080.545512° (±18.6ft) Altitude: 2095ft (±25.4ft) Datum: WGS-84 Azimuth/Bearing: 268° S 88W 474mils True (±35°) Elevation Angle: -02.2° Horizon Angle: -00.9° Zoom: 1.0X ROW stable. No erosion detected. Sedimented. 11050+00</p>			
<b>GPS Location</b>	On photo	<b>GPS Location</b>	On photo		
<b>Field Station#</b>	11050+00	<b>Field Station#</b>	11050+00		
<b>Pic 5 Desc.</b>	S-IJ16B crossing stable. Equipment mats to be checked by contractor for soundness.	<b>Pic 6 Desc.</b>	ROW well vegetated. Slope breakers effective. No erosion occurring.

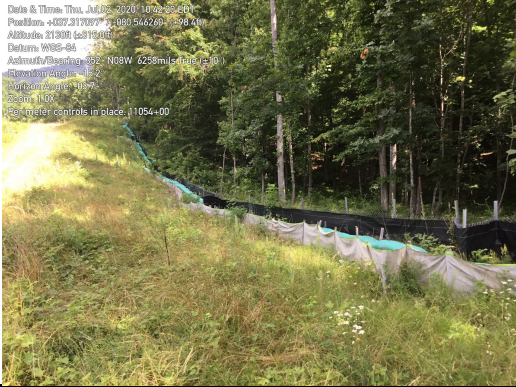
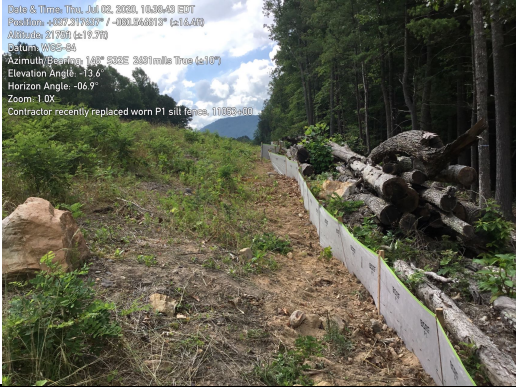
<b>GPS Location</b>	On photo	<b>GPS Location</b>	On photo		
<b>Field Station#</b>	11054+00	<b>Field Station#</b>	11053+00		
<b>Pic 7 Desc.</b>	Perimeter controls in place and in acceptable condition.	<b>Pic 8 Desc.</b>	Worn P1 silt fence was replaced in this area recently. No sediment movement discovered.

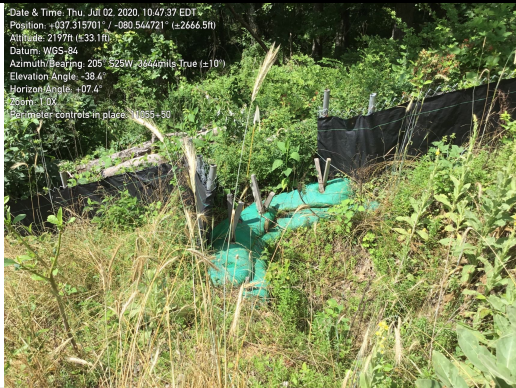
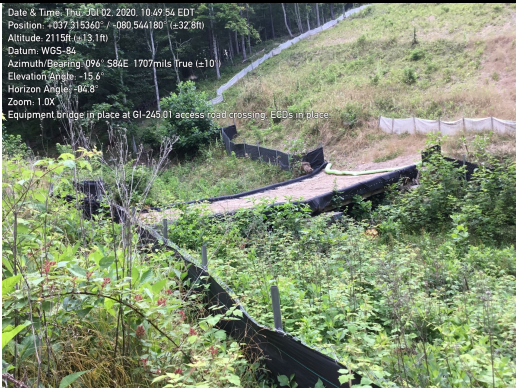
<b>GPS Location</b>	On photo	<b>GPS Location</b>	On photo		
<b>Field Station#</b>	11055+50	<b>Field Station#</b>	11064+53		
<b>Pic 9 Desc.</b>	End treatments are functioning as designed.	<b>Pic 10 Desc.</b>	Equipment bridge at access road GI-245.01. ROW stable with environmental controls in place.		
Insert image here		Insert image here			
<b>GPS Location</b>		<b>GPS Location</b>			
<b>Field Station#</b>		<b>Field Station#</b>			
<b>Pic 11 Desc.</b>		<b>Pic 12 Desc.</b>

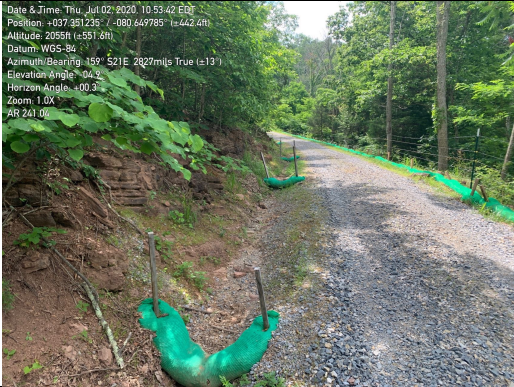
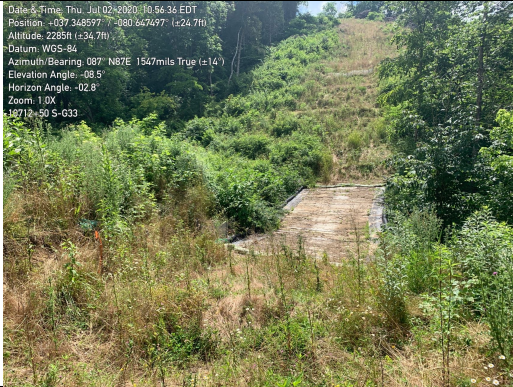
<b>GPS Location</b>	See photo for GPS location.		<b>GPS Location</b>	See photo for GPS location.	
<b>Field Station#</b>	10710+00		<b>Field Station#</b>	10712+50	
<b>Pic 1 Desc.</b>	Compost filter sock checks in place along access road 241.04 in bar ditch.		<b>Pic 2 Desc.</b>	Sensitive resource buffer in place at stream S-G33.

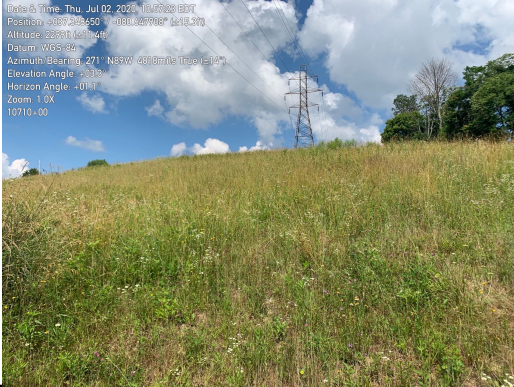
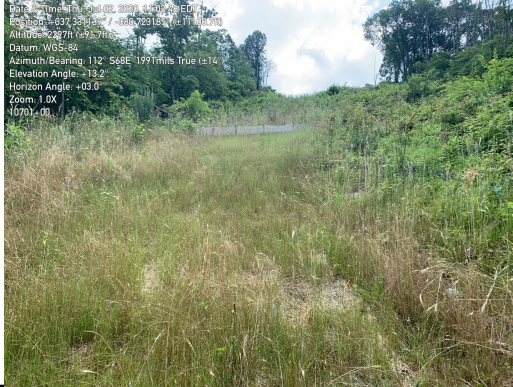
<b>GPS Location</b>	See photo for GPS location.		<b>GPS Location</b>	See photo for GPS location.	
<b>Field Station#</b>	10710+00		<b>Field Station#</b>	10701+00	
<b>Pic 3 Desc.</b>	ROW is stabilized with natural vegetation growth.		<b>Pic 4 Desc.</b>	ECB is stalled in travel lane with vegetation growth for stabilization.

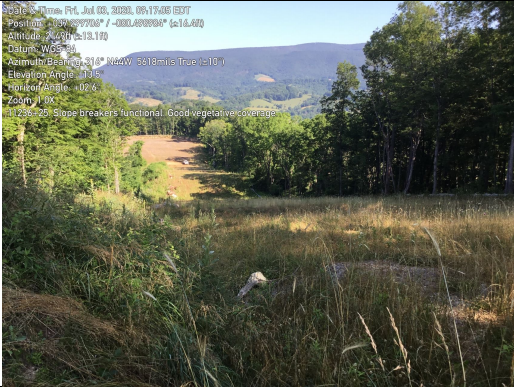
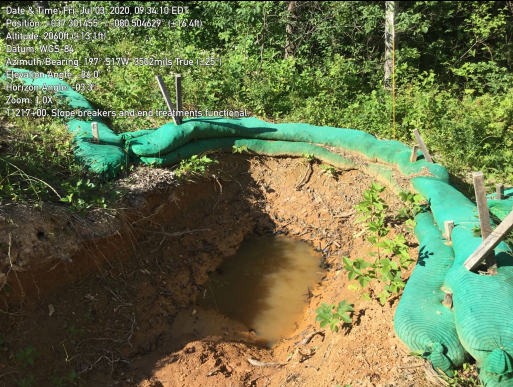
<b>GPS Location</b>	On photo	<b>GPS Location</b>	On photo		
<b>Field Station#</b>	11236+25	<b>Field Station#</b>	11217+00		
<b>Pic 1 Desc.</b>	ROW stable. Perimeter controls in place and working properly.	<b>Pic 2 Desc.</b>	End treatments effective

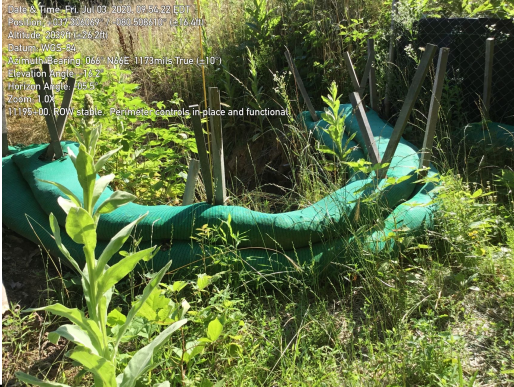
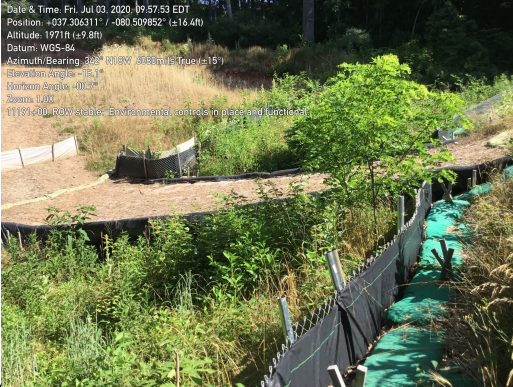
<b>GPS Location</b>	On photo	<b>GPS Location</b>	On photo		
<b>Field Station#</b>	11195+00	<b>Field Station#</b>	11191+00		
<b>Pic 3 Desc.</b>	Perimeter controls working as designed	<b>Pic 4 Desc.</b>	ROW stable. ECDs in place and effective.

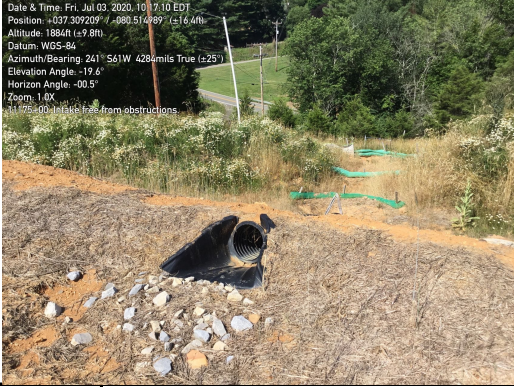
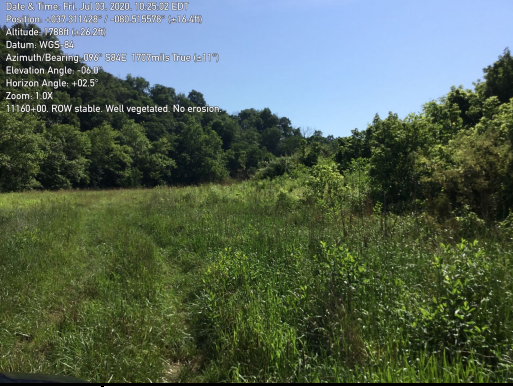
<b>GPS Location</b>	On photo	<b>GPS Location</b>	On photo		
<b>Field Station#</b>	11175+00	<b>Field Station#</b>	11160+00		
<b>Pic 5 Desc.</b>	Intake free from obstruction.	<b>Pic 6 Desc.</b>	ROW well vegetated and stable.

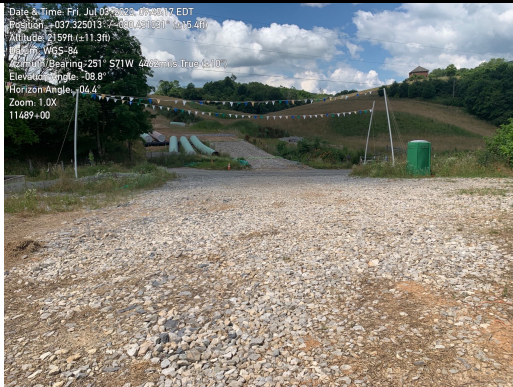
GPS Location		See photo for GPS location.						GPS Location		See photo for GPS location.	
Field Station#		11493+00						Field Station#		11489+00	
Pic 1 Desc.		Slope drain with rock inlet in place.						Pic 2 Desc.		RCE at Stevers Gap Road in place.

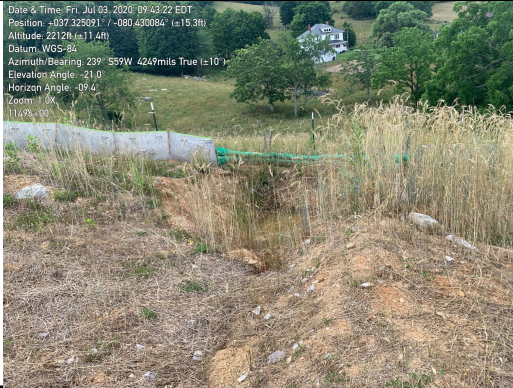
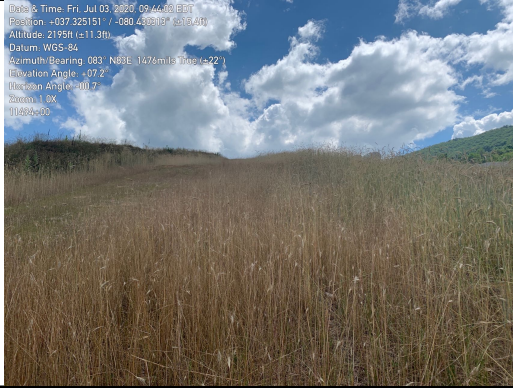
GPS Location		See photo for GPS location.						GPS Location		See photo for GPS location.	
Field Station#		11496+00						Field Station#		11494+00	
Pic 5 Desc.		Waterbar, sump pit, and waterbar end treatment in place.						Pic 6 Desc.		ROW is stabilized with thick vegetation growth.
