Visual Site Inspection Report

Project Name	H-600 Pipeline Spread G	AFE	124300137	Spread	H-600 Pipeline Spread G
Contractor	Precision			Report #	12639
Inspector	Len Kruizenga			Date/Time	7/13/2020 8:56 AM
Permit #	TBD	Inspection Type	VA SWPP	Station Begin	12005+00
State	VA	Inspection Area	Full	Station End	12005+00
County	Giles	Ground	Wet	Temperature (°F)	80.00
Municipality	N/A	Weather	Sunny	Rain Gauge (in)	0.10
				Rain Accumulation Time (days)	1.00

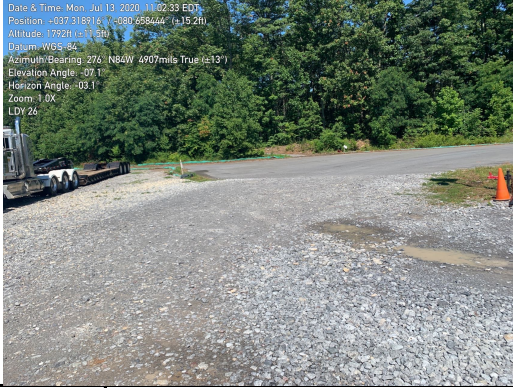
<p>Date & Time: Mon, Jul 13, 2020, 11:02:33 EDT Position: +037 319241 / -080 658444 (+135.2ft) Altitude: 1792ft (+52.8ft) Datum: WGS 84 Azimuth/Bearing: 276° N84W 4907mils True (+13°) Elevation Angle: -07.1° Horizon Angle: -03.1° Zoom: 1.0X LDY 26</p>			
GPS Location	See photo for GPS location.		GPS Location	See photo for GPS location.	
Field Station#	12005+00		Field Station#	12005+00	
Pic 1 Desc.	Triple stack compost filter sock in place around drainage.		Pic 2 Desc.	RCE in place at LDY 26 entrance.

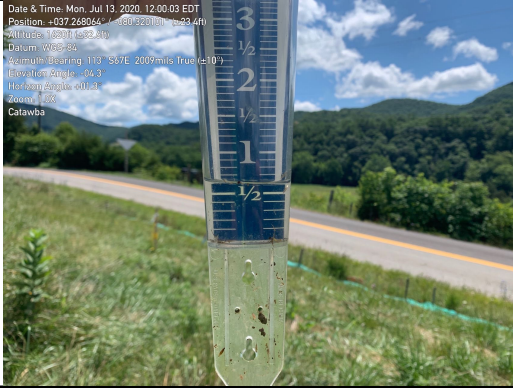
<p>Date & Time: Mon, Jul 13, 2020, 12:00:03 EDT Position: +037 248244 / -080 528101 (+53.4ft) Altitude: 2015ft (+61.6ft) Datum: WGS 84 Azimuth/Bearing: 113° S07E 2009mils True (+10°) Elevation Angle: -06.3° Horizon Angle: -00.1° Zoom: 1.0X Catawba</p>			
GPS Location	See photo for GPS location.		GPS Location	See photo for GPS location.	
Field Station#	11767+00		Field Station#	11990+00	
Pic 5 Desc.	Rain gauge at Mount Tabor Road reads 0.4 inches.		Pic 6 Desc.	Rain gauge at Catawba Road reads 0.6 inches.

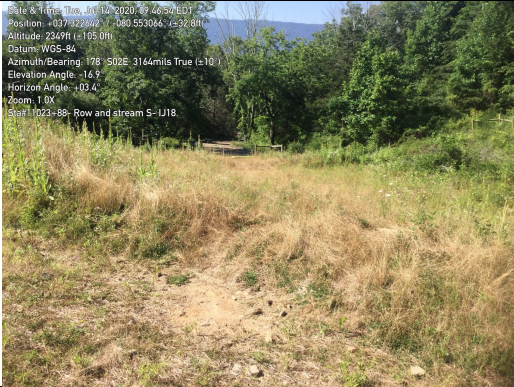
<p>Date & Time: Tue, Jul 14, 2020, 07:46:52 EDT Position: +43°13'22.94"N / -70°55'30.64"W (+32.8m) Altitude: 2349ft (+105.0m) Datum: WGS-84 Azimuth/Bearing: 178 S02E 314mils True (±10°) Elevation Angle: -16.7° Horizon Angle: -10.4° Zoom: 1.0x Sta# 11023+88- Row and stream S-IJ18</p>

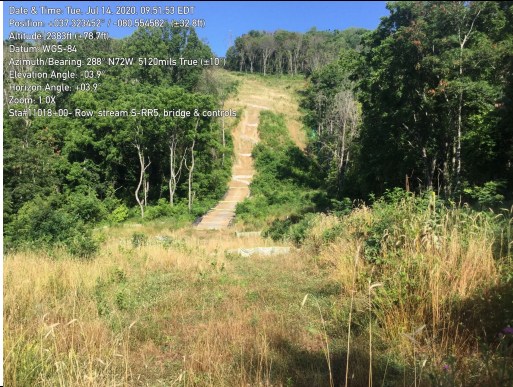
<p>Date & Time: Tue, Jul 14, 2020, 09:51:53 EDT Position: +43°13'01.65"N / -70°46'40.21"W (+32.8m) Altitude: 2335ft (+70.3m) Datum: WGS-84 Azimuth/Bearing: 288 N72W 512mils True (±10°) Elevation Angle: -03.9° Horizon Angle: -10.9° Zoom: 1.0x Sta# 11018+00- Row stream S-RR5, bridge & controls</p>			
GPS Location	See photo GPS	GPS Location	See photo GPS		
Field Station#	11023+88	Field Station#	11018+00		
Pic 1 Desc.	Row and stream S-IJ18	Pic 2 Desc.	Row, stream S- RR5 equipment bridge and stream controls.

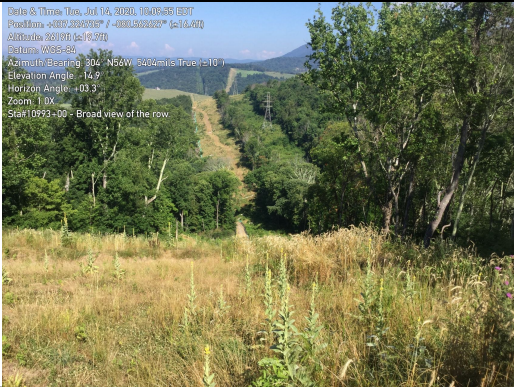
<p>Date & Time: Tue, Jul 14, 2020, 10:16:45 EDT Position: +43°13'22.94"N / -70°55'30.64"W (+32.8m) Altitude: 2349ft (+105.0m) Datum: WGS-84 Azimuth/Bearing: 304 N56W 504mils True (±10°) Elevation Angle: -14.9° Horizon Angle: -10.3° Zoom: 1.0x Sta# 10993+00- Broad view of the row</p>

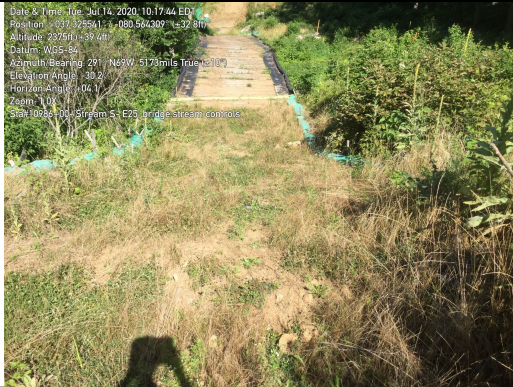
<p>Date & Time: Tue, Jul 14, 2020, 10:17:44 EDT Position: +43°13'22.94"N / -70°55'30.64"W (+32.8m) Altitude: 2375ft (+72.4m) Datum: WGS-84 Azimuth/Bearing: 291 N69W 517mils True (±10°) Elevation Angle: -10.2° Horizon Angle: -10.1° Zoom: 1.0x Sta# 10986+00- Stream S- E25, bridge stream controls</p>

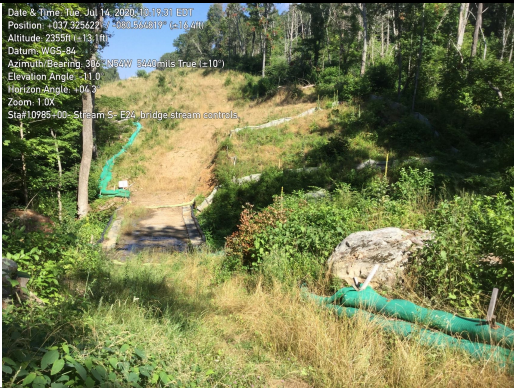
<p>Date & Time: Tue, Jul 14, 2020, 10:19:51 EDT Position: +43°13'22.94"N / -70°55'30.64"W (+32.8m) Altitude: 2350ft (+72.1m) Datum: WGS-84 Azimuth/Bearing: 305 N56W 504mils True (±10°) Elevation Angle: -11.0° Horizon Angle: -10.3° Zoom: 1.0x Sta# 10985+00- Stream S- E24, bridge stream controls</p>

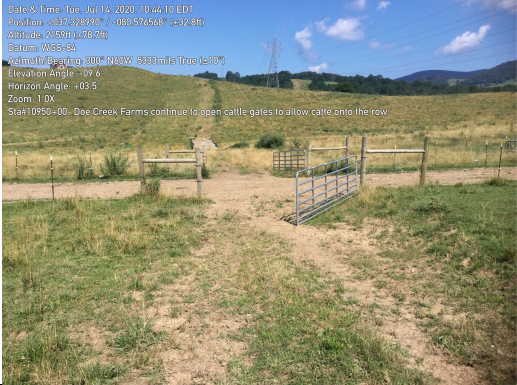
GPS Location	See photo GPS	GPS Location			
Field Station#	10950+00	Field Station#			
Pic 7 Desc.	Doe Creek Farms continues to open cattle gates to allow cattle onto row.	Pic 8 Desc.			
Insert image here		Insert image here			
GPS Location		GPS Location			
Field Station#		Field Station#			
Pic 9 Desc.		Pic 10 Desc.			
Insert image here		Insert image here			
GPS Location		GPS Location			
Field Station#		Field Station#			
Pic 11 Desc.		Pic 12 Desc.

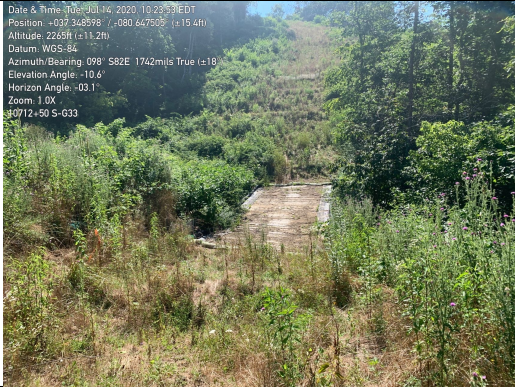
<p>Date & Time: Tue, Jul 14, 2020 10:23:59 EDT Position: +037.345978, -080.647505 (+15.4ft) Altitude: 2265ft (+11.2ft) Datum: WGS-84 Azimuth/Bearing: 098° S82E 1742mils True (+18°) Elevation Angle: +10.6° Horizon Angle: +03.1° Zoom: 1.0X 10712+50 S-G33</p>			
GPS Location	See photo for GPS location.		GPS Location	See photo for GPS location.	
Field Station#	10750+00		Field Station#	10712+50	
Pic 1 Desc.	ROW is stabilized with natural vegetation.		Pic 2 Desc.	Sensitive resource buffer in place at stream S-G33.

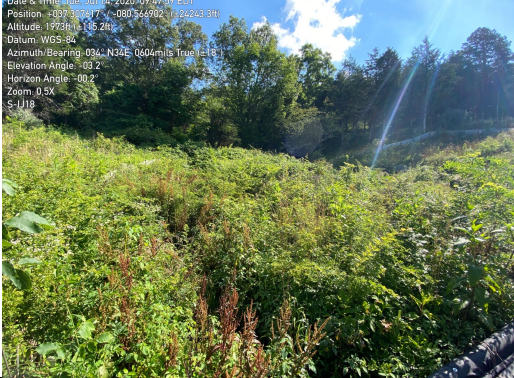
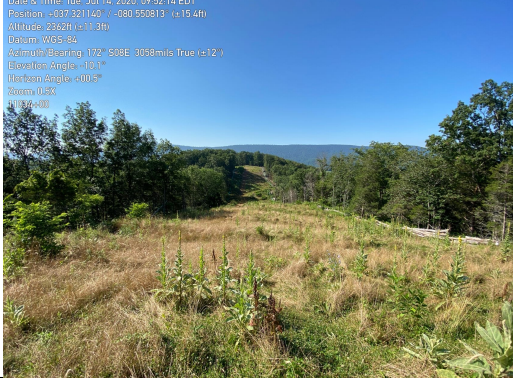
GPS Location	1	GPS Location	2		
Field Station#	11025+50	Field Station#	11034+00		
Pic 1 Desc.	S-IJ18 and controls.	Pic 2 Desc.	Section of RoW showing conditions and controls.		
<p>Date & Time: Tue Jul 14, 2020 10:10:38 EDT Position: +037.311421, -080.541928 (+15.44ft) Altitude: 2150ft (+10.82ft) Datum: WGS-84 Azimuth/Bearing: 035.1 N35E 0597mils True (+12.1) Elevation Angle: +03.7 Horizon Angle: +00.6 Zoom: 0.5X S-IJ16B/S-IJ17</p>

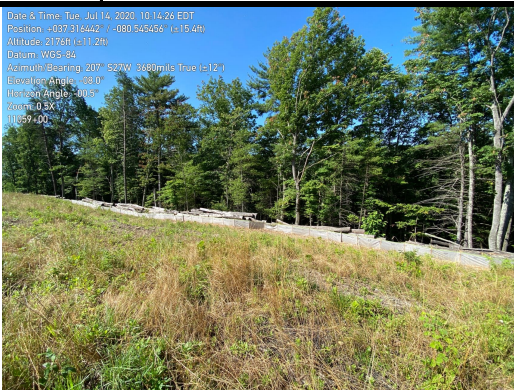
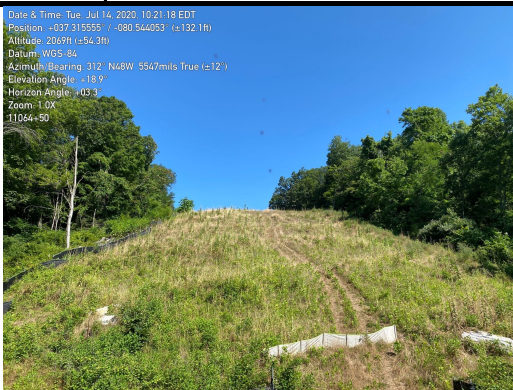
GPS Location	5	GPS Location	6		
Field Station#	11059+00	Field Station#	11064+50		
Pic 5 Desc.	Perimeter controls functional.	Pic 6 Desc.	Section of RoW showing conditions and controls.

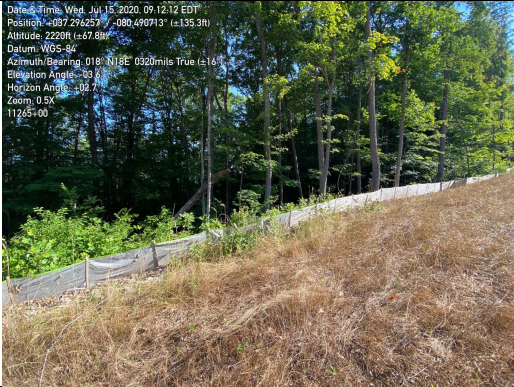
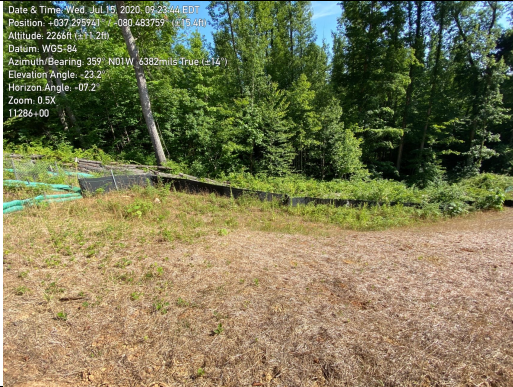
GPS Location	1	GPS Location	2		
Field Station#	11265+00	Field Station#	11286+00		
Pic 1 Desc.	Perimeter controls functional.	Pic 2 Desc.	Perimeter controls functional.

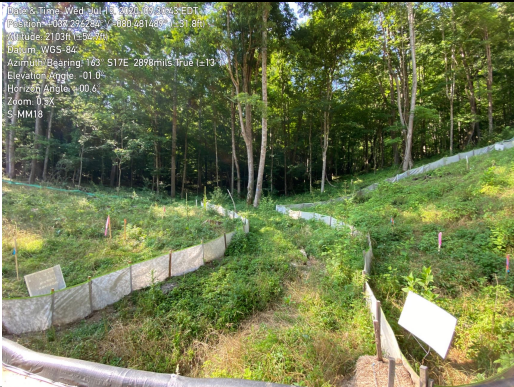
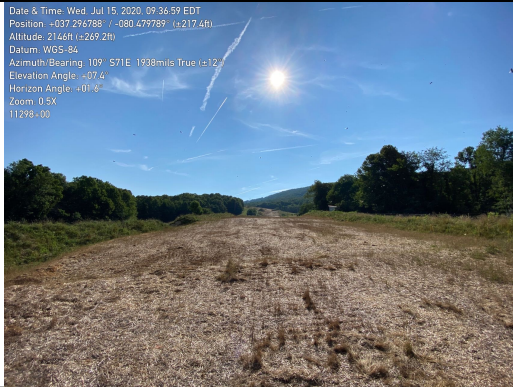
GPS Location	3	GPS Location	4		
Field Station#	11292+80	Field Station#	11298+00		
Pic 3 Desc.	S-MM18 and controls.	Pic 4 Desc.	Section of RoW showing conditions.

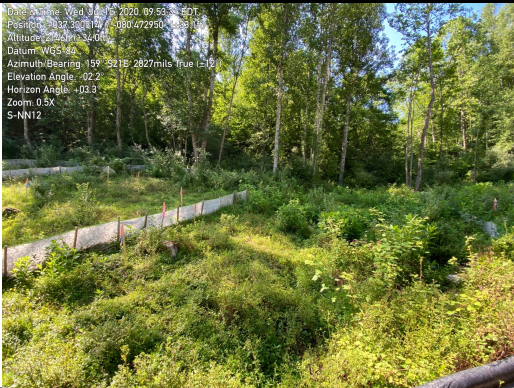
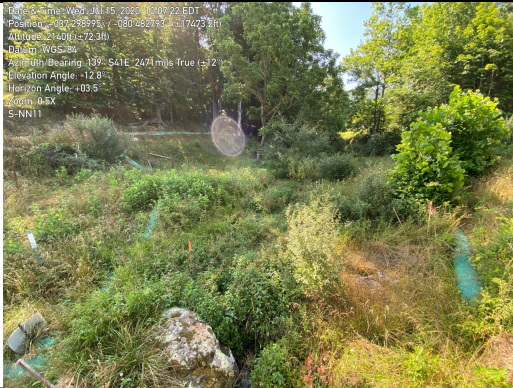
GPS Location	5	GPS Location	6		
Field Station#	11327+85	Field Station#	11352+97		
Pic 5 Desc.	S-NN12 and controls.	Pic 6 Desc.	S-NN11 and controls.

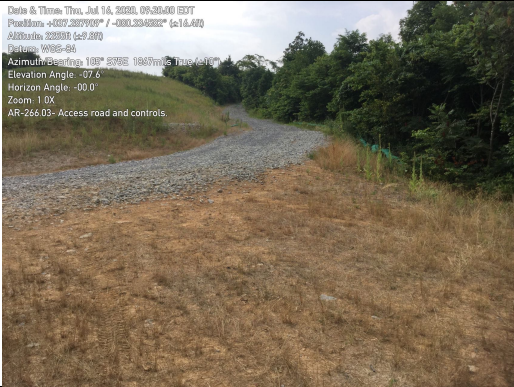
<p>Date & Time: Thu, Jul 16, 2020, 09:50:00 EDT Position: +037.207993° / -080.327591° (+16.4ft) Altitude: 2215ft (+26.2ft) Datum: WGS-84 Azimuth Bearing: 180° 57'00" 3022mils True (+10°) Elevation Angle: -07.6° Horizon Angle: -00.0° Zoom: 1.0X Sta#11905+00- Access road and controls.</p>

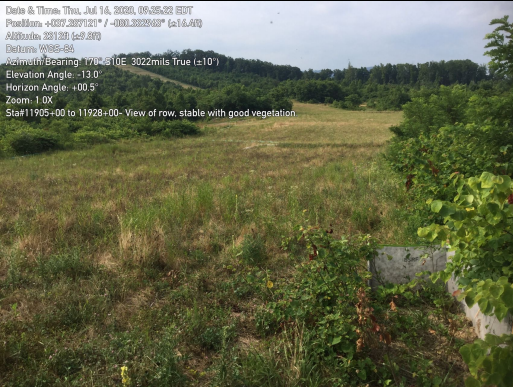
<p>Date & Time: Thu, Jul 16, 2020, 09:55:00 EDT Position: +037.207993° / -080.327591° (+16.4ft) Altitude: 2215ft (+26.2ft) Datum: WGS-84 Azimuth Bearing: 170° 5'10" 3022mils True (+10°) Elevation Angle: -13.0° Horizon Angle: +00.5° Zoom: 1.0X Sta#11905+00 to 11928+00- View of row, stable with good vegetation.</p>			
GPS Location	See photo GPS		GPS Location	See photo GPS	
Field Station#	11900+00		Field Station#	11905+00	
Pic 1 Desc.	AR-266.03- Access road and controls.		Pic 2 Desc.	Sta#11905 to 11928+00- View of row, stable with good vegetation.

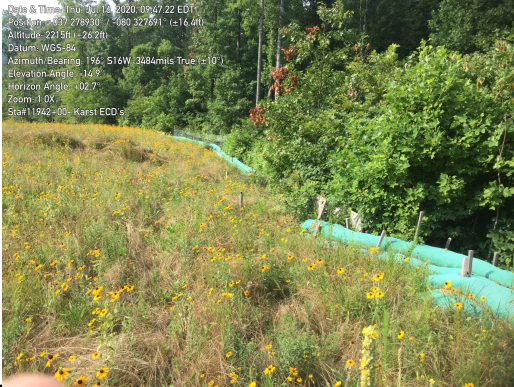
<p>Date & Time: Thu, Jul 16, 2020, 09:47:22 EDT Position: +037.278993° / -080.327591° (+16.4ft) Altitude: 2215ft (+26.2ft) Datum: WGS-84 Azimuth Bearing: 154° 51'40" 3024mils True (+10°) Elevation Angle: -14.7° Horizon Angle: +02.7° Zoom: 1.0X Sta#11942+00- Karst ECD's.</p>

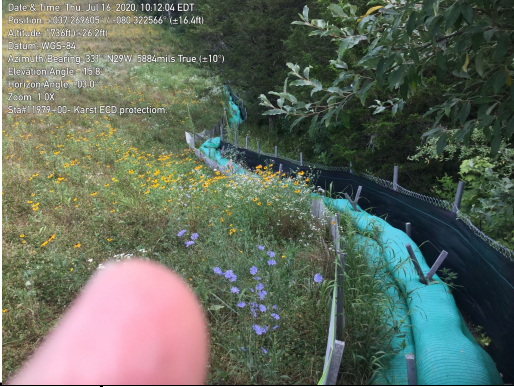
<p>Date & Time: Thu, Jul 16, 2020, 10:12:04 EDT Position: +037.283093° / -080.322566° (+16.4ft) Altitude: 1930ft (+26.2ft) Datum: WGS-84 Azimuth Bearing: 331° 23'50" 3024mils True (+10°) Elevation Angle: -15.8° Horizon Angle: +01.0° Zoom: 1.0X Sta#11979+00- Karst ECD protection.</p>

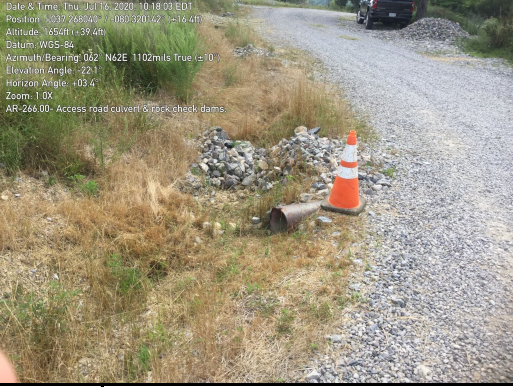
<p>Date & Time: Thu, Jul 16, 2020, 10:18:03 EDT Position: +037.283093° / -080.320162° (+16.4ft) Altitude: 1650ft (+39.4ft) Datum: WGS-84 Azimuth Bearing: 062° N42E 1102mils True (+10°) Elevation Angle: -22.1° Horizon Angle: +09.4° Zoom: 1.0X AR-266.00- Access road culvert & rock check dams.</p>
