Visual Site Inspection Report

Project Name	H-600 Pipeline Spread G	AFE	124300137	Spread	H-600 Pipeline Spread G
Contractor	Precision			Report #	12991
Inspector	Chris Burns			Date/Time	7/27/2020 8:00 AM
Permit #	TBD	Inspection Type	VA SWPP	Station Begin	11254+99
State	VA	Inspection Area	Partial	Station End	11353+67
County	Giles	Ground	Wet	Temperature (°F)	88.00
Municipality	N/A	Weather	Sunny	Rain Gauge (in)	0.25
				Rain Accumulation Time (days)	1.00

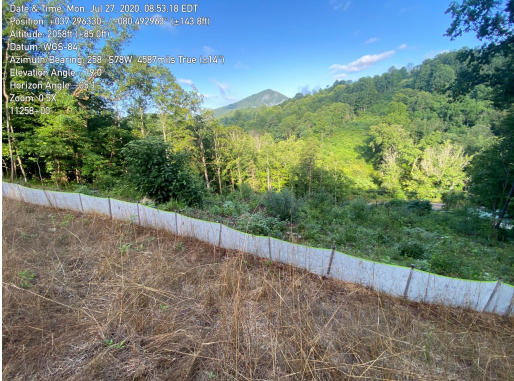
GPS Location	1	GPS Location	2		
Field Station#	11258+00	Field Station#	11263+00		
Pic 1 Desc.	Section of RoW showing conditions and controls.	Pic 2 Desc.	Perimeter controls functional.

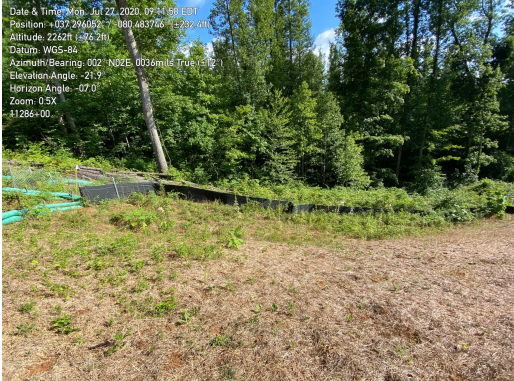
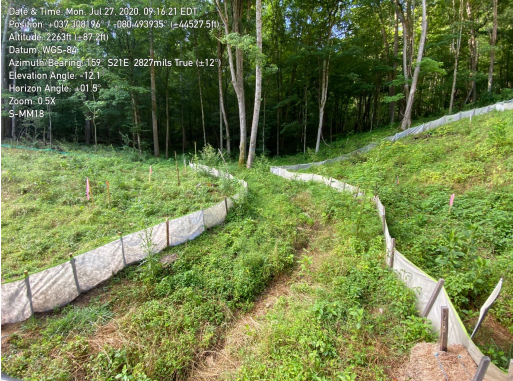
GPS Location	3	GPS Location	4		
Field Station#	11286+00	Field Station#	11292+80		
Pic 3 Desc.	Perimeter controls functional.	Pic 4 Desc.	S-MM18 and controls.

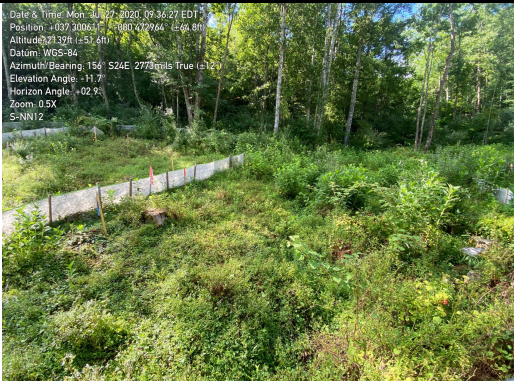
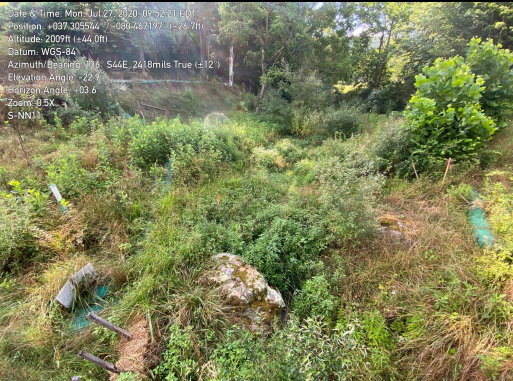
GPS Location	5	GPS Location	6		
Field Station#	11327+85	Field Station#	11352+97		
Pic 5 Desc.	S-NN12 and controls.	Pic 6 Desc.	S-NN11 and controls.

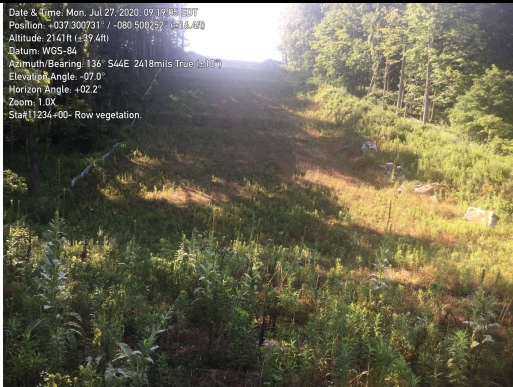
<p>Date & Time: Mon, Jul 27, 2020, 09:19:06 EDT Position: +037.300721° / -080.509257° (±16.1ft) Altitude: 2141ft (±39.4ft) Datum: WGS-84 Azimuth/Bearing: 136° S44E 2418mils True (±10°) Elevation Angle: -07.0° Horizon Angle: +02.2° Zoom: 1.0x Sta# 11234+00 - Row vegetation.</p>

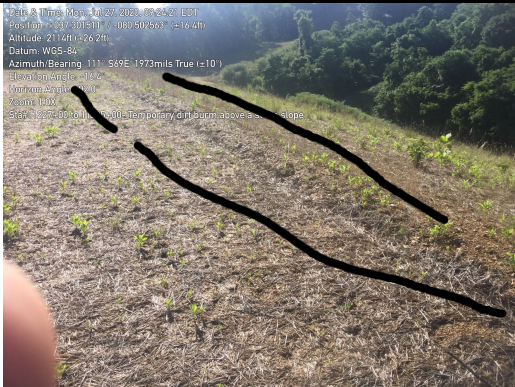
<p>Date & Time: Mon, Jul 27, 2020, 09:24:21 EDT Position: +037.301015° / -080.509203° (±16.4ft) Altitude: 2114ft (±39.2ft) Datum: WGS-84 Azimuth/Bearing: 111° S49E 1973mils True (±10°) Elevation Angle: -14.0° Horizon Angle: +0.0° Zoom: 1.0x Sta# 11224+00 - Temporary dirt berm above steep slope.</p>			
GPS Location	See photo GPS		GPS Location	See photo GPS	
Field Station#	11234+00		Field Station#	11224+00	
Pic 1 Desc.	Row vegetation		Pic 2 Desc.	Temporary dirt berm above steep slope.

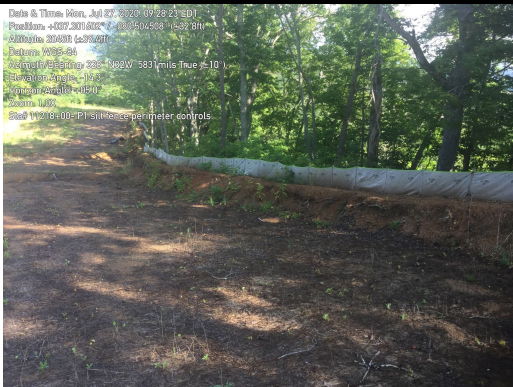
<p>Date & Time: Mon, Jul 27, 2020, 09:28:21 EDT Position: +037.301602° / -080.504568° (±16.2ft) Altitude: 2040ft (±39.0ft) Datum: WGS-84 Azimuth/Bearing: 235° N89W 583mils True (±10°) Elevation Angle: -15.5° Horizon Angle: +0.0° Zoom: 1.0x Sta# 11218+00 - Silt fence perimeter controls.</p>

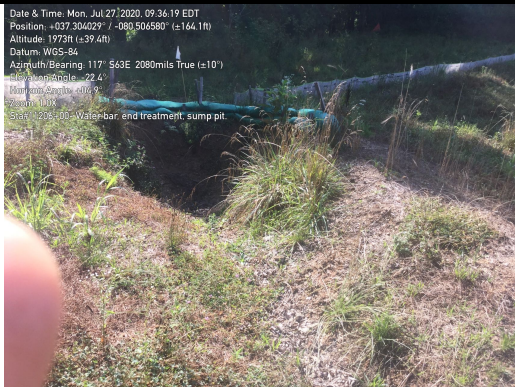
<p>Date & Time: Mon, Jul 27, 2020, 09:36:19 EDT Position: +037.304029° / -080.506580° (±16.4ft) Altitude: 1973ft (±39.4ft) Datum: WGS-84 Azimuth/Bearing: 117° S43E 2080mils True (±10°) Elevation Angle: -22.4° Horizon Angle: +0.0° Zoom: 1.0x Sta# 11206+00 - Water bar, end treatment, sump pit.</p>

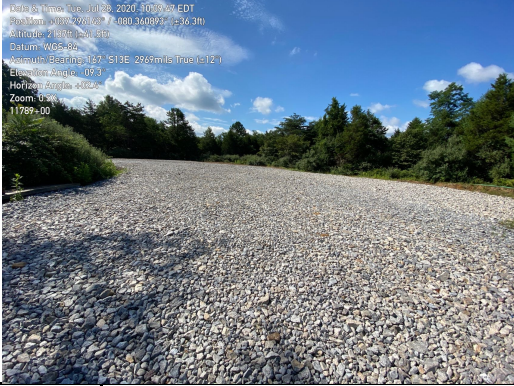
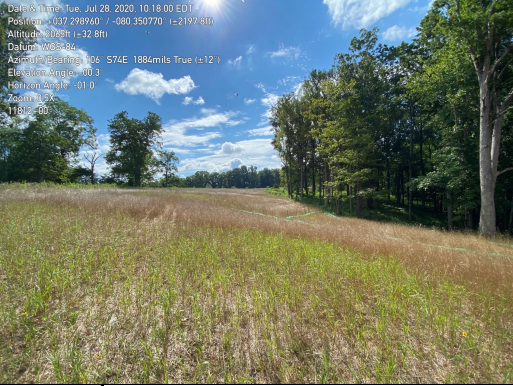
GPS Location	1	GPS Location	2		
Field Station#	11789+00	Field Station#	11812+00		
Pic 1 Desc.	RCE on the South side of Mt Tabor rd.	Pic 2 Desc.	Section of restored RoW showing conditions and controls.

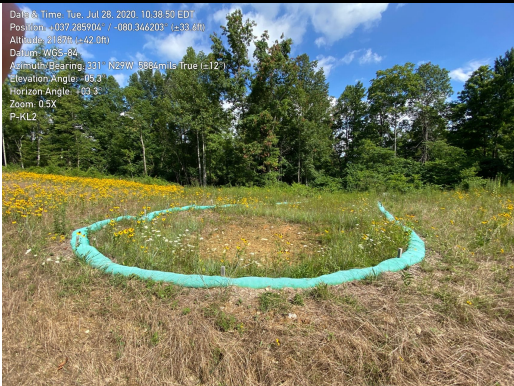
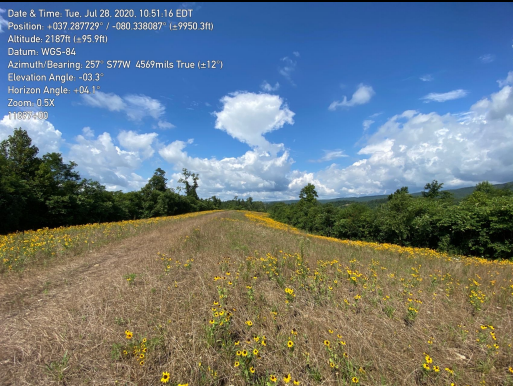
GPS Location	5	GPS Location	6		
Field Station#	11863+65	Field Station#	11897+00		
Pic 5 Desc.	P-KL2 and controls.	Pic 6 Desc.	Section of restored RoW showing conditions and controls.

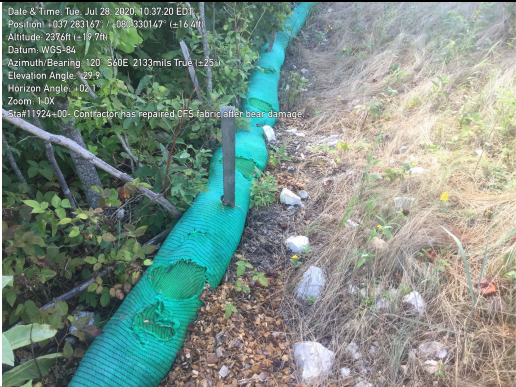
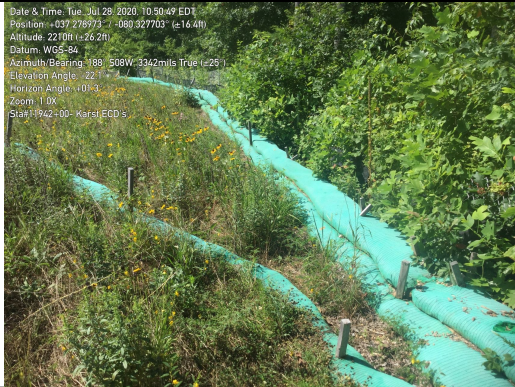
GPS Location	See photo GPS	GPS Location	See photo GPS		
Field Station#	11924+00	Field Station#	11942+00		
Pic 3 Desc.	The contractor has made repairs to the CFS perimeter controls damaged by bear.	Pic 4 Desc.	Karst ECD's		
<p>Date & Time: Tue, Jul 28, 2020, 10:55:14 EDT Position: +037.277469 / -080.326803 (-16.4ft) Altitude: 2061ft (-157.5ft) Datum: WGS-84 Azimuth/Bearing: 165° S15E 2933mils True (±25°) Elevation Angle: -27.5° Horizon Angle: +03.5° Zoom: 1.0X Start 11949+00- Water bars & tree vegetation is very good</p>

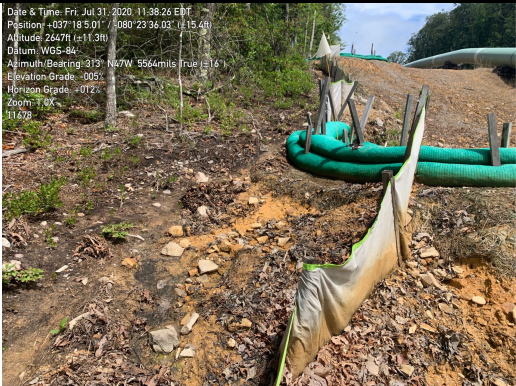
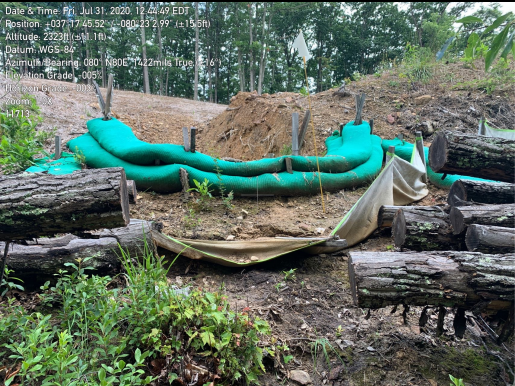
GPS Location		See picture above for GPS coordinates		GPS Location	
Field Station#		11677+00		Field Station#	
Pic 5 Desc.		Sediment off row		Pic 6 Desc.	
				Damaged P1 added to PL

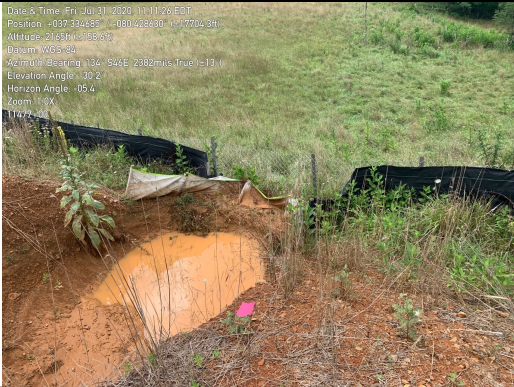
GPS Location	See photo for GPS location.		GPS Location	See photo for GPS location.	
Field Station#	11477+00		Field Station#	11441+00	
Pic 3 Desc.	Overtopped priority one silt fence. Item added to the punchlist.		Pic 4 Desc.	Hole in priority one silt fence. Item added to the punchlist.

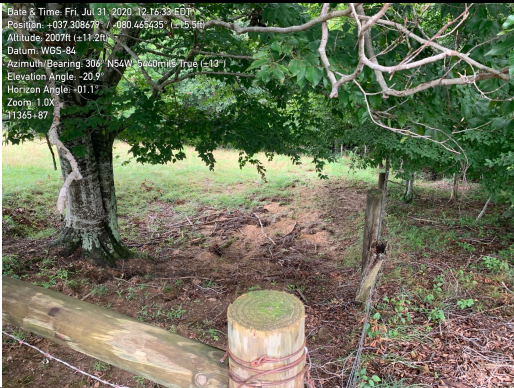
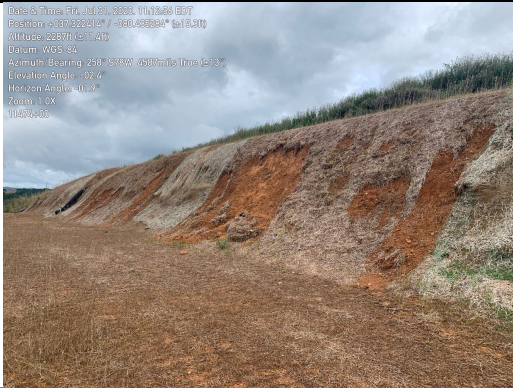
GPS Location	See photo for GPS location.		GPS Location	See photo for GPS location.	
Field Station#	11365+87		Field Station#	11747+00	
Pic 5 Desc.	Off ROW sediment reported and added to the punchlist.		Pic 6 Desc.	ECB needs replaced due to sloughing of two-tone. Item added to the punchlist.
