# Visual Site Inspection Report

<b>Project Name</b>	H-600 Pipeline Spread G	<b>AFE</b>	124300137	<b>Spread</b>	H-600 Pipeline Spread G
<b>Contractor</b>	Precision			<b>Report #</b>	13489
<b>Inspector</b>	Garrett Barclay			<b>Date/Time</b>	8/10/2020 8:23 AM
<b>Permit #</b>	TBD	<b>Inspection Type</b>	VA SWPP	<b>Station Begin</b>	12005+00
<b>State</b>	VA	<b>Inspection Area</b>	Partial	<b>Station End</b>	12005+00
<b>County</b>	Giles	<b>Ground</b>	Damp	<b>Temperature (°F)</b>	82.00
<b>Municipality</b>	N/A	<b>Weather</b>	Sunny	<b>Rain Gauge (in)</b>	0.00
				<b>Rain Accumulation Time (days)</b>	1.00

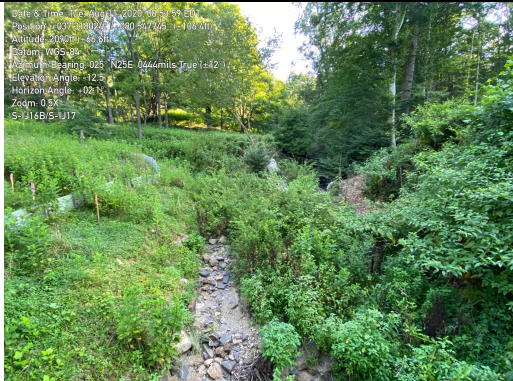
<b>GPS Location</b>	3	<b>GPS Location</b>	4		
<b>Field Station#</b>	11034+00	<b>Field Station#</b>	11050+10		
<b>Pic 3 Desc.</b>	Section of RoW showing conditions and controls.	<b>Pic 4 Desc.</b>	S-IJ16B/S-IJ17 and controls.

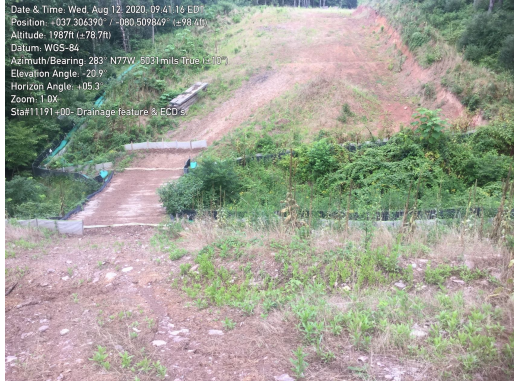
<b>GPS Location</b>	See photo GPS	<b>GPS Location</b>	See photo GPS		
<b>Field Station#</b>	11201+00	<b>Field Station#</b>	11191+00		
<b>Pic 3 Desc.</b>	Water bars on slope.	<b>Pic 4 Desc.</b>	Drainage feature and ECD's		
<p>Date &amp; Time: Wed Aug 12, 2020, 09:45:00 EDT  Position: +037.306414° / -080.507807° (+32.8m)  Altitude: 2030ft (+315.6ft)  Datum: WGS-84  Azimuth/Bearing: 224° S26W 4018mils Tr  Elevation Angle: -36.2  Horizon Angle: +13.2  Zoom: 1.0X  Sta#11191+00- Drainage feature &amp; ECD's  P1 stakes broken off</p>

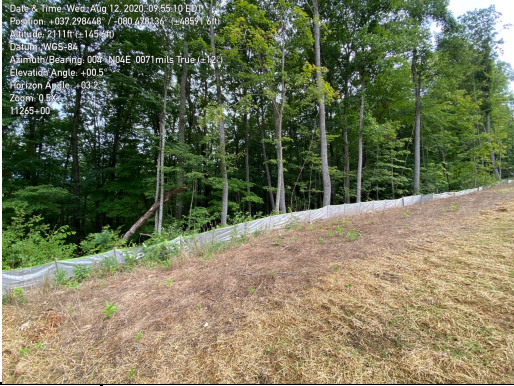
<b>GPS Location</b>	1	<b>GPS Location</b>	2		
<b>Field Station#</b>	11265+00	<b>Field Station#</b>	11286+50		
<b>Pic 1 Desc.</b>	Perimeter controls functional.		<b>Pic 2 Desc.</b>	Perimeter controls functional.

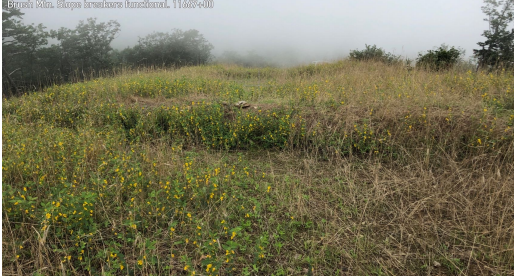
<p>Date &amp; Time: Thu, Aug 13, 2020, 09:30:43 EDT  Position: +482.29599° / -880.39599° (+14.47)  Altitude: 2220 (+19.37)  Datum: WGS-84  Azimuth/Bearing: 179° 501E 3162mils Magnetic (+15°)  Elevation Angle: 23.6°  Horizon Angle: -08.4°  Zoom: 1.0x  Brush Min. Slope breakers functional, 11662+00</p>

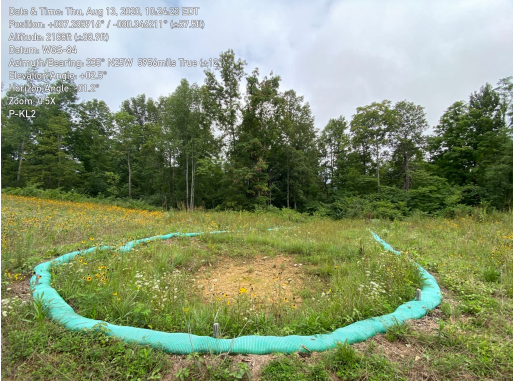
<b>GPS Location</b>	3	<b>GPS Location</b>	4		
<b>Field Station#</b>	11848+00	<b>Field Station#</b>	11863+65		
<b>Pic 3 Desc.</b>	Section of restored RoW showing conditions and controls.		<b>Pic 4 Desc.</b>	P-KL2 and conditions.

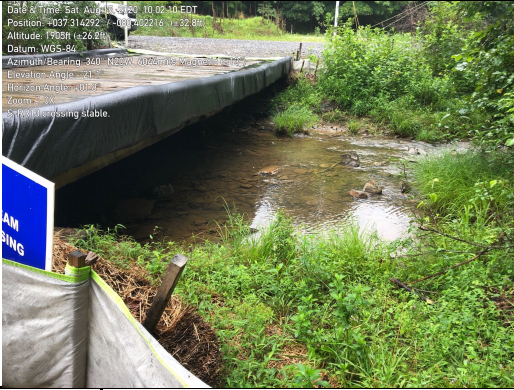
<p>Date &amp; Time Sat, Aug 15, 2020, 10:02:10 EDT Position: +037°31'42.92" / -080°40'26.81" (±16.4m) Altitude: 1912m (±26.8m) Datum: WGS-84 Azimuth: 340° - 002°mils (±13°) Elevation Angle: +03.8° Horizon Angle: -06.8° Zoom: 1.0X S-RR13 crossing stable.</p>

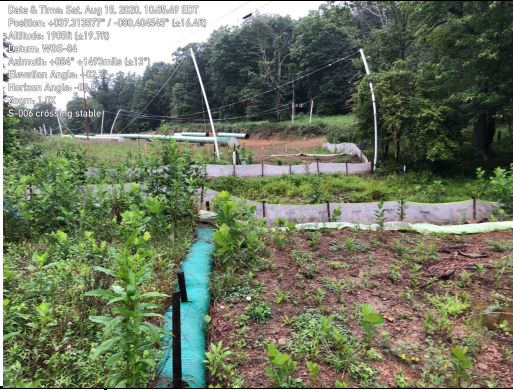
<p>Date &amp; Time Sat, Aug 15, 2020, 10:06:49 EDT Position: +037°31'39.77" / -080°40'56.67" (±16.4m) Altitude: 1908m (±26.8m) Datum: WGS-84 Azimuth: +004° - 014°mils (±13°) Elevation Angle: +03.3° Horizon Angle: -06.3° Zoom: 1.0X S-006 crossing stable.</p>	
<b>GPS Location</b>	On photo	<b>GPS Location</b>	On photo
<b>Field Station#</b>	11613+69	<b>Field Station#</b>	11608+17
<b>Pic 1 Desc.</b>	S-RR13 crossing on AR MN-258.04 stable	<b>Pic 2 Desc.</b>	S-006 crossing stable with no sign of impact.

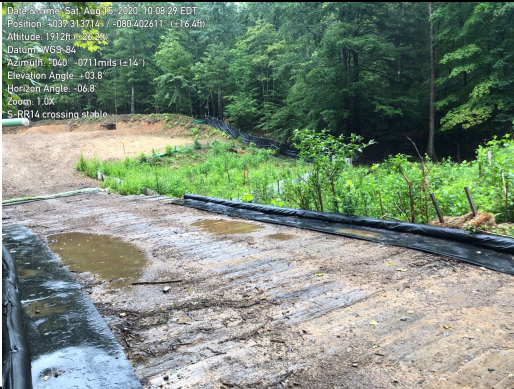
<p>Date &amp; Time Sat, Aug 15, 2020, 10:08:29 EDT Position: +037°31'37.14" / -080°40'26.11" (±16.4m) Altitude: 1912m (±26.8m) Datum: WGS-84 Azimuth: 104° - 071°mils (±14°) Elevation Angle: +03.8° Horizon Angle: -06.8° Zoom: 1.0X S-RR14 crossing stable.</p>
