Visual Site Inspection Report

Project Name	H-600 Pipeline Spread G	AFE	124300137	Spread	H-600 Pipeline Spread G
Contractor	Precision			Report #	13658
Inspector	Len Kruizenga			Date/Time	8/17/2020 8:36 AM
Permit #	TBD	Inspection Type	VA SWPP	Station Begin	11023+88
State	VA	Inspection Area	Full	Station End	10930+00
County	Giles	Ground	Muddy	Temperature (°F)	81.00
Municipality	N/A	Weather	Light Rain	Rain Gauge (in)	1.20
				Rain Accumulation Time (days)	2.00

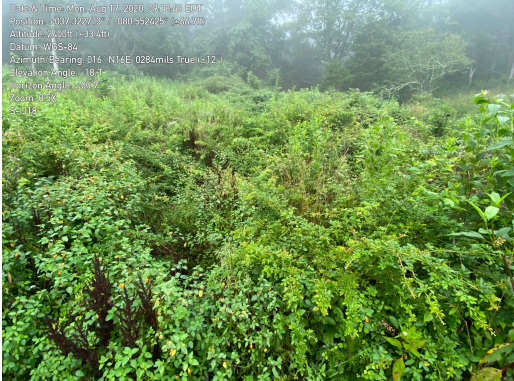
GPS Location	1	GPS Location	2		
Field Station#	11025+50	Field Station#	11029+00		
Pic 1 Desc.	S-IJ18 and controls.	Pic 2 Desc.	Perimeter controls functional.

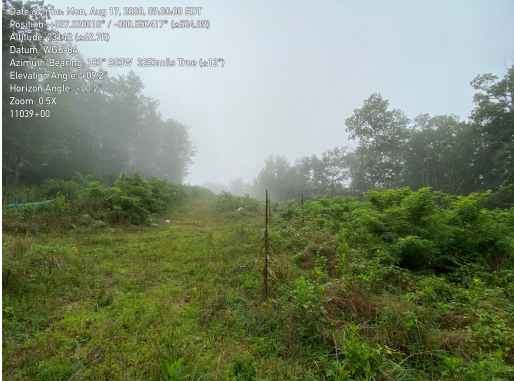
GPS Location	3	GPS Location	4		
Field Station#	11039+00	Field Station#	11050+10		
Pic 3 Desc.	Section of RoW showing conditions and controls.	Pic 4 Desc.	S-IJ16B/S-IJ17 and controls.

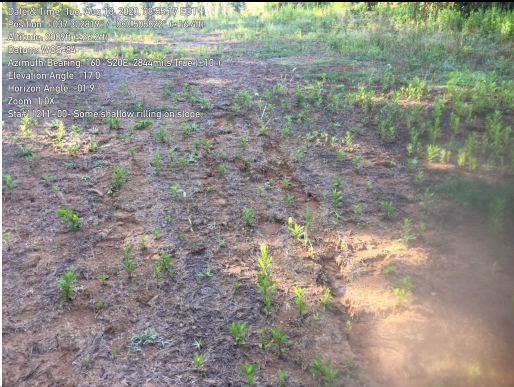
Field Station#	11211+00	Field Station#	11204+00	GPS Location	See photo GPS
Pic 3 Desc.	Some shallow rilling on slopes observed.	Pic 4 Desc.	Triple stack CFS end treatment's.	GPS Location	See photo GPS
  <p>Date & Time: Tue, Aug 18, 2020, 09:11:46 EDT Position: +037.303648° / -080.8916213° (-49m) Altitude: 2011ft (-32m) Datum: WGS-84 Azimuth/Bearing: 103° S05E-234m(-11.6m) Elevation Angle: -17.1° Horizon Angle: -01.9° Zoom: 1.0x Sta#11190+00- Row on slope coming into a drainage feature.</p>

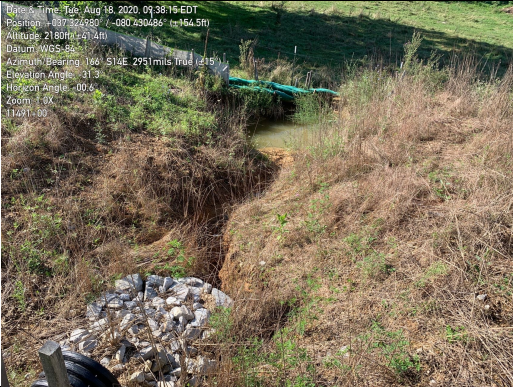
GPS Location		See photo for GPS location.						GPS Location		See photo for GPS location.	
Field Station#		11507+00						Field Station#		11491+00	
Pic 1 Desc.		Plunge pool and clean water diversion pipe in place.						Pic 2 Desc.		Waterbar throat channeling. Item added to the punchlist.

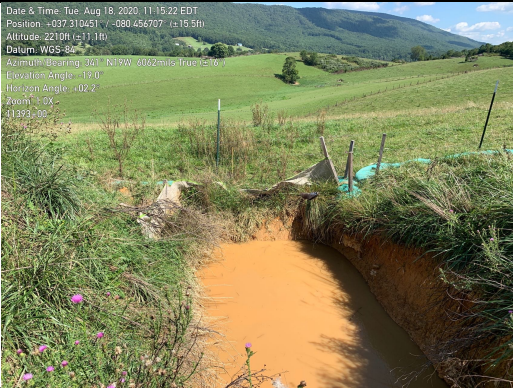
GPS Location		See photo for GPS location.						GPS Location		See photo for GPS location.	
Field Station#		11772+00						Field Station#		11393+00	
Pic 5 Desc.		ECB and slope drain in place over two-tone.						Pic 6 Desc.		Priority one silt fence stakes broken at end treatment.

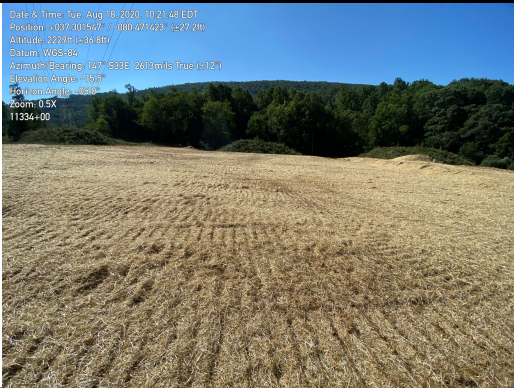
GPS Location	5	GPS Location	6		
Field Station#	11334+00	Field Station#	11352+97		
Pic 5 Desc.	Recently stabilized section of RoW.	Pic 6 Desc.	S-NN11 and controls.

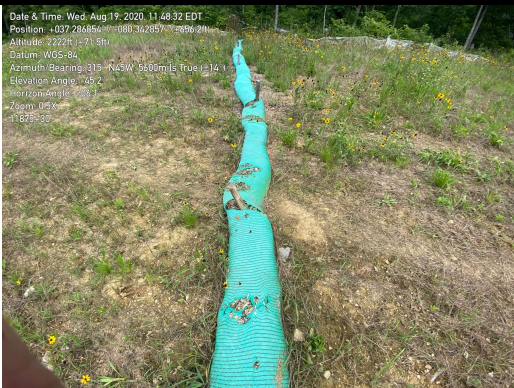
GPS Location	5	GPS Location	6		
Field Station#	11875+30	Field Station#	11791+00		
Pic 5 Desc.	Damaged temporary CFS water bars from unknown parties.		Pic 6 Desc.	Fencing installed in the RCE on the South side of Mt Tabor rd to prevent travel on the RoW.

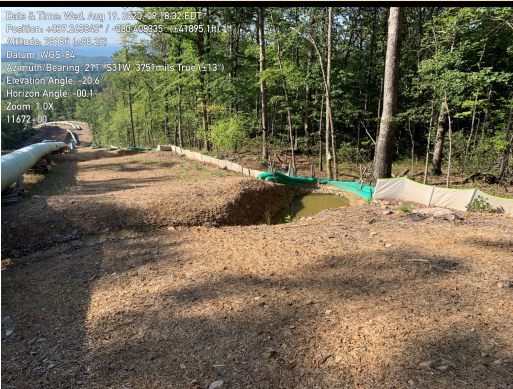
<p>Date & Time: Wed Aug 19, 2020, 09:48:32 EDT Position: +037 230333 / -080 360657 (+56004.3ft) Altitude: 2930ft (+893m) Datum: WGS-84 Azimuth/Bearing: 271° S31W 3751mils True (±13°) Elevation Angle: -20.6° Horizon Angle: -00.1° Zoom: 1.0X 11672+00</p>			
GPS Location	See photo for GPS location.		GPS Location	See photo for GPS location.	
Field Station#	11670+00		Field Station#	11672+00	
Pic 1 Desc.	Triple stack compost filter sock and priority one silt fence in place along LOD.		Pic 2 Desc.	Waterbar, sump pit, and waterbar end treatment in place.
