# Visual Site Inspection Report

<b>Project Name</b>	H-600 Pipeline Spread G	<b>AFE</b>	124300137	<b>Spread</b>	H-600 Pipeline Spread G
<b>Contractor</b>	Precision			<b>Report #</b>	13868
<b>Inspector</b>	Len Kruizenga			<b>Date/Time</b>	8/24/2020 8:17 AM
<b>Permit #</b>	TBD	<b>Inspection Type</b>	VA SWPP	<b>Station Begin</b>	11254+99
<b>State</b>	VA	<b>Inspection Area</b>	Full	<b>Station End</b>	11158+27
<b>County</b>	Giles	<b>Ground</b>	Dry	<b>Temperature (°F)</b>	82.00
<b>Municipality</b>	N/A	<b>Weather</b>	Cloudy	<b>Rain Gauge (in)</b>	0.00
				<b>Rain Accumulation Time (days)</b>	1.00

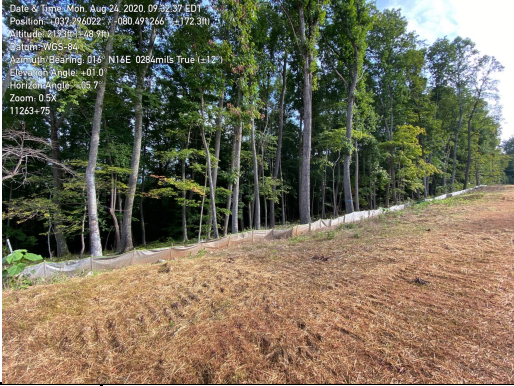
<b>GPS Location</b>	1	<b>GPS Location</b>	2		
<b>Field Station#</b>	11263+75	<b>Field Station#</b>	11286+00		
<b>Pic 1 Desc.</b>	Perimeter controls functional.	<b>Pic 2 Desc.</b>	Perimeter controls functional.

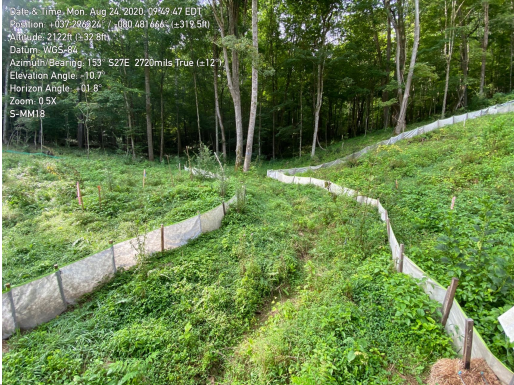
<b>GPS Location</b>	3	<b>GPS Location</b>	4		
<b>Field Station#</b>	11292+80	<b>Field Station#</b>	11301+00		
<b>Pic 3 Desc.</b>	S-MM18 and controls.	<b>Pic 4 Desc.</b>	Section of RoW showing conditions and controls.

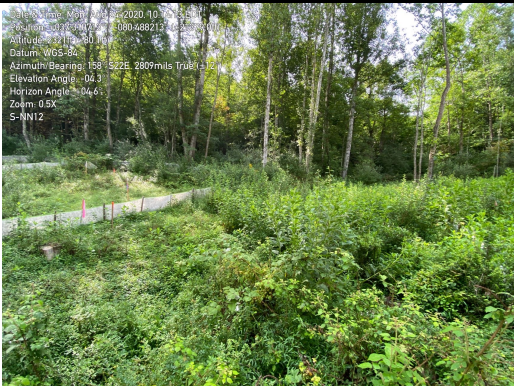
<b>GPS Location</b>	5	<b>GPS Location</b>	6		
<b>Field Station#</b>	11327+85	<b>Field Station#</b>	11352+97		
<b>Pic 5 Desc.</b>	S-NN12 and controls.	<b>Pic 6 Desc.</b>	S-NN11 and controls.

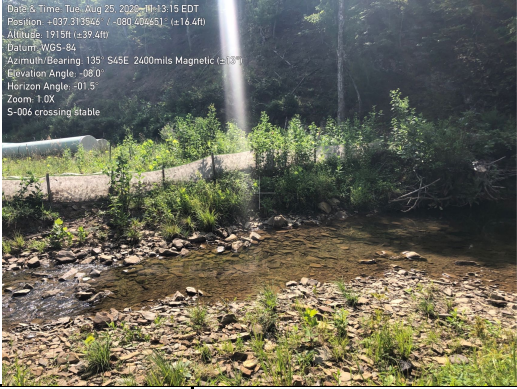
<b>GPS Location</b>		On photo		<b>GPS Location</b>	
<b>Field Station#</b>		11608+17		<b>Field Station#</b>	
<b>Pic 7 Desc.</b>		S-006 crossing is stable with ECDs in place.		<b>Pic 8 Desc.</b>	
<b>GPS Location</b>				<b>GPS Location</b>	
<b>Field Station#</b>				<b>Field Station#</b>	
<b>Pic 9 Desc.</b>				<b>Pic 10 Desc.</b>	
<b>GPS Location</b>				<b>GPS Location</b>	
<b>Field Station#</b>				<b>Field Station#</b>	
<b>Pic 11 Desc.</b>				<b>Pic 12 Desc.</b>

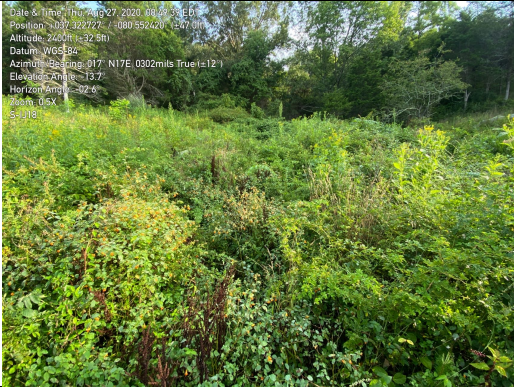
<b>GPS Location</b>	1	<b>GPS Location</b>	2		
<b>Field Station#</b>	11025+50	<b>Field Station#</b>	11037+50		
<b>Pic 1 Desc.</b>	S-IJ18 and controls.	<b>Pic 2 Desc.</b>	Section of RoW showing conditions and controls.

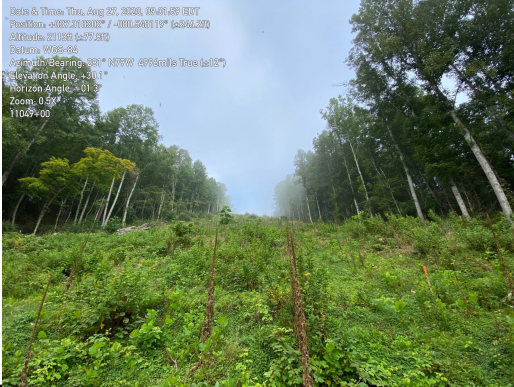
<b>GPS Location</b>	3	<b>GPS Location</b>	4		
<b>Field Station#</b>	11049+00	<b>Field Station#</b>	11050+10		
<b>Pic 3 Desc.</b>	Section of RoW showing conditions and controls.	<b>Pic 4 Desc.</b>	S-IJ16B/S-IJ17 and controls.

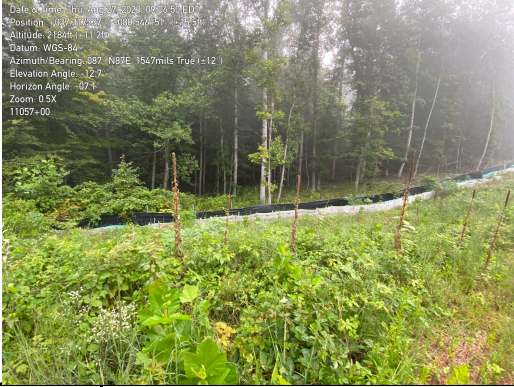
<b>GPS Location</b>	5	<b>GPS Location</b>	6		
<b>Field Station#</b>	11057+00	<b>Field Station#</b>	11064+50		
<b>Pic 5 Desc.</b>	Karst perimeter controls functional.	<b>Pic 6 Desc.</b>	Section of RoW showing conditions and controls.

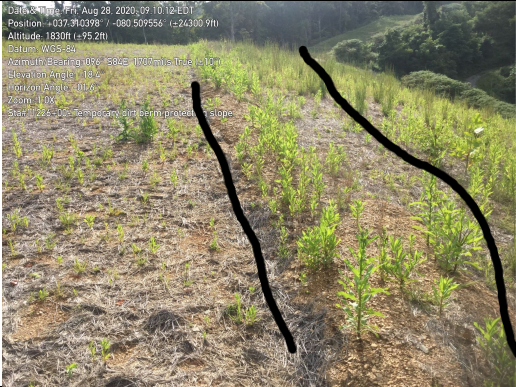
<p>Date &amp; Time: Fri, Aug 28, 2020, 09:10:12 EDT Position: +037.303398 / -080.509556 (+24300.9ft) Altitude: 1830ft (+95.2m) Datum: WGS-84 Azimuth Bearing: 086° S82° 1004mils True (+10°) Elevation Angle: +1.5° Horizon Angle: +06.8° Zoom: 1.0X Stat#11225+00- Temporary dirt berm protect. slope</p>

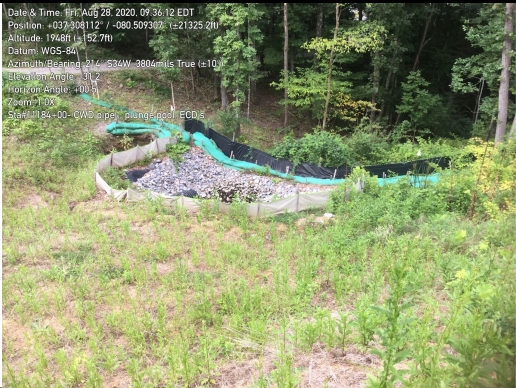
<p>Date &amp; Time: Fri, Aug 28, 2020, 09:36:12 EDT Position: +037.305112 / -080.509310 (+21325.2ft) Altitude: 1969ft (+152.7m) Datum: WGS-84 Azimuth Bearing: 214° S24W 3804mils True (+10°) Elevation Angle: +3.2° Horizon Angle: +06.8° Zoom: 1.0X Stat#11184+00- CWD pipe and plunge pool ECD's</p>

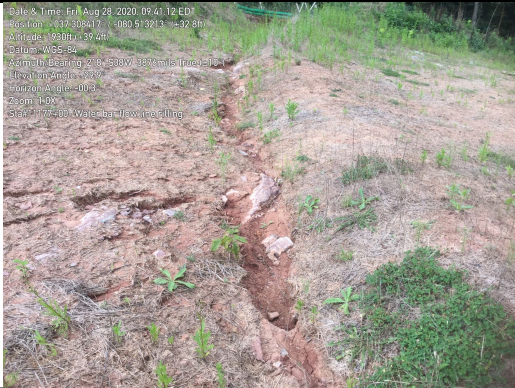
<p>Date &amp; Time: Fri, Aug 28, 2020, 09:41:12 EDT Position: +037.309471 / -080.513213 (+97.8m) Altitude: 1938ft (+139.4ft) Datum: WGS-84 Azimuth Bearing: 218° S38W 3825mils True (+10°) Elevation Angle: +1.2° Horizon Angle: +06.8° Zoom: 1.0X Stat#11177+00- Water bar flow line</p>

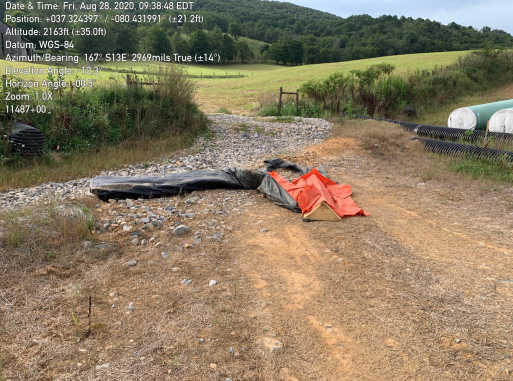
<b>GPS Location</b>	See photo for GPS location.		<b>GPS Location</b>	See photo for GPS location.	
<b>Field Station#</b>	11497+50		<b>Field Station#</b>	11487+00	
<b>Pic 1 Desc.</b>	Broken priority one silt fence.		<b>Pic 2 Desc.</b>	Silt foam dike damaged at landowner access point.

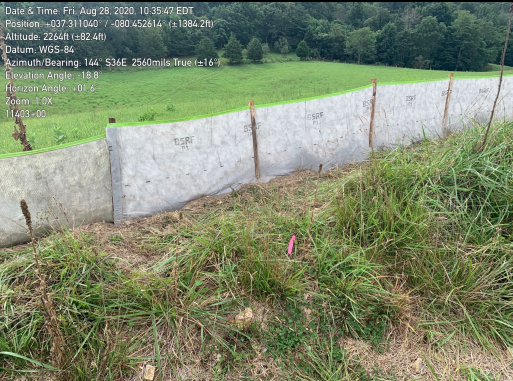
<b>GPS Location</b>	See photo for GPS location.		<b>GPS Location</b>	See photo for GPS location.	
<b>Field Station#</b>	11489+00		<b>Field Station#</b>	11403+00	
<b>Pic 5 Desc.</b>	RCE in place at Stevers Gap Road.		<b>Pic 6 Desc.</b>	Priority one silt fence repaired where holes were found previous inspection.
