# Visual Site Inspection Report

<b>Project Name</b>	H-600 Pipeline Spread G	<b>AFE</b>	124300137	<b>Spread</b>	H-600 Pipeline Spread G
<b>Contractor</b>	Precision			<b>Report #</b>	14137
<b>Inspector</b>	Rob Robertson			<b>Date/Time</b>	8/31/2020 12:30 PM
<b>Permit #</b>	TBD	<b>Inspection Type</b>	VA SWPP	<b>Station Begin</b>	11600+01
<b>State</b>	VA	<b>Inspection Area</b>	Full	<b>Station End</b>	11670+00
<b>County</b>	Montgomery	<b>Ground</b>	Muddy	<b>Temperature (°F)</b>	68.00
<b>Municipality</b>	N/A	<b>Weather</b>	Light Rain	<b>Rain Gauge (in)</b>	0.50
				<b>Rain Accumulation Time (days)</b>	1.00

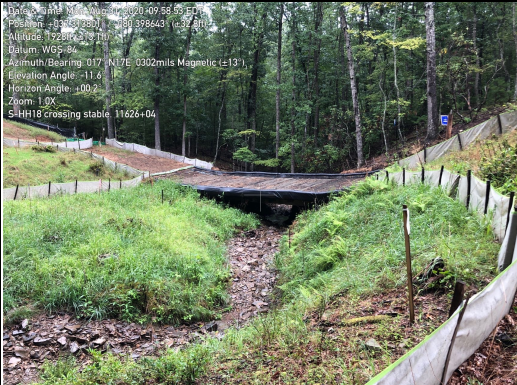
GPS Location	On photo		GPS Location	On photo	
Field Station#	11626+04		Field Station#	11614+20	
Pic 7 Desc.	S-HH18 crossing stable with ECDs in place		Pic 8 Desc.	The S-RR14 crossing is stable with ECDs in place.

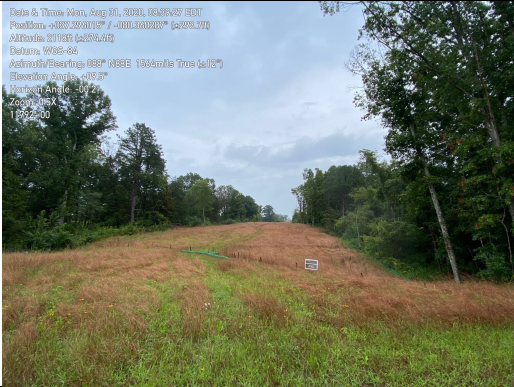
<b>GPS Location</b>	1	<b>GPS Location</b>	2		
<b>Field Station#</b>	11792+00	<b>Field Station#</b>	11826+00		
<b>Pic 1 Desc.</b>	Section of restored RoW showing conditions and controls.		<b>Pic 2 Desc.</b>	Section of restored RoW showing conditions and controls.

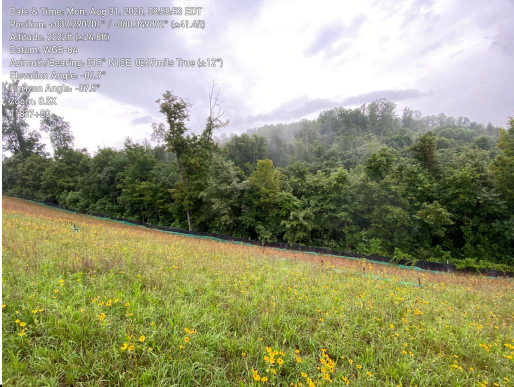
<b>GPS Location</b>	3	<b>GPS Location</b>	4		
<b>Field Station#</b>	11837+00	<b>Field Station#</b>	11863+65		
<b>Pic 3 Desc.</b>	Perimeter controls functional.		<b>Pic 4 Desc.</b>	P-KL2 and controls.

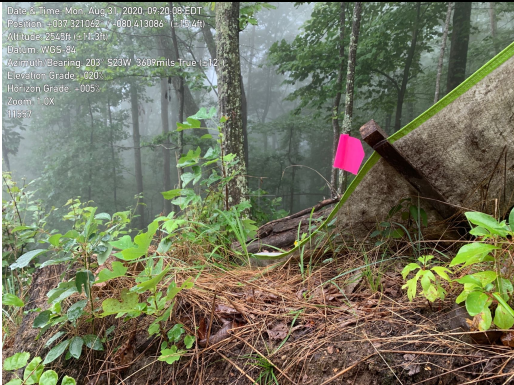
<b>GPS Location</b>	See picture above for GPS coordinates		<b>GPS Location</b>	See picture above for GPS coordinates	
<b>Field Station#</b>	11557+00		<b>Field Station#</b>	11558+00	
<b>Pic 3 Desc.</b>	Damaged P1		<b>Pic 4 Desc.</b>	ECD's and row conditions SPP22

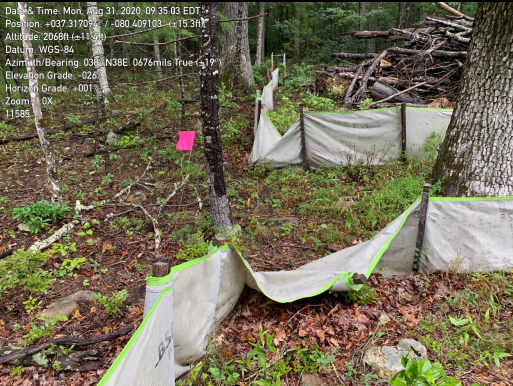
<b>GPS Location</b>	See picture above for GPS coordinates		<b>GPS Location</b>	See picture above for GPS coordinates	
<b>Field Station#</b>	11582+00		<b>Field Station#</b>	11585+00	
<b>Pic 5 Desc.</b>	ECD's and row conditions		<b>Pic 6 Desc.</b>	Damaged P1

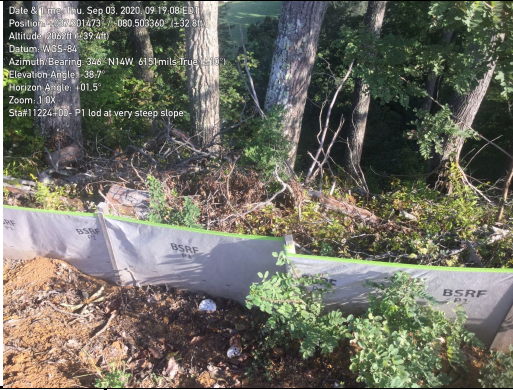
<b>GPS Location</b>	See photo GPS	<b>GPS Location</b>	See photo GPS		
<b>Field Station#</b>	11227+00	<b>Field Station#</b>	11224+00		
<b>Pic 1 Desc.</b>	Row is muddy and slippery.	<b>Pic 2 Desc.</b>	P1 lod protecting steep slope

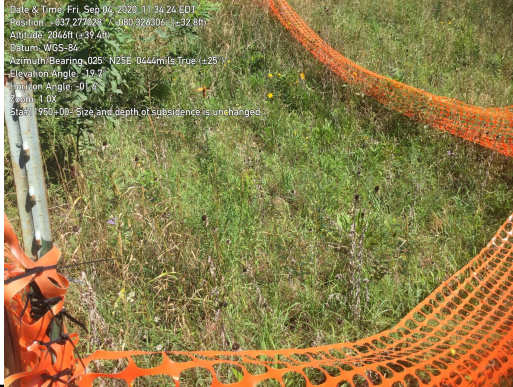
<p>Date &amp; Time: Fri, Sep 04, 2020, 11:24:24 EDT Position: 437.27263, -80.32762, 143.400 Altitude: 2066ft (+39.4ft) Datum: WGS-84 Azimuth/Bearing: 025° N 35E 0644mils True (+25°) Elevation Angle: -13.2° Horizon Angle: -0.3° Zoom: 1.0x Sta#11950+00- Size and depth of subsidence is unchanged.</p>		<b>GPS Location</b>	See photo GPS
<b>Field Station#</b>	11942+00	<b>Field Station#</b>	11950+00	<b>GPS Location</b>	See photo GPS
<b>Pic 3 Desc.</b>	Karst ECD's are in acceptable condition.	<b>Pic 4 Desc.</b>	Size and depth of subsidence remains unchanged.	<b>GPS Location</b>	See photo GPS
