Visual Site Inspection Report

Project Name	H-600 Pipeline Spread H	AFE	124300138	Spread	H-600 Pipeline Spread H
Contractor	Precision			Report #	11854
Inspector	John Brcic			Date/Time	6/15/2020 1:31 PM
Permit #	TBD	Inspection Type	VA SWPP	Station Begin	12433+75
State	VA	Inspection Area	Partial	Station End	12544+06
County	Montgomery	Ground	Wet	Temperature (°F)	60.00
Municipality	N/A	Weather	Light Rain	Rain Gauge (in)	1.00
				Rain Accumulation Time (days)	1.00

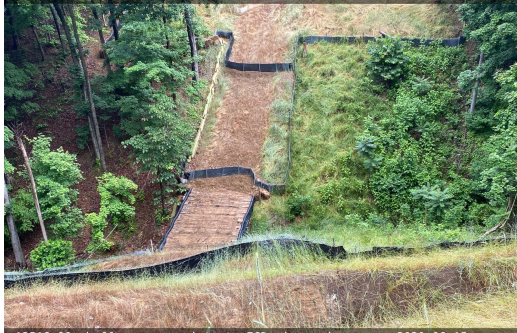
12522+00: slope on GAS side of S-EF19 well vegetated and stable 2020-06-15 11:42:52-04:00			
GPS Location	See photo		GPS Location	See photo	
Field Station#	12529+00		Field Station#	12522+00	
Pic 7 Desc.	Plastic sheeting on stockpiles approximately 1500 feet on CIS of Yellow Finch Road is intact and functioning properly.		Pic 8 Desc.	Slope on GAS of stream S-EF19 well vegetated and stable.	
DIRECTION N (T) 37.21569°N 080.19732°W ACCURACY 13 m DATUM WGS84

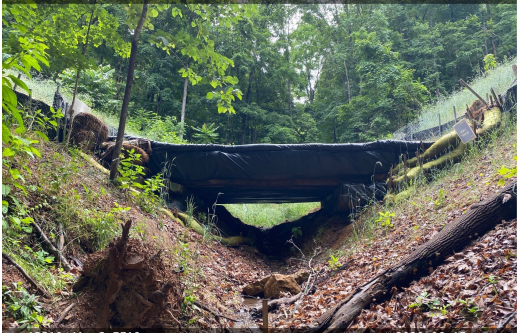
12518+90: buffer zone of stream S-EF19 intact, ECDs in good condition 2020-06-15 11:21:49-04:00		DIRECTION E (T) 37.21605°N 080.19760°W ACCURACY 5 m DATUM WGS84

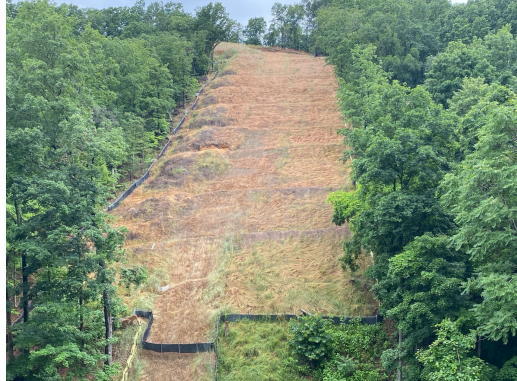
12519+41: S-EF19, facing east, upstream 2020-06-15 11:33:29-04:00

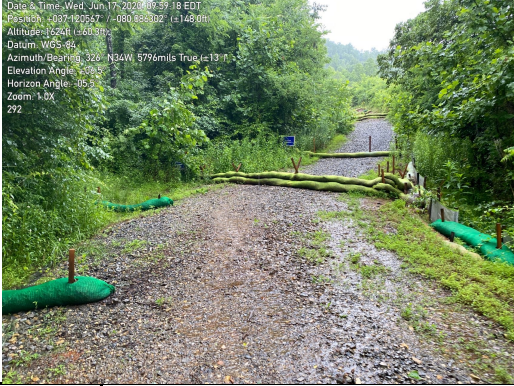
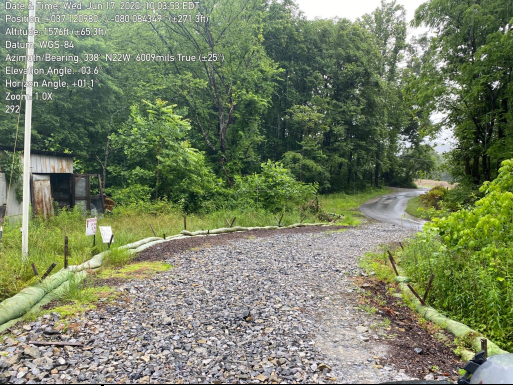
GPS Location	See photo for coordinates.		GPS Location	See photo for coordinates.	
Field Station#	13141+00		Field Station#	13141+00	
Pic 1 Desc.	MVP-FR-292, ECDs functioning acceptably.		Pic 2 Desc.	MVP-FR-292, ECDs functioning acceptably.

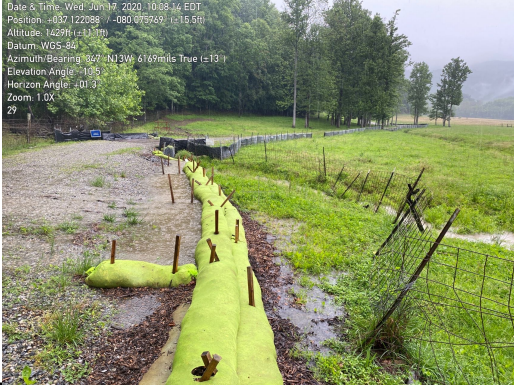
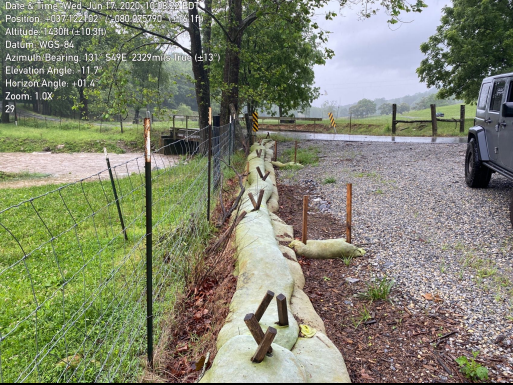
GPS Location	See photo for coordinates.		GPS Location	See photo for coordinates.	
Field Station#	13190+00		Field Station#	13190+00	
Pic 5 Desc.	MVP-AR-29, water flowing across access road and down ECDs, no impacts noted.		Pic 6 Desc.	MVP-AR-29, ECDs functioning acceptably, road clean of sediment and debris.

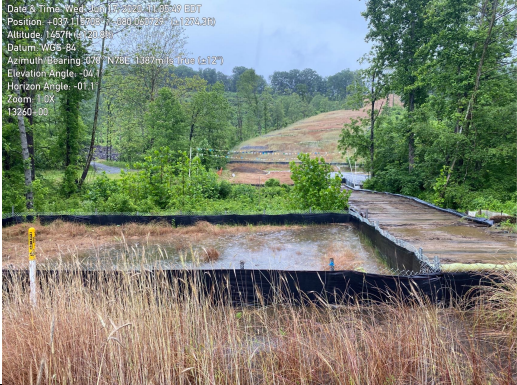
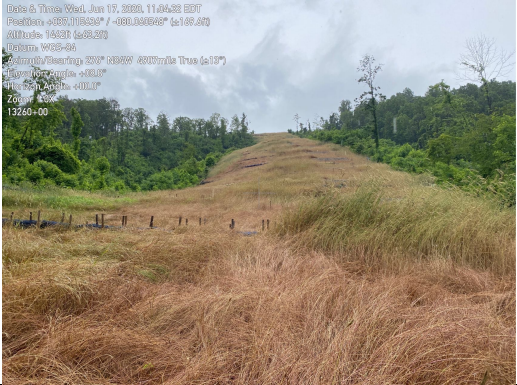
GPS Location	See photo for coordinates.		GPS Location	See photo for coordinates.	
Field Station#	13260+00		Field Station#	13260+60	
Pic 13 Desc.	ECDs functioning acceptably, good vegetative cover in stabilized area.		Pic 14 Desc.	Good vegetative cover noted across LOD, permanent waterbars stable.

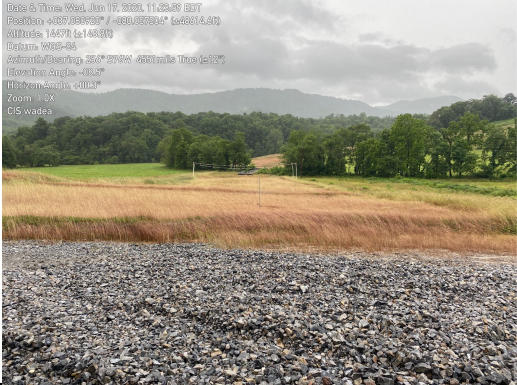
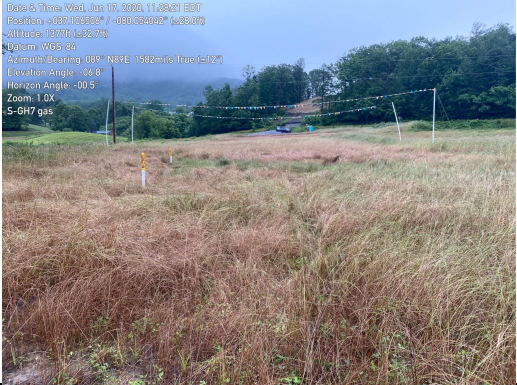
GPS Location	See photo for coordinates.		GPS Location	See photo for coordinates.	
Field Station#	13314+00		Field Station#	13311+00	
Pic 15 Desc.	CIS Wades Gap, good vegetative cover across LOD.		Pic 16 Desc.	CIS Wades Gap, good vegetative cover across LOD.

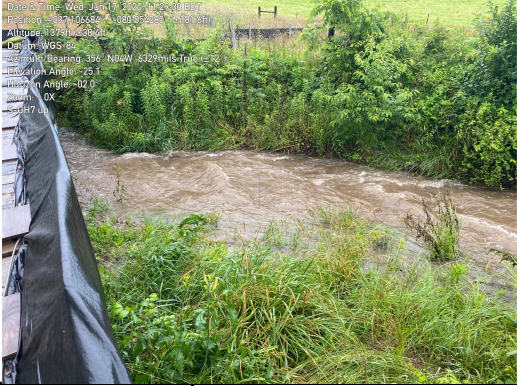
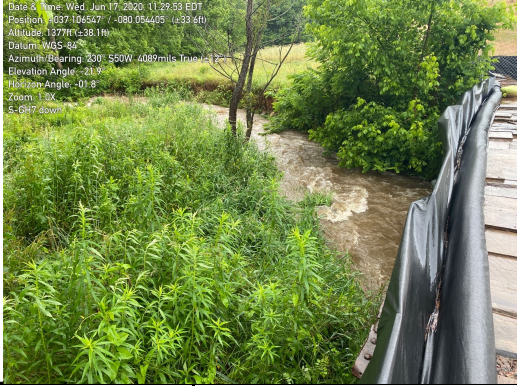
GPS Location	See photo for coordinates.		GPS Location	See photo for coordinates.	
Field Station#	13309+09		Field Station#	13309+09	
Pic 17 Desc.	S-GH7, upstream, water flowing swiftly, stream at bankfull width, no impacts noted.		Pic 18 Desc.	S-GH7, downstream, water flowing swiftly, stream at bankfull width, no impacts noted.

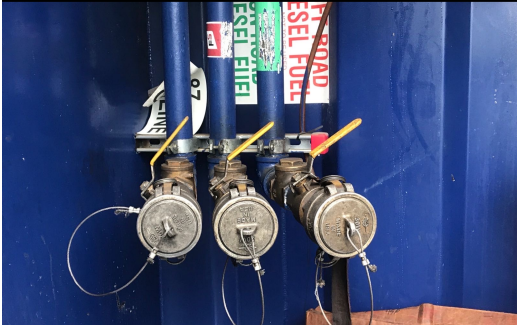
MVP-PY-006_061820 No leaky internal fittings 2020-06-18 07:15:31-04:00		DIRECTION S (M) +37.23570° -080.22675° ACCURACY 16 ft DATUM WGS84

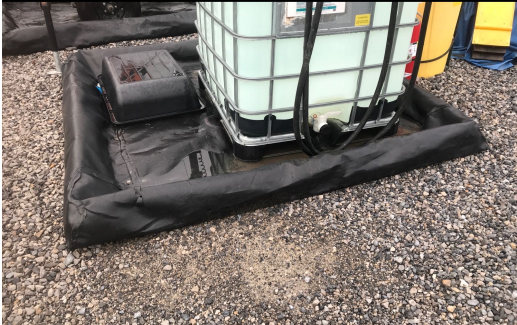
MVP-PY-006_061820 Condition of containment under DEF tank. 2020-06-18 07:16:32-04:00			
GPS Location	MVP-PY-006 See photo for gps data		GPS Location	MVP-PY-006 See photo for gps data	
Field Station#	+0		Field Station#	+0	
Pic 7 Desc.	Blue bulk fuel tanks no leaky internal fittings. Looking W.		Pic 8 Desc.	Condition of containment under DEF tank. Looking S.	
DIRECTION W (M) +37.23570° -080.22675° ACCURACY 16 ft DATUM WGS84

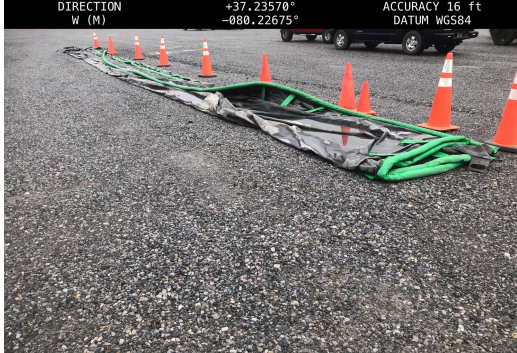
MVP-PY-006_061820 Secondary containment on site for tankers offloading fuel into blue bulk fuel tanks. Looking W. 2020-06-18 07:16:35-04:00		DIRECTION SW (M) +37.23570° -080.22675° ACCURACY 16 ft DATUM WGS84

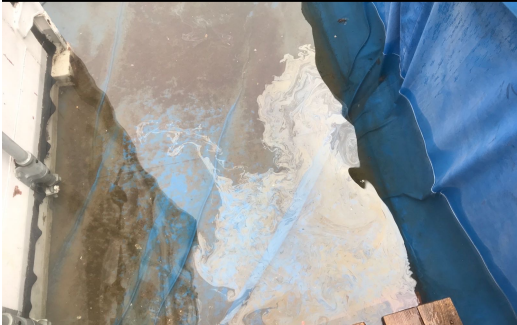
DIRECTION W (M) +37.23443° -080.22630° ACCURACY 33 ft DATUM WGS84	
MVP-PY-006_061820		Containment holding Stormwater with sheen		MVP-PY-006_061820	
		2020-06-18 07:19:46-04:00		No debris around hazardous waste dumpster. Looking W.	
				2020-06-18 07:28:06-04:00	
GPS Location	MVP-PY-006 See photo for gps data		GPS Location	MVP-PY-006 See photo for gps data	
Field Station#	+0		Field Station#	+0	
Pic 13 Desc.	Off Road Fuel unit containment holding stormwater with sheen present. Looking NE.		Pic 14 Desc.	No debris around hazardous waste dumpster. Looking W.	
DIRECTION S (M) +37.23459° -080.22793° ACCURACY 16 ft DATUM WGS84

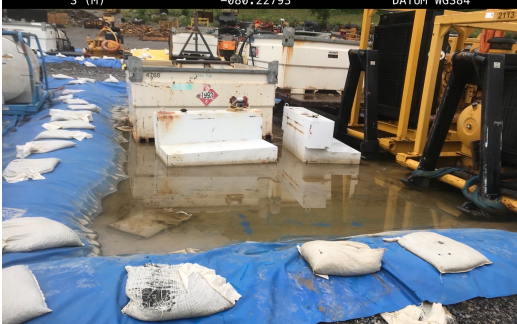
DIRECTION SE (M) +37.23425° -080.22815° ACCURACY 16 ft DATUM WGS84	
MVP-PY-006_061820		Condition of containment holding ...		MVP-PY-006_061820

2020-06-18 07:29:21-04:00		Condition of containment, holding...	
				2020-06-18 07:30:00-04:00	
GPS Location	MVP-PY-006 See photo for gps data		GPS Location	MVP-PY-006 See photo for gps data	
Field Station#	+0		Field Station#	+0	
Pic 15 Desc.	Condition of poly lined/rock berm containment. Holding some stormwater no sheen. Looking S.		Pic 16 Desc.	Condition of poly lined/rock berm containment. Holding some stormwater no sheen. Looking SE.	
DIRECTION SW (M) +37.23433° -080.22832° ACCURACY 0.37 mi DATUM WGS84

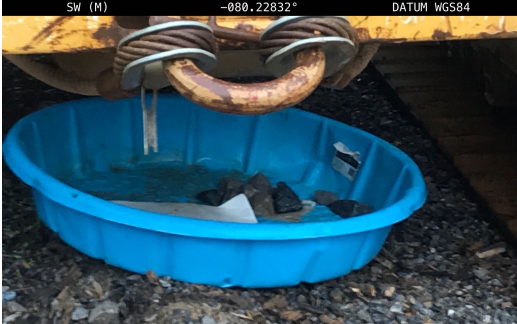
DIRECTION SW (M) +37.23463° -080.22878° ACCURACY 16 ft DATUM WGS84	
MVP-PY-006_061820		Containment under stored equipment		MVP-PY-006_061820	
		2020-06-18 07:35:01-04:00		Containment under stored equipment	
				2020-06-18 07:35:29-04:00	
GPS Location	MVP-PY-006 See photo for gps data		GPS Location	MVP-PY-006 See photo for gps data	
Field Station#	+0		Field Station#	+0	
Pic 17 Desc.	Condition of containment under stored equipment. Looking SW.		Pic 18 Desc.	Condition of containment under stored equipment. Looking SW.

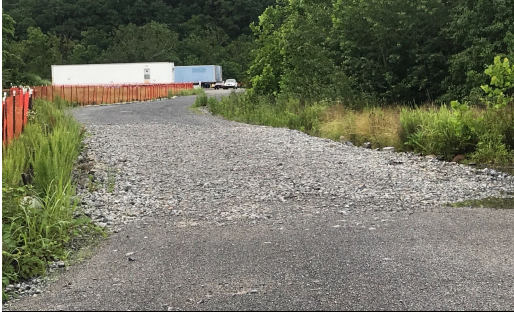
<div>MVP-LY-049_061820</div> <div>Condition of rock entrance</div> <div>2020-06-18 08:06:12-04:00</div>		<div> <div>DIRECTION SE (M)</div> <div>+37.27060° -080.12155°</div> <div>ACCURACY 164 ft DATUM WGS84</div> </div>

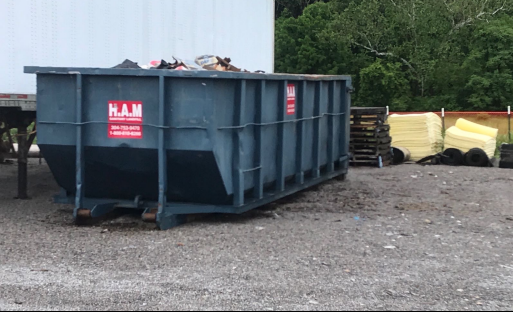
<div>MVP-LY-049_061820</div> <div>No loose trash around south dumpster.</div> <div>2020-06-18 08:19:49-04:00</div>			
GPS Location	MVP-LY-049 See photo for gps data		GPS Location	MVP-LY-049 See photo for gps data	
Field Station#	+0		Field Station#	+0	
Pic 1 Desc.	Condition of rock entrance on center drive. Looking SE.		Pic 2 Desc.	No loose trash around south dumpster. Looking SE.	
<div> <div>DIRECTION W (M)</div> <div>+37.27054° -080.12244°</div> <div>ACCURACY 16 ft DATUM WGS84</div> </div>

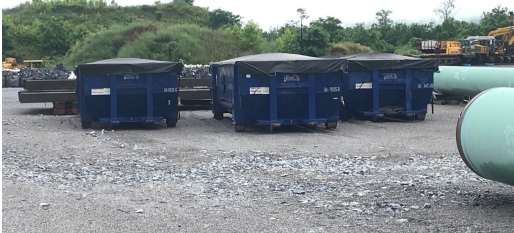
<div>MVP-LY-049_061820</div> <div>No debris around hazardous waste ...</div> <div>2020-06-18 08:20:25-04:00</div>		<div> <div>DIRECTION W (M)</div> <div>+37.27045° -080.12336°</div> <div>ACCURACY 16 ft DATUM WGS84</div> </div>

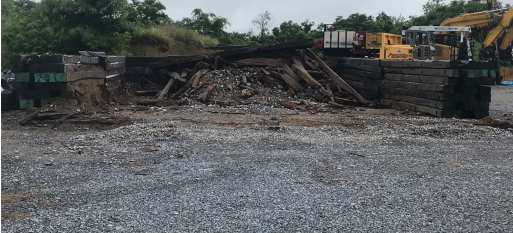
<div>MVP-LY-049_061820</div> <div>Condition of temporary trash ...</div> <div>2020-06-18 08:21:07-04:00</div>

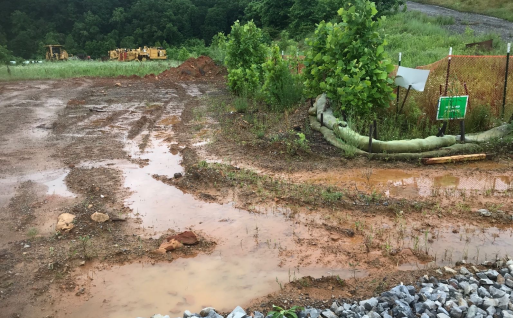
<div>MVP-LY-049_061820</div> <div>Landowner disturbance along CFS and feature</div> <div>2020-06-18 08:23:31-04:00</div>			
GPS Location	MVP-LY-049 See photo for gps data		GPS Location	MVP-LY-049 See photo for gps data	
Field Station#	+0		Field Station#	+0

Pic 5 Desc.	Condition of compost filter sock and safety fence along edge of feature W-CV21A. Looking W.		Pic 6 Desc.	Landowner disturbance along compost filter sock and feature. No impacts. Looking S.

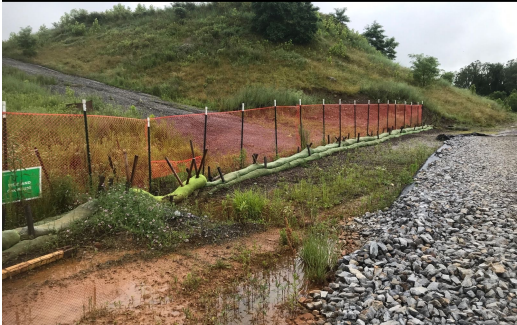
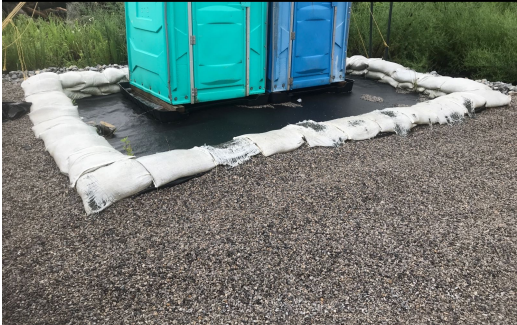
MVP-LY-049_061820 Landowner disturbance within 100' of ... 2020-06-18 08:24:03-04:00		MVP-LY-049_061820 Condition of trays and containment 2020-06-18 08:25:31-04:00			
GPS Location	MVP-LY-049 See photo for gps data		GPS Location	MVP-LY-049 See photo for gps data	
Field Station#	+0		Field Station#	+0	
Pic 7 Desc.	Landowner disturbance within 100' of feature. No impacts. Looking SW.		Pic 8 Desc.	Condition of trays and containment under toilets. Looking N.	
DIRECTION SW (M) +37.26940° -080.12361° ACCURACY 16 ft DATUM WGS84		DIRECTION SE (M) +37.26901° -080.12358° ACCURACY 16 ft DATUM WGS84

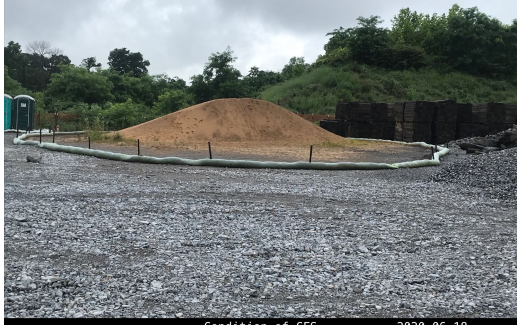
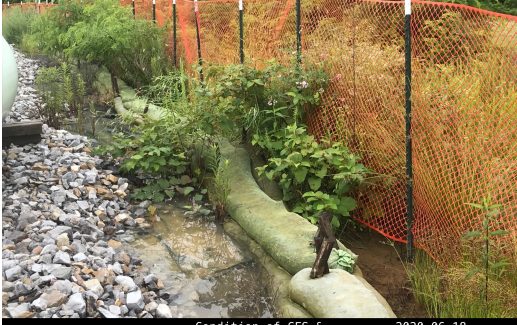
MVP-LY-049_061820 Condition of CFS around sand pile 2020-06-18 08:27:27-04:00		MVP-LY-049_061820 Condition of CFS & safety fence 2020-06-18 08:28:45-04:00

GPS Location	MVP-LY-049 See photo for gps data		GPS Location	MVP-LY-049 See photo for gps data	
Field Station#	+0		Field Station#	+0	
Pic 9 Desc.	Condition of compost filter sock around sand pile. Looking SW.		Pic 10 Desc.	Condition of compost filter sock and safety fence along south LOD. Looking SE.	
DIRECTION W (M) +37.26903° -080.12349° ACCURACY 16 ft DATUM WGS84		DIRECTION E (M) +37.27126° -080.12140° ACCURACY 16 ft DATUM WGS84

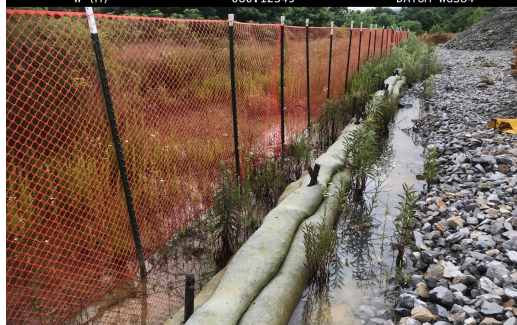
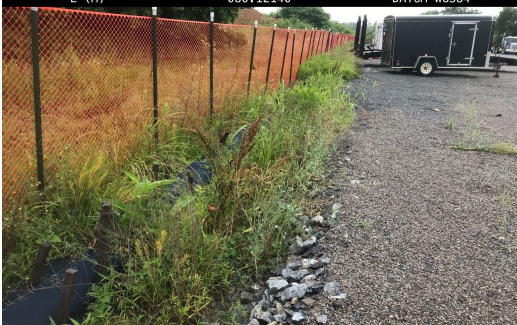
MVP-PY-049_061820 Condition of CFS & safety fence 2020-06-18 08:28:54-04:00		MVP-LY-049_061820 Condition of CFS & safety fence 2020-06-18 09:14:54-04:00			
GPS Location	MVP-LY-049 See photo for gps data		GPS Location	MVP-LY-049 See photo for gps data	
Field Station#	+0		Field Station#	+0	
Pic 11 Desc.	Condition of compost filter sock and safety fence along south LOD. Looking W.		Pic 12 Desc.	Condition of compost filter sock and safety fence along north LOD. Looking E.

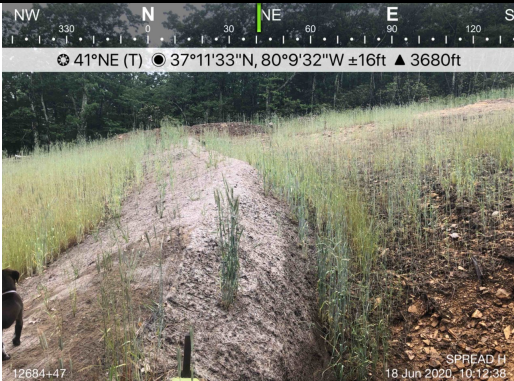
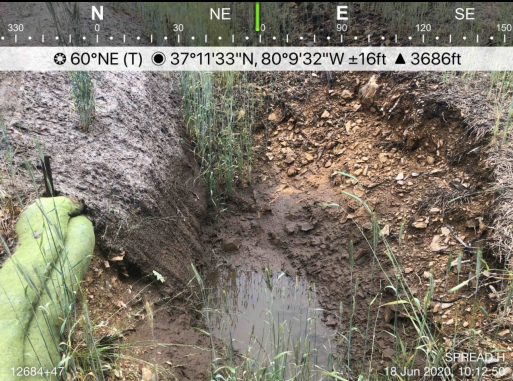
GPS Location	see photo		GPS Location	see photo	
Field Station#	12684+47		Field Station#	12684+47	
Pic 5 Desc.	Waterbars on this slope in good condition and functioning.		Pic 6 Desc.	Sumps have received a small amount of runoff from rain event.

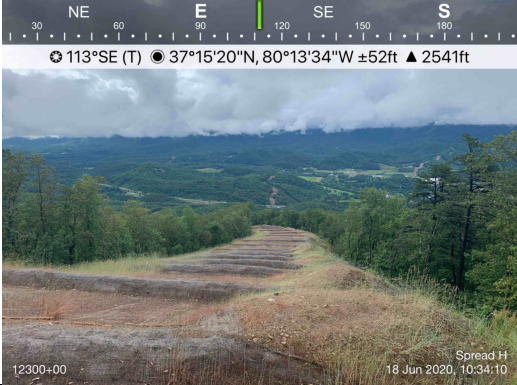
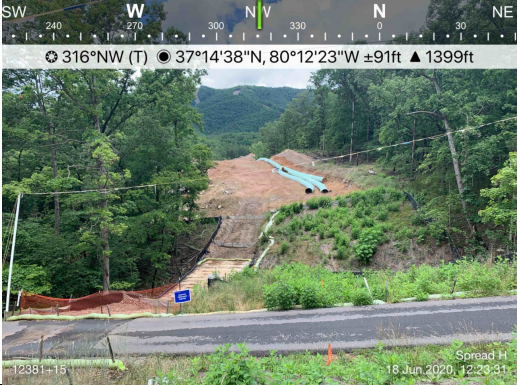
GPS Location	See Photo		GPS Location	See Photo	
Field Station#	12300+00		Field Station#	12381+19	
Pic 7 Desc.	ROW is adequately covered with mature vegetation.		Pic 8 Desc.	Stream crossings are in good condition.

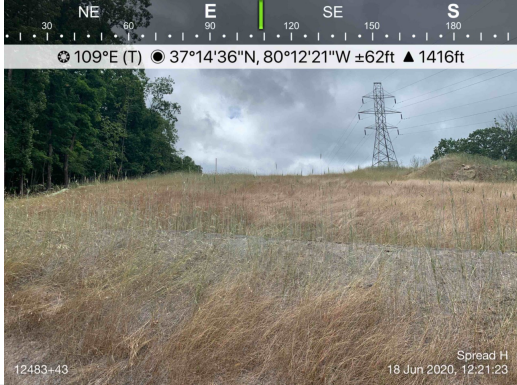
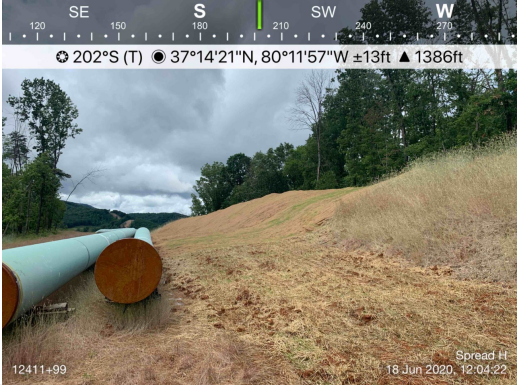
GPS Location	See Photo		GPS Location	See Photo	
Field Station#	12483+43		Field Station#	1241+99	
Pic 9 Desc.	ROW is adequately covered with mature vegetation.		Pic 10 Desc.	Spoil piles are stable and in good condition.

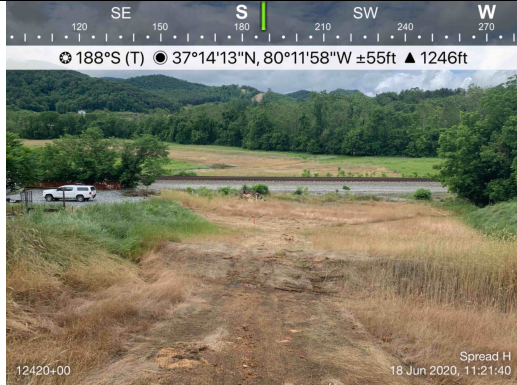
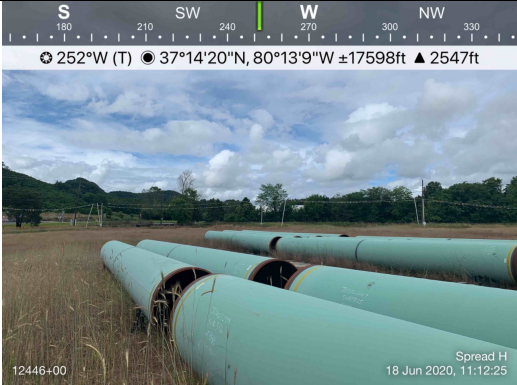
GPS Location	See Photo		GPS Location	See Photo	
Field Station#	12420+00		Field Station#	12446+00	
Pic 11 Desc.	Watersbars are in good condition.		Pic 12 Desc.	ROW is adequately covered with mature vegetation.

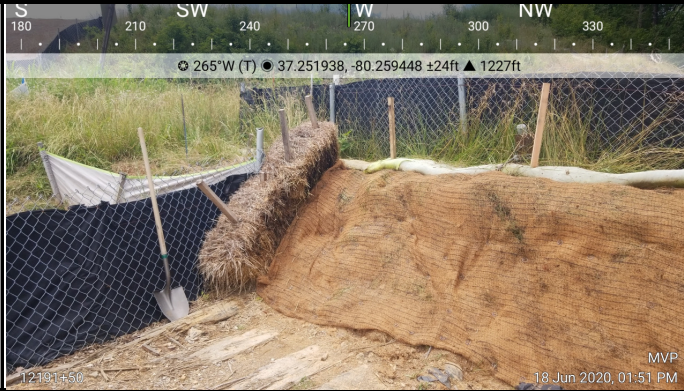
GPS Location	See Above		GPS Location	See Above	
Field Station#	12191+50		Field Station#	12191+50	
Pic 13 Desc.	Punchlist Item. Repair/Replace erosion control blanket.		Pic 14 Desc.	Punchlist Item completed. Erosion control blanket has been replaced.

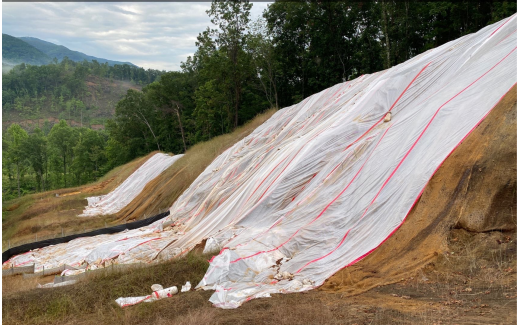
12529+00: plastic sheeting intact 2020-06-19 08:01:24-04:00		DIRECTION S (T) 37.21638°N 080.19746°W ACCURACY 8 m DATUM WGS84   12522+00: slope on GAS of S-EF19 well vegetated and stable 2020-06-19 08:30:53-04:00			
GPS Location	See photo		GPS Location	See photo	
Field Station#	12529+00		Field Station#	12522+00	
Pic 7 Desc.	Plastic sheeting still in place on stockpiles approximately 1500 feet from Yellow Finch Road.		Pic 8 Desc.	Slope on going away side of stream S-EF19 remains stable.	
DIRECTION E (T) 37.21600°N 080.19757°W ACCURACY 72 m DATUM WGS84   12519+41: stream S-EF19, facing East, upstream 2020-06-19 08:26:49-04:00		DIRECTION S (T) 37.21633°N 080.19753°W ACCURACY 21 m DATUM WGS84

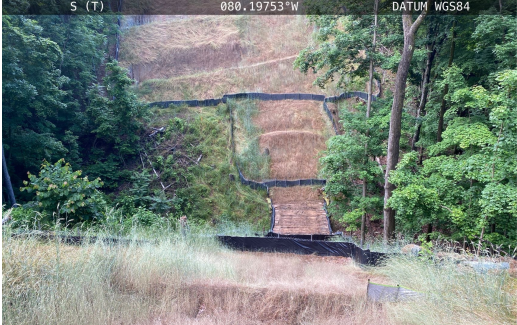
12519+41: buffer zone of stream S-EF19 stable, ECDs in good condition 2020-06-19 08:30:42-04:00

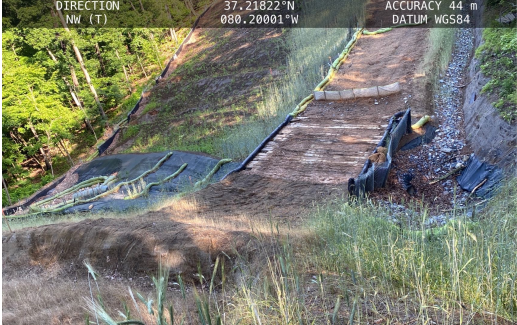
12503+70: clean water diversion pipe functioning per design 2020-06-19 09:02:22-04:00			
GPS Location	See photo		GPS Location	See photo	
Field Station#	12517+00		Field Station#	12503+70	
Pic 11 Desc.	Slope on coming in side of stream S-EF19 remains stable.		Pic 12 Desc.	Clean water diversion pipe in satisfactory condition.
