# Visual Site Inspection Report

| <b>Project Name</b> | H-600 Pipeline Spread H | <b>AFE</b> | 124300138 | <b>Spread</b> | H-600 Pipeline Spread H |
| <b>Contractor</b> | Precision | | | <b>Report #</b> | 12081 |
| <b>Inspector</b> | Logan Box | | | <b>Date/Time</b> | 6/24/2020 4:18 PM |

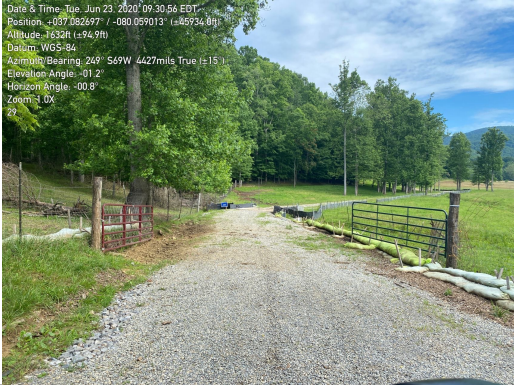
| <b>Pic 1 Desc.</b> | MVP-FR-292, Adney Gap, RCE in acceptable condition, ECDs functioning acceptably. | | <b>Pic 2 Desc.</b> | MVP-FR-292, ECDs functioning acceptably. | |

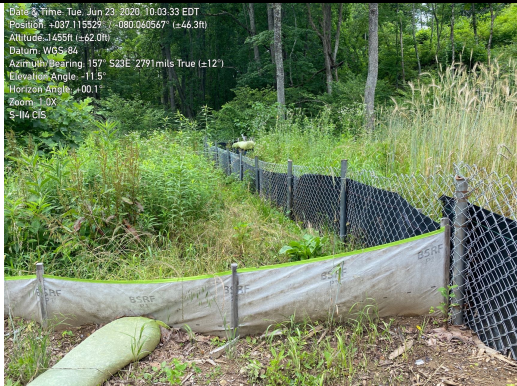
| <b>Pic 7 Desc.</b> | Good vegetative cover noted across LOD, waterbars and rock weirs stable. | | <b>Pic 8 Desc.</b> | CIS S-II4, ECDs functioning acceptably. | |

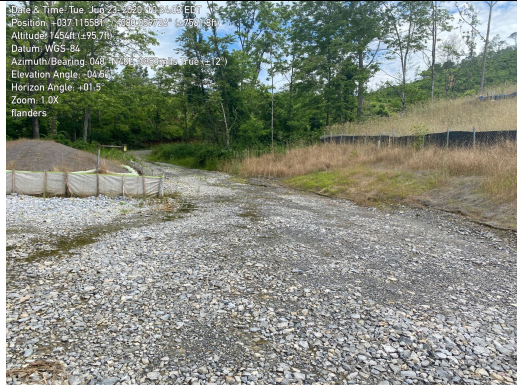
| <b>Pic 9 Desc.</b> | CIS S-II4, ECDs functioning acceptably. | | <b>Pic 10 Desc.</b> | S-II4, bridge in acceptably condition. | |

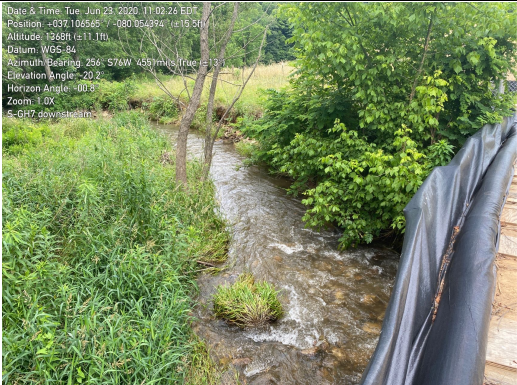
| <b>Pic 15 Desc.</b> | S-GH7, upstream, no changes noted to stream bed or banks at crossing. | | <b>Pic 16 Desc.</b> | S-GH7, upstream, native material deposition on right descending bank noted upstream of crossing. | |

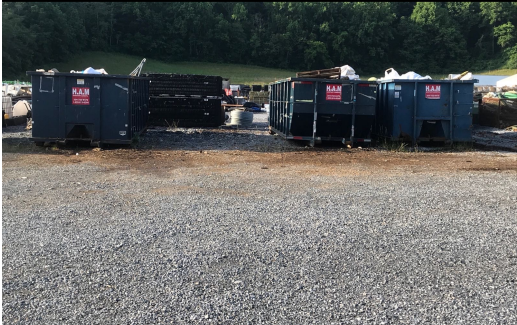
| MVP-PY-006_062420    No loose trash around dumpsters    2020-06-24 07:46:54-04:00 | | MVP-PY-006_062420    No leaky internal fittings    2020-06-24 07:47:54-04:00 | | | |
| <b>Pic 13 Desc.</b> | No loose trash around dumpsters. Looking S. | | <b>Pic 14 Desc.</b> | Blue Bulk Fuel tanks no leaky internal fittings. Looking W. | |

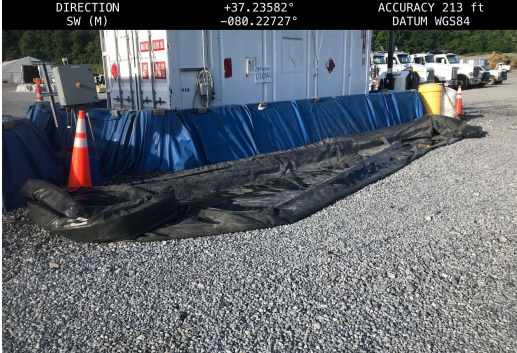
| MVP-PY-006_062420    Containment on site for tankers ...    2020-06-24 07:52:08-04:00 | | MVP-PY-006_062420    Internal drip tray empty    2020-06-24 07:53:06-04:00 | | | |
| <b>Pic 15 Desc.</b> | Containment on site for tankers offloading fuel into off road fuel unit. Looking SW. | | <b>Pic 16 Desc.</b> | Off Road Fuel unit internal drip pan empty. Looking NW. | |

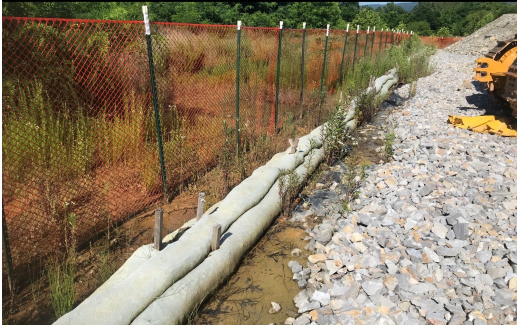
| MVP-LY-049_062420 Condition of CFS and safety fence 2020-06-24 09:26:30-04:00 | | MVP-LY-049_062420 Condition of CFS around sand pile 2020-06-24 09:27:26-04:00 | | | |
| <b>Pic 7 Desc.</b> | Condition of compost filter sock and safety fence along south LOD. Looking W. | | <b>Pic 8 Desc.</b> | Condition of compost filter sock around sand pile. Looking W. | |

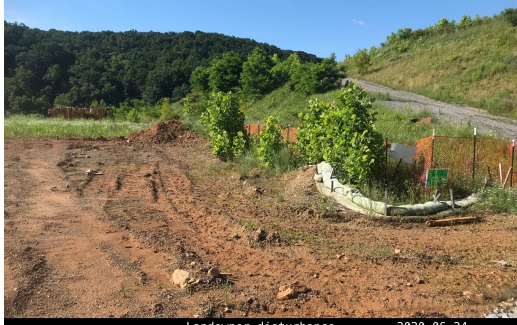
| MVP-LY-049_062420 Landowner disturbance next to CFS and ... 2020-06-24 09:33:45-04:00 | | MVP-LY-049_062420 Landowner disturbance within 100' of ... 2020-06-24 09:33:52-04:00 | | | |
| <b>Pic 9 Desc.</b> | Landowner disturbance along compost filter sock and feature. No impacts. Looking S. | | <b>Pic 10 Desc.</b> | Landowner disturbance within 100' of feature. No impacts. Looking SW. | |

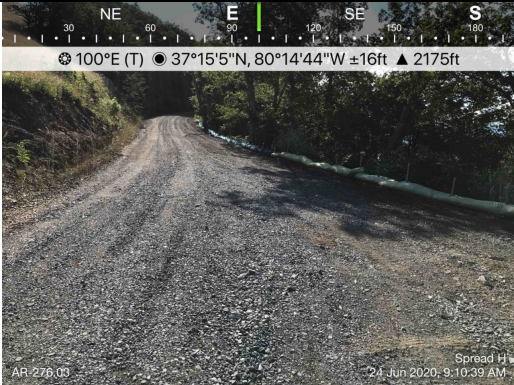
| <b>Pic 1 Desc.</b> | Start of inspection area, permanent waterbars in good condition. | | <b>Pic 2 Desc.</b> | Portajohns in secondary containment. | |

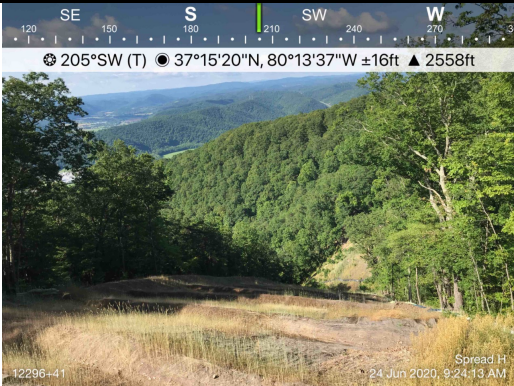
| <b>Pic 3 Desc.</b> | Controls in place and functioning on AR-276.03 | | <b>Pic 4 Desc.</b> | SSF controls in good condition. Vegetative stabilization tall and uniform. | |

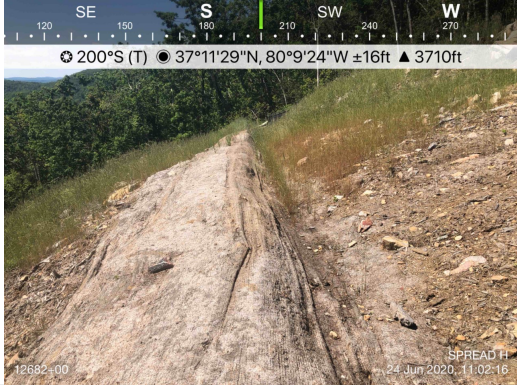
| <b>Pic 7 Desc.</b> | CE's in good condition at the Honeysuckle Rd. crossing. | | <b>Pic 8 Desc.</b> | Slope on the GAS of Honeysuckle Rd. in good condition. | |

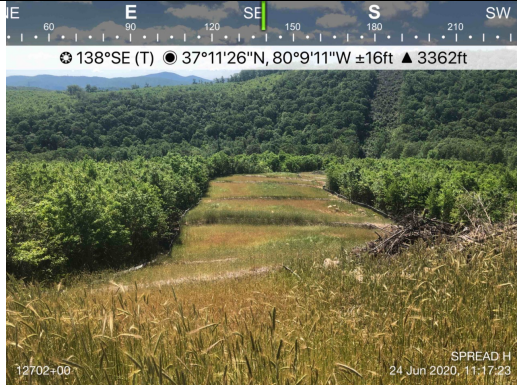
| <b>Pic 9 Desc.</b> | Waterbars functioning on the GAS of Honeysuckle Rd. | | <b>Pic 10 Desc.</b> | Additional controls in place at this location in good condition and functioning. | |

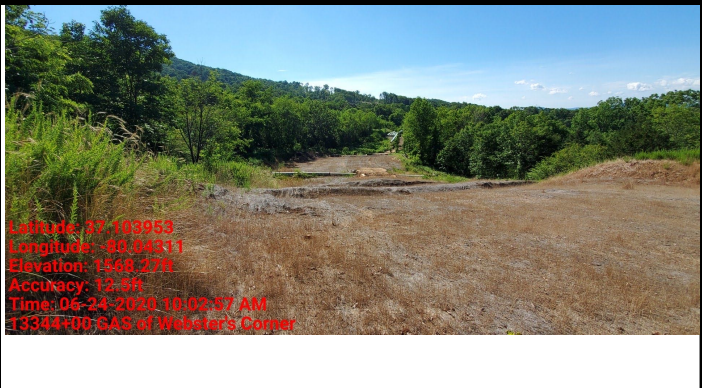
| Pic 7 Desc. | S-GH11, stream buffer well vegetated, ECDs functioning acceptably. | | Pic 8 Desc. | S-GH9, ECDs in acceptable condition along stream banks, moderate vegetation noted across LOD. | |
