Visual Site Inspection Report

Project Name	H-600 Pipeline Spread H	AFE	124300138	Spread	H-600 Pipeline Spread H
Contractor	Precision			Report #	12276
Inspector	Dawn McCullough			Date/Time	6/29/2020 1:24 PM
Permit #	TBD	Inspection Type	VA SWPP	Station Begin	13140+00
State	VA	Inspection Area	Partial	Station End	13315+70
County	Franklin	Ground	Dry	Temperature (°F)	88.00
Municipality	N/A	Weather	Sunny	Rain Gauge (in)	0.00
				Rain Accumulation Time (days)	1.00

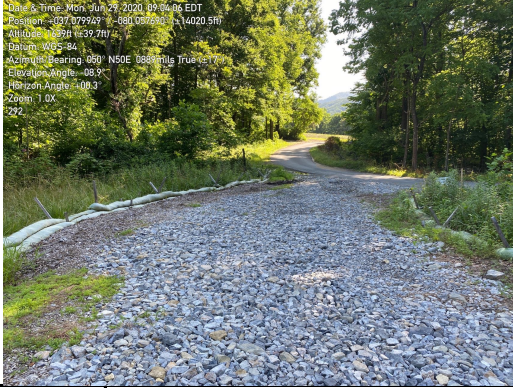
<p>Date & Time: Mon, Jun 29, 2020 09:14:06 EDT Position: +037.072049 / -080.03760 (-114020.5 ft) Altitude: 1639ft (-500m) Datum: WGS 84 Azimuth Bearing: 050° NSOE 088mils True (-1.1°) Elevation Angle: -08.8° Horizon Angle: -00.3° Horizon Angle: -00.3° Zoom: 1.0X S-114</p>		GPS Location	See photo for coordinates.
Field Station#	13141+00	Field Station#	13141+00	GPS Location	See photo for coordinates.
Pic 1 Desc.	MVP-FR-292, ECDs functioning acceptably.	Pic 2 Desc.	MVP-FR-292, Adney Gap, RCE in acceptable condition.	Field Station#	13141+00

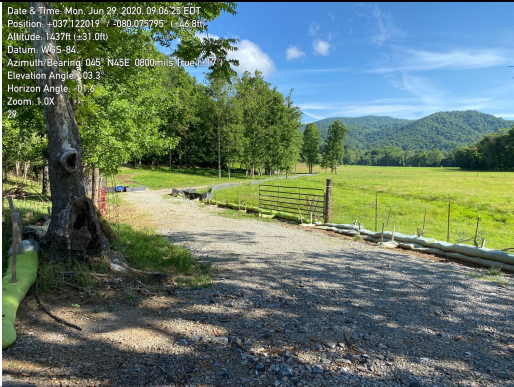
Field Station#	13190+00	Field Station#	13190+00	GPS Location	See photo for coordinates.
Pic 3 Desc.	MVP-AR-29, ECDs and RCE in acceptable condition.	Pic 4 Desc.	S-D10, upstream, vehicle noted adjacent to access road.	Field Station#	13190+00

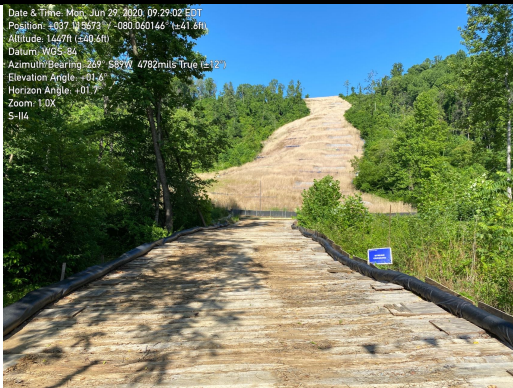
<p>Date & Time: Mon, Jun 29, 2020 09:29:02 EDT Position: +037.142671 / -080.040146 (-11841 ft) Altitude: 1447ft (-430.4 ft) Datum: WGS 84 Azimuth Bearing: 269° S69W 4782mils True (-13.3°) Elevation Angle: -01.0° Horizon Angle: -01.7° Zoom: 1.0X S-114</p>		GPS Location	See photo for coordinates.
Field Station#	13190+00	Field Station#	13260+75	GPS Location	See photo for coordinates.
Pic 5 Desc.	Looking towards GAS Dillons Mill, ROW stabilized. No disturbance in field.	Pic 6 Desc.	S-II4, CIS, ROW stable with good vegetative cover LOD, bridge in acceptable condition.	Field Station#	13260+75

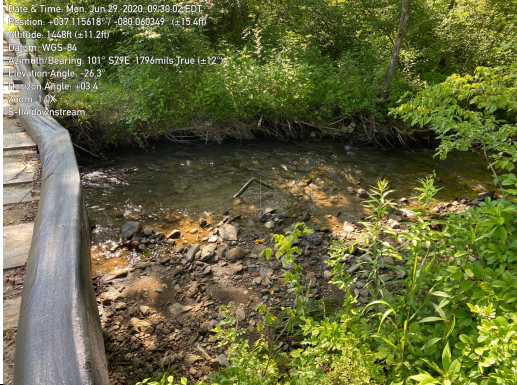
GPS Location		See photo for coordinates.		GPS Location	
Field Station#		13260+60		Field Station#	
Pic 7 Desc.		S-II4, upstream, no environmental issues noted at stream crossing.		Pic 8 Desc.	
<p>Date & Time: Mon, Jun 29, 2020, 10:00:27 EDT Position: +037.115805° / -080.059186° (+183.3m) Altitude: 1420ft (+51.2m) Datum: WGS-84 Azimuth/Bearing: 200° 888W 2765mils True (+124°) Elevation Angle: +05.3° Horizon Angle: +00.9° Zoom: 1.0X Handers</p>

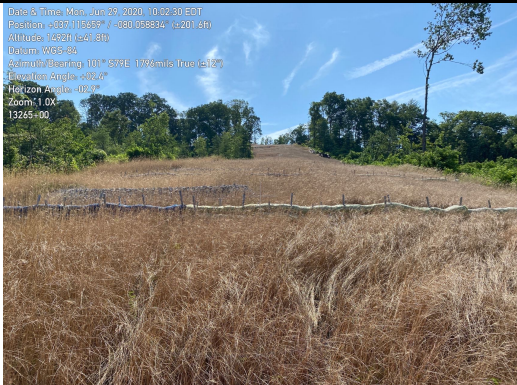
GPS Location		See photo for coordinates.		GPS Location	
Field Station#		13286+00		Field Station#	
Pic 11 Desc.		Good vegetative cover noted across LOD, permanent waterbars and waterbar extensions in acceptable condition.		Pic 12 Desc.

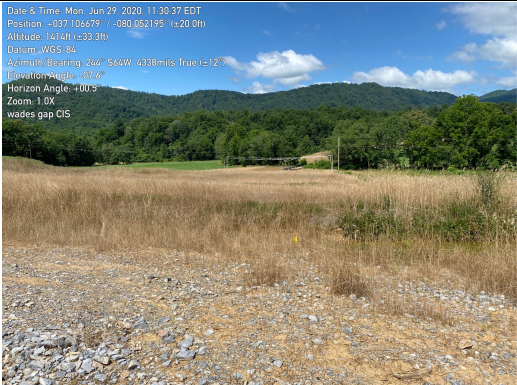
Pic 17 Desc.	Temporary waterbars, sumps, and outlet protection functioning acceptably.		Pic 18 Desc.	Wades Gap, RCE in good condition.

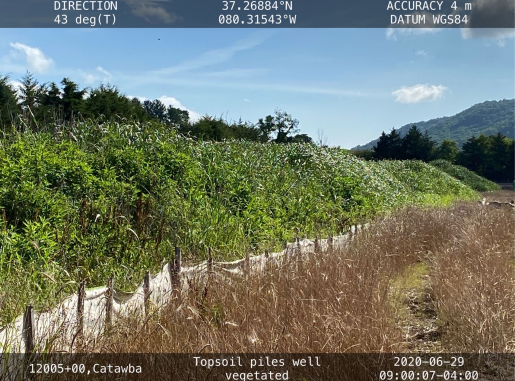
GPS Location	See photo GPS for location		GPS Location	See photo GPS for location	
Field Station#	12007+00		Field Station#	12005+00	
Pic 1 Desc.	Rain gauge reading: 0.1".		Pic 2 Desc.	Topsoil piles are well vegetated.

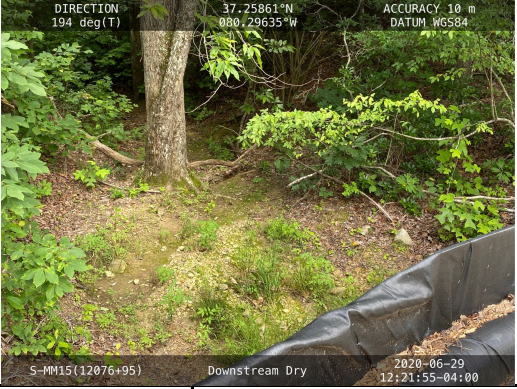
<p>DIRECTION 194 deg(T) 37.25861°N 080.29635°W ACCURACY 10 m DATUM WGS84</p> <p>S-MM15(12076+95) Downstream Dry 2020-06-29 12:21:55-04:00</p>			
GPS Location	See photo GPS for location		GPS Location	See photo GPS for location	
Field Station#	12075+00		Field Station#	12076+95	
Pic 13 Desc.	Sump and water bar are in acceptable condition.		Pic 14 Desc.	ECDs surrounding S-MM15 are stable. Stream is dry.

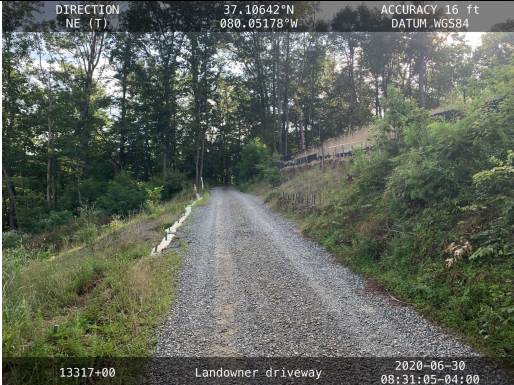
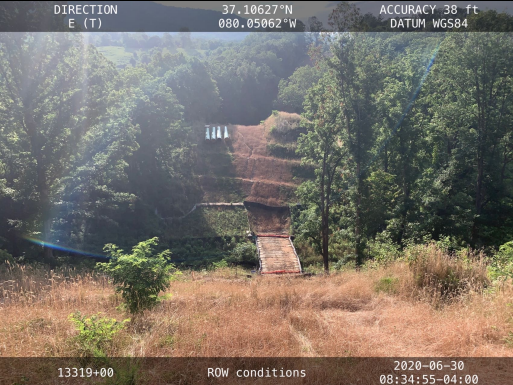
GPS Location	See photo for gps location data.		GPS Location	See photo for gps location data.	
Field Station#	13317+00		Field Station#	13319+00	
Pic 1 Desc.	Photo shows the landowner driveway crossing near Wades Gap Road.		Pic 2 Desc.	Photo shows the ROW conditions from about 13319+00 to 13323+00.

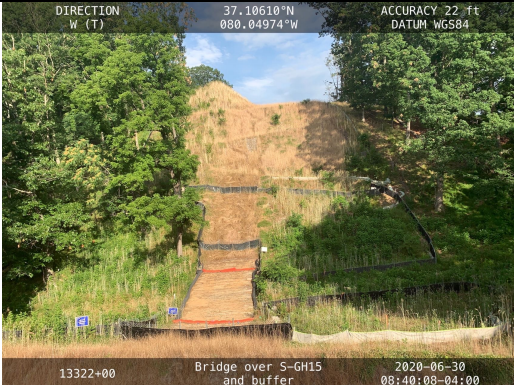
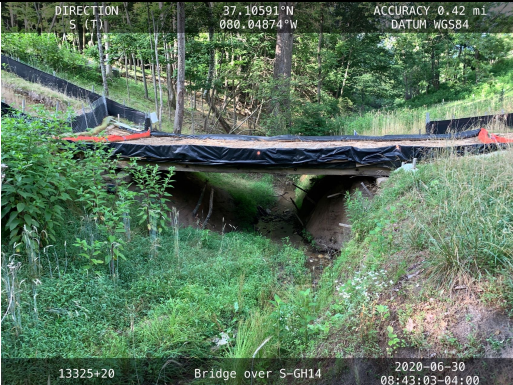
GPS Location	See photo for gps location data.		GPS Location	See photo for gps location data.	
Field Station#	13322+00		Field Station#	13325+20	
Pic 3 Desc.	Photo shows the bridge over stream S-GH15 and buffer ECDs.		Pic 4 Desc.	Photo shows the bridge over stream S-GH14.

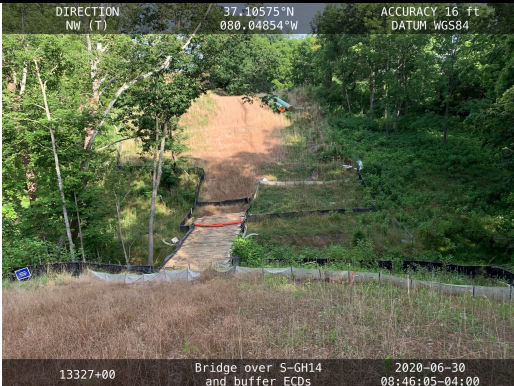
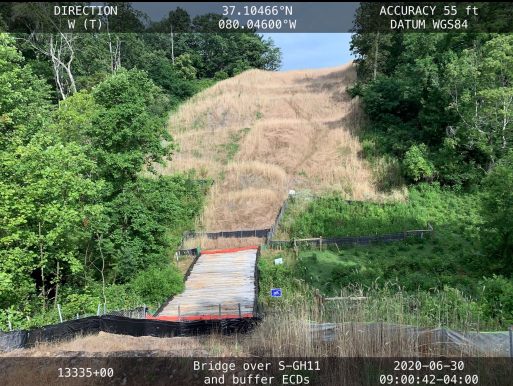
GPS Location	See photo for gps location data.		GPS Location	See photo for gps location data.	
Field Station#	13327+00		Field Station#	13335+00	
Pic 5 Desc.	Photo shows the bridge over stream S-GH14 and buffer ECDs.		Pic 6 Desc.	Photo shows the ROW condition from about 13332+00 to 13335+00.

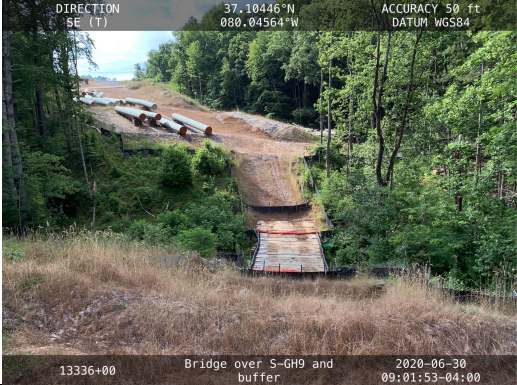
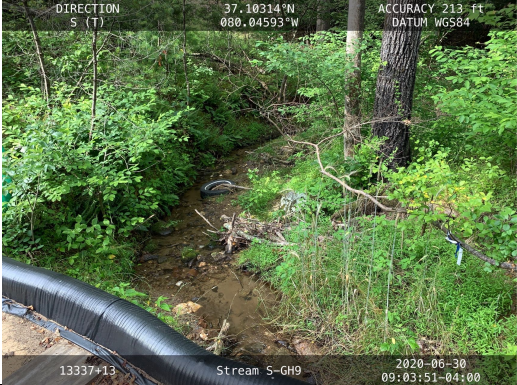
GPS Location	See photo for gps location data.		GPS Location	See photo for gps location data.	
Field Station#	13336+00		Field Station#	13337+13	
Pic 7 Desc.	Photo shows the bridge over stream S-GH9 and buffer ECDs.		Pic 8 Desc.	Photo shows stream S-GH9 downstream from the ROW crossing.

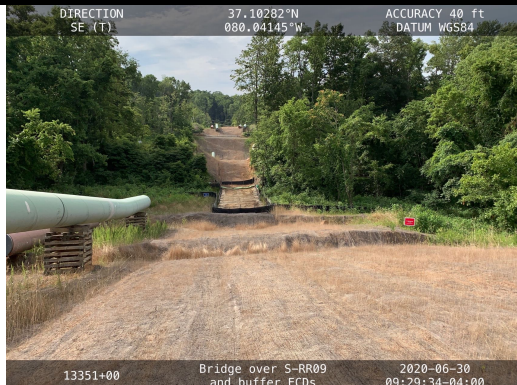
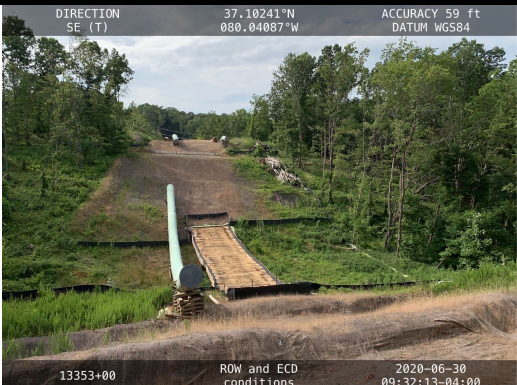
GPS Location	See photo for gps location data.		GPS Location	See photo for gps location data.	
Field Station#	13351+00		Field Station#	13353+00	
Pic 11 Desc.	Photo shows the bridge over stream S-RR09 and buffer ECDs.		Pic 12 Desc.	Photo shows the ROW conditions from about 13353+00 to 13356+00.

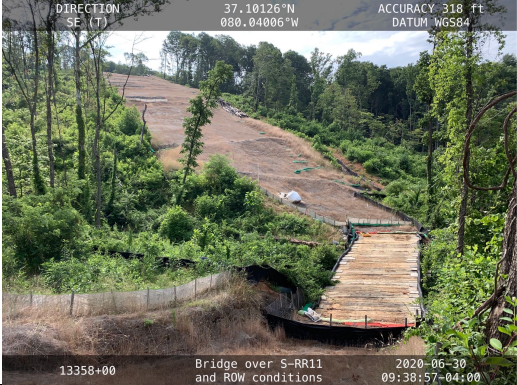
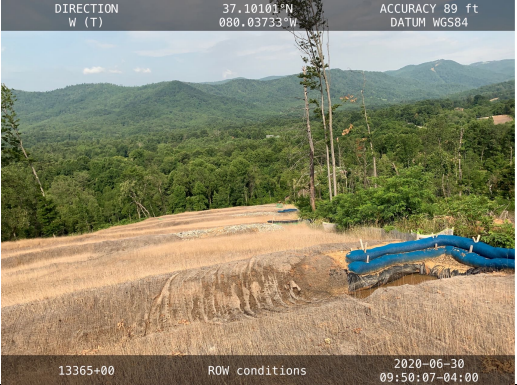
GPS Location	See photo for gps location data.		GPS Location	See photo for gps location data.	
Field Station#	13358+00		Field Station#	13365+00	
Pic 13 Desc.	Photo shows the bridge over stream S-RR11 and ROW conditions from about 13358+00 to 13363+00.		Pic 14 Desc.	Photo shows the ROW conditions from about 13363+00 to 13365+00.

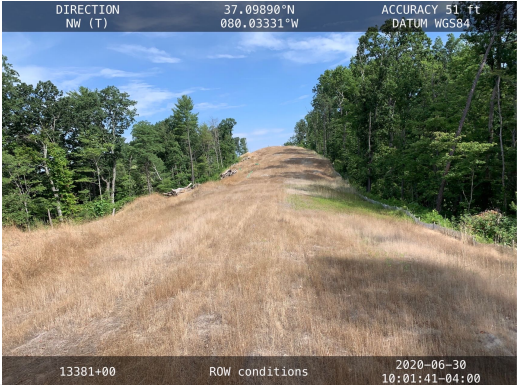
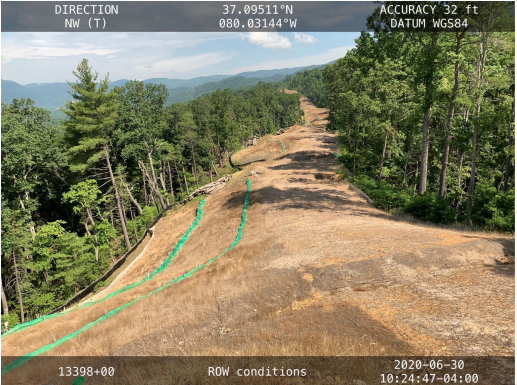
GPS Location	See photo for gps location data.		GPS Location	See photo for gps location data.	
Field Station#	13381+00		Field Station#	13398+00	
Pic 15 Desc.	Photo shows the ROW condition from about 13376+00 to 13381+00.		Pic 16 Desc.	Photo shows the ROW condition from about 13385+00 to 13398+00.

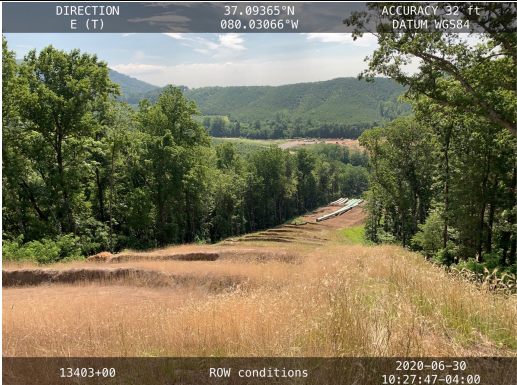
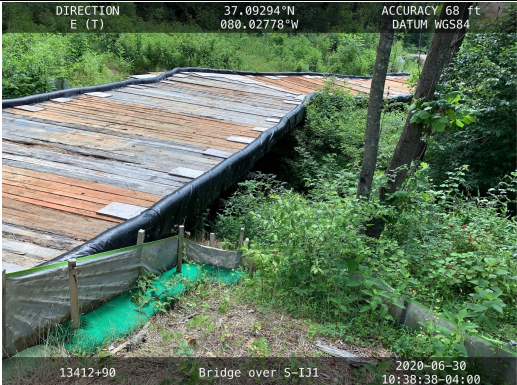
GPS Location	See photo for gps location data.		GPS Location	See photo for gps location data.	
Field Station#	13403+00		Field Station#	13412+90	
Pic 17 Desc.	Photo shows the ROW condition from about 13403+00 to 13410+00.		Pic 18 Desc.	Photo shows the bridge over stream S-IJ1.

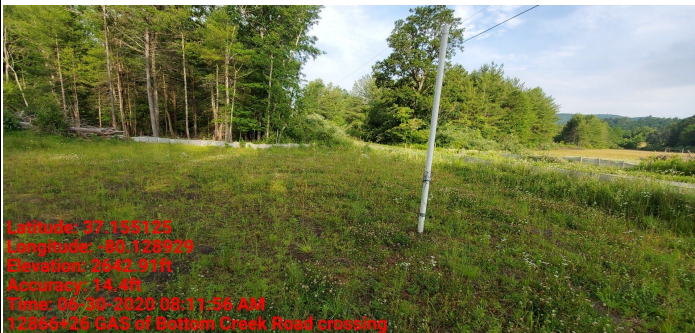
<p>Latitude: 37.155123 Longitude: -80.128939 Elevation: 2642.91ft Accuracy: 14.4ft Time: 06/30/2020 08:11:56 AM 12866+26 GAS of Bottom Creek Road crossing</p>

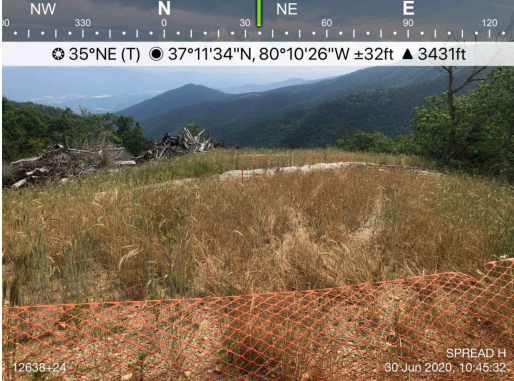
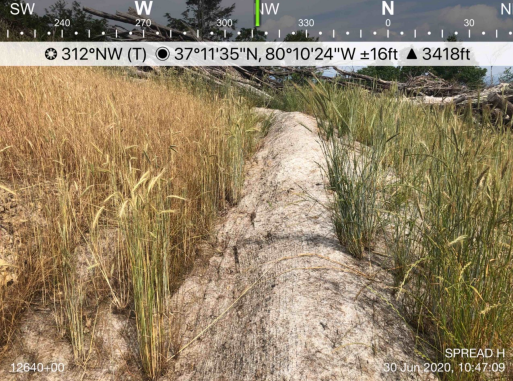
GPS Location	see photo		GPS Location	see photo	
Field Station#	12638+24		Field Station#	12640+00	
Pic 1 Desc.	GAS slope of AR-279.01 in good condition.		Pic 2 Desc.	Waterbars on this slope in good condition and functioning.

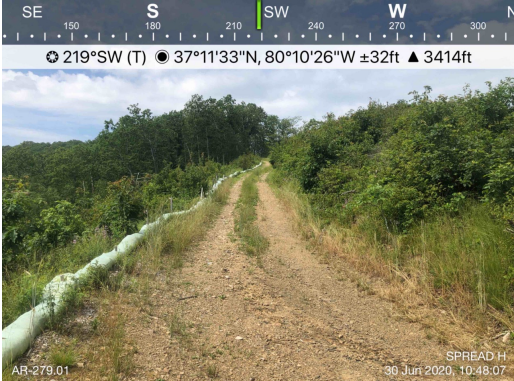
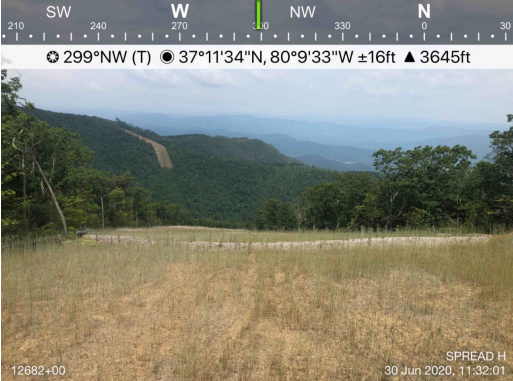
GPS Location	see photo		GPS Location	see photo	
Field Station#	279+01		Field Station#	12682+00	
Pic 3 Desc.	Ar-279.01 in good condition with controls in place.		Pic 4 Desc.	CIS slope of Honeysuckle Rd. in good condition with vegetation continuing to fill in.

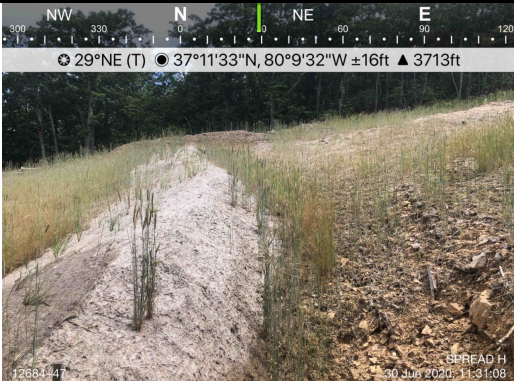
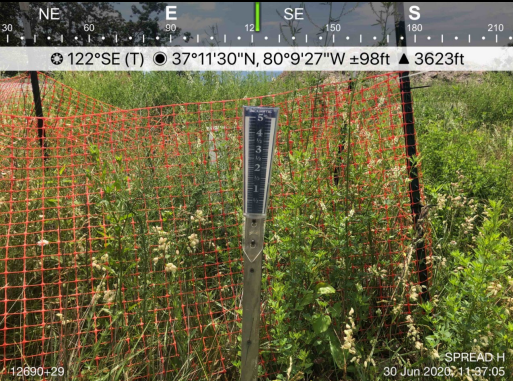
GPS Location	see photo		GPS Location	see photo	
Field Station#	12684+47		Field Station#	12690+29	
Pic 5 Desc.	Waterbars on the CIS of Honeysuckle in good condition.		Pic 6 Desc.	Rain gauge at Honeysuckle Rd. showing 0"

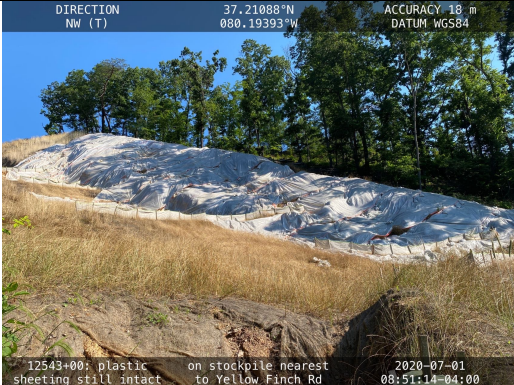
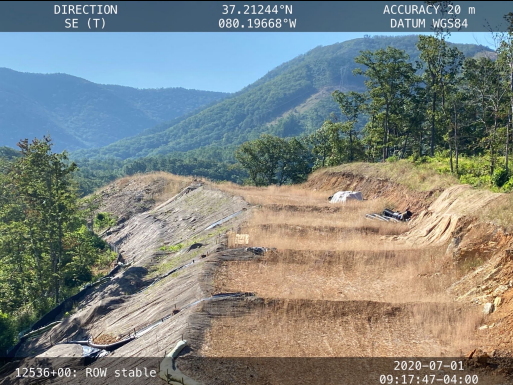
GPS Location	See photo		GPS Location	See photo	
Field Station#	12543+00		Field Station#	12536+00	
Pic 1 Desc.	Plastic sheeting still secure on stockpile nearest to Yellow Finch Road.		Pic 2 Desc.	View of ROW on going away side of landowner's crossing near Yellow Finch Road.

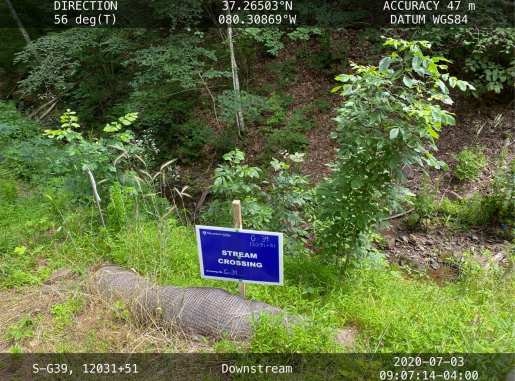
GPS Location	See photo GPS for location		GPS Location	See photo GPS for location	
Field Station#	12031+51		Field Station#	12031+51	
Pic 1 Desc.	Downstream water is low and clear.		Pic 2 Desc.	New signage installed with stream ID on it.

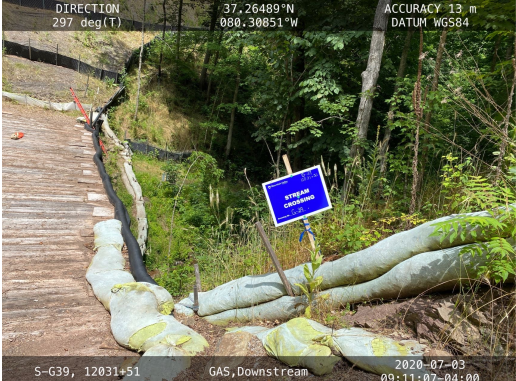
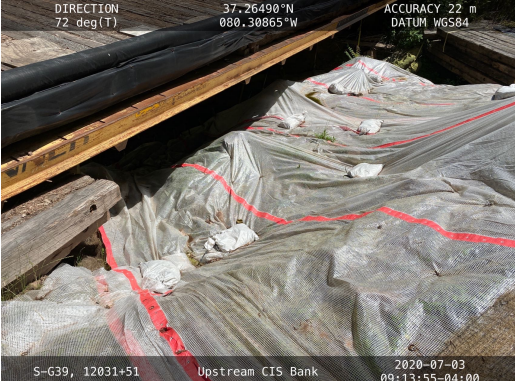
GPS Location	See photo GPS for location		GPS Location	See photo GPS for location	
Field Station#	12031+51		Field Station#	12031+51	
Pic 3 Desc.	New signage installed with stream ID on it.		Pic 4 Desc.	ECDs in acceptable condition.

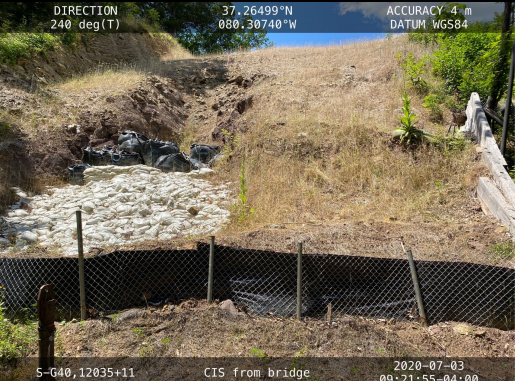
GPS Location	See photo GPS for location		GPS Location	See photo GPS for location	
Field Station#	12035+11		Field Station#	12035+11	
Pic 5 Desc.	Stream running low and clear. ECDs are in acceptable condition.		Pic 6 Desc.	ECDs and vegetation are acceptable.

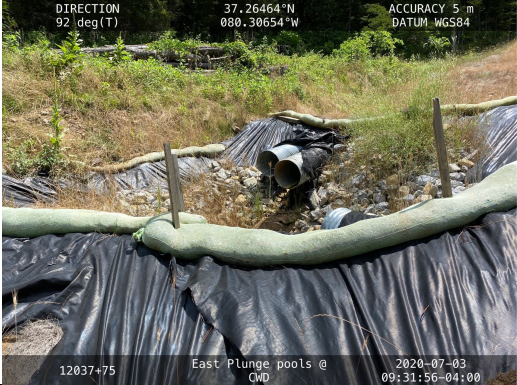
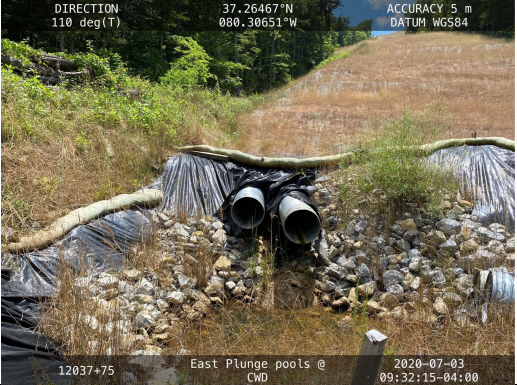
GPS Location	See photo GPS for location		GPS Location	See photo GPS for location	
Field Station#	12037+75		Field Station#	12037+75	
Pic 13 Desc.	Plunge pools and CWD are in acceptable condition.		Pic 14 Desc.	Plunge pools and CWD are in acceptable condition.

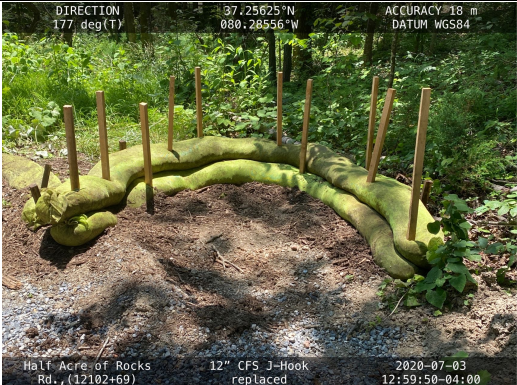
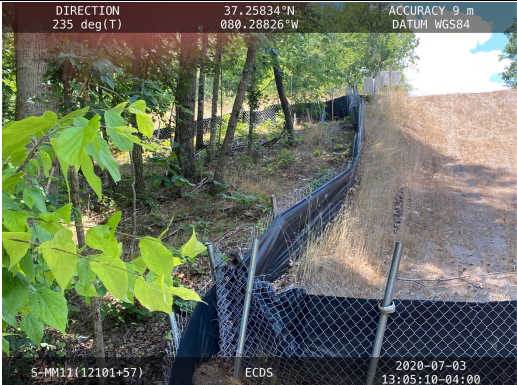
GPS Location	See photo GPS for location		GPS Location	See photo GPS for location	
Field Station#	12102+69		Field Station#	12101+57	
Pic 17 Desc.	Deteriorated 12" CFS J-hook replaced.		Pic 18 Desc.	ECDs at stream are in acceptable condition.

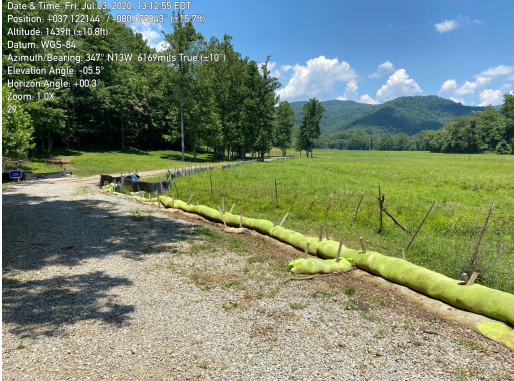
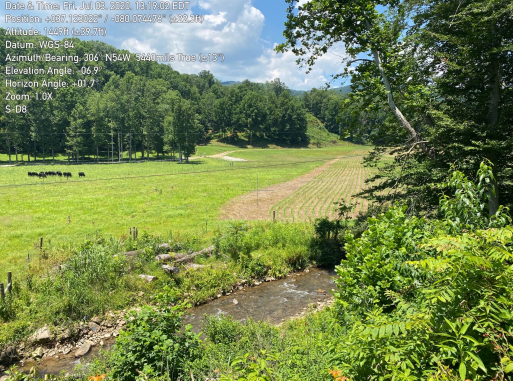
GPS Location	See photos for coordinates.		GPS Location	See photos for coordinates.	
Field Station#	13190+00		Field Station#	13197+50	
Pic 1 Desc.	MVP-SR-29, ECDs in acceptable condition, cattle noted in field.		Pic 2 Desc.	S-D8, no disturbance in this area.

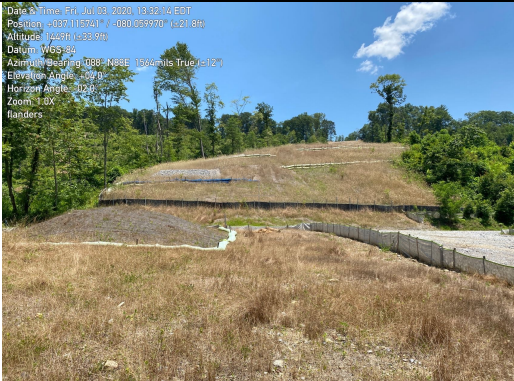
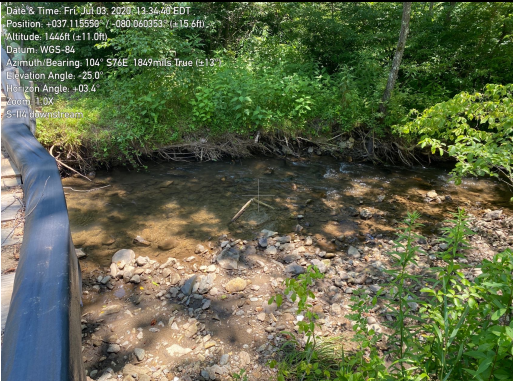
GPS Location	See photos for coordinates.		GPS Location	See photos for coordinates.	
Field Station#	13261+50		Field Station#	13260+60	
Pic 3 Desc.	ROW temporarily stabilized on the CIS and Flanders Road and permanently restored on GAS of road crossing.		Pic 4 Desc.	S-II4, downstream, no environmental concerns noted.

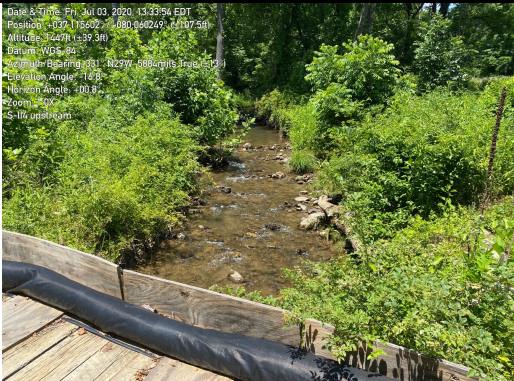
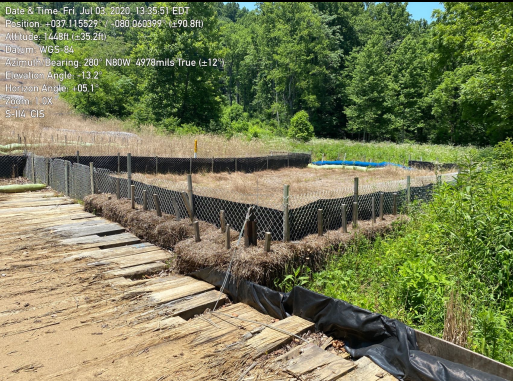
GPS Location	See photos for coordinates.		GPS Location	See photos for coordinates.	
Field Station#	13260+60		Field Station#	13260+00	
Pic 5 Desc.	S-II4, upstream, ECDs in acceptable condition along banks, no environmental issues noted.		Pic 6 Desc.	Perimeter ECDs in acceptable condition.

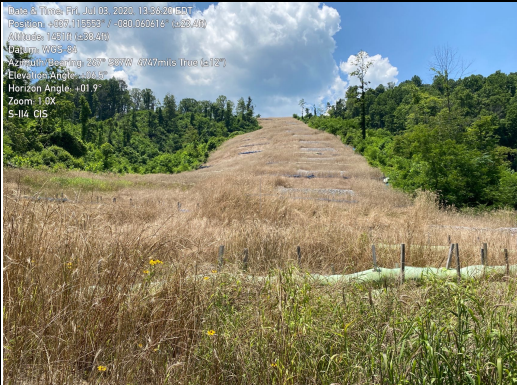
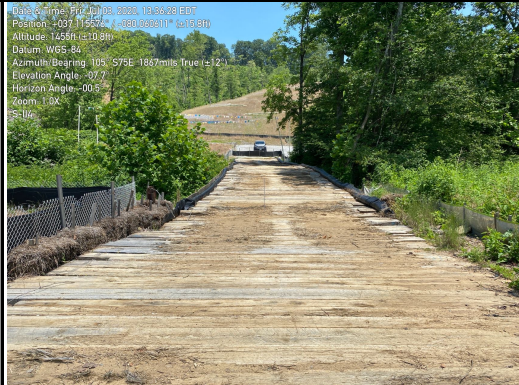
GPS Location				See photos for coordinates.				GPS Location				See photos for coordinates.			
Field Station#				13259+50				Field Station#				13260+00			
Pic 7 Desc.				ROW restored, some temporary vegetation dying off, permanent waterbars stable.				Pic 8 Desc.				Bridge over S-114 in acceptable condition.

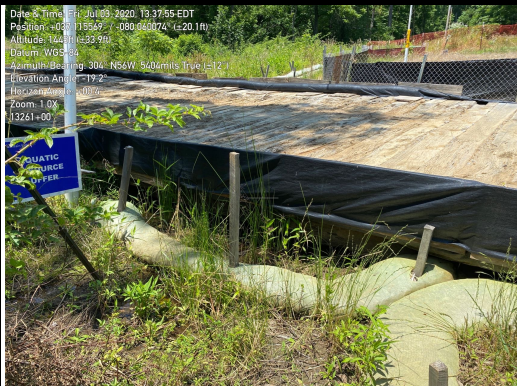
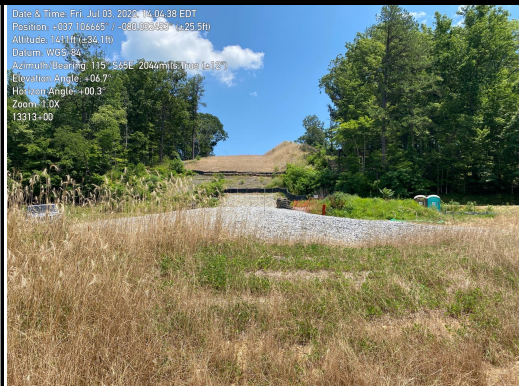
GPS Location				See photos for coordinates.				GPS Location				See photos for coordinates.			
Field Station#				13260+85				Field Station#				13314+00			
Pic 9 Desc.				ECDs in acceptable condition.				Pic 10 Desc.				Wades Gap Road, RCE in good condition, ROW temporarily stabilized.

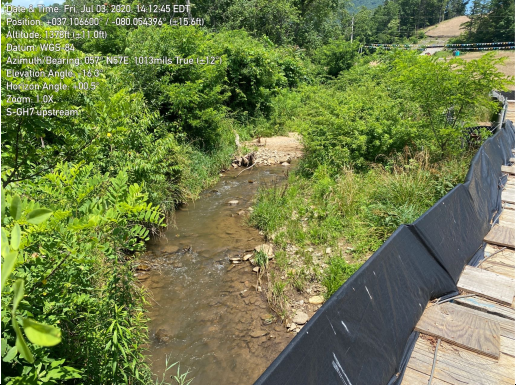
GPS Location	See photos for coordinates.	GPS Location	See photos for coordinates.
Field Station#	13309+25	Field Station#	13309+09
Pic 13 Desc.	GAS S-GH7, bridge and perimeter ECDs in acceptable condition.	Pic 14 Desc.	S-GH7, upstream, no changes noted to stream bed or banks.
<p>Date & Time: Fri Jul 03, 2020 14:13:09 EDT Position: -037.106556, -080.054229 (s1675.5H) Altitude: 1300ft (s151.4H) Datum: WGS 84 Azimuth/Bearing: 314° N44W 359mils True (s12.1) Elevation Angle: -42.5 Horizon Angle: -04.6 Zoom: 1.0X S-GH7 upstream</p>

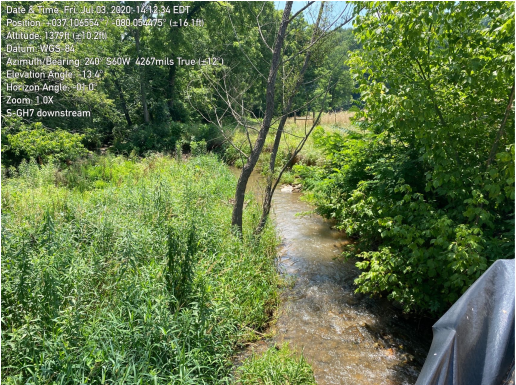
GPS Location	See photos for coordinates.	GPS Location	See photos for coordinates.
Field Station#	13309+09	Field Station#	13309+09
Pic 15 Desc.	S-GH7, upstream, no changes noted to stream bed or banks.	Pic 16 Desc.	S-GH7, downstream, no environmental issues noted.
<p>Date & Time: Fri Jul 03, 2020 14:15:40 EDT Position: -037.106557, -080.053387 (s1675.5H) Altitude: 1305ft (s11.1H) Datum: WGS 84 Azimuth/Bearing: 100° NS/W 591mils True (s12.1) Elevation Angle: -07.2 Horizon Angle: -02.2 Zoom: 1.0X 13308+00</p>

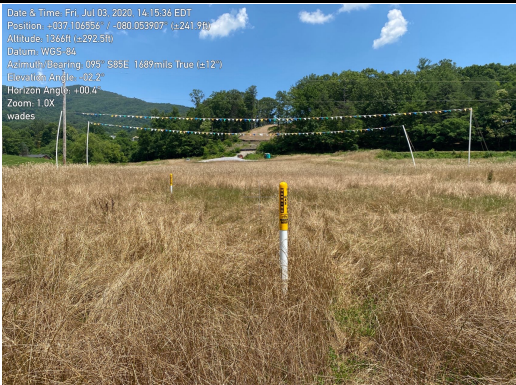
GPS Location	See photos for coordinates.	GPS Location	See photos for coordinates.
Field Station#	13308+00	Field Station#	13311+00
Pic 17 Desc.	ROW permanently restored.	Pic 18 Desc.	ROW stable, with vegetative cover noted across LOD.
