Visual Site Inspection Report

| Project Name | H-600 Pipeline Spread H | AFE | 124300138 | Spread | H-600 Pipeline Spread H |
| Inspector | John Brcic | | | Date/Time | 7/13/2020 1:53 PM |
| Permit # | TBD | Inspection Type | VA SWPP | Station Begin | 12443+75 |

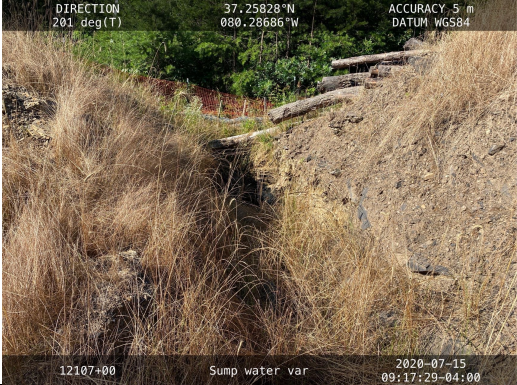
| Field Station# | 12107+00 | | Field Station# | 12107+00 | |

| Pic 7 Desc. | Sump and water bar | | Pic 8 Desc. | Sump and water bar | |

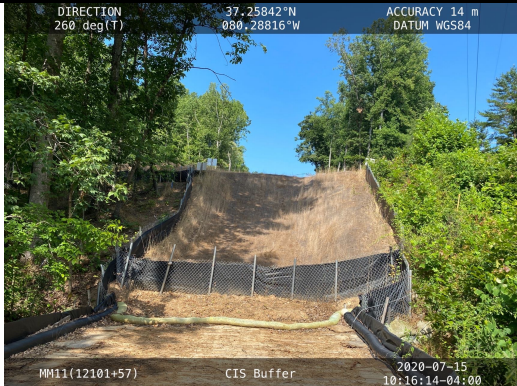
| Field Station# | 12101+57 | | Field Station# | 12101+57 | |

| Pic 9 Desc. | MM11, CIS buffer | | Pic 10 Desc. | MM11, upstream | |

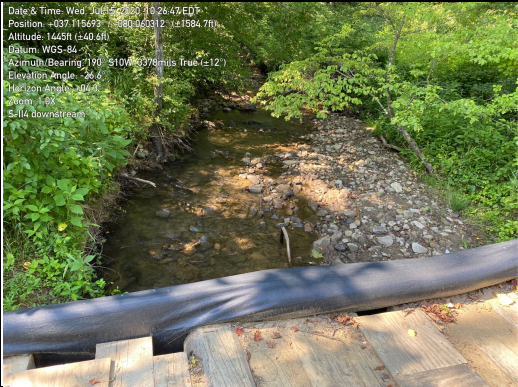
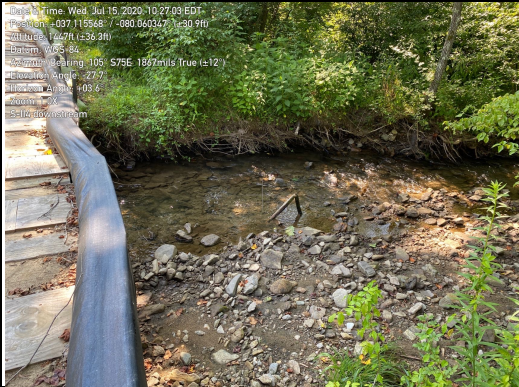
| AFE | 124300138 | Date/Time | 7/15/2020 7:21 PM | Report # | |
|--|--|---|---|--|--|
| Field Station# | 13260+60 | | Field Station# | 13260+60 | |

| AFE | 124300138 | Date/Time | 7/15/2020 7:21 PM | Report # | |
|--|--|---|---|--|--|
| Pic 7 Desc. | S-II4, downstream, no changes noted at stream. | | Pic 8 Desc. | S-II4, water level low, no environmental issues. | |

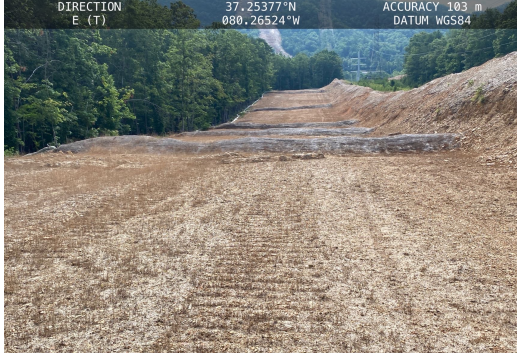
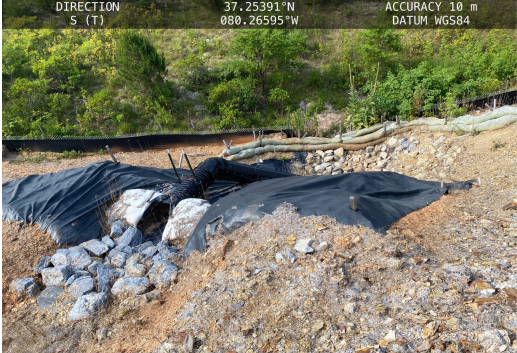
| Pic 9 Desc. | ROW stable | | Pic 10 Desc. | Slope drain in satisfactory condition. | |

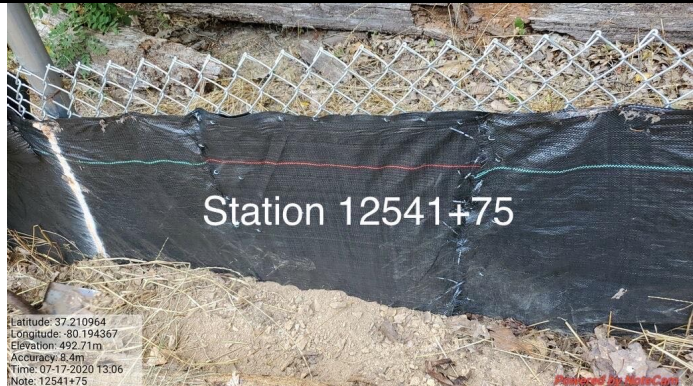
| Pic 3 Desc. | MVP ROW crossing at Yellow Finch Road. | | Pic 4 Desc. | A small hole was observed near the bottom off the SSF on the slope on CIS of Yellow Finch Road. | |

| 7. Identify all remedial measures that have been taken since the previous inspection was conducted. Station 12443+75 to 12544+06.....Activity since last SWPPP inspection. Super silt fence fabric was replaced where a hole was found next to Cove Hollow Road. | | | | | |

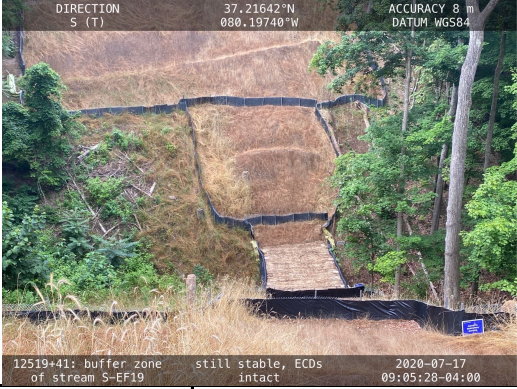
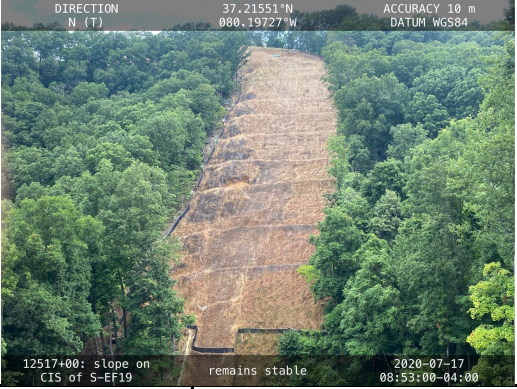
| Pic 13 Desc. | Buffer zone of stream S-EF19 remains stable, ECDs intact and effective. | | Pic 14 Desc. | The slope on the coming in side of stream S-EF19 remains stable. | |

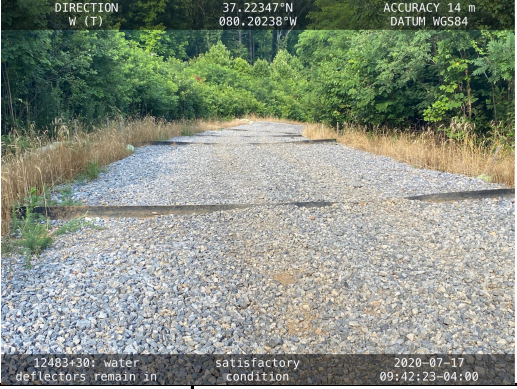
| Pic 15 Desc. | Clean water diversion pipe intact and functioning properly. | | Pic 16 Desc. | Water deflectors remain in satisfactory condition on MVP-MLV-AR-28. | |
