## Visual Site Inspection Report

| <b>Project Name</b> | H-600 Pipeline Spread H | <b>AFE</b> | 124300138 | <b>Spread</b> | H-600 Pipeline Spread H |
| <b>Contractor</b> | Precision | | | <b>Report #</b> | 12861 |
| <b>Inspector</b> | Logan Box | | | <b>Date/Time</b> | 7/22/2020 5:05 PM |

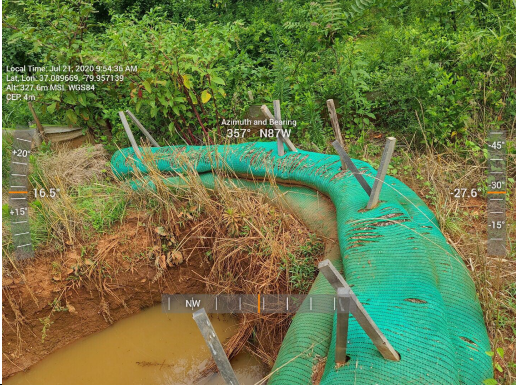
| <b>Field Station#</b> | 13655+00 | <b>Field Station#</b> | 13659+03 | | |

| <b>Pic 1 Desc.</b> | CFS at sump end treatment needs replaced, added to the punch list. | <b>Pic 2 Desc.</b> | ECDs and equipment bridge protection in functioning order | | |

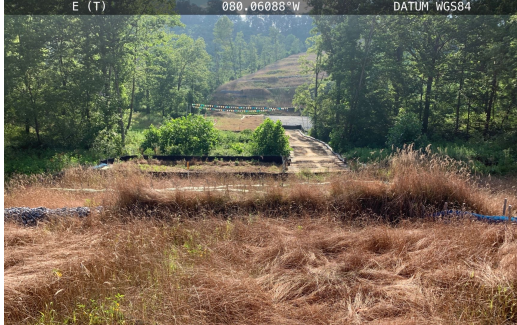
| <b>Pic 9 Desc.</b> | Photo shows the bridge over stream S-II4 and adjacent buffer ECDs. | | <b>Pic 10 Desc.</b> | Photo shows stream S-II4 downstream from the ROW crossing. | |

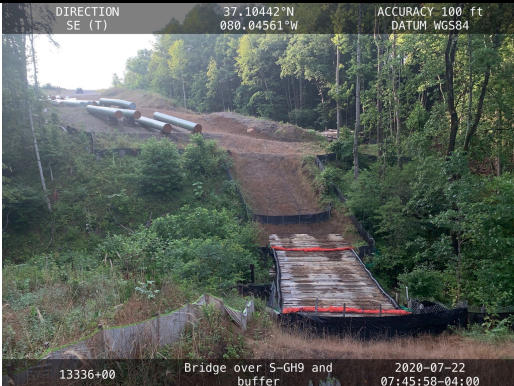
| <b>Pic 3 Desc.</b> | Photo shows the bridge over stream S-GH9 and adjacent buffer. | | <b>Pic 4 Desc.</b> | Photo shows stream S-GH9 downstream from the ROW crossing. | |

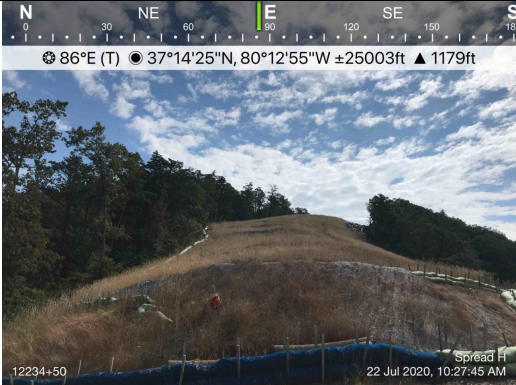
| <b>Pic 1 Desc.</b> | Start of inspection area, Perm. waterbars in good condition. | | <b>Pic 2 Desc.</b> | Portajohns in secondary containment. | |

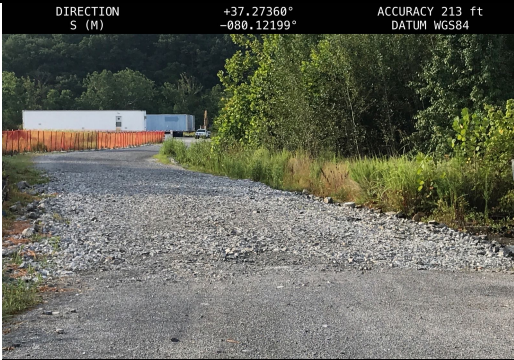
| <b>Pic 1 Desc.</b> | Condition of rock entrance. No sediment on stone surface. Looking S. | | <b>Pic 2 Desc.</b> | Condition of containment under light plant. Free of stormwater. Looking SW. | |

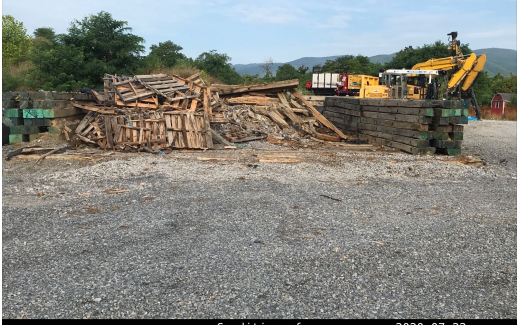
| <b>Pic 15 Desc.</b> | Condition of temporary trash transfer pit. Looking W. | | <b>Pic 16 Desc.</b> | Landowner disturbance along compost filter sock and feature W-CV21B. No impacts. Looking S. | |
