Visual Site Inspection Report

Project Name	H-600 Pipeline Spread H	AFE	124300138	Spread	H-600 Pipeline Spread H
Contractor	Precision			Report #	13015
Inspector	Tammy Kruizenga			Date/Time	7/27/2020 4:35 PM
Permit #	TBD	Inspection Type	VA SWPP	Station Begin	12005+00
State	VA	Inspection Area	Partial	Station End	12119+17
County	Montgomery	Ground	Dry	Temperature (°F)	88.00
Municipality	N/A	Weather	Sunny	Rain Gauge (in)	0.40
				Rain Accumulation Time (days)	1.00

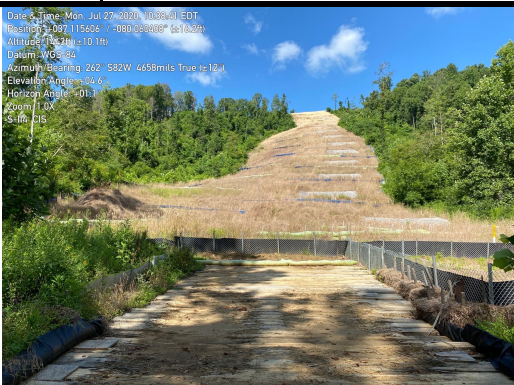
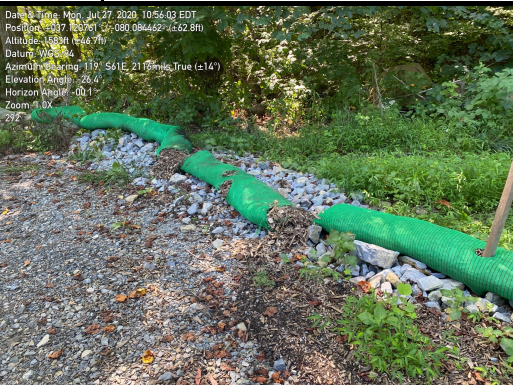
GPS Location	See photo for coordinates.		GPS Location	See photo for coordinates.	
Field Station#	13260+50		Field Station#	13148+00	
Pic 5 Desc.	CIS S-II4, vegetative cover noted across LOD, permanent waterbars and extensions stable.		Pic 6 Desc.	MVP-FR-292, CFS damaged, MBP punch list item.

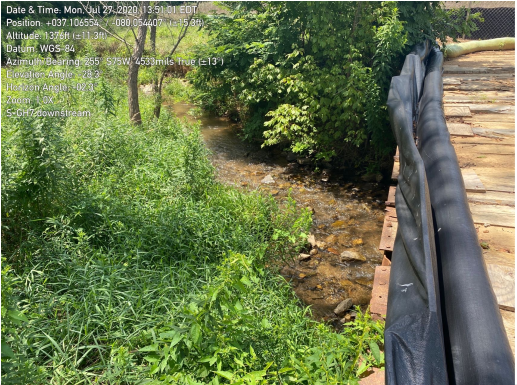
GPS Location	See photo for coordinates.		GPS Location	See photo for coordinates.	
Field Station#	13310+00		Field Station#	13309+09	
Pic 15 Desc.	GAS S-GH7, ECDs in acceptable condition.		Pic 16 Desc.	S-GH7, downstream, no changes noted to stream bed or banks.

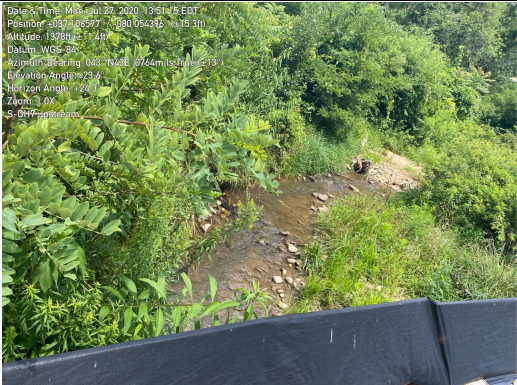
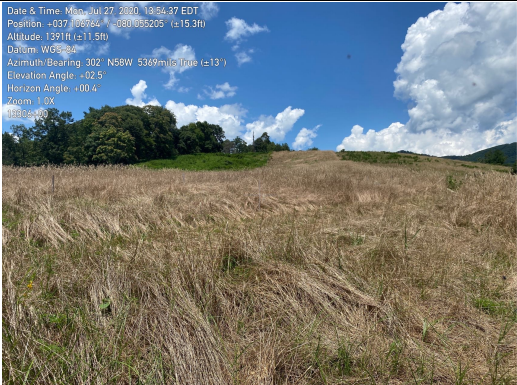
Pic 17 Desc.	S-GH7, upstream, no changes noted to stream bed or banks.		Pic 18 Desc.	Good vegetative coverage noted across LOD.

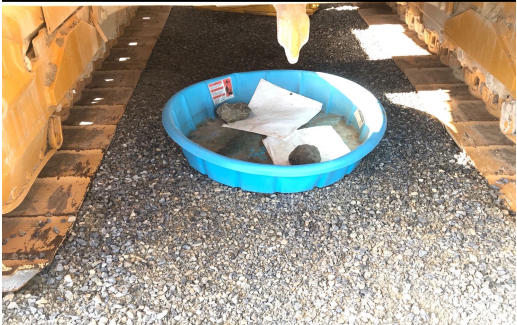
MVP-LY-049_072820		Containments under stored equipment		2020-07-28 08:42:32-04:00	
GPS Location	MVP-LY-049 See photo for gps data		GPS Location	MVP-LY-049 See photo for gps data	
Field Station#	+0		Field Station#	+0	
Pic 13 Desc.	Condition of containments under stored equipment. Looking SE.		Pic 14 Desc.	Condition of containment under stored equipment. Looking S.	
DIRECTION W (M) +37.27046° -080.12468° ACCURACY 164 ft DATUM WGS84

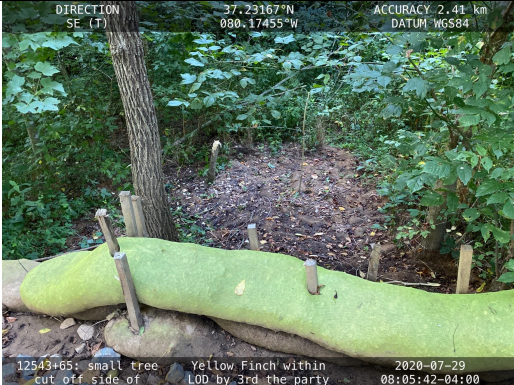
<p>DIRECTION SE (T) 37.23167°N 080.17455°W ACCURACY 2.41 km DATUM WGS84</p> <p>12543+65: small tree cut off side of Yellow Finch within LOD by 3rd the party 2020-07-29 08:05:42-04:00</p>

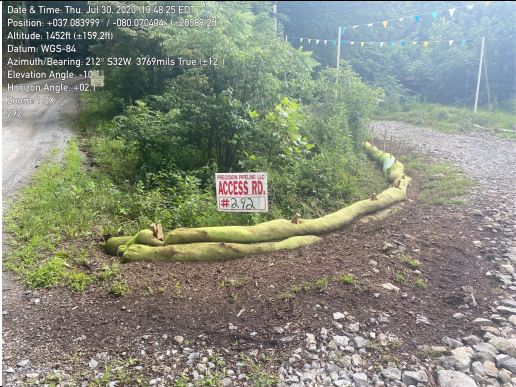
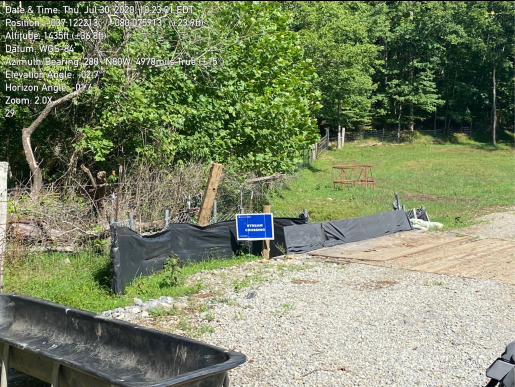
GPS Location	See photo for coordinates.		GPS Location	See photo for coordinates.	
Field Station#	13148+00		Field Station#	13190+00	
Pic 1 Desc.	MVP-FR-292, punch list item (repair CFS along RCE) complete.		Pic 2 Desc.	MVP-AR-29, access road in acceptable condition, wood beam left against SSF, cattle feeding trough in access road.
