Visual Site Inspection Report

Project Name	H-600 Pipeline Spread H	AFE	124300138	Spread	H-600 Pipeline Spread H
Contractor	Precision			Report #	12452
Inspector	Pat Davis			Date/Time	7/6/2020 4:00 PM
Permit #	TBD	Inspection Type	VA SWPP	Station Begin	+0
State	VA	Inspection Area	Partial	Station End	+0
County	Montgomery	Ground	Damp	Temperature (°F)	91.00
Municipality	N/A	Weather	Sunny	Rain Gauge (in)	0.10
				Rain Accumulation Time (days)	0.00

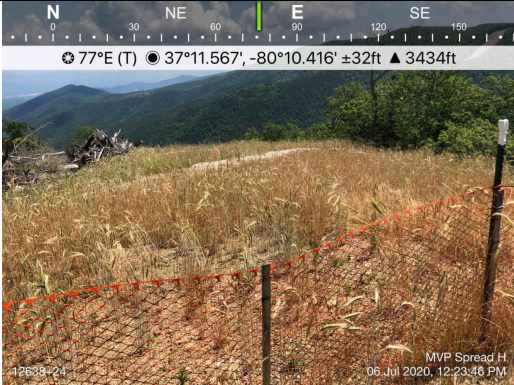
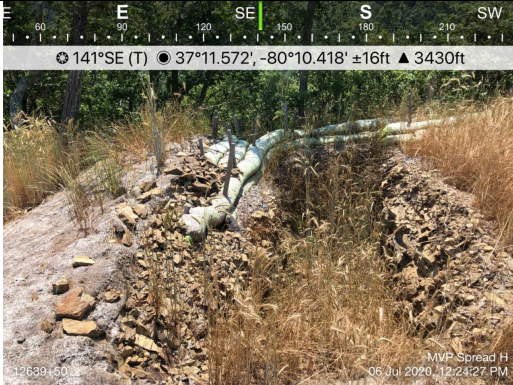
GPS Location	See Picture Watermark		GPS Location	See Picture Watermark	
Field Station#	12638+24		Field Station#	12638+50	
Pic 1 Desc.	Start of inspection area. ROW vegetated and in good condition.		Pic 2 Desc.	Waterbar sump pit dry and in good condition.

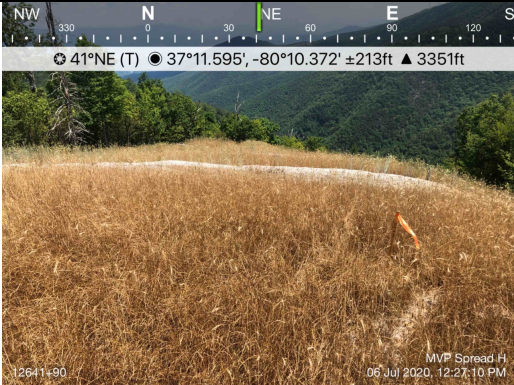
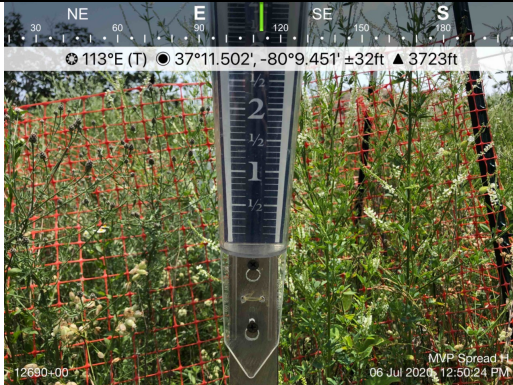
GPS Location	See Picture Watermark		GPS Location	See Picture Watermark	
Field Station#	12641+90		Field Station#	12690+00	
Pic 3 Desc.	Vegetated ROW and waterbar in good condition.		Pic 4 Desc.	Honeysuckle rain gauge showing 0.00" of rain since previous inspection.

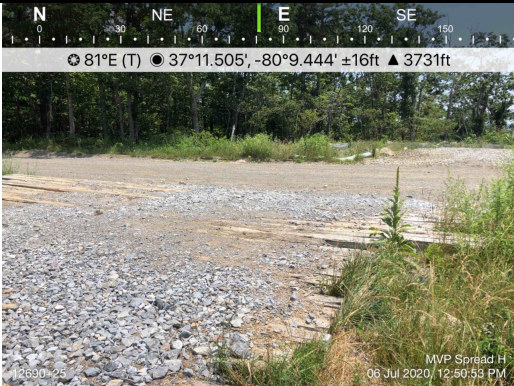
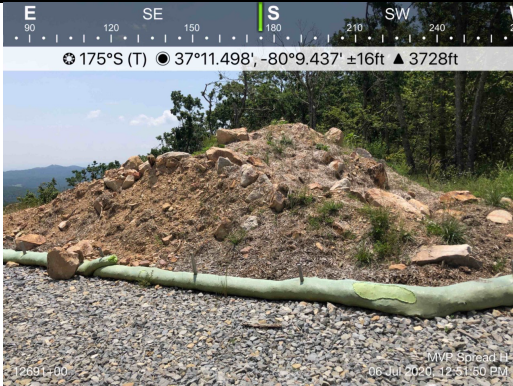
GPS Location	See Picture Watermark		GPS Location	See Picture Watermark	
Field Station#	12690+25		Field Station#	12691+00	
Pic 5 Desc.	Construction at CIS Honeysuckle is in good condition.		Pic 6 Desc.	Temporary stockpile near construction entrance on GAS Honeysuckle is in good condition.

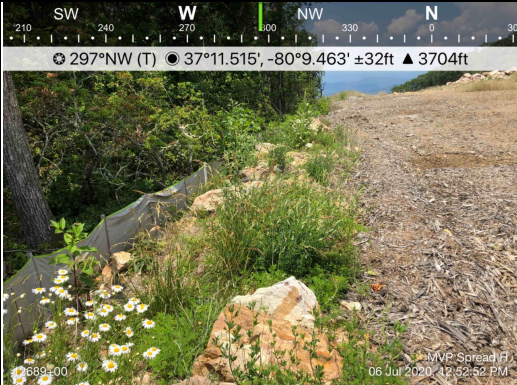
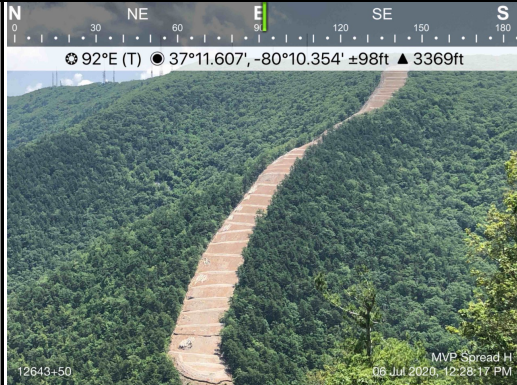
GPS Location	See Picture Watermark		GPS Location	See Picture Watermark	
Field Station#	12689+00		Field Station#	12643+50	
Pic 7 Desc.	Perimeter berm and controls are in good condition.		Pic 8 Desc.	Overall view of ROW on CIS Honeysuckle Road.

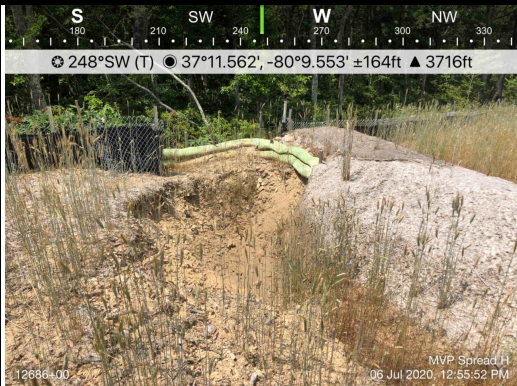
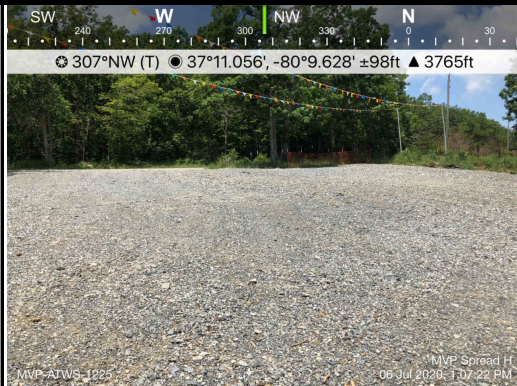
GPS Location	See Picture Watermark		GPS Location	See Picture Watermark	
Field Station#	12686+00		Field Station#	12701+00	
Pic 9 Desc.	Waterbar sump pit and end treatment in good condition.		Pic 10 Desc.	MVP-ATWS-1225 in good condition. No equipment or material stored in this area.

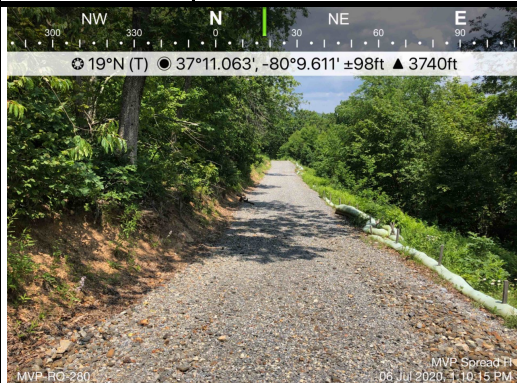
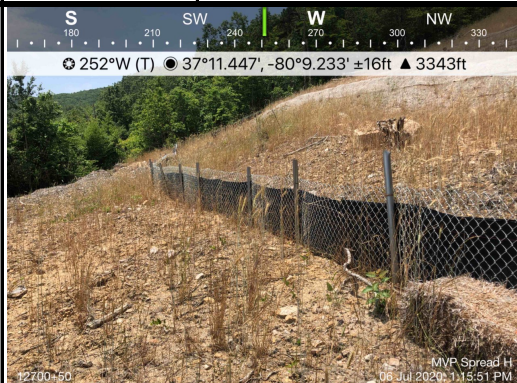
GPS Location	See Picture Watermark		GPS Location	See Picture Watermark	
Field Station#	12701+00		Field Station#	12700+50	
Pic 11 Desc.	MVP-RO-280 is in good condition.		Pic 12 Desc.	Super silt fence remains in good condition.

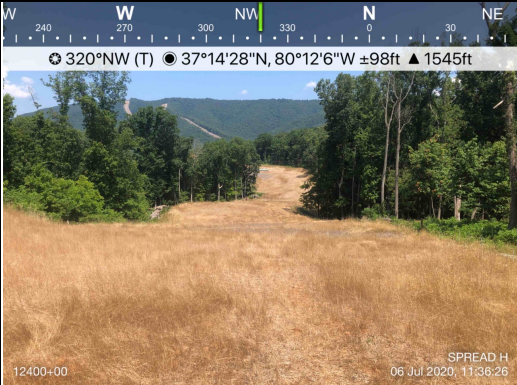
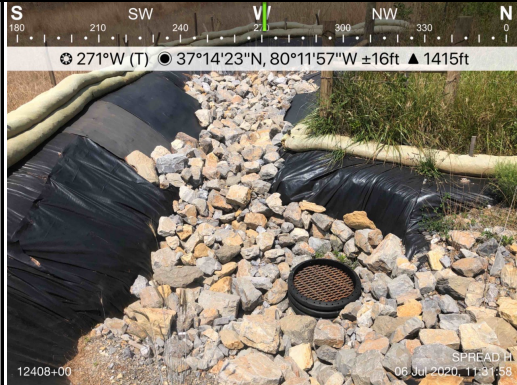
GPS Location	see photo		GPS Location	see photo	
Field Station#	12400+00		Field Station#	12408+00	
Pic 7 Desc.	GAS of I-81 remains stabilized with controls in place.		Pic 8 Desc.	CWD in good condition and functioning.

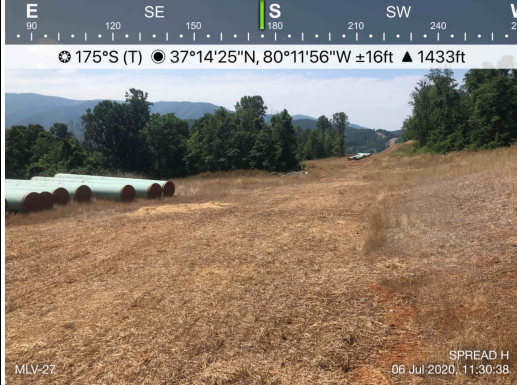
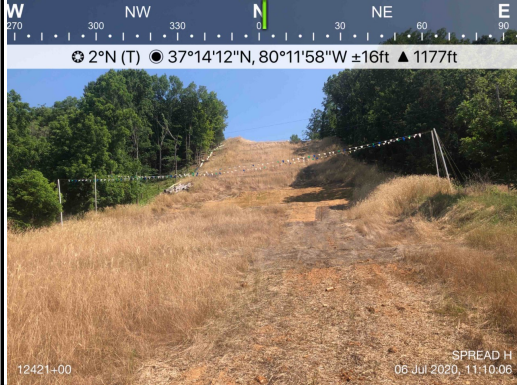
GPS Location	see photo		GPS Location	see photo	
Field Station#	+27		Field Station#	12421+00	
Pic 9 Desc.	MLV-027 remains stabilized.		Pic 10 Desc.	Slope on the CIS of the railroad tracks in good condition.

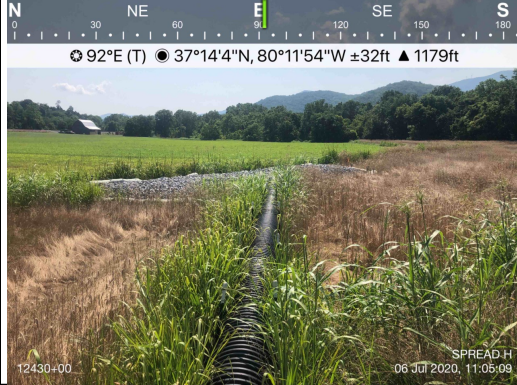
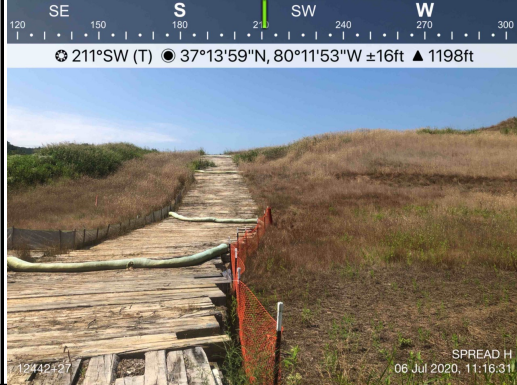
GPS Location	see photo		GPS Location	see photo	
Field Station#	12430+00		Field Station#	12442+27	
Pic 11 Desc.	CWD at this location in good condition.		Pic 12 Desc.	Controls and vegetation on this slope in good condition.

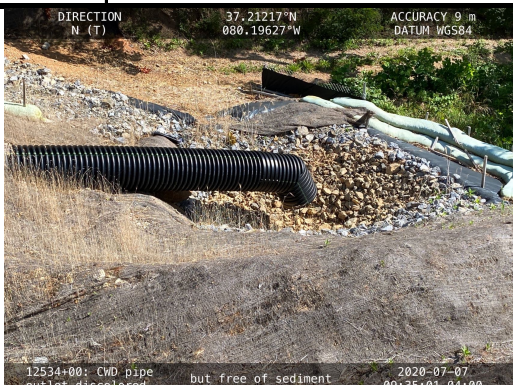
<p>DIRECTION N (T) 37.21217°N 080.19627°W ACCURACY 9 m DATUM WGS84</p> <p>12534+00: CWD pipe outlet discolored, but free of sediment 2020-07-07 09:35:01-04:00</p>			
GPS Location	See photo		GPS Location	See photo	
Field Station#	12535+00		Field Station#	12534+00	
Pic 5 Desc.	Fill slope drain and outlet in satisfactory condition.		Pic 6 Desc.	CWD pipe plunge pool outlet is discolored, but free of any sediment.

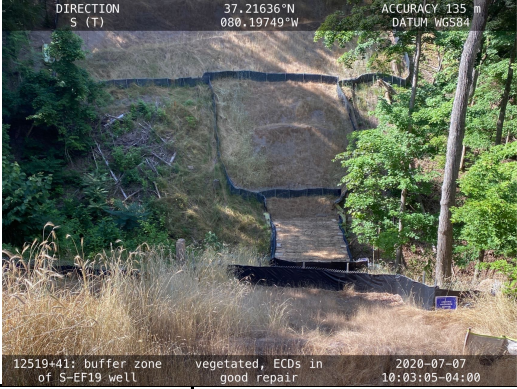
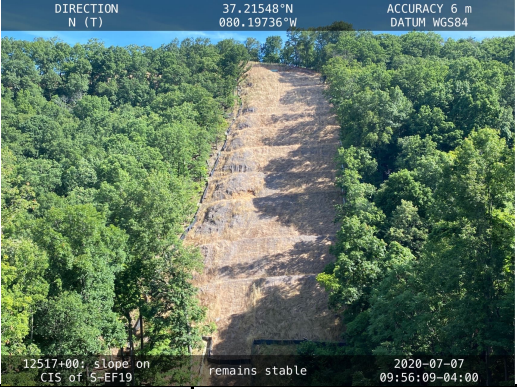
GPS Location	See photo		GPS Location	See photo	
Field Station#	12519+21		Field Station#	12517+00	
Pic 13 Desc.	Buffer zone of stream S-EF19 remains stable, ECDs in good repair.		Pic 14 Desc.	Slope on coming in side of stream S-EF19 remains stable.

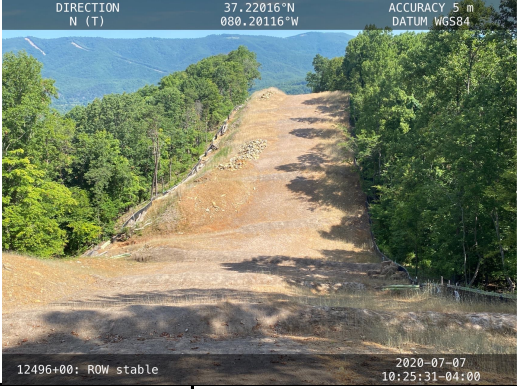
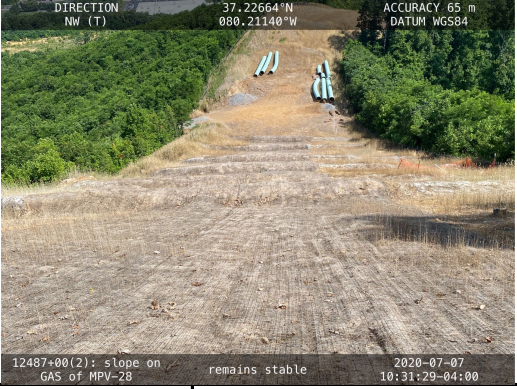
GPS Location	See photo		GPS Location	See photo	
Field Station#	12496+00		Field Station#	12487+00	
Pic 15 Desc.	ROW stable		Pic 16 Desc.	Slope on going away side MLV-28 remains stable.

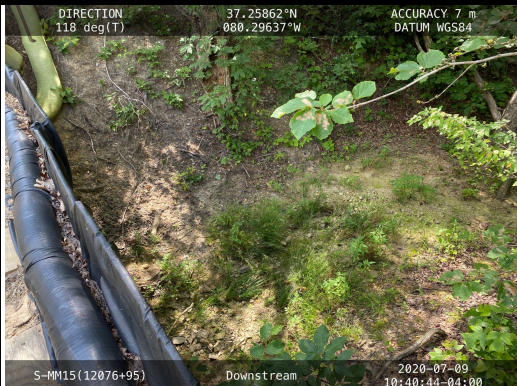
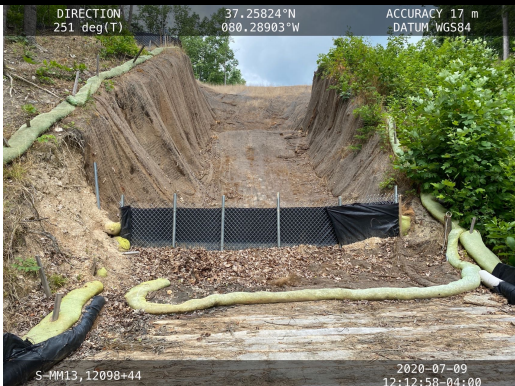
GPS Location	See photo GPS for location		GPS Location	See photo GPS for location	
Field Station#	12076+95		Field Station#	12098+44	
Pic 9 Desc.	Stream is dry and ECDs are in acceptable condition at S-MM15		Pic 10 Desc.	ECDs are in acceptable condition at S-MM13.

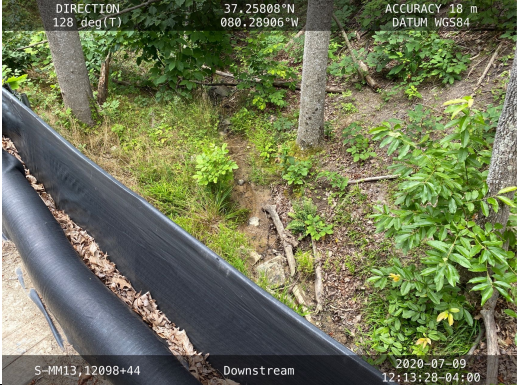
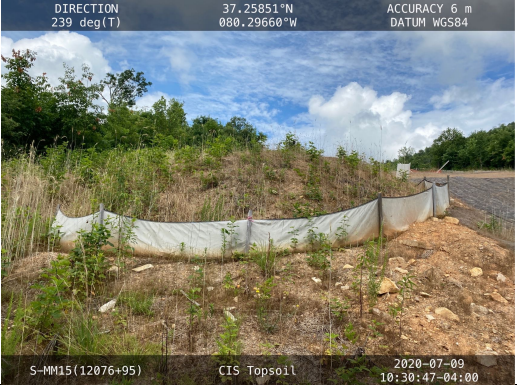
GPS Location	See photo GPS for location		GPS Location	See photo GPS for location	
Field Station#	12098+44		Field Station#	12076+00	
Pic 13 Desc.	S-MM13 is dry and surrounding ECDs are in acceptable condition.		Pic 14 Desc.	Topsoil pile on CIS of S-MM-15 is contained, vegetated, and stable.

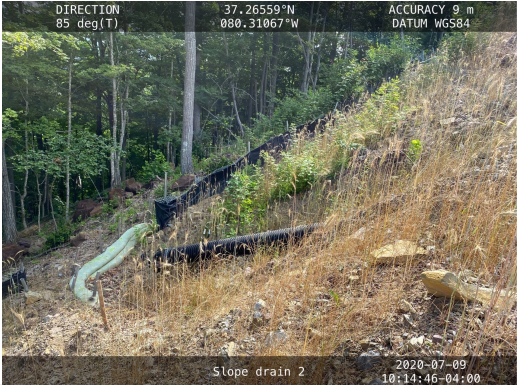
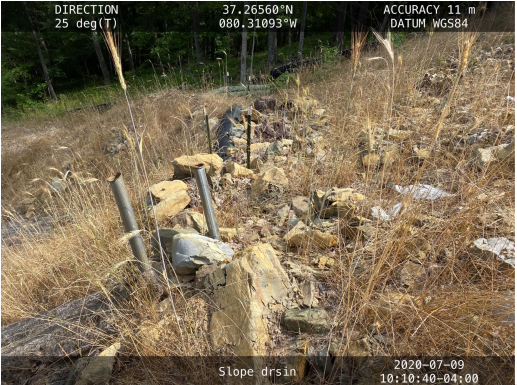
GPS Location	See photo GPS for location		GPS Location	See photo GPS for location	
Field Station#	12019+00		Field Station#	12019+50	
Pic 15 Desc.	Slope drain intact and stable.		Pic 16 Desc.	Slope drain intact and stable.

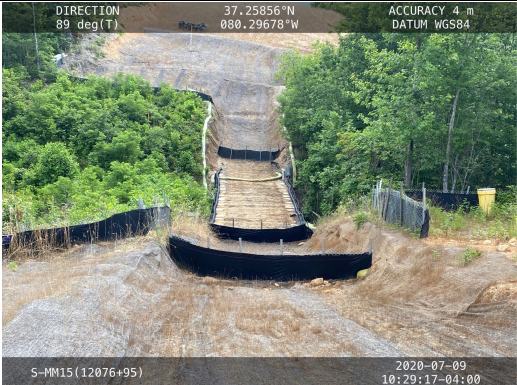
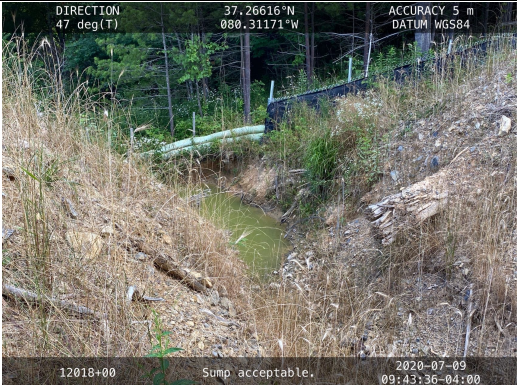
GPS Location	See photo GPS for location		GPS Location	See photo GPS for location	
Field Station#	12076+95		Field Station#	12018+00	
Pic 17 Desc.	ECDs are in acceptable condition surrounding S-MM15.		Pic 18 Desc.	Sump is in acceptable condition.

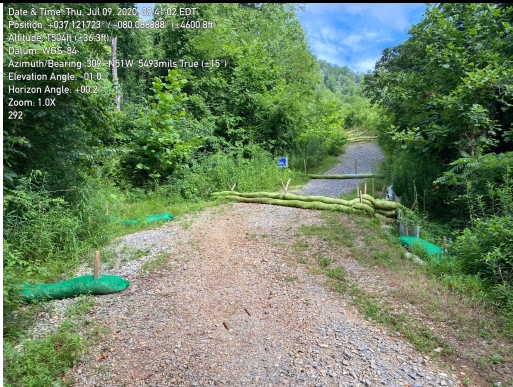
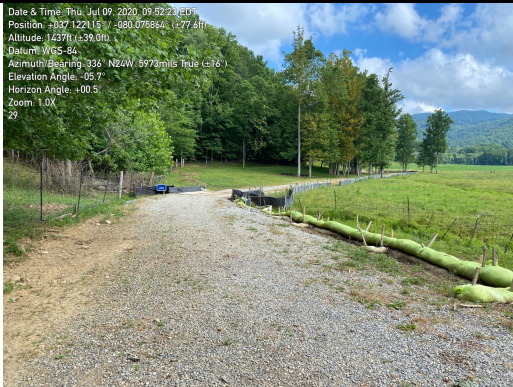
GPS Location		See photo for coordinates.				GPS Location		See photo for coordinates.			
Field Station#		13142+00				Field Station#		13190+00			
Pic 1 Desc.		MVP-FR-292, ECDs in acceptable condition.				Pic 2 Desc.		MVP-AR-29, ECDs in acceptable condition, cattle noted in field.

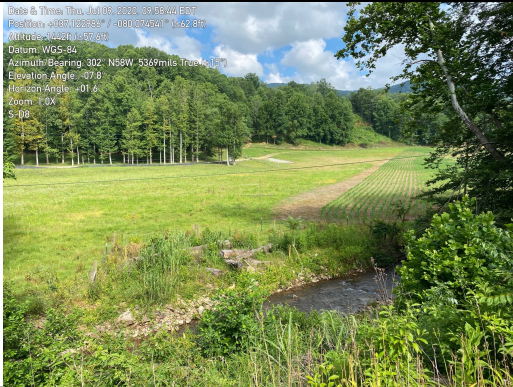
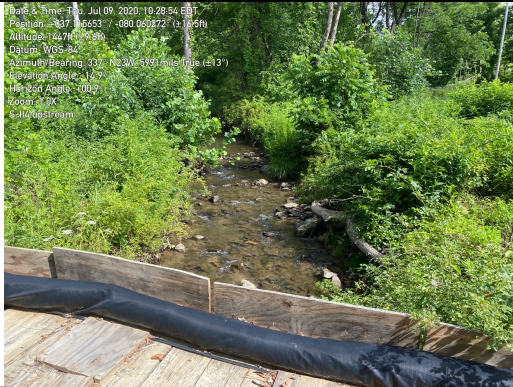
GPS Location		See photo for coordinates.				GPS Location		See photo for coordinates.			
Field Station#		13197+50				Field Station#		13260+60			
Pic 3 Desc.		S-D8, no disturbance along ROW or at stream crossing.				Pic 4 Desc.		S-II4, upstream, no changes noted to stream bed or banks.

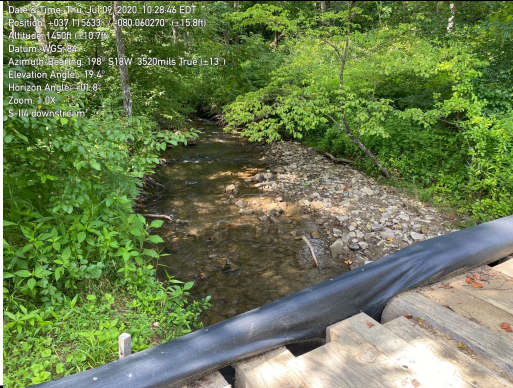
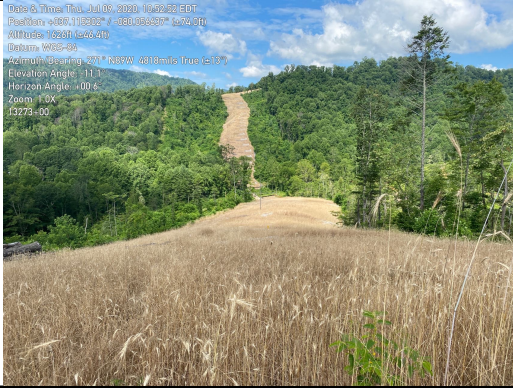
GPS Location		See photo for coordinates.				GPS Location		See photo for coordinates.			
Field Station#		13260+60				Field Station#		13273+00			
Pic 5 Desc.		S-II4, downstream, no environmental concerns noted.				Pic 6 Desc.		Vegetative cover noted across LOD, permanent waterbars stable.

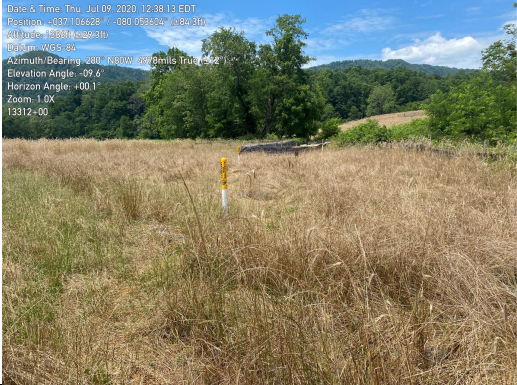
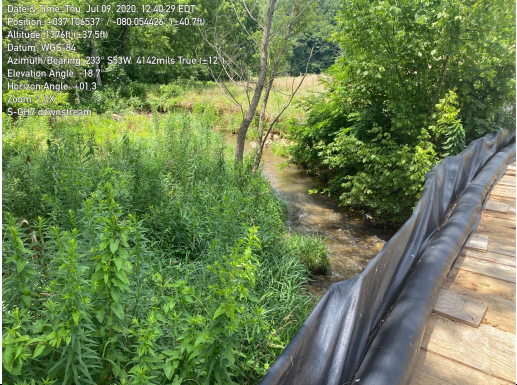
GPS Location	See photo for coordinates.		GPS Location	See photo for coordinates.	
Field Station#	13312+00		Field Station#	13309+09	
Pic 13 Desc.	Vegetative cover noted across LOD.		Pic 14 Desc.	S-GH7, downstream, no environmental issues noted.

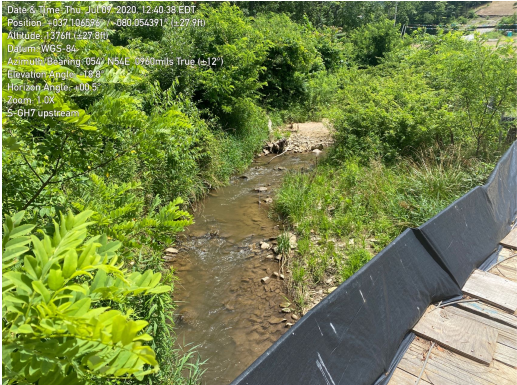
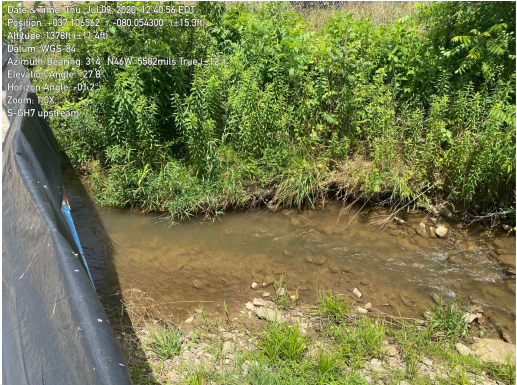
GPS Location	See photo for coordinates.		GPS Location	See photo for coordinates.	
Field Station#	13309+09		Field Station#	13309+09	
Pic 15 Desc.	S-GH7, no changes noted to stream bed or banks.		Pic 16 Desc.	S-GH7, upstream, water flowing clear.

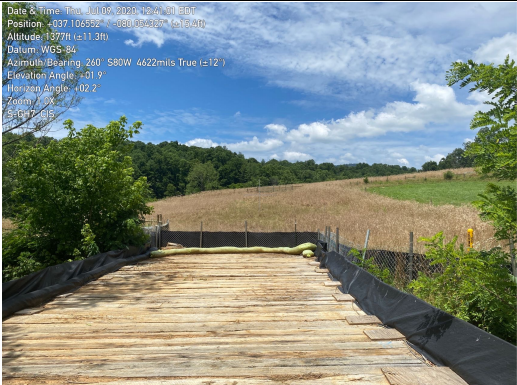
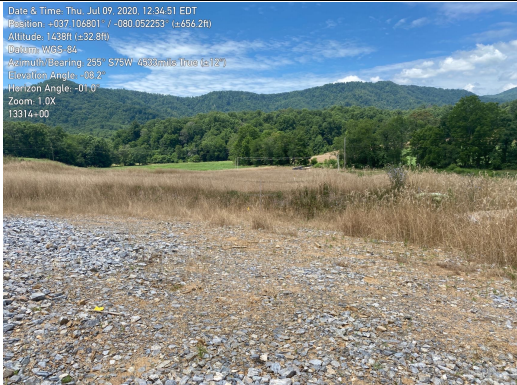
GPS Location	See photo for coordinates.		GPS Location	See photo for coordinates.	
Field Station#	13309+09		Field Station#	13314+00	
Pic 17 Desc.	CIS S-GH7, perimeter controls in acceptable condition, vegetative cover noted across LOD.		Pic 18 Desc.	ROW stabilized, waterbars and sumps functioning acceptably.

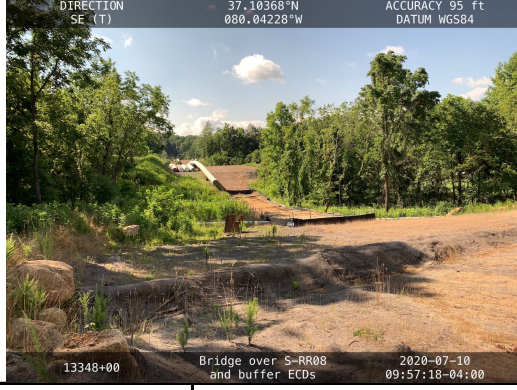
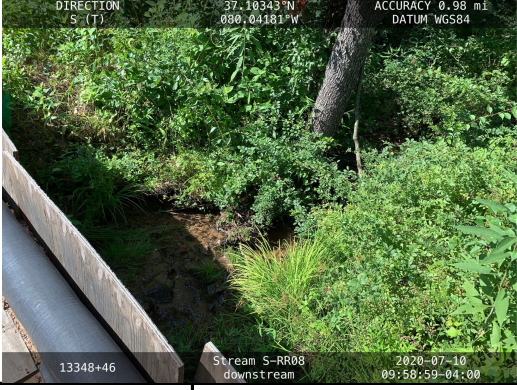
GPS Location	See photo for gps location data.		GPS Location	See photo for gps location data.	
Field Station#	13348+00		Field Station#	13348+46	
Pic 11 Desc.	Photo shows the ROW condition from about 13348+00 to 13350+00.		Pic 12 Desc.	Photo shows stream S-RR08 downstream from the ROW crossing.

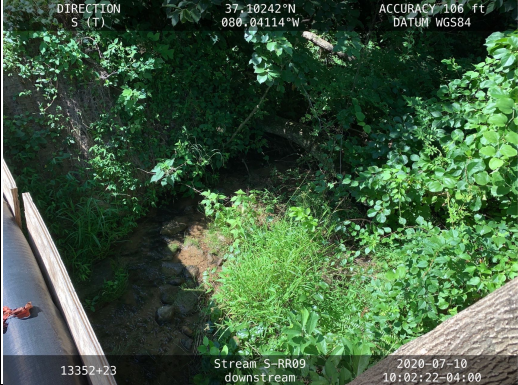
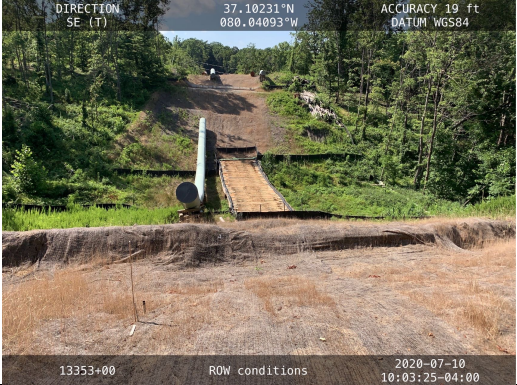
GPS Location	See photo for gps location data.		GPS Location	See photo for gps location data.	
Field Station#	13352+23		Field Station#	13353+00	
Pic 13 Desc.	Photo shows stream S-RR09 downstream from the ROW crossing.		Pic 14 Desc.	Photo shows the ROW conditions from about 13353+00 to 13356+00.

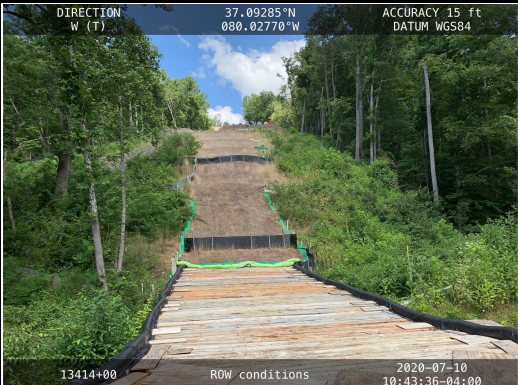
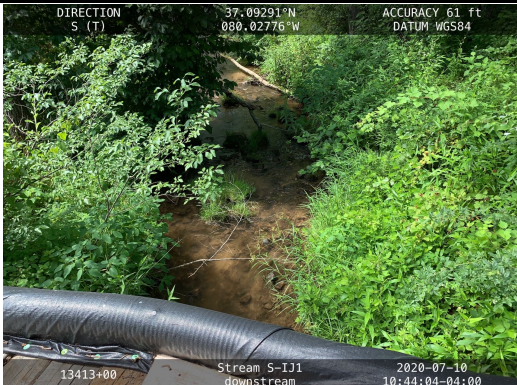
GPS Location	See photo for gps location data.		GPS Location	See photo for gps location data.	
Field Station#	13414+00		Field Station#	13413+00	
Pic 17 Desc.	Photo shows the ROW condition from about 13411+00 to 13414+00.		Pic 18 Desc.	Photo shows stream S-IJ1 downstream from the ROW crossing.
