# Visual Site Inspection Report

<b>Project Name</b>	H-600 Pipeline Spread H	<b>AFE</b>	124300138	<b>Spread</b>	H-600 Pipeline Spread H
<b>Contractor</b>	Precision			<b>Report #</b>	13474
<b>Inspector</b>	John Brcic			<b>Date/Time</b>	8/10/2020 11:45 AM
<b>Permit #</b>	TBD	<b>Inspection Type</b>	VA SWPP	<b>Station Begin</b>	12443+75
<b>State</b>	VA	<b>Inspection Area</b>	Partial	<b>Station End</b>	12544+06
<b>County</b>	Montgomery	<b>Ground</b>	Dry	<b>Temperature (°F)</b>	83.00
<b>Municipality</b>	N/A	<b>Weather</b>	Sunny	<b>Rain Gauge (in)</b>	0.00
				<b>Rain Accumulation Time (days)</b>	3.00

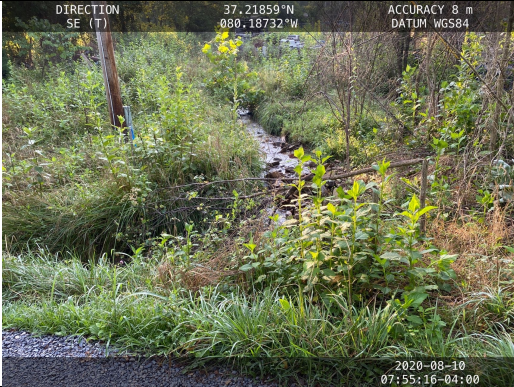
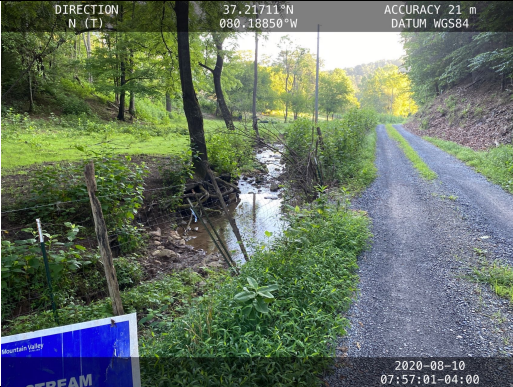
<b>GPS Location</b>	See photo		<b>GPS Location</b>	See photo	
<b>Field Station#</b>	12543+56		<b>Field Station#</b>	12543+56	
<b>Pic 1 Desc.</b>	Stream S-KL54, facing southeast from Yellow Finch Road, upstream		<b>Pic 2 Desc.</b>	Stream S-EF20b, facing north from Yellow Finch Road, upstream

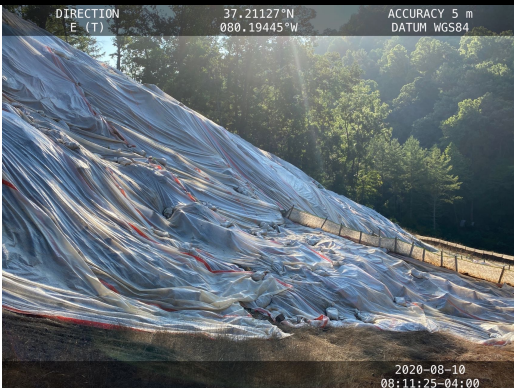
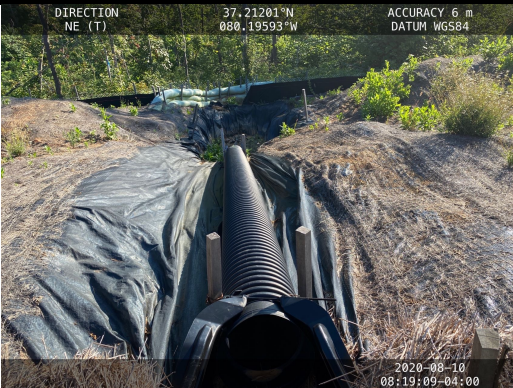
<b>GPS Location</b>	See photo		<b>GPS Location</b>	See photo	
<b>Field Station#</b>	12542+00		<b>Field Station#</b>	12535+00	
<b>Pic 5 Desc.</b>	Plastic sheeting nearest to Yellow Finch Road remains intact and secure.		<b>Pic 6 Desc.</b>	Slope drain in satisfactory condition.

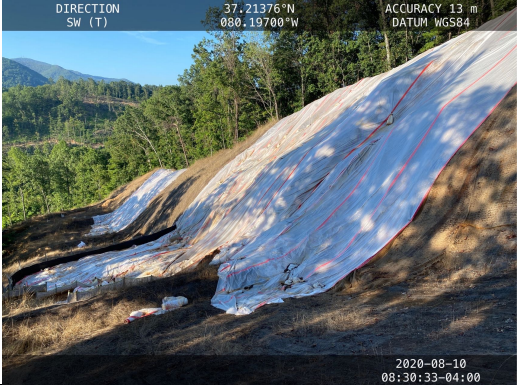
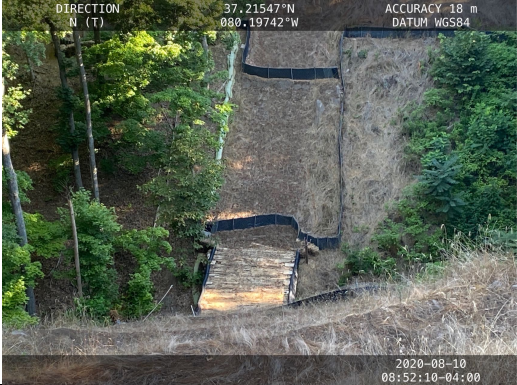
<b>GPS Location</b>	See photo		<b>GPS Location</b>	See photo	
<b>Field Station#</b>	12529+00		<b>Field Station#</b>	12519+41	
<b>Pic 7 Desc.</b>	Plastic sheeting approximately 1500 feet from Yellow Finch Road remains intact and secure.		<b>Pic 8 Desc.</b>	The buffer zone of stream S-EF19 remains stable, ECDs in satisfactory condition.

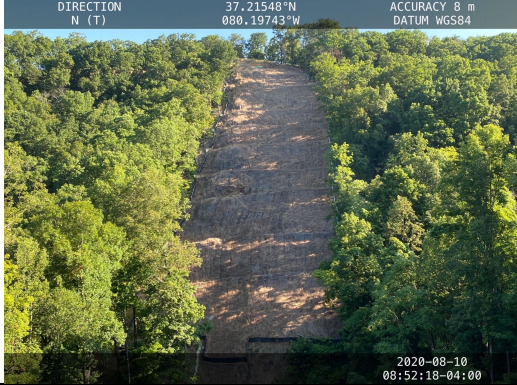
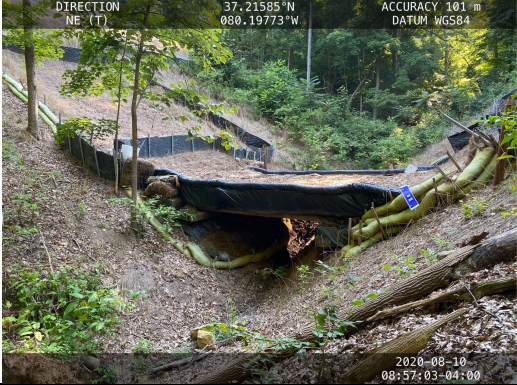
<b>GPS Location</b>	See photo		<b>GPS Location</b>	See photo	
<b>Field Station#</b>	12517+00		<b>Field Station#</b>	12519+41	
<b>Pic 9 Desc.</b>	Slope on coming in side of stream S-EF19 remains stable.		<b>Pic 10 Desc.</b>	Stream S-EF19, facing northeast, upstream

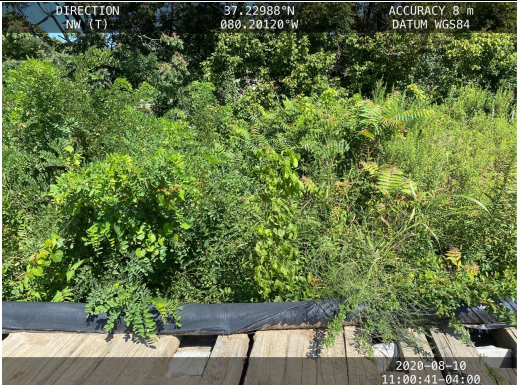
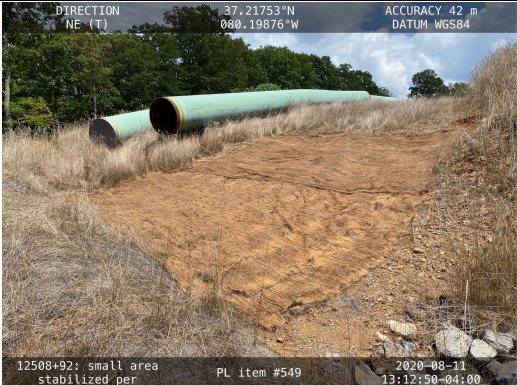
<b>GPS Location</b>	See photo		<b>GPS Location</b>	See photo	
<b>Field Station#</b>	12455+21		<b>Field Station#</b>	12508+29	
<b>Pic 17 Desc.</b>	Stream S-CD12, facing northwest, downstream		<b>Pic 18 Desc.</b>	This bare are where minor erosion had been observed was stabilized with erosion control blanket.

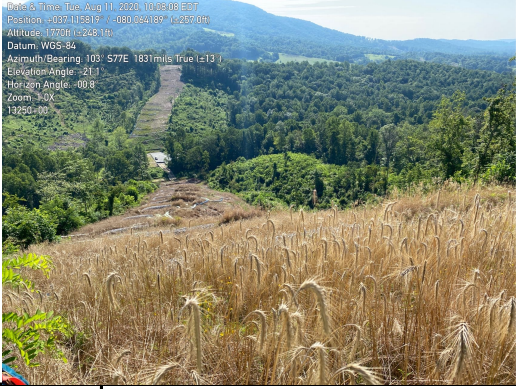
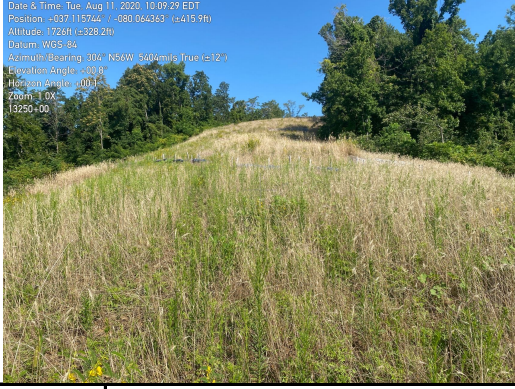
<b>GPS Location</b>	See photo for coordinates.		<b>GPS Location</b>	See photo for coordinates.	
<b>Field Station#</b>	13250+00		<b>Field Station#</b>	13250+00	
<b>Pic 5 Desc.</b>	Restored ROW stable.		<b>Pic 6 Desc.</b>	Temporary and permanent vegetative cover noted across LOD.

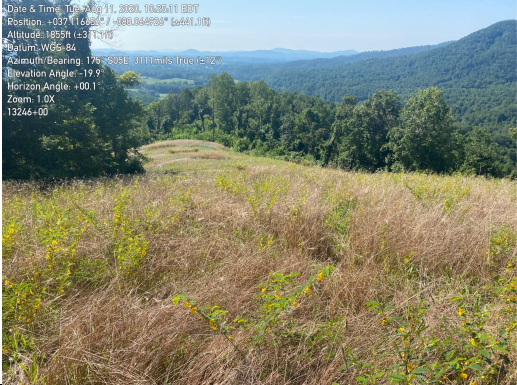
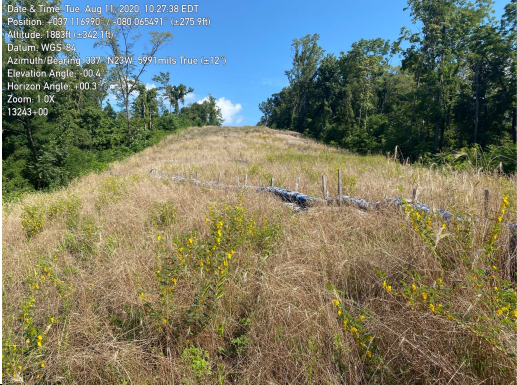
<b>GPS Location</b>	See photo for coordinates.		<b>GPS Location</b>	See photo for coordinates.	
<b>Field Station#</b>	13246+00		<b>Field Station#</b>	13243+00	
<b>Pic 7 Desc.</b>	Temporary and permanent vegetative cover noted across LOD, ROW stable.		<b>Pic 8 Desc.</b>	Temporary and permanent vegetative cover noted across LOD.

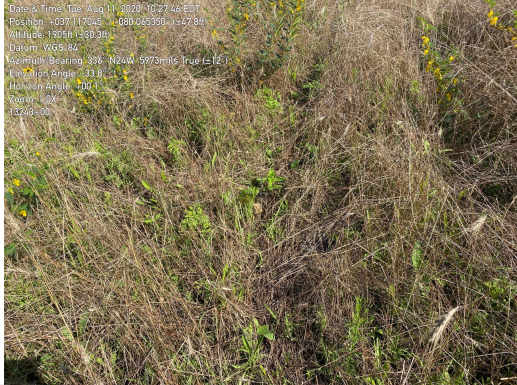
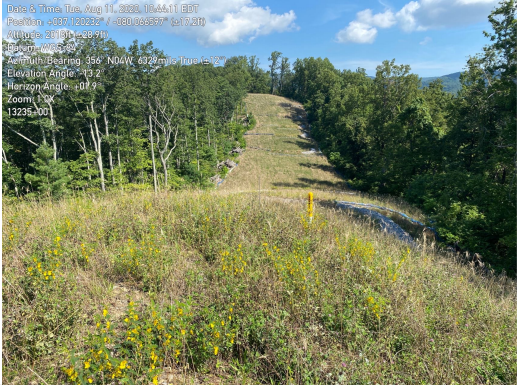
<b>GPS Location</b>	See photo for coordinates.		<b>GPS Location</b>	See photo for coordinates.	
<b>Field Station#</b>	13243+00		<b>Field Station#</b>	13235+00	
<b>Pic 9 Desc.</b>	Temporary and permanent vegetative cover noted.		<b>Pic 10 Desc.</b>	Temporary and permanent vegetative cover noted across LOD, ROW stable.

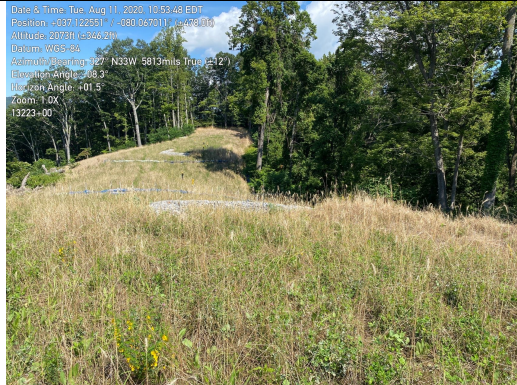
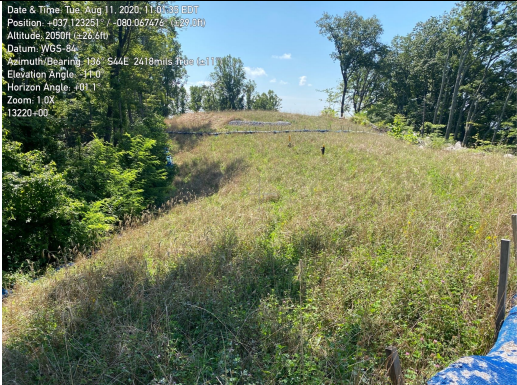
<b>Pic 11 Desc.</b>	Temporary and permanent vegetative cover noted across LOD.		<b>Pic 12 Desc.</b>	Temporary and permanent vegetative cover noted across LOD.

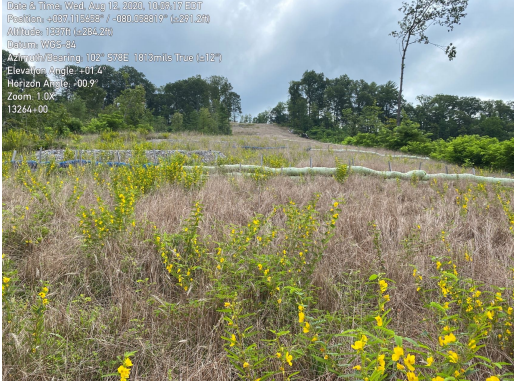
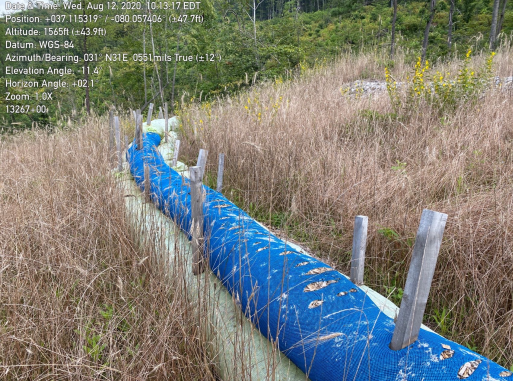
<b>GPS Location</b>	See photo for coordinates.		<b>GPS Location</b>	See photo for coordinates.	
<b>Field Station#</b>	13264+00		<b>Field Station#</b>	13267+00	
<b>Pic 1 Desc.</b>	Restored ROW stable with vegetative cover noted across LOD.		<b>Pic 2 Desc.</b>	Permanent waterbar extension CFS deteriorating.

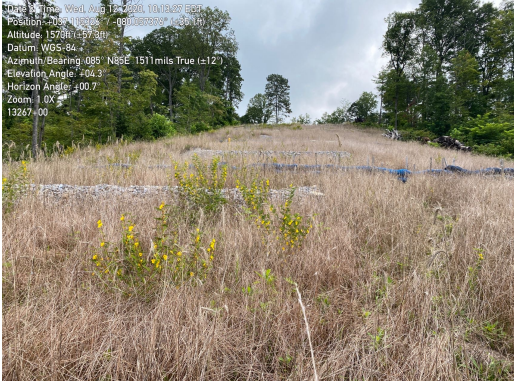
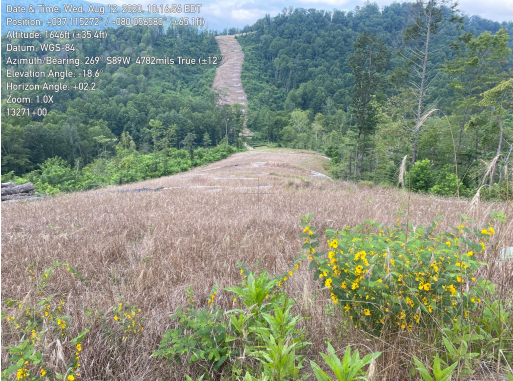
<b>GPS Location</b>	See photo for coordinates.		<b>GPS Location</b>	See photo for coordinates.	
<b>Field Station#</b>	13267+00		<b>Field Station#</b>	13271+00	
<b>Pic 3 Desc.</b>	Restored ROW stable with vegetative cover noted across LOD.		<b>Pic 4 Desc.</b>	Restored ROW stable with vegetative cover noted across LOD.

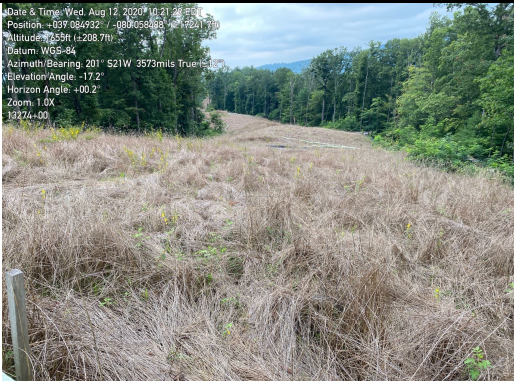
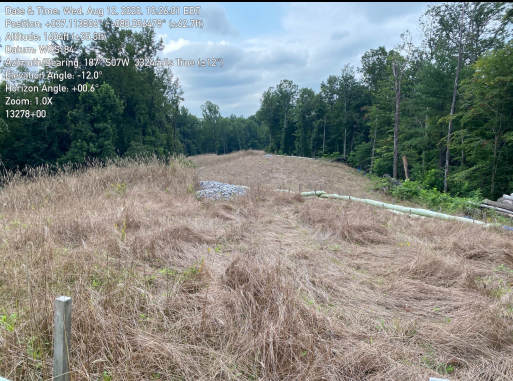
<b>Pic 5 Desc.</b>	Restored ROW stable with vegetative cover noted across LOD.		<b>Pic 6 Desc.</b>	Restored ROW stable with vegetative cover noted across LOD.

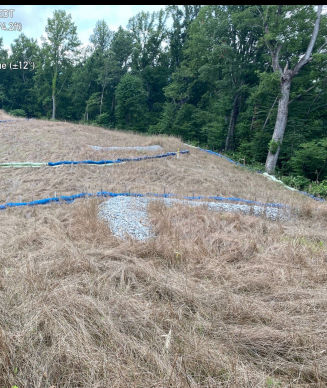
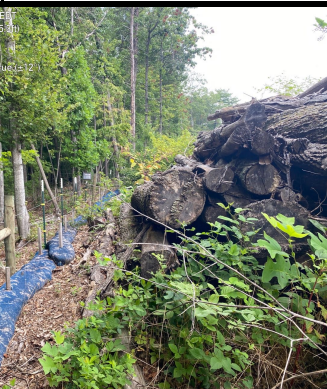
<b>GPS Location</b>	See photo for coordinates.		<b>GPS Location</b>	See photo for coordinates.	
<b>Field Station#</b>	13297+00		<b>Field Station#</b>	13297+00	
<b>Pic 11 Desc.</b>	Perimeter CFS in acceptable condition. Solar box of electrical fence in place.		<b>Pic 12 Desc.</b>	Solar box noted along electrical fence.

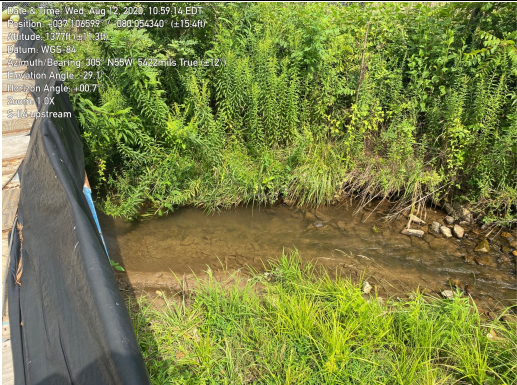
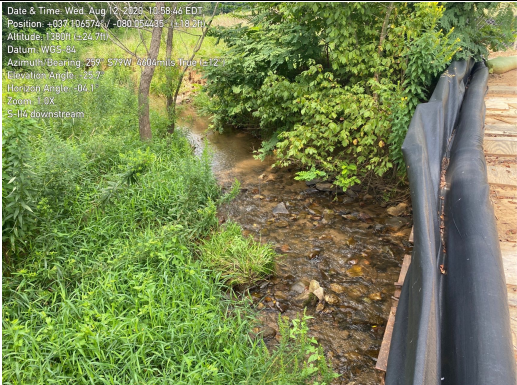
<b>GPS Location</b>	See photo for coordinates.		<b>GPS Location</b>	See photo for coordinates.	
<b>Field Station#</b>	13309+09		<b>Field Station#</b>	13309+09	
<b>Pic 17 Desc.</b>	S-GH7, upstream, no changes noted to stream bed or banks, water flowing clear.		<b>Pic 18 Desc.</b>	S-GH7, downstream, no changes noted to stream bed or banks.

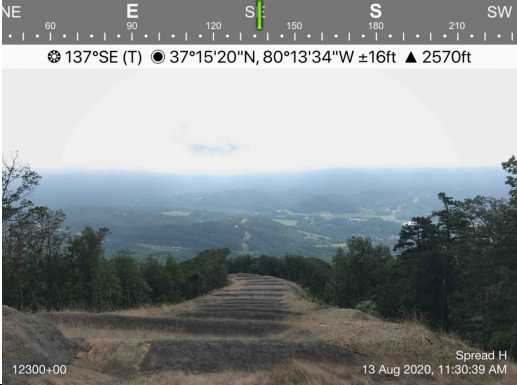
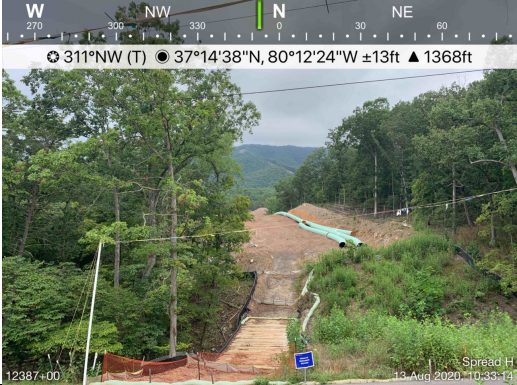
<b>GPS Location</b>	See photo		<b>GPS Location</b>	See photo	
<b>Field Station#</b>	12300+00		<b>Field Station#</b>	12387+00	
<b>Pic 7 Desc.</b>	Waterbars and end treatments on this slope are stabilized and appear to be functioning.		<b>Pic 8 Desc.</b>	Controls are in place and in good condition at this stream crossing.

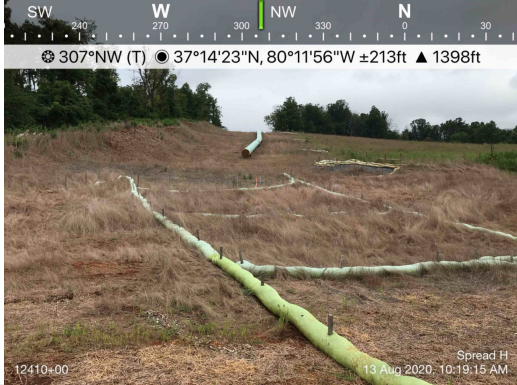
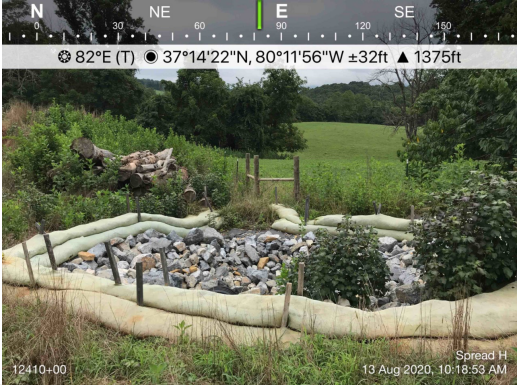
<b>GPS Location</b>	See photo		<b>GPS Location</b>	See photo	
<b>Field Station#</b>	12410+00		<b>Field Station#</b>	12410+00	
<b>Pic 9 Desc.</b>	CFS and CWD berm in good condition on this slope.		<b>Pic 10 Desc.</b>	CWD outlet in good condition.

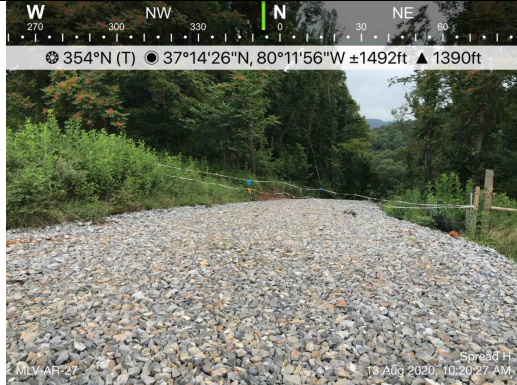
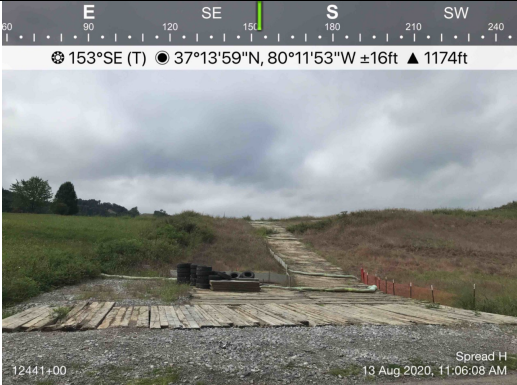
<b>GPS Location</b>	See photo		<b>GPS Location</b>	See photo	
<b>Field Station#</b>	+27		<b>Field Station#</b>	12441+00	
<b>Pic 11 Desc.</b>	Rock CE at MLV-AR-27 in good condition.		<b>Pic 12 Desc.</b>	Timbermatting and Equipment bridge in good condition. End of inspection area.

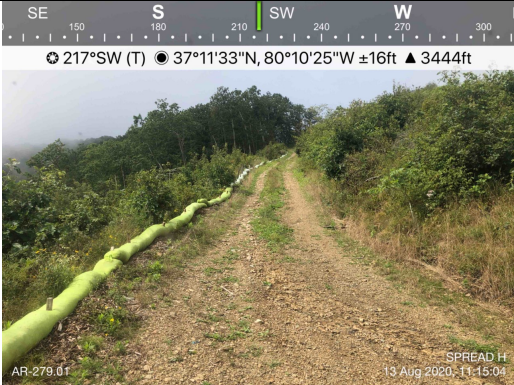
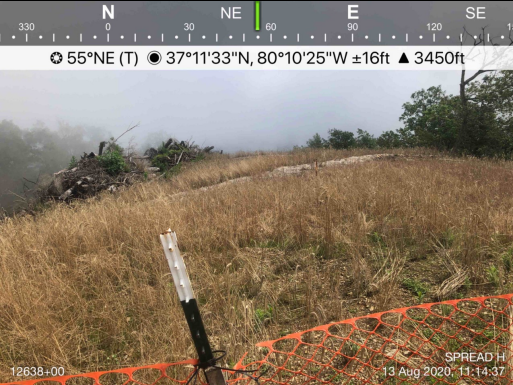
<b>GPS Location</b>	see photo		<b>GPS Location</b>	see photo	
<b>Field Station#</b>	279+01		<b>Field Station#</b>	12638+24	
<b>Pic 1 Desc.</b>	AR-279.01 in good condition with controls in place.		<b>Pic 2 Desc.</b>	GAS slope of AR-279.01 in good condition. Controls functioning and vegetation filling in.

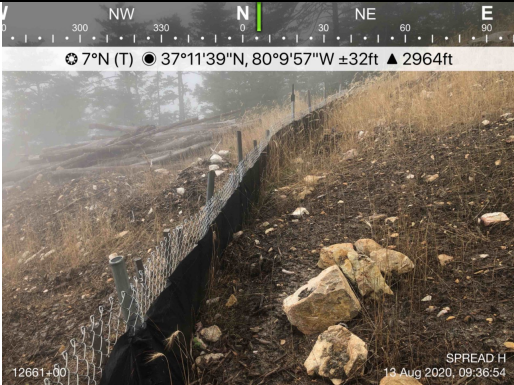
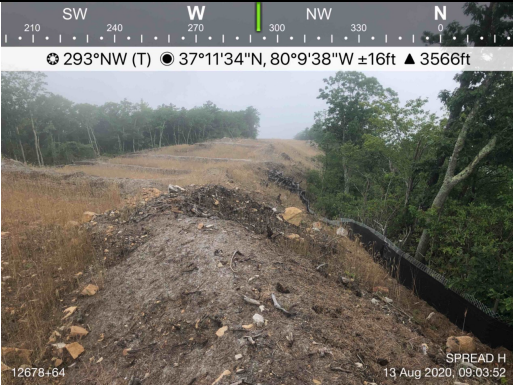
<b>GPS Location</b>	see photo		<b>GPS Location</b>	see photo	
<b>Field Station#</b>	12661+00		<b>Field Station#</b>	12678+64	
<b>Pic 3 Desc.</b>	Additional controls at the base of this slope in good condition.		<b>Pic 4 Desc.</b>	CIS slope of Honeysuckle Rd. in good condition. Controls functioning.

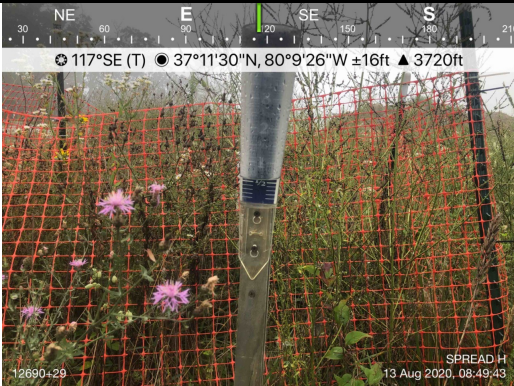
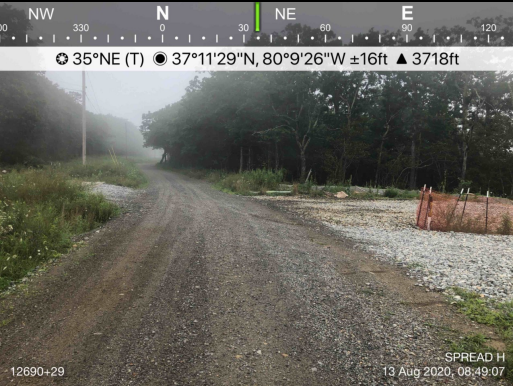
<b>GPS Location</b>	see photo		<b>GPS Location</b>	see photo	
<b>Field Station#</b>	12690+29		<b>Field Station#</b>	12690+29	
<b>Pic 5 Desc.</b>	Rain gauge at Honeysuckle Rd. crossing showing .6".		<b>Pic 6 Desc.</b>	CE's at Honeysuckle Rd. crossing remain in good condition.

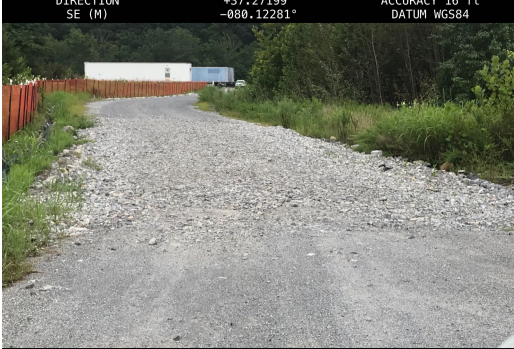
<p>DIRECTION SE (M) +37.27199° -080.12281° ACCURACY 16 ft DATUM WGS84</p> <p>MVP-LY-049_081320 Condition of rock entrance 2020-08-13 08:35:03-04:00</p>

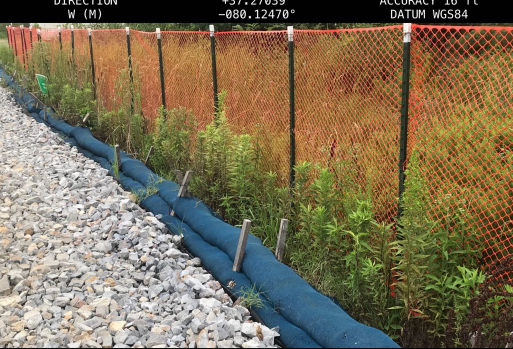
<p>DIRECTION W (M) +37.27039° -080.12470° ACCURACY 16 ft DATUM WGS84</p> <p>MVP-LY-049_081320 Condition of CFS &amp; safety fence 2020-08-13 08:42:25-04:00</p>			
<b>GPS Location</b>	MVP-LY-049 See photo for gps data		<b>GPS Location</b>	MVP-LY-049 See photo for gps data	
<b>Field Station#</b>	+0		<b>Field Station#</b>	+0	
<b>Pic 1 Desc.</b>	Condition of rock entrance on center drive. Looking SE.		<b>Pic 2 Desc.</b>	Condition of compost filter sock and safety fence along feature W-CV21A. Looking W.

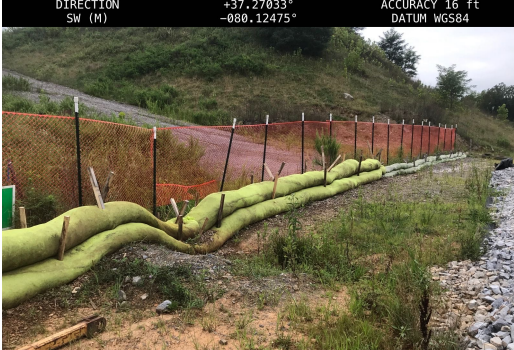
<p>DIRECTION SW (M) +37.27033° -080.12475° ACCURACY 16 ft DATUM WGS84</p> <p>MVP-LY-049_081320 Landowner disturbance within 100' of ... 2020-08-13 08:42:41-04:00</p>

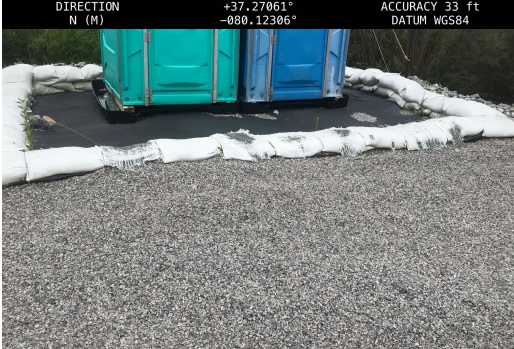
<p>DIRECTION N (M) +37.27061° -080.12306° ACCURACY 33 ft DATUM WGS84</p> <p>MVP-LY-049_081320 Condition of trays and containment 2020-08-13 08:45:20-04:00</p>

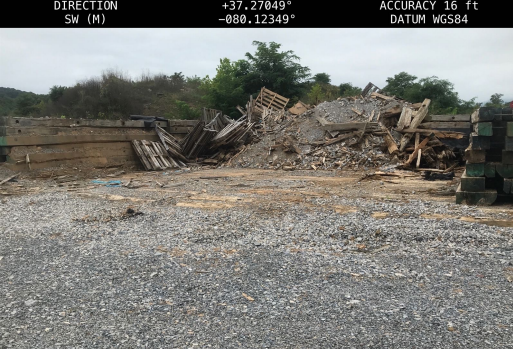
<p>DIRECTION SW (M) +37.27049° -080.12349° ACCURACY 16 ft DATUM WGS84</p> <p>MVP-LY-049_081320 Condition of temporary trash ... 2020-08-13 08:46:14-04:00</p>			
<b>GPS Location</b>	MVP-LY-049 See photo for gps data		<b>GPS Location</b>	MVP-LY-049 See photo for gps data	
<b>Field Station#</b>	+0		<b>Field Station#</b>	+0	
<b>Pic 5 Desc.</b>	Condition of trays and containment under toilets. Looking N.		<b>Pic 6 Desc.</b>	Condition of temporary trash transfer pit. Looking SW.

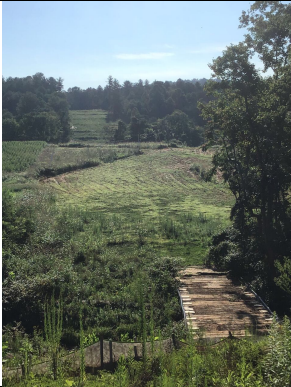
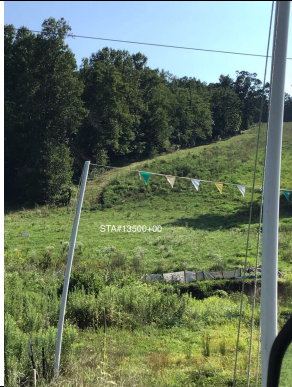
<b>GPS Location</b>	00000	<b>GPS Location</b>	00000		
<b>Field Station#</b>	13547+66	<b>Field Station#</b>	13500+00		
<b>Pic 1 Desc.</b>	Photo showing where a land owner mowed a large section of row at House Rock rd		<b>Pic 2 Desc.</b>	Photo showing where a land owner mowed down the edge of the row

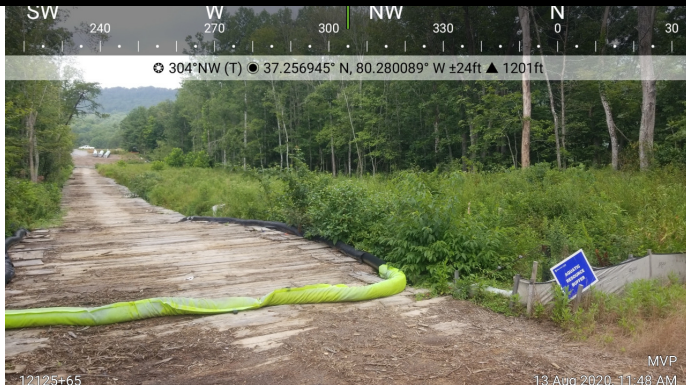
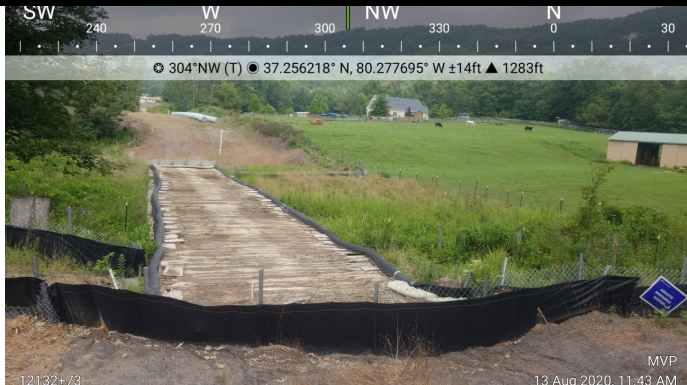
<b>GPS Location</b>	See Above	<b>GPS Location</b>	See Above		
<b>Field Station#</b>	12125+65	<b>Field Station#</b>	12132+73		
<b>Pic 3 Desc.</b>	Overview of Waterbody S-MM31. ECDs functional and in good condition.	<b>Pic 4 Desc.</b>	Overview of Waterbody S-C29. ECDs functional and in good condition.

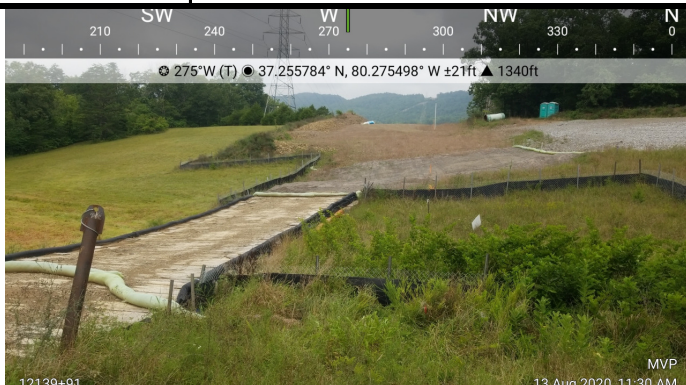
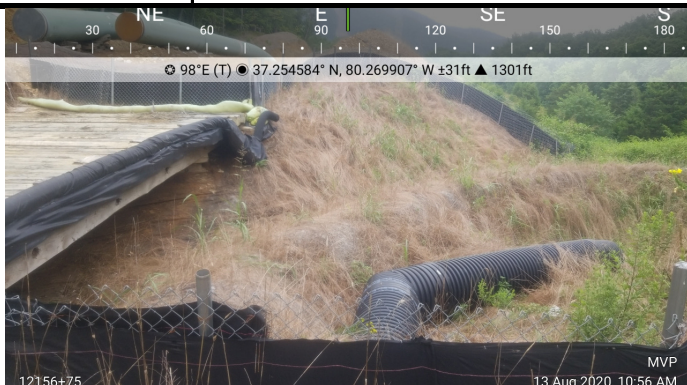
<b>GPS Location</b>	See Above	<b>GPS Location</b>	See Above		
<b>Field Station#</b>	12139+91	<b>Field Station#</b>	12156+75		
<b>Pic 5 Desc.</b>	Overview of Wetland W-C6. ECDs functional and in good condition.	<b>Pic 6 Desc.</b>	Overview of Head Water Area of Waterbody S-C23. ECDs functional and in good condition.

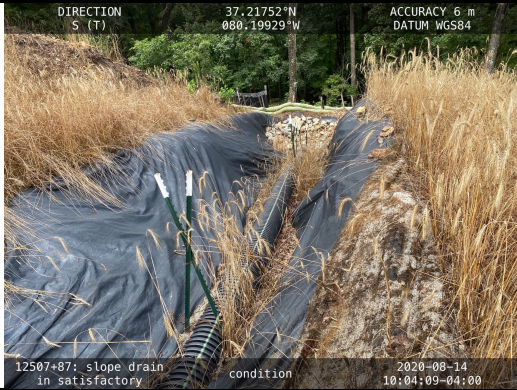
<p>DIRECTION S (T) 37.21752°N 080.19929°W ACCURACY 6 m DATUM WGS84</p> <p>12507+87: slope drain in satisfactory condition 2020-08-14 10:04:09-04:00</p>
