# Visual Site Inspection Report

<b>Project Name</b>	H-600 Pipeline Spread H	<b>AFE</b>	124300138	<b>Spread</b>	H-600 Pipeline Spread H
<b>Contractor</b>	Precision			<b>Report #</b>	13683
<b>Inspector</b>	Dawn McCullough			<b>Date/Time</b>	8/17/2020 5:05 PM
<b>Permit #</b>	TBD	<b>Inspection Type</b>	VA SWPP	<b>Station Begin</b>	13140+00
<b>State</b>	VA	<b>Inspection Area</b>	Partial	<b>Station End</b>	13262+50
<b>County</b>	Franklin	<b>Ground</b>	Damp	<b>Temperature (°F)</b>	84.00
<b>Municipality</b>	N/A	<b>Weather</b>	Sunny	<b>Rain Gauge (in)</b>	0.10
				<b>Rain Accumulation Time (days)</b>	1.00

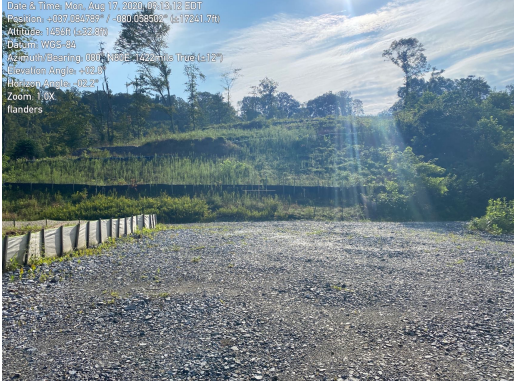
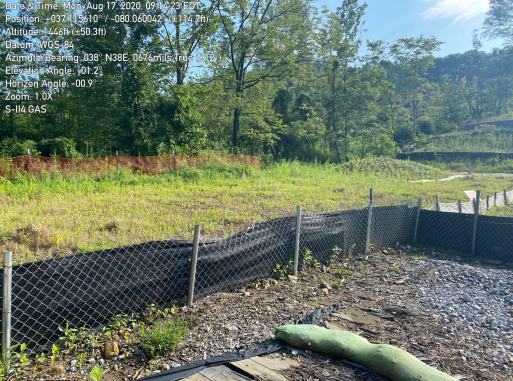
<b>GPS Location</b>	See photo for coordinates.		<b>GPS Location</b>	See photo for coordinates.	
<b>Field Station#</b>	13262+00		<b>Field Station#</b>	13261+50	
<b>Pic 1 Desc.</b>	MVP-FR-293.01, Flanders Road, RCE and perimeter controls in acceptable condition.		<b>Pic 2 Desc.</b>	Vegetation noted across LOD in stabilized area, topsoil pile stable.

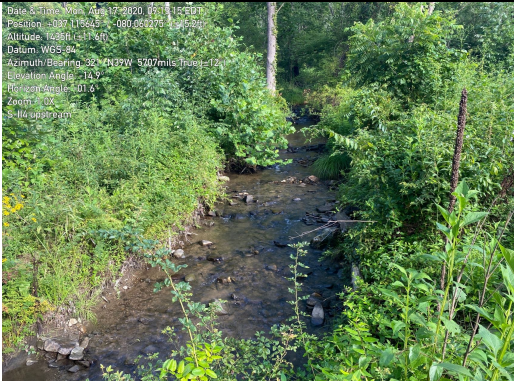
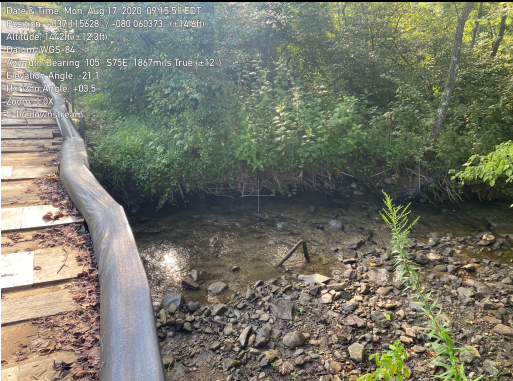
<b>GPS Location</b>	See photo for coordinates.		<b>GPS Location</b>	See photo for coordinates.	
<b>Field Station#</b>	13260+60		<b>Field Station#</b>	13260+60	
<b>Pic 3 Desc.</b>	S-II4, upstream, no changes noted to stream bed or banks.		<b>Pic 4 Desc.</b>	S-II4, downstream, no changes noted to stream bed or banks.

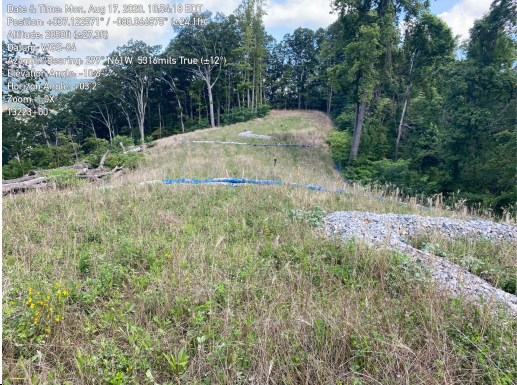
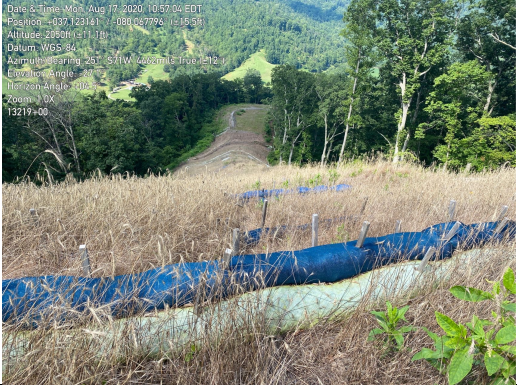
<b>GPS Location</b>	See photo for coordinates.		<b>GPS Location</b>	See photo for coordinates.	
<b>Field Station#</b>	13223+00		<b>Field Station#</b>	13219+00	
<b>Pic 13 Desc.</b>	Restored ROW stable, no changes noted.		<b>Pic 14 Desc.</b>	Mostly vegetative cover noted across LOD, no erosion was observed.

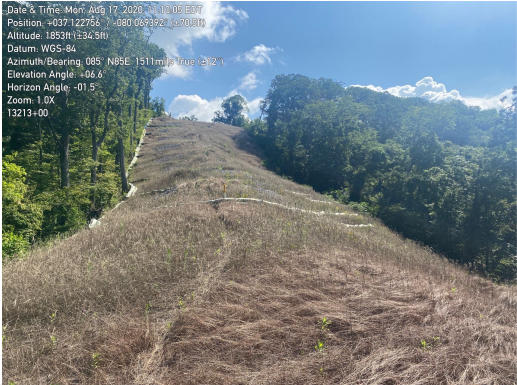
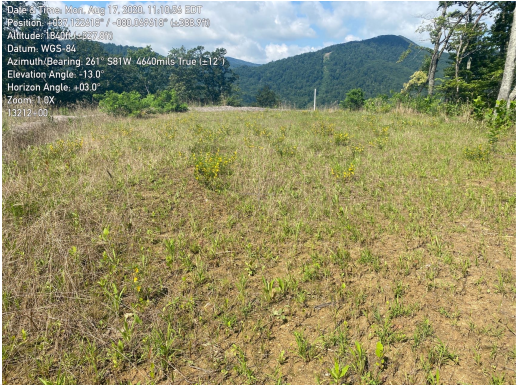
<b>GPS Location</b>	See photo for coordinates.		<b>GPS Location</b>	See photo for coordinates.	
<b>Field Station#</b>	13213+00		<b>Field Station#</b>	13212+00	
<b>Pic 15 Desc.</b>	Mostly dead vegetative cover noted across LOD, no erosion was observed.		<b>Pic 16 Desc.</b>	Some new growth noted in stabilized section of ROW, moderate coverage, no erosion observed.

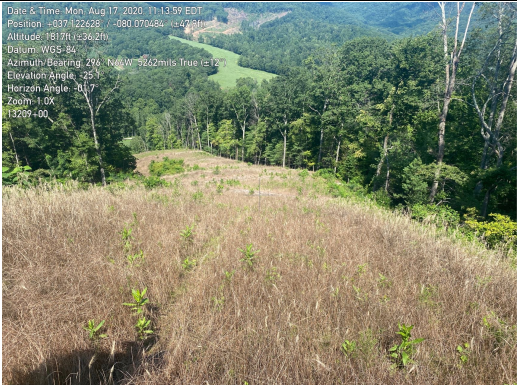
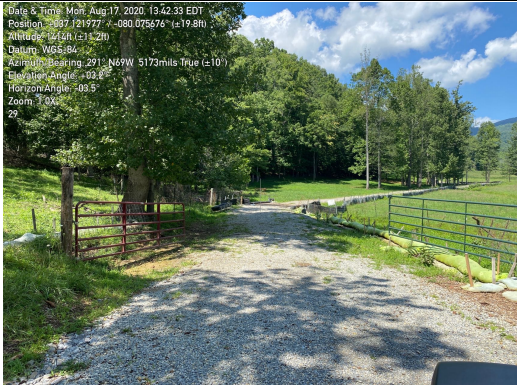
<b>Pic 17 Desc.</b>	Vegetative cover noted across LOD, with some sparse to moderately vegetated areas in travel lane.		<b>Pic 18 Desc.</b>	MVP-AR-29, ECDs in acceptable condition.

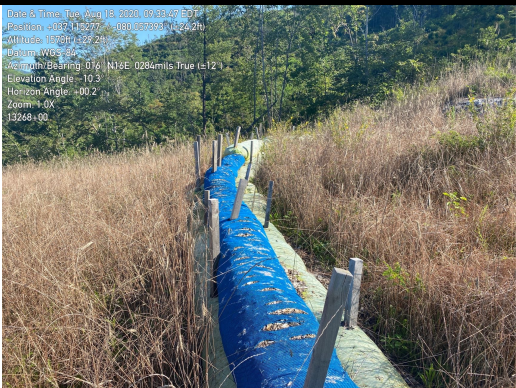
Pic 5 Desc.	CFS degrading at accelerated rate, has not worsened since last inspection.		Pic 6 Desc.	Permanently restored ROW stable with acceptable vegetative cover.

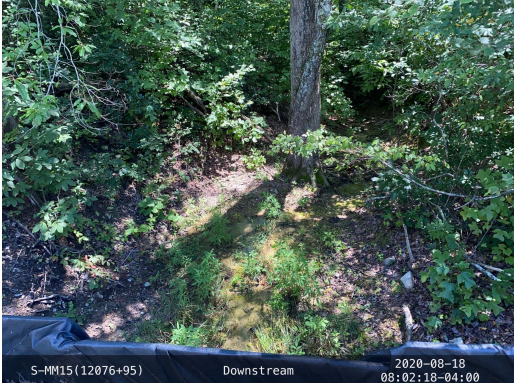
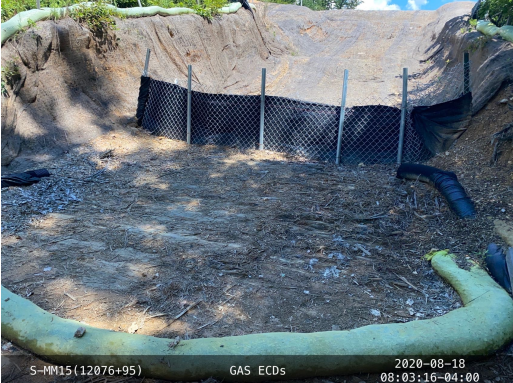
<b>GPS Location</b>	See photo GPS for location		<b>GPS Location</b>	See photo GPS for location	
<b>Field Station#</b>	12076+95		<b>Field Station#</b>	12076+95	
<b>Pic 1 Desc.</b>	Downstream		<b>Pic 2 Desc.</b>	GAS ECDs

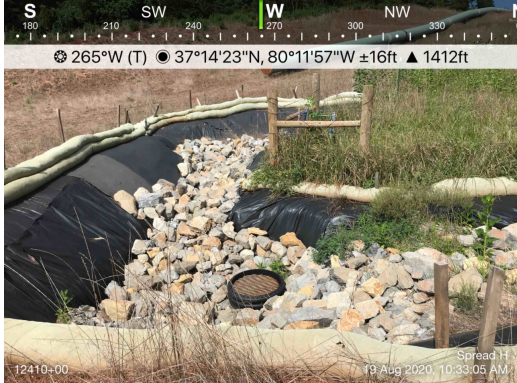
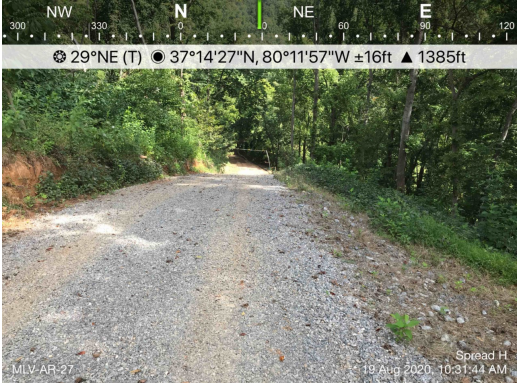
<b>GPS Location</b>	See photo		<b>GPS Location</b>	See photo	
<b>Field Station#</b>	12410+00		<b>Field Station#</b>	+27	
<b>Pic 9 Desc.</b>	CWD inlet in good condition.		<b>Pic 10 Desc.</b>	Controls are in place and functioning on MLV-AR-27

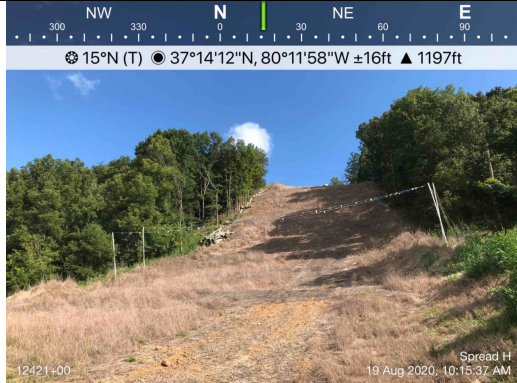
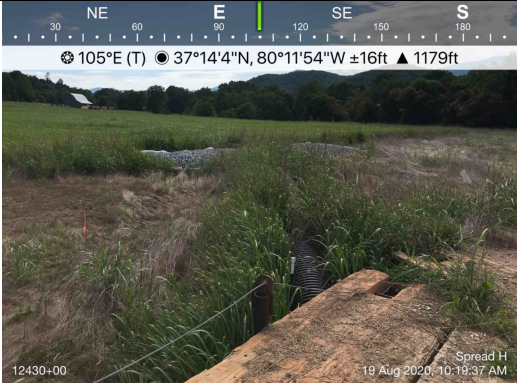
<b>GPS Location</b>	See photo		<b>GPS Location</b>	See photo	
<b>Field Station#</b>	12421+00		<b>Field Station#</b>	12430+00	
<b>Pic 11 Desc.</b>	Waterbars, end treatments, and CFS controls are in good condition near Stones Keep Rd and the Railroad crossing.		<b>Pic 12 Desc.</b>	CWD pipe and berm in good condition near future Roanoke River Bore crossing.

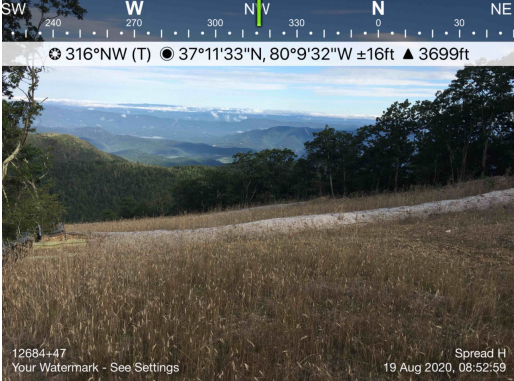
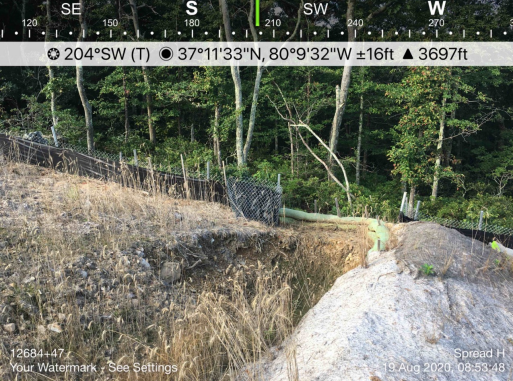
<b>GPS Location</b>	See watermark		<b>GPS Location</b>	See watermark	
<b>Field Station#</b>	12684+47		<b>Field Station#</b>	12684+47	
<b>Pic 1 Desc.</b>	ROW well vegetated, looking at incoming side, near construction entrance		<b>Pic 2 Desc.</b>	Sump in good condition, typical of reach.

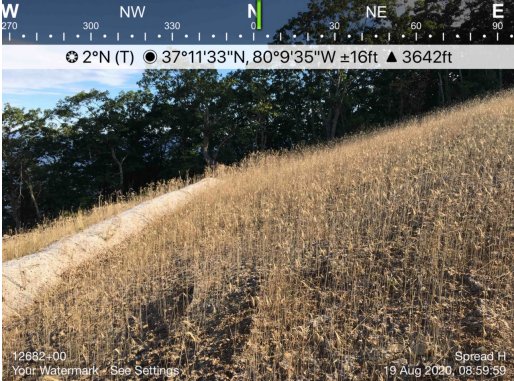
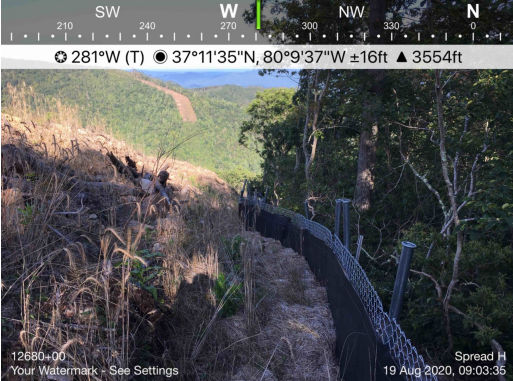
<b>GPS Location</b>	See watermark		<b>GPS Location</b>	See watermark	
<b>Field Station#</b>	12682+00		<b>Field Station#</b>	12680+00	
<b>Pic 3 Desc.</b>	Waterbar in good condition, functioning properly, typically of reach.		<b>Pic 4 Desc.</b>	Super silt fence, good condition.

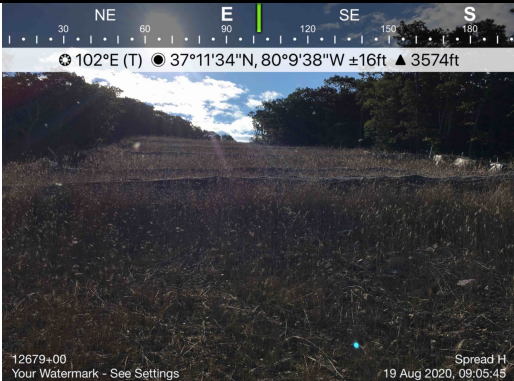
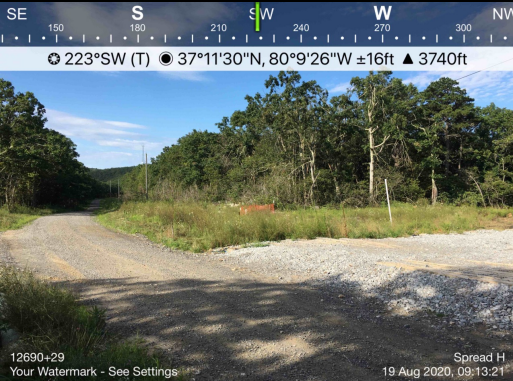
<b>GPS Location</b>	See watermark		<b>GPS Location</b>	See watermark	
<b>Field Station#</b>	12679+00		<b>Field Station#</b>	12690+29	
<b>Pic 5 Desc.</b>	Looking in the outgoing direction. Slope well vegetated and stable.		<b>Pic 6 Desc.</b>	Construction entrance on Honeysuckle Rd. crossing in good order.

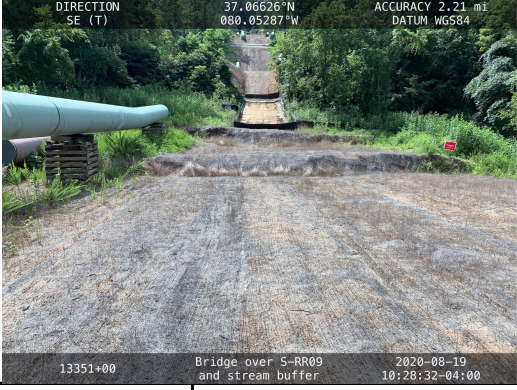
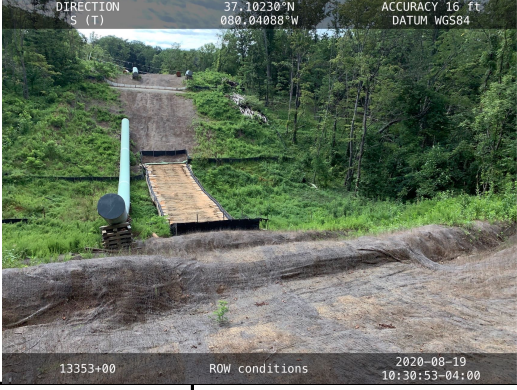
<b>Pic 17 Desc.</b>	Photo shows the bridge over stream S-RR09 and stream buffer.		<b>Pic 18 Desc.</b>	Photo shows the ROW condition from about 13353+00 to 13356+00.

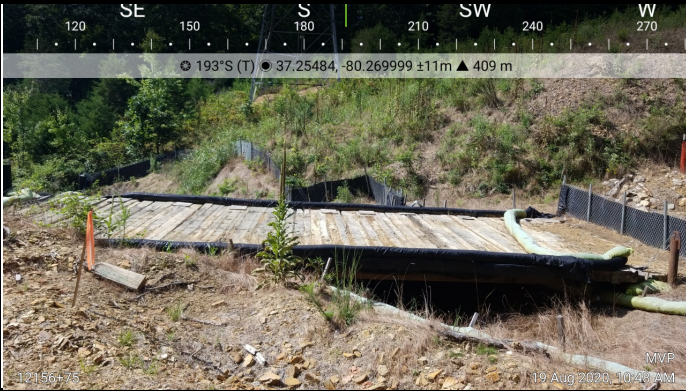
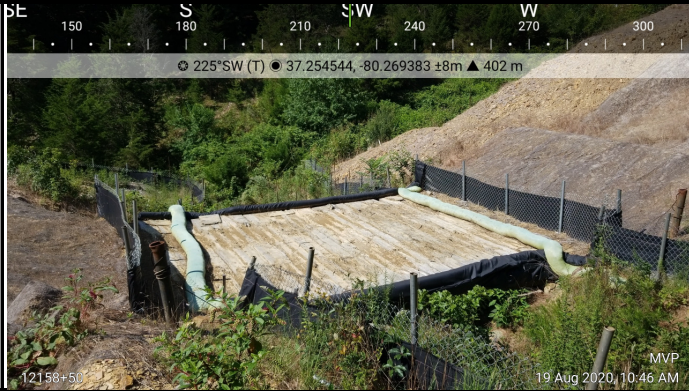
<b>GPS Location</b>	See Above		<b>GPS Location</b>	See Above	
<b>Field Station#</b>	12156+75		<b>Field Station#</b>	12158+50	
<b>Pic 7 Desc.</b>	Overview of Head Water Area of Waterbody S-C23. ECDs functional and in good condition.		<b>Pic 8 Desc.</b>	Overview of Head Water Area of Waterbody S-C23. ECDs functional and in good condition.

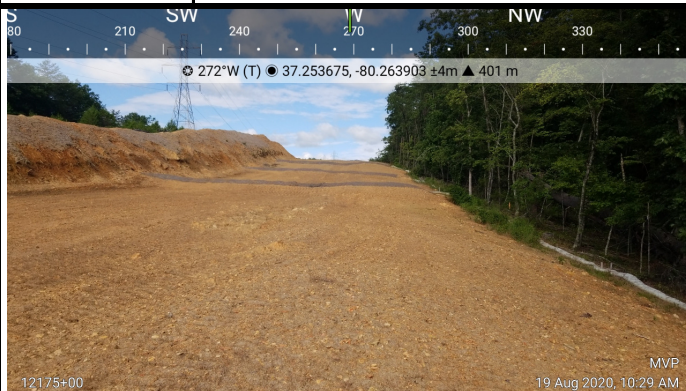
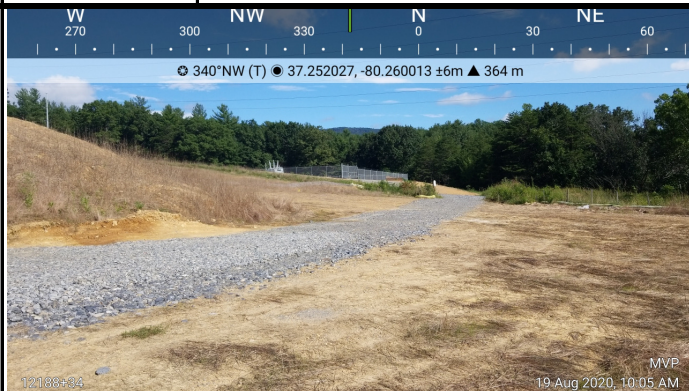
<b>GPS Location</b>	See Above		<b>GPS Location</b>	See Above	
<b>Field Station#</b>	12175+00		<b>Field Station#</b>	12188+34	
<b>Pic 11 Desc.</b>	ROW Overview. Temporary Restoration. ECDs functional and in good condition.		<b>Pic 12 Desc.</b>	ROW/Access Road 274 Overview. Temporary Restoration. ECDs functional and in good condition.

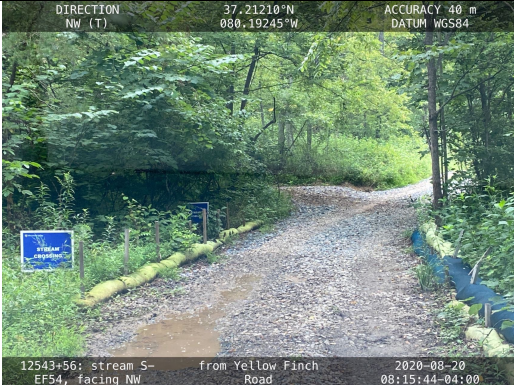
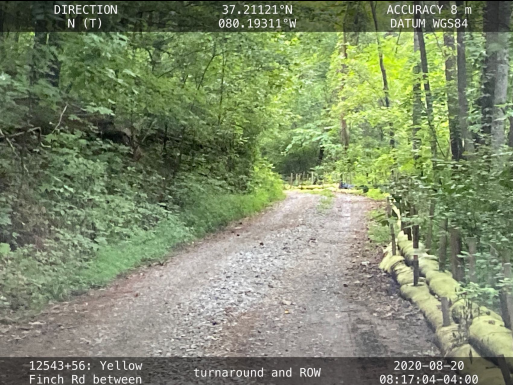
<b>GPS Location</b>	See photo		<b>GPS Location</b>	See photo	
<b>Field Station#</b>	12543+56		<b>Field Station#</b>	12543+56	
<b>Pic 1 Desc.</b>	Stream S-EF54, facing northwest, on Yellow Finch Road		<b>Pic 2 Desc.</b>	Yellow Finch Road between turnaround and MVP ROW.

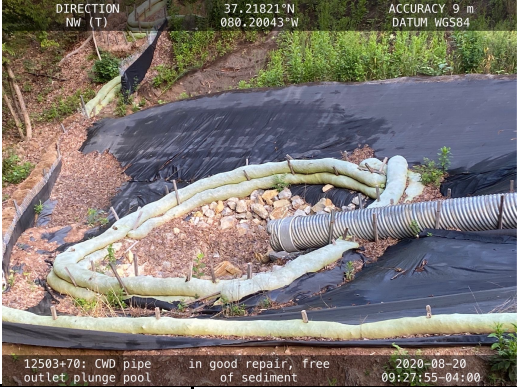
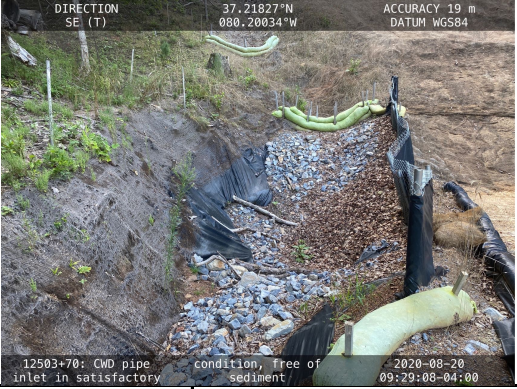
<b>GPS Location</b>	See photo		<b>GPS Location</b>	See photo	
<b>Field Station#</b>	12503+70		<b>Field Station#</b>	12503+70	
<b>Pic 13 Desc.</b>	Clean water diversion pipe outlet remains in good repair and is free of sediment.		<b>Pic 14 Desc.</b>	Clean water diversion pipe inlet is in satisfactory condition and free of sediment.

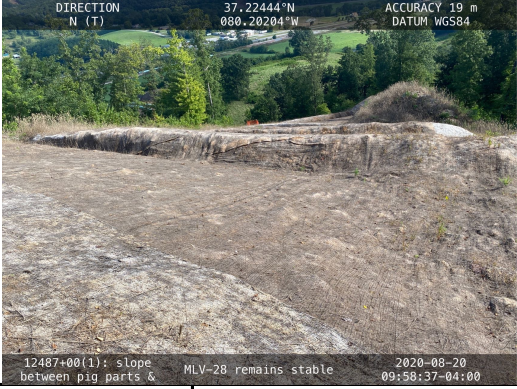
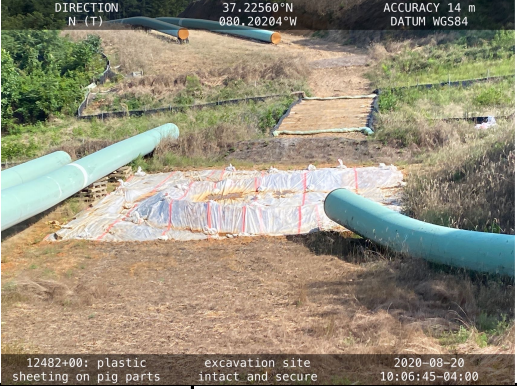
<b>GPS Location</b>	See photo		<b>GPS Location</b>	See photo	
<b>Field Station#</b>	12487+00		<b>Field Station#</b>	12482+00	
<b>Pic 15 Desc.</b>	The slope between "pig parts" excavation site and MLV-28 is stable.		<b>Pic 16 Desc.</b>	Plastic sheeting remains intact and secure at the "pig parts" excavation site.

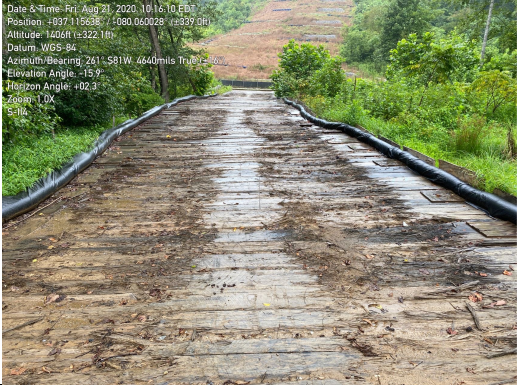
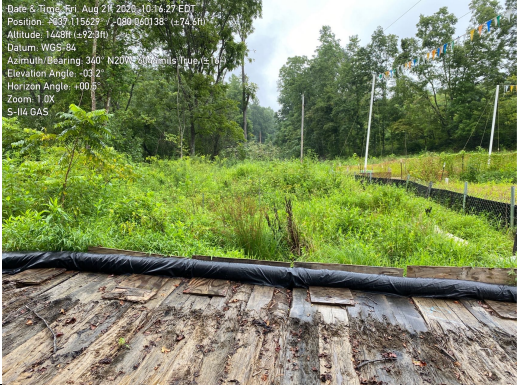
<b>GPS Location</b>	See photo for coordinates.		<b>GPS Location</b>	See photo for coordinates.	
<b>Field Station#</b>	13261+00		<b>Field Station#</b>	13261+00	
<b>Pic 7 Desc.</b>	S-II4, bridge over S-II4 in acceptable condition.		<b>Pic 8 Desc.</b>	S-II4 stream buffer well vegetated.

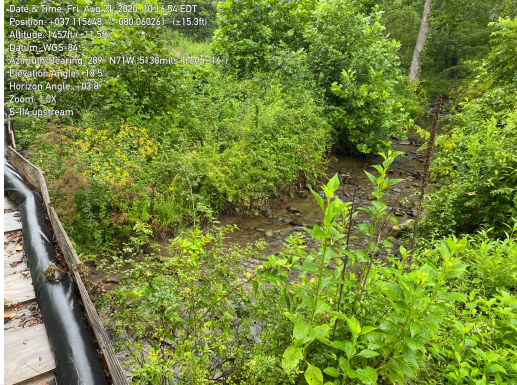
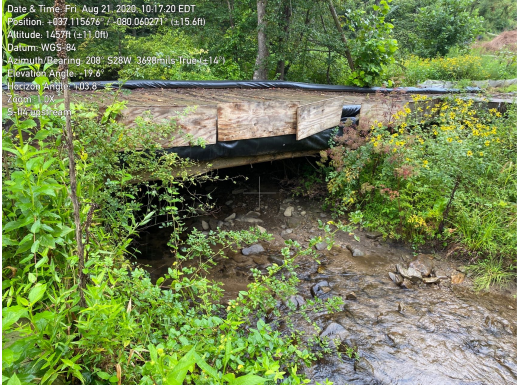
<b>GPS Location</b>	See photo for coordinates.		<b>GPS Location</b>	See photo for coordinates.	
<b>Field Station#</b>	13260+60		<b>Field Station#</b>	13260+60	
<b>Pic 9 Desc.</b>	S-II4, upstream, no changes noted to stream bed or banks.		<b>Pic 10 Desc.</b>	S-II4, bridge in acceptable condition.

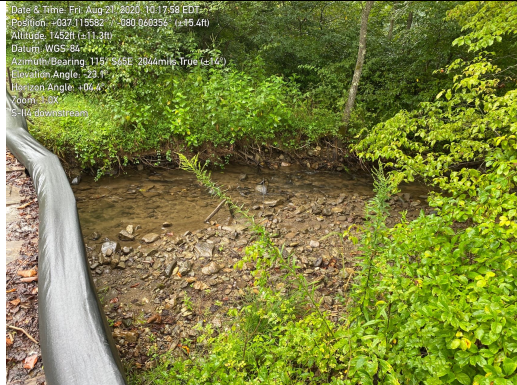
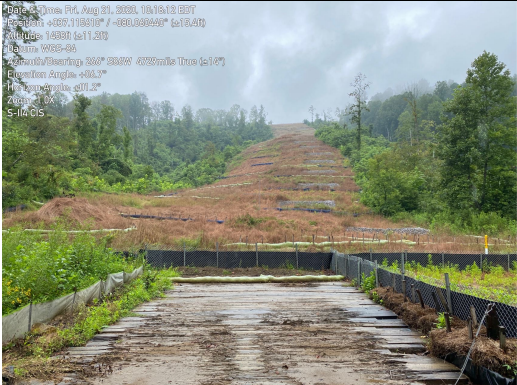
<b>GPS Location</b>	See photo for coordinates.		<b>GPS Location</b>	See photo for coordinates.	
<b>Field Station#</b>	13260+60		<b>Field Station#</b>	13260+50	
<b>Pic 11 Desc.</b>	S-II4, downstream, no change noted to stream bed or banks.		<b>Pic 12 Desc.</b>	CIS S-II4, restored ROW stable, waterbars and rock weird stable, good vegetative cover across LOD.
