Visual Site Inspection Report

Project Name	H-600 Pipeline Spread H	AFE	124300138	Spread	H-600 Pipeline Spread H
Contractor	Precision			Report #	13882
Inspector	Dawn McCullough			Date/Time	8/24/2020 2:00 PM
Permit #	TBD	Inspection Type	VA SWPP	Station Begin	13262+50
State	VA	Inspection Area	Partial	Station End	13315+70
County	Franklin	Ground	Damp	Temperature (°F)	86.00
Municipality	N/A	Weather	Sunny	Rain Gauge (in)	0.60
				Rain Accumulation Time (days)	1.00

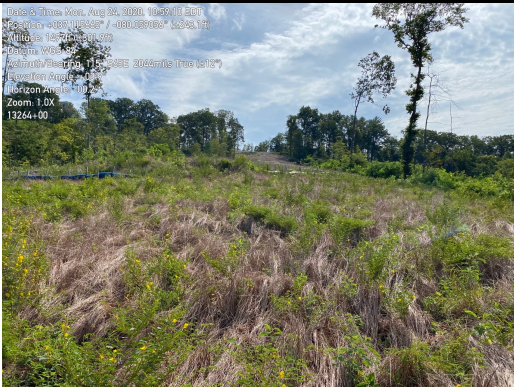
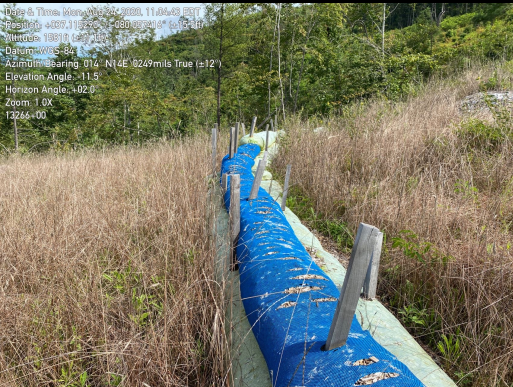
GPS Location	See photo for coordinates.		GPS Location	See photo for coordinates.	
Field Station#	13264+00		Field Station#	13266+00	
Pic 1 Desc.	ROW stable, temporary and permanent vegetation noted across LOD.		Pic 2 Desc.	CFS extension, accelerated degradation of filter sock fabric previously reported.

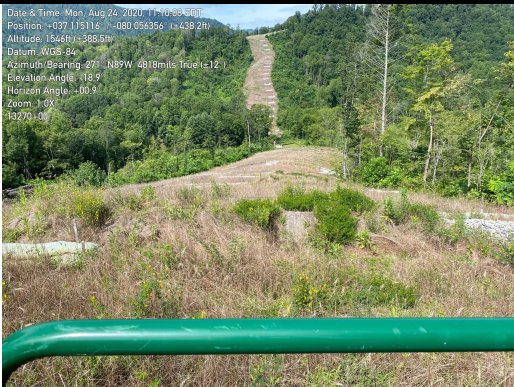
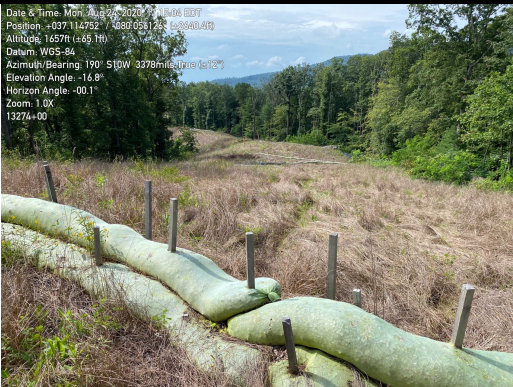
GPS Location	See photo for coordinates.		GPS Location	See photo for coordinates.	
Field Station#	13270+00		Field Station#	13274+00	
Pic 3 Desc.	ROW stable, vegetation noted across LOD, majority of cover temporary species that have seeded and died.		Pic 4 Desc.	Permanent waterbars and extensions stable, vegetative cover noted across LOD.

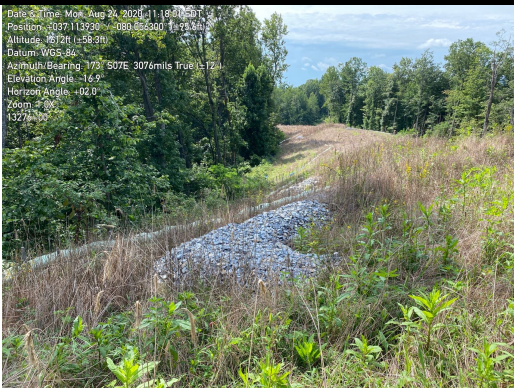
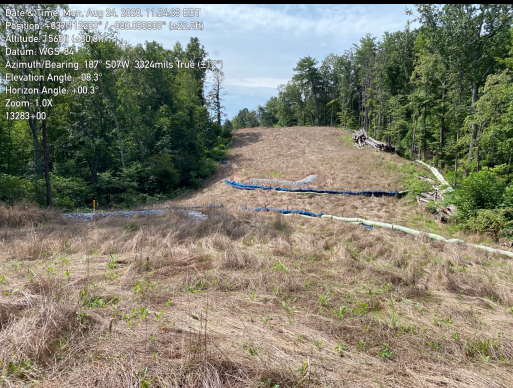
GPS Location	See photo for coordinates.		GPS Location	See photo for coordinates.	
Field Station#	13276+00		Field Station#	13283+00	
Pic 5 Desc.	Permanent waterbars and perimeter controls functioning acceptably.		Pic 6 Desc.	Vegetative cover noted across LOD, mostly temporary with less than 10 percent living.

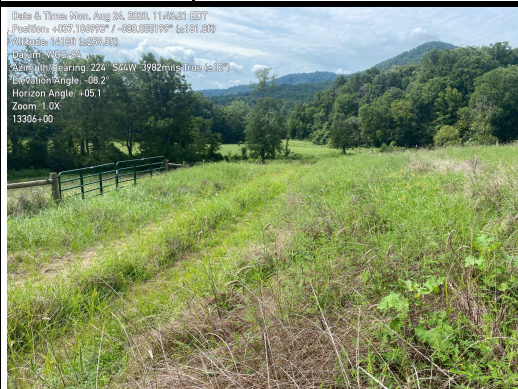
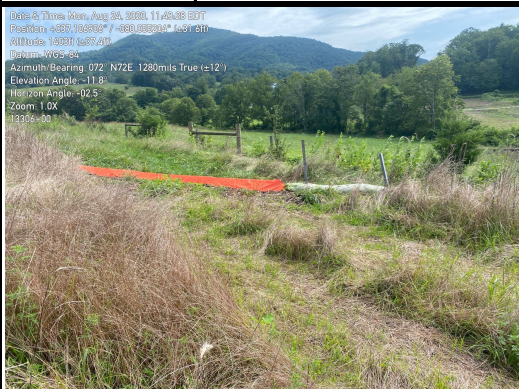
Pic 11 Desc.	Upper landowner crossing well vegetated, crossing showing evidence of vehicle use.		Pic 12 Desc.	Diversion dike in acceptable condition at landowner crossing.

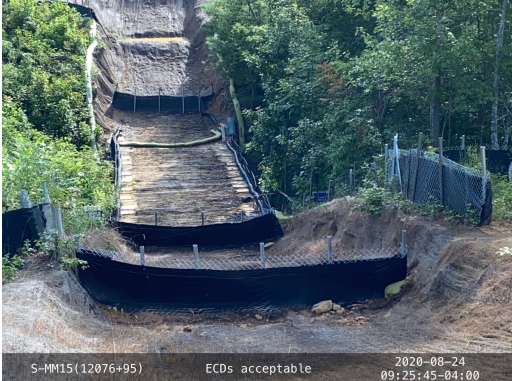
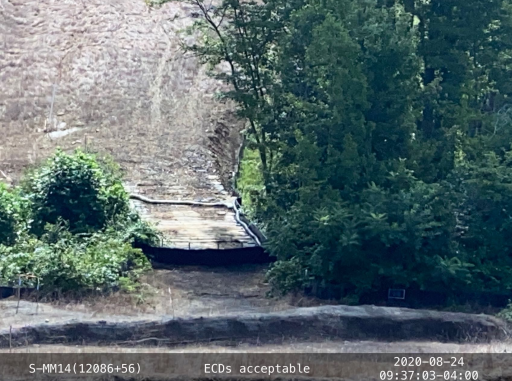
S-MM15(12076+95) ECDs acceptable 2020-08-24 09:25:45-04:00		S-MM14(12086+56) ECDs acceptable 2020-08-24 09:37:03-04:00			
GPS Location	See photo GPS for location		GPS Location	See photo GPS for location	
Field Station#	12076+95		Field Station#	12086+56	
Pic 1 Desc.	ECDs are acceptable		Pic 2 Desc.	ECDs are acceptable

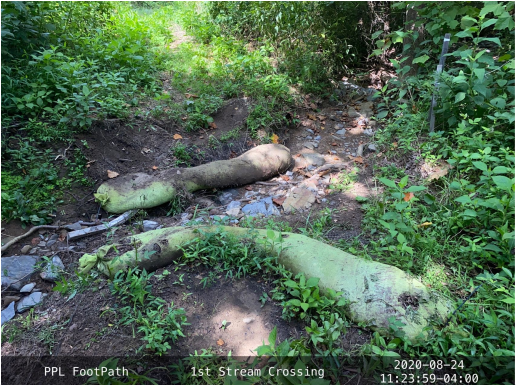
<p>PPL FootPath 1st Stream Crossing 2020-08-24 11:23:59-04:00</p>			
GPS Location	See photo GPS for location		GPS Location	See photo GPS for location	
Field Station#	00000+00		Field Station#	00000+00	
Pic 15 Desc.	Damaged CFS and stakes at 1st stream crossing on PPL Footpath		Pic 16 Desc.	Damaged CFS and stakes at 1st stream crossing on PPL Footpath

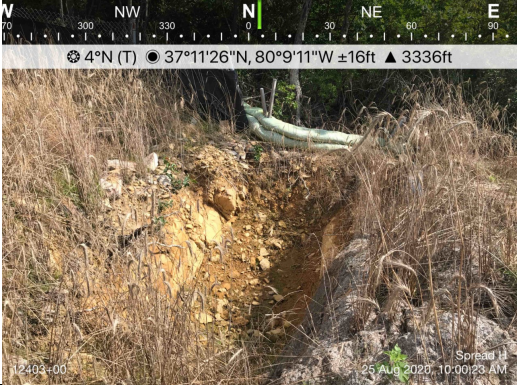
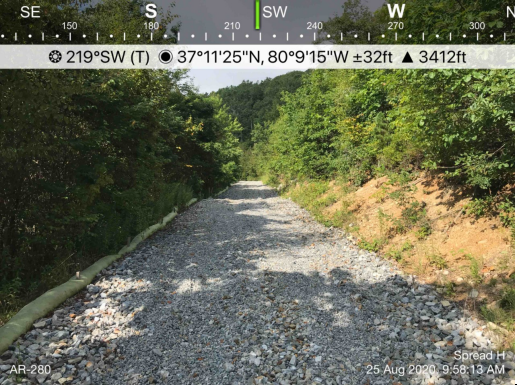
GPS Location	See photo		GPS Location	See photo	
Field Station#	12403+00		Field Station#	2+80	
Pic 7 Desc.	Sump and end treatment in acceptable condition.		Pic 8 Desc.	Controls are in place and functioning on AR-280

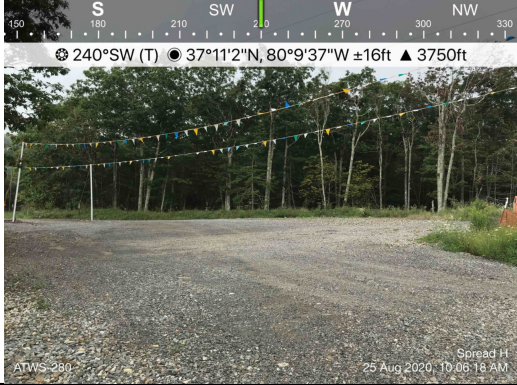
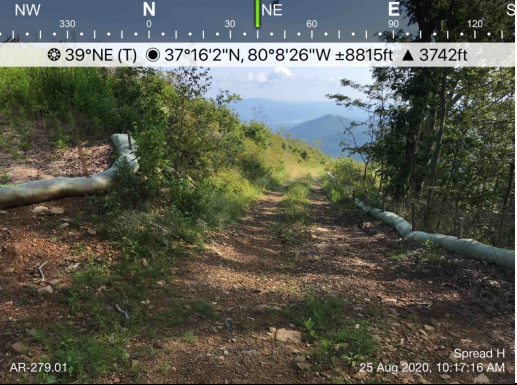
GPS Location	See photo		GPS Location	See photo	
Field Station#	2+80		Field Station#	279+01	
Pic 9 Desc.	ATWS-280 area inactive and in acceptable condition.		Pic 10 Desc.	Controls in place and functioning on AR-279.01

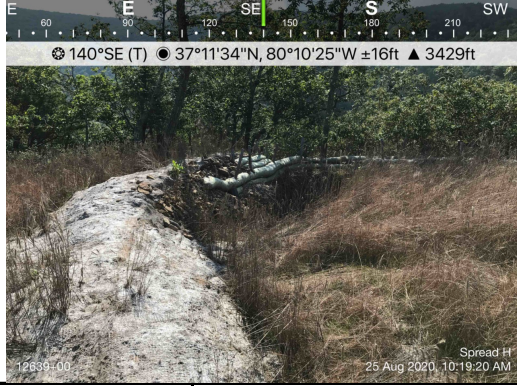
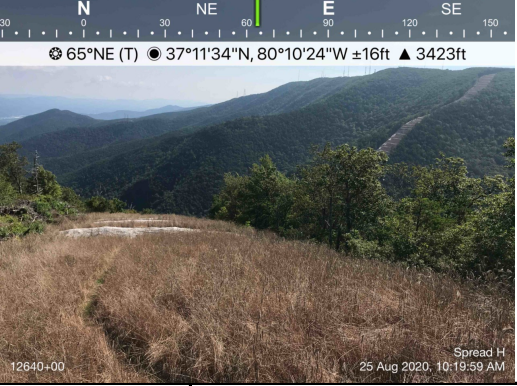
GPS Location	See photo		GPS Location	See photo	
Field Station#	12639+00		Field Station#	12640+00	
Pic 11 Desc.	Waterbar and end treatment in acceptable condition.		Pic 12 Desc.	Controls on this slope are stabilized and in good condition.

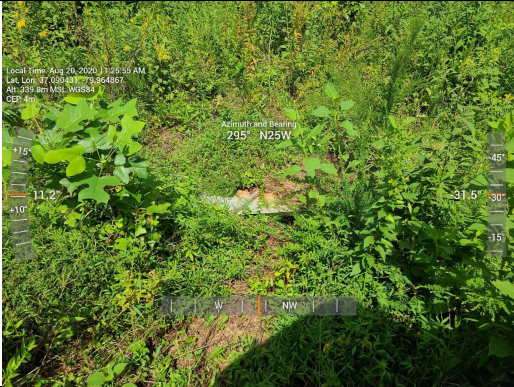
GPS Location	00000	GPS Location	00000		
Field Station#	13631+27	Field Station#	13643+63		
Pic 1 Desc.	P1 damaged from land owner, added to the punch list	Pic 2 Desc.	Stream crossing photo facing downstream

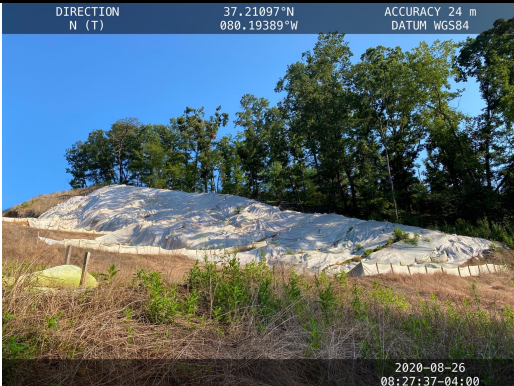
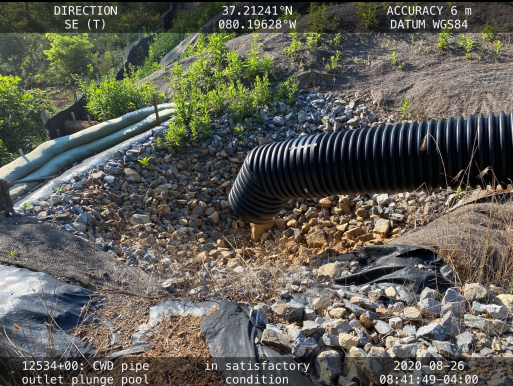
GPS Location	See photo		GPS Location	See photo	
Field Station#	12543+00		Field Station#	12534+00	
Pic 5 Desc.	Plastic sheeting used for stabilizing the stockpile nearest to Yellow Finch Road remains intact and secure.		Pic 6 Desc.	This clean water diversion pipe outlet plunge pool remains in satisfactory condition, free of sediment.

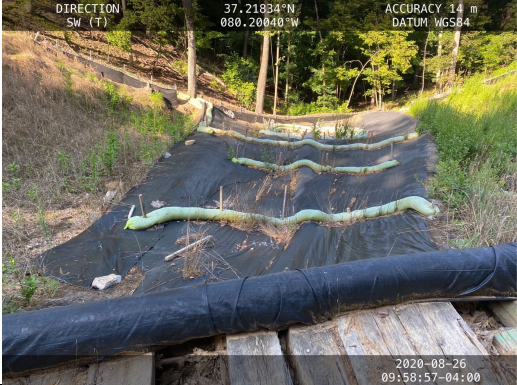
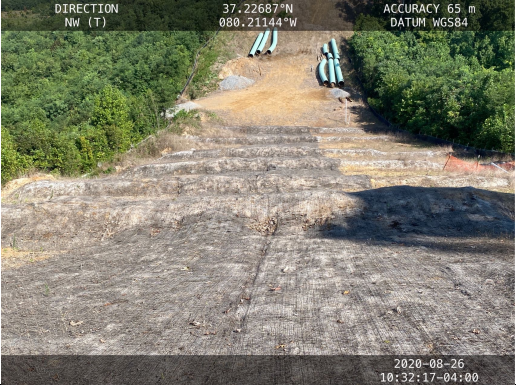
GPS Location	See photo		GPS Location	See photo	
Field Station#	12503+72		Field Station#	12487+00	
Pic 13 Desc.	The clean water diversion pipe on going away side of Enbridge pipeline crossing remains in satisfactory condition.		Pic 14 Desc.	The slope on the going away side of MLV-28 remains stable.

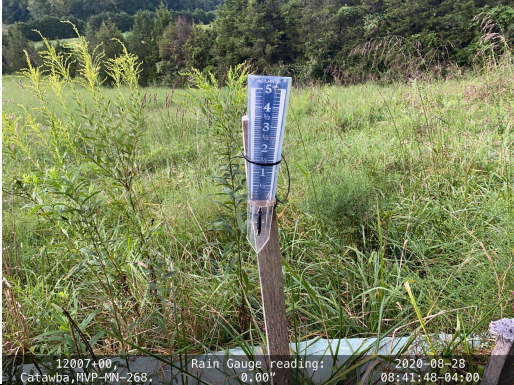
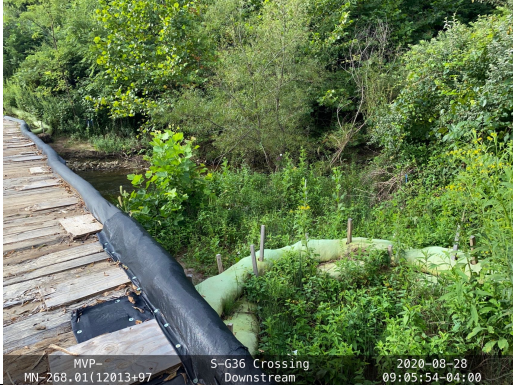
GPS Location	See photo GPS for location		GPS Location	See photo GPS for location	
Field Station#	12013+97		Field Station#	12013+97	
Pic 1 Desc.	Rain gauge reading is 0.00".		Pic 2 Desc.	MVP-MN-268.01 Bridge crossing S-G36.

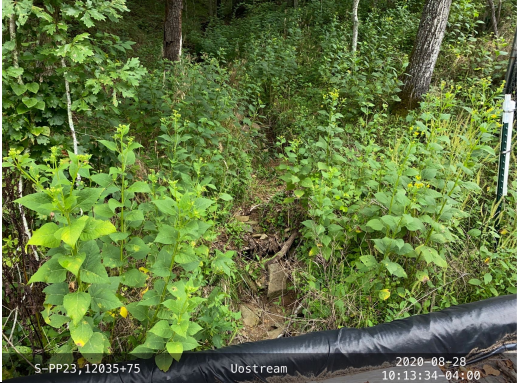
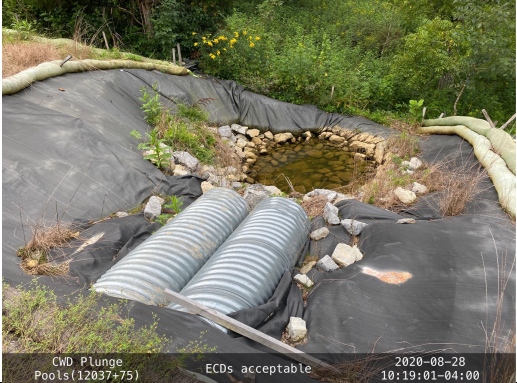
GPS Location	See photo GPS for location	GPS Location	See photo GPS for location		
Field Station#	12035+75	Field Station#	12037+75		
Pic 13 Desc.	S-PP23 Upstream	Pic 14 Desc.	Plunge pool is in acceptable condition.
