Visual Site Inspection Report

| Project Name | H-600 Pipeline Spread I | AFE | 124300139 | Spread | H-600 Pipeline Spread I |
| Contractor | Precision | | | Report # | 12418 |

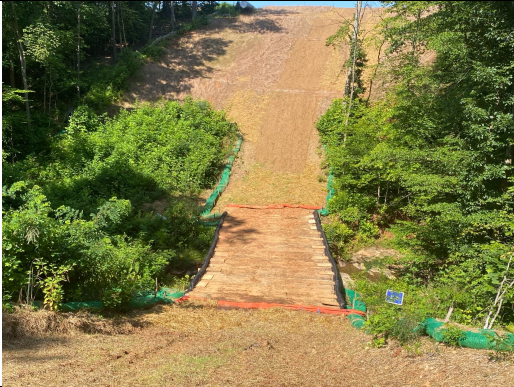
| Field Station# | 14105+26 | Field Station# | 14115+00 | | |

| Pic 1 Desc. | Approximately 14105+26. Overview of stream crossing, equipment bridge and ECDs at stream S-KL41. | | Pic 2 Desc. | Approximately 14115+00. Overview of ROW. ROW temporarily stabilized and has temporary and permanent vegetation growing. | |

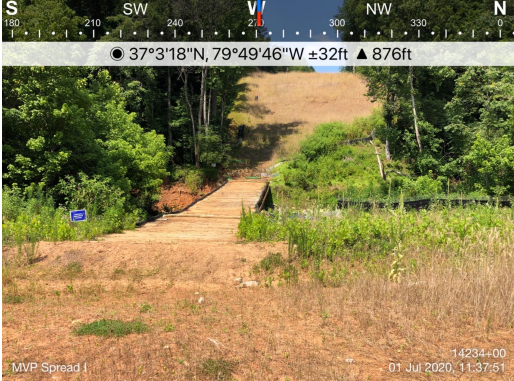
| Pic 1 Desc. | Equipment bridge in acceptable condition | Pic 2 Desc. | Rock lined channel in acceptable condition | | |

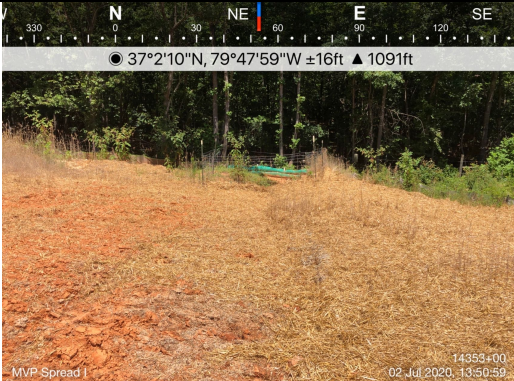
| Pic 3 Desc. | Waterbar in acceptable condition | Pic 4 Desc. | Super silt fence in acceptable condition | | |

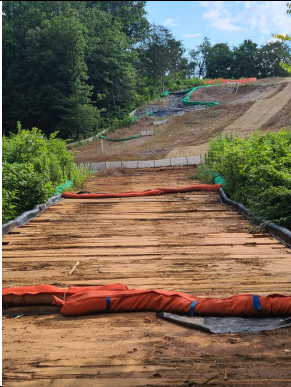
| Pic 1 Desc. | Monitored equipment bridge and ECDs | Pic 2 Desc. | Stream crossing photo facing downstream | | |

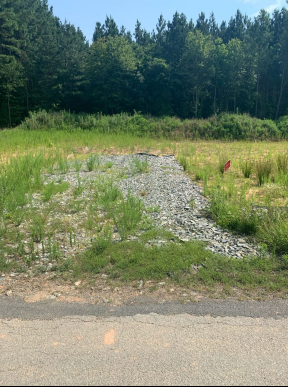
| Pic 1 Desc. | Observing RCE. | Pic 2 Desc. | Observing temporary vegetation. | | |

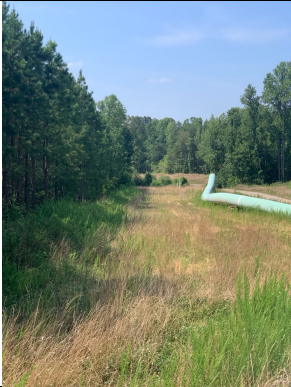
| Pic 1 Desc. | Observing temporary vegetation. | Pic 2 Desc. | Observing access road and temporary vegetation. | | |

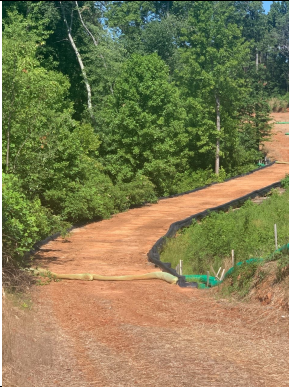
| Pic 1 Desc. | Observing equipment crossing and ECD's performing as they should. | | Pic 2 Desc. | Observing ECD's performing as they should. | |

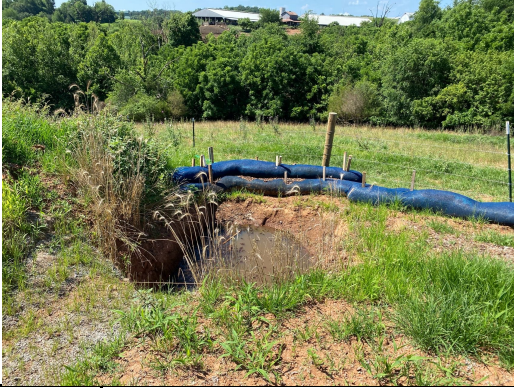
| Pic 1 Desc. | CFS at sump in proper working condition. | Pic 2 Desc. | Stream crossing S-CC3. No issues to report. | | |

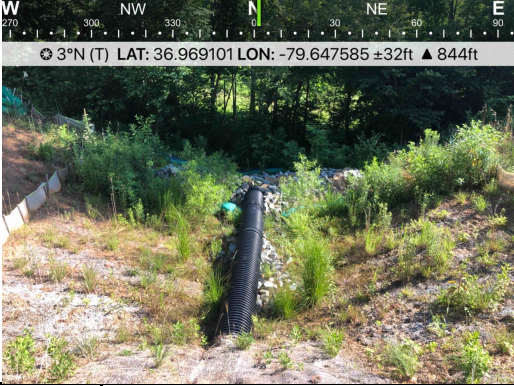
| Pic 1 Desc. | Temporary level spreader functioning as intended | | Pic 2 Desc. | Sump pit functioning as intended | |

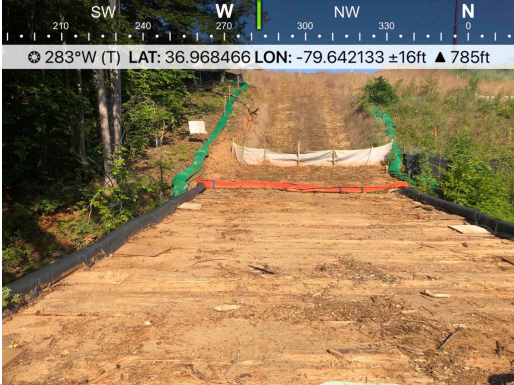
| Pic 3 Desc. | Equipment bridge clean at stream S-GH16 | | Pic 4 Desc. | Permanent stabilization on the CIS of Ramsey Memorial Road | |

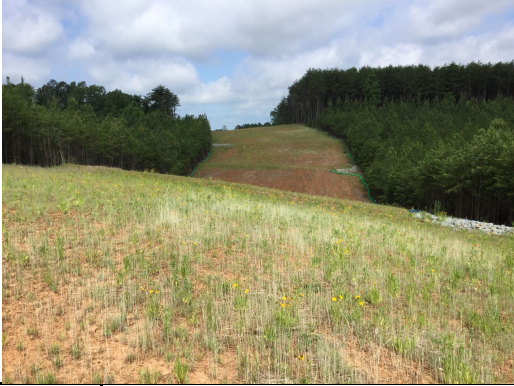
| Pic 1 Desc. | Permanent vegetation coming in along ROW in final cleanup area. | | Pic 2 Desc. | Permanent breaker rock end treatment and perimeter CFS in place and functional. | |

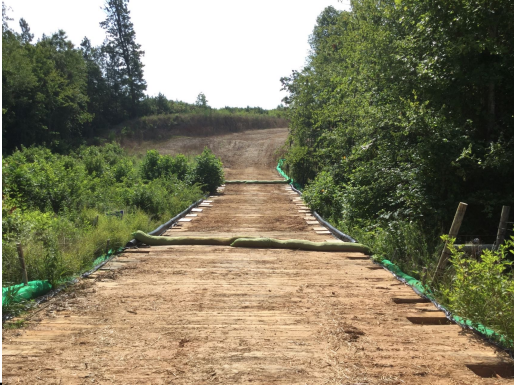
| Pic 3 Desc. | Equipment bridge and surrounding ECD's in place and functional at streams S-CC13/14 | | Pic 4 Desc. | Downstream view of S-CC14. No issues observed. | |

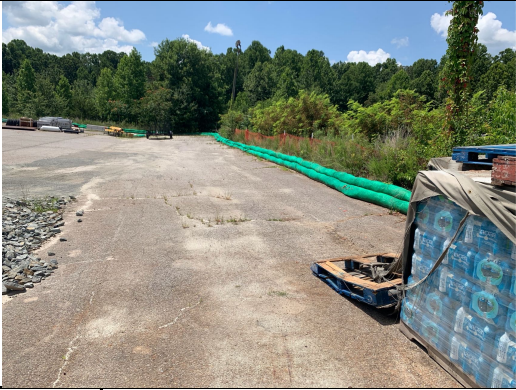
| Pic 1 Desc. | Perimeter ECD's on west side of paved road in good condition. | Pic 2 Desc. | Inlet protection on south end of paved yard in good condition | | |

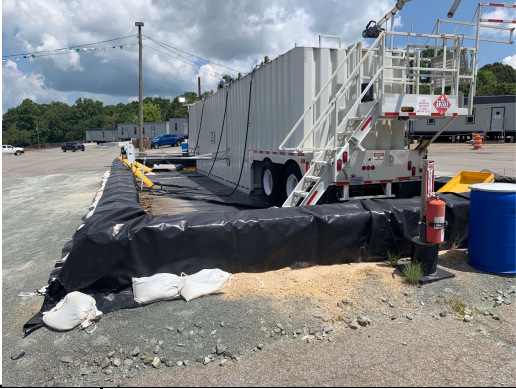
| Pic 3 Desc. | Secondary containment structure for fuel cell in compliance. | Pic 4 Desc. | Secondary containment structure on north end of gravel yard liner has been replaced. (Issue from previous inspection addressed by contractor) | | |

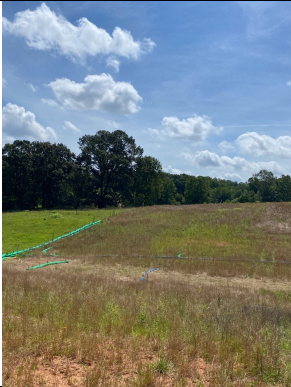
| Pic 1 Desc. | Approximately 14274+00. Overview of ROW. ROW temporarily stabilized and has temporary vegetation growing. | | Pic 2 Desc. | Approximately 13958+00. Overview of ROW and RCE. ROW temporarily stabilized and has temporary vegetation growing. RCE appears to be installed and functioning correctly at time of inspection. | |

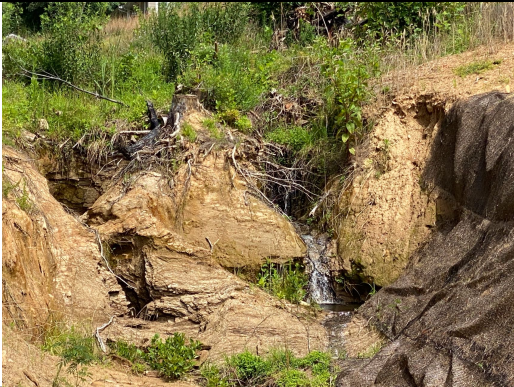
| Pic 3 Desc. | Approximately 14000+00. Overview of adjacent pond overflow flowing onto ROW. Minimal flow across ROW at time of inspection. | | Pic 4 Desc. | Approximately 13998+15. Overview of stream crossing, equipment bridge and ECDs at stream S-KL36. | |

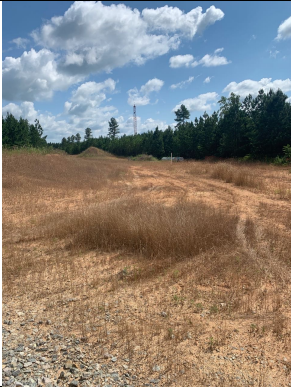
| Pic 1 Desc. | Observing temporary vegetation. | Pic 2 Desc. | Observing RCE. | | |

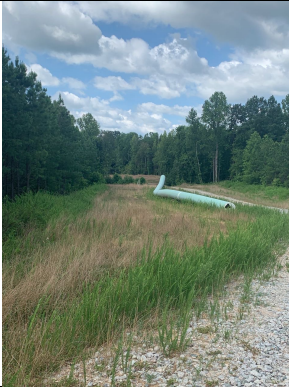
| Pic 1 Desc. | Observing temporary vegetation. | | Pic 2 Desc. | Observing temporary vegetation and signage. | |

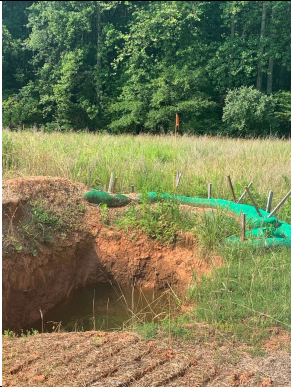
| Pic 1 Desc. | Observing sump and end treatment performing as they should. | Pic 2 Desc. | Observing p1 that requires maintenance. | | |

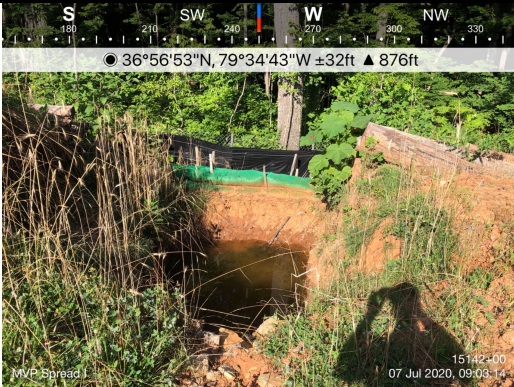
| Pic 1 Desc. | Waterbar end treatment in acceptable condition | | Pic 2 Desc. | Clean water diversion plunge pool in acceptable condition | |

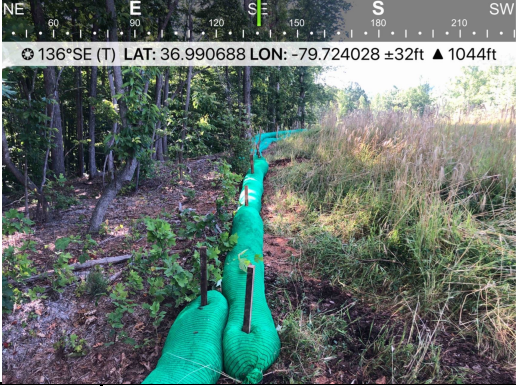
| Pic 1 Desc. | Perimeter CFS replaced on the GAS of Hwy 40 | Pic 2 Desc. | Perimeter CFS replaced and water bar built up on the GAS of Hwy 40 | | |

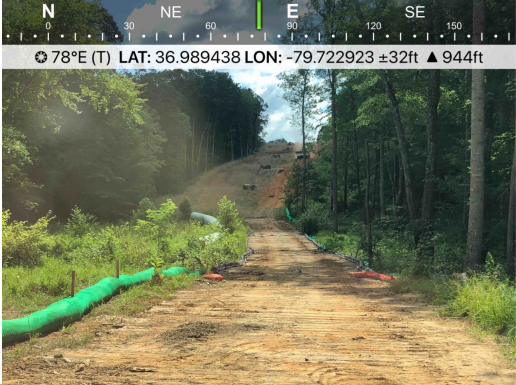
| Pic 3 Desc. | Equipment bridge clean and maintained at stream S-H38 | Pic 4 Desc. | Sump pit cleaned out on the CIS of Simmons Creek Road | | |
