Visual Site Inspection Report

Project Name H-600 Pipeline Spread I		AFE 124300139	Spread H-600 Pipeline Spread I
Contractor Precision		Report # 13753	
Inspector Justin Burch		Date/Time 8/19/2020 9:17 AM	
Permit # TBD	Inspection Type VA SWPP	Station Begin 14694+75	
State VA	Inspection Area Full	Station End 15142+66	
County Franklin/Pittsylvania	Ground Wet	Temperature (°F) 83.00	
Municipality Chatham	Weather Sunny	Rain Gauge (in) 2.00	
			Rain Accumulation Time (days) 6.00

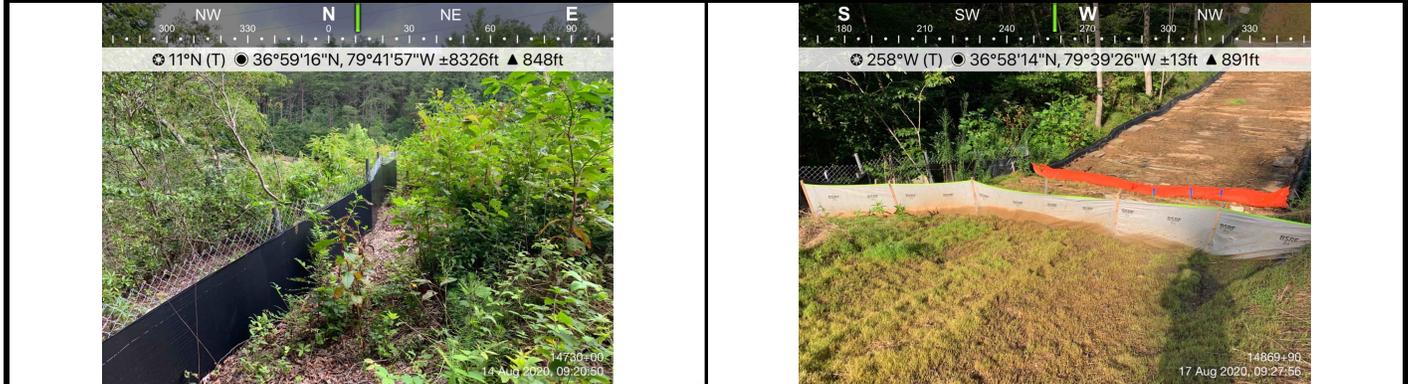
Field Station#	14730+00	Field Station#	14869+00
-----------------------	----------	-----------------------	----------

Pic 1 Desc.	Super silt fence in acceptable condition	Pic 2 Desc.	P1 silt fence in acceptable condition
--------------------	--	--------------------	---------------------------------------

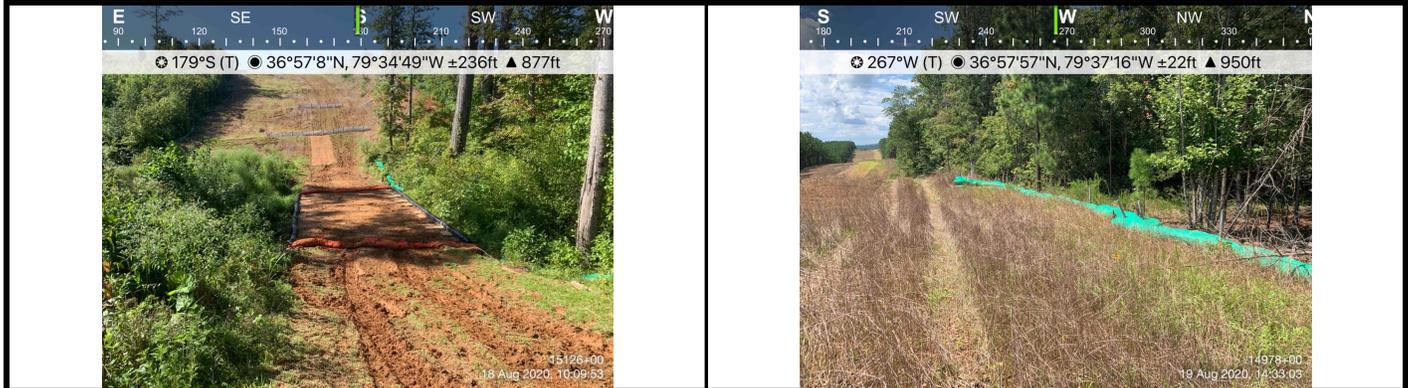
Field Station#	15126+00	Field Station#	14978+00
-----------------------	----------	-----------------------	----------

Pic 3 Desc.	Equipment bridge in acceptable condition	Pic 4 Desc.	Perimeter CFS in acceptable condition
--------------------	--	--------------------	---------------------------------------

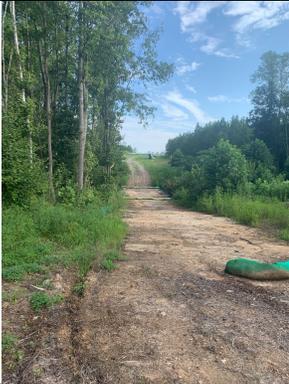
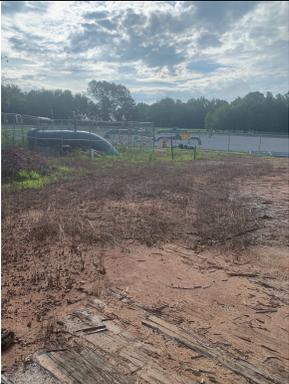
GPS Location	O		GPS Location	O	
Field Station#	12+65		Field Station#	18+00	
Pic 1 Desc.	Observing equipment crossing and ECD's performing as they should.		Pic 2 Desc.	Observing the row.

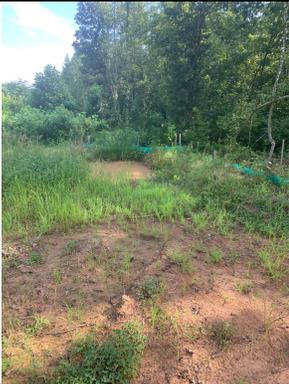
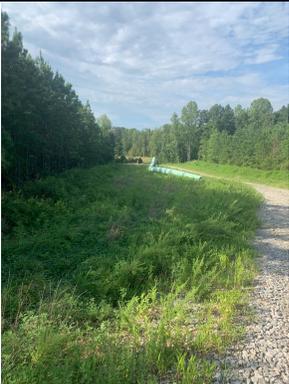
GPS Location	O		GPS Location	O	
Field Station#	13+50		Field Station#	8+00	
Pic 3 Desc.	Observing sump and end treatment.		Pic 4 Desc.	Observing temporary vegetation.	
Insert image here			Insert image here		
GPS Location			GPS Location		
Field Station#			Field Station#		
Pic 5 Desc.			Pic 6 Desc.

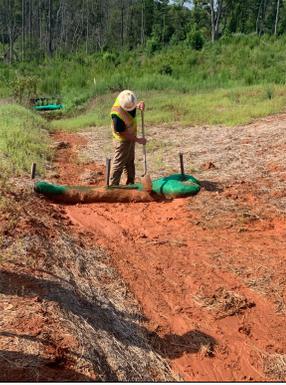
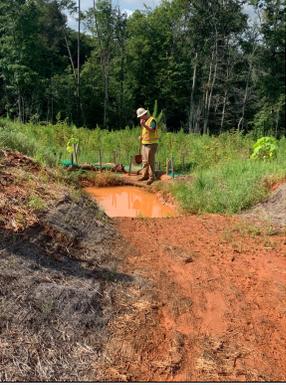
GPS Location O		GPS Location O			
Field Station# 15768+50		Field Station# 15706+00			
Pic 1 Desc. Observing the Contractor performing ECD maintenance.		Pic 2 Desc. Observing the Contractor performing ECD maintenance.

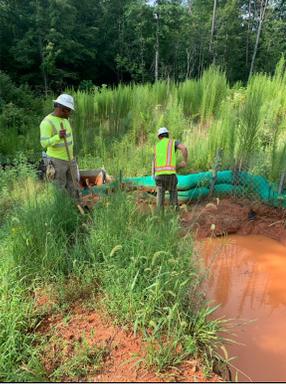
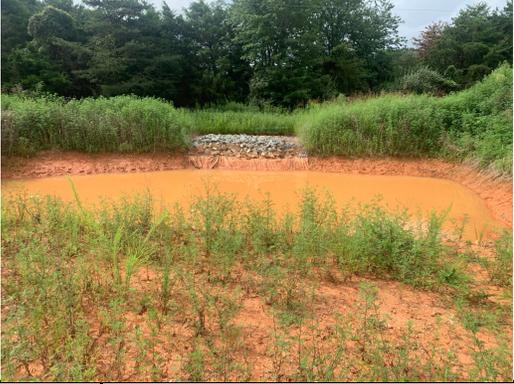
GPS Location O		GPS Location O			
Field Station# 15768+50		Field Station# 15739+00			
Pic 3 Desc. Observing the Contractor performing ECD maintenance.		Pic 4 Desc. Observing sump and rock drain.			
Insert image here			Insert image here		
GPS Location		GPS Location			
Field Station#		Field Station#			
Pic 5 Desc.		Pic 6 Desc.

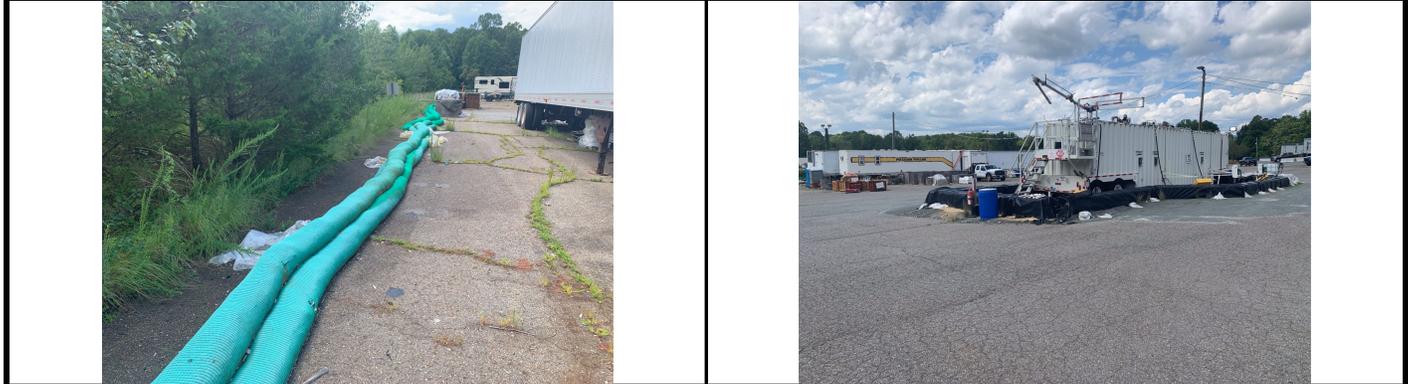
Field Station#	0000+00	Field Station#	0000+00
-----------------------	---------	-----------------------	---------

Pic 1 Desc.	Perimeter ECD's on south end of paved yard in good condition. Housekeeping needed on perimeter.	Pic 2 Desc.	Secondary containment structure for fuel cell in compliance.
--------------------	---	--------------------	--

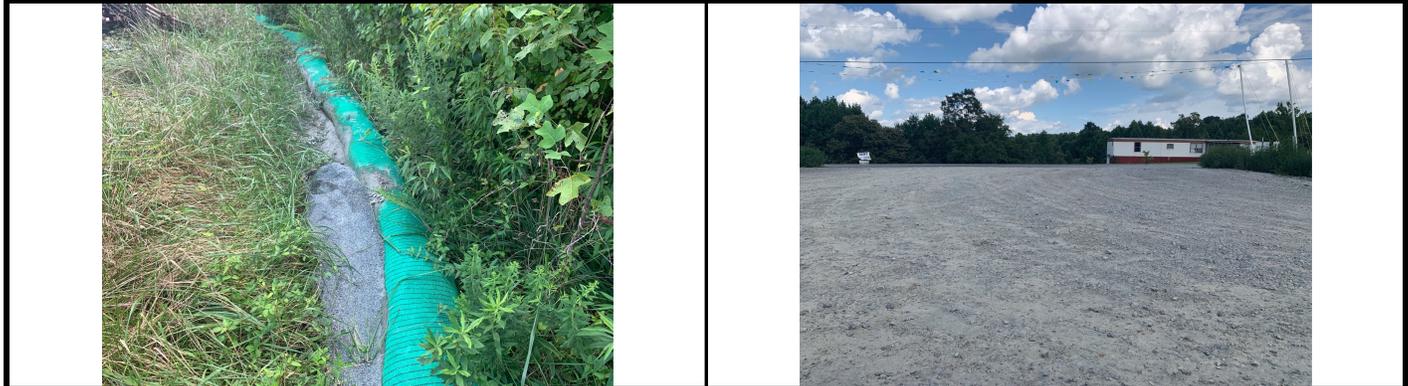
Field Station#	0000+00	Field Station#	0000+00
-----------------------	---------	-----------------------	---------

Performed SWPPP inspection of Spread I main Laydown yard in Rocky Mount, Va. The location has received 2.75" of rainfall since the last inspection. All perimeter ECD's were inspected and one issue was observed on the west side of the gravel yard the CFS is full near the conex boxes. The inlet protection for the parking lot drains in the paved yard were in good condition. There was also a housekeeping issue observed on the south perimeter of the paved yard. All secondary containment structures were in compliance at the time of inspection. The RCE at the gravel yard was in good condition. The General Construction permits and contact information are posted at the entrance of the paved yard as required. All issues found during today's inspection will be placed on the punch list and given to the contractor to address.

Pic 3 Desc.	CFS full on west side of gravel yard near conex requires maintenance.	Pic 4 Desc.	RCE at gravel yard in good condition.
--------------------	---	--------------------	---------------------------------------

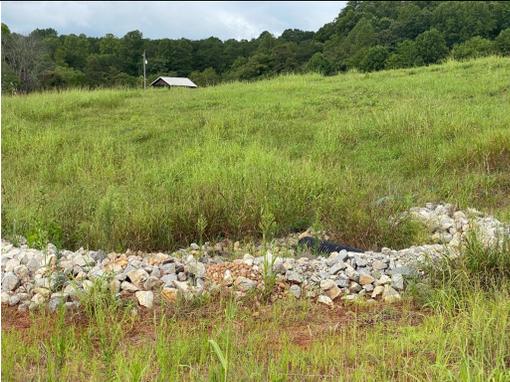
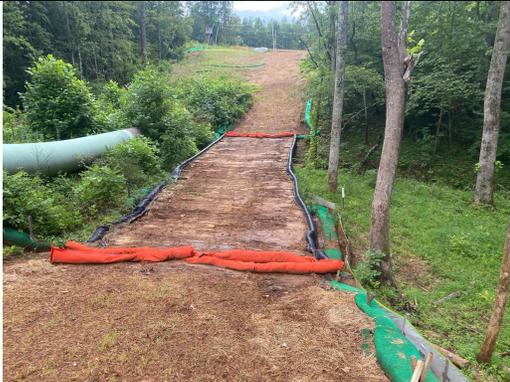
GPS Location 0		GPS Location 0			
Field Station# 14132+25		Field Station# 14141+62			
Pic 1 Desc. Approximately 14132+25. Overview of ROW and CWD piping and plunge pool. ROW temporarily stabilized and has temporary vegetation growing. CWD piping and plunge pool.		Pic 2 Desc. Approximately 14141+62. Overview of stream crossing, equipment bridge and ECDs at stream S-C8.

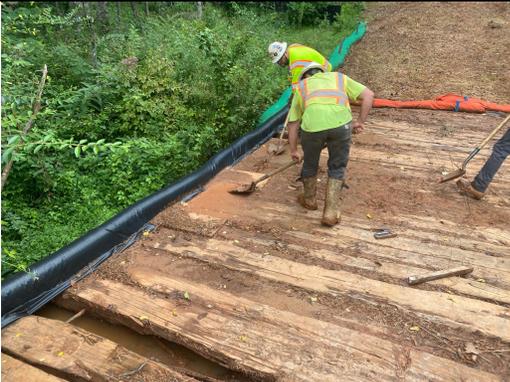
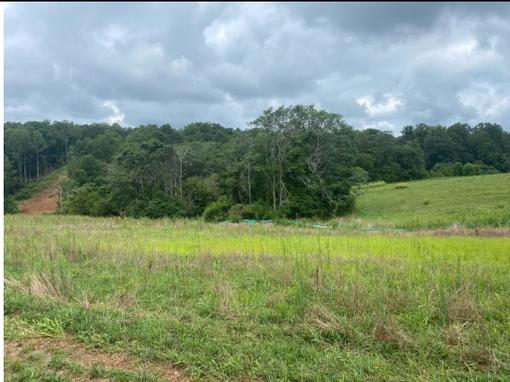
GPS Location 0		GPS Location 0			
Field Station# 14157+55		Field Station# 14164+00			
Pic 3 Desc. Approximately 14157+55. Contractor removing minor sediment from equipment bridge spanning stream S-KL51.		Pic 4 Desc. Approximately 14164+00. Overview of ROW. ROW temporarily stabilized and has temporary vegetation growing.

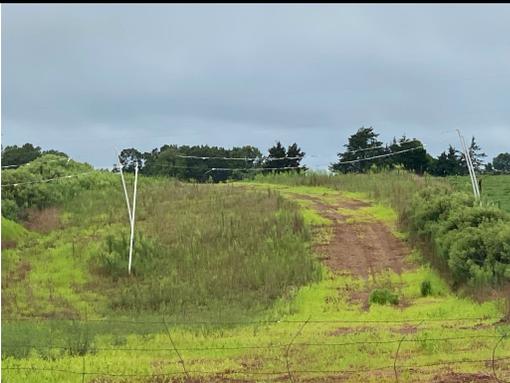
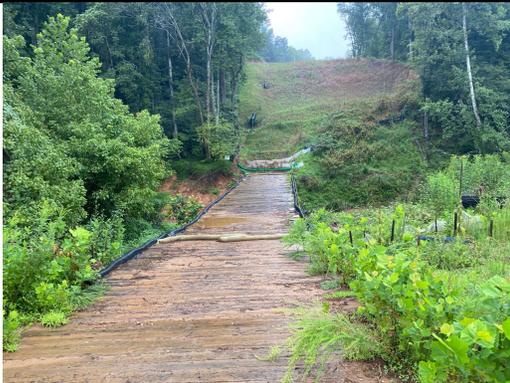
GPS Location 0		GPS Location 0			
Field Station# 14307+00		Field Station# 14233+35			
Pic 5 Desc. Approximately 14307+00. Overview of ROW. ROW temporarily stabilized and has temporary vegetation growing.		Pic 6 Desc. Approximately 14233+35. Overview of stream crossing, equipment bridge and ECDs at stream S-C19.

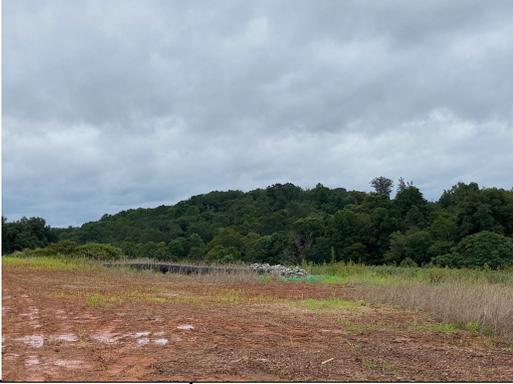
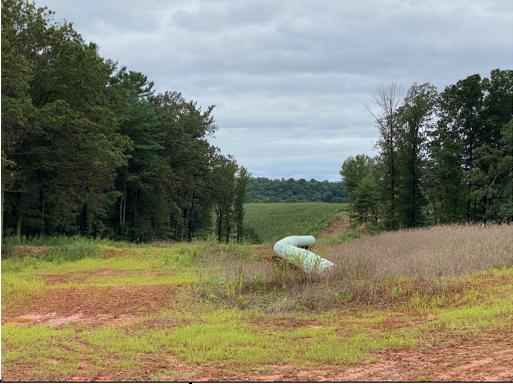
GPS Location 0		GPS Location 0			
Field Station# 13960+50		Field Station# 13956+00			
Pic 7 Desc. Approximately 13960+50. Overview of ROW and CWD. ROW temporarily stabilized and has temporary vegetation growing. CWD appears to be installed and functional.		Pic 8 Desc. Approximately 13956+00. Overview of ROW. ROW temporarily stabilized and has temporary vegetation growing.

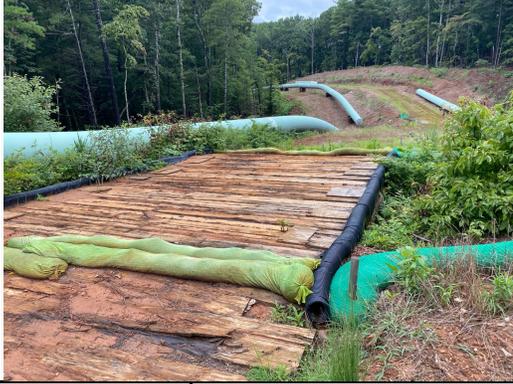
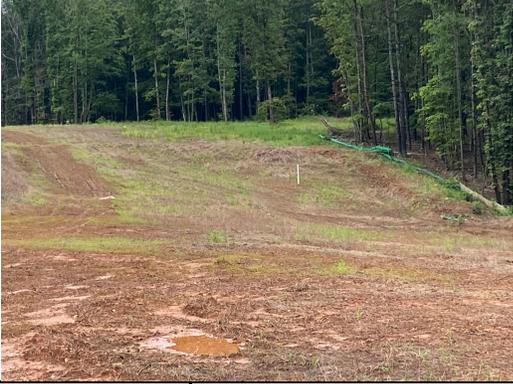
GPS Location 0		GPS Location 0			
Field Station# 14072+45		Field Station# 14077+50			
Pic 9 Desc. Approximately 14072+45. Overview of stream crossing, equipment bridge and ECDs at stream S-KL61.		Pic 10 Desc. Approximately 14077+50. Overview of ROW. ROW temporarily stabilized and has temporary vegetation growing.

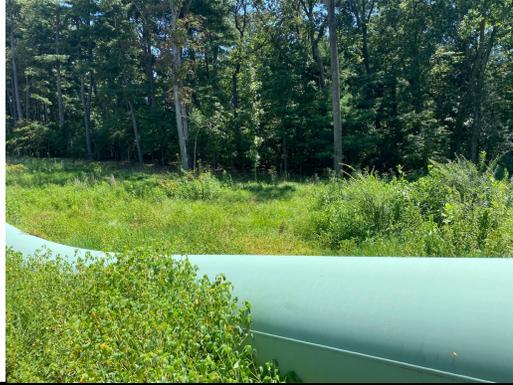
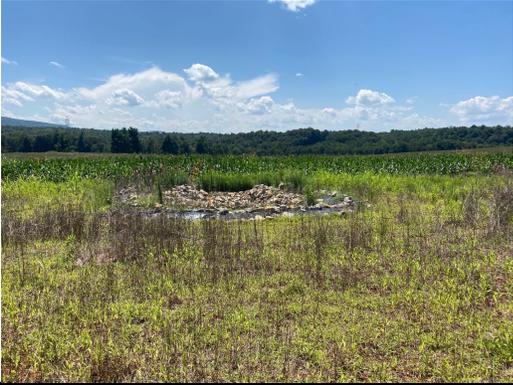
GPS Location 0		GPS Location 0			
Field Station# 13950+25		Field Station# 13945+00			
Pic 11 Desc. Approximately 13950+25. Overview of wetland W-CD1.		Pic 12 Desc. Approximately 13945+00. Overview of ROW and CWD plunge pool. ROW temporarily stabilized and has temporary vegetation growing. CWD appears to be installed and functional.

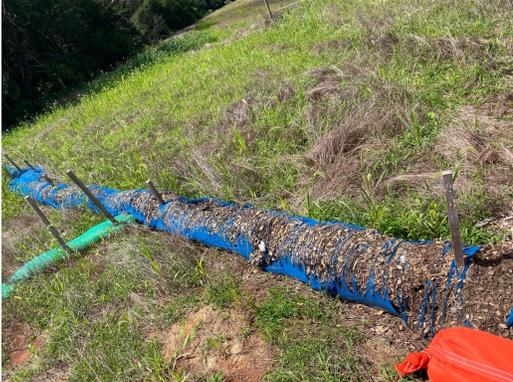
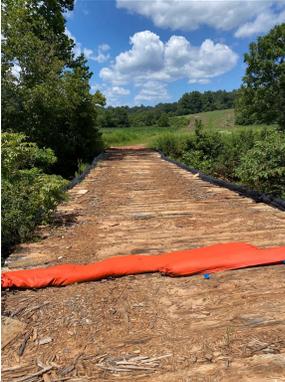
ert image here	
GPS Location 0		GPS Location 0			
Field Station# 13927+00		Field Station# 13915+82			
Pic 13 Desc. Approximately 13927+00. CFS damaged by either third party or wildlife.		Pic 14 Desc. Approximately 13915+82. Overview of stream crossing, equipment bridge and ECDs at stream S-II2.

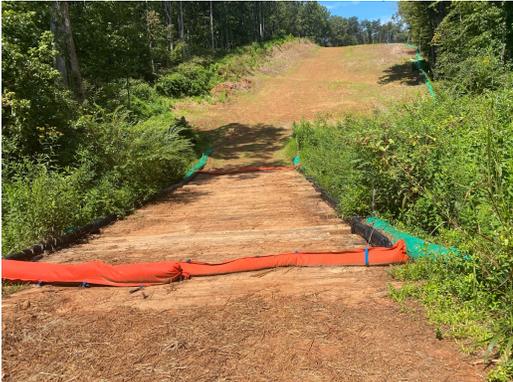
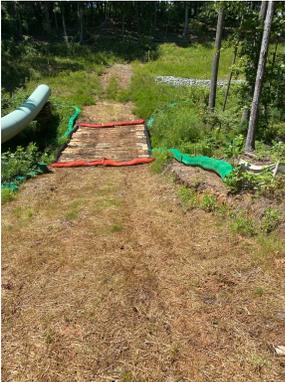
ert image here	
GPS Location 0		GPS Location 0			
Field Station# 14157+55		Field Station# 14066+77			
Pic 15 Desc. Approximately 14157+55. Overview of stream crossing, equipment bridge and ECDs at stream S-KL51.		Pic 16 Desc. Approximately 14066+77. Overview of stream crossing, equipment bridge and ECDs at stream S-EF48.

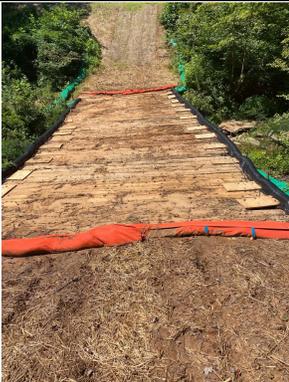
Insert image here	
GPS Location 0		GPS Location 0			
Field Station# 14105+26		Field Station#			
Pic 17 Desc. Approximately 14105+26. Overview of stream crossing, equipment bridge and ECDs at stream S-KL41.		Pic 18 Desc.

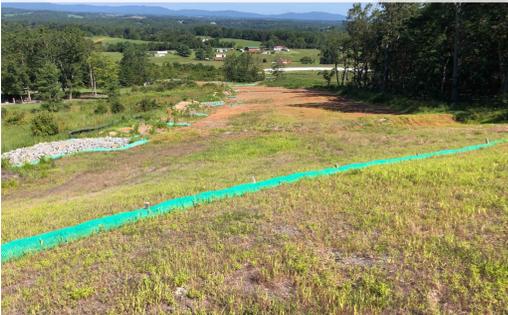
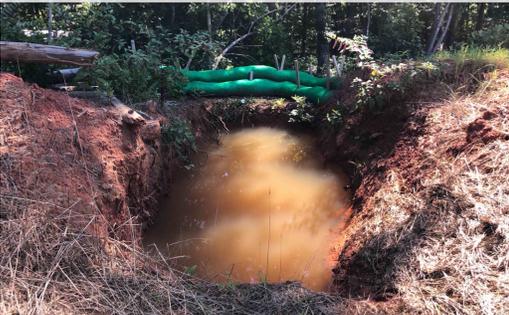
GPS Location	0	GPS Location	0
Field Station#	14328+00	Field Station#	14336+00
Pic 1 Desc.	Temporary stabilization on the CIS of Golden View Road	Pic 2 Desc.	Sump pit functioning as intended on the GAS of Golden View Road

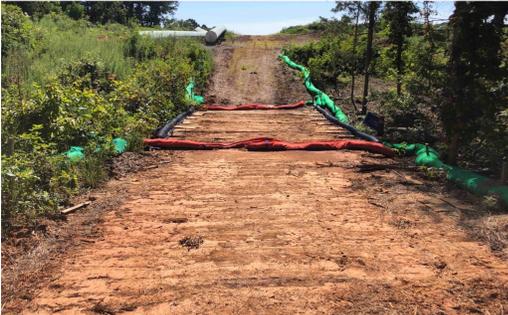
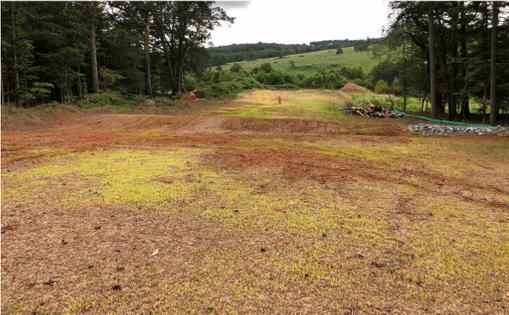
GPS Location	0	GPS Location	0
Field Station#	14338+56	Field Station#	14400+00
Pic 3 Desc.	Equipment bridge clean at stream S-A36	Pic 4 Desc.	Temporary stabilization on the CIS of Webster Road

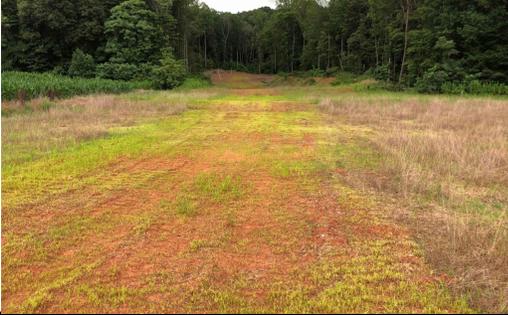
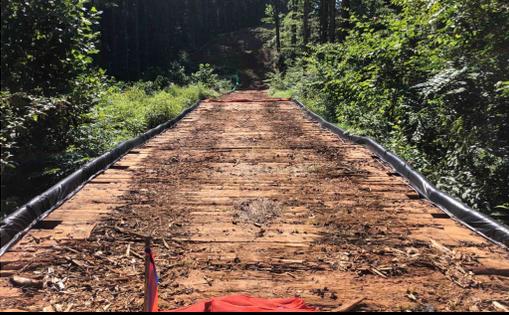
GPS Location	0	GPS Location	0
Field Station#	14415+00	Field Station#	14420+21
Pic 5 Desc.	Temporary stabilization on the CIS of Webster Road	Pic 6 Desc.	Equipment bridge clean at stream S-GH36

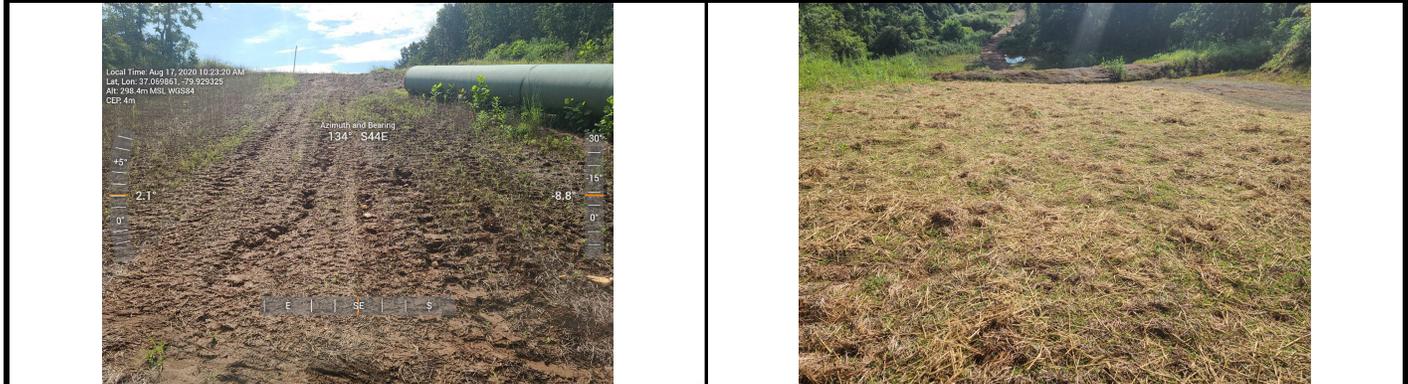
Field Station#	13797+53	Field Station#	13786+90
-----------------------	----------	-----------------------	----------

Documented areas with erosion on hill side above stream crossings and sparse vegetation growth, added to the punch list for repair and over seed area.

Pic 1 Desc.	Erosion on hill side, added to the punch list for repair and stabilization	Pic 2 Desc.	Punch list item completed and new vegetation growing
--------------------	--	--------------------	--

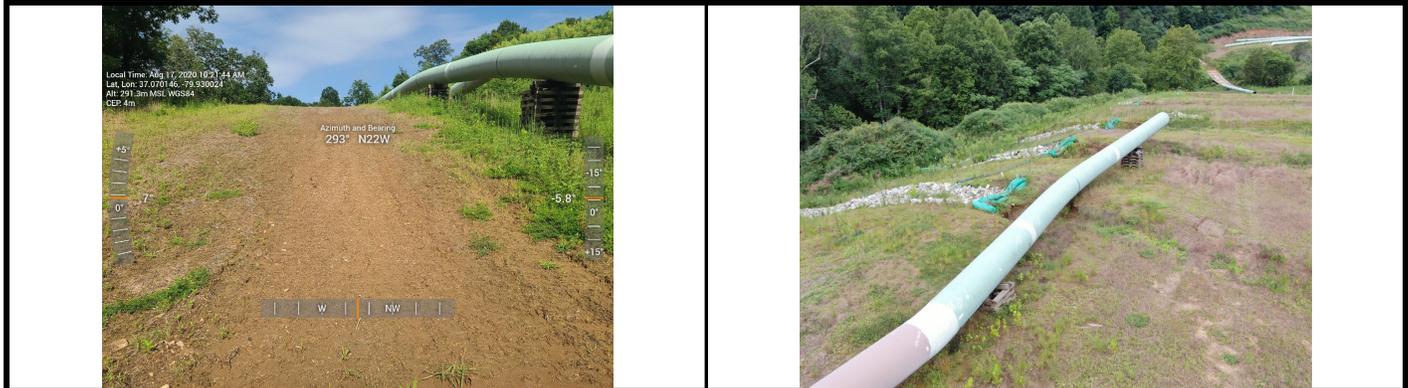
Field Station#	13794+38	Field Station#	13710+00
-----------------------	----------	-----------------------	----------

Pic 3 Desc.	Sparse vegetation on hill side above stream crossing added to the punch list for repair	Pic 4 Desc.	Photo showing rock lined channels in place as well as ECDs functioning
--------------------	---	--------------------	--

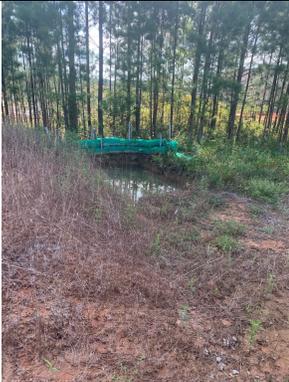
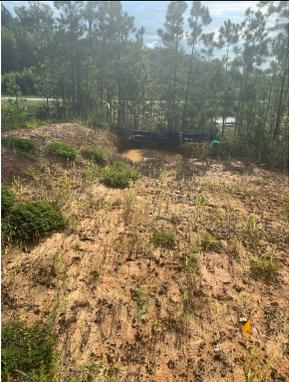
GPS Location	O		GPS Location	O	
Field Station#	10+00		Field Station#	8+00	
Pic 1 Desc.	Observing sump and end treatment.		Pic 2 Desc.	Observing sump and end.

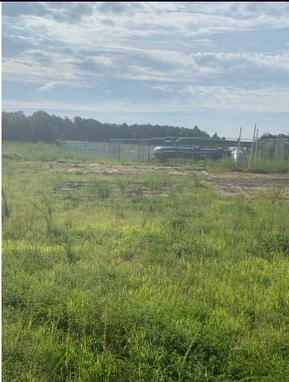
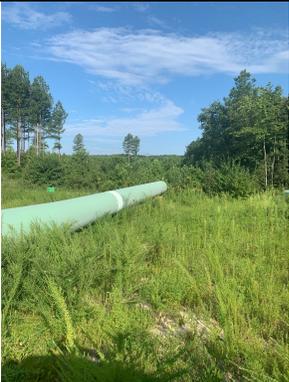
GPS Location	O		GPS Location	O	
Field Station#	22+00		Field Station#	17+55	
Pic 3 Desc.	Observing temporary vegetation.		Pic 4 Desc.	Observing temporary vegetation and signage.	
Insert image here			Insert image here		
GPS Location			GPS Location		
Field Station#			Field Station#		
Pic 5 Desc.			Pic 6 Desc.

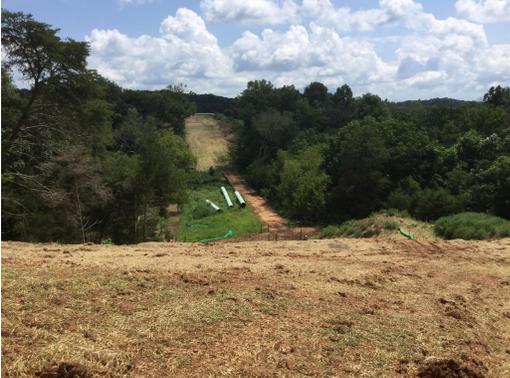
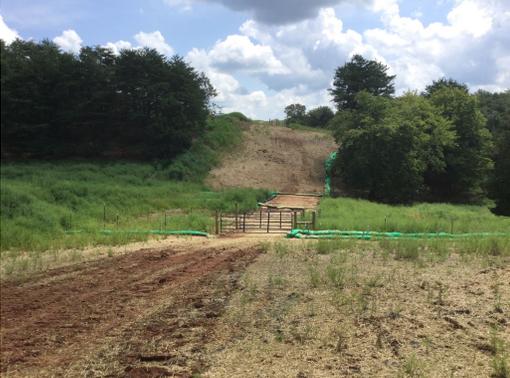
GPS Location 1		GPS Location 2			
Field Station# 15307+00		Field Station# 15326+50			
Pic 1 Desc. Contractor repairing equipment bridges and stabilizing ROW.		Pic 2 Desc. Contractor repairing equipment bridges and stabilizing ROW.

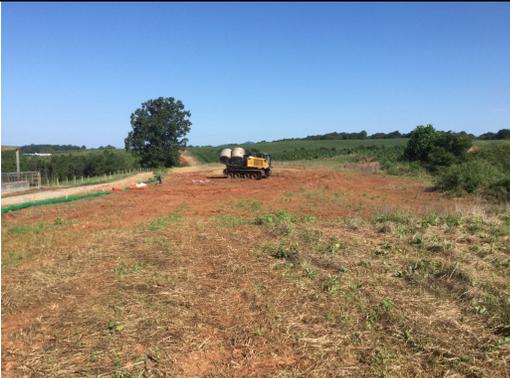
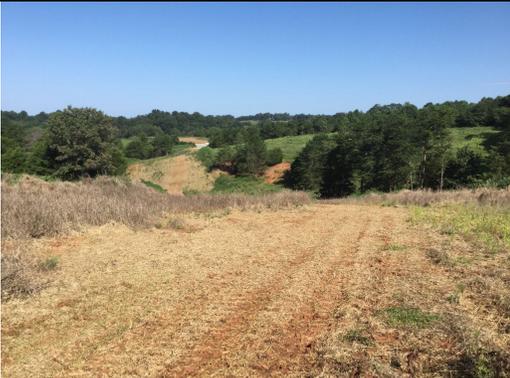
GPS Location 3		GPS Location 4			
Field Station# 15354+00		Field Station# 15335+00			
Pic 3 Desc. Contractor repairing equipment bridges and stabilizing ROW.		Pic 4 Desc. Contractor repairing equipment bridges and stabilizing ROW.

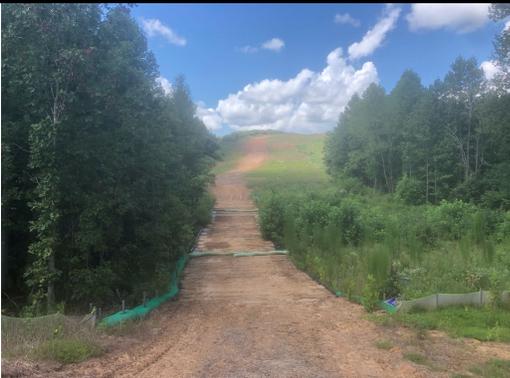
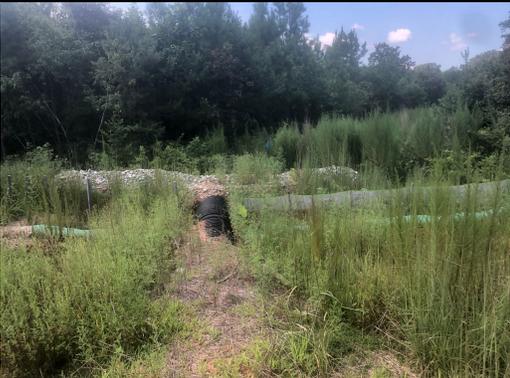
GPS Location 5		GPS Location 6			
Field Station# 15508+02		Field Station# 15515+00			
Pic 5 Desc. Equipment bridge and surrounding ECD's in place and functional at S-CC14.		Pic 6 Desc. CWD pipe and rock outlet in good condition.

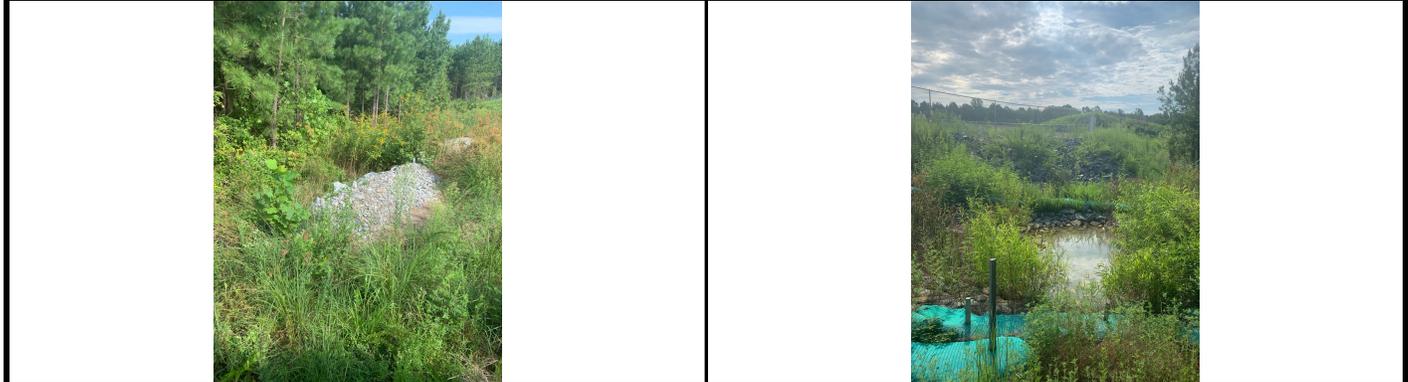
Field Station#	00+00	Field Station#	00+00
-----------------------	-------	-----------------------	-------

Pic 1 Desc.	Observing rock drain	Pic 2 Desc.	Observing emergency overflow at the storm water pond.
--------------------	----------------------	--------------------	---
