Visual Site Inspection Report

Project Name	H-600 Pipeline Spread I	AFE	124300139	Spread	H-600 Pipeline Spread I
Contractor	Precision			Report #	13947
Inspector	Charles Head			Date/Time	8/25/2020 1:38 PM
Permit #	TBD	Inspection Type	VA SWPP	Station Begin	13853+45
State	VA	Inspection Area	Partial	Station End	14311+57
County	Franklin	Ground	Damp	Temperature (°F)	88.00
Municipality	N/A	Weather	Sunny	Rain Gauge (in)	1.70
				Rain Accumulation Time (days)	6.00

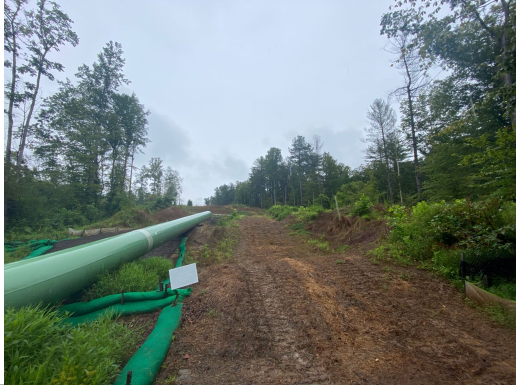
GPS Location	0	GPS Location	0		
Field Station#	14202+50	Field Station#	14176+09		
Pic 1 Desc.	Approximately 14202+50. Overview of ROW. ROW temporarily stabilized and has temporary vegetation growing.		Pic 2 Desc.	Approximately 14176+09. Overview of stream crossing, equipment bridge and ECDs at stream S-KL52.

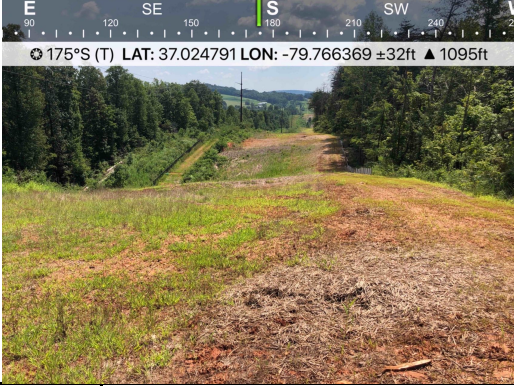
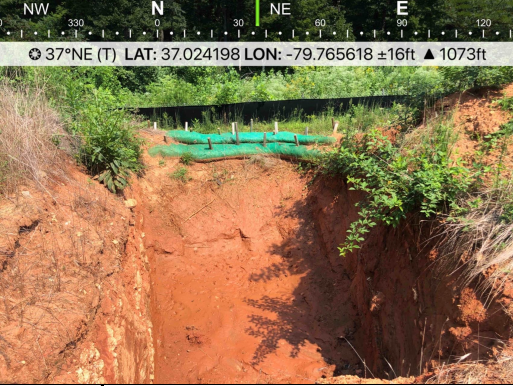
GPS Location	0	GPS Location	0		
Field Station#	14465+00	Field Station#	14475+00		
Pic 1 Desc.	Temporary stabilization on the GAS of Webster Road	Pic 2 Desc.	Sump pit functioning as intended

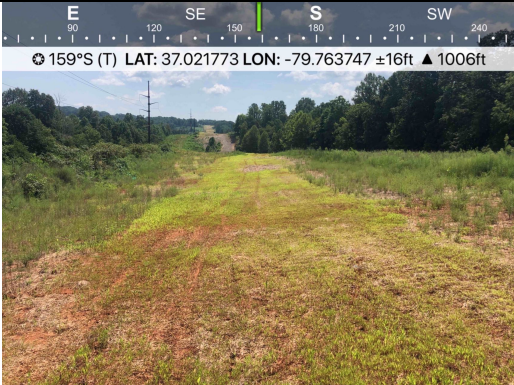
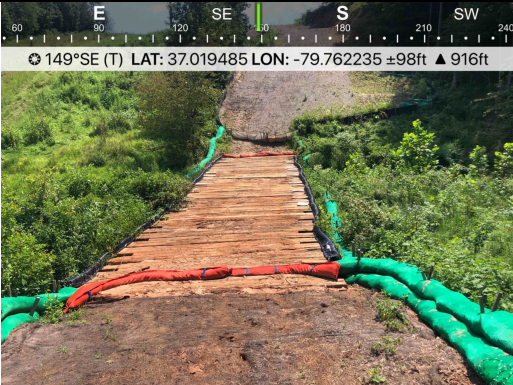
GPS Location	0	GPS Location	0		
Field Station#	14480+00	Field Station#	14486+56		
Pic 3 Desc.	Temporary stabilization on the GAS of Webster Road	Pic 4 Desc.	Equipment bridge clean at stream S-G22

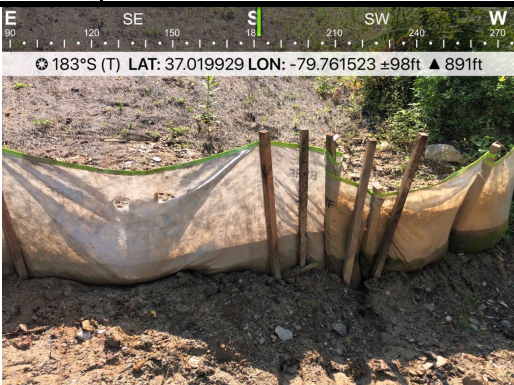
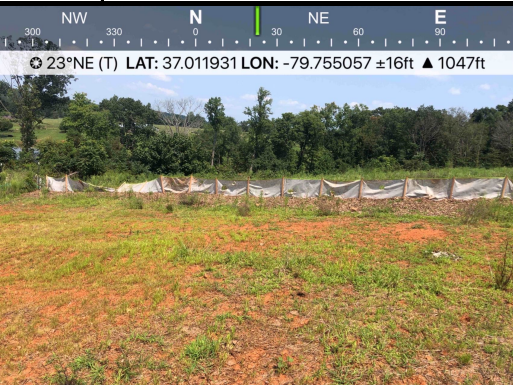
GPS Location	0	GPS Location	0		
Field Station#	14487+00	Field Station#	14521+00		
Pic 5 Desc.	P1 silt fence has holes in it and is undermined. Recommend replacing p1 silt fence	Pic 6 Desc.	P1 silt fence is down and is damaged in multiple areas. Recommend replacing

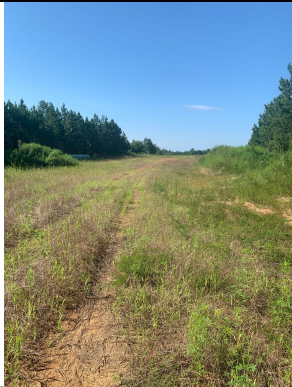
GPS Location	O		GPS Location	O	
Field Station#	15+60		Field Station#	21+00	
Pic 1 Desc.	Observing temporary vegetation.		Pic 2 Desc.	Observing temporary vegetation.

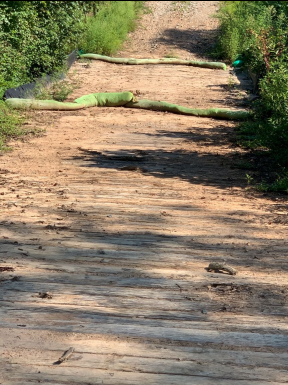
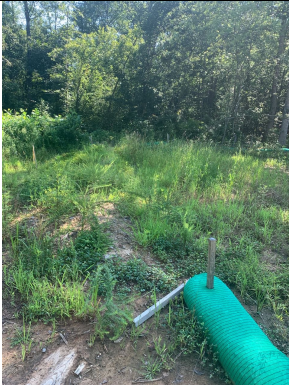
GPS Location	O	GPS Location	O		
Field Station#	12+65	Field Station#	13+50		
Pic 1 Desc.	Observing equipment crossing and ECD's performing as they should.	Pic 2 Desc.	Observing water bar and temporary vegetation.

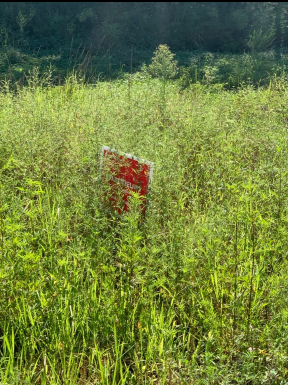
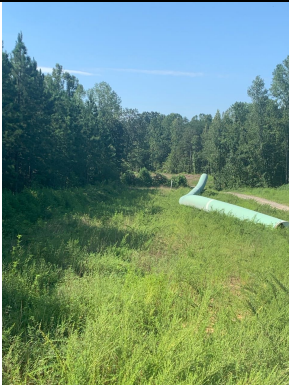
GPS Location	O	GPS Location	O		
Field Station#	11+40	Field Station#	7+00		
Pic 3 Desc.	Observing signage and temporary vegetation.	Pic 4 Desc.	Observing temporary vegetation.		
Insert image here			Insert image here		
GPS Location		GPS Location			
Field Station#		Field Station#			
Pic 5 Desc.		Pic 6 Desc.

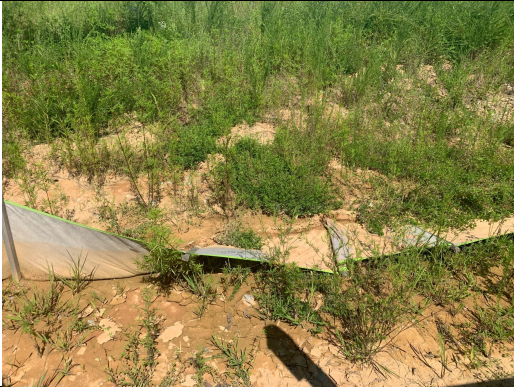
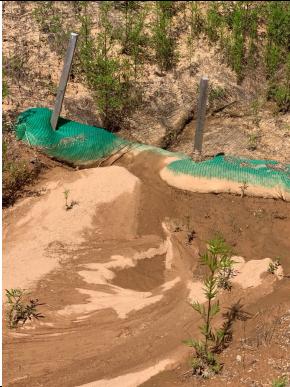
GPS Location	O	GPS Location	O		
Field Station#	16026+00	Field Station#	16021+00		
Pic 1 Desc.	Observing p1 that requires maintenance.	Pic 2 Desc.	Observing CFS that requires maintenance.

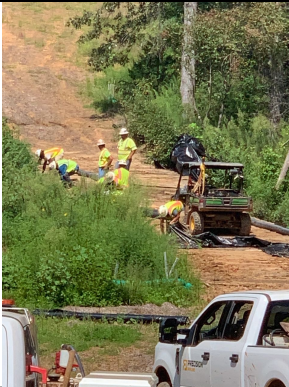
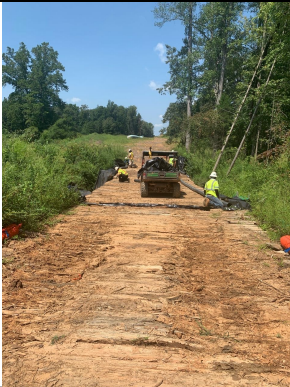
GPS Location	O	GPS Location	O		
Field Station#	15923+49	Field Station#	15923+49		
Pic 3 Desc.	Observing the Contractor performing maintenance on bridge.	Pic 4 Desc.	Observing the Contractor performing maintenance on bridge		
Insert image here			Insert image here		
GPS Location		GPS Location			
Field Station#		Field Station#			
Pic 5 Desc.		Pic 6 Desc.

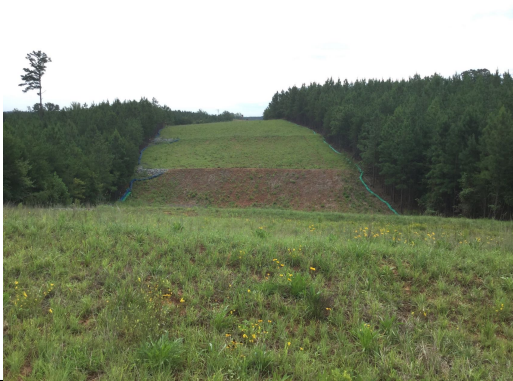
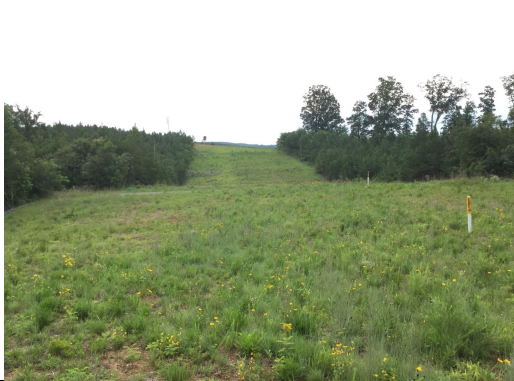
GPS Location		1		GPS Location 2	
Field Station#		15214+00		Field Station# 15220+00	
Pic 1 Desc.		View of permanent vegetation growing along ROW between Starland Dr and Grassland Dr		Pic 2 Desc. View of permanent vegetation growing along ROW at Grassland Dr RC

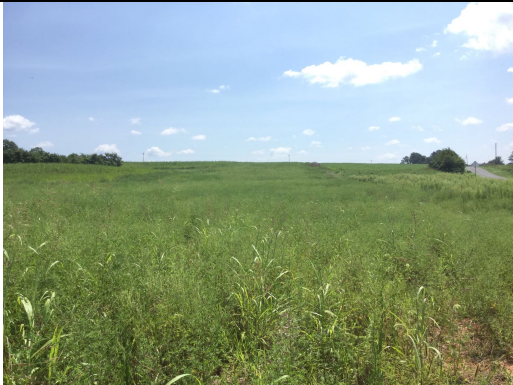
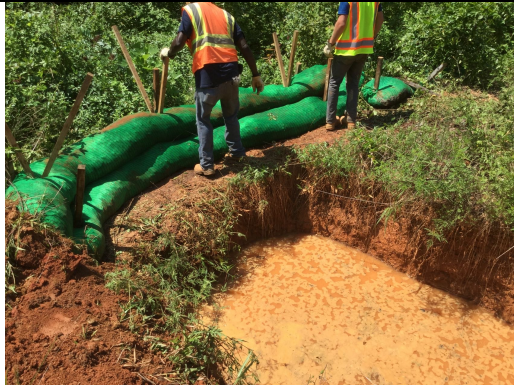
GPS Location		3		GPS Location 4	
Field Station#		15485+00		Field Station# 15434+00	
Pic 3 Desc.		View of permanent vegetation growing along ROW between Toshes Rd and Climax Rd		Pic 4 Desc. Contractor repairing bridges and replacing ECD's between Snowberry Rd and Toshes Rd

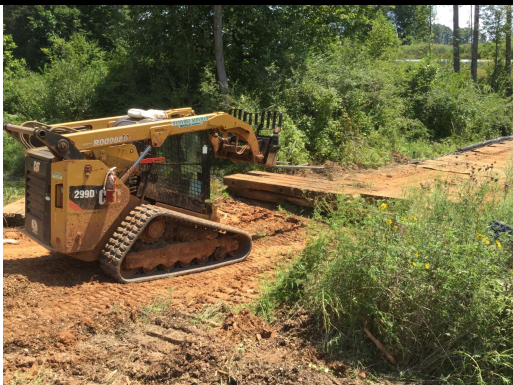
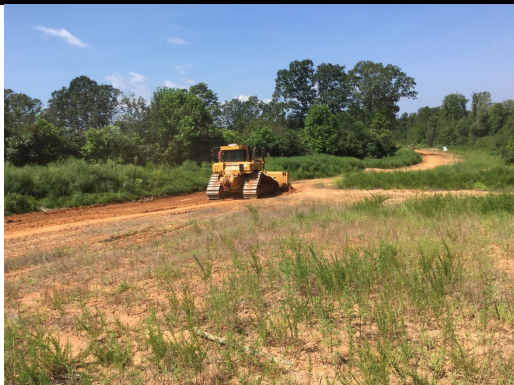
GPS Location		5		GPS Location 6	
Field Station#		15447+61		Field Station# 15461+00	
Pic 5 Desc.		Contractor repairing bridges and replacing ECD's between Snowberry Rd and Toshes Rd		Pic 6 Desc. Contractor repairing bridges and replacing ECD's between Snowberry Rd and Toshes Rd

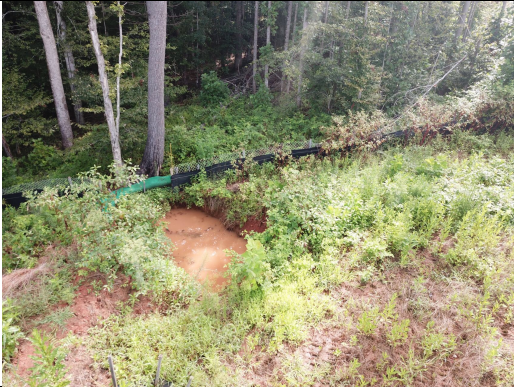
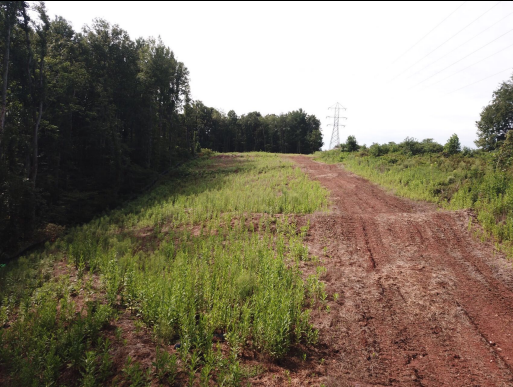
GPS Location	00000	GPS Location	0000		
Field Station#	13850+50	Field Station#	13844+90		
Pic 1 Desc.	Checked sump pits throughout my travels today	Pic 2 Desc.	Row photo showing vegetation

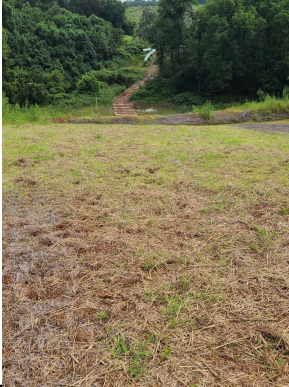
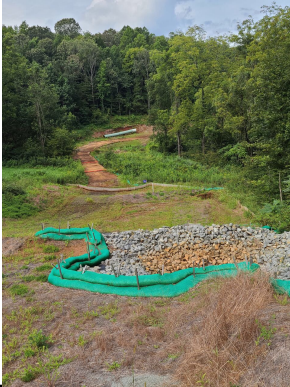
GPS Location	00000	GPS Location	00000		
Field Station#	13786+40	Field Station#	13784+44		
Pic 3 Desc.	Checked repaired punch list areas and observed good vegetation coverage	Pic 4 Desc.	Monitored hot spots areas and sump pits after recent rain showers.		
Insert image here			Insert image here		
GPS Location		GPS Location			
Field Station#		Field Station#			
Pic 5 Desc.		Pic 6 Desc.

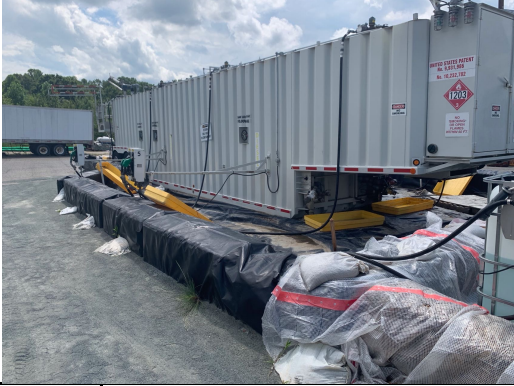
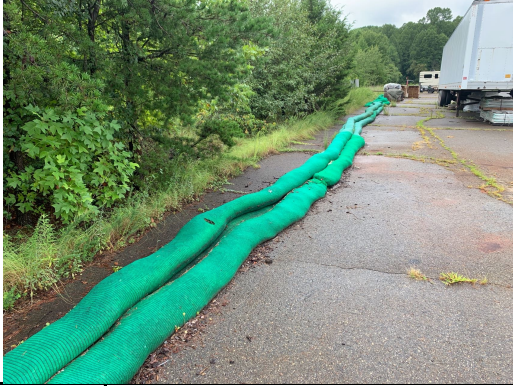
GPS Location	000000000000	GPS Location	000000000000		
Field Station#	0000+00	Field Station#	0000+00		
Pic 1 Desc.	Secondary containment structure for fuel cell in compliance.	Pic 2 Desc.	Perimeter ECD's on south end of paved yard in good condition and housekeeping issue addressed by contractor

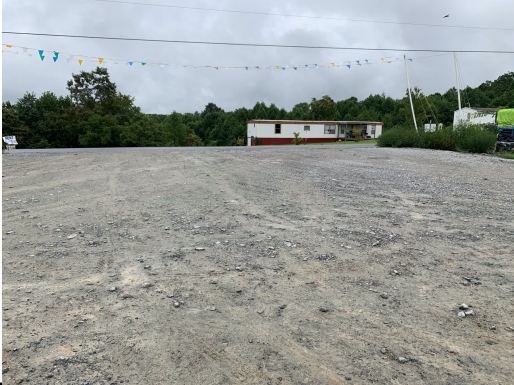
Insert image here			
GPS Location	000000000000	GPS Location			
Field Station#	0000+00	Field Station#			
Pic 5 Desc.	RCE at gravel yard in good condition	Pic 6 Desc.
