Visual Site Inspection Report

Project Name	H-600 Pipeline Spread G	AFE	124300137	Spread	H-600 Pipeline Spread G
Contractor	Precision			Report #	17728
Inspector	Len Kruizenga			Date/Time	12/7/2020 8:26 AM
Permit #	TBD	Inspection Type	VA SWPP	Station Begin	12005+00
State	VA	Inspection Area	Full	Station End	12005+00
County	Giles	Ground	Wet	Temperature (°F)	33.00
Municipality	N/A	Weather	Cloudy	Rain Gauge (in)	0.00
				Rain Accumulation Time (days)	1.00

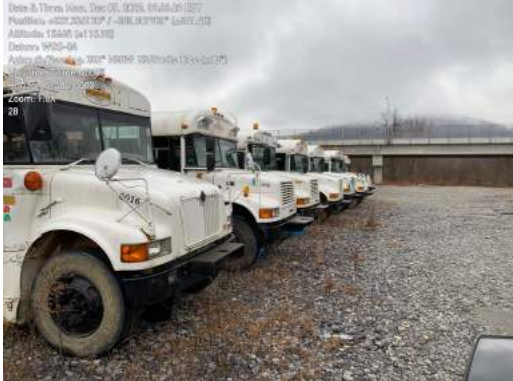
GPS Location	See picture above for GPS coordinates		GPS Location	See picture above for GPS coordinates	
Field Station#	12005+00		Field Station#	12005+00	
Pic 1 Desc.	ECD's and row conditions		Pic 2 Desc.	ECD's and row conditions

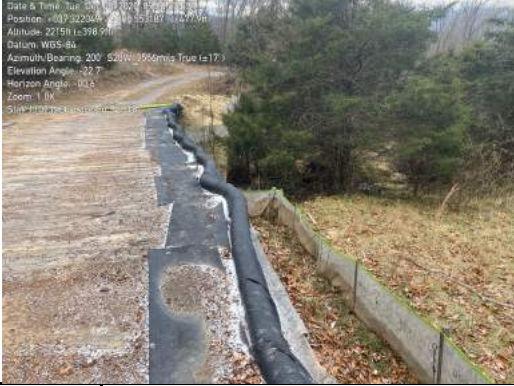
<p>Date & Time: Tue, 09/01/2020 12:22:34 Position: 43°22'23.44"N 76°19'55.81"W (43.37317778, -76.33244444) Altitude: 2215ft (675m) Datum: WGS-84 Azimuth/Bearing: 200° (Azimuth True is 17.1°) Elevation Angle: -22.7° Horizon Angle: -92.5° Zoom: 1.0x Site# 11023+88 - Stream S-IJ18</p>

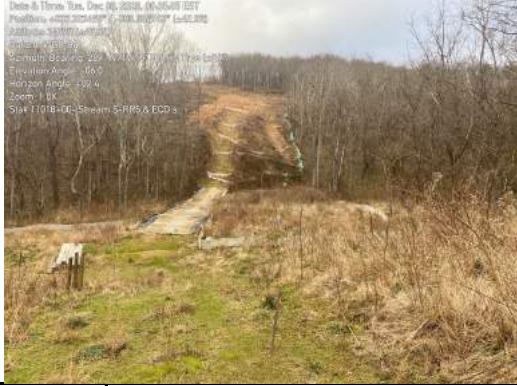
<p>Date & Time: Tue, 09/01/2020 12:22:34 Position: 43°22'23.44"N 76°19'55.81"W (43.37317778, -76.33244444) Altitude: 2215ft (675m) Datum: WGS-84 Azimuth/Bearing: 200° (Azimuth True is 17.1°) Elevation Angle: -22.7° Horizon Angle: -92.5° Zoom: 1.0x Site# 11018+00 - Stream S-RR5</p>			
GPS Location	See photo GPS		GPS Location	See photo GPS	
Field Station#	11023+88		Field Station#	11018+00	
Pic 1 Desc.	Stream S-IJ18		Pic 2 Desc.	Stream S- RR5

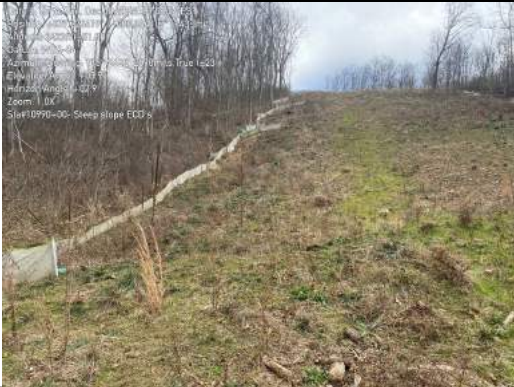
<p>Date & Time: Tue, 09/01/2020 12:22:34 Position: 43°22'23.44"N 76°19'55.81"W (43.37317778, -76.33244444) Altitude: 2215ft (675m) Datum: WGS-84 Azimuth/Bearing: 200° (Azimuth True is 17.1°) Elevation Angle: -22.7° Horizon Angle: -92.5° Zoom: 1.0x Site# 10990+00 - Steep slope ECD's</p>

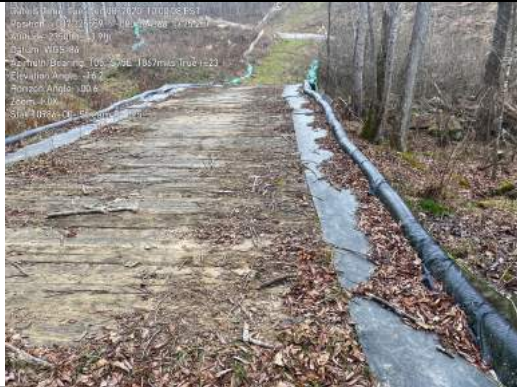
<p>Date & Time: Tue, 09/01/2020 12:22:34 Position: 43°22'23.44"N 76°19'55.81"W (43.37317778, -76.33244444) Altitude: 2215ft (675m) Datum: WGS-84 Azimuth/Bearing: 200° (Azimuth True is 17.1°) Elevation Angle: -22.7° Horizon Angle: -92.5° Zoom: 1.0x Site# 10986+00 - Stream S- E25</p>

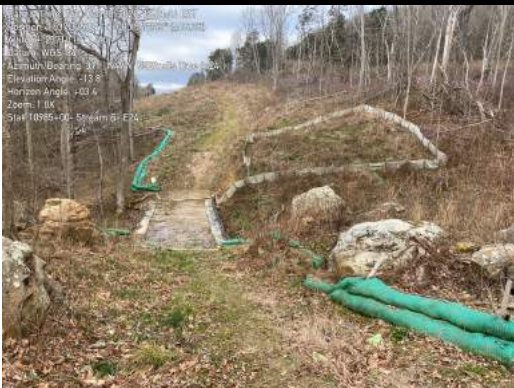
<p>Date & Time: Tue, 09/01/2020 12:22:34 Position: 43°22'23.44"N 76°19'55.81"W (43.37317778, -76.33244444) Altitude: 2215ft (675m) Datum: WGS-84 Azimuth/Bearing: 200° (Azimuth True is 17.1°) Elevation Angle: -22.7° Horizon Angle: -92.5° Zoom: 1.0x Site# 10985+00 - Stream S- E24</p>

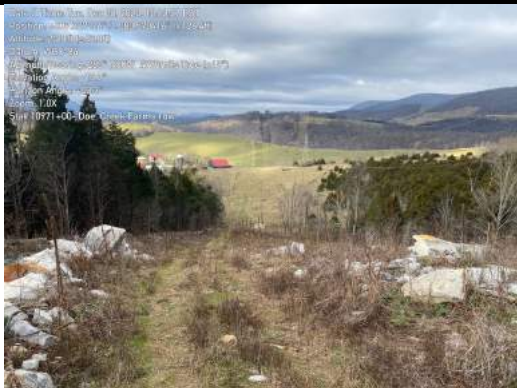
<p>Date & Time: Tue, 09/01/2020 12:22:34 Position: 43°22'23.44"N 76°19'55.81"W (43.37317778, -76.33244444) Altitude: 2215ft (675m) Datum: WGS-84 Azimuth/Bearing: 200° (Azimuth True is 17.1°) Elevation Angle: -22.7° Horizon Angle: -92.5° Zoom: 1.0x Site# 10971+00 - Doe Creek Farms row</p>			
GPS Location	See photo GPS		GPS Location	See photo GPS	
Field Station#	10985+00		Field Station#	10971+00	
Pic 5 Desc.	Stream S - E24		Pic 6 Desc.	Doe Creek Farms row

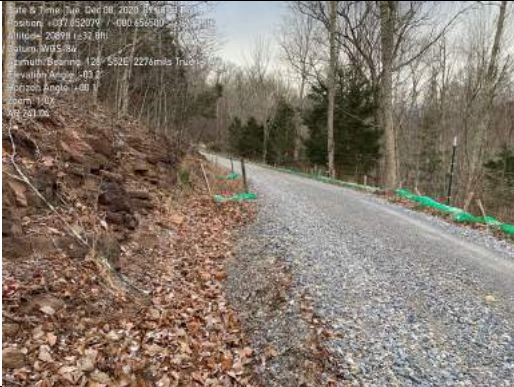
GPS Location	See photo for GPS location.		GPS Location	See photo for GPS location.	
Field Station#	10710+00		Field Station#	10712+50	
Pic 1 Desc.	Compost filter sock and compost filter sock checks in place along access road 241.04.		Pic 2 Desc.	Sensitive resource buffer in place at stream S-G33.

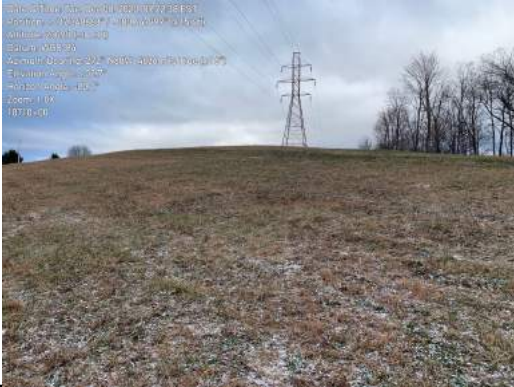
GPS Location	See photo for GPS location.		GPS Location	See photo for GPS location.	
Field Station#	10710+00		Field Station#	10701+00	
Pic 3 Desc.	ROW stabilized with natural vegetation growth.		Pic 4 Desc.	Steep slope stabilized with ECB.

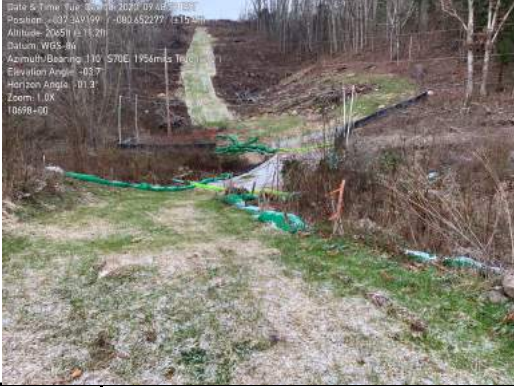
GPS Location	See photo for GPS location.		GPS Location	See photo for GPS location.	
Field Station#	10698+00		Field Station#	10696+00	
Pic 5 Desc.	Sensitive resource buffer in place at stream S-G32.		Pic 6 Desc.	RCE in place at Buffalo Anklets Road.

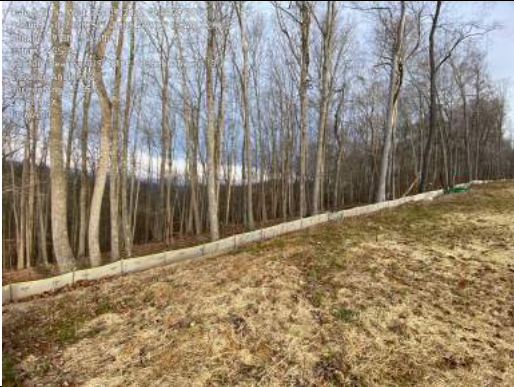
GPS Location	1	GPS Location	2		
Field Station#	11264+00	Field Station#	11292+80		
Pic 1 Desc.	Perimeter controls functional.	Pic 2 Desc.	S-MM18 and controls.

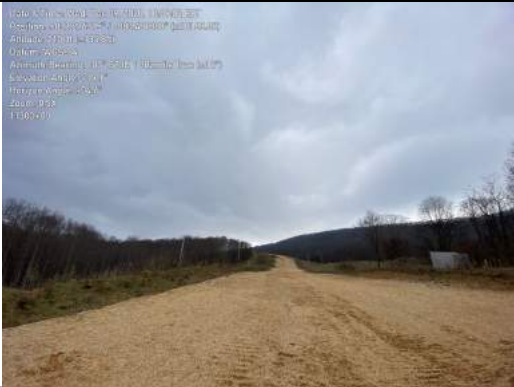
GPS Location	3	GPS Location	4		
Field Station#	11300+00	Field Station#	11327+85		
Pic 3 Desc.	Section of RoW showing conditions and controls near	Pic 4 Desc.	S-NN12 and controls.

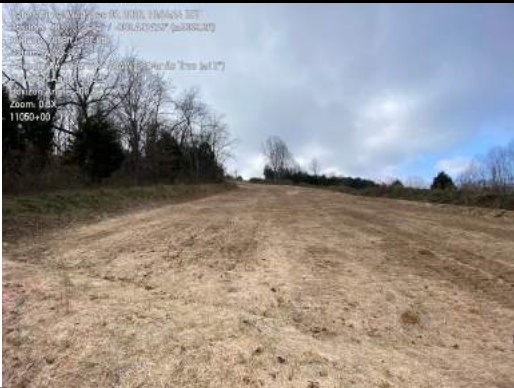
GPS Location	5	GPS Location	6		
Field Station#	11050+00	Field Station#	11352+97		
Pic 5 Desc.	Section of RoW showing conditions and controls.	Pic 6 Desc.	S-NN11 and controls.

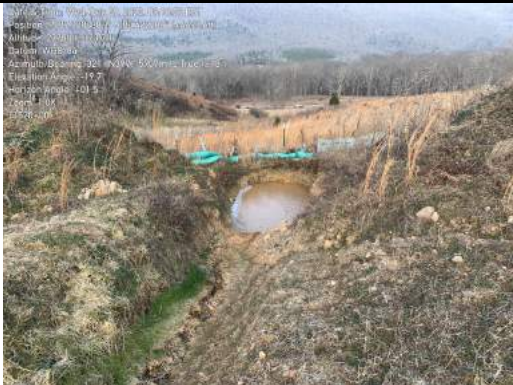
GPS Location	See photo for GPS location.		GPS Location	See photo for GPS location.	
Field Station#	11520+00		Field Station#	11507+00	
Pic 1 Desc.	Waterbar, sump pit, and waterbar end treatment in place.		Pic 2 Desc.	Clean water diversion pipe and plunge pool in place.

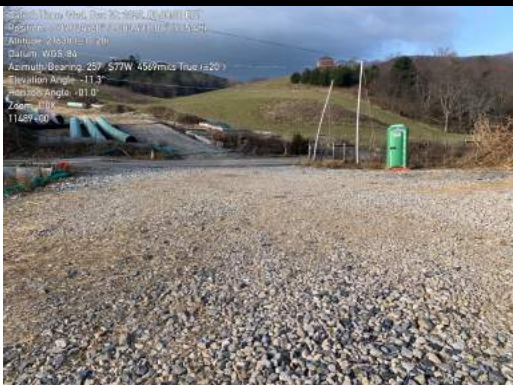
GPS Location	See photo for GPS location.		GPS Location	See photo for GPS location.	
Field Station#	11489+00		Field Station#	11475+00	
Pic 3 Desc.	RCE in place at Stevers Gap Road.		Pic 4 Desc.	Slope drains and ECB in place on two-tone.

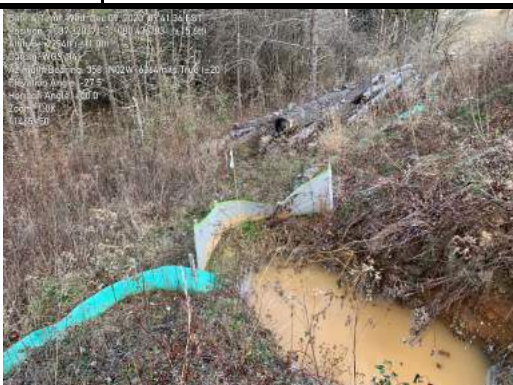
GPS Location	See photo for GPS location.		GPS Location	See photo for GPS location.	
Field Station#	11465+50		Field Station#	11451+00	
Pic 5 Desc.	Broken priority one silt fence stake. Item repaired before EOD.		Pic 6 Desc.	Sensitive resource buffer in place at stream S-0012 and S-0013.

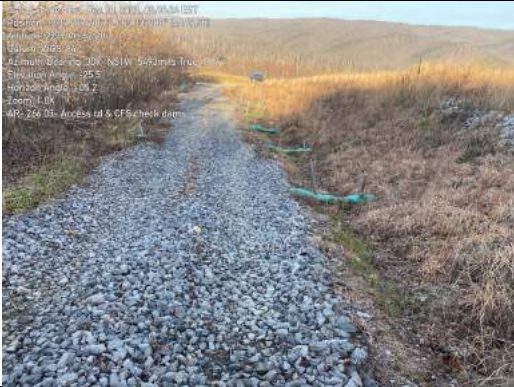
GPS Location	See photo GPS		GPS Location	See photo GPS	
Field Station#	11900+00		Field Station#	11922+00	
Pic 1 Desc.	AR-266.03- Access road and CFS check dams.		Pic 2 Desc.	CFS perimeter controls and water bar outlet.

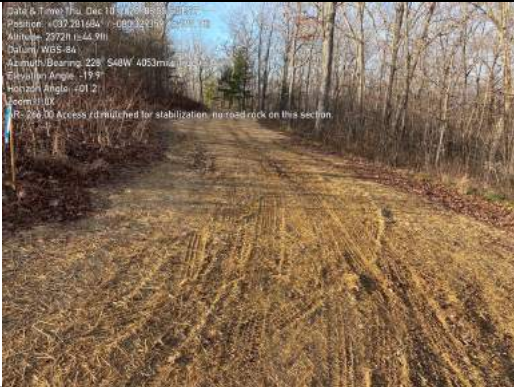
GPS Location	See photo GPS		GPS Location	See photo GPS	
Field Station#	11930+00		Field Station#	11942+00	
Pic 3 Desc.	AR- 266.00- Access road mulched for stabilization, no road rock on this portion of the access road.		Pic 4 Desc.	Karst ECD's

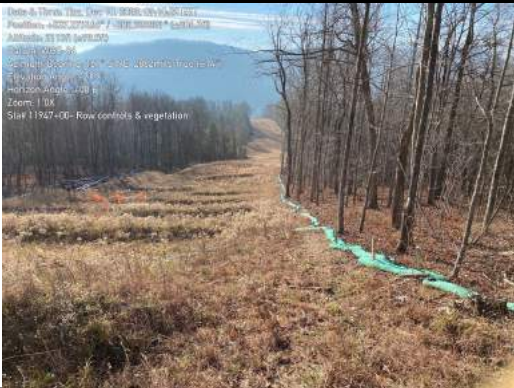
GPS Location	See photo GPS		GPS Location	See photo GPS	
Field Station#	11947+00		Field Station#	11979+00	
Pic 5 Desc.	Row controls and vegetation.		Pic 6 Desc.	Karst ECD's

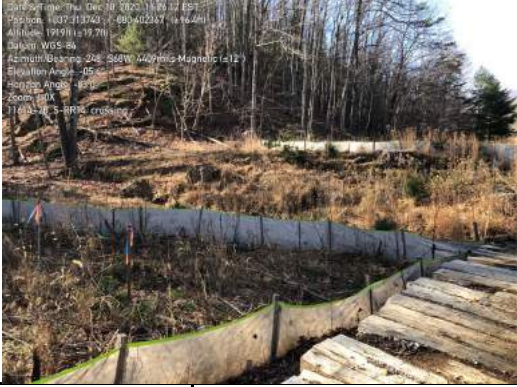
<p> <small> Pic 7: S-RR14 crossing 11614+20 Position: 437.13749, -89.402247 Altitude: 1919 ft (584.5 m) Datum: WGS-84 Azimuth/Bearing: 228.564W 344mils Magnetic (+12) Elevation Angle: -05.6 Horizon Angle: -80.4 Zoom: 1.0X S-RR14 crossing 11614+20 </small> </p>

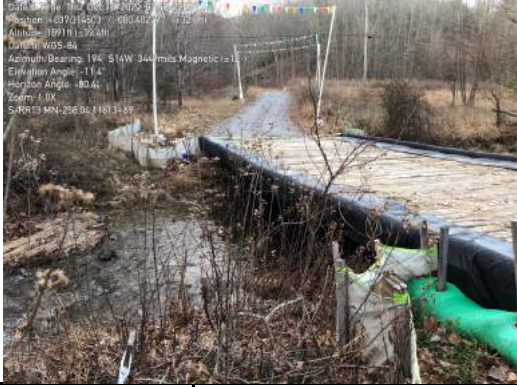
<p> <small> Pic 8: S-RR13 crossing 11613+69 Position: 437.01550, -89.402247 Altitude: 1891 ft (576.3 m) Datum: WGS-84 Azimuth/Bearing: 194.514W 344mils Magnetic (+12) Elevation Angle: -11.4 Horizon Angle: -80.4 Zoom: 1.0X S-RR13 MN-258.04 11613+69 </small> </p>			
GPS Location	On photo	GPS Location	On photo		
Field Station#	11614+20	Field Station#	11613+69		
Pic 7 Desc.	The S-RR14 crossing is stable. Buffers are well vegetated. ECDs in place. No impact observed.		Pic 8 Desc.	The S-RR13 crossing at access road MN-258.04 has not been impacted. ECDs are in place.

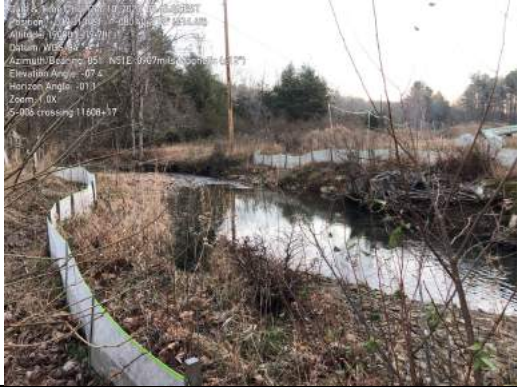
<p> <small> Pic 9: S-006 crossing 11608+17 Position: 437.01550, -89.402247 Altitude: 1891 ft (576.3 m) Datum: WGS-84 Azimuth/Bearing: 051.527W 344mils Magnetic (+12) Elevation Angle: -07.4 Horizon Angle: -01.1 Zoom: 1.0X S-006 crossing 11608+17 </small> </p>		<div style="text-align: center; height: 80px;">Insert image here</div>			
GPS Location	On photo	GPS Location			
Field Station#	11608+17	Field Station#			
Pic 9 Desc.	The S-006 crossing is currently stable. No additional controls are needed.		Pic 10 Desc.		
<div style="text-align: center;">Insert image here</div>		<div style="text-align: center;">Insert image here</div>			
GPS Location		GPS Location			
Field Station#		Field Station#			
Pic 11 Desc.		Pic 12 Desc.
