Visual Site Inspection Report

Project Name	H-600 Pipeline Spread H	AFE	124300138	Spread	H-600 Pipeline Spread H
Contractor	Precision	Report #	16021		
Inspector	Pat Davis	Date/Time	10/26/2020 5:00 PM		
Permit #	TBD	Inspection Type	VA SWPP	Station Begin	+0
State	VA	Inspection Area	Partial	Station End	+0
County	Montgomery	Ground	Damp	Temperature (°F)	71.00
Municipality	N/A	Weather	Sunny	Rain Gauge (in)	0.20
				Rain Accumulation Time (days)	0.00

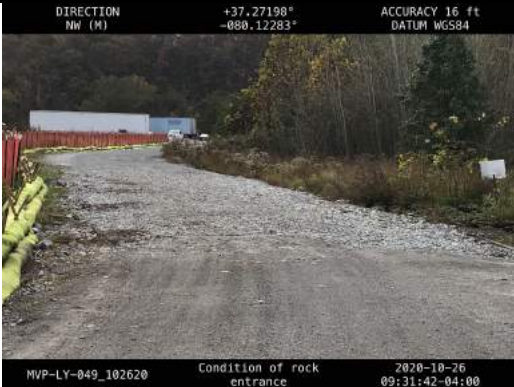
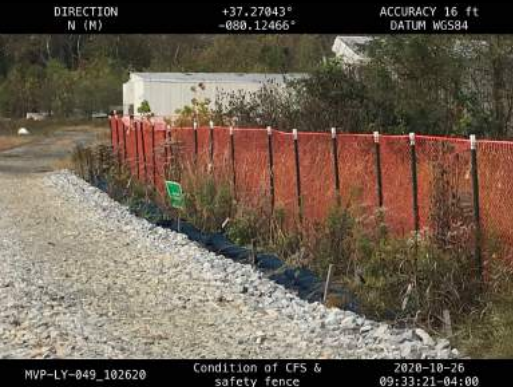
GPS Location	MVP-LY-049 See photo for gps data		GPS Location	MVP-LY-049 See photo for gps data	
Field Station#	+0		Field Station#	+0	
Pic 1 Desc.	Condition of rock entrance on center drive. No sediment on stone surface. Looking S.		Pic 2 Desc.	Condition of compost filter sock and safety fence along feature W-CV21A. Looking W.

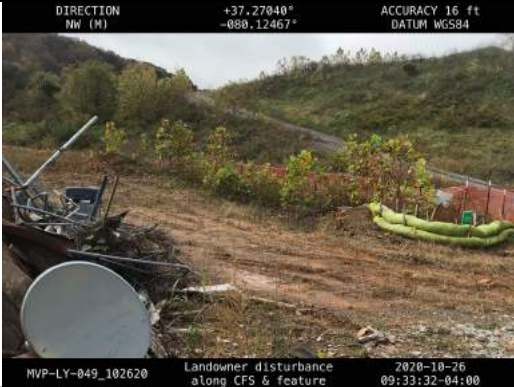
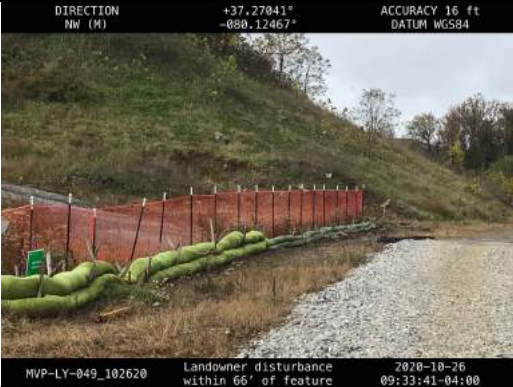
GPS Location	MVP-LY-049 See photo for gps data		GPS Location	MVP-LY-049 See photo for gps data	
Field Station#	+0		Field Station#	+0	
Pic 3 Desc.	Landowner disturbance soil disturbance along compost filter sock and feature. No impacts. Looking SW.		Pic 4 Desc.	Landowner soil disturbance within 66' of feature W-CV21B. Area not stabilized. No impacts. Looking W.

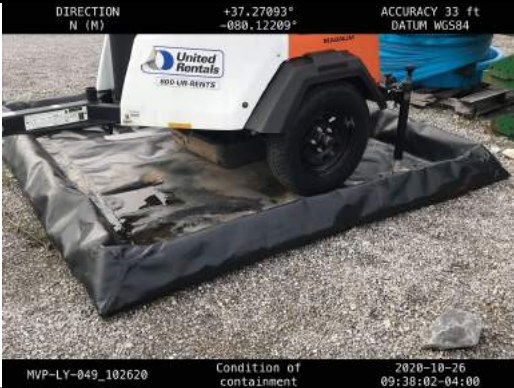
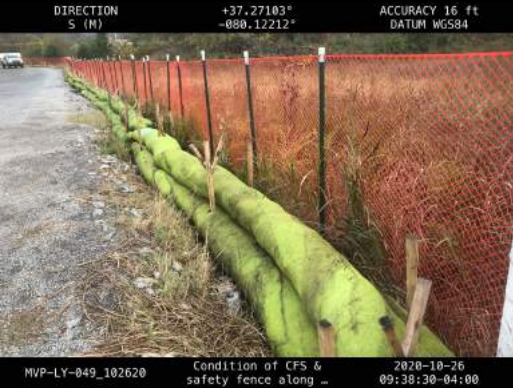
Pic 5 Desc.	Condition of containment under light plant. Looking SW.		Pic 6 Desc.	Condition of compost filter sock and safety fence along center drive. Looking N.

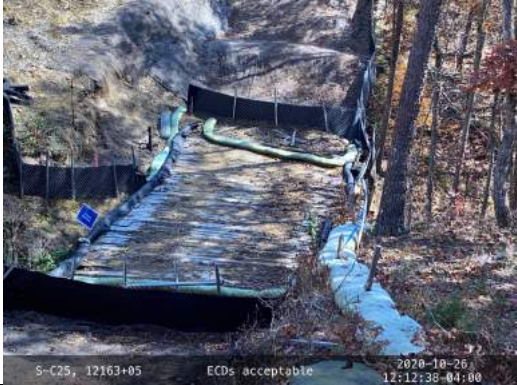
<p>S-C25, 12163+05 ECDs acceptable 2020-10-26 12:12:30-04:00</p>			
GPS Location	See photo GPS for location		GPS Location	See photo GPS for location	
Field Station#	12163+05		Field Station#	12163+05	
Pic 7 Desc.	All ECDs surrounding S-C25 are in acceptable condition.		Pic 8 Desc.	All ECDs surrounding S-C25 are in acceptable condition.

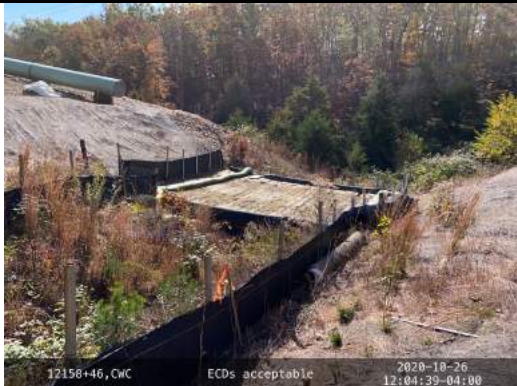
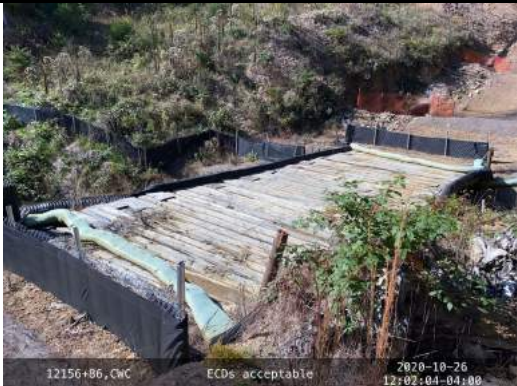
<p>12156+86, CWC ECDs acceptable 2020-10-26 12:02:04-04:00</p>			
GPS Location	See photo GPS for location		GPS Location	See photo GPS for location	
Field Station#	12158+46		Field Station#	12156+86	
Pic 9 Desc.	All ECDs surrounding this clean water crossing are in acceptable condition.		Pic 10 Desc.	All ECDs surrounding this clean water crossing are in acceptable condition.

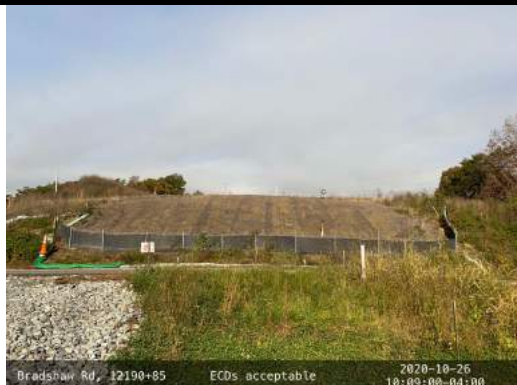
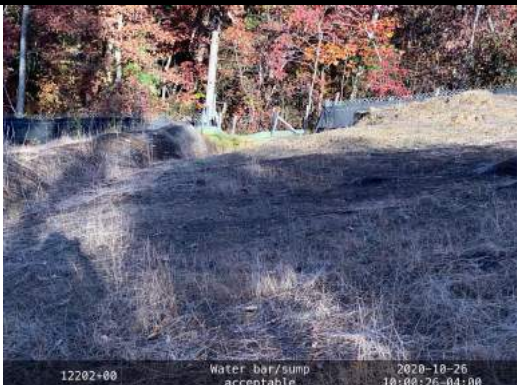
<p>12202+00 Water bar/sump acceptable 2020-10-26 10:00:26-04:00</p>			
GPS Location	See photo GPS for location		GPS Location	See photo GPS for location	
Field Station#	12190+85		Field Station#	12202+00	
Pic 11 Desc.	All ECDs are in acceptable condition at the CIS of Bradshaw Rd.		Pic 12 Desc.	Water bar and sump are in acceptable condition.

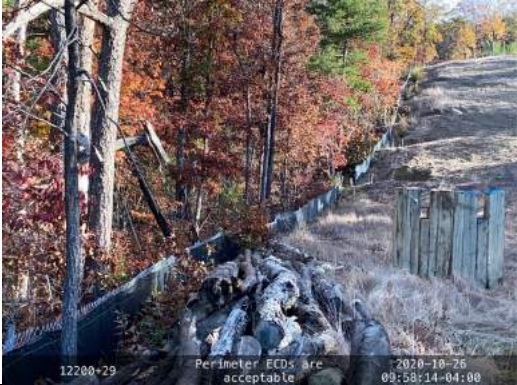
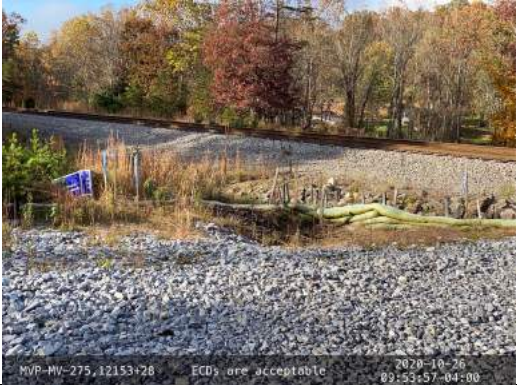
GPS Location	See photo GPS for location		GPS Location	See photo GPS for location	
Field Station#	12200+29		Field Station#	12153+28	
Pic 13 Desc.	Perimeter ECDs and vegetation are acceptable condition.		Pic 14 Desc.	ECDs are in acceptable condition and filtering sediment at MVP-MN-275 adjacent to S-0011.

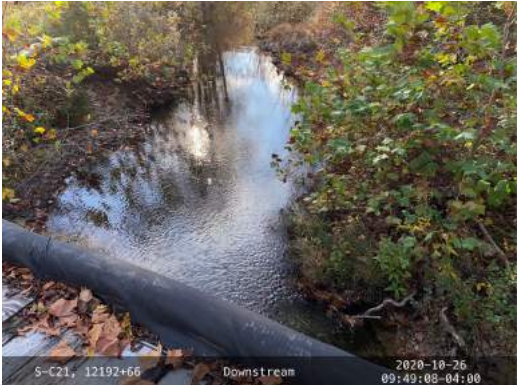
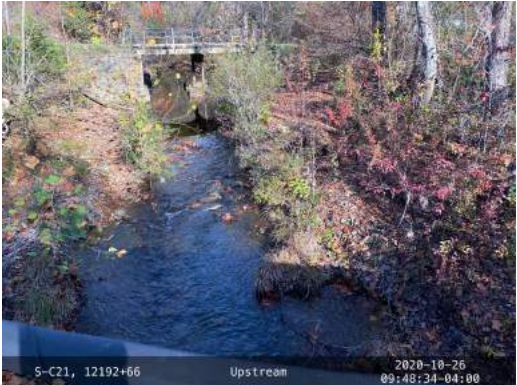
GPS Location	See photo GPS for location		GPS Location	See photo GPS for location	
Field Station#	12192+66		Field Station#	12192+66	
Pic 15 Desc.	Downstream at S-C21 has stable banks and is free of turbidity.		Pic 16 Desc.	Upstream at S-C21 has stable banks and is free of turbidity.

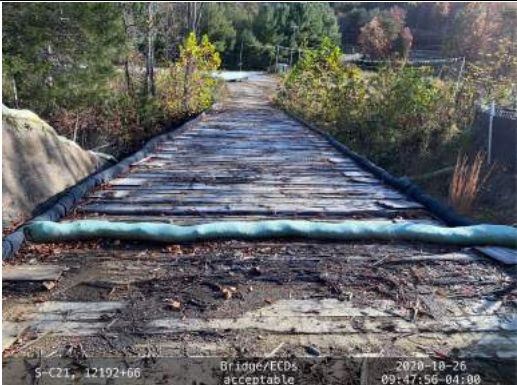
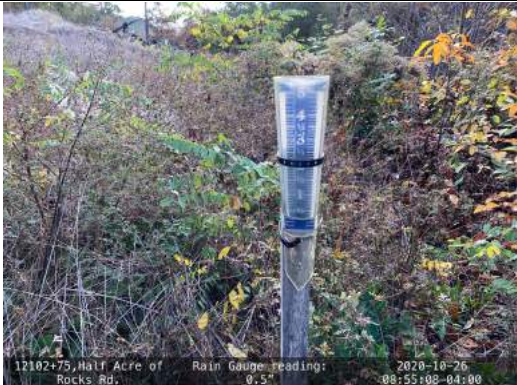
GPS Location	See photo GPS for location		GPS Location	See photo GPS for location	
Field Station#	12192+66		Field Station#	12102+75	
Pic 17 Desc.	Bridge and surrounding ECDs are in acceptable condition at S-C21 at the time of this inspection.		Pic 18 Desc.	Half Acre of Rock Rain Gauge Reading: 0.50"

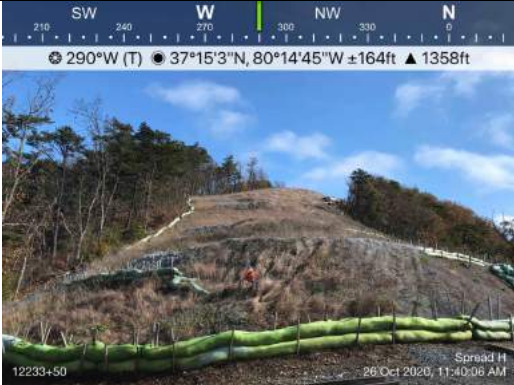
GPS Location	See photo	GPS Location	See photo		
Field Station#	12233+50	Field Station#	276+03		
Pic 1 Desc.	Start of inspection area, Perm. Waterbars in good condition.	Pic 2 Desc.	Portajohns within secondary containment.

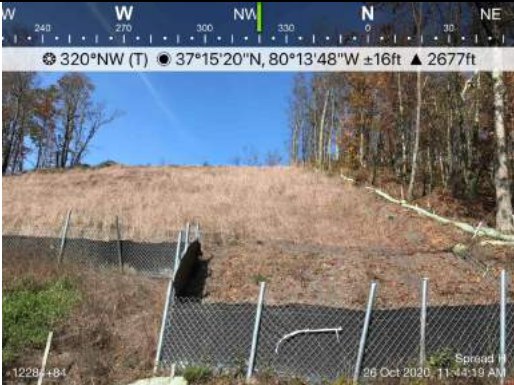
GPS Location	See photo	GPS Location	See photo		
Field Station#	12284+84	Field Station#	12299+00		
Pic 3 Desc.	SSF and CFS controls in good condition.	Pic 4 Desc.	Waterbars are stabilized with ECB and in good condition in the Reese Mtn "V"

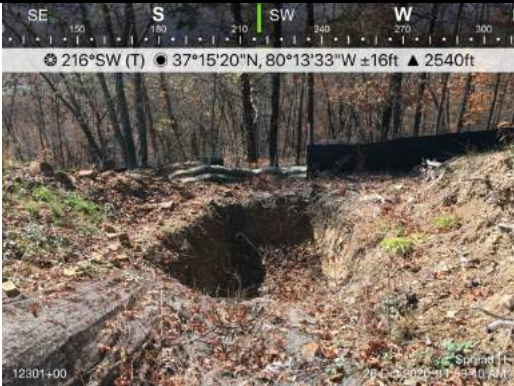
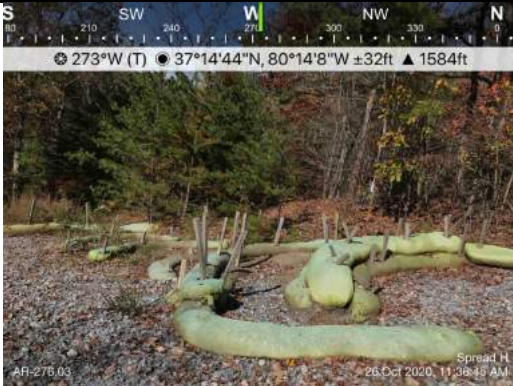
GPS Location	See photo	GPS Location	See photo		
Field Station#	12301+00	Field Station#	276+03		
Pic 5 Desc.	Sump in good condition, appears to be functioning as designed.	Pic 6 Desc.	Controls are in place and functioning on AR-276.03.

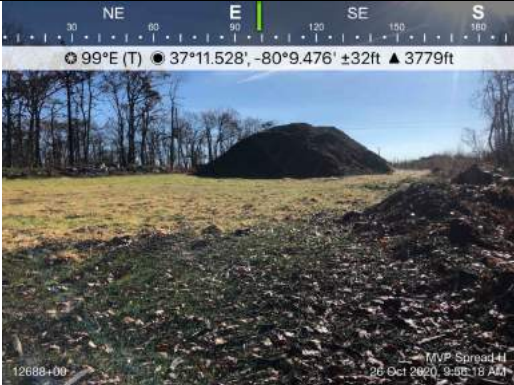
GPS Location	See Picture Watermark		GPS Location	See Picture Watermark	
Field Station#	12688+00		Field Station#	12688+00	
Pic 1 Desc.	Previously stabilized area on CIS Honeysuckle Road. Seed germination was observed.		Pic 2 Desc.	Stabilized area on CIS Honeysuckle Road. Seed germination was consist within straw area.

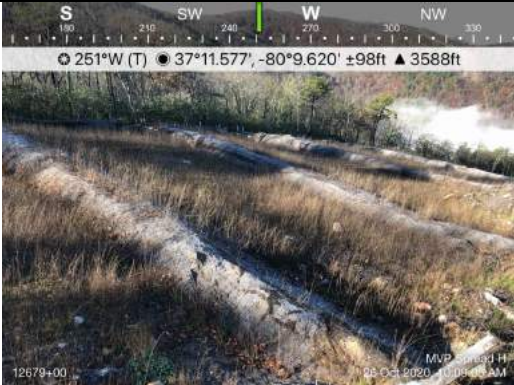
GPS Location	See Picture Watermark		GPS Location	See Picture Watermark	
Field Station#	12679+00		Field Station#	12683+00	
Pic 3 Desc.	Waterbars stabilized with erosion control matting, and vegetation is well established on the ROW between waterbars.		Pic 4 Desc.	Waterbar sump pit and end treatment in good condition.

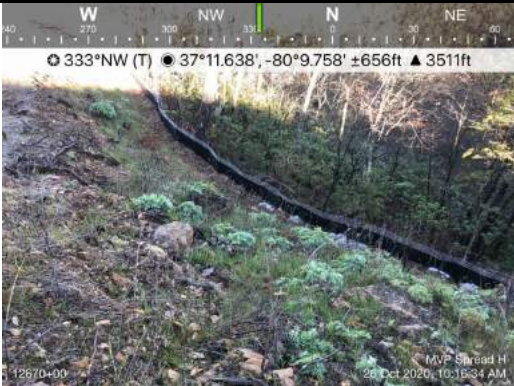
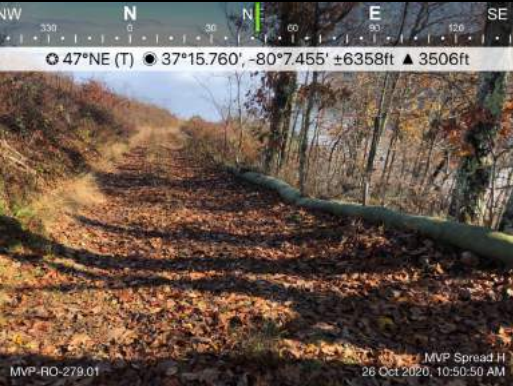
GPS Location	See Picture Watermark		GPS Location	See Picture Watermark	
Field Station#	12670+00		Field Station#	12638+24	
Pic 5 Desc.	Perimeter super silt fence is in good condition, and no maintenance is needed.		Pic 6 Desc.	MVP-RO-279.01 is in good condition with perimeter controls installed.

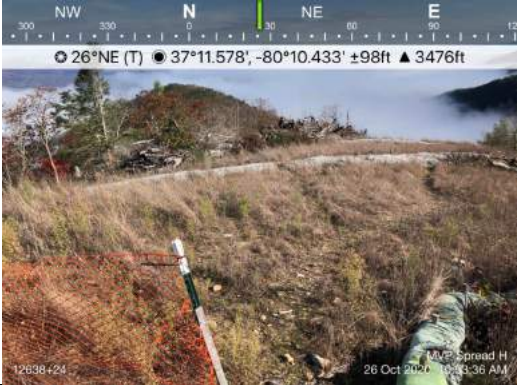
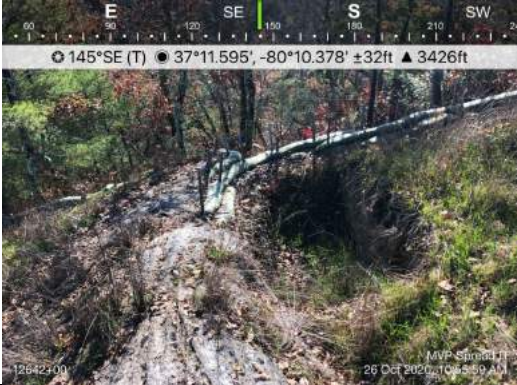
GPS Location	See Picture Watermark		GPS Location	See Picture Watermark	
Field Station#	12638+24		Field Station#	12642+00	
Pic 7 Desc.	ROW vegetation is established and is currently inhibiting accelerated erosion.		Pic 8 Desc.	Waterbar sump pit and CFS end treatment is in good condition.

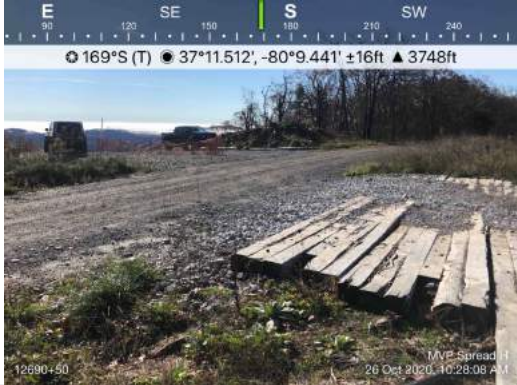
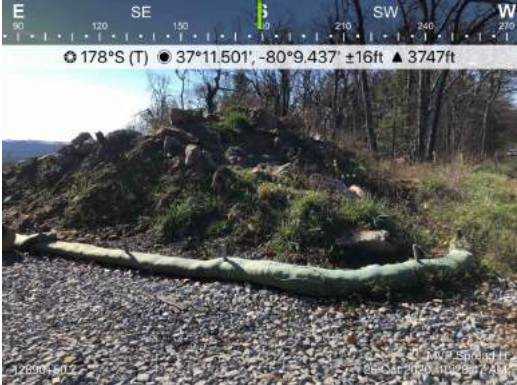
GPS Location	See Picture Watermark		GPS Location	See Picture Watermark	
Field Station#	12690+50		Field Station#	12690+50	
Pic 9 Desc.	Construction entrances at Honeysuckle Road are in good condition.		Pic 10 Desc.	Temporary stabilization of a temporary stockpile.

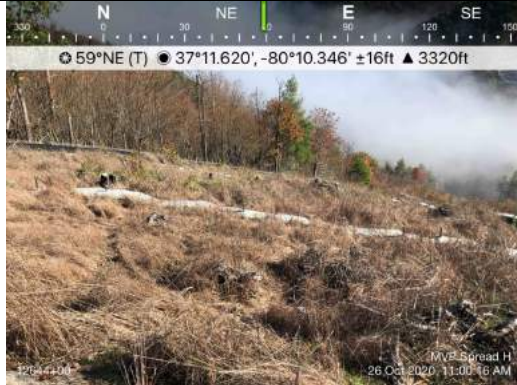
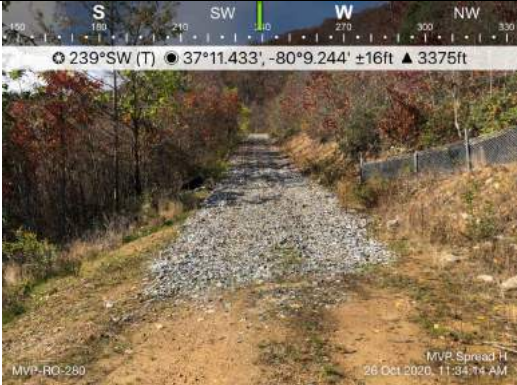
GPS Location	See Picture Watermark		GPS Location	See Picture Watermark	
Field Station#	12644+00		Field Station#	12701+00	
Pic 11 Desc.	CFS utilized across cleared, but not grubbed ROW. ROW remains well vegetated and no maintenance is needed.		Pic 12 Desc.	MVP-RO-280 is in good condition with controls installed.

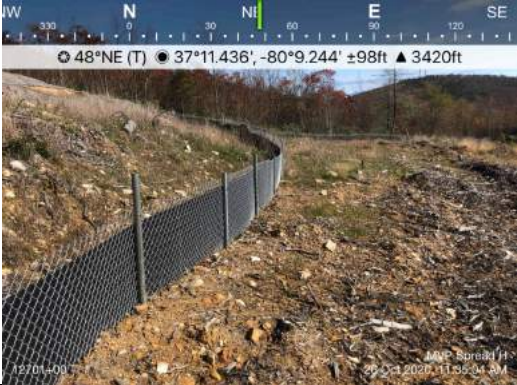
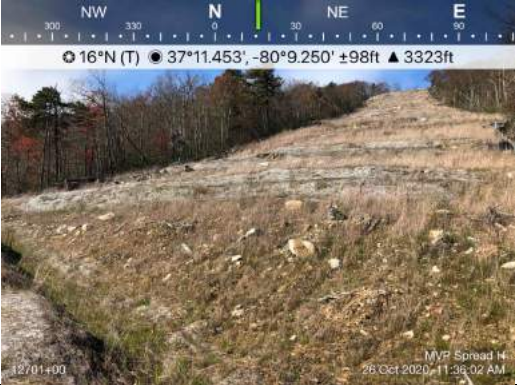
GPS Location	See Picture Watermark		GPS Location	See Picture Watermark	
Field Station#	12701+00		Field Station#	12701+00	
Pic 13 Desc.	Super silt fence is installed at bottom of slope and in good condition.		Pic 14 Desc.	Waterbars along slope and ROW vegetation are in good condition with no maintenance needed.

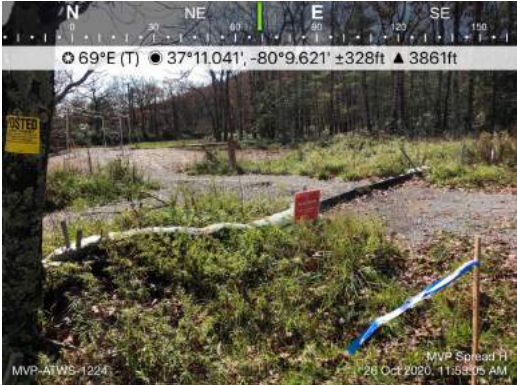
GPS Location	See Picture Watermark		GPS Location	See Picture Watermark	
Field Station#	12701+00		Field Station#	12703+00	
Pic 15 Desc.	MVP-ATWS-1224 is in good condition with controls installed.		Pic 16 Desc.	Waterbars and ROW vegetation remains in good condition and no maintenance is needed.

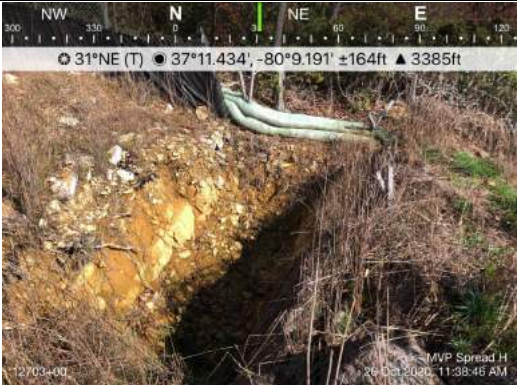
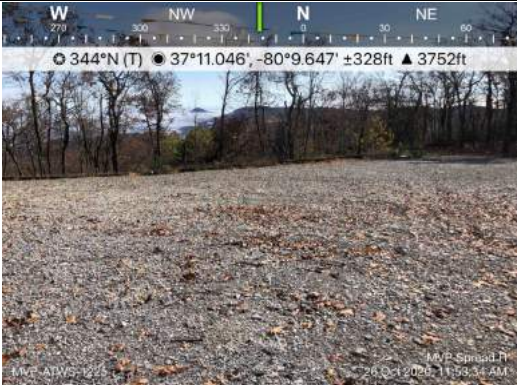
GPS Location	See Picture Watermark		GPS Location	See Picture Watermark	
Field Station#	12703+00		Field Station#	12701+00	
Pic 17 Desc.	Sump pit and CFS end treatment is in good condition with no maintenance needed.		Pic 18 Desc.	MVP-ATWS-1225 is in good condition and no maintenance needed to the perimeter controls.

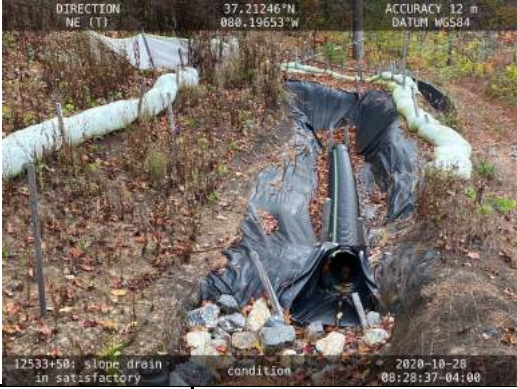
GPS Location	See photo		GPS Location	See photo	
Field Station#	12533+50		Field Station#	12529+00	
Pic 7 Desc.	Fill slope drain in satisfactory condition.		Pic 8 Desc.	Plastic sheeting approximately 1500 feet from Yellow Finch Road is still intact and secure.

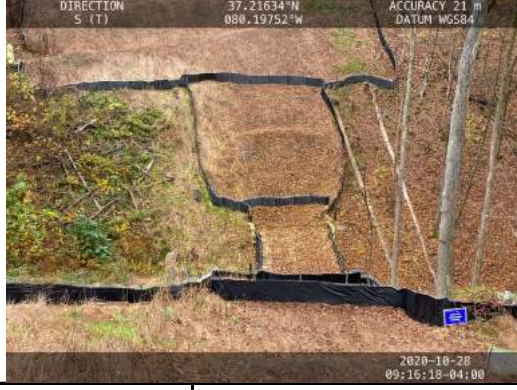
GPS Location	See photo		GPS Location	See photo	
Field Station#	12519+41		Field Station#	12522+00	
Pic 11 Desc.	The buffer zone of stream S-EF19 is stable, ECDs and bridge in good repair.		Pic 12 Desc.	Slope on GAS of stream S-EF19 remains stable.

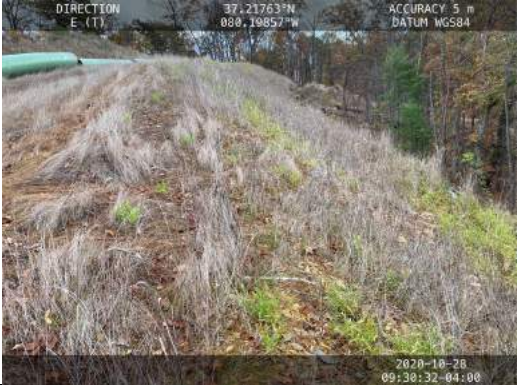
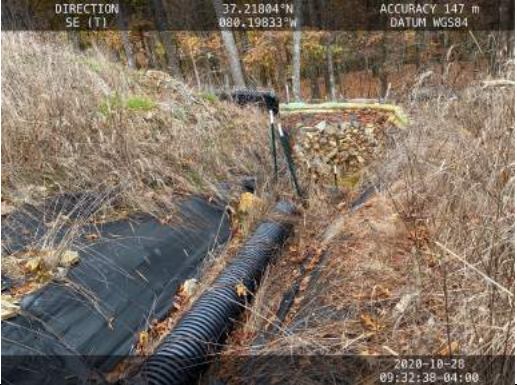
GPS Location	See photo		GPS Location	See photo	
Field Station#	12513+00		Field Station#	12508+90	
Pic 13 Desc.	The fill slope at the top of the hill on the coming in side of S-EF19 is well vegetated and stable.		Pic 14 Desc.	Slope drain is in good repair and functioning properly.

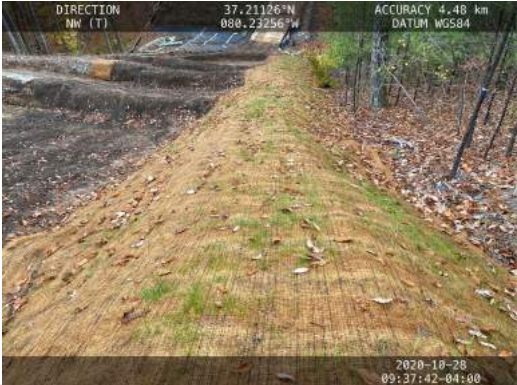
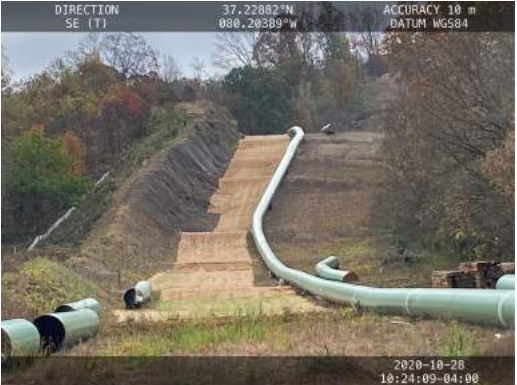
GPS Location	See photo		GPS Location	See photo	
Field Station#	12505+00		Field Station#	12477+00	
Pic 15 Desc.	This recently re-stabilized diversion berm is showing new vegetative growth.		Pic 16 Desc.	ROW stable

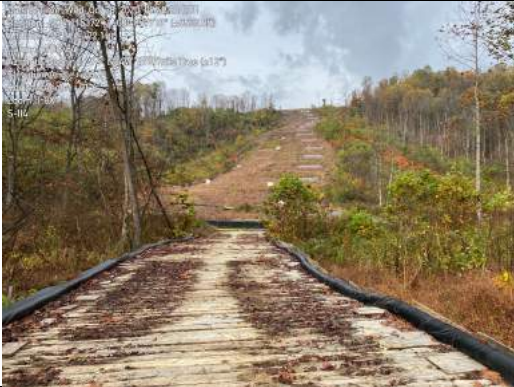
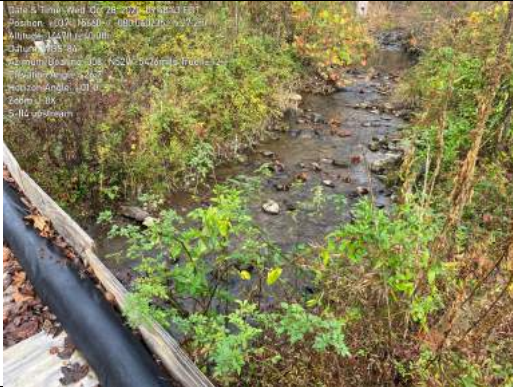
GPS Location	See photo for coordinates.		GPS Location	See photo for coordinates.	
Field Station#	13260+75		Field Station#	13260+60	
Pic 1 Desc.	S-II4, equipment bridge in acceptable condition.		Pic 2 Desc.	S-II4, upstream, no changes noted to stream bed or banks.

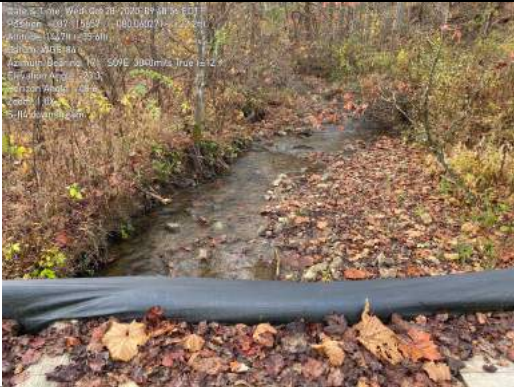
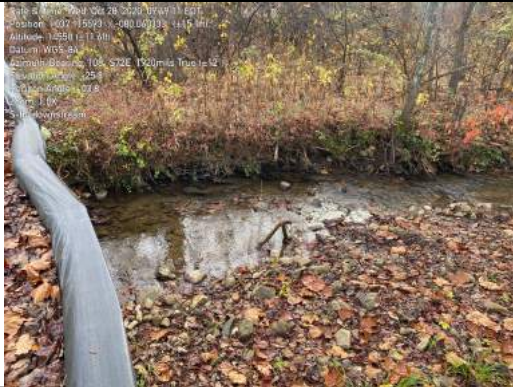
GPS Location	See photo for coordinates.		GPS Location	See photo for coordinates.	
Field Station#	13260+60		Field Station#	13260+60	
Pic 3 Desc.	S-II4, downstream, no changes noted to stream bed or banks.		Pic 4 Desc.	S-II4, downstream, no changes noted to stream bed or banks.

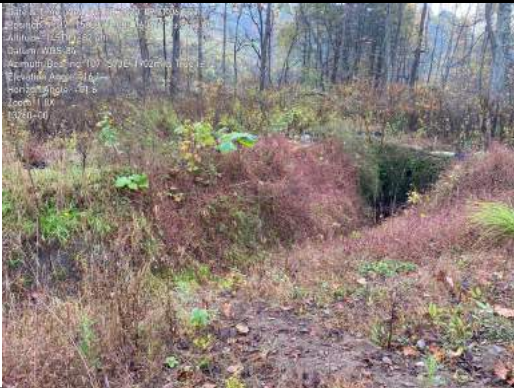
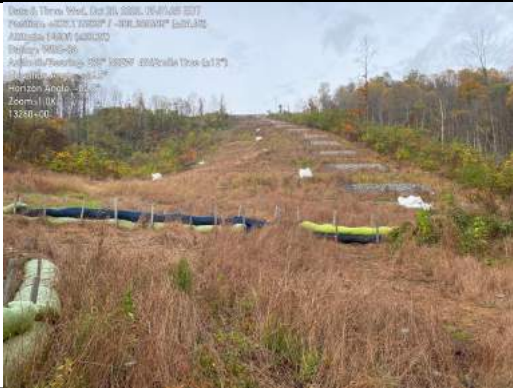
GPS Location	See photo for coordinates.		GPS Location	See photo for coordinates.	
Field Station#	13260+00		Field Station#	13260+00	
Pic 5 Desc.	Waterbar, sump, and outlet functioning acceptably.		Pic 6 Desc.	ROW stable with acceptable vegetative cover across LOD.

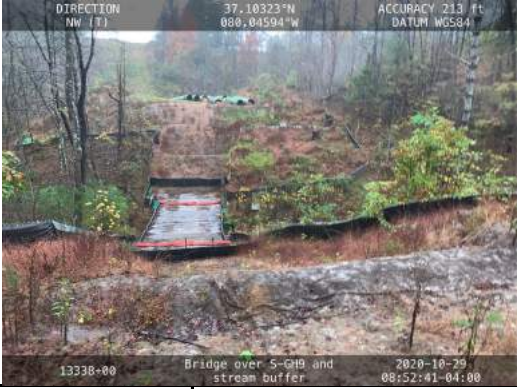
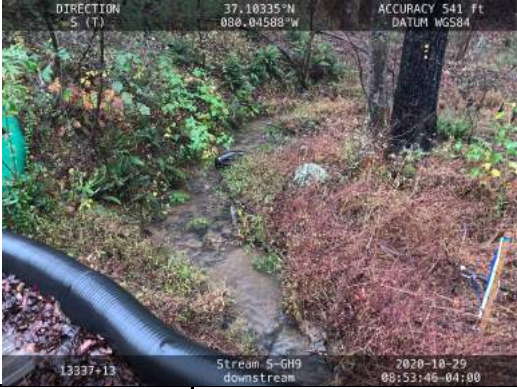
GPS Location	See photo for gps location data.		GPS Location	See photo for gps location data.	
Field Station#	13338+00		Field Station#	13337+13	
Pic 7 Desc.	Photo shows the bridge over stream S-GH9 and adjacent stream buffer.		Pic 8 Desc.	Photo shows stream S-GH9 downstream from the bridge.

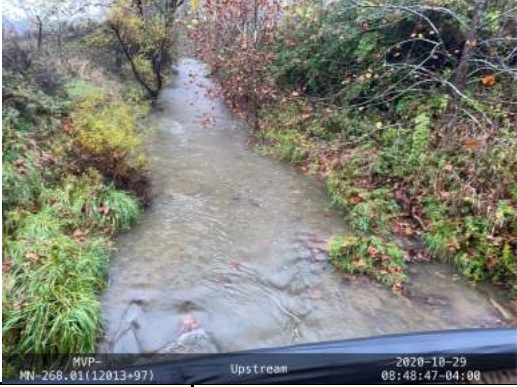
GPS Location	See photo GPS for location		GPS Location	See photo GPS for location	
Field Station#	12013+97		Field Station#	12013+97	
Pic 7 Desc.	Upstream shows some turbidity at the bridge at S-G36 crossing on MVP-MN-268.01.		Pic 8 Desc.	Downstream shows some turbidity at the bridge at S-G36 crossing on MVP-MN-268.01.

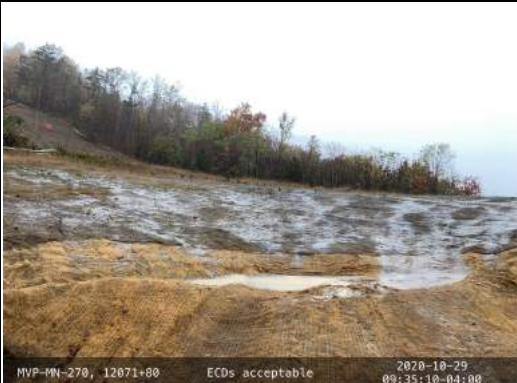
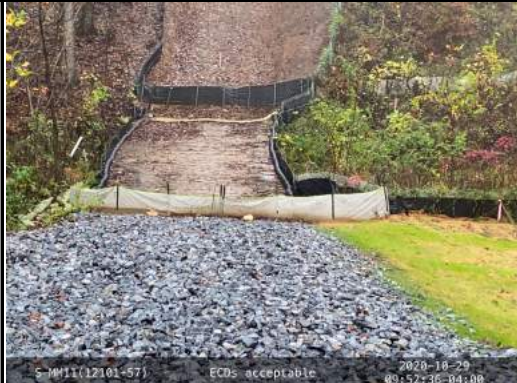
GPS Location	See photo GPS for location		GPS Location	See photo GPS for location	
Field Station#	12071+80		Field Station#	12101+57	
Pic 13 Desc.	Water bar, erosion blanket , and sump are handling and filtering excessive rain effectively where ROW and MVP-MN-270 meet.		Pic 14 Desc.	Surrounding ECDs at S-MM11 are in acceptable condition.

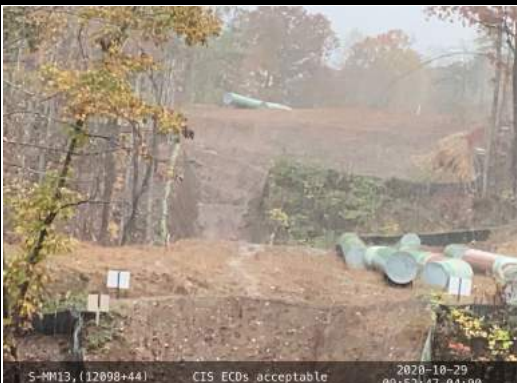
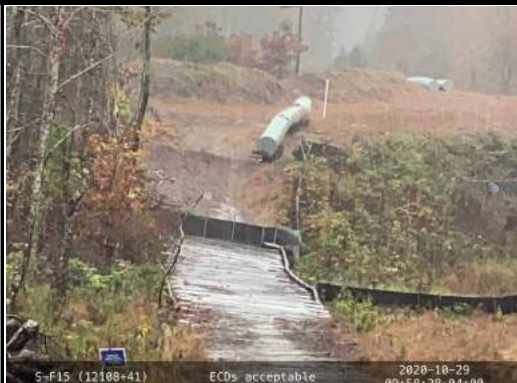
GPS Location	See photo GPS for location		GPS Location	See photo GPS for location	
Field Station#	12098+44		Field Station#	12108+41	
Pic 15 Desc.	ECDs on CIS of S-MM13 are in acceptable condition.		Pic 16 Desc.	ECDs surrounding S-F15 are in acceptable condition.

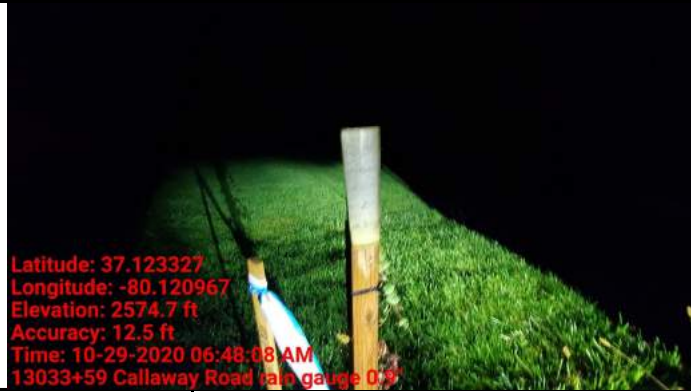
<p>Latitude: 37.123327 Longitude: -80.120967 Elevation: 2574.7 ft Accuracy: 12.5 ft Time: 10-29-2020 06:48:08 AM 13033+59 Callaway Road rain gauge 0.9"</p>		  <p>Latitude: 37.191708 Longitude: -80.157417 Elevation: 3807.84 ft Accuracy: 40.4 ft Time: 10-29-2020 08:03:31 AM 12690+00 Honeysuckle Road rain gauge 0.9"</p>			
GPS Location	See pic for GPS location		GPS Location	See pic for GPS location	
Field Station#	13033+59		Field Station#	12690+00	
Pic 1 Desc.	Callaway Road rain gauge. 0.9" total precipitation.		Pic 2 Desc.	Honeysuckle Road rain gauge. 0.9" total precipitation.

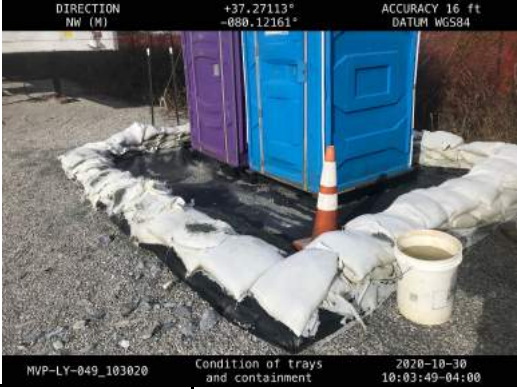
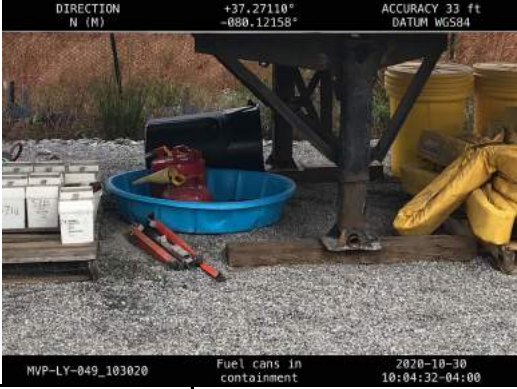
GPS Location	MVP-LY-049 See photo for gps data		GPS Location	MVP-LY-049 See photo for gps data	
Field Station#	+0		Field Station#	+0	
Pic 7 Desc.	Condition of trays and containment under toilets. Looking NW.		Pic 8 Desc.	Supplies under NCI's warehouse trailer. Fuel cans in containment. Looking N.

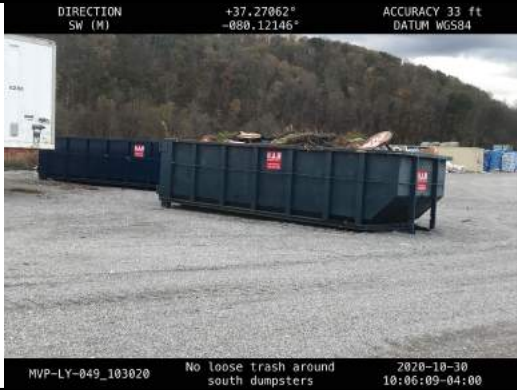
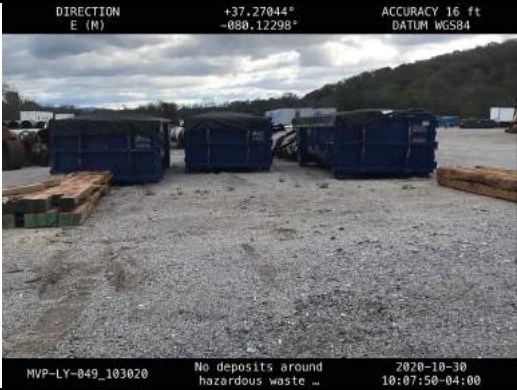
GPS Location	MVP-LY-049 See photo for gps data		GPS Location	MVP-LY-049 See photo for gps data	
Field Station#	+0		Field Station#	+0	
Pic 9 Desc.	No loose trash around south dumpsters. Looking SW.		Pic 10 Desc.	No deposits around hazardous waste dumpsters. Looking E.

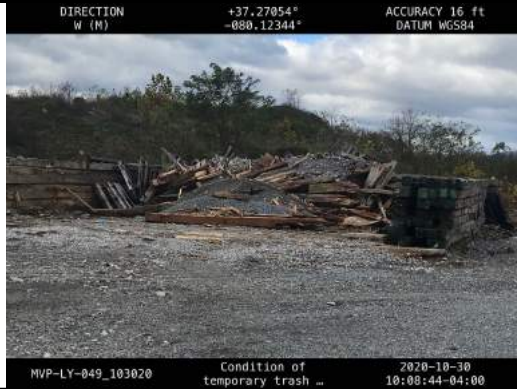
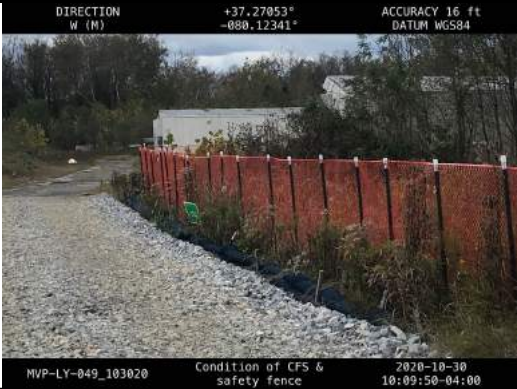
GPS Location	MVP-LY-049 See photo for gps data		GPS Location	MVP-LY-049 See photo for gps data	
Field Station#	+0		Field Station#	+0	
Pic 11 Desc.	Condition of temporary trash transfer pit. Looking W.		Pic 12 Desc.	Condition of compost filter sock and safety fence along feature W-CV21A. Looking W.

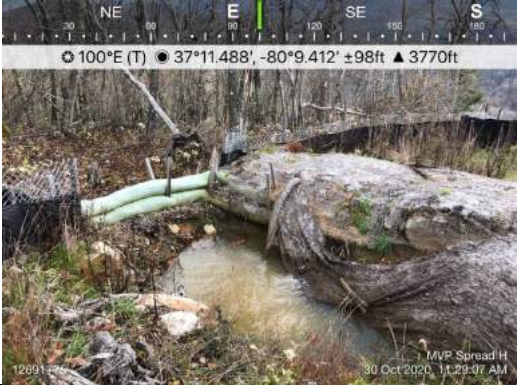
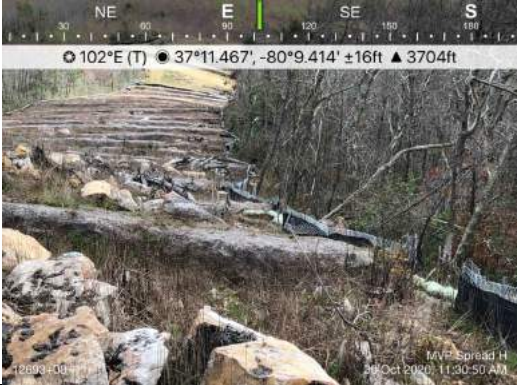
GPS Location	See Picture Watermark		GPS Location	See Picture Watermark	
Field Station#	12691+75		Field Station#	12693+00	
Pic 7 Desc.	Sump and end treatment in good condition.		Pic 8 Desc.	End treatments along GAS Honeysuckle in good condition. No maintenance necessary.

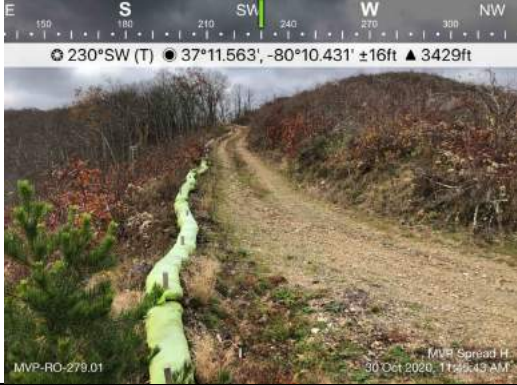
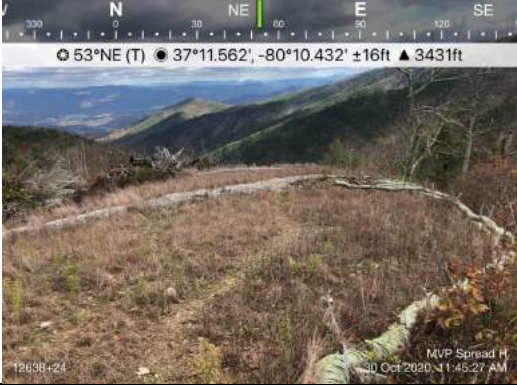
GPS Location	See Picture Watermark		GPS Location	See Picture Watermark	
Field Station#	12638+24		Field Station#	12638+24	
Pic 9 Desc.	Access road MVP-RO-279.01 is in good condition and no maintenance is needed.		Pic 10 Desc.	ROW is well vegetated and no accelerated erosion was observed.

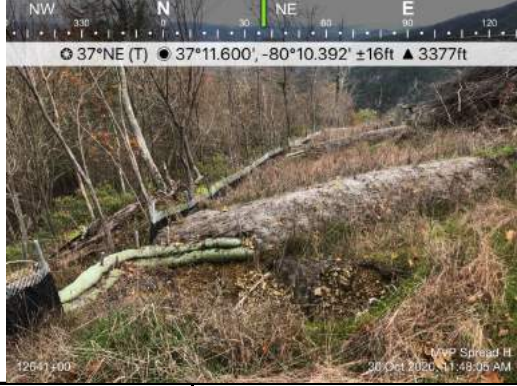
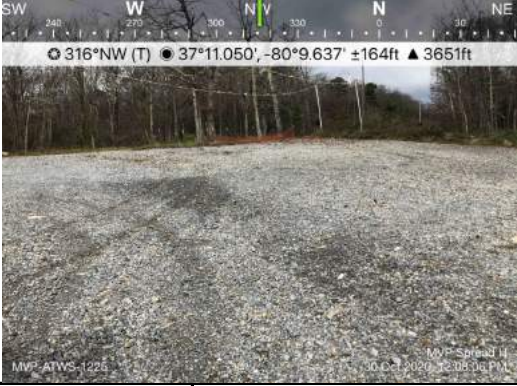
GPS Location	See Picture Watermark		GPS Location	See Picture Watermark	
Field Station#	12641+00		Field Station#	12701+00	
Pic 11 Desc.	Waterbars and end treatments in good condition with no maintenance needed.		Pic 12 Desc.	ATWS-1225 is in good condition. No material stored here.

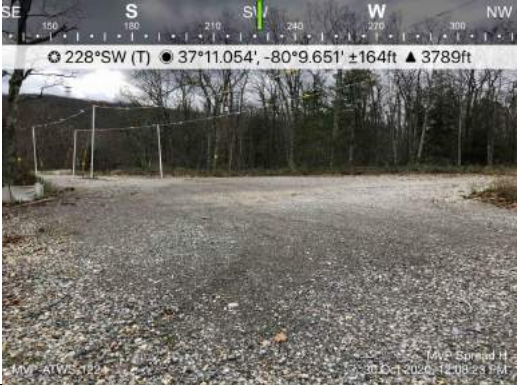
GPS Location	See Picture Watermark		GPS Location	See Picture Watermark	
Field Station#	12701+00		Field Station#	12701+00	
Pic 13 Desc.	ATWS-1224 is in good condition. No material currently stored here.		Pic 14 Desc.	MVP-RO-280 is in good condition with no maintenance necessary.

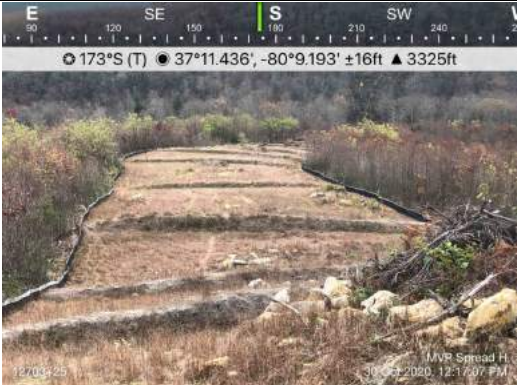
GPS Location	See Picture Watermark		GPS Location	See Picture Watermark	
Field Station#	12703+25		Field Station#	12703+00	
Pic 17 Desc.	Waterbars and ROW are well vegetated and no maintenance needed.		Pic 18 Desc.	Temporary mulch stockpile within ROW limits.
