Visual Site Inspection Report

Project Name	H-600 Pipeline Spread H	AFE	124300138	Spread	H-600 Pipeline Spread H
Contractor	Precision			Report #	16595
Inspector	Logan Box			Date/Time	11/9/2020 4:25 PM
Permit #	TBD	Inspection Type	VA SWPP	Station Begin	13415+51
State	VA	Inspection Area	Partial	Station End	13525+99
County	Franklin	Ground	Damp	Temperature (°F)	70.00
Municipality	N/A	Weather	Cloudy	Rain Gauge (in)	0.00
				Rain Accumulation Time (days)	0.00

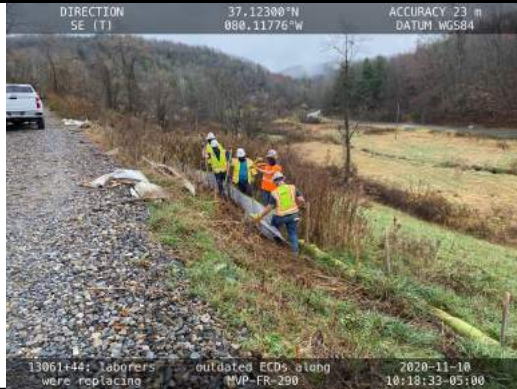
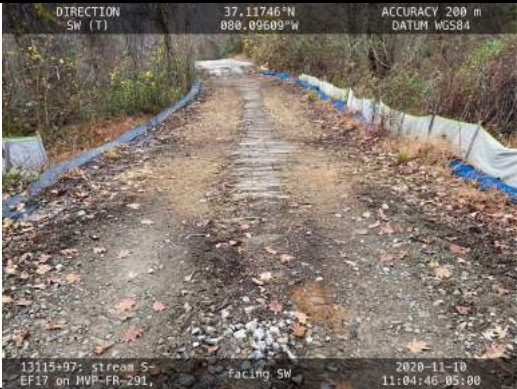
GPS Location	See photo		GPS Location	See photo	
Field Station#	13061+44		Field Station#	13115+97	
Pic 11 Desc.	Laborers replaced P1 silt fence that had become overgrown outdated.		Pic 12 Desc.	Stream S-EF17 on access road MVP-FR-291, facing southwest

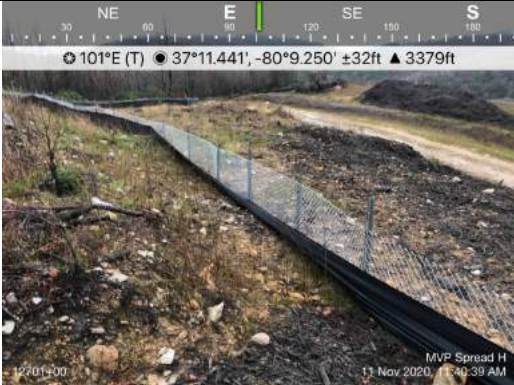
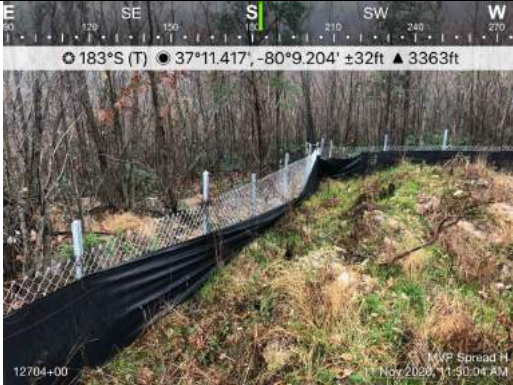
GPS Location	See Picture Watermark		GPS Location	See Picture Watermark	
Field Station#	12701+00		Field Station#	12704+00	
Pic 1 Desc.	Super silt fence fabric has detached from the fencing, and should be repaired. Communicated to LEI.		Pic 2 Desc.	Super silt fence fabric has detached from the fencing, and should be repaired. Communicated to LEI,

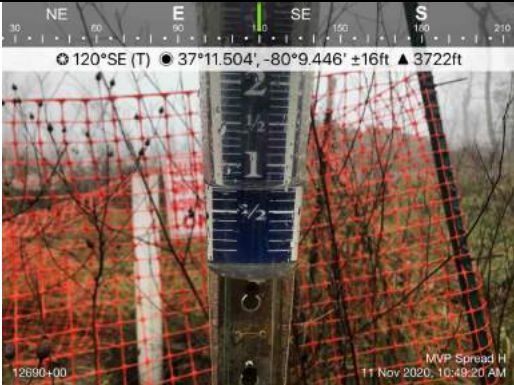
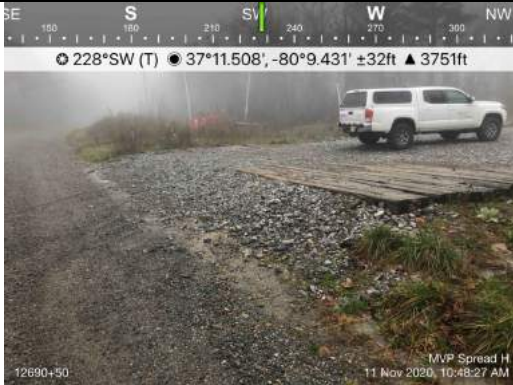
GPS Location	See Picture Watermark		GPS Location	See Picture Watermark	
Field Station#	12690+00		Field Station#	12690+50	
Pic 3 Desc.	Honeysuckle rain gauge depicted 0.75". Project staff continues to monitor the rain while storms persist in the region.		Pic 4 Desc.	Rock construction entrances on Honeysuckle are in good condition, and no maintenance needed.

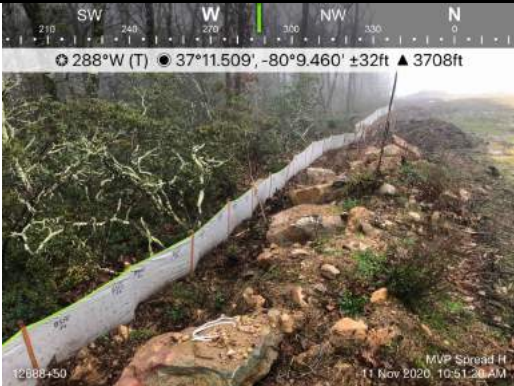
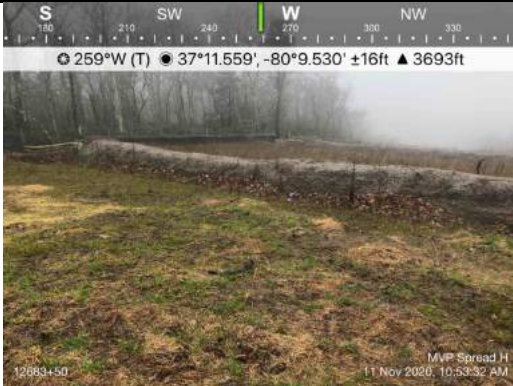
Pic 5 Desc.	Perimeter silt fence is in good condition, and no maintenance is needed.		Pic 6 Desc.	Waterbar and ROW is stable and vegetation continues to inhibit accelerated erosion.

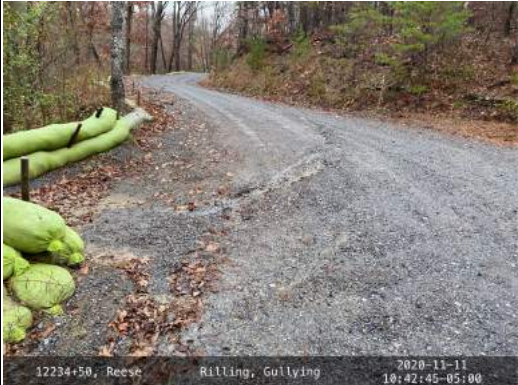
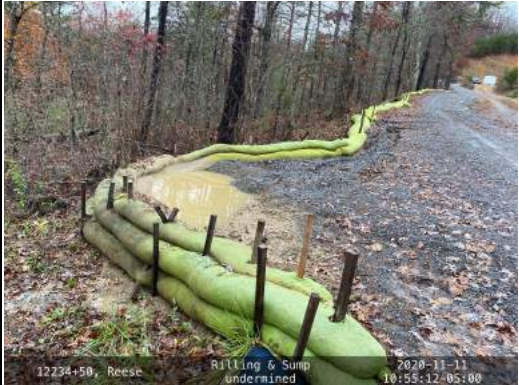
GPS Location	See photo GPS for location		GPS Location	See photo GPS for location	
Field Station#	12234+50		Field Station#	12234+50	
Pic 15 Desc.	This rilling and gully on MVP-MN-276.03 has been submitted to the punch list for maintenance.		Pic 16 Desc.	This undermined and over-topped sump on MVP-MN-276.03 has been put on the punch list for maintenance.

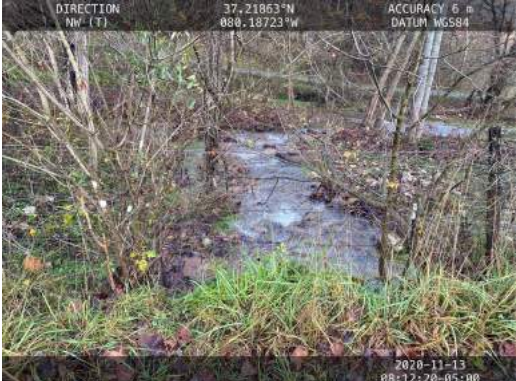
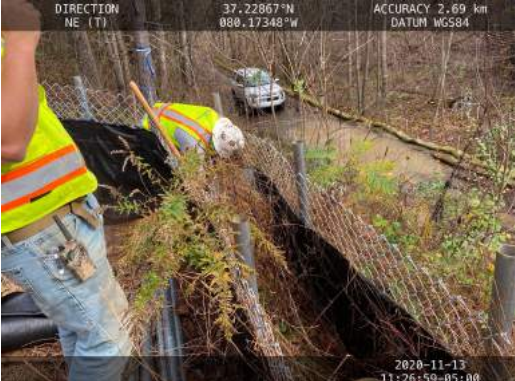
GPS Location	See photo		GPS Location	See photo	
Field Station#	12544+06		Field Station#	12543+00	
Pic 3 Desc.	Stream S-KL32, facing northwest, downstream from Yellow Finch Road		Pic 4 Desc.	SSF was repaired where MBP inspection documented an action item due to a hole in the fabric.

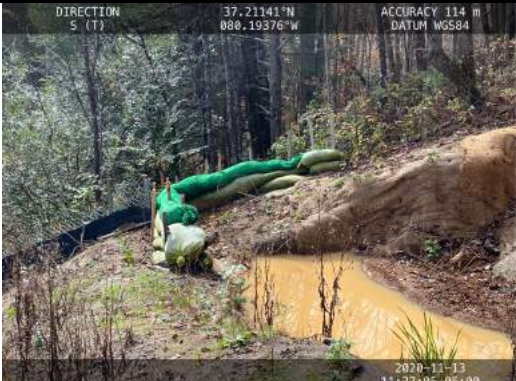
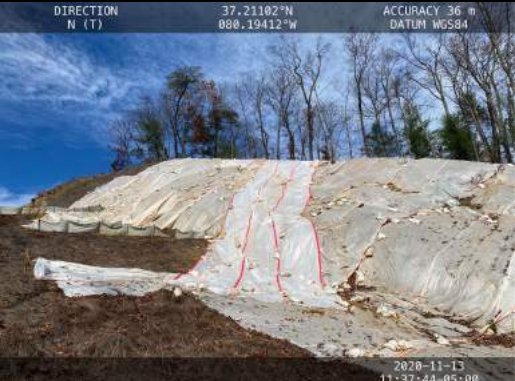
GPS Location	See photo		GPS Location	See photo	
Field Station#	12543+40		Field Station#	12542+40	
Pic 5 Desc.	Another layer of CFS was added to this end treatment per internal punch list item.		Pic 6 Desc.	A row of plastic sheeting was added over an area that was displaced by sloughing material per internal punch list item.

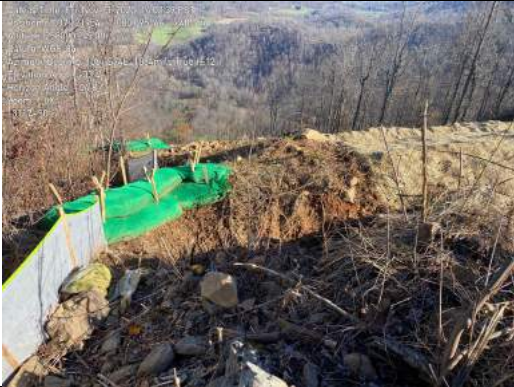
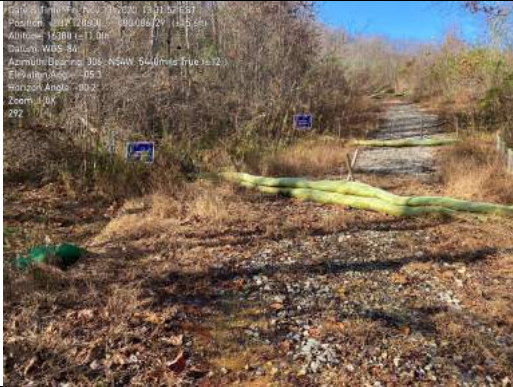
GPS Location	See photo for coordinates.		GPS Location	See photo for coordinates.	
Field Station#	13117+50		Field Station#	13242+00	
Pic 1 Desc.	Waterbars, sumps, and outlets functioning acceptably.		Pic 2 Desc.	MVP-FR-292, water flowing out of S-D14 across access road.

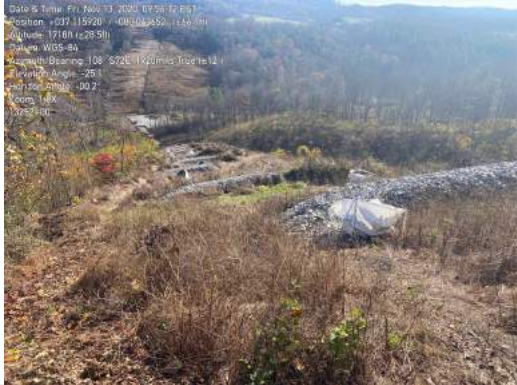
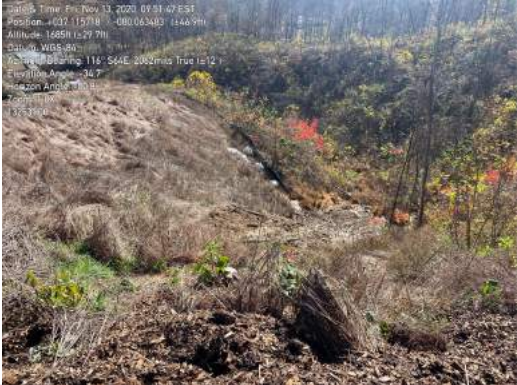
GPS Location	See photo for coordinates.		GPS Location	See photo for coordinates.	
Field Station#	13252+00		Field Station#	13253+00	
Pic 9 Desc.	ROW stable with acceptable vegetative cover across LOD.		Pic 10 Desc.	Slip noted on steep slope during 11-12-20 inspection, no additional movement noted.

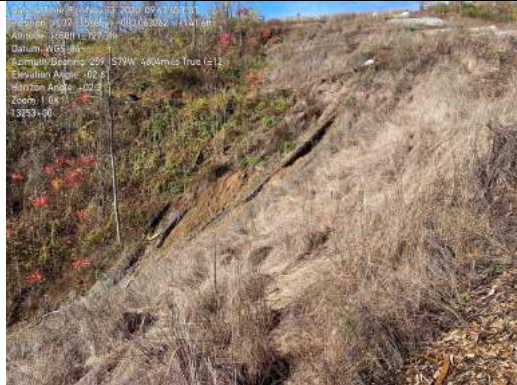
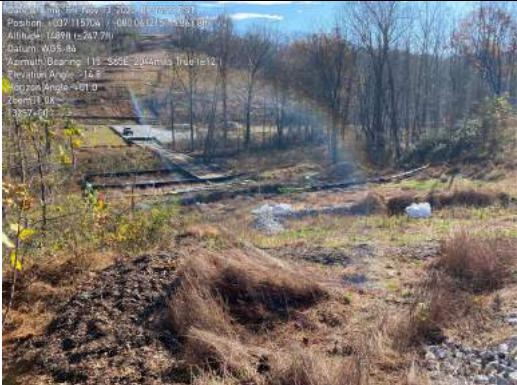
GPS Location	See photo for coordinates.		GPS Location	See photo for coordinates.	
Field Station#	13253+00		Field Station#	13257+00	
Pic 11 Desc.	Slip on steep slope.		Pic 12 Desc.	ROW stable with acceptable vegetative cover across LOD.
