## Visual Site Inspection Report

<b>Project Name</b>	H-600 Pipeline Spread H	<b>AFE</b>	124300138	<b>Spread</b>	H-600 Pipeline Spread H
<b>Contractor</b>	Precision			<b>Report #</b>	14777
<b>Inspector</b>	Tammy Kruizenga			<b>Date/Time</b>	9/21/2020 12:56 PM
<b>Permit #</b>	TBD	<b>Inspection Type</b>	VA SWPP	<b>Station Begin</b>	12005+00
<b>State</b>	VA	<b>Inspection Area</b>	Partial	<b>Station End</b>	12119+17
<b>County</b>	Montgomery	<b>Ground</b>	Dry	<b>Temperature (°F)</b>	60.00
<b>Municipality</b>	N/A	<b>Weather</b>	Sunny	<b>Rain Gauge (in)</b>	0.00
				<b>Rain Accumulation Time (days)</b>	1.00

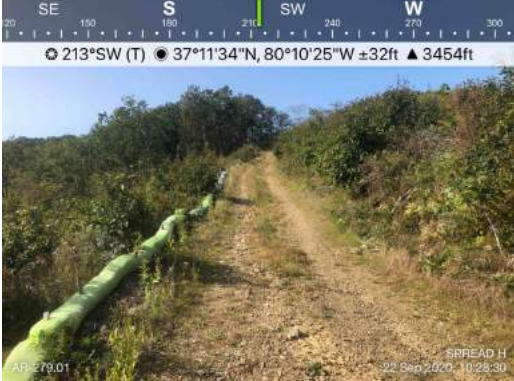
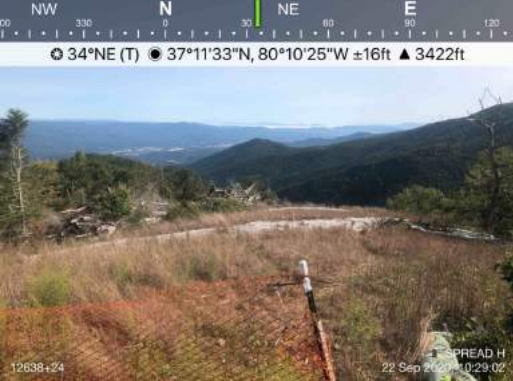
<b>GPS Location</b>	see photo		<b>GPS Location</b>	see photo	
<b>Field Station#</b>	279+01		<b>Field Station#</b>	12638+24	
<b>Pic 1 Desc.</b>	AR-279.01 in good condition with controls in place.		<b>Pic 2 Desc.</b>	GAS slope of AR-279.01 in good condition. Slope remains stabilized.

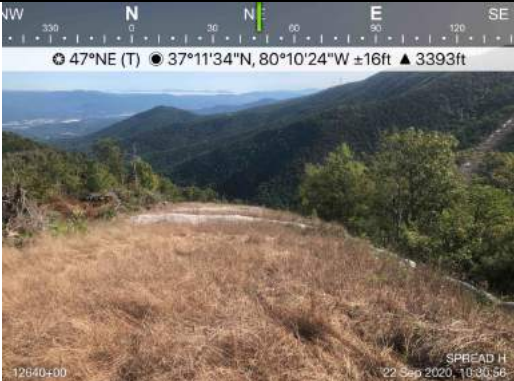
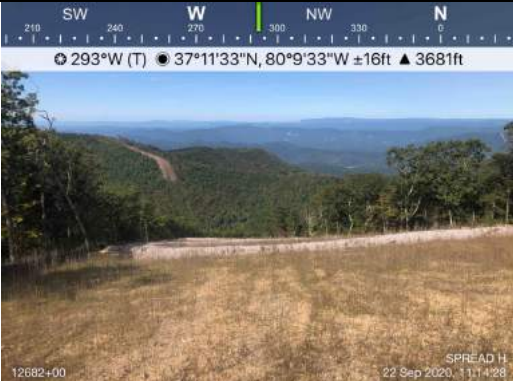
<b>GPS Location</b>	see photo		<b>GPS Location</b>	see photo	
<b>Field Station#</b>	12640+00		<b>Field Station#</b>	12682+00	
<b>Pic 3 Desc.</b>	Waterbars in good condition on this slope.		<b>Pic 4 Desc.</b>	CIS slope of Honeysuckle Rd. in good condition.

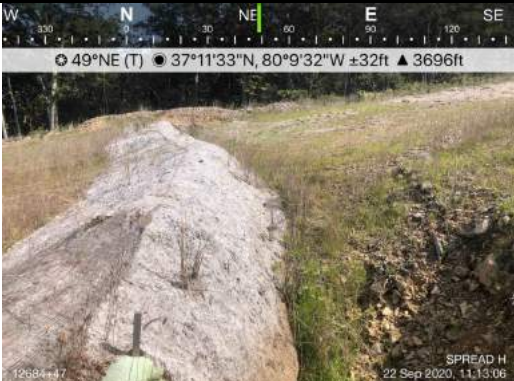
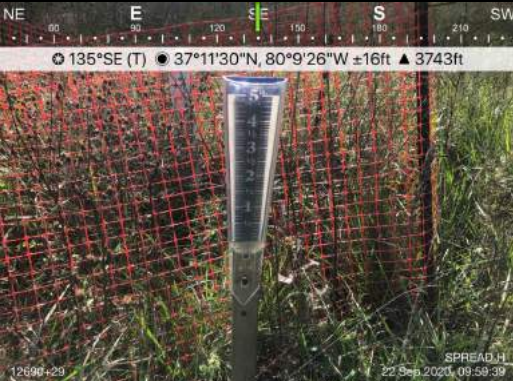
<b>GPS Location</b>	see photo		<b>GPS Location</b>	see photo	
<b>Field Station#</b>	12684+47		<b>Field Station#</b>	12690+29	
<b>Pic 5 Desc.</b>	Waterbars on this slope remain in good condition and functioning.		<b>Pic 6 Desc.</b>	Rain gauge at Honeysuckle Rd. showing 0.0" of rain.

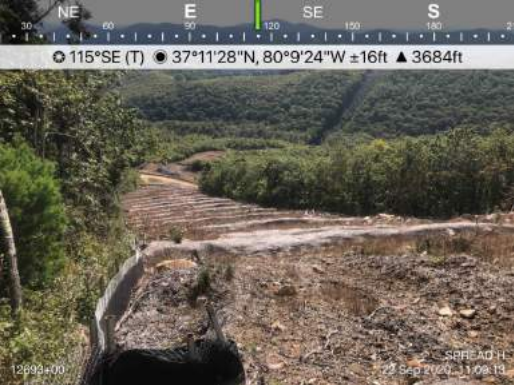
<b>GPS Location</b>	see photo		<b>GPS Location</b>	see photo	
<b>Field Station#</b>	12690+29		<b>Field Station#</b>	12693+00	
<b>Pic 7 Desc.</b>	CE's at Honeysuckle Rd. in good condition.		<b>Pic 8 Desc.</b>	GAS slope of Honeysuckle Rd. in good condition with controls in place.

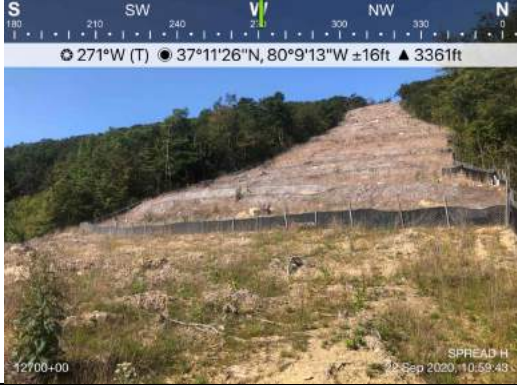
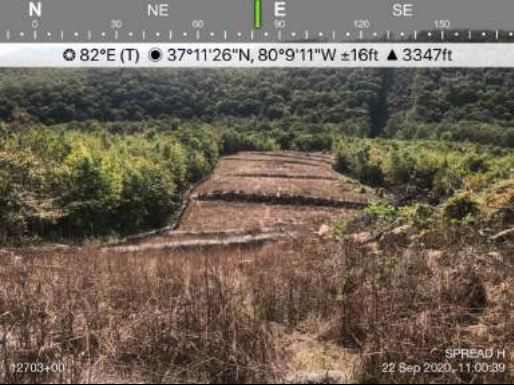
<b>GPS Location</b>	see photo		<b>GPS Location</b>	see photo	
<b>Field Station#</b>	12700+00		<b>Field Station#</b>	12703+00	
<b>Pic 9 Desc.</b>	Additional controls at this location in good condition.		<b>Pic 10 Desc.</b>	GAS of AR-280 in good condition. Slope remains stabilized.

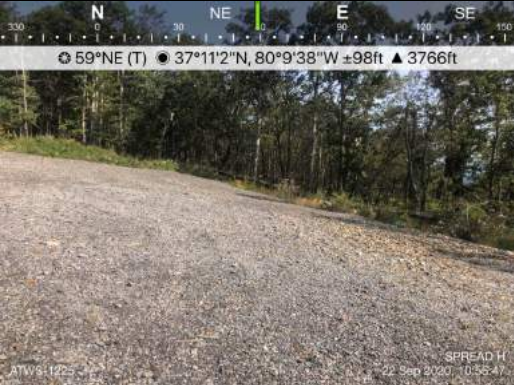
<b>GPS Location</b>	see photo		<b>GPS Location</b>	see photo	
<b>Field Station#</b>	280+00		<b>Field Station#</b>	1225+00	
<b>Pic 11 Desc.</b>	AR-280 in good condition with controls in place.		<b>Pic 12 Desc.</b>	ATWS-1225 remains dormant with controls in place.

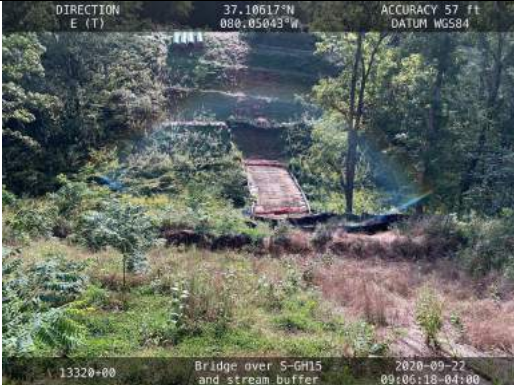
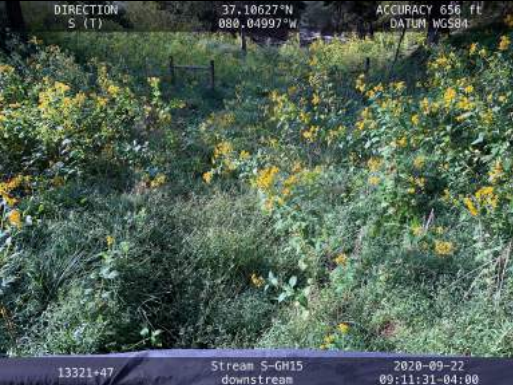
<b>GPS Location</b>	See photo for gps location data.		<b>GPS Location</b>	See photo for gps location data.	
<b>Field Station#</b>	13320+00		<b>Field Station#</b>	13321+47	
<b>Pic 1 Desc.</b>	Photo shows the bridge over stream S-GH15 and adjacent stream buffer.		<b>Pic 2 Desc.</b>	Photo shows stream S-GH15 downstream from the bridge.

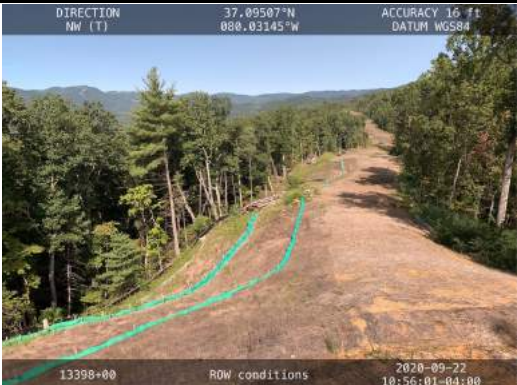
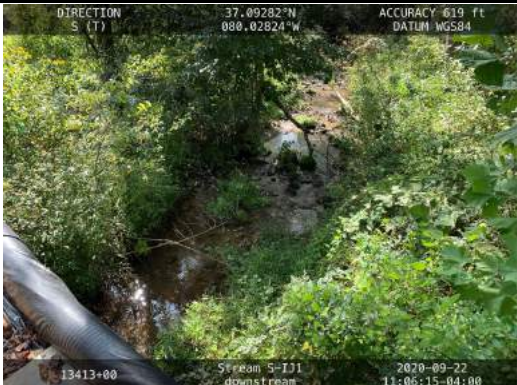
<b>Field Station#</b>	13398+00		<b>Field Station#</b>	13413+00	
<b>Pic 17 Desc.</b>	photo shows the ROW condition from about 13385+00 to 13398+00.		<b>Pic 18 Desc.</b>	Photo shows stream S-IJ1 downstream from the bridge.

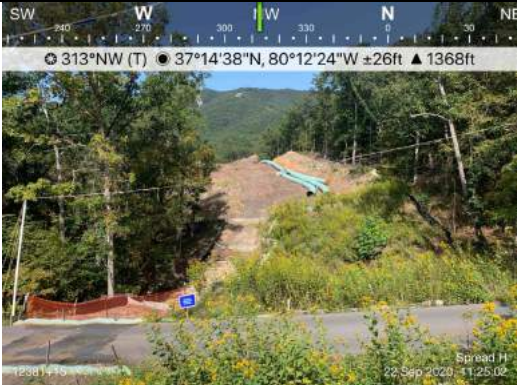
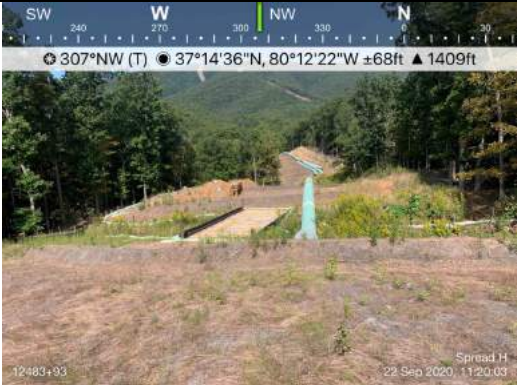
<b>GPS Location</b>	See Watermark		<b>GPS Location</b>	See Watermark	
<b>Field Station#</b>	12381+15		<b>Field Station#</b>	12483+93	
<b>Pic 7 Desc.</b>	Bridge crossings and controls are functional.		<b>Pic 8 Desc.</b>	Waterbars and ROW are stable and in acceptable in condition.

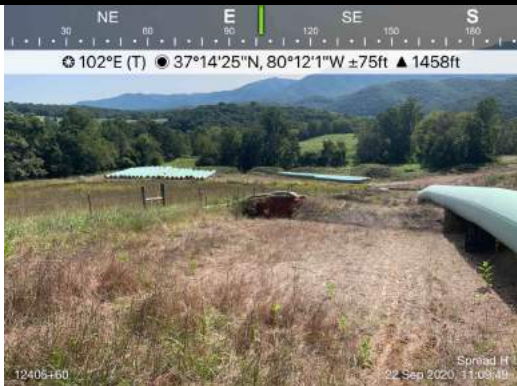
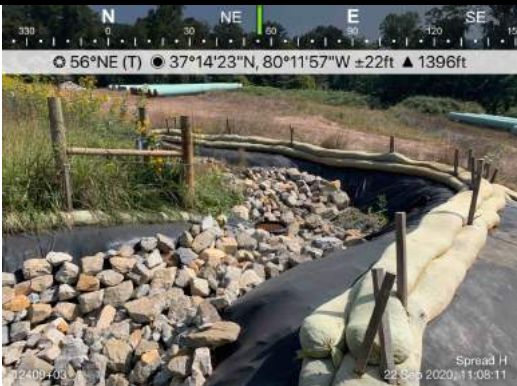
<b>GPS Location</b>	See Watermark		<b>GPS Location</b>	See Watermark	
<b>Field Station#</b>	12406+60		<b>Field Station#</b>	12409+03	
<b>Pic 9 Desc.</b>	ROW is well stabilized with vegetation and erosion control blanket.		<b>Pic 10 Desc.</b>	Clean water diversion berm is in acceptable condition.

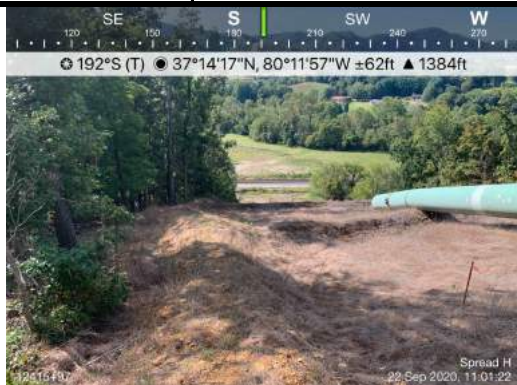
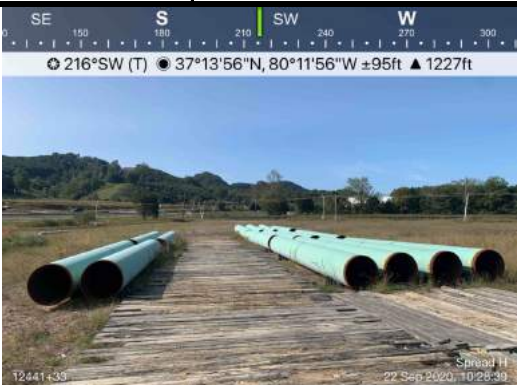
<b>GPS Location</b>	See Watermark		<b>GPS Location</b>	See Watermark	
<b>Field Station#</b>	124+15		<b>Field Station#</b>	12441+50	
<b>Pic 11 Desc.</b>	ROW is well stabilized with vegetation and erosion control blanket.		<b>Pic 12 Desc.</b>	Woodmatting and stockpiles are in acceptable condition.

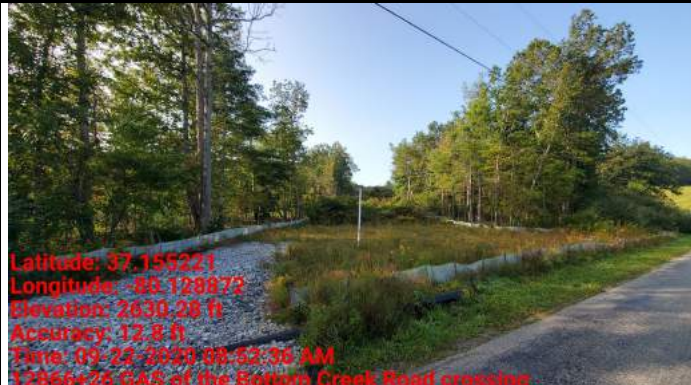
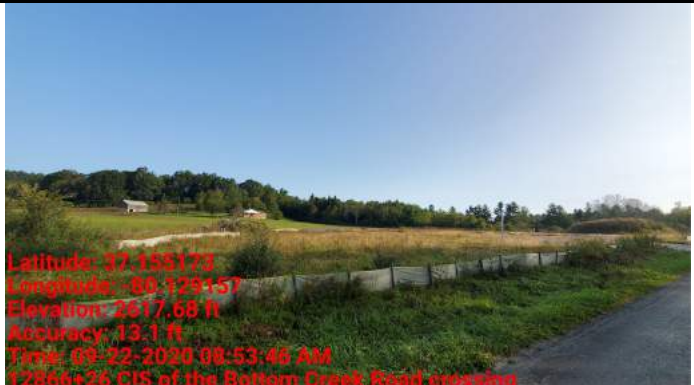
GPS Location	See pic for GPS location		GPS Location	See pic for GPS location	
Field Station#	12866+26		Field Station#	12866+26	
Pic 1 Desc.	GAS of the Bottom Creek Road crossing.		Pic 2 Desc.	CIS of the Bottom Creek Road crossing.

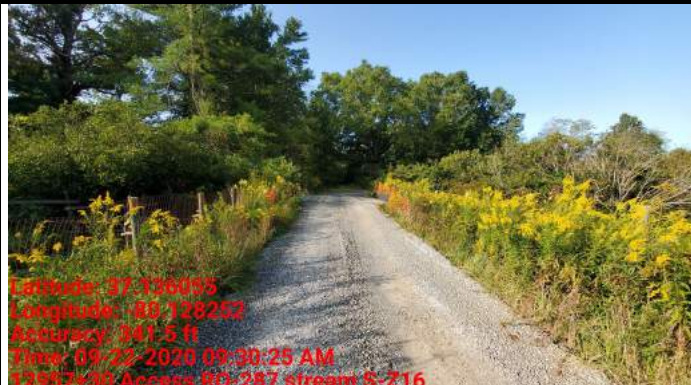
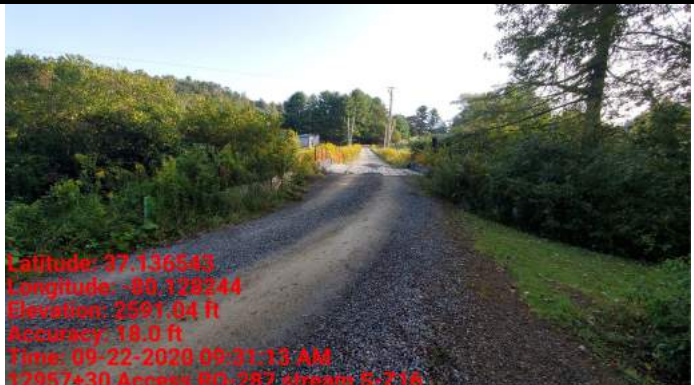
GPS Location	See pic for GPS location		GPS Location	See pic for GPS location	
Field Station#	12957+30		Field Station#	12957+30	
Pic 3 Desc.	Access road RO-287 at stream S-Z16.		Pic 4 Desc.	Access road RO-287 at stream S-Z16.

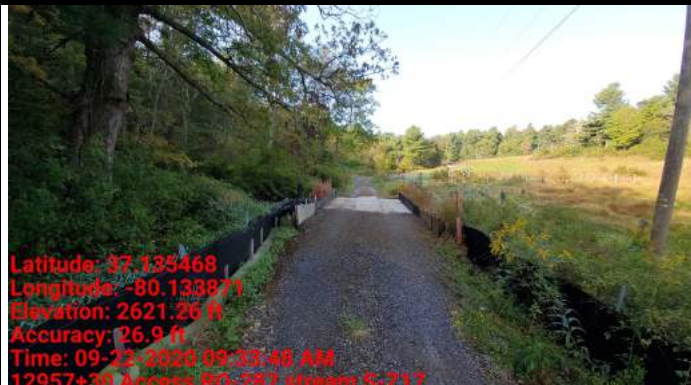
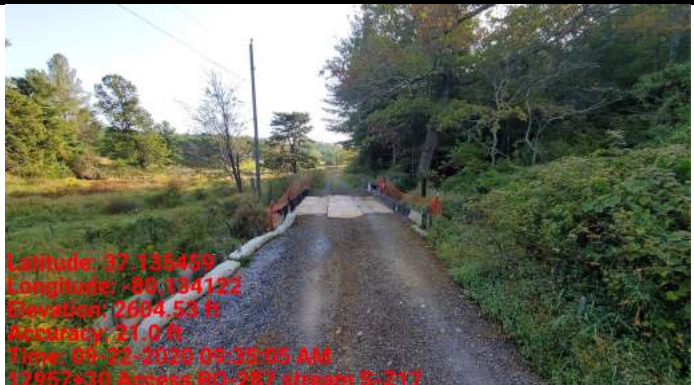
GPS Location	See pic for GPS location		GPS Location	See pic for GPS location	
Field Station#	12957+30		Field Station#	12957+30	
Pic 5 Desc.	Access road RO-287 at stream S-Z17.		Pic 6 Desc.	Access road RO-287 at stream S-Z17.

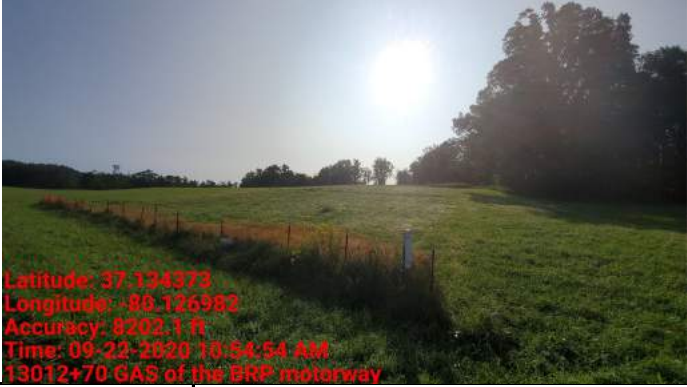
<p>Latitude: 37.124373 Longitude: -88.126982 Accuracy: 8202.1 ft Time: 09-22-2020 10:54:54 AM 13012+70 GAS of the BRP motorway</p>			
<b>GPS Location</b>	See pic for GPS location		<b>GPS Location</b>	See pic for GPS location	
<b>Field Station#</b>	13012+40		<b>Field Station#</b>	13012+70	
<b>Pic 13 Desc.</b>	CIS of the BRP motorway.		<b>Pic 14 Desc.</b>	GAS of the BRP motorway.

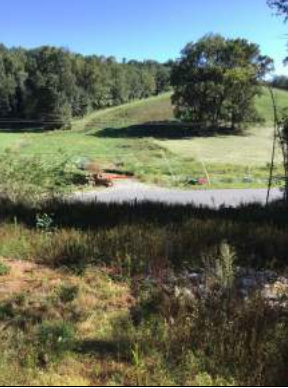
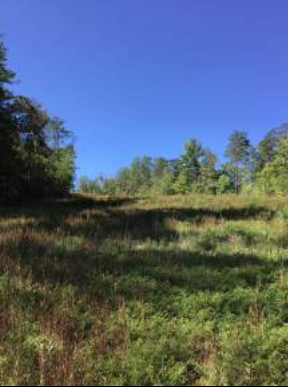
<b>GPS Location</b>	00000	<b>GPS Location</b>	0000		
<b>Field Station#</b>	13496+38	<b>Field Station#</b>	13480+00		
<b>Pic 1 Desc.</b>	Vegetation photo	<b>Pic 2 Desc.</b>	Vegetation photo observation, good coverage observed over the row

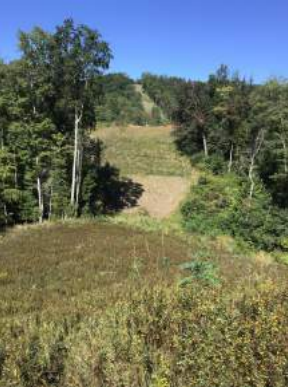
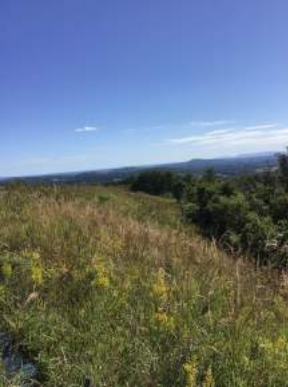
<b>GPS Location</b>	000000	<b>GPS Location</b>	00000		
<b>Field Station#</b>	13425+01	<b>Field Station#</b>	13472+00		
<b>Pic 3 Desc.</b>	Vegetation photo observation, good coverage over the row	<b>Pic 4 Desc.</b>	Vegetation observation photo, good coverage documented		
Insert image here			Insert image here		
<b>GPS Location</b>		<b>GPS Location</b>			
<b>Field Station#</b>		<b>Field Station#</b>			
<b>Pic 5 Desc.</b>		<b>Pic 6 Desc.</b>

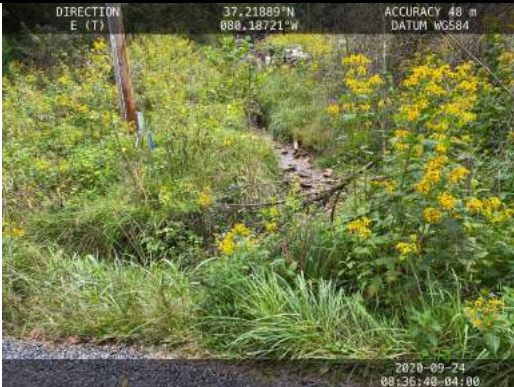
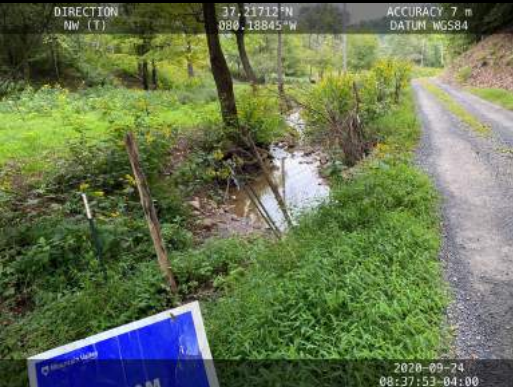
<b>GPS Location</b>	See photo		<b>GPS Location</b>	See photo	
<b>Field Station#</b>	12543+56		<b>Field Station#</b>	12543+56	
<b>Pic 1 Desc.</b>	Stream S-KL32, facing east from Yellow Finch Road, upstream		<b>Pic 2 Desc.</b>	Stream S-EF20b, facing northwest from Yellow Finch Road, upstream

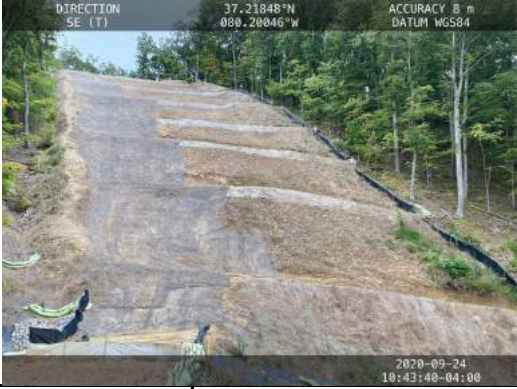
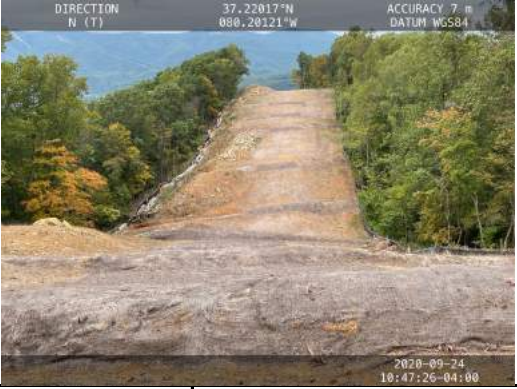
<b>GPS Location</b>	See photo		<b>GPS Location</b>	See photo	
<b>Field Station#</b>	12506+00		<b>Field Station#</b>	12496+00	
<b>Pic 13 Desc.</b>	Slope on going away side of the Enbridge line crossing and clean water diversion pipe re,ain't stable.		<b>Pic 14 Desc.</b>	ROW stable

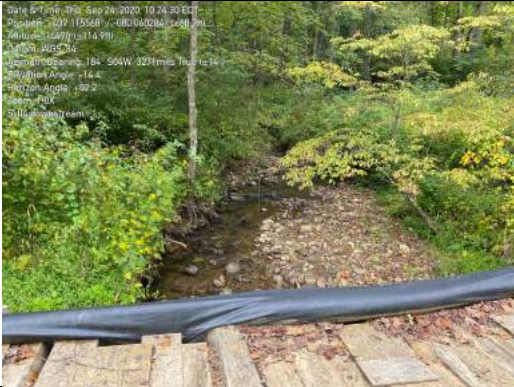
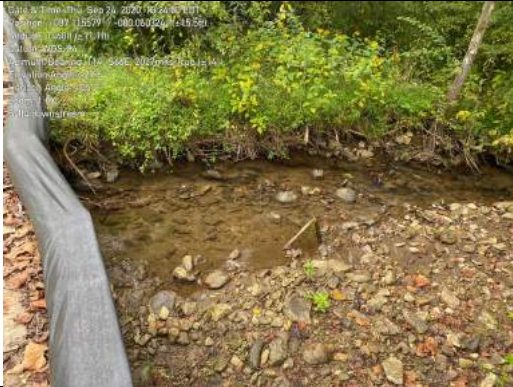
<b>GPS Location</b>	See photo for coordinates.		<b>GPS Location</b>	See photo for coordinates.	
<b>Field Station#</b>	13260+60		<b>Field Station#</b>	13260+69	
<b>Pic 1 Desc.</b>	S-II4, downstream, no changes noted to steam bed or banks.		<b>Pic 2 Desc.</b>	S-II4, downstream, no changes noted to steam bed or banks.

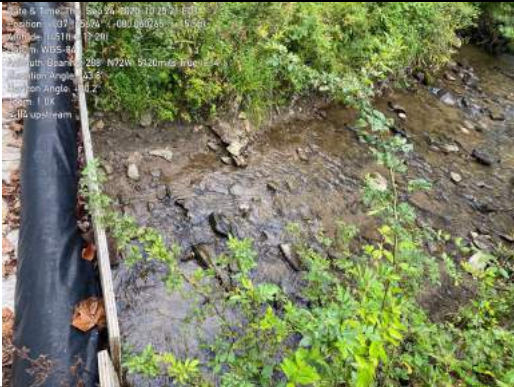
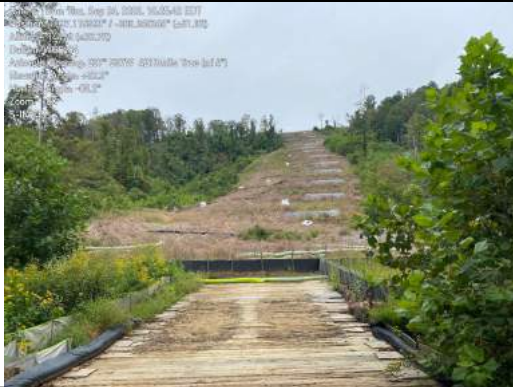
<b>GPS Location</b>	See photo for coordinates.		<b>GPS Location</b>	See photo for coordinates.	
<b>Field Station#</b>	13260+60		<b>Field Station#</b>	13260+50	
<b>Pic 3 Desc.</b>	S-II4, upstream, no changes noted to steam bed or banks.		<b>Pic 4 Desc.</b>	CIS S-II4, ROW stable with vegetation across LOD.

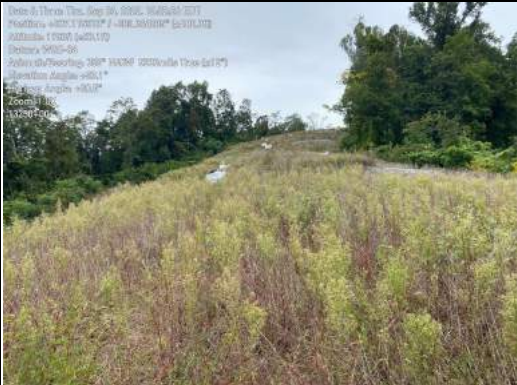
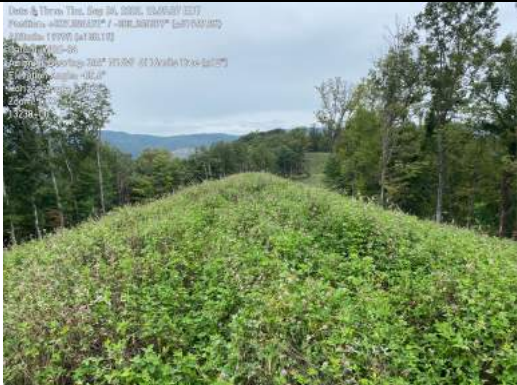
<b>GPS Location</b>	See photo for coordinates.		<b>GPS Location</b>	See photo for coordinates.	
<b>Field Station#</b>	13250+00		<b>Field Station#</b>	13238+00	
<b>Pic 7 Desc.</b>	ROW stable with vegetation noted across LOD.		<b>Pic 8 Desc.</b>	ROW stable with vegetation noted across LOD.

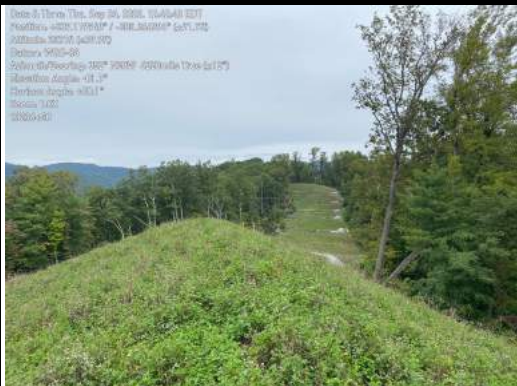
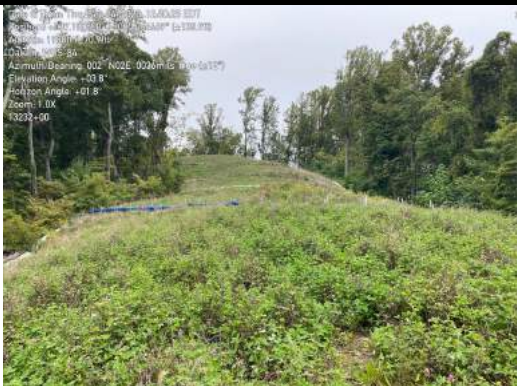
<b>GPS Location</b>	See photo for coordinates.		<b>GPS Location</b>	See photo for coordinates.	
<b>Field Station#</b>	13236+00		<b>Field Station#</b>	13332+00	
<b>Pic 9 Desc.</b>	ROW stable with vegetation noted across LOD.		<b>Pic 10 Desc.</b>	ROW stable with vegetation noted across LOD.

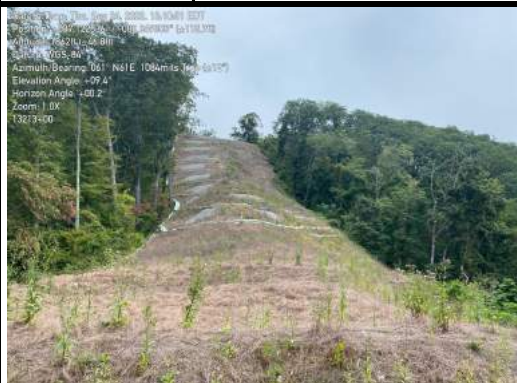
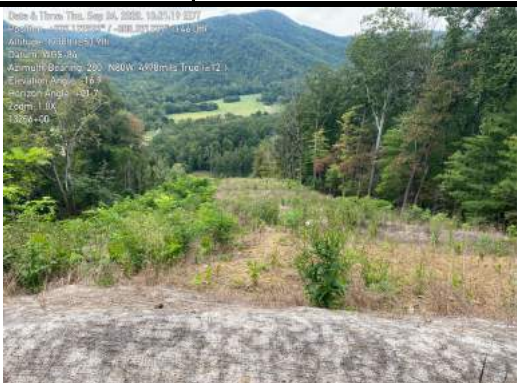
<b>GPS Location</b>	See photo for coordinates.		<b>GPS Location</b>	See photo for coordinates.	
<b>Field Station#</b>	13213+00		<b>Field Station#</b>	13206+00	
<b>Pic 11 Desc.</b>	ROW stable with acceptable vegetative cover noted across LOD.		<b>Pic 12 Desc.</b>	ROW stable with acceptably vegetive cover noted across LOD.

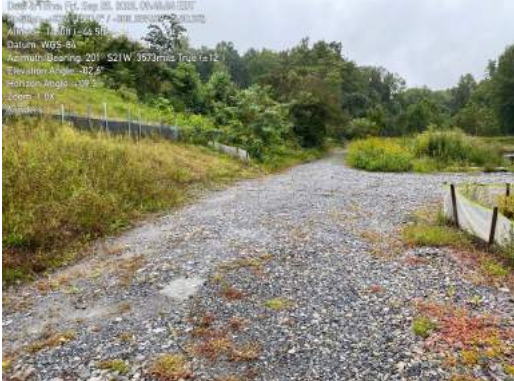
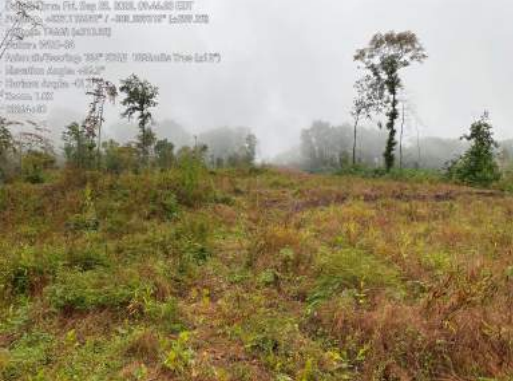
<b>GPS Location</b>	See photo for coordinates.		<b>GPS Location</b>	See photo for coordinates.	
<b>Field Station#</b>	13262+50		<b>Field Station#</b>	13264+00	
<b>Pic 1 Desc.</b>	MVP-FR-293.01, Flanders Road, road crossing in acceptable condition.		<b>Pic 2 Desc.</b>	ROW stable with acceptable vegetation across LOD.

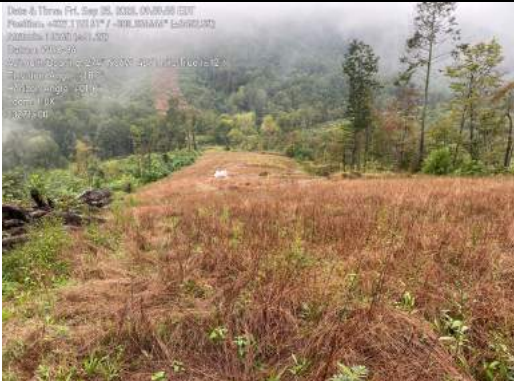
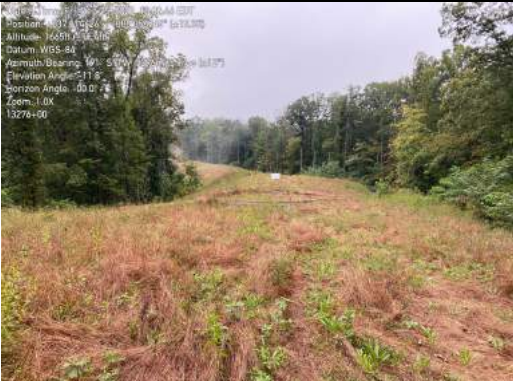
<b>GPS Location</b>	See photo for coordinates.		<b>GPS Location</b>	See photo for coordinates.	
<b>Field Station#</b>	13271+00		<b>Field Station#</b>	13276+00	
<b>Pic 3 Desc.</b>	ROW stable with acceptable vegetation across LOD.		<b>Pic 4 Desc.</b>	ROW stable with acceptable vegetation across LOD.

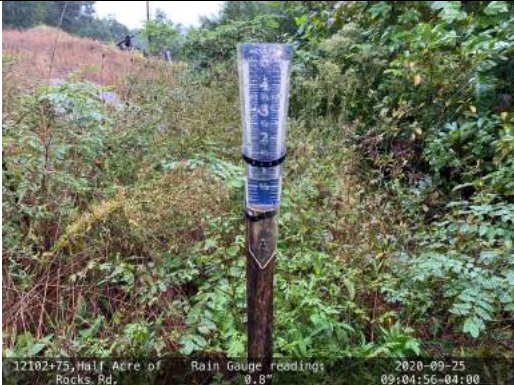
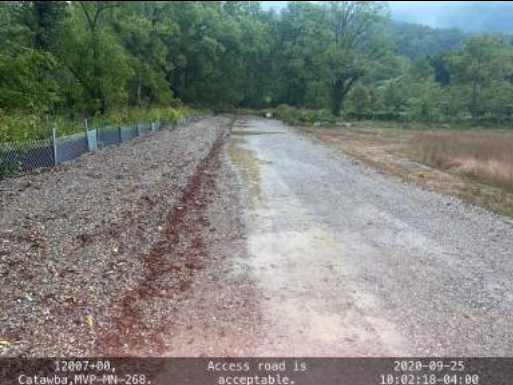
<b>GPS Location</b>	See photo GPS for location		<b>GPS Location</b>	See photo GPS for location	
<b>Field Station#</b>	12007+00		<b>Field Station#</b>	12007+00	
<b>Pic 1 Desc.</b>	Non recorded rainfall 0.8".		<b>Pic 2 Desc.</b>	Access road is n acceptable condition.

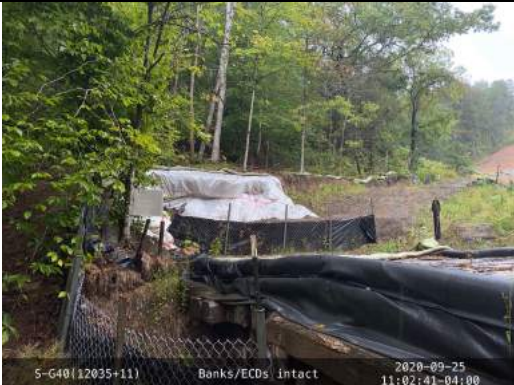
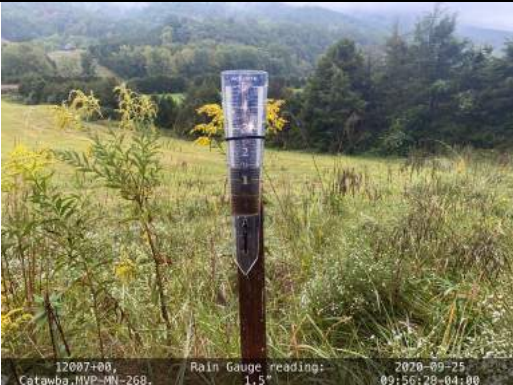
<b>GPS Location</b>	See photo GPS for location		<b>GPS Location</b>	See photo GPS for location	
<b>Field Station#</b>	12035+11		<b>Field Station#</b>	12007+00	
<b>Pic 3 Desc.</b>	All surrounding ECDs are in acceptable condition.		<b>Pic 4 Desc.</b>	Non recorded rainfall 1.5".

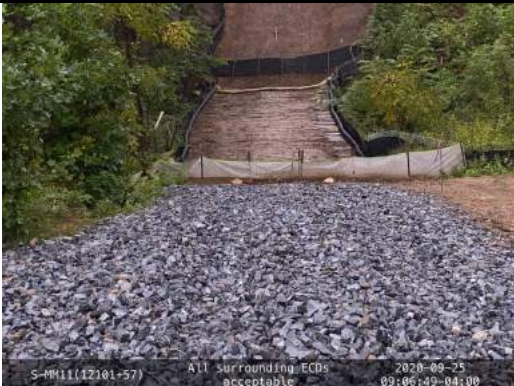
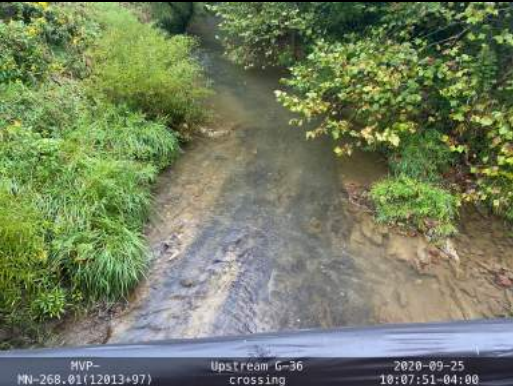
<b>GPS Location</b>	See photo GPS for location		<b>GPS Location</b>	See photo GPS for location	
<b>Field Station#</b>	12101+57		<b>Field Station#</b>	12013+97	
<b>Pic 5 Desc.</b>	All surrounding ECDs are in acceptable condition.		<b>Pic 6 Desc.</b>	No turbid water.

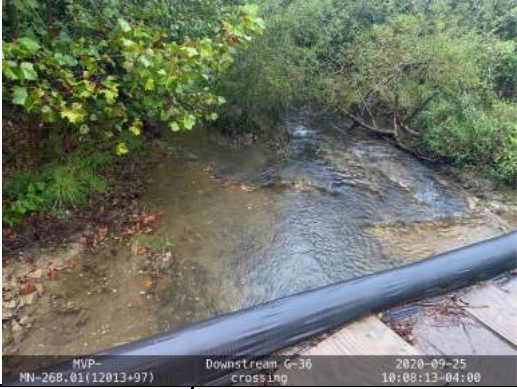
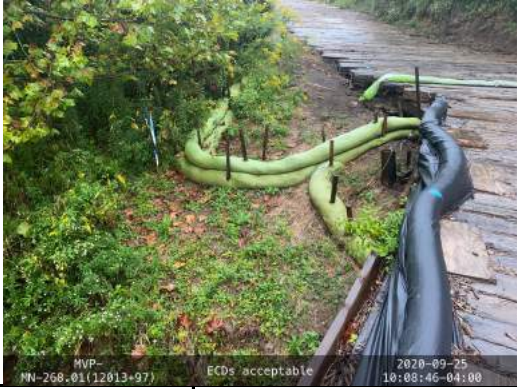
<b>GPS Location</b>	See photo GPS for location	<b>GPS Location</b>	See photo GPS for location		
<b>Field Station#</b>	12013+97	<b>Field Station#</b>	12013+97		
<b>Pic 7 Desc.</b>	No turbid water.	<b>Pic 8 Desc.</b>	All surrounding ECDs are in acceptable condition.

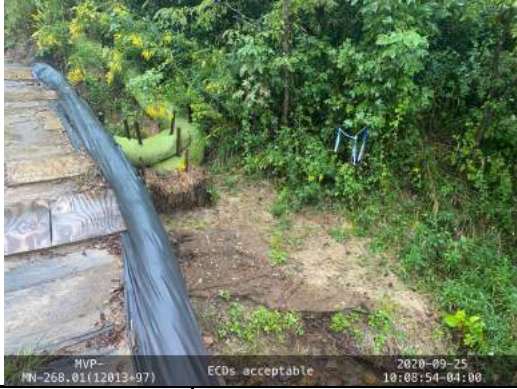
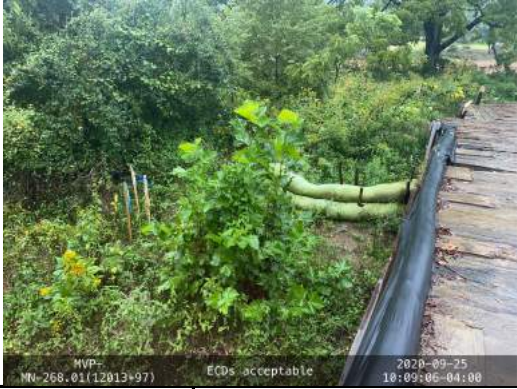
<b>GPS Location</b>	See photo GPS for location	<b>GPS Location</b>	See photo GPS for location		
<b>Field Station#</b>	12013+97	<b>Field Station#</b>	12013+97		
<b>Pic 9 Desc.</b>	All surrounding ECDs are in acceptable condition.	<b>Pic 10 Desc.</b>	All surrounding ECDs are in acceptable condition.

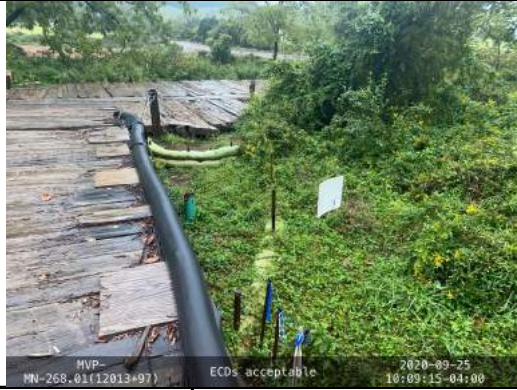
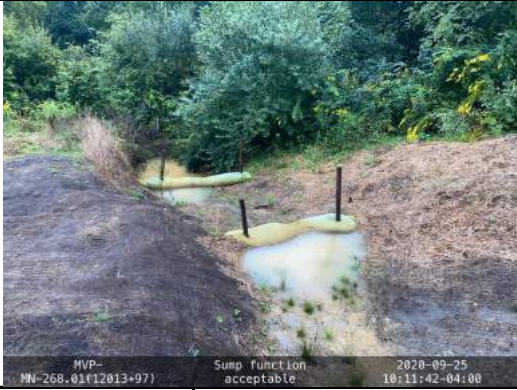
<b>GPS Location</b>	See photo GPS for location	<b>GPS Location</b>	See photo GPS for location		
<b>Field Station#</b>	12013+97	<b>Field Station#</b>	12013+97		
<b>Pic 11 Desc.</b>	All surrounding ECDs are in acceptable condition.	<b>Pic 12 Desc.</b>	All surrounding ECDs are in acceptable condition.

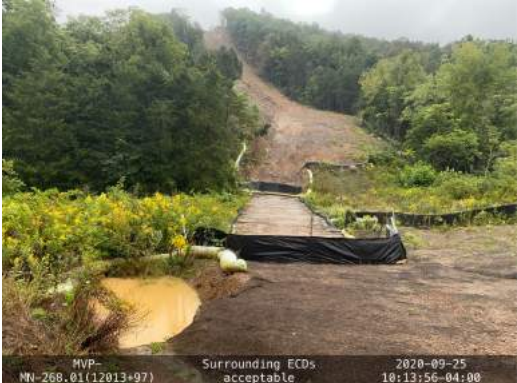
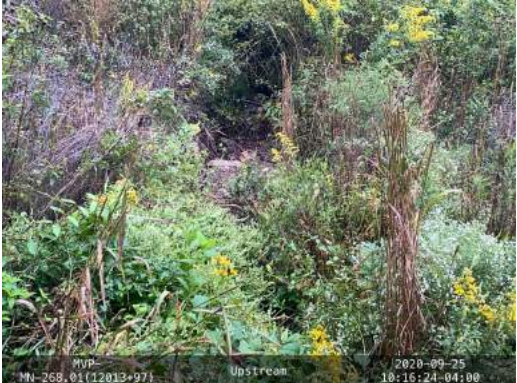
<b>GPS Location</b>	See photo GPS for location		<b>GPS Location</b>	See photo GPS for location	
<b>Field Station#</b>	12013+97		<b>Field Station#</b>	12015+84	
<b>Pic 13 Desc.</b>	All surrounding ECDs are in acceptable condition.		<b>Pic 14 Desc.</b>	Upstream

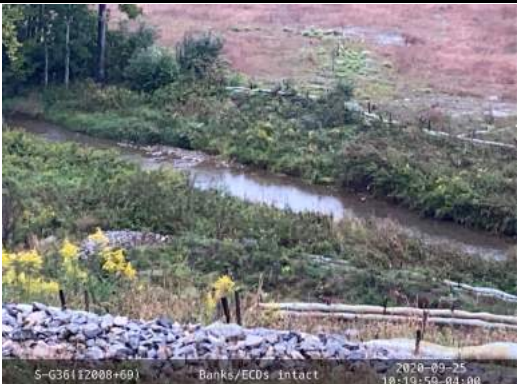
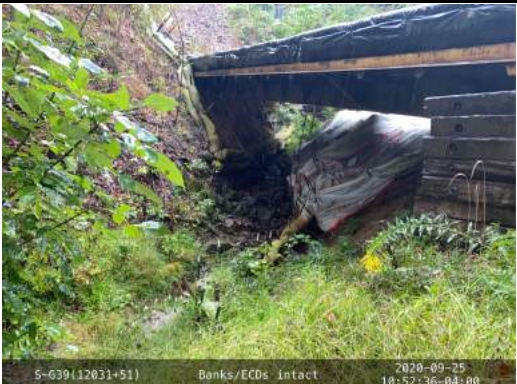
<b>GPS Location</b>	See photo GPS for location		<b>GPS Location</b>	See photo GPS for location	
<b>Field Station#</b>	12008+69		<b>Field Station#</b>	12031+51	
<b>Pic 15 Desc.</b>	All surrounding ECDs are in acceptable condition.		<b>Pic 16 Desc.</b>	All surrounding ECDs are in acceptable condition.

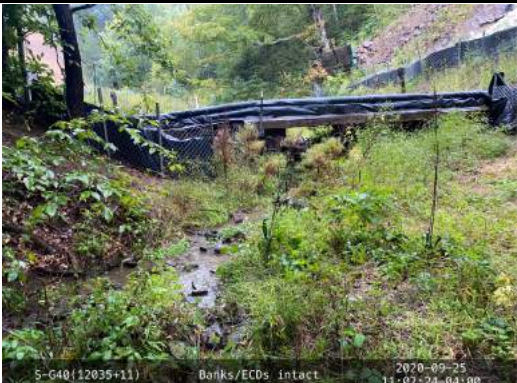
<div style="text-align: center; height: 150px;">Insert image here</div>			
<b>GPS Location</b>	See photo GPS for location		<b>GPS Location</b>		
<b>Field Station#</b>	12035+12		<b>Field Station#</b>		
<b>Pic 17 Desc.</b>	All surrounding ECDs are in acceptable condition.		<b>Pic 18 Desc.</b>
