# Visual Site Inspection Report

<b>Project Name</b>	H-600 Pipeline Spread H	<b>AFE</b>	124300138	<b>Spread</b>	H-600 Pipeline Spread H	
<b>Contractor</b>	Precision			<b>Report #</b>	14374	
<b>Inspector</b>	Pat Davis			<b>Date/Time</b>	9/7/2020 4:04 PM	
<b>Permit #</b>	TBD	<b>Inspection Type</b>	VA SWPP	<b>Station Begin</b>	+0	
<b>State</b>	VA	<b>Inspection Area</b>	Partial	<b>Station End</b>	+0	
<b>County</b>	Montgomery	<b>Ground</b>	Damp	<b>Temperature (°F)</b>	82.00	
<b>Municipality</b>	N/A	<b>Weather</b>	Sunny	<b>Rain Gauge (in)</b>	0.00	
				<b>Rain Accumulation Time (days)</b>	0.00

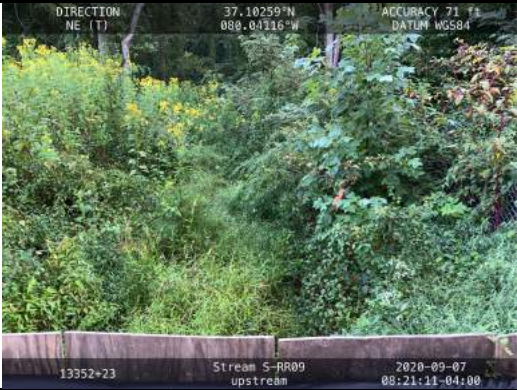
<b>GPS Location</b>	See photo for gps location data.		<b>GPS Location</b>	See photo for gps location data.	
<b>Field Station#</b>	13352+23		<b>Field Station#</b>	13352+23	
<b>Pic 9 Desc.</b>	Photo shows stream S-RR09 downstream from the bridge.		<b>Pic 10 Desc.</b>	Photo shows stream S-RR09 upstream from the bridge.

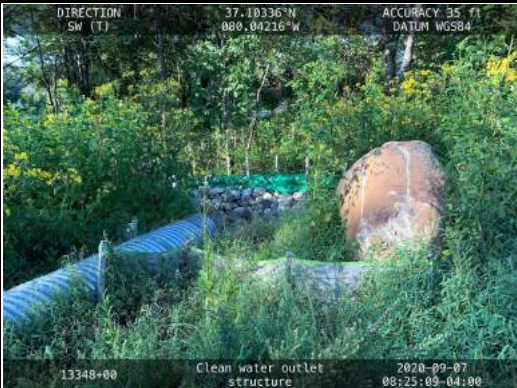
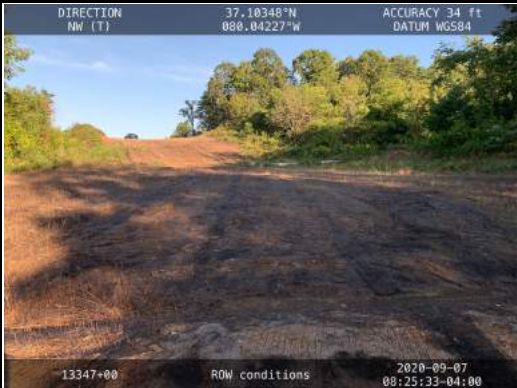
<b>GPS Location</b>	See photo for gps location data.		<b>GPS Location</b>	See photo for gps location data.	
<b>Field Station#</b>	13348+00		<b>Field Station#</b>	13347+00	
<b>Pic 15 Desc.</b>	Photo shows the clean water outlet structure.		<b>Pic 16 Desc.</b>	Photo shows the ROW condition from about 13344+00 to 13347+00.

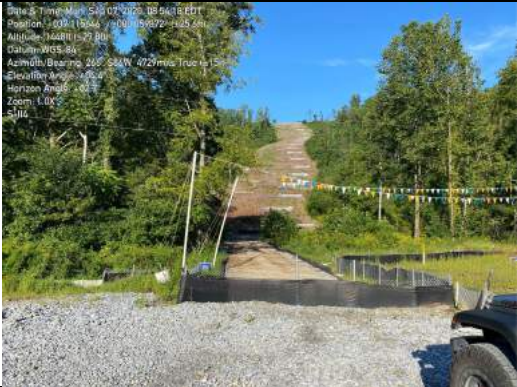
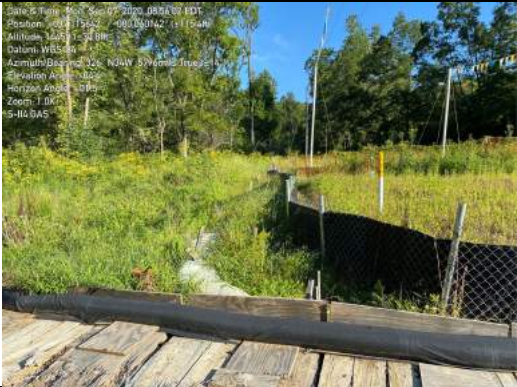
<b>GPS Location</b>	See photo for coordinates.		<b>GPS Location</b>	See photo for coordinates.	
<b>Field Station#</b>	13261+00		<b>Field Station#</b>	13261+00	
<b>Pic 7 Desc.</b>	GAS S-II4, ECD in acceptable condition.		<b>Pic 8 Desc.</b>	ECDs along stream buffer functioning acceptably.

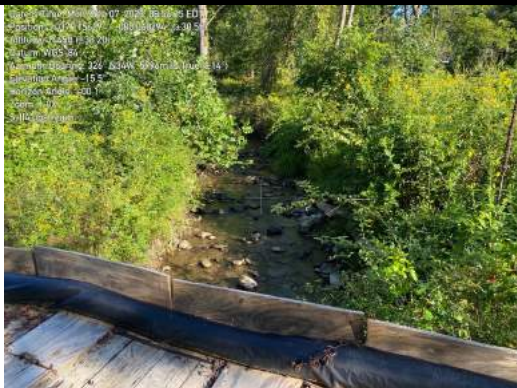
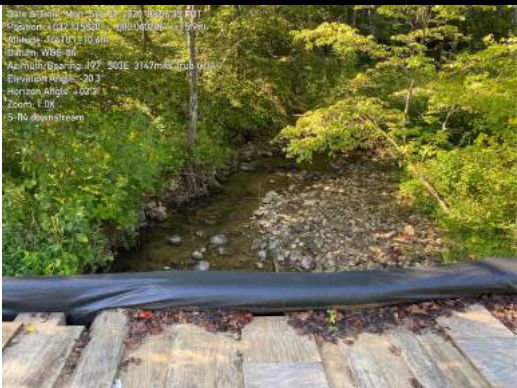
<b>GPS Location</b>	See photo for coordinates.		<b>GPS Location</b>	See photo for coordinates.	
<b>Field Station#</b>	13260+60		<b>Field Station#</b>	13260+60	
<b>Pic 9 Desc.</b>	S-II4, upstream, no changes noted to bed to banks, no turbidity noted.		<b>Pic 10 Desc.</b>	S-II4, downstream, no changes noted to bed to banks, no turbidity noted.

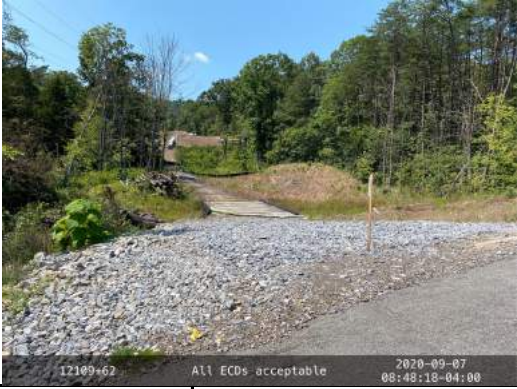
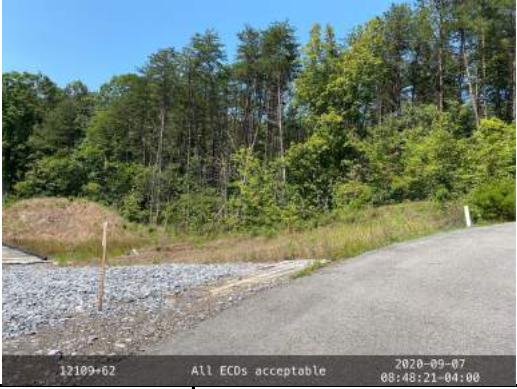
<b>GPS Location</b>	See photo GPS for location	<b>GPS Location</b>	See photo GPS for location		
<b>Field Station#</b>	12109+62	<b>Field Station#</b>	12109+62		
<b>Pic 13 Desc.</b>	All ECDs are in acceptable condition.	<b>Pic 14 Desc.</b>	All ECDs are in acceptable condition.

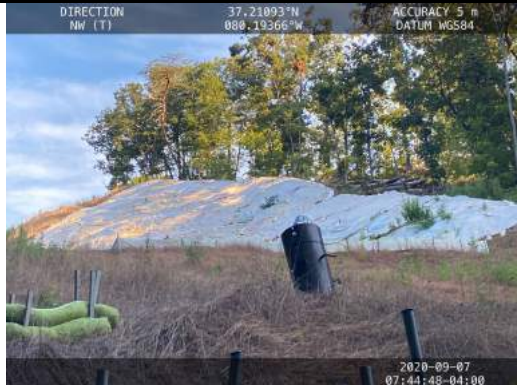
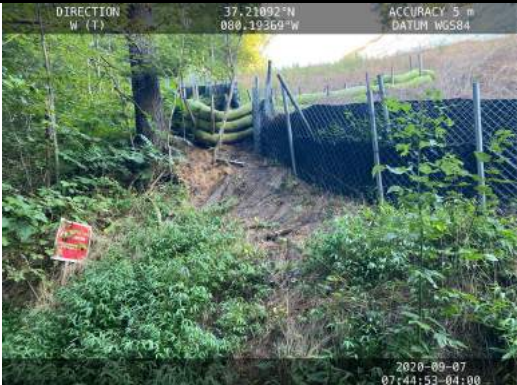
<b>GPS Location</b>	See photo		<b>GPS Location</b>	See photo	
<b>Field Station#</b>	12543+00		<b>Field Station#</b>	12543+40	
<b>Pic 11 Desc.</b>	Plastic sheeting remains intact and secure on stockpiles nearest to Yellow Finch Road.		<b>Pic 12 Desc.</b>	ECDs in satisfactory condition on coming in side of Yellow Finch Road.

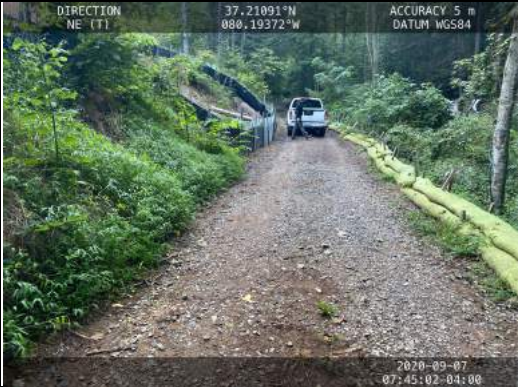
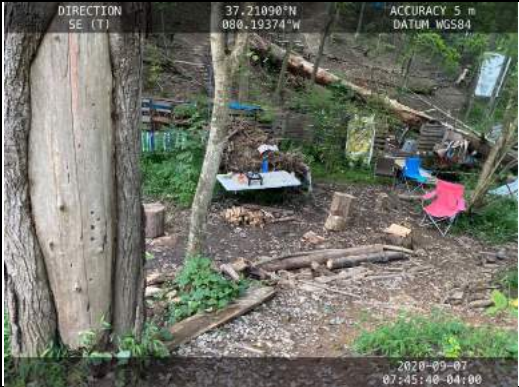
<b>GPS Location</b>	See photo		<b>GPS Location</b>	See photo	
<b>Field Station#</b>	12543+56		<b>Field Station#</b>	12543+65	
<b>Pic 13 Desc.</b>	Yellow Finch Road at ROW crossing, facing northeast		<b>Pic 14 Desc.</b>	Staging area for Yellow Finch Road protester gathering held over the weekend.

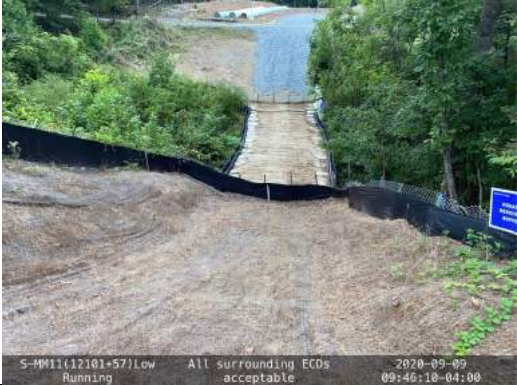
<p>S-M11(12101+57)Low Running All surrounding ECDs acceptable 2020-09-09 09:46:10-04:00</p>

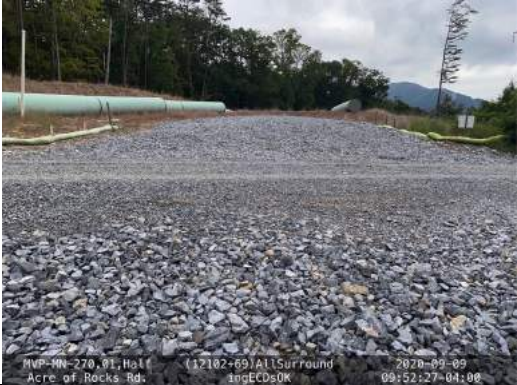
<p>MVP-MV-278.01, Half Acre of Rocks Rd. 12102+69 All Surrounding ECDs OK 2020-09-09 09:52:27-04:00</p>			
<b>GPS Location</b>	See photo GPS for location		<b>GPS Location</b>	See photo GPS for location	
<b>Field Station#</b>	12101+57		<b>Field Station#</b>	12102+69	
<b>Pic 7 Desc.</b>	All surrounding ECDs are in acceptable condition.		<b>Pic 8 Desc.</b>	All surrounding ECDs are in acceptable condition.

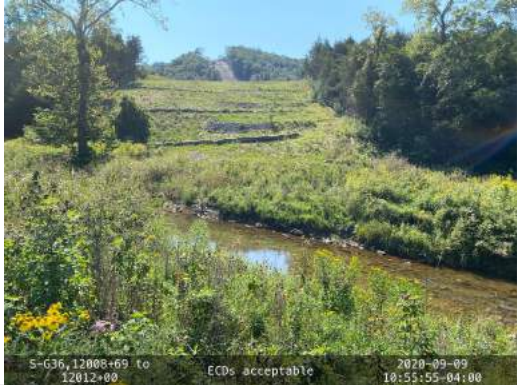
<p>S-G36, 12008+69 to 12012+00 ECDs acceptable 2020-09-09 10:55:55-04:00</p>

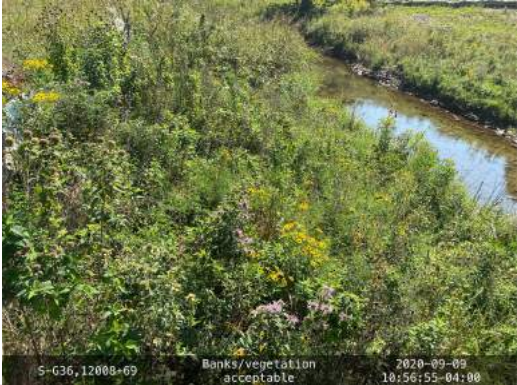
<p>S-G36, 12008+69 Banks/vegetation acceptable 2020-09-09 10:56:55-04:00</p>			
<b>GPS Location</b>	See photo GPS for location		<b>GPS Location</b>	See photo GPS for location	
<b>Field Station#</b>	12010+00		<b>Field Station#</b>	12008+69

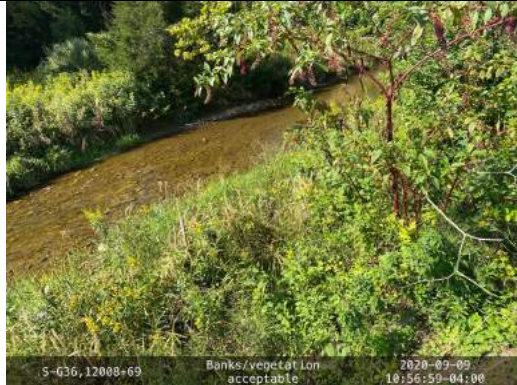
<p>S-G36, 12008+69 Banks/vegetation acceptable 2020-09-09 10:56:59-04:00</p>

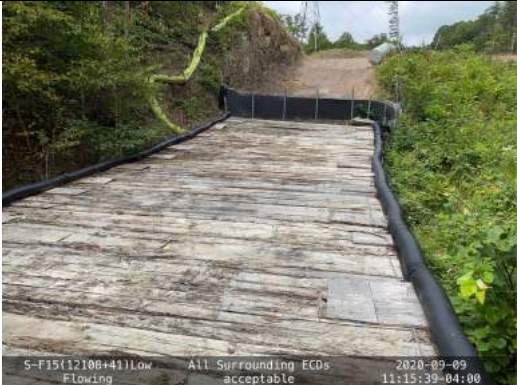
<p>S-F15(12108+41)Low Flowing All Surrounding ECDs acceptable 2020-09-09 11:15:39-04:00</p>			
<b>GPS Location</b>	See photo GPS for location		<b>GPS Location</b>	See photo GPS for location	
<b>Field Station#</b>	12008+69		<b>Field Station#</b>	12108+41	
<b>Pic 11 Desc.</b>	All surrounding ECDs are in acceptable condition.		<b>Pic 12 Desc.</b>	All surrounding ECDs are in acceptable condition.

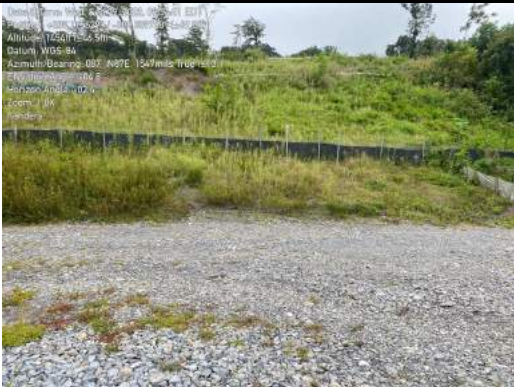
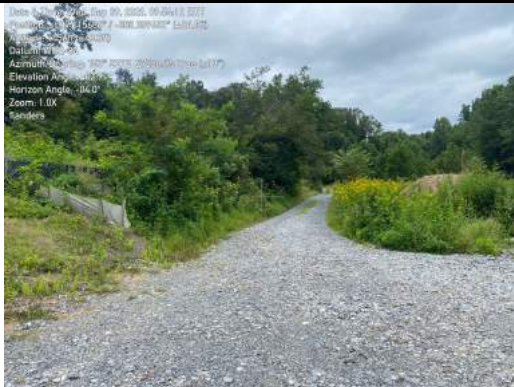
<b>GPS Location</b>	See photo for coordinates.		<b>GPS Location</b>	See photo for coordinates.	
<b>Field Station#</b>	13262+50		<b>Field Station#</b>	13262+50	
<b>Pic 1 Desc.</b>	MVP-FR-293.01, Flanders Road crossing, RCE and access road in acceptable condition.		<b>Pic 2 Desc.</b>	MVP-FR-293.01, Flanders Road crossing, RCE and access road in acceptable condition.

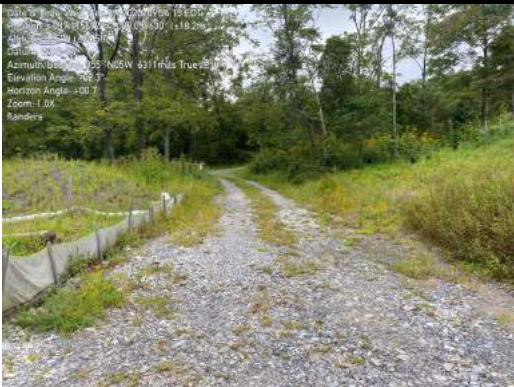
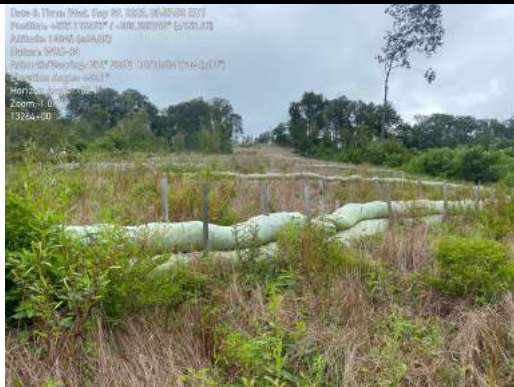
<b>GPS Location</b>	See photo for coordinates.		<b>GPS Location</b>	See photo for coordinates.	
<b>Field Station#</b>	13262+50		<b>Field Station#</b>	13262+50	
<b>Pic 3 Desc.</b>	MVP-FR-293.01, Flanders Road crossing, access road in acceptable condition.		<b>Pic 4 Desc.</b>	ROW stable, vegetative cover noted across LOD.

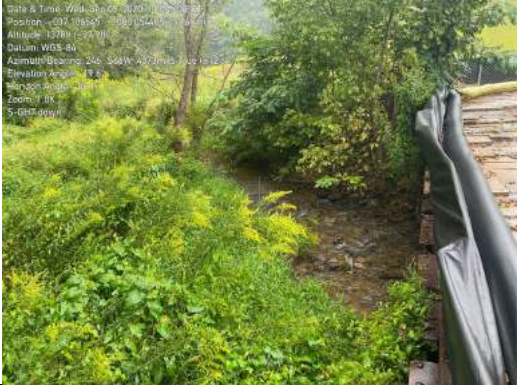
<p>Photo 13: Downstream view of S-GH7. Position: 33° 11' 54.00" N, 82° 52' 13.00" W. Altitude: 1378 ft. Datum: WGS 84. Azimuth/Bearing: 240.56° W. Elevation angle: 12.5°. Horizon angle: 131.0°. Zoom: 1.0X. S-GH7 gas.</p>

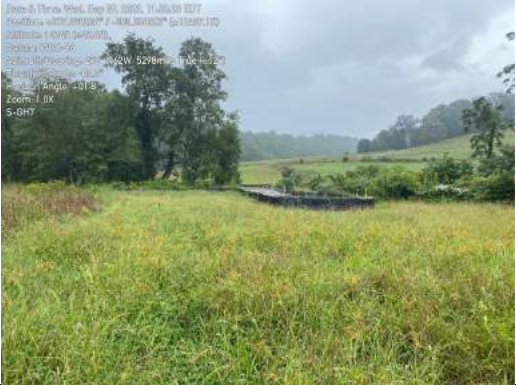
<p>Photo 14: Three View, Sep 09, 2020, 11:46:00 EDT. Position: 33° 11' 54.00" N, 82° 52' 13.00" W. Altitude: 1378 ft. Datum: WGS 84. Azimuth/Bearing: 240.56° W. Elevation angle: 12.5°. Horizon angle: 131.0°. Zoom: 1.0X. S-GH7.</p>			
<b>GPS Location</b>	See photo for coordinates.		<b>GPS Location</b>	See photo for coordinates.	
<b>Field Station#</b>	13309+09		<b>Field Station#</b>	13312+00	
<b>Pic 13 Desc.</b>	S-GH7, downstream, no changes noted to bed or banks.		<b>Pic 14 Desc.</b>	S-GH7, ROW well vegetated.

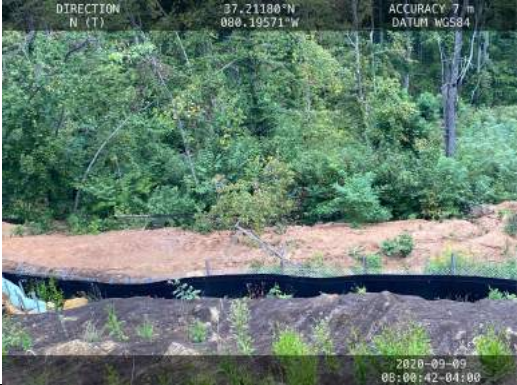
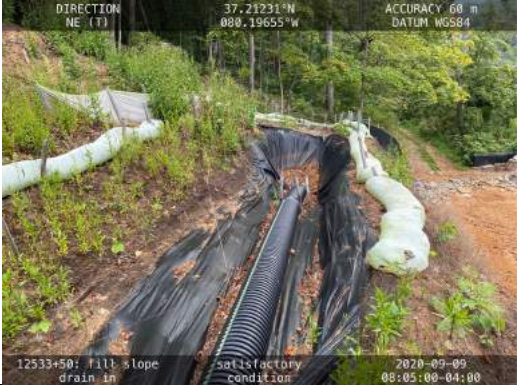
<b>GPS Location</b>	See photo	<b>GPS Location</b>	See photo		
<b>Field Station#</b>	12536+00	<b>Field Station#</b>	12533+50		
<b>Pic 7 Desc.</b>	Denuded logging road adjacent to MVP ROW displaying significant erosion.	<b>Pic 8 Desc.</b>	Fill slope drain in good repair on coming in side of landowner's crossing.

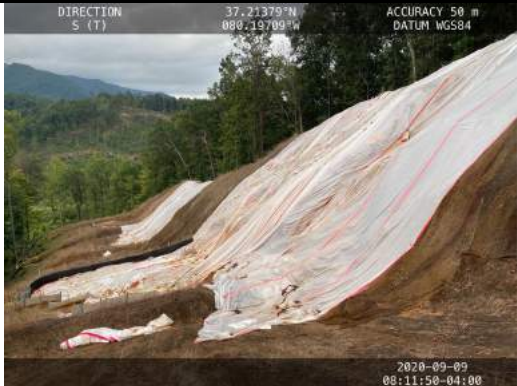
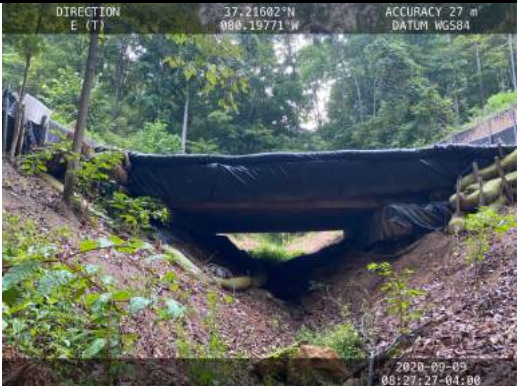
<b>GPS Location</b>	See photo	<b>GPS Location</b>	See photo		
<b>Field Station#</b>	12529+00	<b>Field Station#</b>	12519+41		
<b>Pic 9 Desc.</b>	Plastic sheeting on stockpiles approximately 1500 feet from Yellow Finch Road remains intact and secure.	<b>Pic 10 Desc.</b>	Stream S-EF19, facing east, upstream

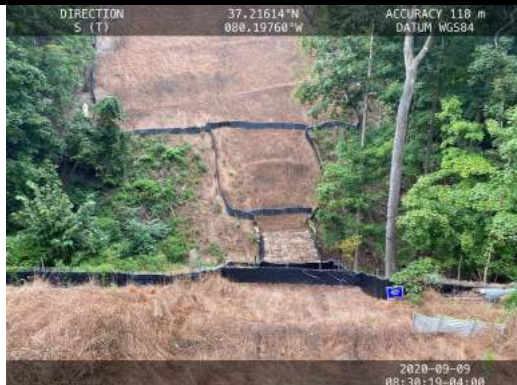
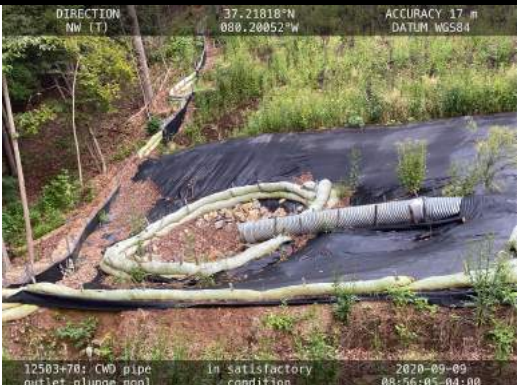
<b>GPS Location</b>	See photo	<b>GPS Location</b>	See photo		
<b>Field Station#</b>	12519+41	<b>Field Station#</b>	12503+70		
<b>Pic 11 Desc.</b>	Buffer zone of stream S-EF19 remains stable with ECDs in satisfactory condition.	<b>Pic 12 Desc.</b>	Clean water diversion pipe outlet in satisfactory condition.

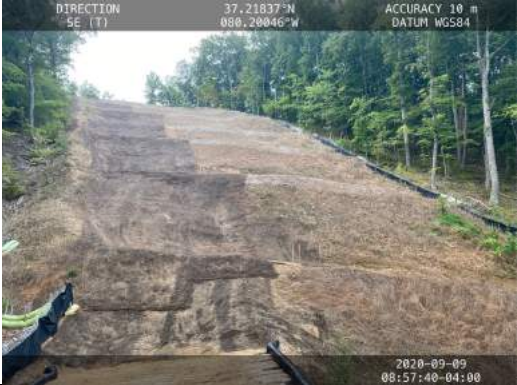
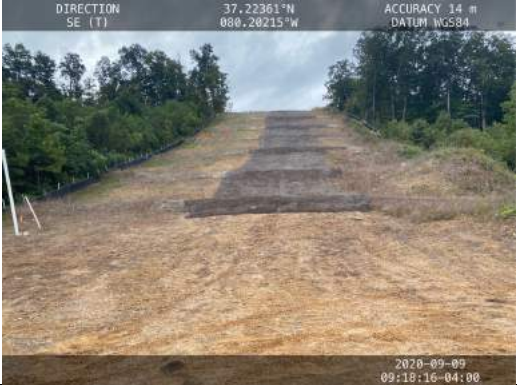
<b>GPS Location</b>	See photo		<b>GPS Location</b>	See photo	
<b>Field Station#</b>	12506+00		<b>Field Station#</b>	12485+00	
<b>Pic 13 Desc.</b>	The slope on the going away side of the clean water diversion pipe remains stable, waterbars in good condition and functioning properly.		<b>Pic 14 Desc.</b>	Slope on going away side of MLV-28 remains stable.

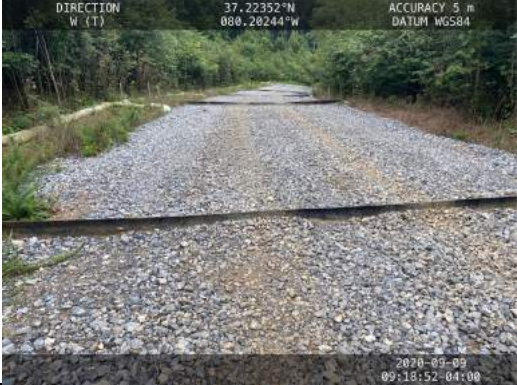
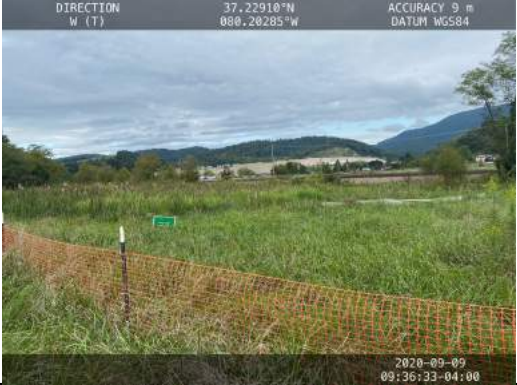
<b>GPS Location</b>	See photo		<b>GPS Location</b>	See photo	
<b>Field Station#</b>	12483+30		<b>Field Station#</b>	124661+00	
<b>Pic 15 Desc.</b>	Water deflectors on access road MVP-MLV-AR-28 remain in satisfactory condition and functioning per design.		<b>Pic 16 Desc.</b>	Wetland W-KL58, facing west

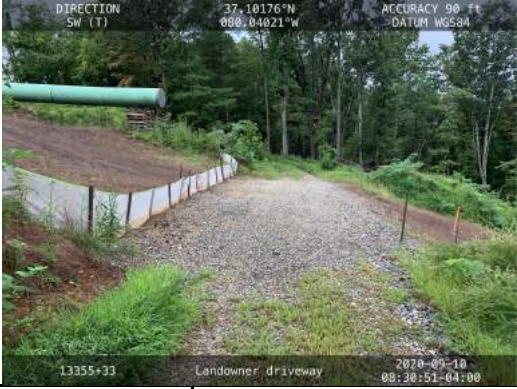
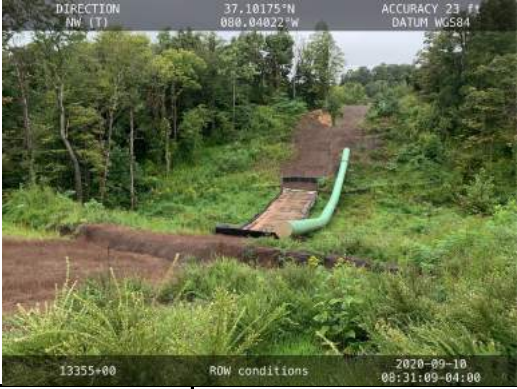
<b>GPS Location</b>	See photo for gps location data.		<b>GPS Location</b>	See photo for gps location data.	
<b>Field Station#</b>	13355+33		<b>Field Station#</b>	13355+00	
<b>Pic 7 Desc.</b>	Photo shows the landowner driveway.		<b>Pic 8 Desc.</b>	Photo shows the ROW condition from about 13353+00 to 13355+00.

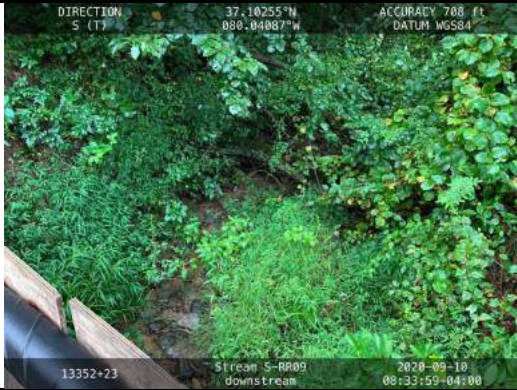
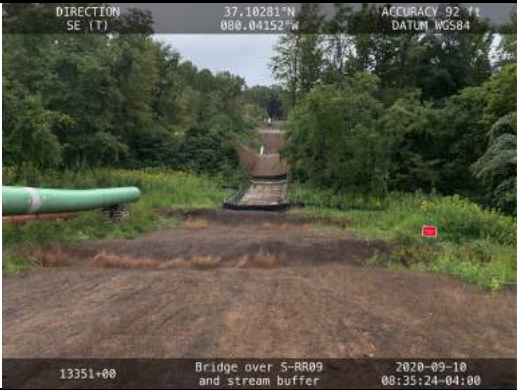
<b>GPS Location</b>	See photo for gps location data.		<b>GPS Location</b>	See photo for gps location data.	
<b>Field Station#</b>	13352+23		<b>Field Station#</b>	13351+00	
<b>Pic 9 Desc.</b>	Photo shows stream S-RR09 downstream from the bridge.		<b>Pic 10 Desc.</b>	Photo shows the bridge over stream S-RR09 and adjacent stream buffer.

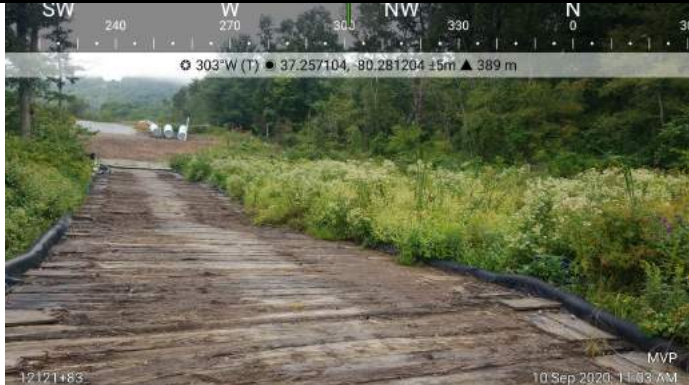
GPS Location	See Above	GPS Location	See Above		
Field Station#	12103+00	Field Station#	12121+83		
Pic 1 Desc.	Rain Gauge at Half Acre of Rock Road reads 0.1".	Pic 2 Desc.	Overview of Waterbody S-C36. ECDs functional and in good condition.

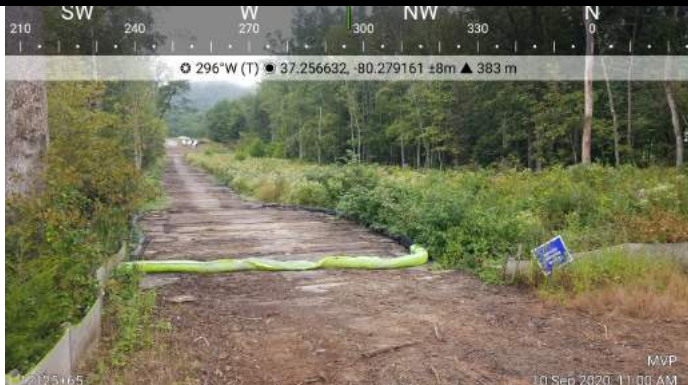
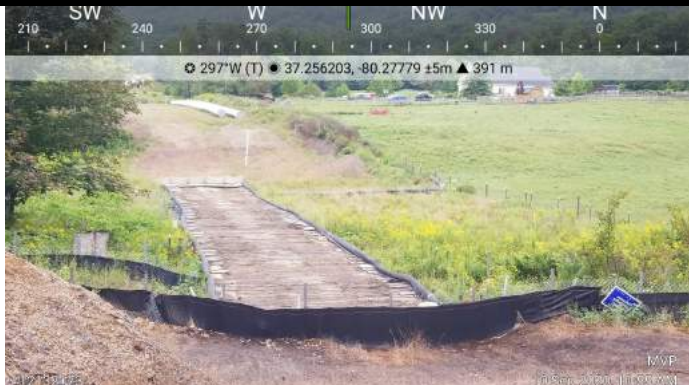
GPS Location	See Above	GPS Location	See Above		
Field Station#	12125+65	Field Station#	12132+73		
Pic 3 Desc.	Overview of Waterbody S-MM31. ECDs functional and in good condition.	Pic 4 Desc.	Overview of Waterbody S-C29. ECDs functional and in good condition.

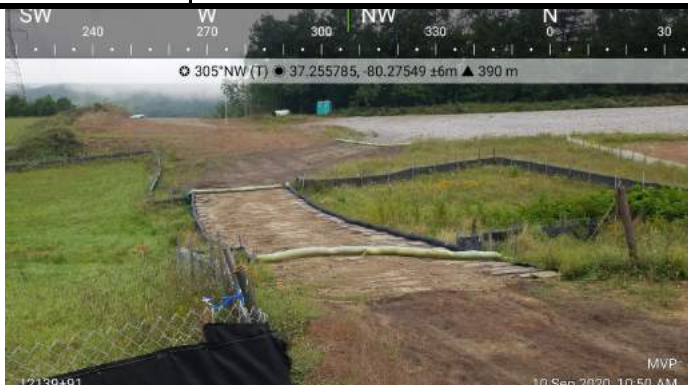
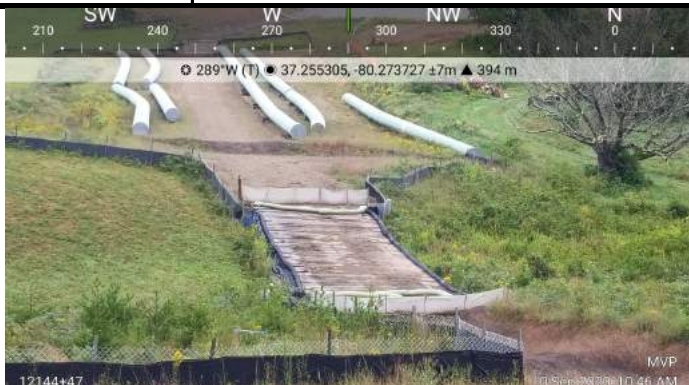
GPS Location	See Above	GPS Location	See Above		
Field Station#	12139+91	Field Station#	12144+47		
Pic 5 Desc.	Overview of Wetland W-C6. ECDs functional and in good condition.	Pic 6 Desc.	Overview of Wetland W-C5. ECDs functional and in good condition.
