Visual Site Inspection Report

| Project Name H-600 Pipeline Spread G | | AFE 124300137 | Spread H-600 Pipeline Spread G |
| Contractor Precision | | Report # 19131 | |
| Inspector Len Kruizenga | | Date/Time 1/18/2021 8:35 AM | |

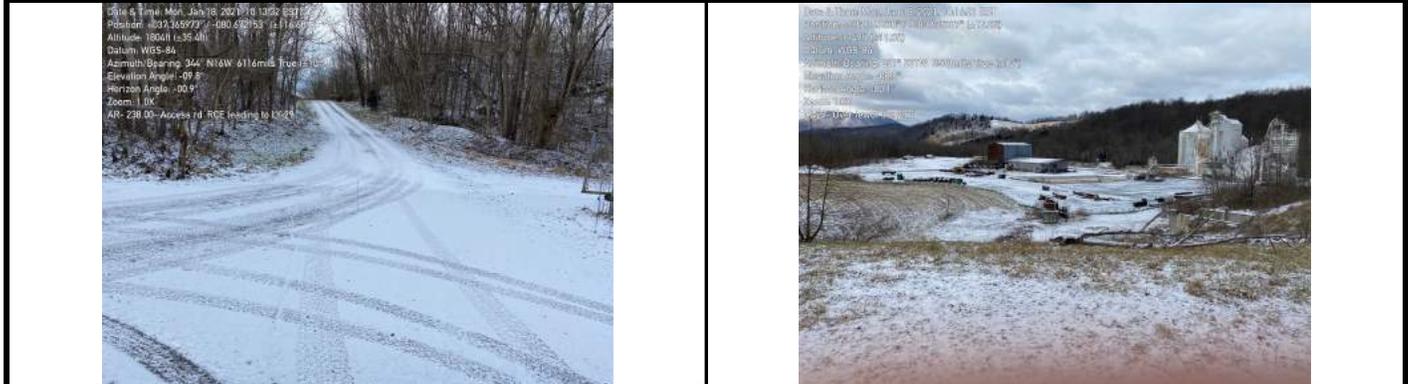
| Pic 1 Desc. | AR-238.00- Access road RCE | Pic 2 Desc. | LY-29- Over view of the yard. |

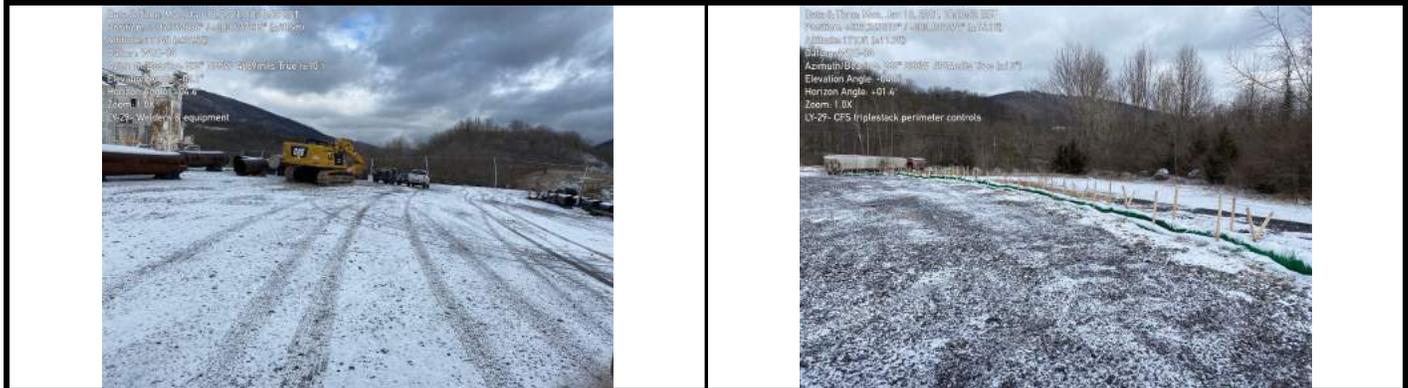
| Pic 3 Desc. | LY29- welders are in the yard | Pic 4 Desc. | LY29- CFS triple stack perimeter controls |

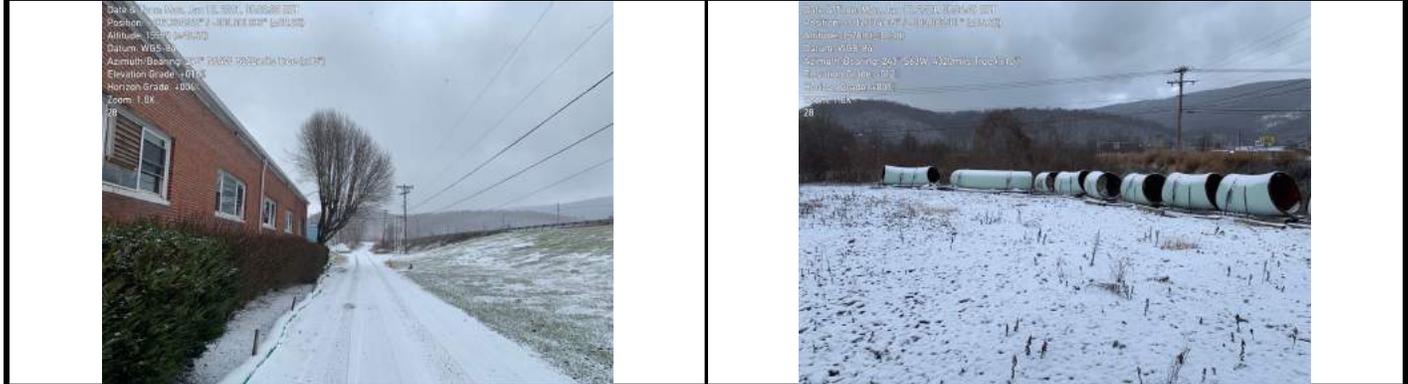
| Pic 1 Desc. | ECDS and ROW Conditions | Pic 2 Desc. | ECDS and ROW Conditions |

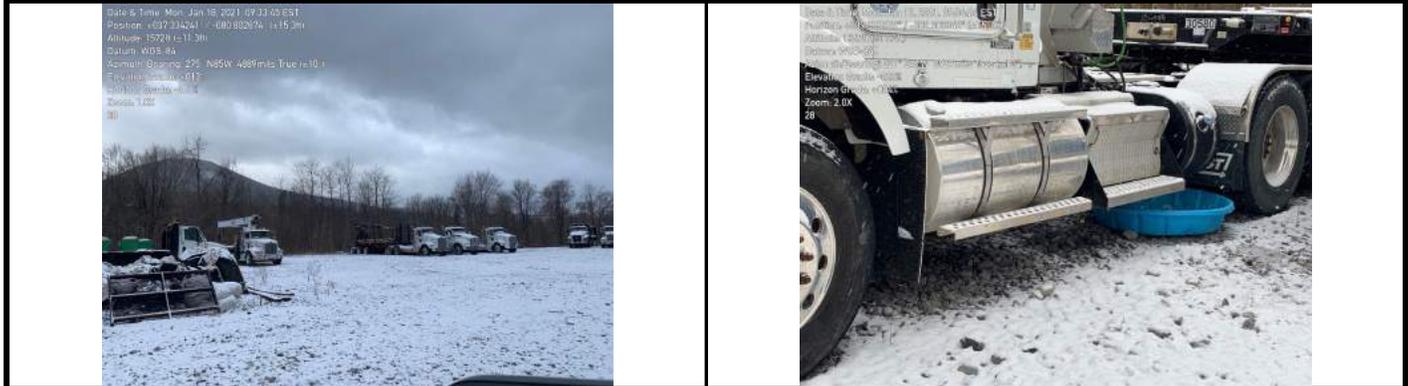
| Pic 3 Desc. | ECDS and ROW Conditions | Pic 4 Desc. | ECDS and ROW Conditions |

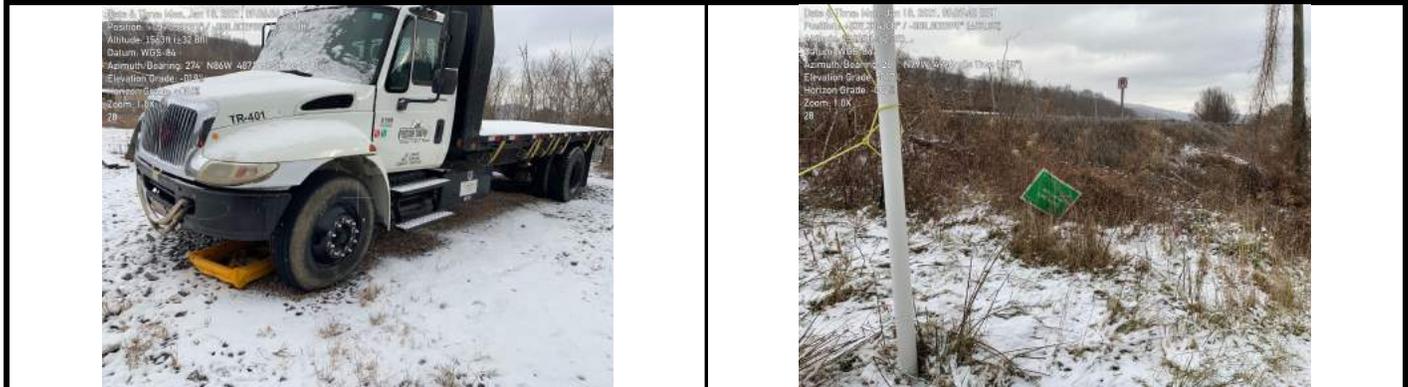
| Pic 5 Desc. | ECDS and ROW Conditions | Pic 6 Desc. | ECDS and ROW Conditions |

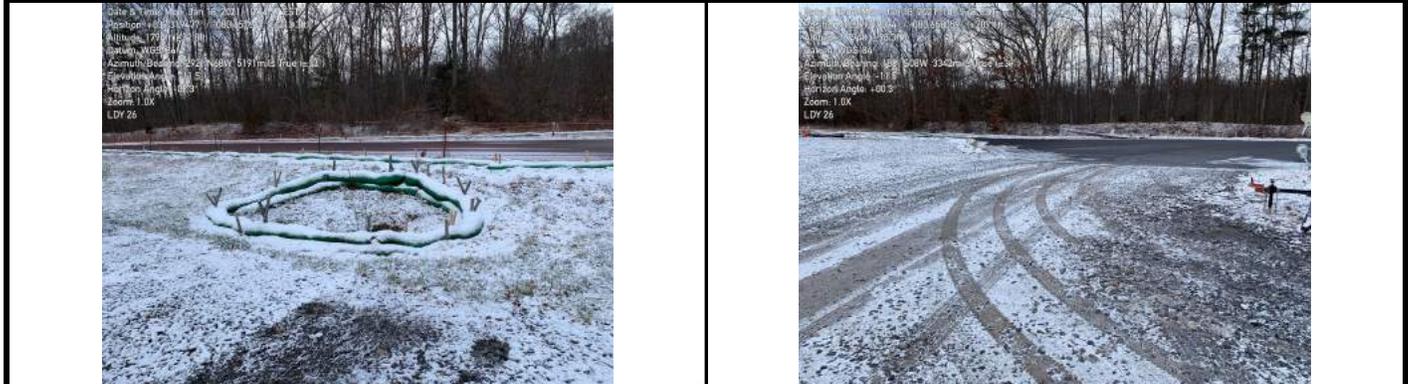
| Pic 1 Desc. | Triple stack compost filter sock in place around drainage. | Pic 2 Desc. | RCE in place at Lay Down Yard 26 entrance. |

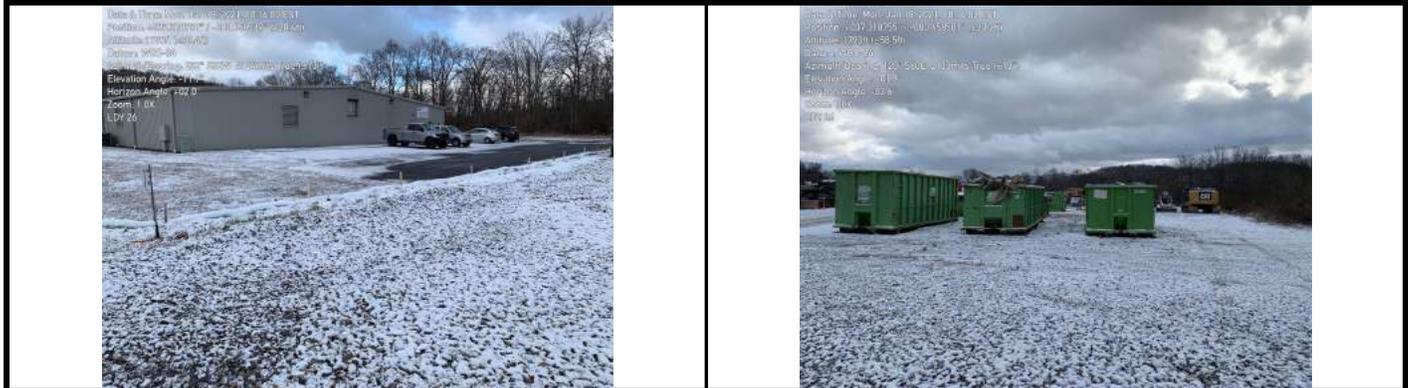
| Pic 3 Desc. | 18 inch compost filter sock in place along LOD. | Pic 4 Desc. | Dumpsters being utilized for trash management. |

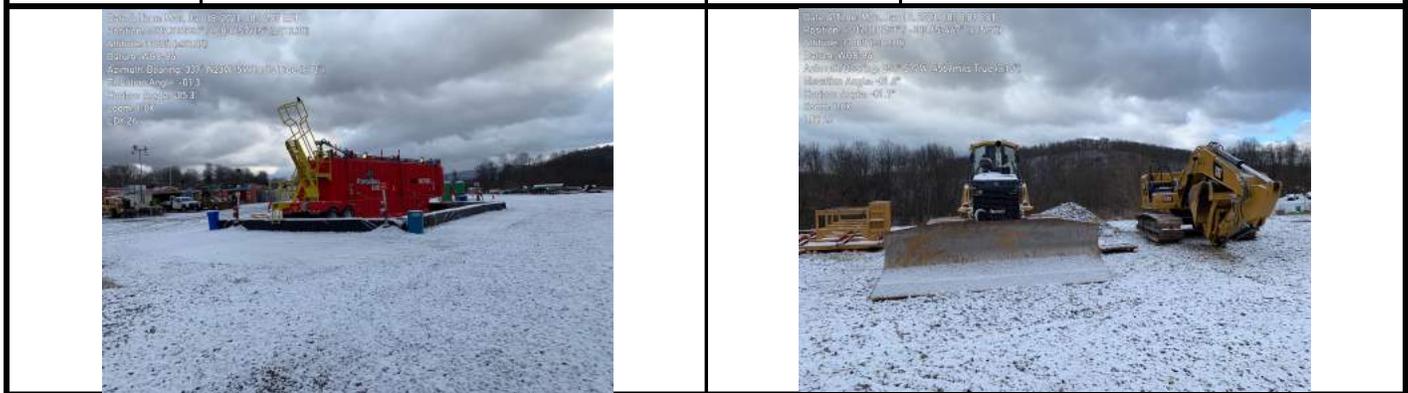
| Pic 5 Desc. | Secondary containment in place under fuel cell. | Pic 6 Desc. | Checked staged equipment for leaks. |

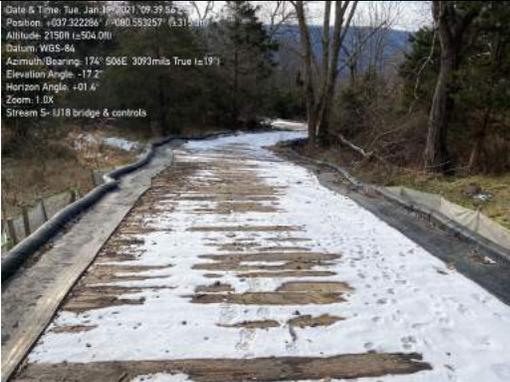
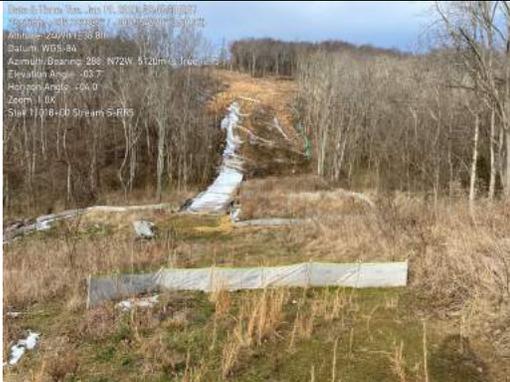
| AFE 124300137 | | Date/Time 1/19/2021 8:13 AM | | Report # | | | |
|---|--|---|--|---|--|--|--|
| <p>Date & Time: Tue, Jan 19, 2021, 09:39:52 EST Position: +037.322284, -080.532937 (431.9m) Altitude: 2150ft (650.0m) Datum: WGS-84 Azimuth/Bearing: 174.506E 309.3mils True (±19°) Elevation Angle: -17.2° Horizon Angle: +01.4° Zoom: 1.0X Staff: 11018+00 Stream S-RP5</p> | | <p>Date & Time: Tue, Jan 19, 2021, 09:40:00 EST Position: +037.322284, -080.532937 (431.9m) Altitude: 2200ft (670.0m) Datum: WGS-84 Azimuth/Bearing: 288.727W 51.20mils True (±15°) Elevation Angle: -03.7° Horizon Angle: -04.0° Zoom: 1.0X Staff: 11018+00 Stream S-RP5</p> | | <p>GPS Location See photo GPS</p> <p>Field Station# 11023+88</p> <p>Pic 1 Desc. Stream S- IJ18 equipment bridge and ECD's are in acceptable condition.</p> | | <p>GPS Location See photo GPS</p> <p>Field Station# 11018+00</p> <p>Pic 2 Desc. Stream S- RR5 - Row, ECD's and equipment bridge.</p> | |

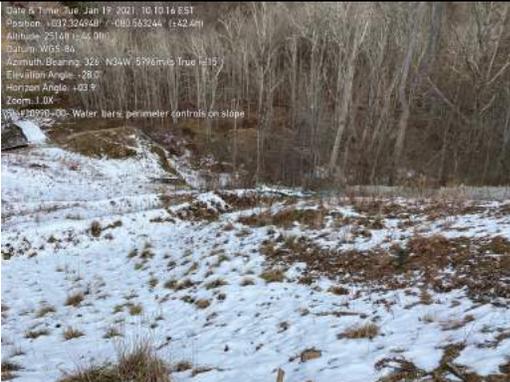
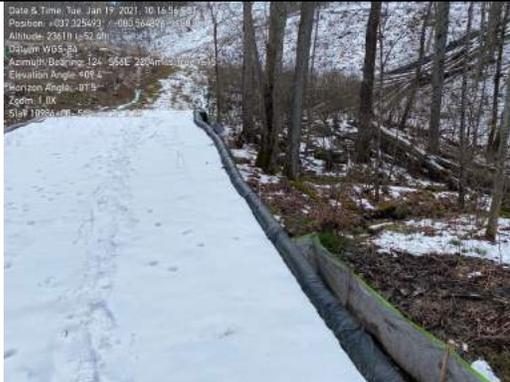
| AFE 124300137 | | Date/Time 1/19/2021 8:13 AM | | Report # | | | |
|---|--|---|--|---|--|--|--|
| <p>Date & Time: Tue, Jan 19, 2021, 10:10:14 EST Position: +037.324649, -080.543244 (442.4m) Altitude: 2510ft (765.0m) Datum: WGS-84 Azimuth/Bearing: 322.834W 599.6mils True (±15°) Elevation Angle: -28.0° Horizon Angle: +03.9° Zoom: 1.0X Staff: 10990+00 Water bars, perimeter controls on slope</p> | | <p>Date & Time: Tue, Jan 19, 2021, 10:16:14 EST Position: +037.324629, -080.544899 (442.4m) Altitude: 2361ft (719.0m) Datum: WGS-84 Azimuth/Bearing: 126.566E 209.4mils True (±15°) Elevation Angle: -01.6° Horizon Angle: -01.5° Zoom: 1.0X Staff: 10986+00</p> | | <p>GPS Location See photo GPS</p> <p>Field Station# 10990+00</p> <p>Pic 3 Desc. Water bars, perimeter controls on slope</p> | | <p>GPS Location See photo GPS</p> <p>Field Station# 10986+00</p> <p>Pic 4 Desc. Stream S- E25 equipment bridge and ECD's</p> | |

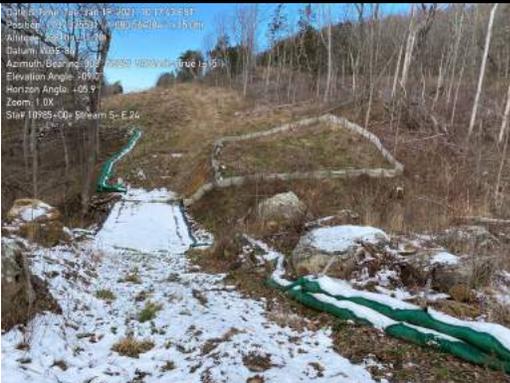
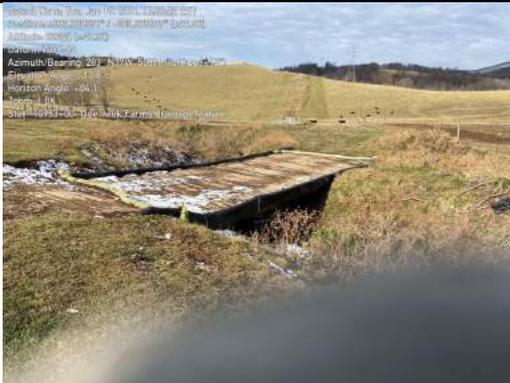
| AFE 124300137 | | Date/Time 1/19/2021 8:13 AM | | Report # | | | |
|---|--|---|--|---|--|--|--|
| <p>Date & Time: Tue, Jan 19, 2021, 10:17:03 EST Position: +037.324629, -080.544899 (442.4m) Altitude: 2361ft (719.0m) Datum: WGS-84 Azimuth/Bearing: 309.3mils True (±19°) Elevation Angle: -20.0° Horizon Angle: +03.9° Zoom: 1.0X Staff: 10985+00 Stream S- E24</p> | | <p>Date & Time: Tue, Jan 19, 2021, 10:20:25 EST Position: +037.324629, -080.544899 (442.4m) Altitude: 2361ft (719.0m) Datum: WGS-84 Azimuth/Bearing: 267.120W 50.7mils True (±15°) Elevation Angle: -01.5° Horizon Angle: -04.1° Zoom: 1.0X Staff: 10953+00 Doe Creek Farms drainage feature</p> | | <p>GPS Location See photo GPS</p> <p>Field Station# 10985+00</p> <p>Pic 5 Desc. Stream S- E24 equipment bridge, buffers and ECD's</p> | | <p>GPS Location See photo GPS</p> <p>Field Station# 10953+00</p> <p>Pic 6 Desc. Equipment bridge over drainage feature on Doe Creek Farms</p> | |

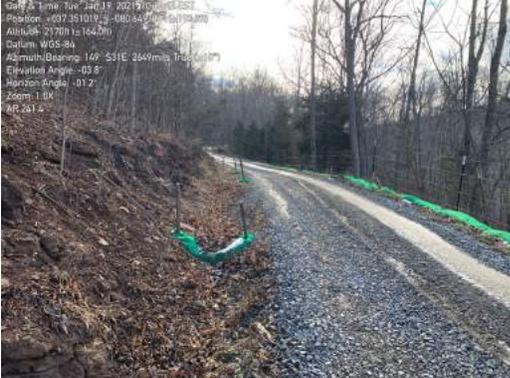
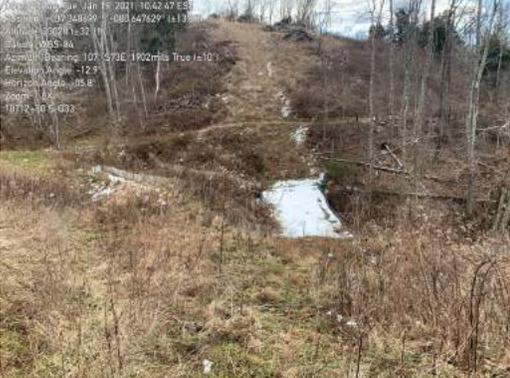
| AFE 124300137 | | Date/Time 1/19/2021 2:37 PM | | Report # | |
|---|--|--|--|---|--|
| <p>Pic 1 Desc. Compost filter sock checks in place along access road 241.04.</p> | | <p>Pic 2 Desc. Sensitive resource buffer in place at stream S-G33.</p> | | <p>Pic 2 Desc. Sensitive resource buffer in place at stream S-G33.</p> | |

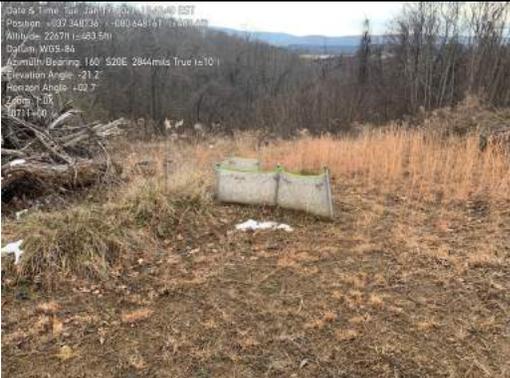
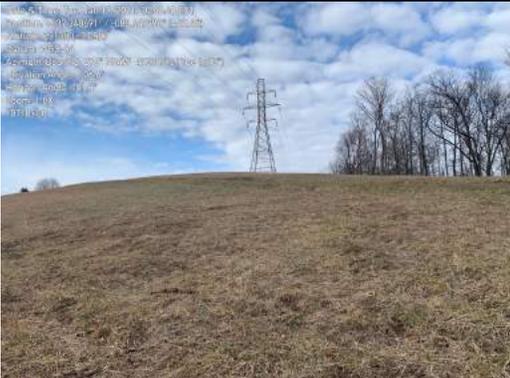
| AFE 124300137 | | Date/Time 1/19/2021 2:37 PM | | Report # | |
|---|--|--|--|---|--|
| <p>Pic 3 Desc. Priority one silt fence checks in place.</p> | | <p>Pic 4 Desc. ROW stabilized with natural vegetation growth.</p> | | <p>Pic 4 Desc. ROW stabilized with natural vegetation growth.</p> | |

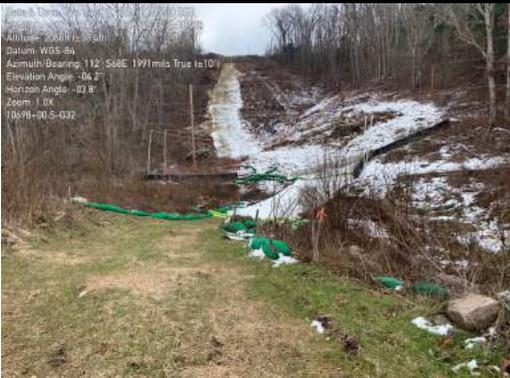
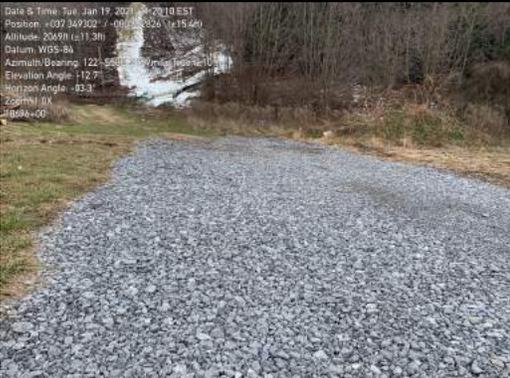
| AFE 124300137 | | Date/Time 1/19/2021 2:37 PM | | Report # | |
|---|--|--|--|---|--|
| <p>Pic 5 Desc. Sensitive resource buffer in place at stream S-G32.</p> | | <p>Pic 6 Desc. RCE in place at Buffalo Anklets Road.</p> | | <p>Pic 6 Desc. RCE in place at Buffalo Anklets Road.</p> | |

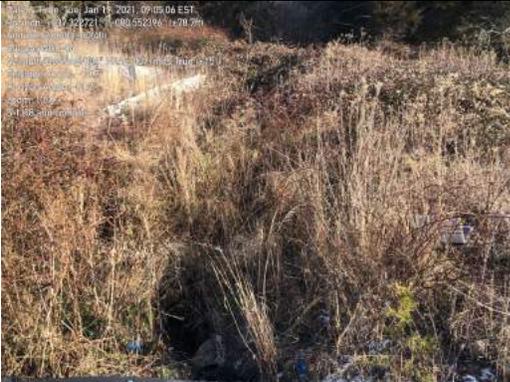
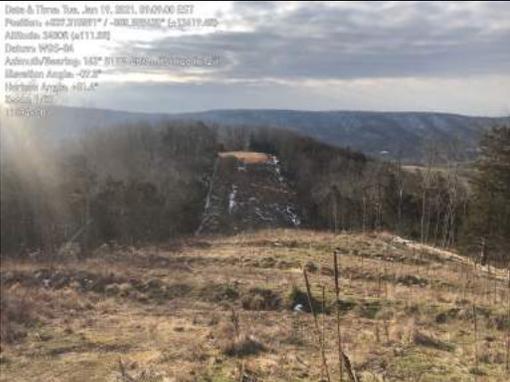
| AFE 124300137 | | Date/Time 1/19/2021 3:11 PM | | Report # | |
|--|--|---|--|---|--|
| Pic 1 Desc. S-IJ18 and controls. | | Pic 2 Desc. Section of RoW showing conditions and controls. | | | |

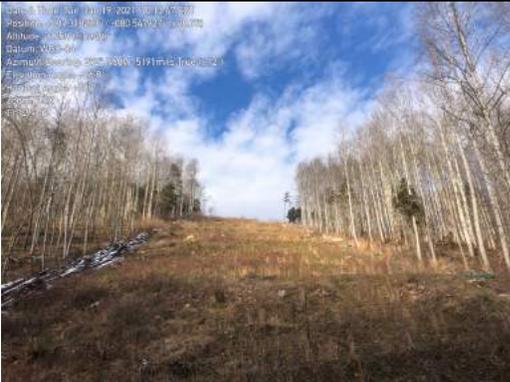
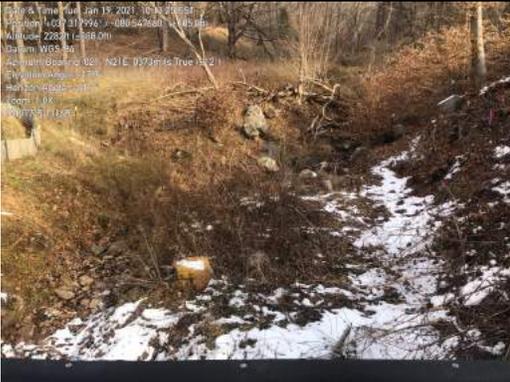
| AFE 124300137 | | Date/Time 1/19/2021 3:11 PM | | Report # | |
|--|--|---|--|---|--|
| Pic 3 Desc. Section of RoW showing conditions and controls. | | Pic 4 Desc. S-IJ16b/S-IJ17 and controls. | | | |

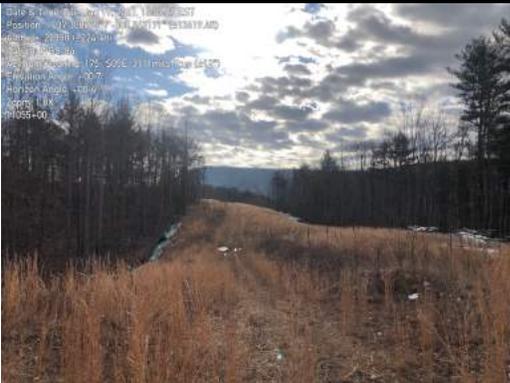
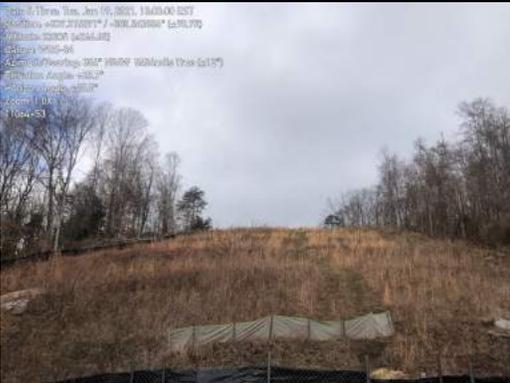
| AFE 124300137 | | Date/Time 1/19/2021 3:11 PM | | Report # | |
|--|--|---|--|---|--|
| Pic 5 Desc. Section of RoW showing conditions and controls. | | Pic 6 Desc. Section of RoW showing conditions and controls. | | | |

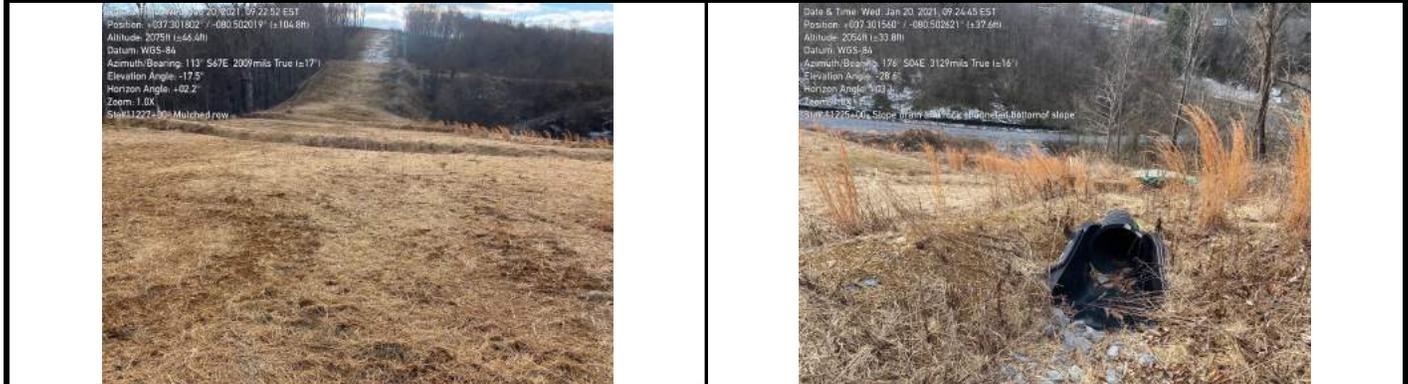
| Pic 1 Desc. | Mulched row | Pic 2 Desc. | Slope drain pipe and rock channel at bottom of slope. |

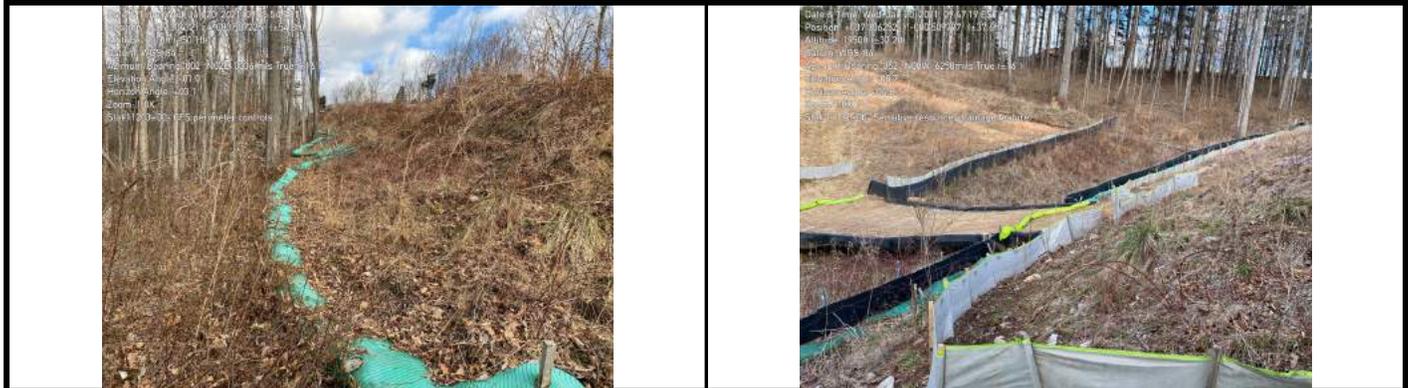
| Pic 3 Desc. | CFS perimeter controls | Pic 4 Desc. | Sensitive resource area, drainage feature. |

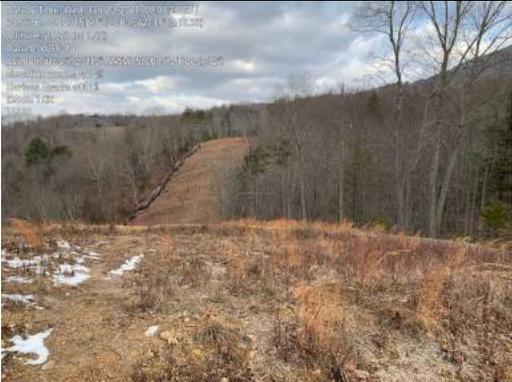
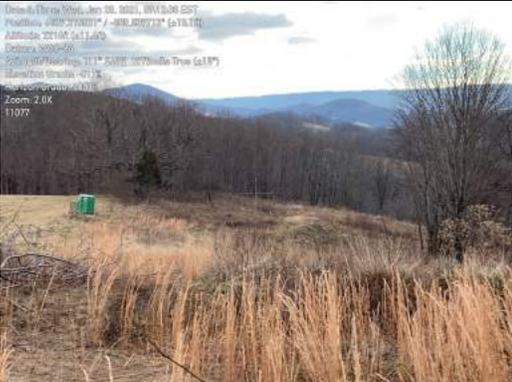
| AFE 124300137 | | Date/Time 1/20/2021 3:50 PM | | Report # | |
|---|---|--|---|---|--|
| Pic 1 Desc. | ECD's and row conditions | | Pic 2 Desc. | ECD's and row conditions | |

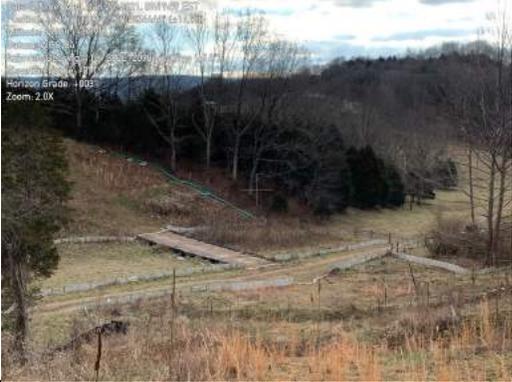
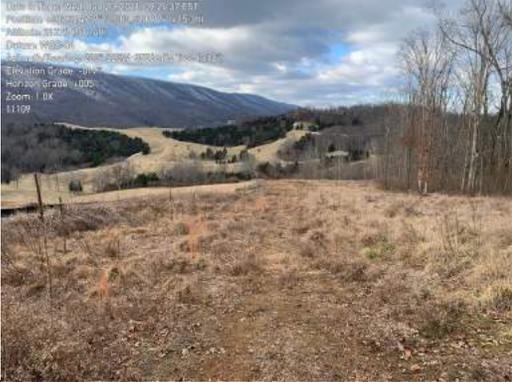
| AFE 124300137 | | Date/Time 1/20/2021 3:50 PM | | Report # | |
|---|---|--|---|---|--|
| Pic 3 Desc. | ECD's and row conditions | | Pic 4 Desc. | ECD's and row conditions | |

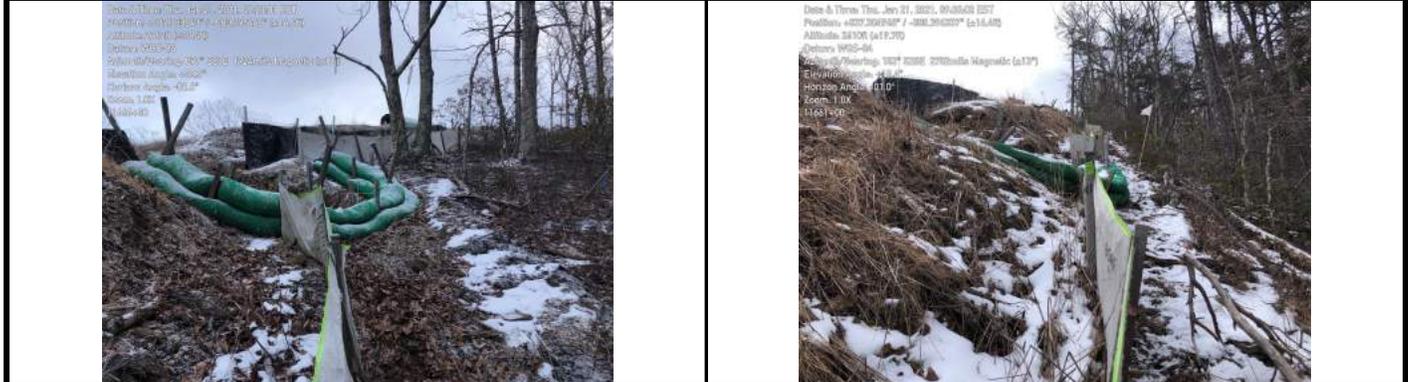
| Pic 1 Desc. | Perimeter controls are in place. | Pic 2 Desc. | ROW stable with perimeter controls in place. |

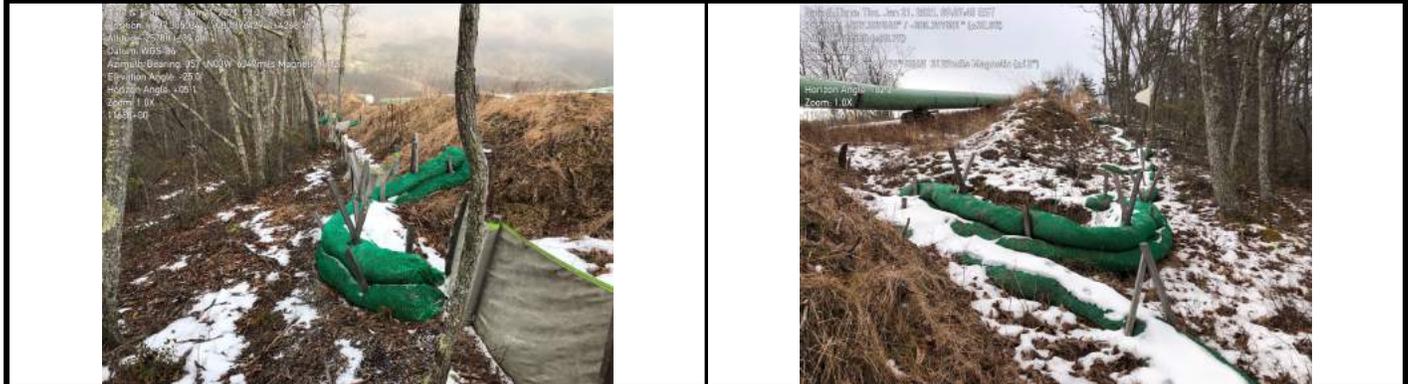
| Pic 3 Desc. | Perimeter controls in place. No erosion. | Pic 4 Desc. | ROW currently stable. Environmental controls are in place. |

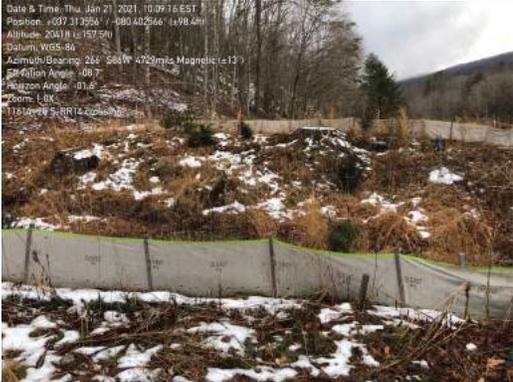
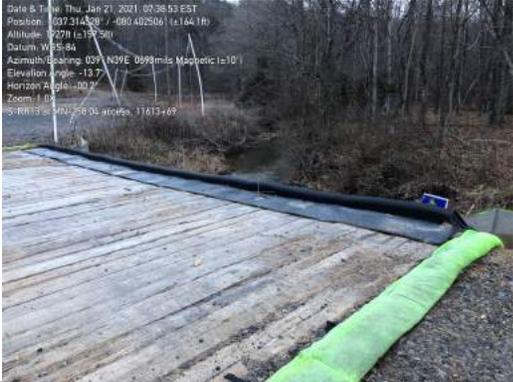
| AFE 124300137 | | Date/Time 1/21/2021 11:15 AM | | Report # | |
|--|---|---|---|---|--|
| Pic 7 Desc. | S-RR14 crossing stable. | | Pic 8 Desc. | S-RR13 crossing at access road MN-258.04 is stable. | |

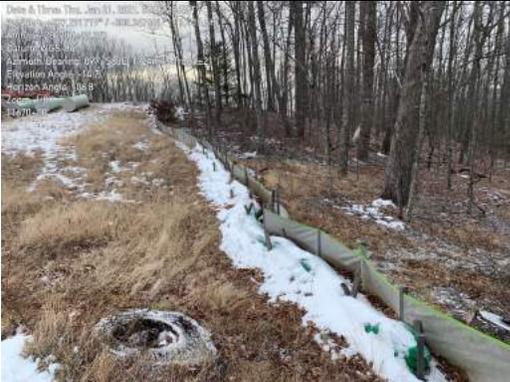
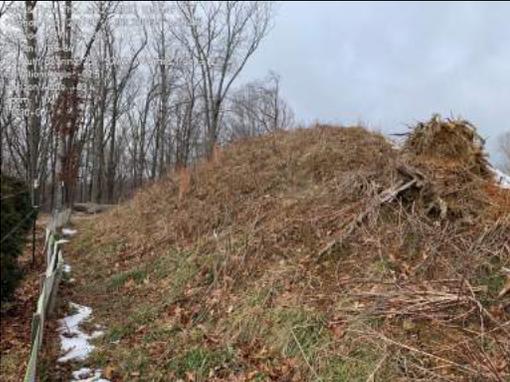
| AFE 124300137 | | Date/Time 1/21/2021 2:56 PM | | Report # | |
|---|--|--|---|---|--|
| Pic 1 Desc. | Triple stack compost filter sock in place along LOD. | | Pic 2 Desc. | Top soil pile stabilized with vegetation growth. | |

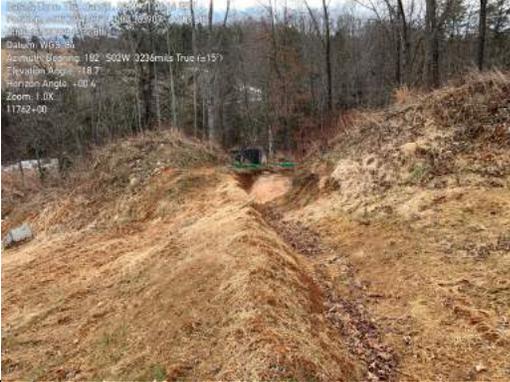
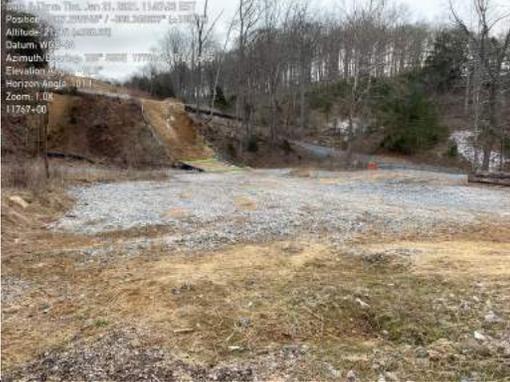
| AFE 124300137 | | Date/Time 1/21/2021 2:56 PM | | Report # | |
|---|--|--|---|---|--|
| Pic 3 Desc. | Waterbar, CFS end treatment, and sump pit in place. | | Pic 4 Desc. | RCE in place at MLV 26. | |

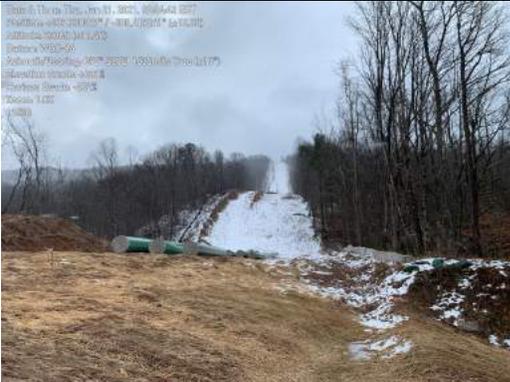
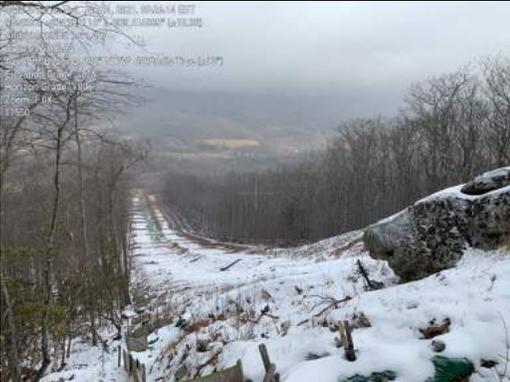
| AFE 124300137 | | Date/Time 1/21/2021 2:57 PM | | Report # | |
|---|---|--|---|---|--|
| Pic 1 Desc. | ECD's and row conditions | | Pic 2 Desc. | ECD's and row conditions | |

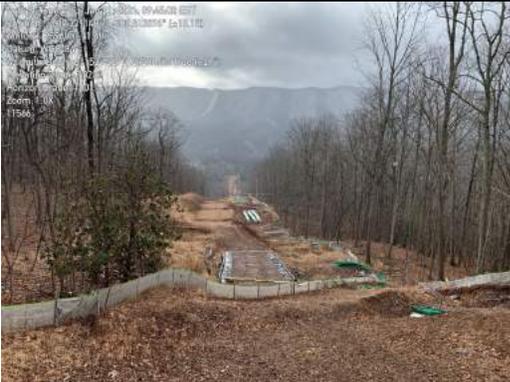
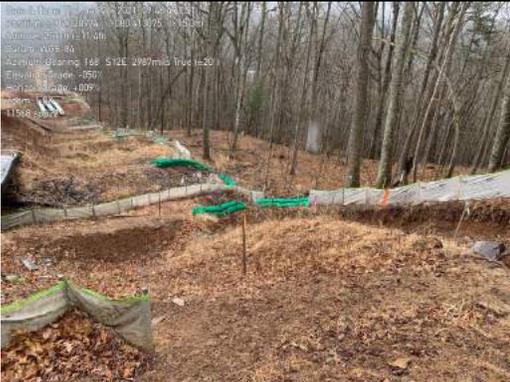
| AFE 124300137 | | Date/Time 1/21/2021 2:57 PM | | Report # | |
|---|---|--|---|---|--|
| Pic 3 Desc. | ECD's and row conditions | | Pic 4 Desc. | ECD's and row conditions | |

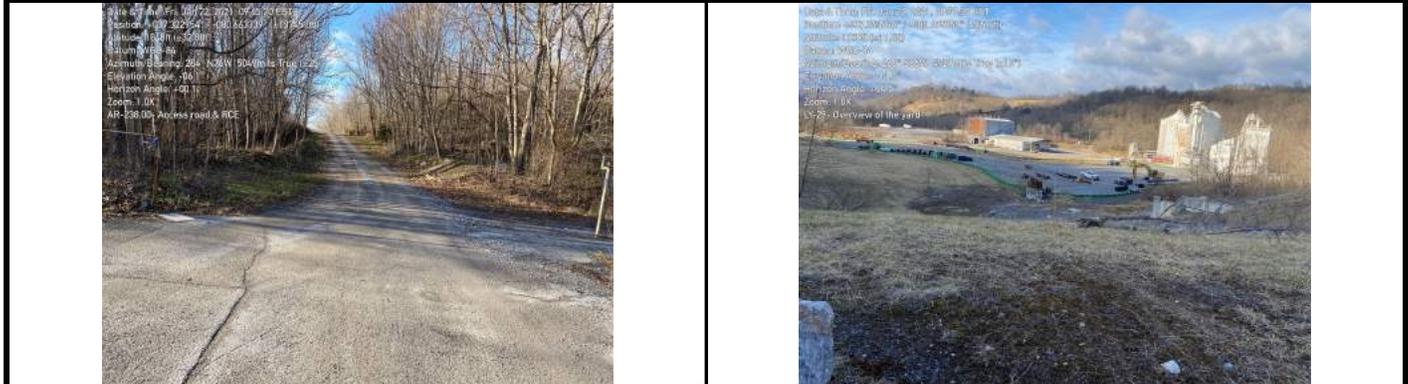
| Pic 1 Desc. | AR-238.00 access road and RCE | Pic 2 Desc. | LY29-Overview of the yard. |

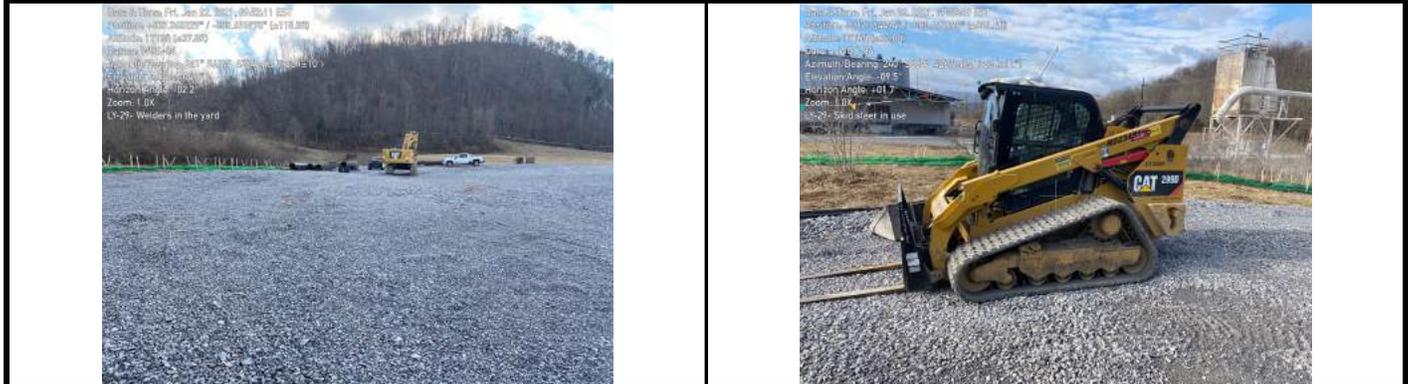
| Pic 3 Desc. | LY29- Track hoe used to move pipe | Pic 4 Desc. | Skid steer for contractor use in the yard. |

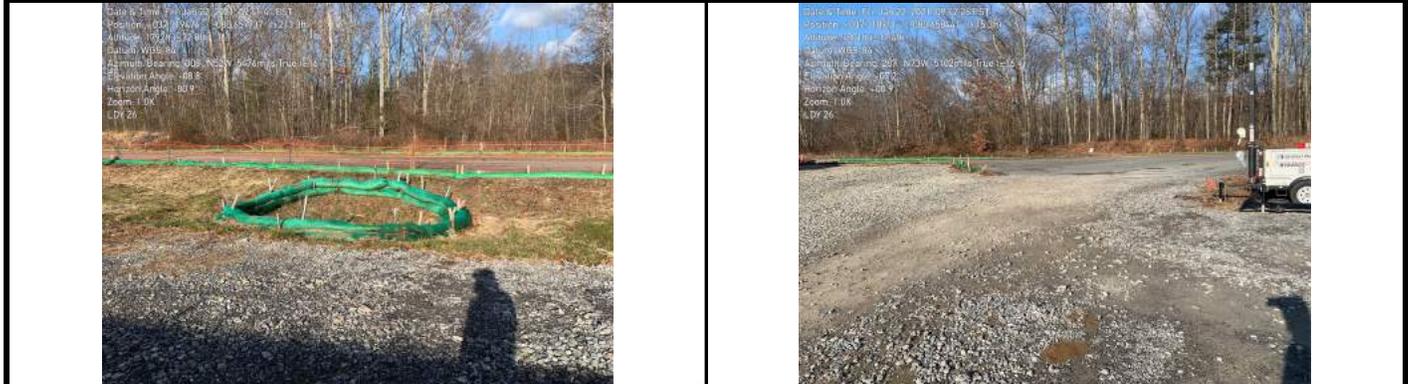
| Pic 1 Desc. | Triple stack cfs in place around drainage. | Pic 2 Desc. | RCE in place at Lay Down Yard 26 entrance. |

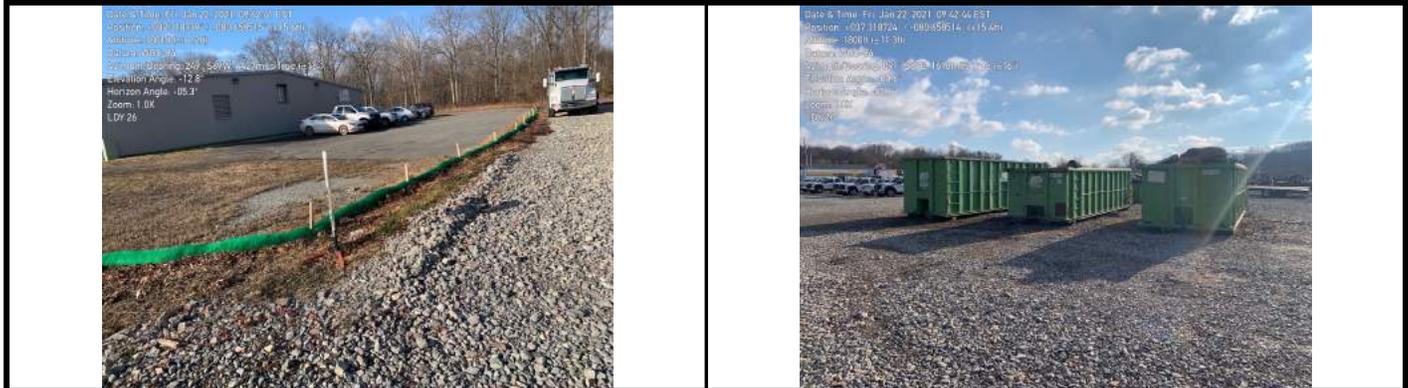
| Pic 3 Desc. | 18 inch compost filter sock in place along LOD. | Pic 4 Desc. | Dumpsters being utilized for trash management. |

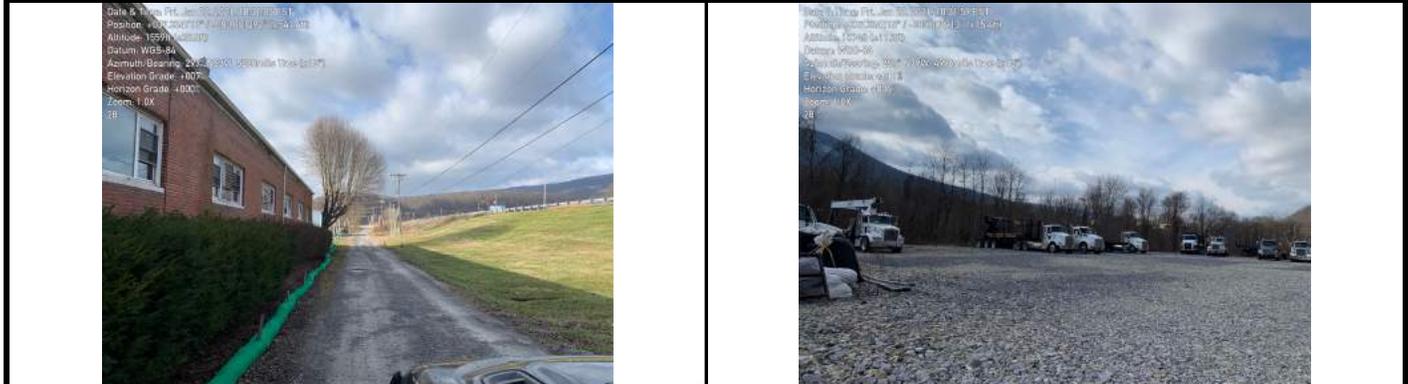
| Pic 1 Desc. | ECD's and row conditions | Pic 2 Desc. | ECD's and row conditions |

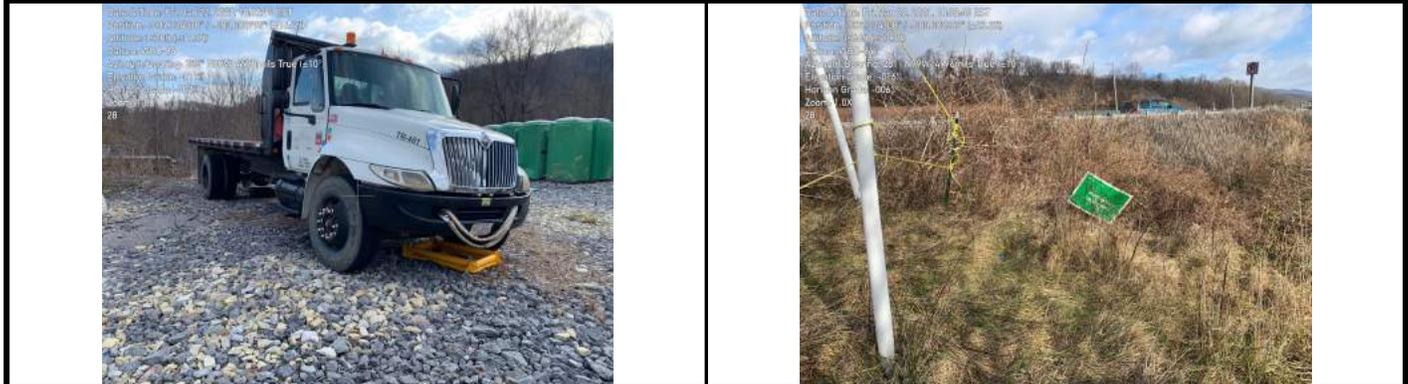
| Pic 3 Desc. | ECD's and row conditions | Pic 4 Desc. | ECD's and row conditions |
