Visual Site Inspection Report

Project Name H-600 Pipeline Spread I		AFE 124300139	Spread H-600 Pipeline Spread I
Contractor Precision		Report # 19136	
Inspector Justin Burch		Date/Time 1/18/2021 11:25 AM	
Permit # TBD	Inspection Type VA SWPP	Station Begin 15063+85	
State VA	Inspection Area Full	Station End 15142+66	
County Pittsylvania	Ground Wet	Temperature (°F) 43.00	
Municipality Chatham	Weather Cloudy	Rain Gauge (in) 0.10	
			Rain Accumulation Time (days) 6.00

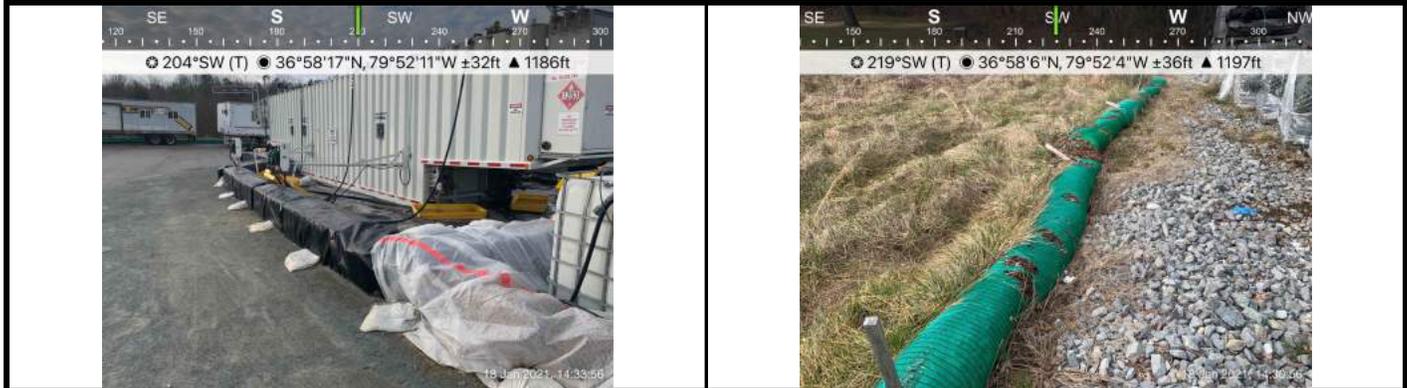
- Performed SWPPP inspection of Spread I main laydown yard in Rocky Mount, Va.
- The site conditions at the time of inspection was dry.
- All perimeter ECD's were inspected and one issue was found on the south end of the gravel yard (CFS requires maintenance see pic4).
- The inlet protection for the parking lot drains in the paved yard were in good condition.
- All secondary containment structures were found to be in acceptable condition.
- The RCE at the gravel yard was in good condition.
- The General Construction permits and contact information are posted at the main entrance of the paved yard as required.
- Any issue observed during today's inspection were placed on the punch list and given to the contractor to address.

GPS Location	000000000000	GPS Location	000000000000
Field Station#	0000+00	Field Station#	0000+00
Pic 3 Desc.	Secondary containment structure for fuel cell in acceptable condition.	Pic 4 Desc.	CFS requires maintenance on far south end of gravel yard.

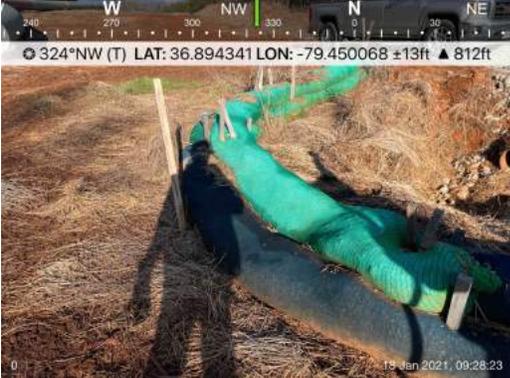
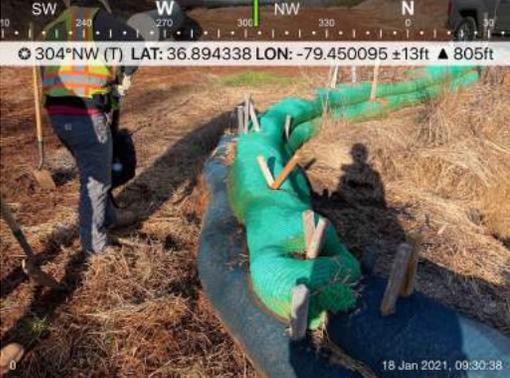
GPS Location	See photo		GPS Location	See photo	
Field Station#	15584+00		Field Station#	15484+00	
Pic 1 Desc.	CFS has been displaced and needs to be restaked.		Pic 2 Desc.	Environmental crew has corrected this issue.

- EI began inspection at Anderson Mill #1.
- EI was accompanied by 2 laborers to address issues as they were discovered.
- CFS has been displaced and needs to be restaked at 15584+00. Environmental crew has corrected this issue.
- P1 is degraded and needs to be replaced at 15572+87.
- Equipment bridge ECDs in place and functioning at all stream/wetland crossings.
- Temporary waterbars and end treatments are in good condition and functioning.
- Stockpiles remain temporarily stabilized.
- CWDs are functioning as intended.

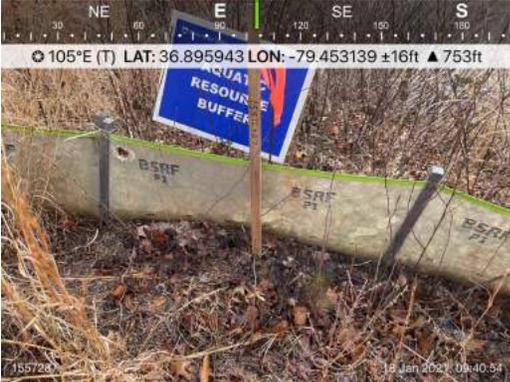
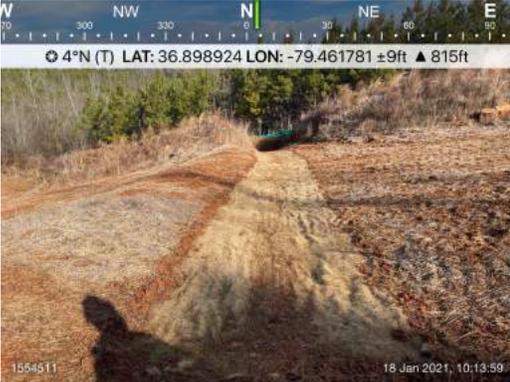
GPS Location	See photo		GPS Location	See photo	
Field Station#	15572+87		Field Station#	15545+11	
Pic 3 Desc.	P1 at this stream buffer is degraded and needs to be replaced.		Pic 4 Desc.	Temporary waterbars are in good condition and functioning.

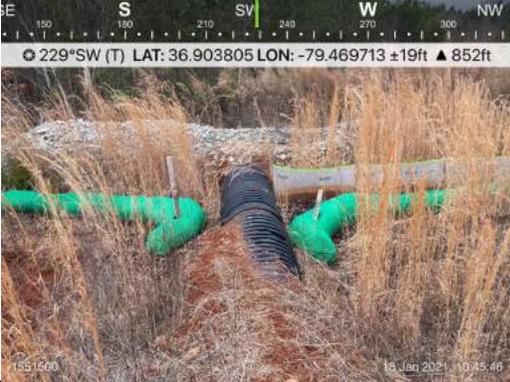
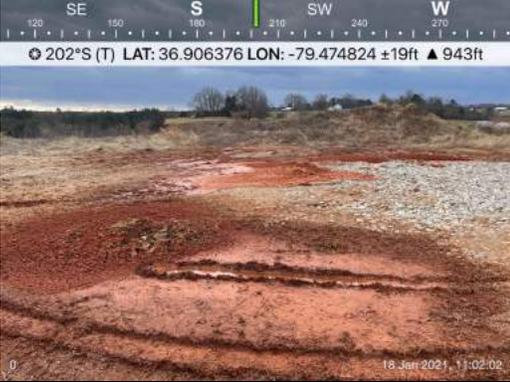
GPS Location	See photo		GPS Location	See photo	
Field Station#	15515+00		Field Station#	15497+00	
Pic 5 Desc.	CWDs are functioning as intended.		Pic 6 Desc.	Unknown 3rd party dumping material in RCE at Climax Rd.

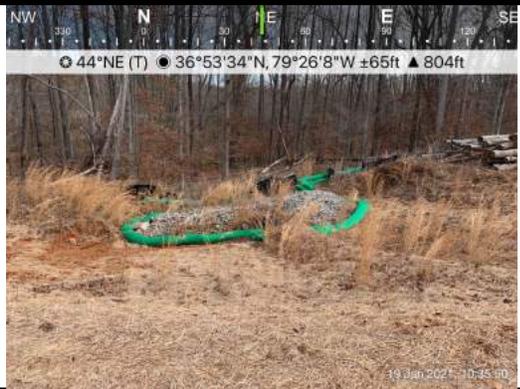
GPS Location	O		GPS Location	O	
Field Station#	15632+00		Field Station#	15607+00	
Pic 5 Desc.	Observing temporary stabilization, CWD outlet and ECD's		Pic 6 Desc.	Observing P1 that requires maintenance/was damaged by wildlife

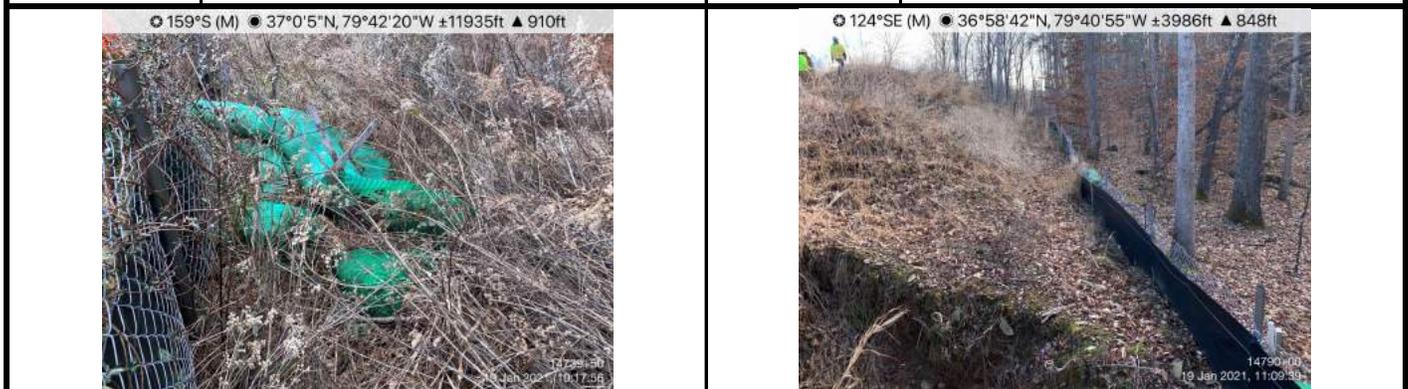
GPS Location	0	GPS Location	0
Field Station#	14739+50	Field Station#	14790+00
Pic 5 Desc.	CFS on waterbar end treatment requiring maintenance	Pic 6 Desc.	Super silt fence in acceptable condition

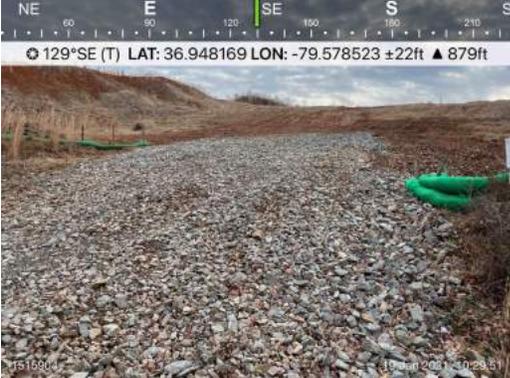
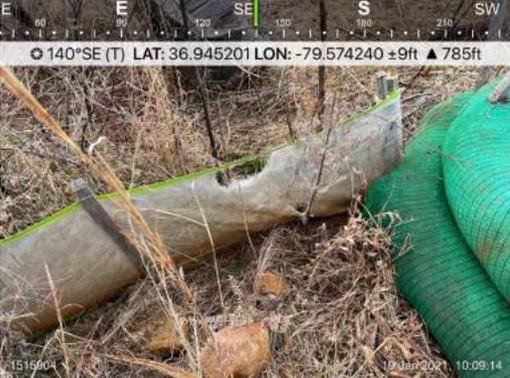
GPS Location	See photo	GPS Location	See photo
Field Station#	15142+66	Field Station#	15159+04
Pic 1 Desc.	RCE at Rockcreek Rd. in good condition.	Pic 2 Desc.	P1 is damaged/degraded and needs to be replaced.

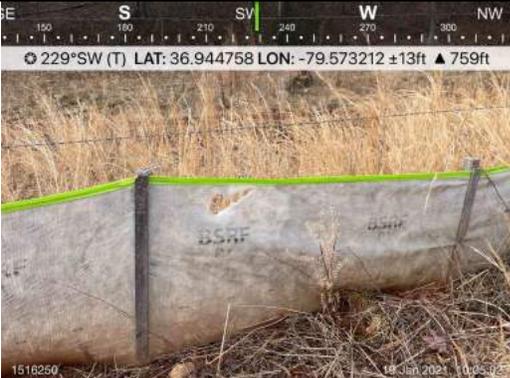
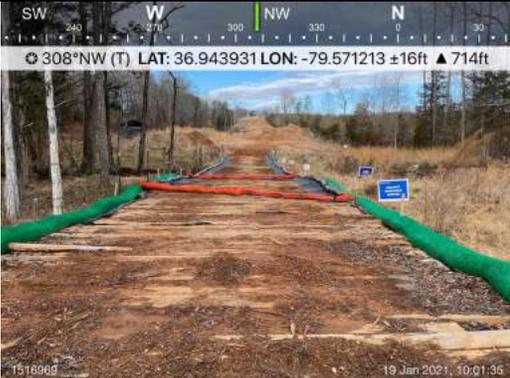
GPS Location	See photo	GPS Location	See photo
Field Station#	15162+50	Field Station#	15169+69
Pic 3 Desc.	P1 is damaged/degraded and needs to be replaced.	Pic 4 Desc.	Equipment bridge ECDs are in place and functioning at all stream and wetland crossings.

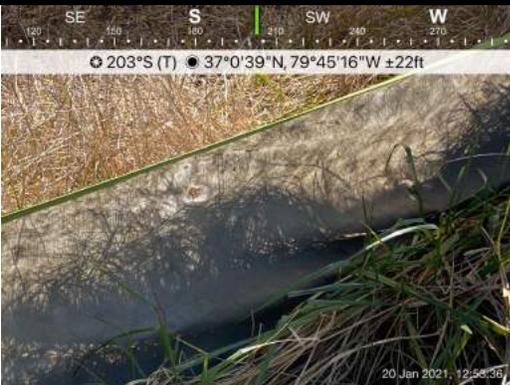
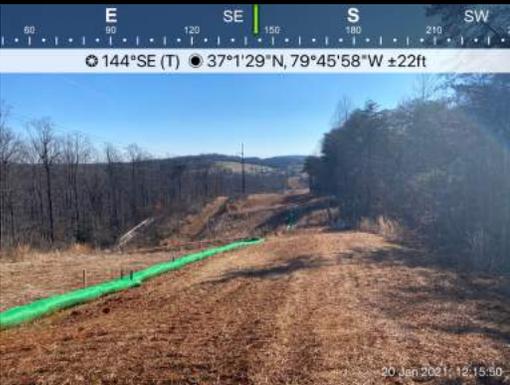
GPS Location	0	GPS Location	0		
Field Station#	14525+00	Field Station#	14470+00		
Pic 5 Desc.	Approximately 14525+00. P-1 damaged or deteriorating in this area.		Pic 6 Desc.	Approximately 14470+00. Overview of ROW.

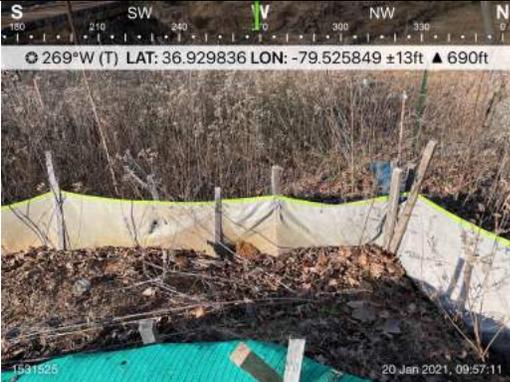
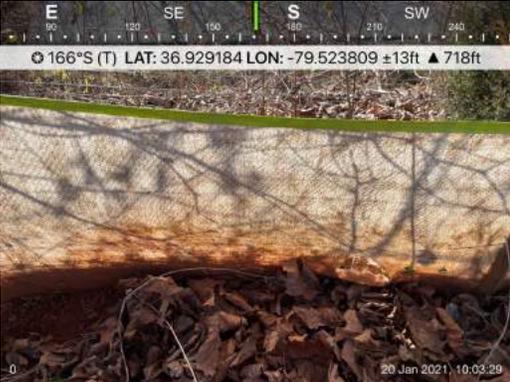
GPS Location See photo		GPS Location See photo			
Field Station# 15315+25		Field Station# 15321+00			
Pic 1 Desc. P1 is damaged and needs to be replaced.		Pic 2 Desc. P1 is damaged and needs to be replaced.

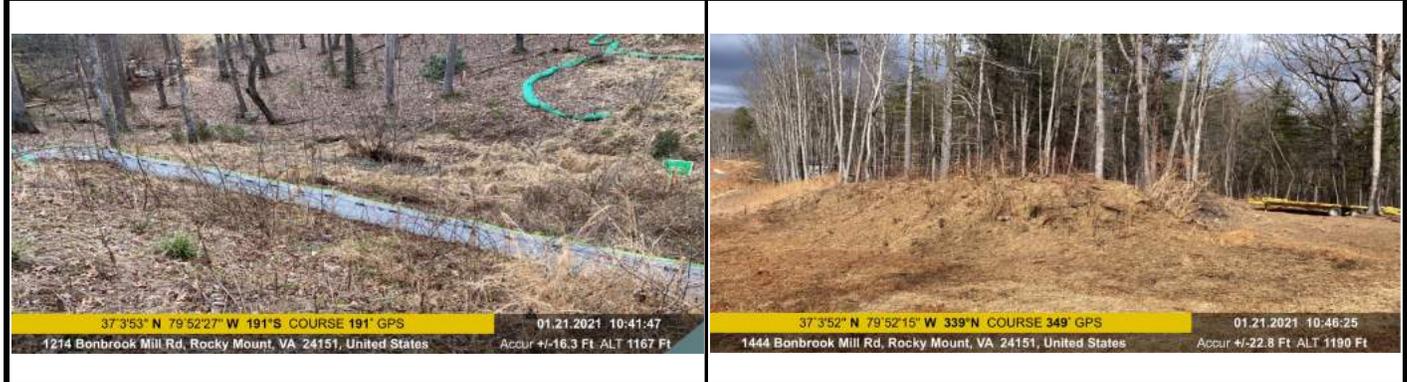
GPS Location	1	GPS Location	2
Field Station#	14067+00	Field Station#	14078+00
Pic 1 Desc.	Contractor replaced row of P1 silt fence per punch list item.	Pic 2 Desc.	Contractor seeded and stabilized burnt spoil pile per punch list item.

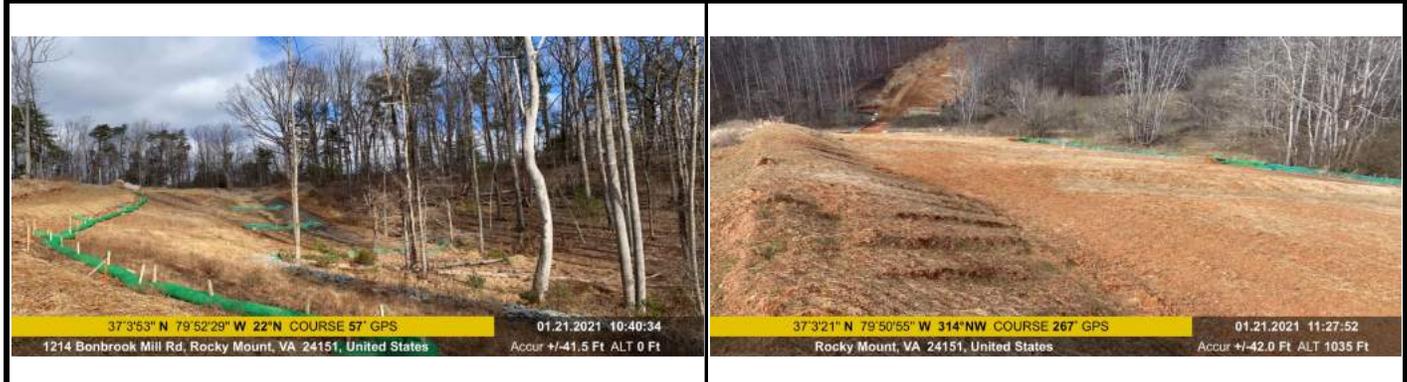
GPS Location	3	GPS Location	4
Field Station#	14065+00	Field Station#	14162+00
Pic 3 Desc.	Perimeter controls and CFS check dams performing intended functions.	Pic 4 Desc.	Signs of erosion beginning to occur in areas along ROW. Will monitor area in subsequent inspections to check for signs of worsening.

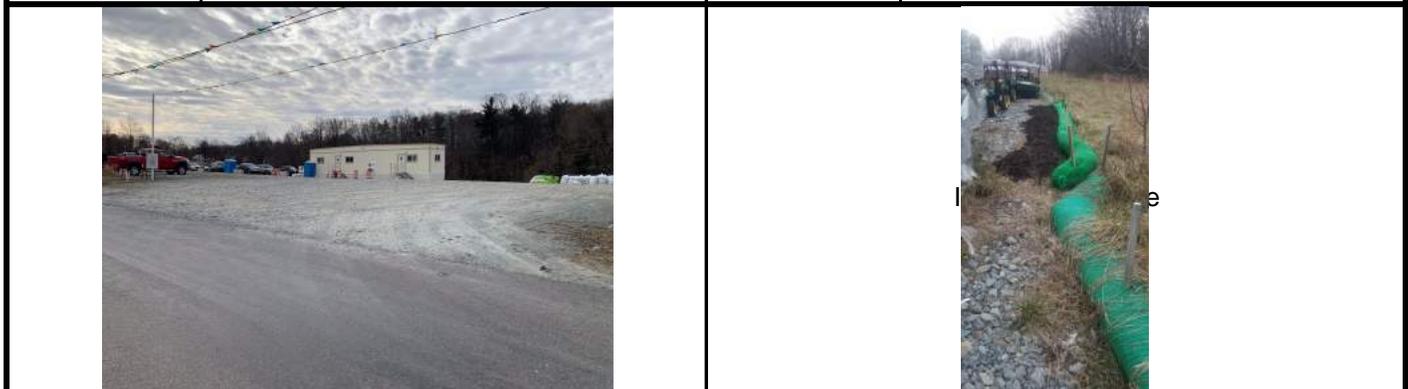
GPS Location	00000000000	GPS Location	00000000000
Field Station#	0000+00	Field Station#	0000+00
Pic 5 Desc.	RCE at gravel yard in good condition.	Pic 6 Desc.	Perimeter ECD issue from previous inspection addressed by contractor on far south end of gravel yard.

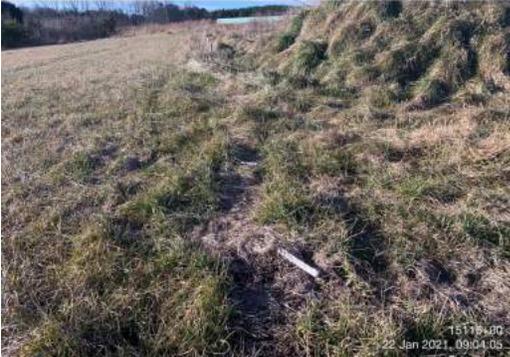
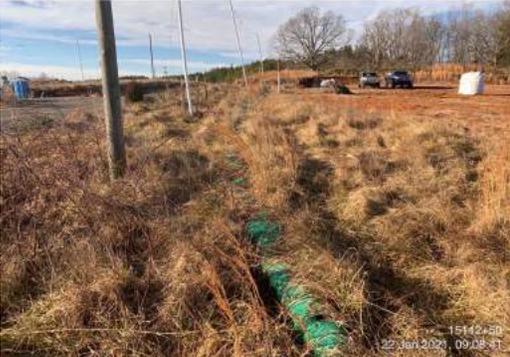
GPS Location 0			GPS Location 0		
Field Station# 15116+00			Field Station# 15112+50		
Pic 1 Desc. CFS damaged by farm equipment in MVP-ATWS-384			Pic 2 Desc. CFS at MVP-ATWS-383 requires maintenance

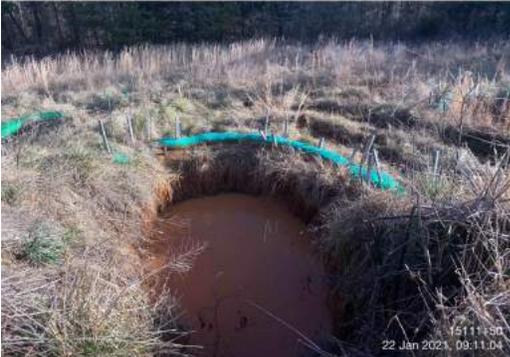
GPS Location 0			GPS Location 0		
Field Station# 15111+50			Field Station# 15116+00		
Pic 3 Desc. CFS on waterbar sumps are plugged with sediment from 15109+00 to 15112+00			Pic 4 Desc. CFS at MVP-ATWS-384A requires maintenance
