Visual Site Inspection Report

Project Name	H-600 Pipeline Spread I	AFE	124300139	Spread	H-600 Pipeline Spread I
Contractor	Precision			Report #	18683
Inspector	Charles Head			Date/Time	1/4/2021 10:15 AM
Permit #	TBD	Inspection Type	VA SWPP	Station Begin	14454+22
State	VA	Inspection Area	Full	Station End	14546+75
County	Franklin	Ground	Muddy	Temperature (°F)	41.00
Municipality	N/A	Weather	Cloudy	Rain Gauge (in)	0.40
				Rain Accumulation Time (days)	2.00

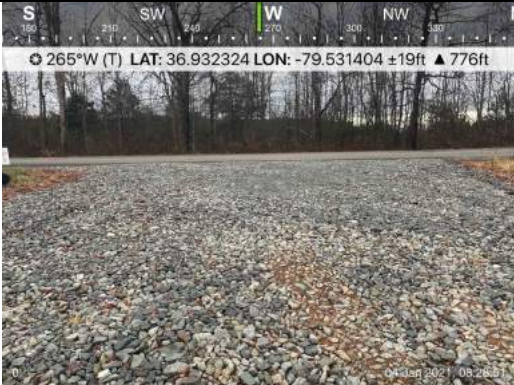
GPS Location	See photo		GPS Location	See photo	
Field Station#	15355+00		Field Station#	15355+00	
Pic 1 Desc.	CFS has been displaced and needs to be restaked.		Pic 2 Desc.	Environmental crew has corrected this issue.

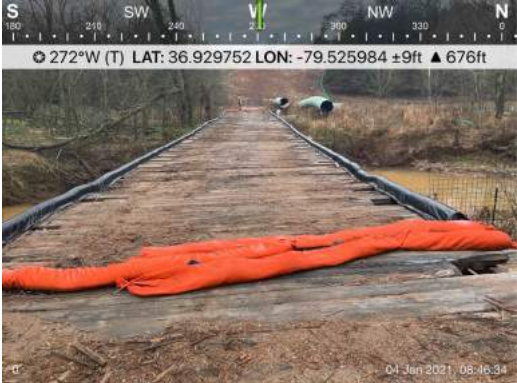
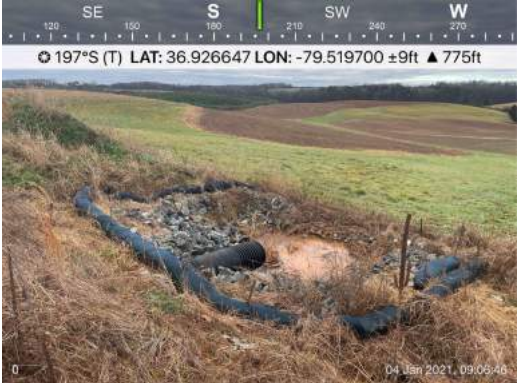
GPS Location	See photo		GPS Location	See photo	
Field Station#	15314+00		Field Station#	15338+00	
Pic 7 Desc.	Equipment bridge ECDs are in place and functioning at all stream and wetland crossings.		Pic 8 Desc.	CWDs are functioning as intended.	
Insert image here			Insert image here		
GPS Location			GPS Location		
Field Station#			Field Station#		
Pic 9 Desc.			Pic 10 Desc.		
Insert image here			Insert image here		
GPS Location			GPS Location		
Field Station#			Field Station#		
Pic 11 Desc.			Pic 12 Desc.

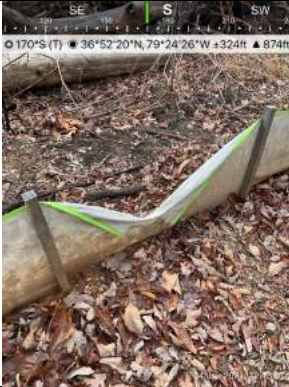
GPS Location	O	GPS Location	O		
Field Station#	15750+00	Field Station#	15752+00		
Pic 1 Desc.	Observing p1 that requires maintenance	Pic 2 Desc.	Observing p1 that requires maintenance

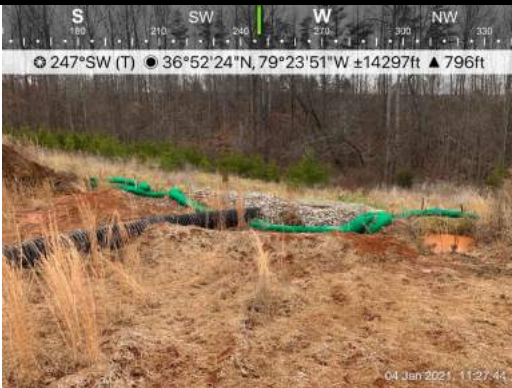
GPS Location	O	GPS Location	O		
Field Station#	15720+00	Field Station#	15713+00		
Pic 5 Desc.	Observing CWD outlet and ECD's	Pic 6 Desc.	Observing sump and end treatment

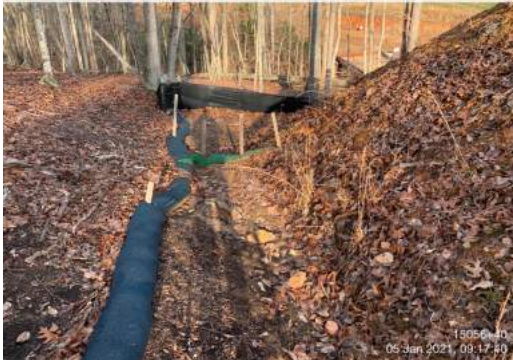
GPS Location			0	GPS Location			0
Field Station#			15056+40	Field Station#			15047+00
Pic 1 Desc.			CFS ditch check full of sediment	Pic 2 Desc.			CFS requiring maintenance

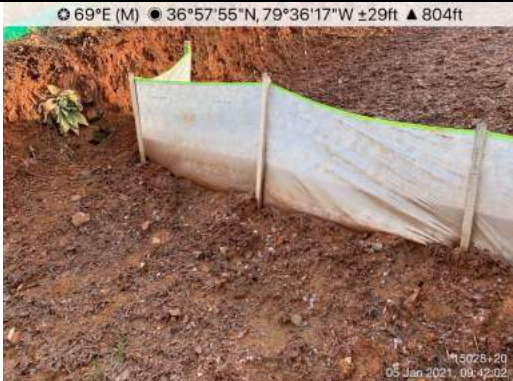
GPS Location			0	GPS Location			0
Field Station#			15028+20	Field Station#			14998+50
Pic 3 Desc.			P1 silt fence undermined	Pic 4 Desc.			Super silt fence requiring maintenance

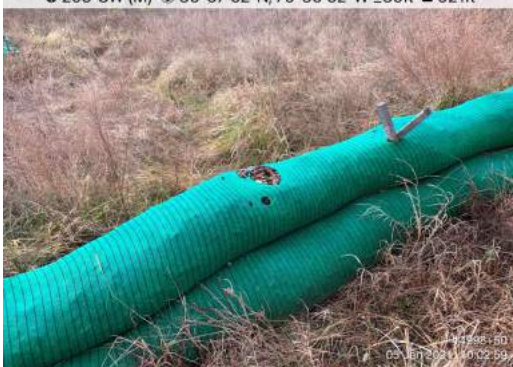
GPS Location			0	GPS Location			0
Field Station#			14998+50	Field Station#			14973+00
Pic 5 Desc.			CFS requiring maintenance	Pic 6 Desc.			Permanent vegetative stabilization in acceptable condition

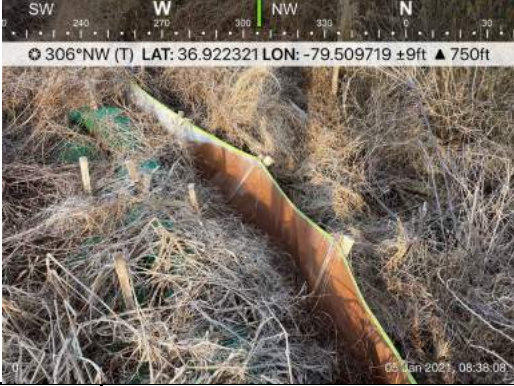
GPS Location	See photo		GPS Location	See photo	
Field Station#	15373+00		Field Station#	15373+00	
Pic 1 Desc.	P1 has been damaged and needs to be restaked.		Pic 2 Desc.	Environmental crew has corrected this issue.

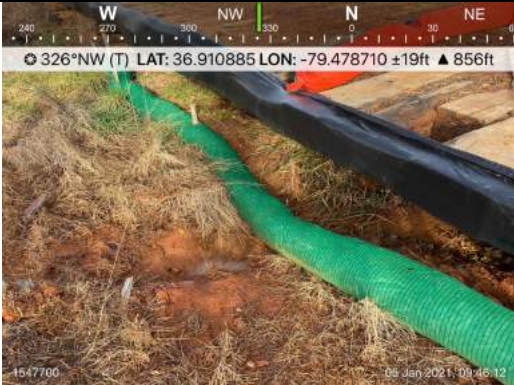
GPS Location	See photo		GPS Location	See photo	
Field Station#	15477+00		Field Station#	15477+00	
Pic 3 Desc.	CFS has been undermined and needs to be keyed in.		Pic 4 Desc.	Environmental crew has corrected this issue.

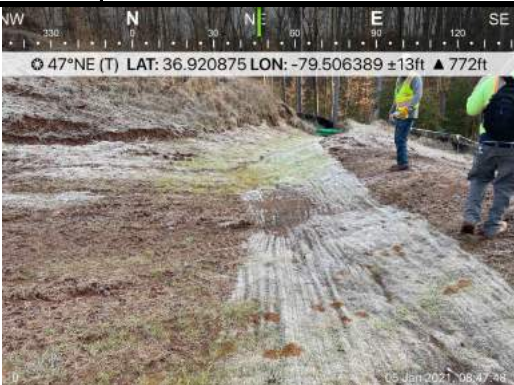
GPS Location	See photo		GPS Location	See photo	
Field Station#	15384+74		Field Station#	15384+74	
Pic 5 Desc.	Waterbars are functioning and in good condition.		Pic 6 Desc.	Equipment bridge ECDs are in place at all stream and wetland crossings.

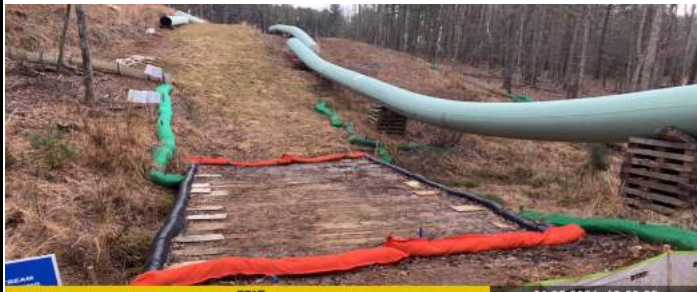
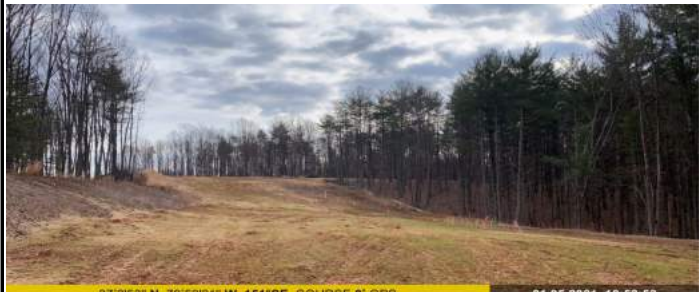
77°E 01.05.2021 10:50:23 Accur +/-213.3 Ft			37°3'53" N 79°52'21" W 151°SE COURSE 0° GPS 01.05.2021 10:53:53 1214 Bonbrook Mill Rd, Rocky Mount, VA 24151, United States Accur +/-213.3 Ft ALT 0 Ft		
GPS Location	1	GPS Location	2		
Field Station#	14066+77	Field Station#	14078+00		
Pic 1 Desc.	Equipment bridge and surrounding ECDs in place and functional at stream crossing.		Pic 2 Desc.	View of stabilization/vegetation in temporary area of ROW.

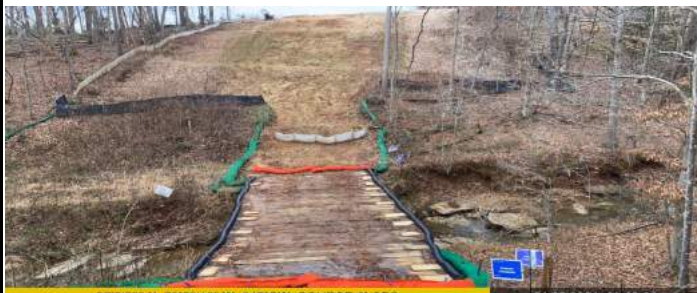
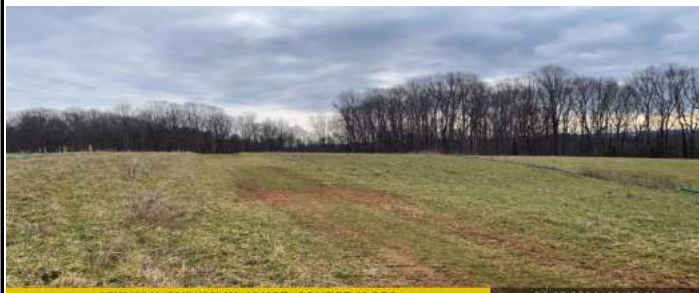
37°3'53" N 79°52'19" W 247°SW COURSE 0° GPS 01.05.2021 11:10:30 Wirtz, VA 24184, United States Accur +/-22350.8 Ft ALT 0 Ft			37°3'48" N 79°51'33" W 131°SE COURSE 0° GPS 01.05.2021 11:15:22 1321 Angle Plantation Rd, Rocky Mount, VA 24151, United States Accur +/-267.3 Ft ALT 0 Ft		
GPS Location	3	GPS Location	4		
Field Station#	14105+20	Field Station#	14116+00		
Pic 3 Desc.	Equipment bridge and surrounding ECDs in place and functional at stream crossing.		Pic 4 Desc.	View of vegetation in final cleanup area of ROW. No issues observed.

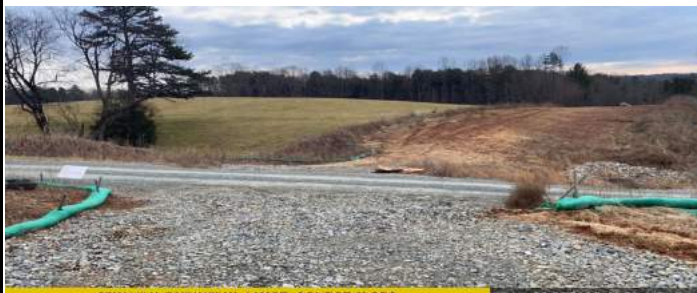
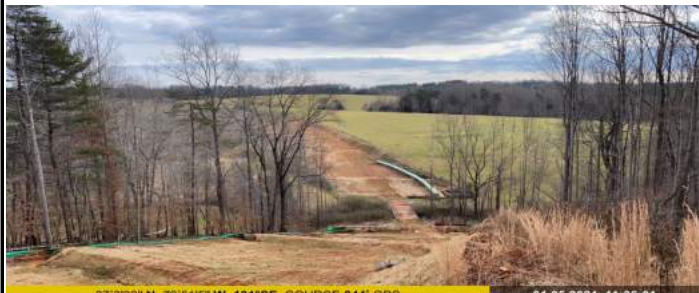
37°3'41" N 79°51'17" W 146°SE COURSE 0° GPS 01.05.2021 11:23:13 Rocky Mount, VA 24151, United States Accur +/-52.3 Ft ALT 0 Ft			37°3'23" N 79°51'5" W 131°SE COURSE 244° GPS 01.05.2021 11:36:01 180 Jonesmill Ln, Rocky Mount, VA 24151, United States Accur +/-149.2 Ft ALT 1079 Ft		
GPS Location	5	GPS Location	6		
Field Station#	14131+28	Field Station#	14155+50		
Pic 5 Desc.	RCE at Jonesmill Rd in good condition.		Pic 6 Desc.	Curlex installed on fill slope performing intended function. Water bars are appropriately filtering runoff into sump pits at perimeter of ROW.

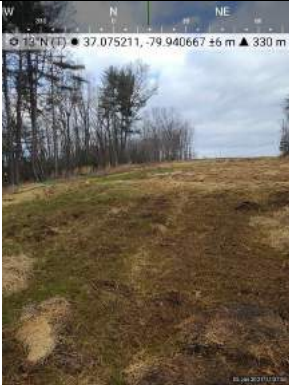
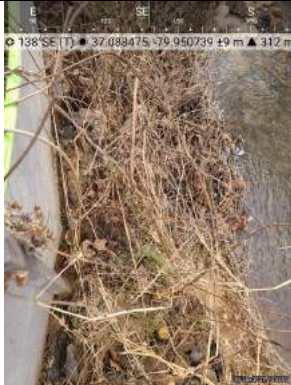
GPS Location	00000	GPS Location	00000		
Field Station#	13746+56	Field Station#	13676+70		
Pic 1 Desc.	Row photo showing vegetation growth, monitored during the EI's travel today.		Pic 2 Desc.	During the EI inspection today the EI noticed during storm water events caused stream banks to wash with potential cause of P1 to be washed off the bank, recommended moving.

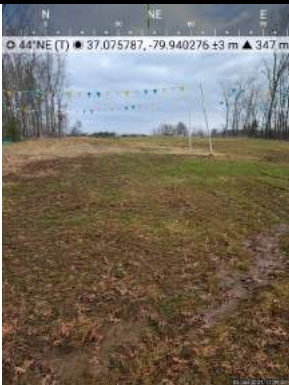
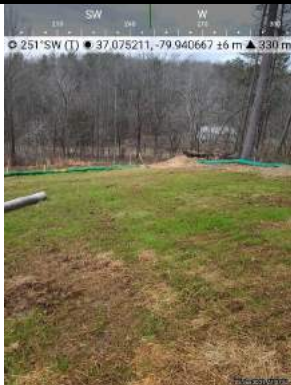
GPS Location	0000	GPS Location	0000		
Field Station#	13745+00	Field Station#	13746+90		
Pic 3 Desc.	Row photo taken by the EI during routine inspection today showing vegetation.		Pic 4 Desc.	Row photo taken by the EI during routine inspection today showing vegetation, and ECDs in place. No environmental issues observed at the time of inspection.

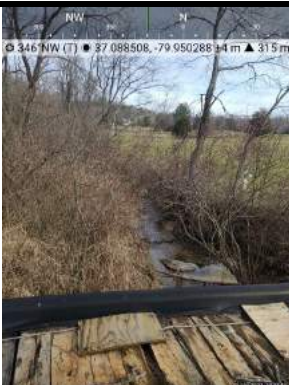
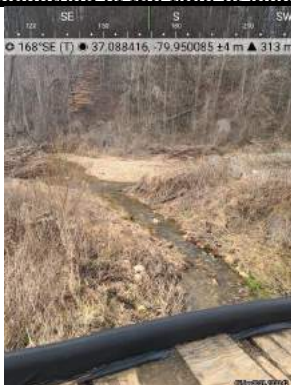
GPS Location	00000	GPS Location	00000		
Field Station#	13678+71	Field Station#	13678+71		
Pic 5 Desc.	Stream observation photo facing upstream by the EI during routine inspection today. No environmental issues observed at the time of inspection.		Pic 6 Desc.	Stream observation photo facing downstream by the EI during routine inspection today. No environmental issues observed at the time of inspection.

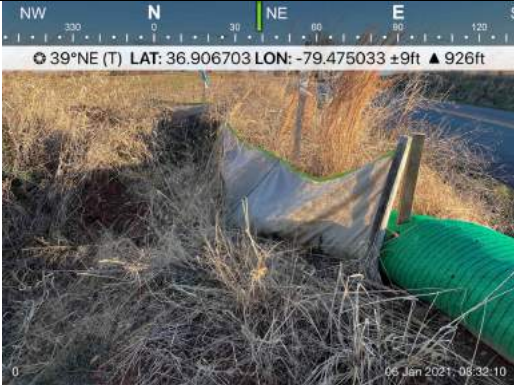
GPS Location	See photo		GPS Location	See photo	
Field Station#	15496+00		Field Station#	15496+00	
Pic 1 Desc.	P1 has been damaged and needs to be restaked.		Pic 2 Desc.	Environmental crew has corrected this issue.

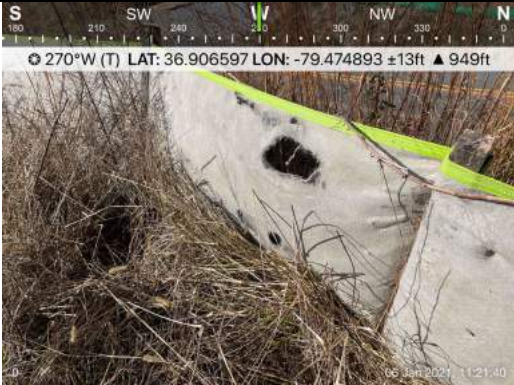
GPS Location	See photo		GPS Location	See photo	
Field Station#	15497+00		Field Station#	15497+00	
Pic 3 Desc.	P1 has been damaged and needs to be replaced.		Pic 4 Desc.	Environmental crew has corrected this issue.

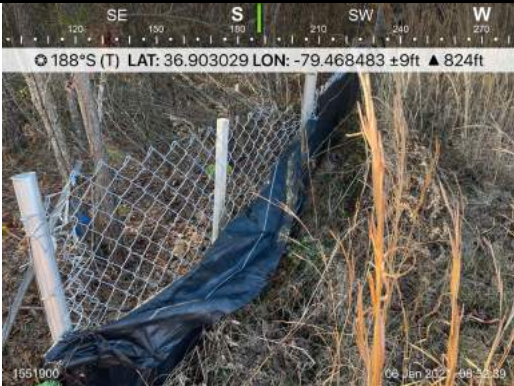
GPS Location	See photo		GPS Location	See photo	
Field Station#	15519+00		Field Station#	15519+00	
Pic 5 Desc.	SSF fabric needs to be reattached.		Pic 6 Desc.	Environmental crew has corrected this issue.

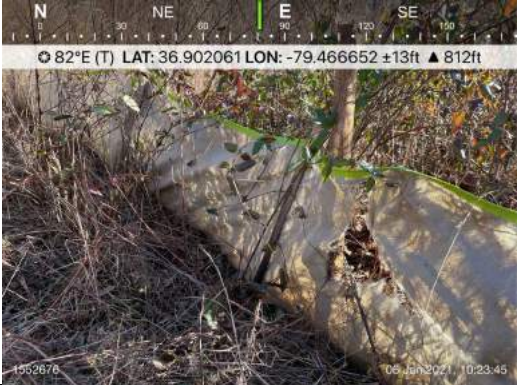
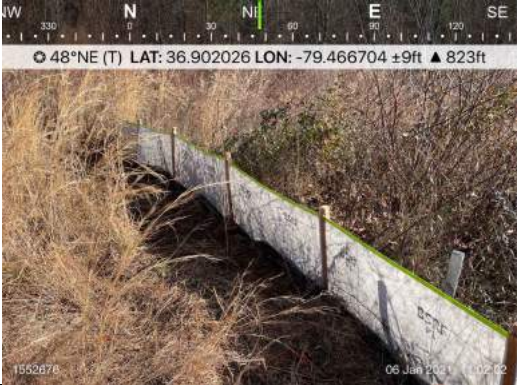
GPS Location	See photo		GPS Location	See photo	
Field Station#	15526+76		Field Station#	15526+76	
Pic 7 Desc.	P1 has been damaged and needs to be replaced.		Pic 8 Desc.	Environmental crew has corrected this issue.	
Insert image here			Insert image here		
GPS Location			GPS Location		
Field Station#			Field Station#		
Pic 9 Desc.			Pic 10 Desc.		
Insert image here			Insert image here		
GPS Location			GPS Location		
Field Station#			Field Station#		
Pic 11 Desc.			Pic 12 Desc.

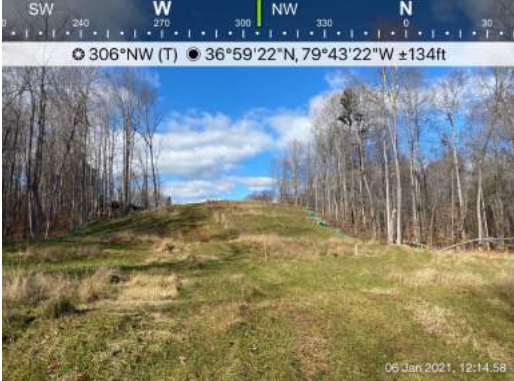
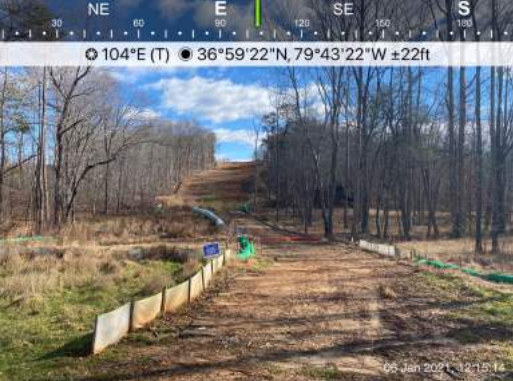
GPS Location	0	GPS Location	0		
Field Station#	14652+00	Field Station#	14656+95		
Pic 1 Desc.	Approximately 14652+00. Overview of ROW. ROW temporarily stabilized and has temporary vegetation growing.		Pic 2 Desc.	Approximately 14656+95. Overview of stream crossing, equipment bridge and ECDs at stream S-H38.

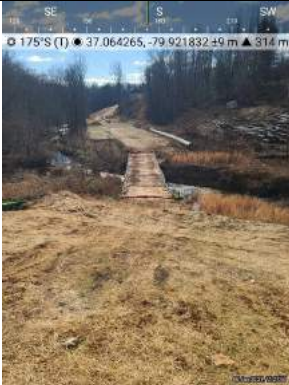
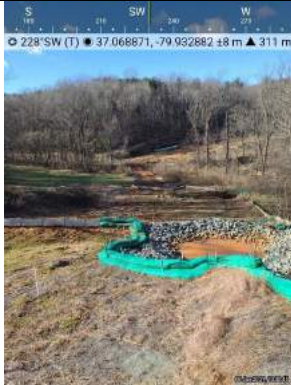
GPS Location	00000	GPS Location	00000		
Field Station#	13833+00	Field Station#	13748+33		
Pic 1 Desc.	Hill side above stream crossing stabilized and equipment bridge in place and ECDs functioning	Pic 2 Desc.	El monitored sump pit and ECDs , no environmental issues observed at the time of inspection

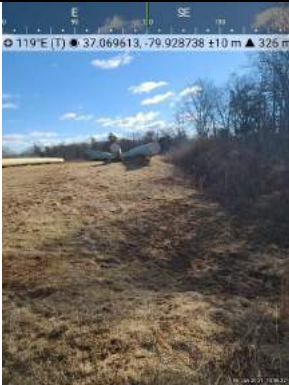
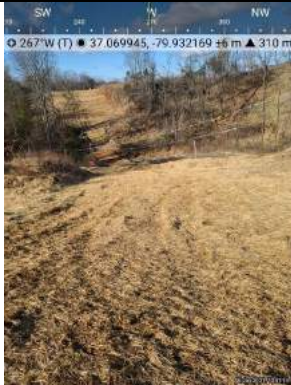
GPS Location	00000	GPS Location	00000		
Field Station#	13800+00	Field Station#	13799+12		
Pic 3 Desc.	Photo taken by the EI showing stabilized row conditions	Pic 4 Desc.	Stabilization practices monitored and no issues observed by the EI at the time of inspection

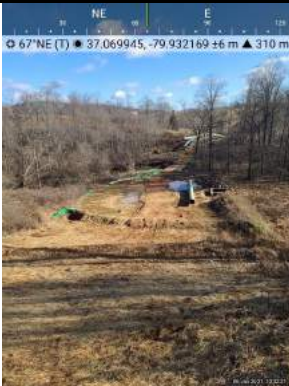
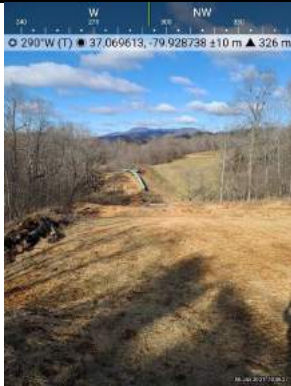
GPS Location	00000	GPS Location	00000		
Field Station#	13788+90	Field Station#	13795+00		
Pic 5 Desc.	El monitored slope breakers and stabilization on hill side above stream crossing, no environmental issues observed at the time of inspection	Pic 6 Desc.	Row photo taken by the EI showing stabilization on row.

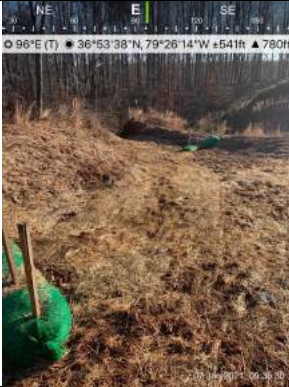
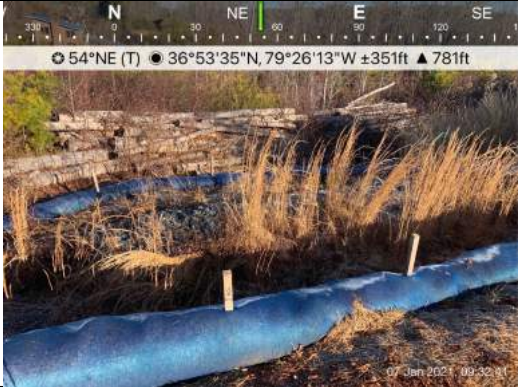
GPS Location	O	GPS Location	O		
Field Station#	15632+00	Field Station#	15623+00		
Pic 1 Desc.	Observing temporary stabilization and ECD's	Pic 2 Desc.	Observing CWD outlet and ECD's

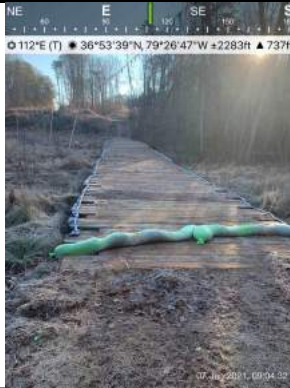
GPS Location	O	GPS Location	O		
Field Station#	15595+00	Field Station#	15596+79		
Pic 5 Desc.	Observing CWD outlet temporary stabilization and ECD's	Pic 6 Desc.	Observing equipment crossing and ECD's

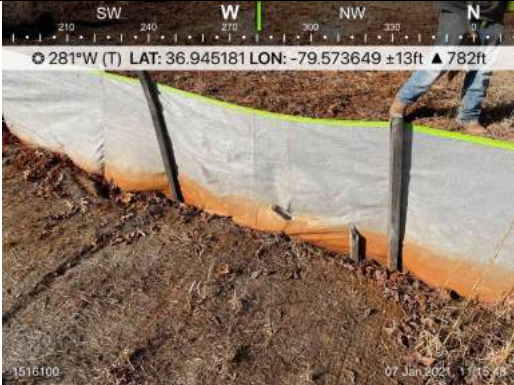
GPS Location	See photo		GPS Location	See photo	
Field Station#	15161+00		Field Station#	15161+00	
Pic 1 Desc.	P1 has been damaged by livestock and needs to be replaced.		Pic 2 Desc.	Environmental crew has corrected this issue.

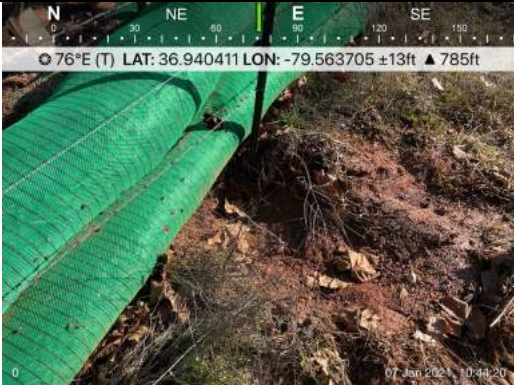
GPS Location	See photo		GPS Location	See photo	
Field Station#	15195+00		Field Station#	15195+00	
Pic 3 Desc.	CFS has been undermined and needs to be keyed in.		Pic 4 Desc.	Environmental crew has corrected this issue.

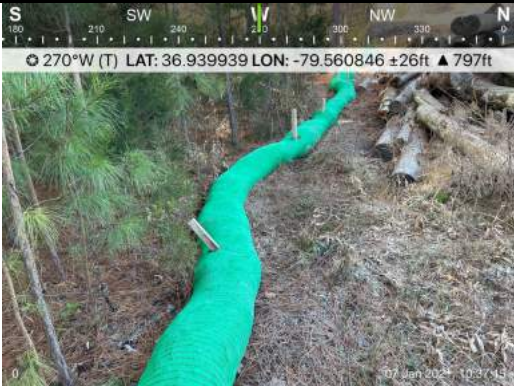
GPS Location	See photo		GPS Location	See photo	
Field Station#	15204+00		Field Station#	15204+00	
Pic 5 Desc.	CFS has been displaced and needs to be restaked.		Pic 6 Desc.	Environmental crew has corrected this issue.

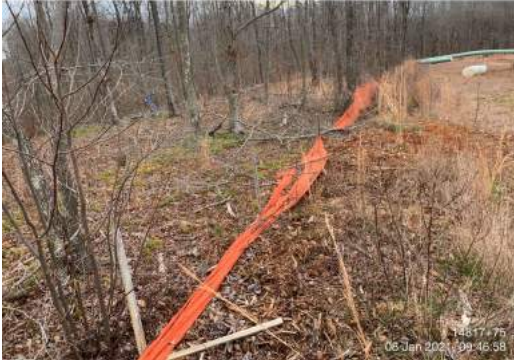
GPS Location	0	GPS Location	0		
Field Station#	14817+75	Field Station#	14837+00		
Pic 1 Desc.	Safety fence requires maintenance from 14817+75 to 14819+00	Pic 2 Desc.	Safety fence requires maintenance from 14835+00 to 14837+00

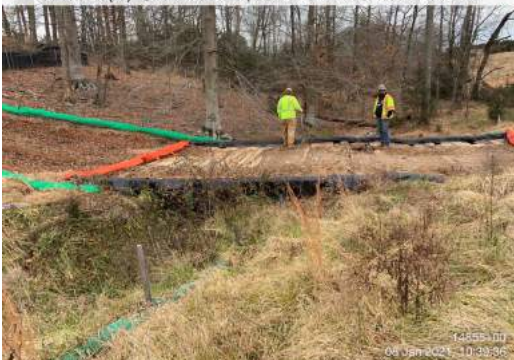
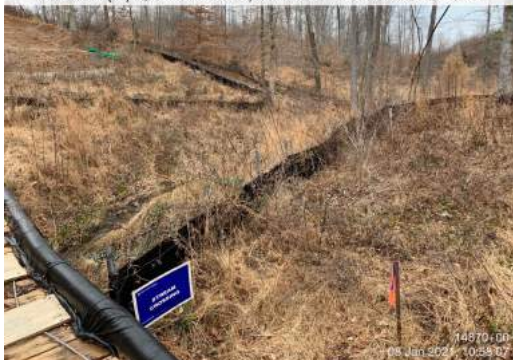
GPS Location	0	GPS Location	0		
Field Station#	14855+00	Field Station#	14870+00		
Pic 3 Desc.	Equipment bridge in acceptable condition	Pic 4 Desc.	Super silt fence in acceptable condition

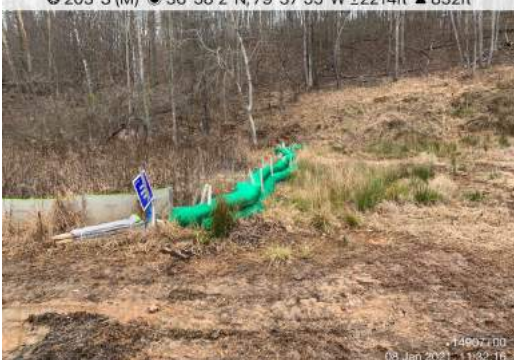
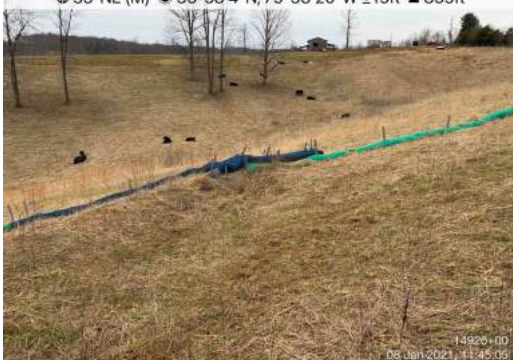
GPS Location	0	GPS Location	0		
Field Station#	14907+00	Field Station#	14926+00		
Pic 5 Desc.	CFS in acceptable condition	Pic 6 Desc.	Waterbar in acceptable condition

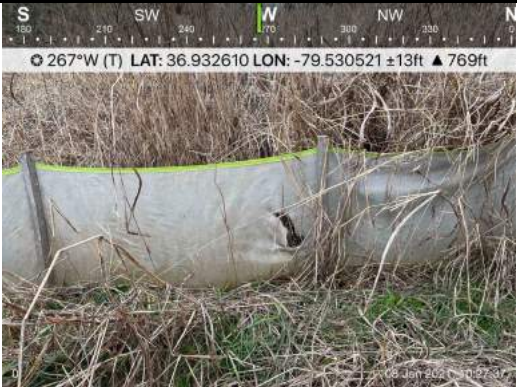
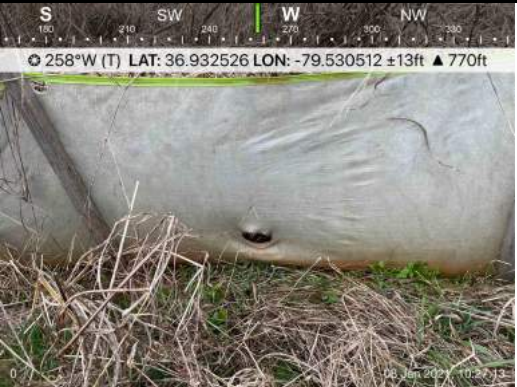
GPS Location	See photo		GPS Location	See photo	
Field Station#	15299+00		Field Station#	15299+00	
Pic 1 Desc.	P1 has been damaged and needs to be replaced.		Pic 2 Desc.	P1 has been damaged and needs to be replaced.

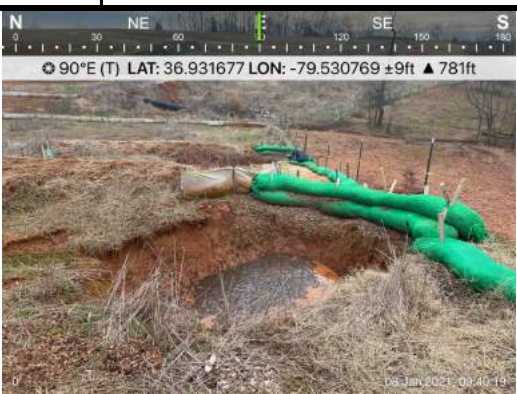
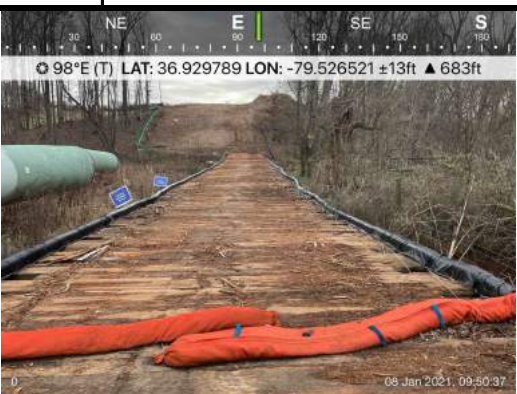
GPS Location	See photo		GPS Location	See photo	
Field Station#	15298+00		Field Station#	15314+19	
Pic 3 Desc.	End treatments are in good condition and functioning.		Pic 4 Desc.	Equipment bridge ECDs are in place at all stream and wetland crossings.

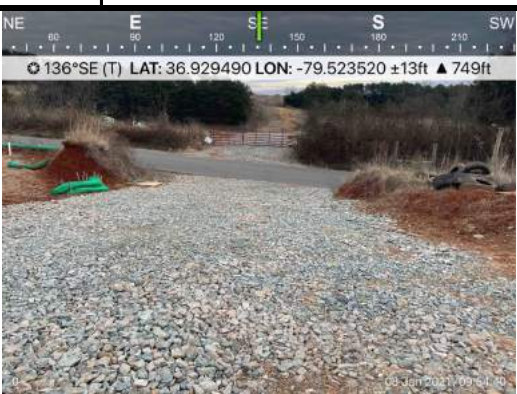
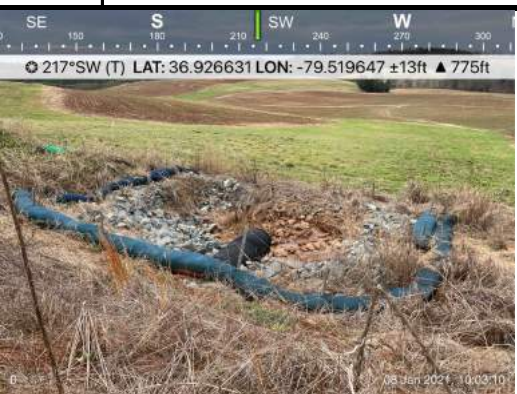
GPS Location	See photo		GPS Location	See photo	
Field Station#	15323+24		Field Station#	15338+00	
Pic 5 Desc.	RCEs are in good condition at all road crossings.		Pic 6 Desc.	CWDs are functioning as intended throughout this section.

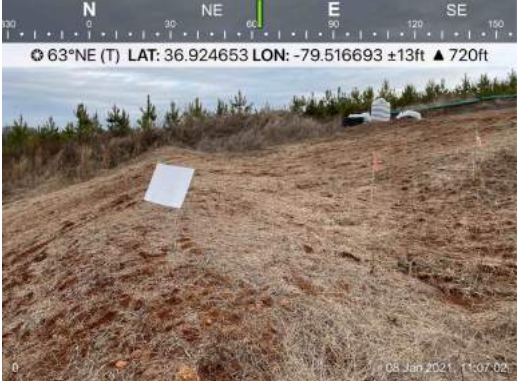
GPS Location	See photo	GPS Location			
Field Station#	15350+00	Field Station#			
Pic 7 Desc.	Waterbars remain in good condition and functioning.	Pic 8 Desc.			
Insert image here		Insert image here			
GPS Location		GPS Location			
Field Station#		Field Station#			
Pic 9 Desc.		Pic 10 Desc.			
Insert image here		Insert image here			
GPS Location		GPS Location			
Field Station#		Field Station#			
Pic 11 Desc.		Pic 12 Desc.
