# Visual Site Inspection Report

<b>Project Name</b>	H-600 Pipeline Spread I	<b>AFE</b>	124300139	<b>Spread</b>	H-600 Pipeline Spread I
<b>Contractor</b>	Precision			<b>Report #</b>	18320
<b>Inspector</b>	Justin Burch			<b>Date/Time</b>	12/21/2020 11:06 AM
<b>Permit #</b>	TBD	<b>Inspection Type</b>	VA SWPP	<b>Station Begin</b>	14802+19
<b>State</b>	VA	<b>Inspection Area</b>	Full	<b>Station End</b>	14928+52
<b>County</b>	Franklin	<b>Ground</b>	Wet	<b>Temperature (°F)</b>	56.00
<b>Municipality</b>	N/A	<b>Weather</b>	Sunny	<b>Rain Gauge (in)</b>	1.20
				<b>Rain Accumulation Time (days)</b>	6.00

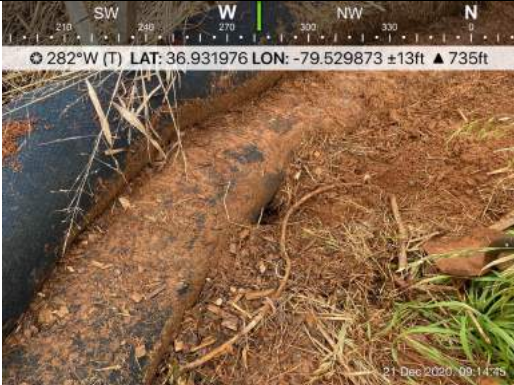
<b>GPS Location</b>	See photo		<b>GPS Location</b>	See photo	
<b>Field Station#</b>	15301+00		<b>Field Station#</b>	15301+00	
<b>Pic 1 Desc.</b>	CFS around CWD inlet has been undermined.		<b>Pic 2 Desc.</b>	Environmental crew has corrected this issue

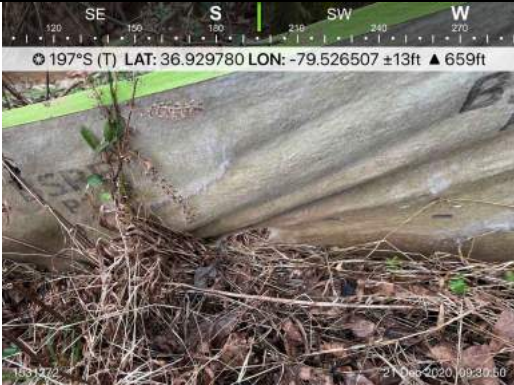
<b>GPS Location</b>	See photo		<b>GPS Location</b>	See photo	
<b>Field Station#</b>	15313+00		<b>Field Station#</b>	15313+00	
<b>Pic 3 Desc.</b>	P1 has been damaged and needs to be replaced.		<b>Pic 4 Desc.</b>	Environmental crew has corrected this issue

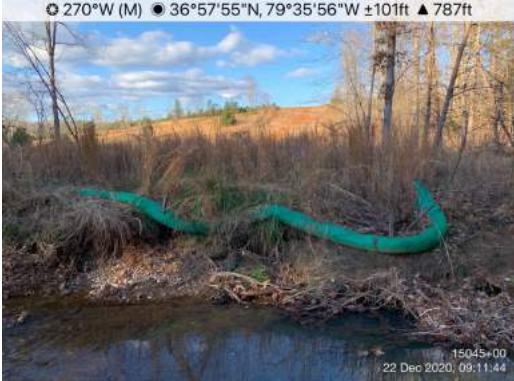
<b>GPS Location</b>	0	<b>GPS Location</b>	0		
<b>Field Station#</b>	15045+00	<b>Field Station#</b>	14985+00		
<b>Pic 1 Desc.</b>	CFS falling over stream bank	<b>Pic 2 Desc.</b>	CFS requires relocation at LOD

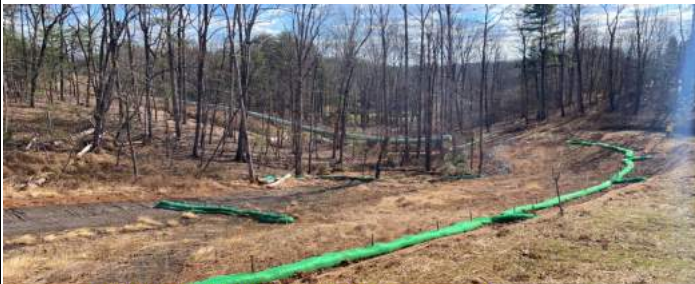
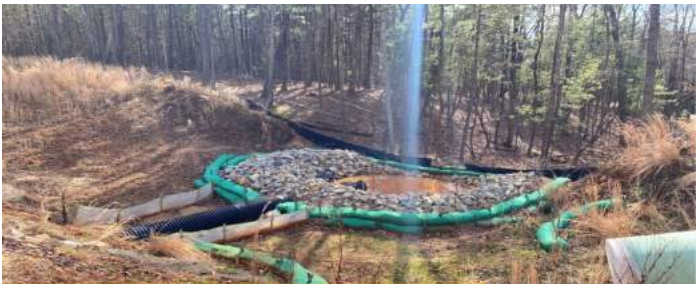
37°3'54" N 79°52'30" W 157°SE COURSE 253' GPS 1338 Bonbrook Mill Rd, Rocky Mount, VA 24151, United States 12.22.2020 11:36:41 Accur +/-87.3 Ft ALT 858 Ft			37°3'54" N 79°52'23" W 129°SE COURSE 168' GPS Rocky Mount, VA 24151, United States 12.22.2020 11:40:35 Accur +/-100.7 Ft ALT 1189 Ft		
GPS Location	1	GPS Location	2		
Field Station#	14064+00	Field Station#	14070+00		
Pic 1 Desc.	Perimeter CFS and triple stacks performing intended functions.		Pic 2 Desc.	Plunge pool and surrounding ECDs performing intended functions.

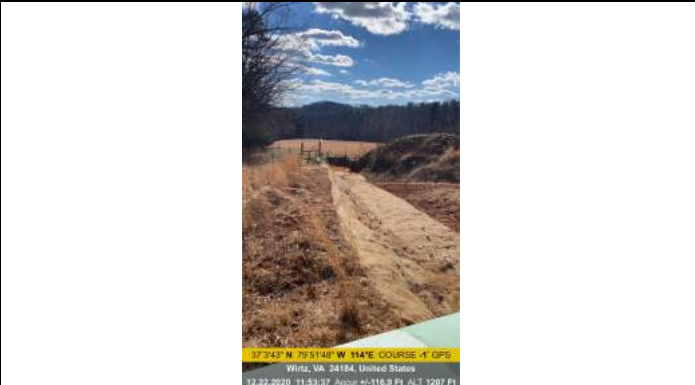
Field Station#	14102+68	Field Station#	14141+00		
Pic 3 Desc.	Curlex installed in throat of water bar to help prevent future erosion issues.		Pic 4 Desc.	ROW stabilized through area during inspection. Equipment bridge and surrounding ECDs in place and functional.

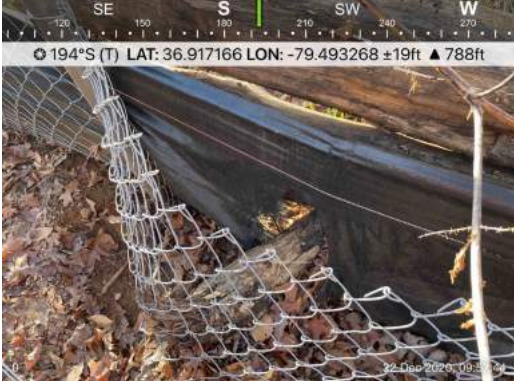
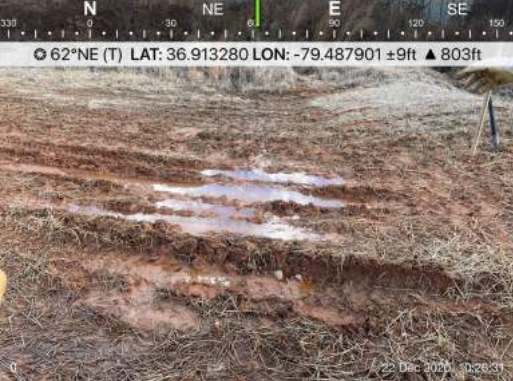
<b>GPS Location</b>	See photo		<b>GPS Location</b>	See photo	
<b>Field Station#</b>	15424+00		<b>Field Station#</b>	15447+00	
<b>Pic 1 Desc.</b>	SSF has been damaged and needs to be replaced.		<b>Pic 2 Desc.</b>	Waterbar channel is obstructed and needs to be regraded.

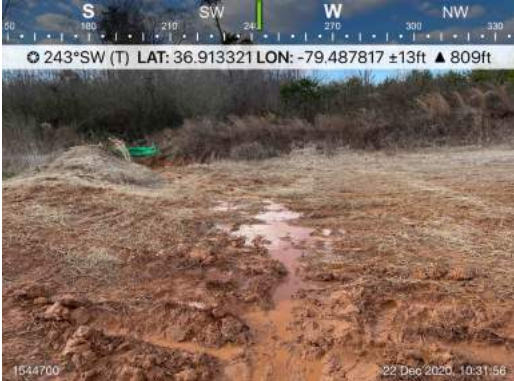
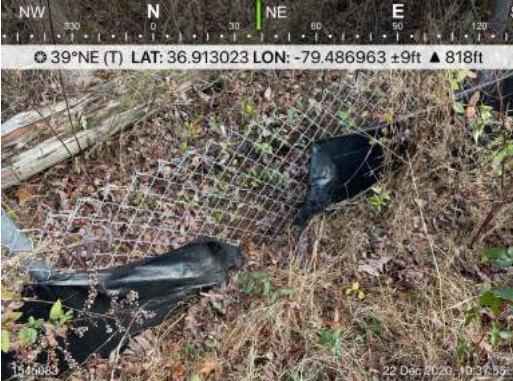
<b>GPS Location</b>	See photo		<b>GPS Location</b>	See photo	
<b>Field Station#</b>	15447+00		<b>Field Station#</b>	15450+83	
<b>Pic 3 Desc.</b>	Environmental crew has corrected this issue.		<b>Pic 4 Desc.</b>	SSF has been damaged and needs to be replaced.

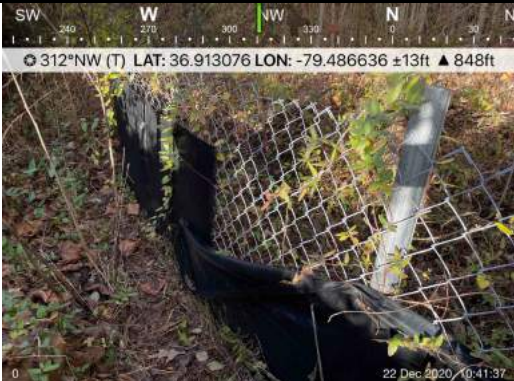
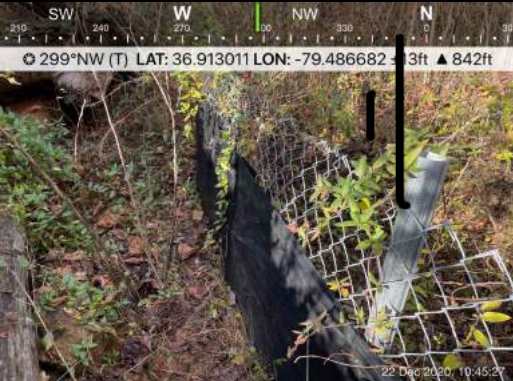
<b>GPS Location</b>	See photo		<b>GPS Location</b>	See photo	
<b>Field Station#</b>	15453+00		<b>Field Station#</b>	15453+00	
<b>Pic 5 Desc.</b>	SSF has been damaged and needs to be replaced.		<b>Pic 6 Desc.</b>	Environmental crew has corrected this issue.

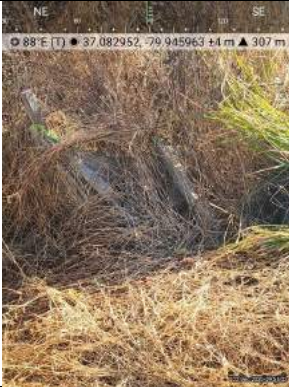
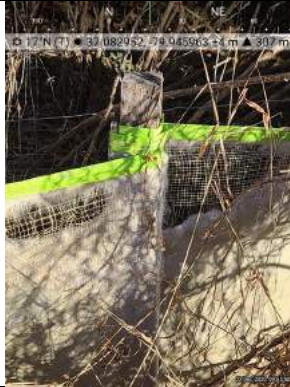
<b>GPS Location</b>	00000	<b>GPS Location</b>	00000		
<b>Field Station#</b>	13702+75	<b>Field Station#</b>	13702+75		
<b>Pic 1 Desc.</b>	During routine inspection today the EI noticed P1 that requires maintenance and added to the punch list		<b>Pic 2 Desc.</b>	During routine inspection today the EI noticed P1 that requires maintenance and added to the punch list

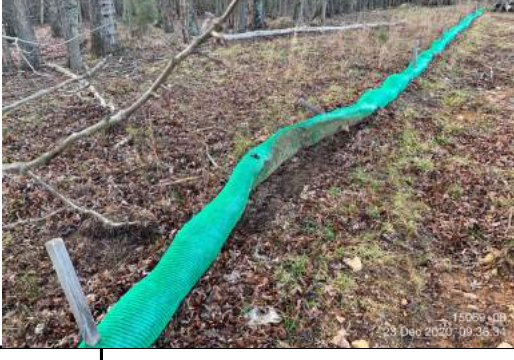
<b>GPS Location</b>	0	<b>GPS Location</b>	0		
<b>Field Station#</b>	15069+00	<b>Field Station#</b>	15069+00		
<b>Pic 5 Desc.</b>	CFS is dislocated	<b>Pic 6 Desc.</b>	Dislocated CFS was relocated immediately

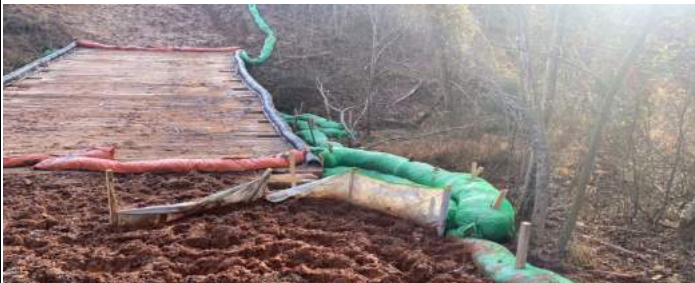
Pic 3 Desc.	Routine maintenance. Remove ineffective P1 silt fence.		Pic 4 Desc.	ROW stabilized in temporary area of ROW. Ground frozen during inspection.

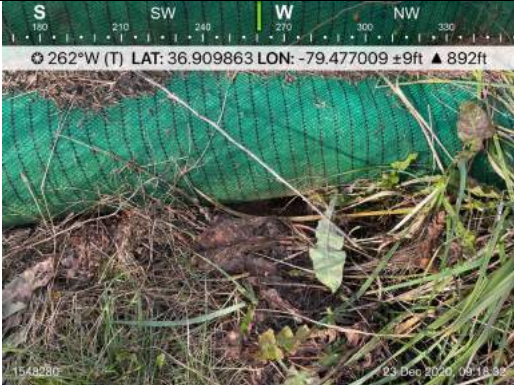
<b>GPS Location</b>	See photo	<b>GPS Location</b>	See photo		
<b>Field Station#</b>	15482+80	<b>Field Station#</b>	15482+80		
<b>Pic 1 Desc.</b>	CFS undermined at this location.	<b>Pic 2 Desc.</b>	Environmental crew has corrected this issue.

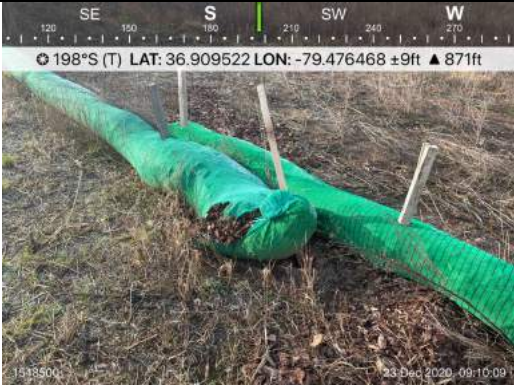
<b>GPS Location</b>	See photo	<b>GPS Location</b>	See photo		
<b>Field Station#</b>	15485+00	<b>Field Station#</b>	15520+00		
<b>Pic 3 Desc.</b>	CFS has been damaged and needs to be repaired/replaced.	<b>Pic 4 Desc.</b>	P1 has been damaged and needs to be replaced.

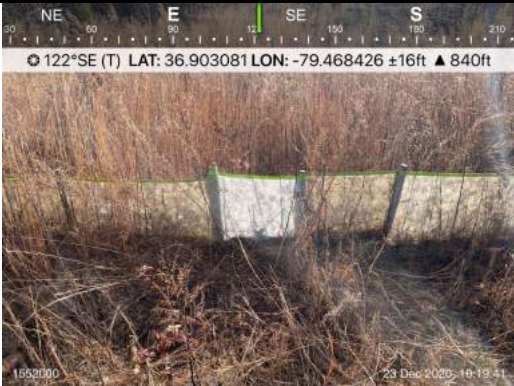
<b>GPS Location</b>	See photo	<b>GPS Location</b>	See photo		
<b>Field Station#</b>	15520+00	<b>Field Station#</b>	15584+23		
<b>Pic 5 Desc.</b>	Environmental crew has corrected this issue.	<b>Pic 6 Desc.</b>	P1 has been damaged and needs to be replaced.

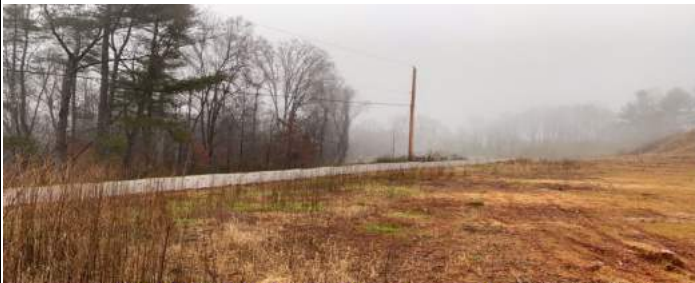
GPS Location	3	GPS Location	4		
Field Station#	13892+50	Field Station#	13894+00		
Pic 3 Desc.	Contractor replaced P1 silt fence along perimeter of ROW per punch list item.		Pic 4 Desc.	Contractor repaired safety fencing around sump pit per punch list item.
