Mountain Valley Pipeline Project – Spread G

Environmental Auditor Quarterly Report for Q1 2021

April 15, 2021

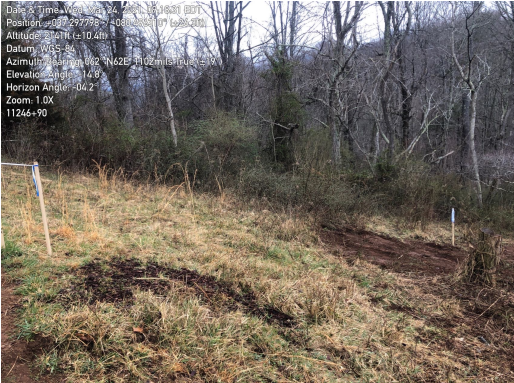
| Field Station# | 11246+90 | Field Station# | 11246+90 | | |

The Spread G EIs observed disturbances caused by the contractor outside the right of way on 3/24/2021 and 3/29/2021 within areas where survey stakes were present. Agency Compliance Forms (Form #617 and #620, respectively) were completed and submitted by the Spread G Environmental Inspection staff. The contractor crews were halted to prevent additional disturbance, respective agencies were contacted as was the MVP Land Department. The Spread G LEI and MVP staff held meetings with the contractor to discuss and provide re-education pertaining to these issues. The contractor implemented an environmental standdown in response to these issues and a contractor staff member was removed from the project as a result of the construction activities operating outside of the right of way. Minor disturbance was observed as result of these activities.

| Pic 1 Desc. | Disturbance past LoD. | | Pic 2 Desc. | Disturbance past LoD. | |

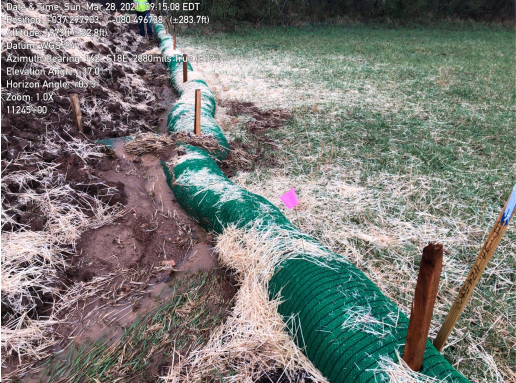
| Field Station# | 11245+00 | Field Station# | 11245+00 | | |

An approximate 1.10-inch rainfall event coupled with incomplete waterbars discharging onto the right of way occurred on March 28, 2021 and caused a perimeter sediment control to become overwhelmed ultimately depositing sediment approximately three-feet off the right of way within an upland area.

| Pic 1 Desc. | Point where sediment has left RoW. | | Pic 2 Desc. | Overview of sediment leaving RoW. | |

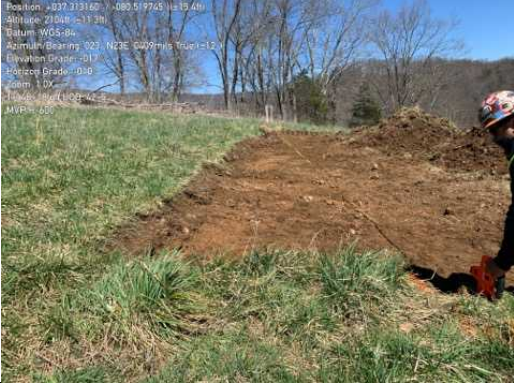
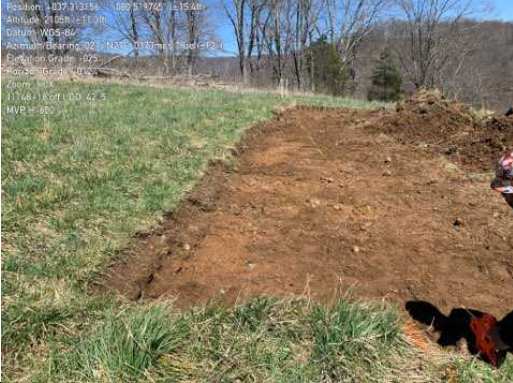
| Field Station# | 11146+18 | Field Station# | 11146+18 | | |

| Pic 1 Desc. | disturbance beyond the LOD 40ft long for a maximum of 8 ft | Pic 2 Desc. | disturbance beyond the LOD 40ft long for a maximum of 8 ft | | |
